APPENDIX F-2

Phase I ESA Memo and Phase I ESA

To: Susan Harris, County of San Diego
From: Audrey Herschberger, Dudek
Subject: Phase 1 Environmental Site Assessment, Boulder Brush Boundary, Additional Assessor Parcel Numbers
Date: October 18, 2019
cc: Glenna McMahon, Vanessa Currie (Dudek)
Attachments: A – Figure 1
B – Phase I Environmental Site Assessment, APNs 529-050-01, 529-060-01, 529-090-02, 529-100-01, 529-100-02, 529-100-03, 529-120-01, 529-120-03, 529-130-01, 611-010-01, 611-010-02, 611-010-03, and 611-020-01 of the Boulder Brush Boundary

Phase I Environmental Site Assessment

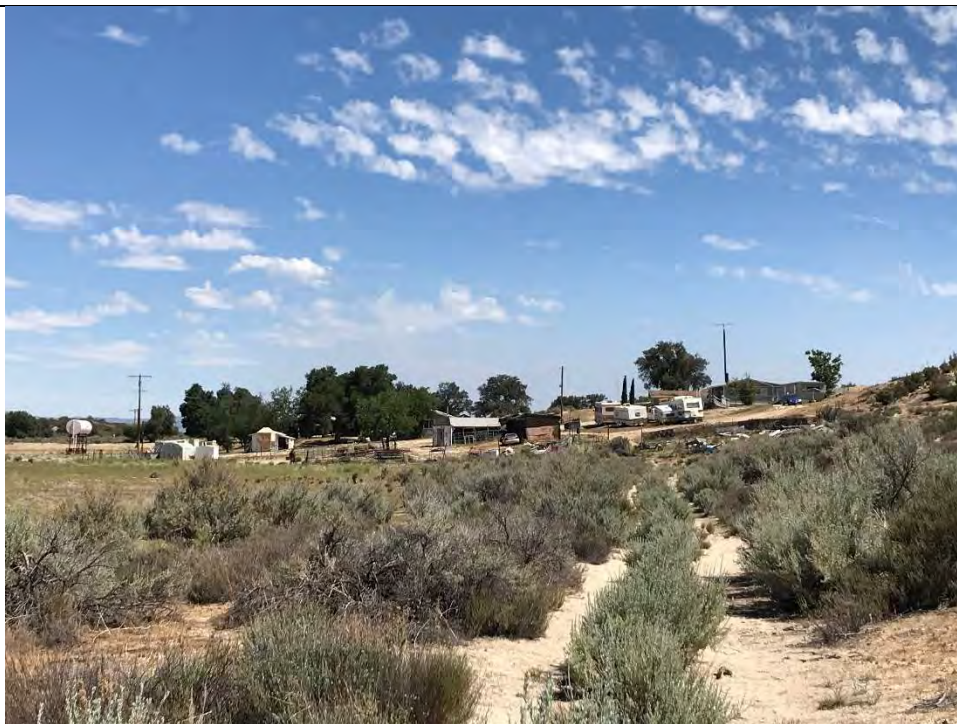
Photo 17. Facing south from the subject property towards the adjacent property. Appeared to be a residence with abandoned vehicles and an AST.

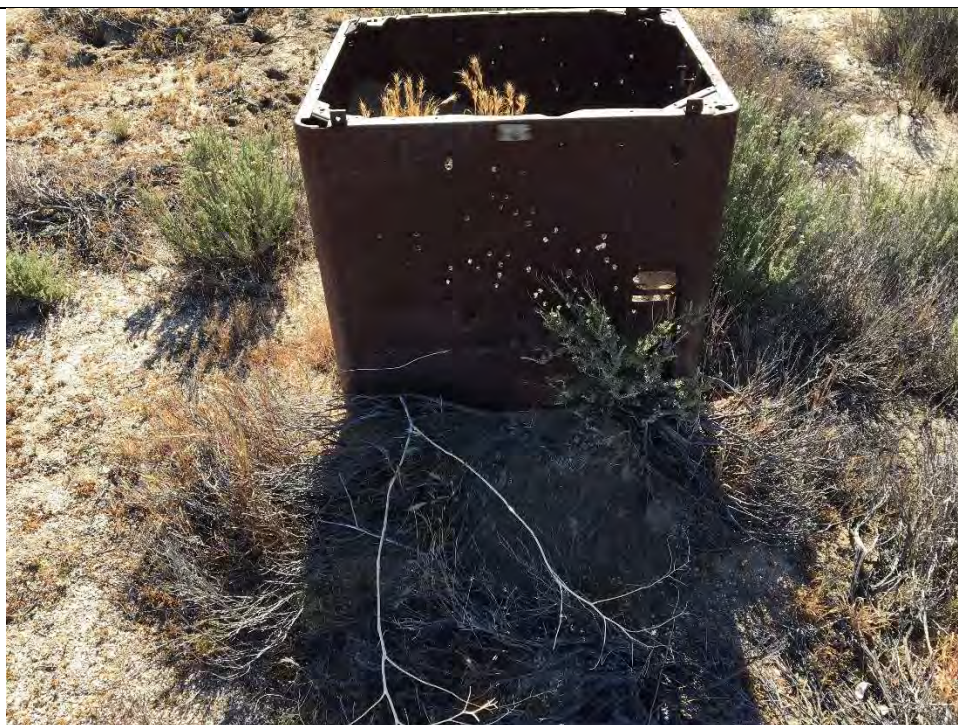
Photo 18. Rusted, empty appliance near the gate entrance.

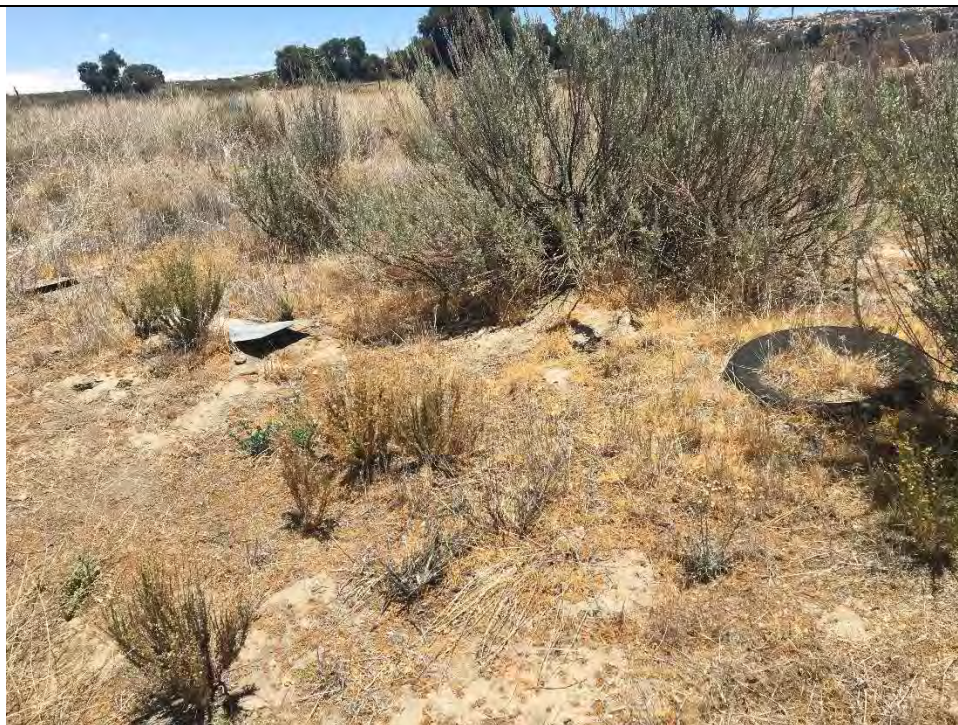
Photo 19. Tires and occasionally scrap metal can be found intermittently across the Subject Property.

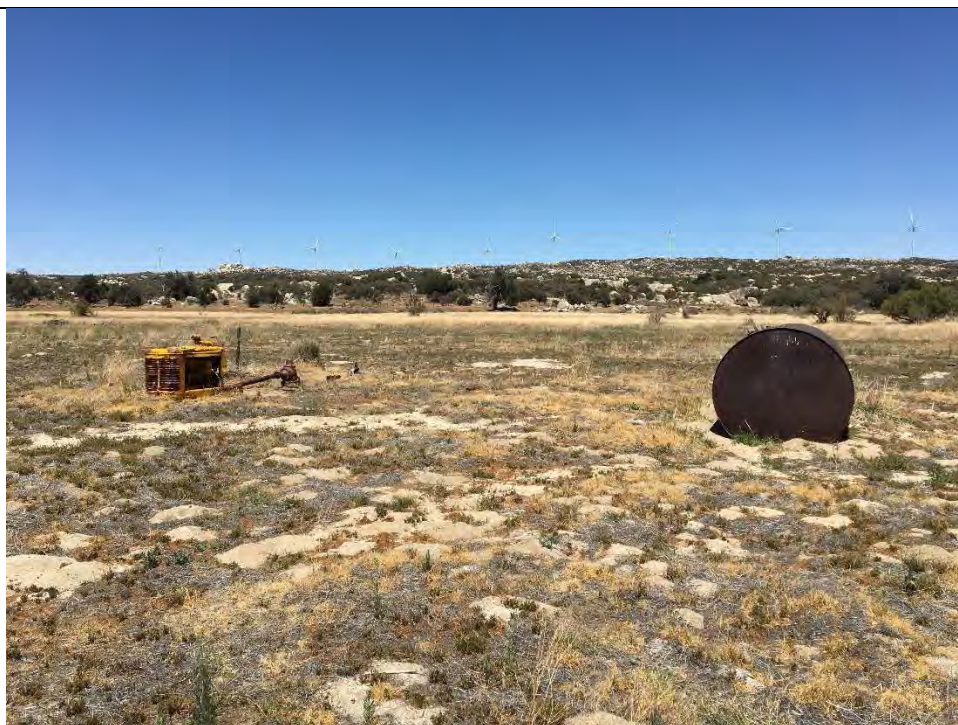
Soil disturbances were observed near the smaller of the two wells with motors (Photograph 20; Figure 2). They appeared to be caused by animals.

Two aboveground storage tanks were observed on the Project site (Figure 2). Both storage tanks were associated with groundwater well pumps. One was a rusted 2,000-gallon tank (Photograph

20) with open ports at the top. Liquid was observed in the tank, and the tank appeared to be approximately one-third full. Petroleum odors were observed near the tank. The second tank was larger, potentially 3,000 to 4,000 gallons (Photograph 23), but the exact volume could not be confirmed because the label had rusted over and was located on top of the tank. The ports at the top were open and petroleum odors were observed near the ports.

Photo 20. One of the wells with a pump and AST on the former ranchland. Well was no longer functional and appeared filled in.

- The groundwater well pumps, motors, and tanks should be properly decommissioned and disposed of in accordance with applicable local, state, and federal guidelines and/or regulations. If impacted or stained soil is observed during disposal, additional investigation or sampling may be necessary.

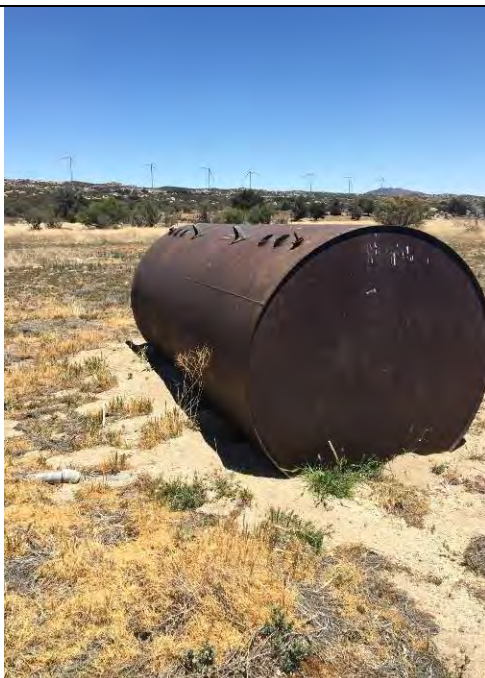
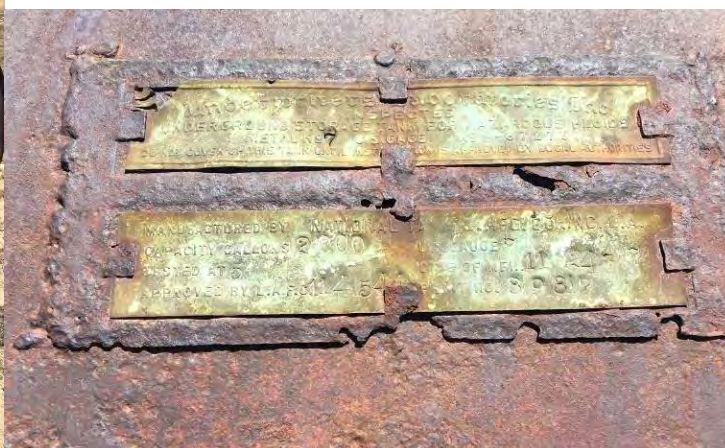
Photo 21. AST had open ports at the top with petroleum odors and visible liquid at least half way down. The label indicated a 2000 gallon capacity.

Two aboveground storage tanks were observed on the Project site (Figure 2). Both storage tanks were associated with groundwater well pumps. One was a rusted 2,000-gallon tank (Photograph 20) with open ports at the top. Liquid was observed in the tank, and the tank appeared to be approximately one-third full. Petroleum odors were observed near the tank. The second tank was a larger tank, potentially 3,000 to 4,000 gallons (Photograph 23), but the exact volume could not be confirmed because the label had rusted over and was located on top of the tank. The ports at the top were open, and petroleum odors were observed near the ports.

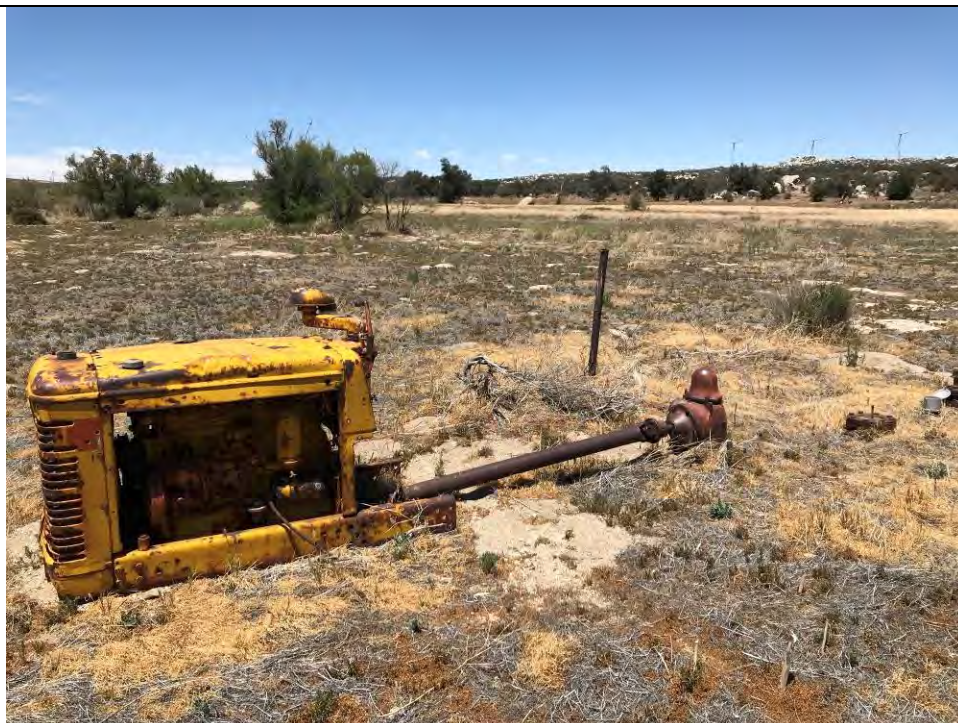
Photo 22. Well and pump assembly. Vegetation near pump appeared stressed based on yellowing.

Around the area of one of the well pump motors, the vegetation appeared stressed (Photograph 22).

Two motors associated with water wells were observed to be in disrepair. No dates were discernible on the labels. The smaller of the two was sitting directly on the ground and the vegetation around it appeared stressed (Photograph 22).

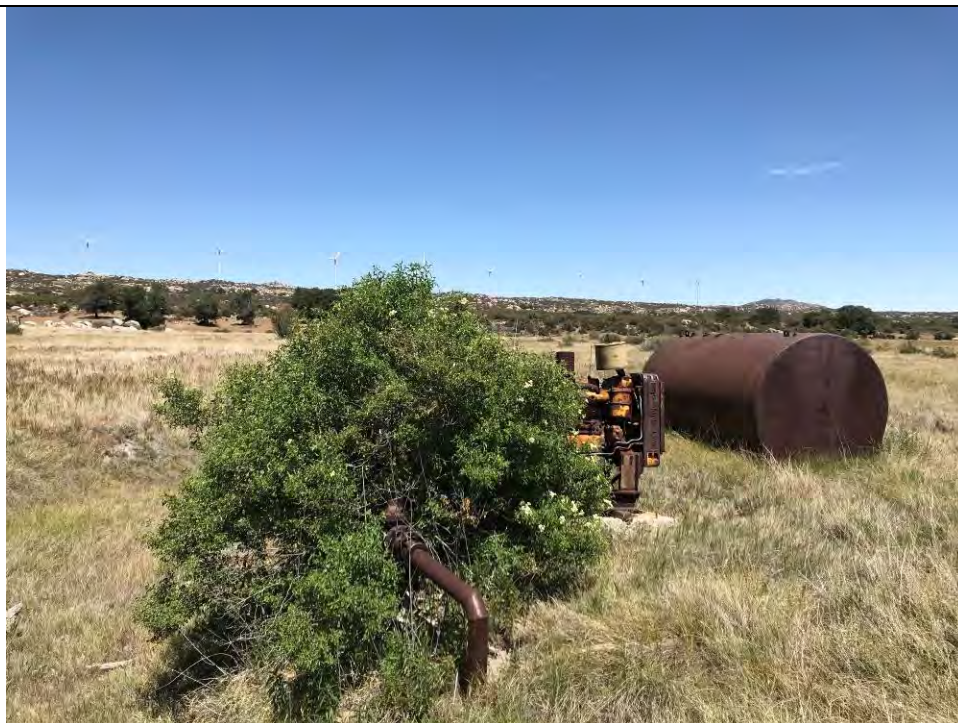
Photo 23. Larger motor and AST with second well south of the smaller well. Well was covered by a bush. Label on AST was rusted over but appeared to be roughly 3-4,000 gallon capacity.

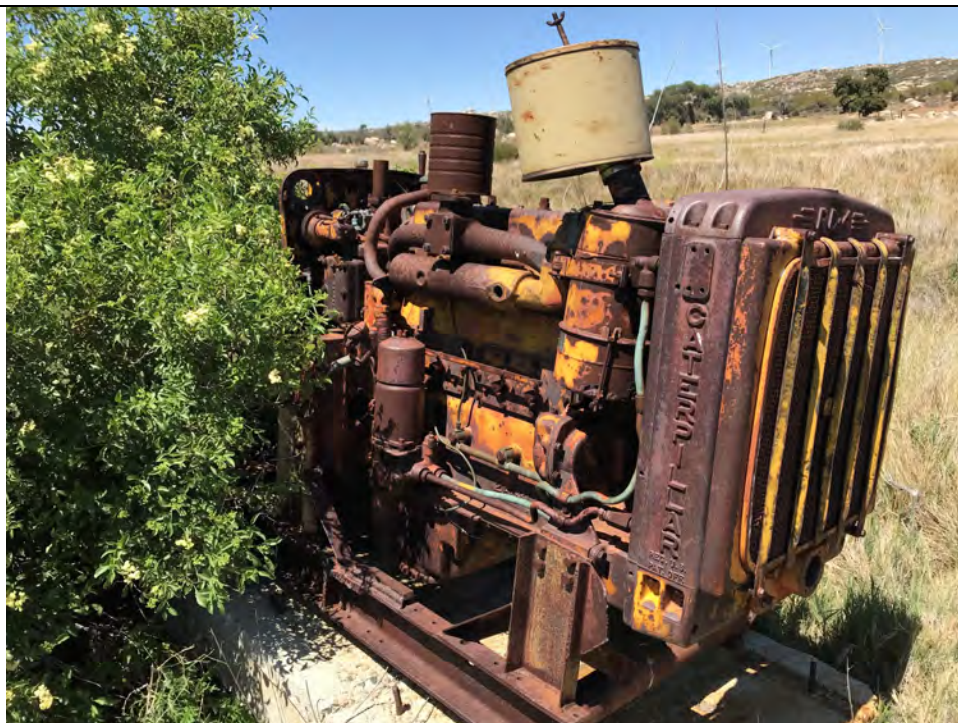
Photo 24. Larger motor next to well.

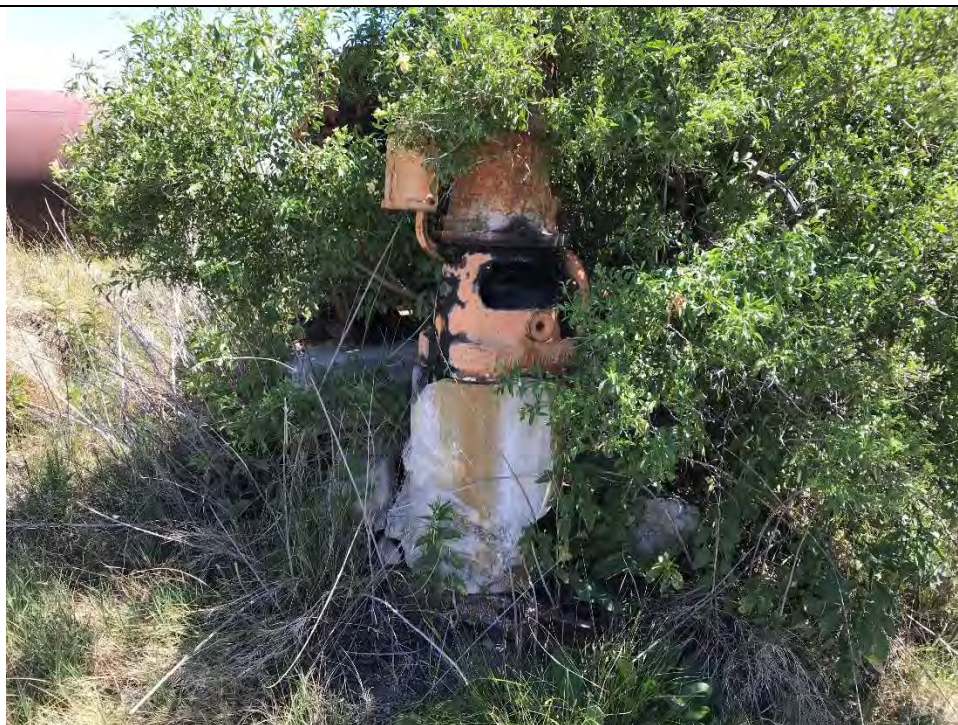
Five wells were observed on the Project site (Figure 2). One was an observation well with a locked cap located on top of a hill near the collapsed structure on the northern portion of the Project site (Photograph 26). Two were abandoned wells with no covers: one in the north-central section (Photograph 30) and one in the southwest section of the Project site near the house with a collapsed roof (Photograph 44). Two wells were located on the ranchland on the western part of the Project site (Photographs 22 and 25). Both had pumps and motors that are no longer operable.

Photo 25. Groundwater well covered in vegetation with AST in the background.

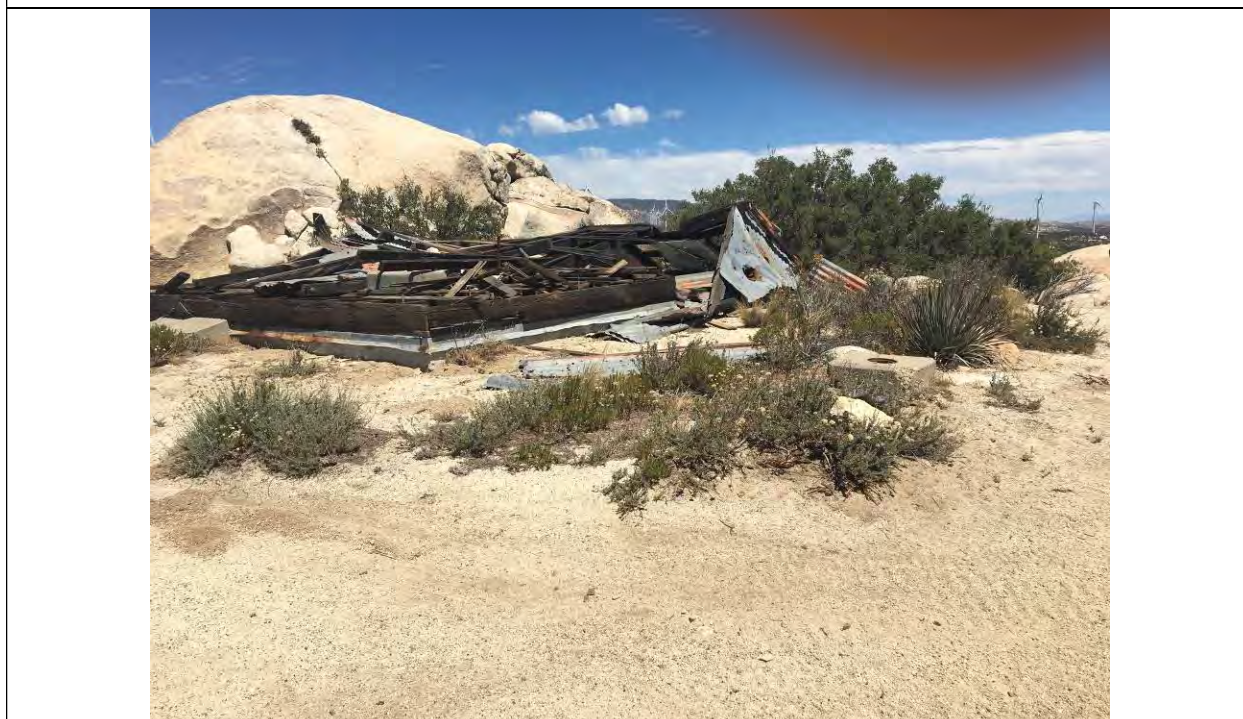
- It is unlikely that adjacent or nearby properties have impacted the environmental conditions at the Project site.
- Asbestos and/or lead may be present in the uninhabitable structures observed on the Project site, given that they were constructed prior to 1959.

Photo 28. Collapsed house/structure near the observation well.

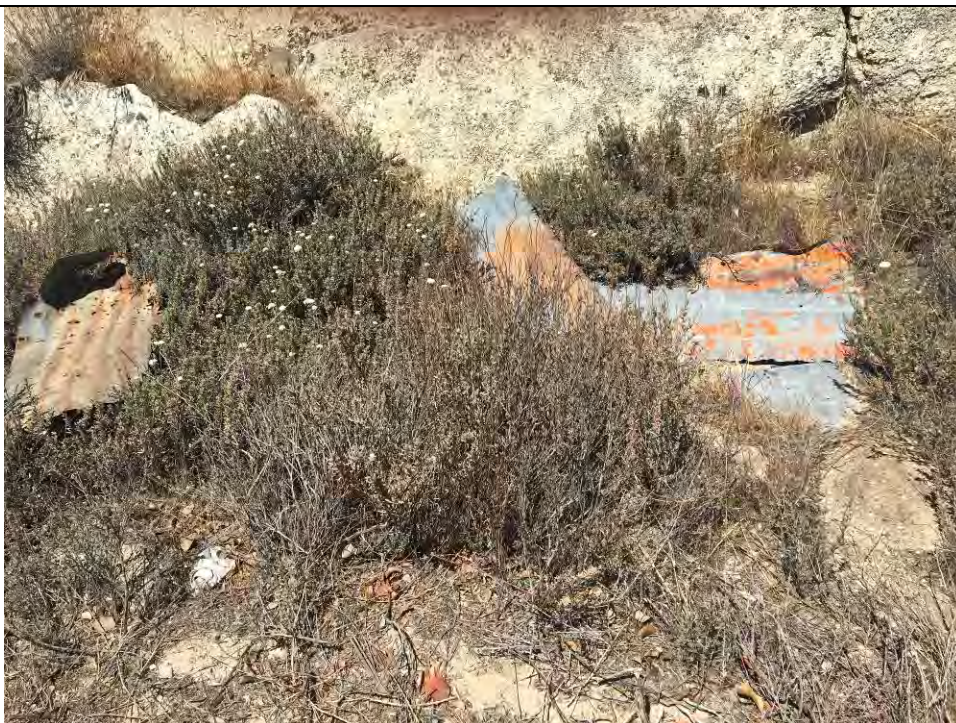
Photo 29. Scrap metal and bits of trash west and down slope of the collapsed house.

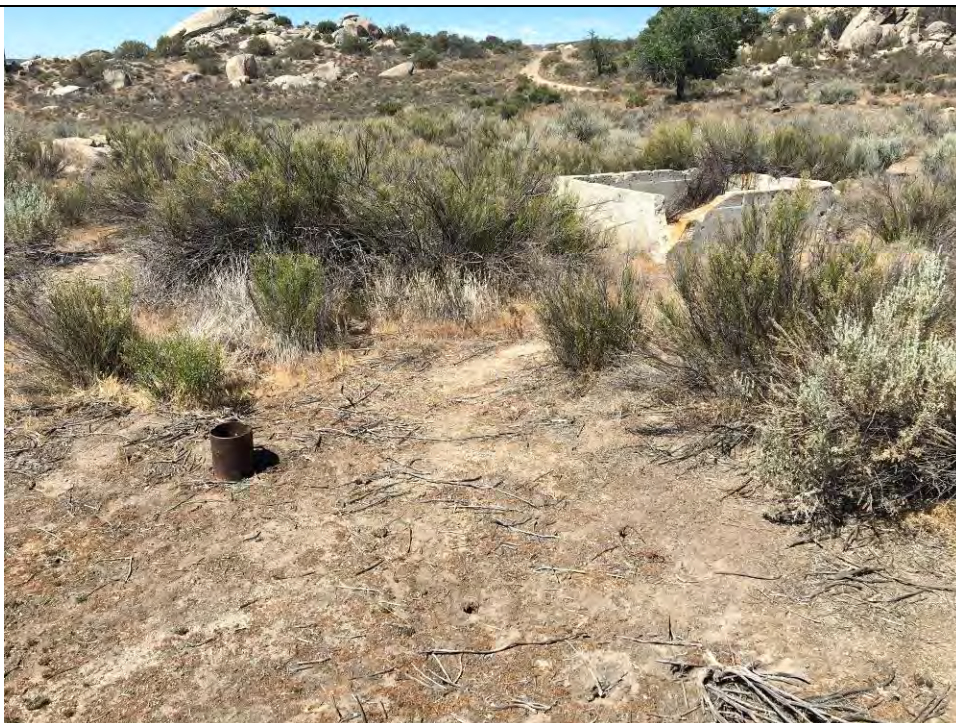
Photo 30. Abandoned well and possible cistern on the right hand side in north central part of property.

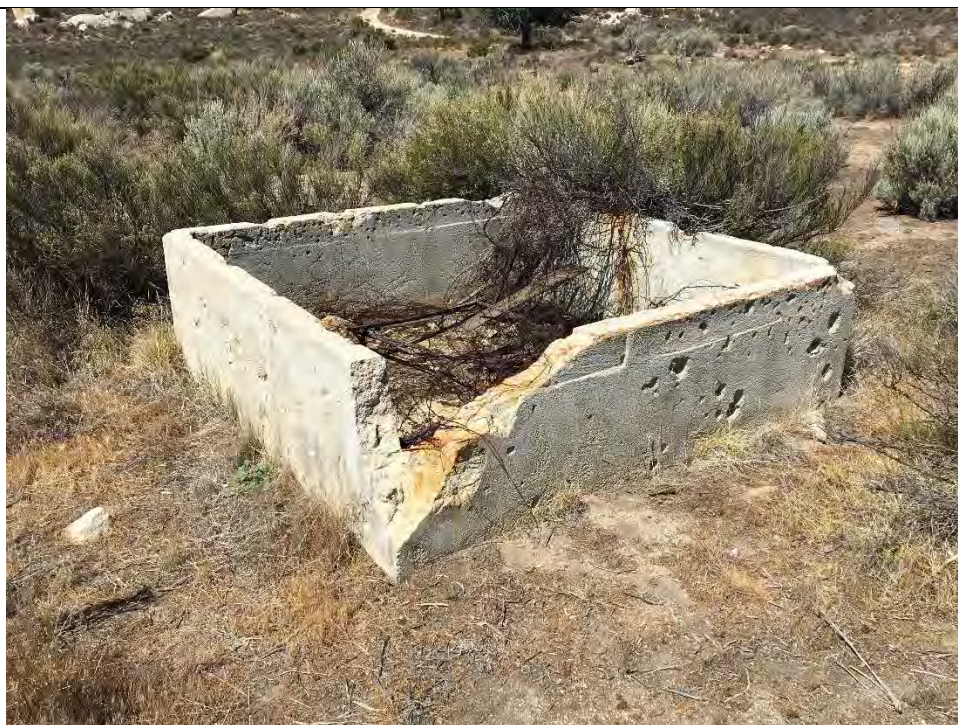
Photo 31. Possible cistern 5' x 5' and about 2' tall. Broken glass, wood planks and metal wiring inside.

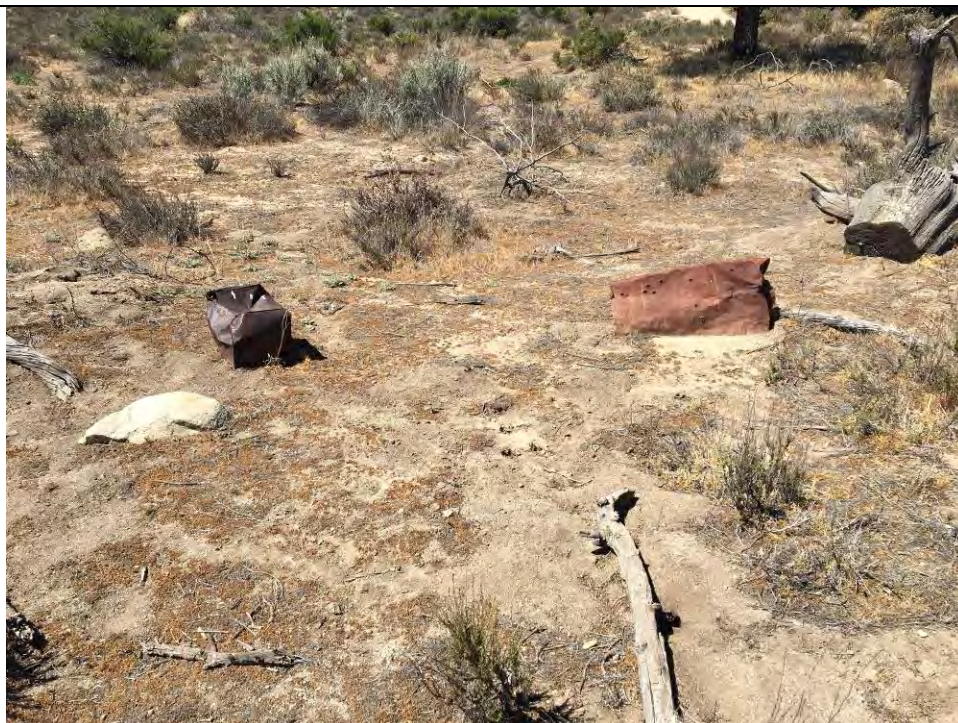
A few tires were observed around the Project site, potentially from recreational off-road vehicles. In two areas, more prevalent trash was observed (Figure 2). One area was near an abandoned well on the northern part of the Project site (Photograph 33). Scattered around the area, close to the dirt roads, were metal sheets, canisters, and parts of drums. A stove and large pipe were found more than 500 feet south of the area. The other area was close to the cattle yard (Photograph 36) in the southeastern portion of the Project site. Abandoned cattle feed and water containers were observed (Photograph 37). Debris was observed near the banks of the stream bed, including canisters, parts of drums, metal wire, tires, and glass (Photographs 38 and 39).

Photo 32. Example of the scattered metal canisters, drums, and scrap within 200 ft around abandoned well.

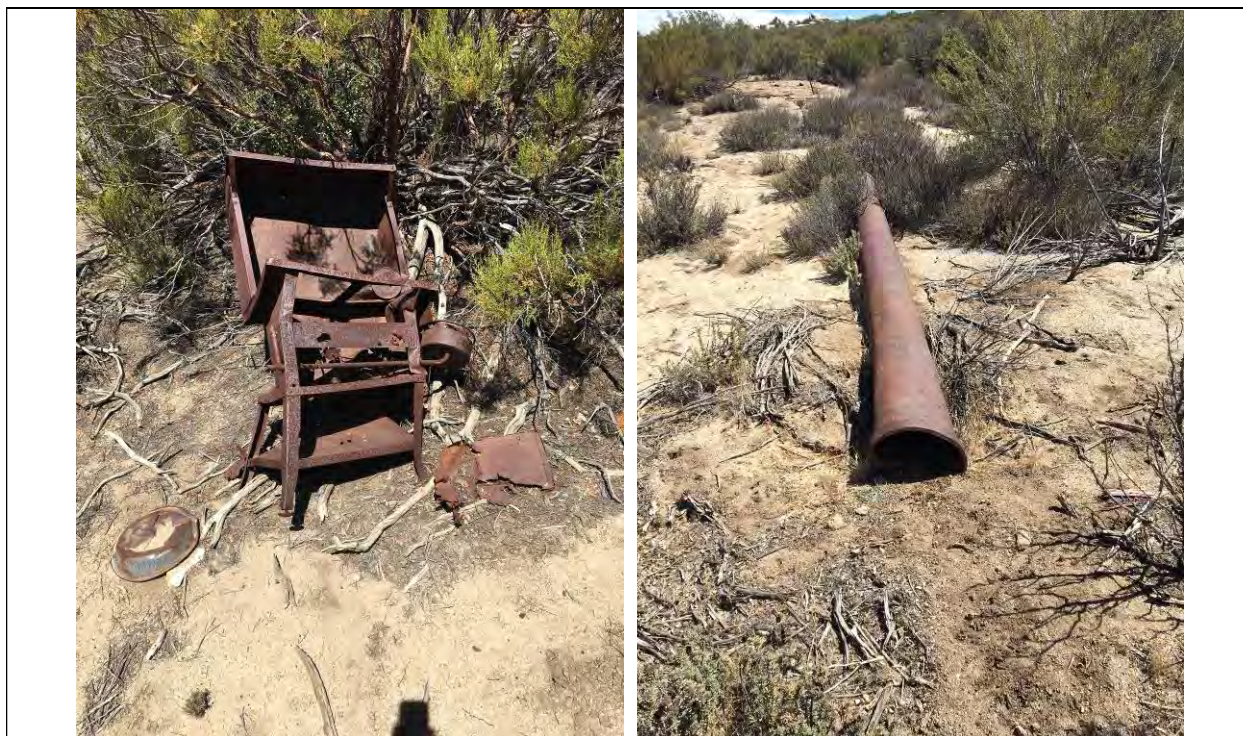
One rusted and disconnected pipe, approximately 9 inches in diameter, was found south of the north-central abandoned well (Photograph 34). Disconnected piping, which appeared to be aluminum and was approximately 1 inch in diameter, was found near the observation well (Photograph 27).

Photo 33 (left). Old stove 500 ft south of abandoned well along dirt road. Bits of glass scattered 30 ft north of stove. Photo 34 (right). 8" diameter pipe 650' south of stove along road.

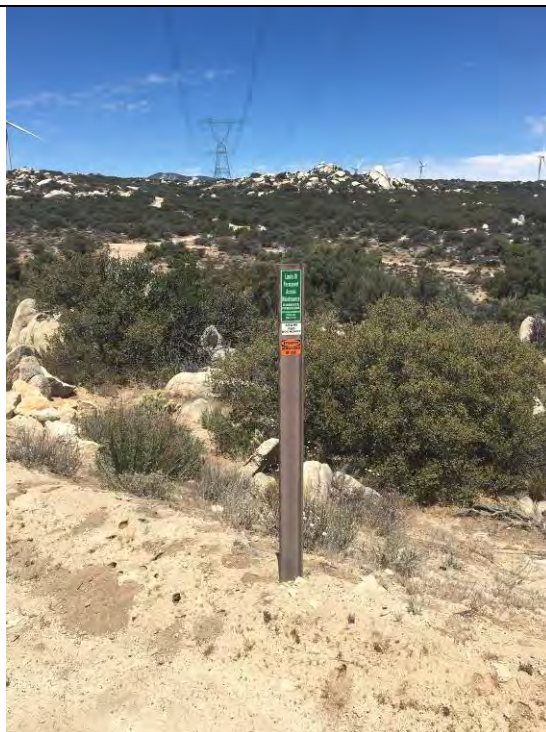
Photo 35. Utility powerline that runs across the northern section of the property. Post is at the edge of a crane pad for one of the stands. Bottom of post mentions herbicides in use.

Signage related to the transmission line that crosses the property indicated that herbicides were in use on the Project site (Photo 35).

Transmission lines cross the northern portion of the Project site. No transformers or visual indications of staining were observed (Photograph 35).

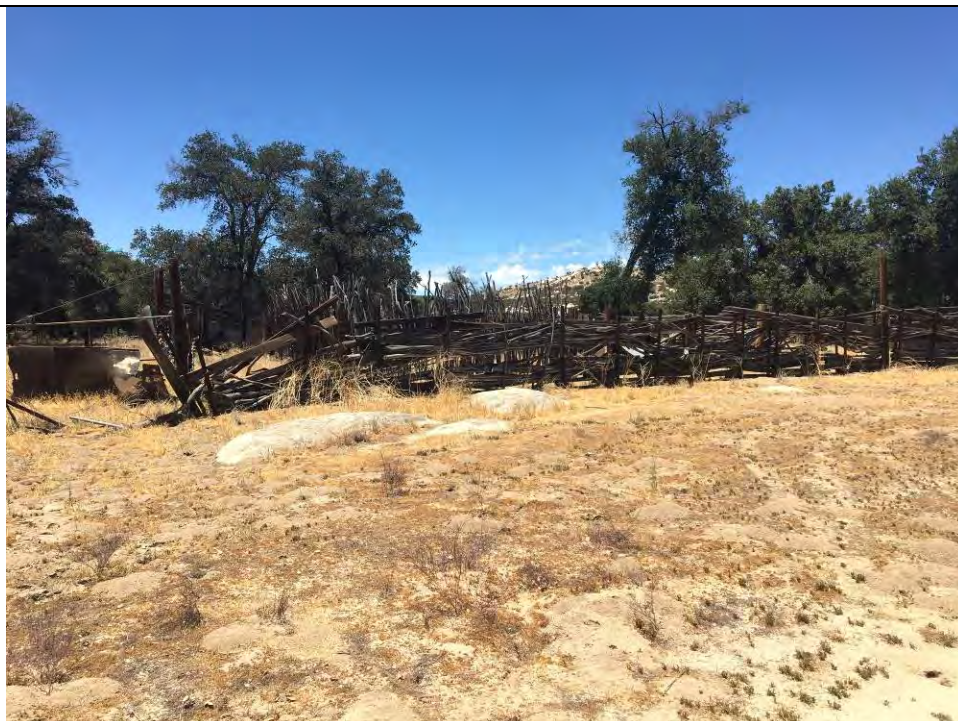
Photo 36. Cattle yard in disrepair in southwestern portion of the subject property.

The other area was close to the cattle yard (Photograph 36) in the southeastern portion of the Project site. Abandoned cattle feed and water containers were observed (Photograph 37). Debris was observed near the banks of the stream bed, including canisters, parts of drums, metal wire, tires, and glass (Photographs 38 and 39).

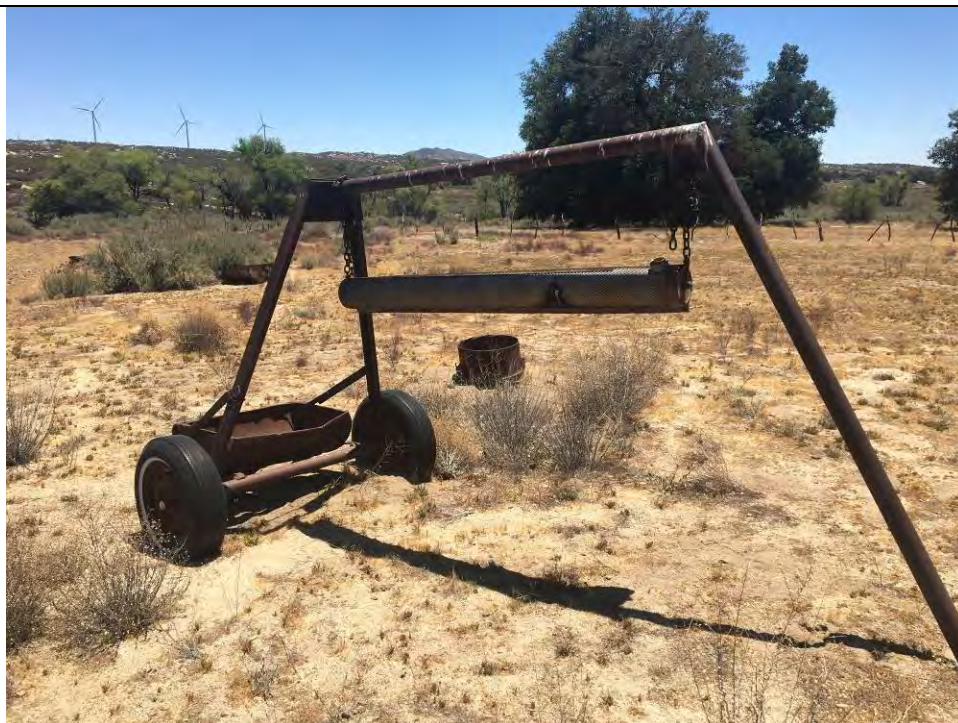
Photo 37. Some of the feed/watering equipment east of the cattle yard

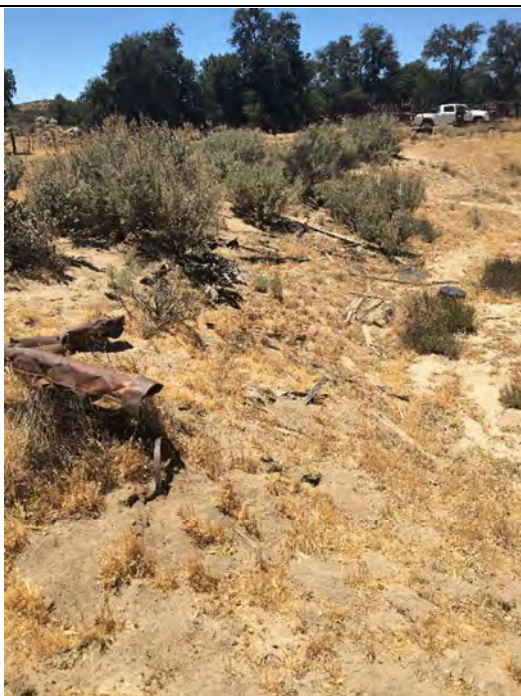
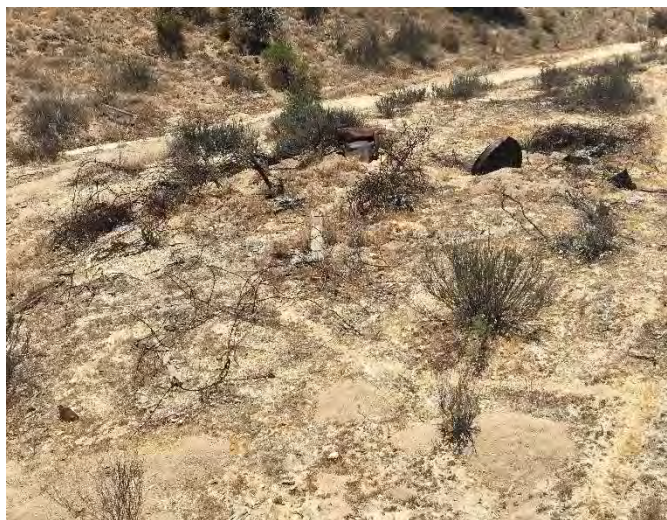
Photo 38 (left) & Photo 39 (right). Metal, glass, and wood debris on banks of dry streambed next to cattle yard.

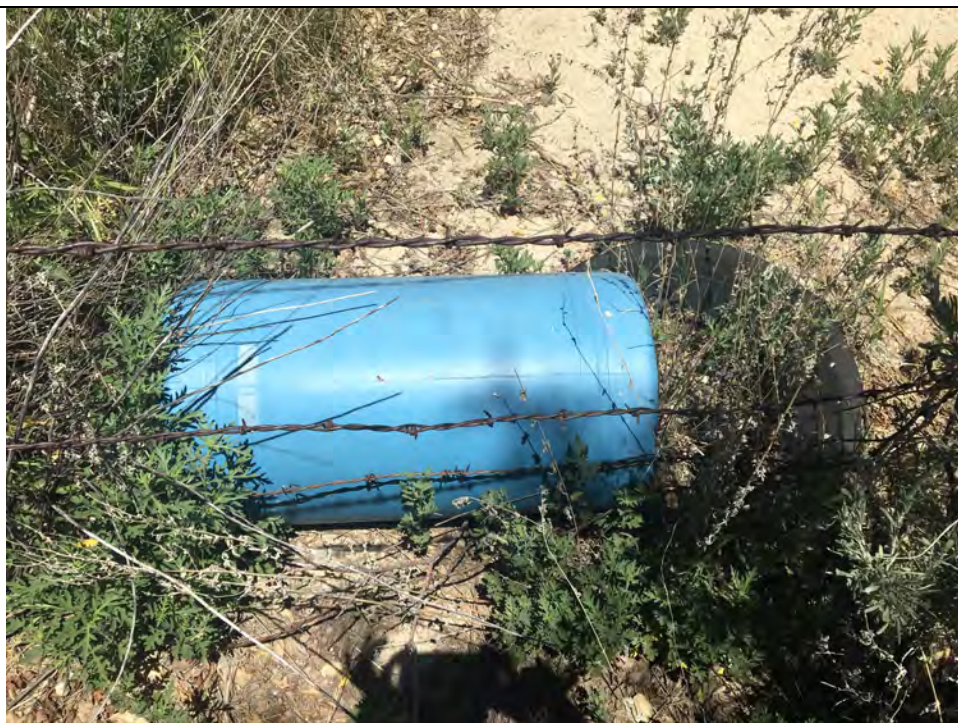
Two 5-gallon fuel containers were observed at an apparent camping location 110 feet north of the cattle yard (Photographs 41 and 42; Figure 2). One blue drum, approximately 8 to 15 gallons, with a faded label was observed in the dry stream bed 400 feet east of the cattle yard (Photograph 40).

Photo 40. Blue drum further down the dry streambed, around 400' east of the cattle yard. Labeling faded but container appeared mostly empty and no odors were observed.

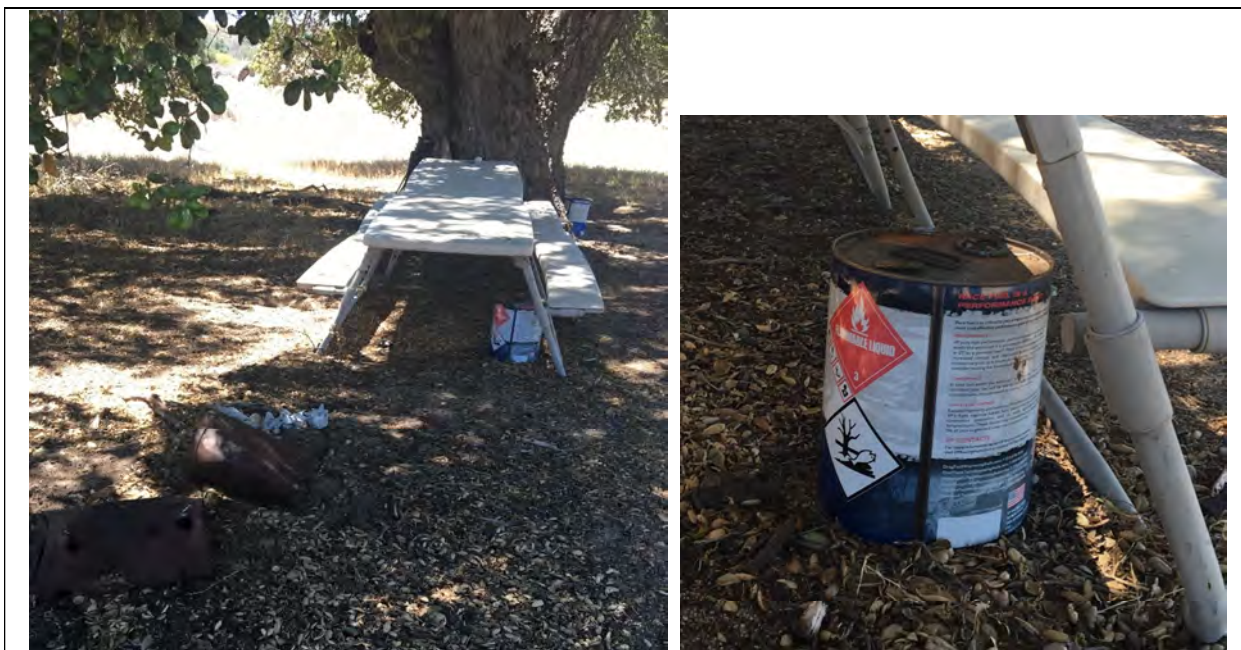
Photo 41 (left). Camping/picnic spot 110' north of cattle yard. Had two 5 gallon fuel containers and rusted empty metal canisters. Photo 42 (right). Close up of one of the fuel containers.

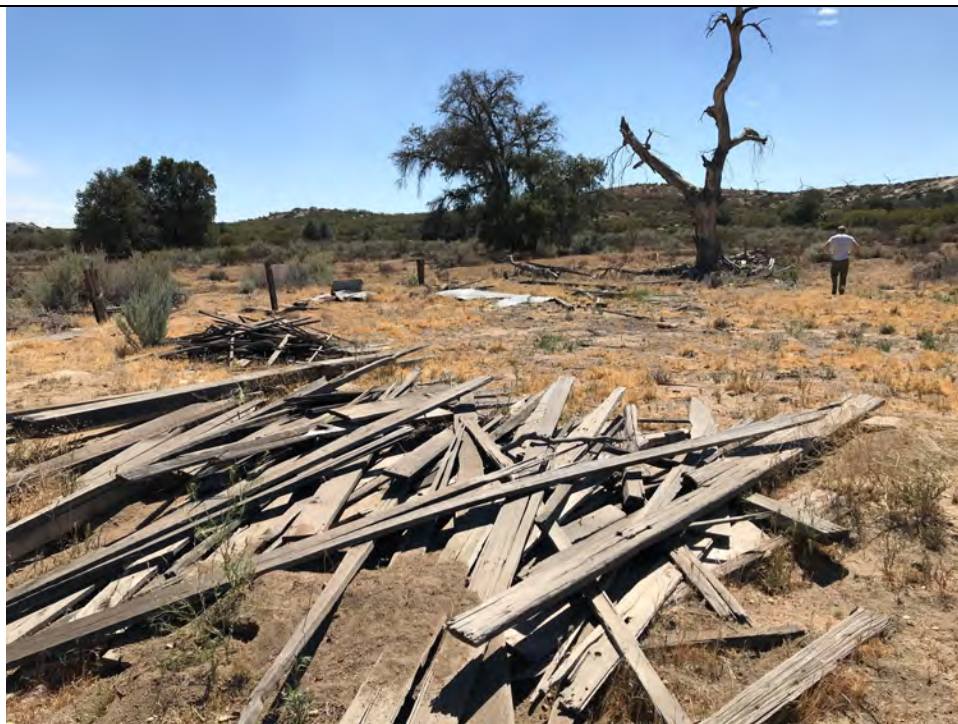
Photo 43. Remnants of a possible collapsed structure 700 feet south of the cattle yard. Wood planks, cut granite blocks, and metal sheet roofing are present. No tanks or other utilities found.

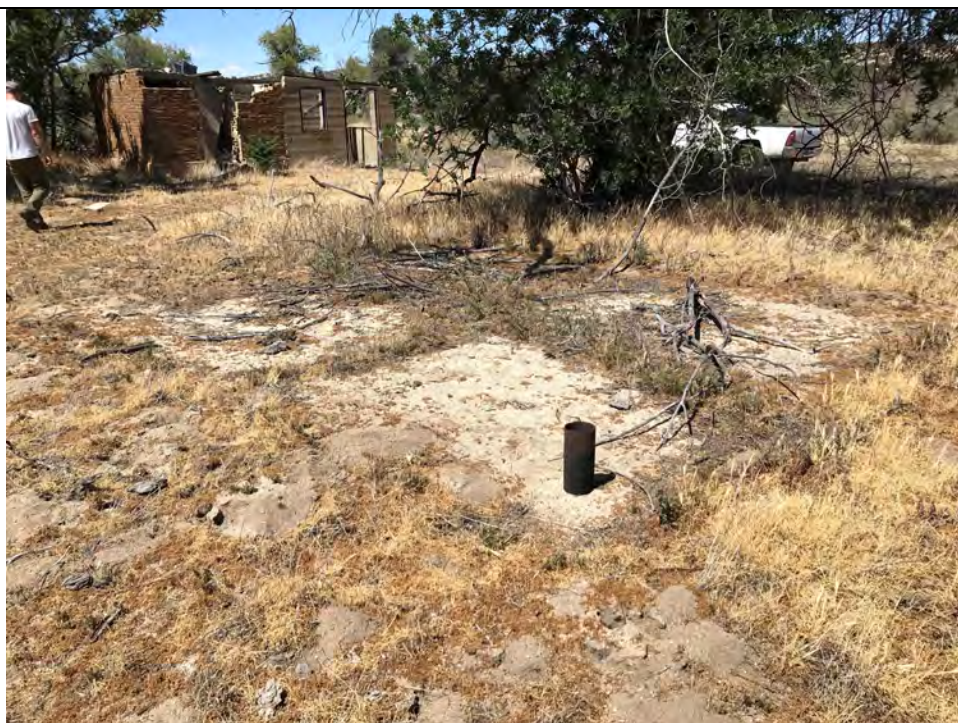
Photo 44. Abandoned well near old residence 1000 feet south of the cattle yard.

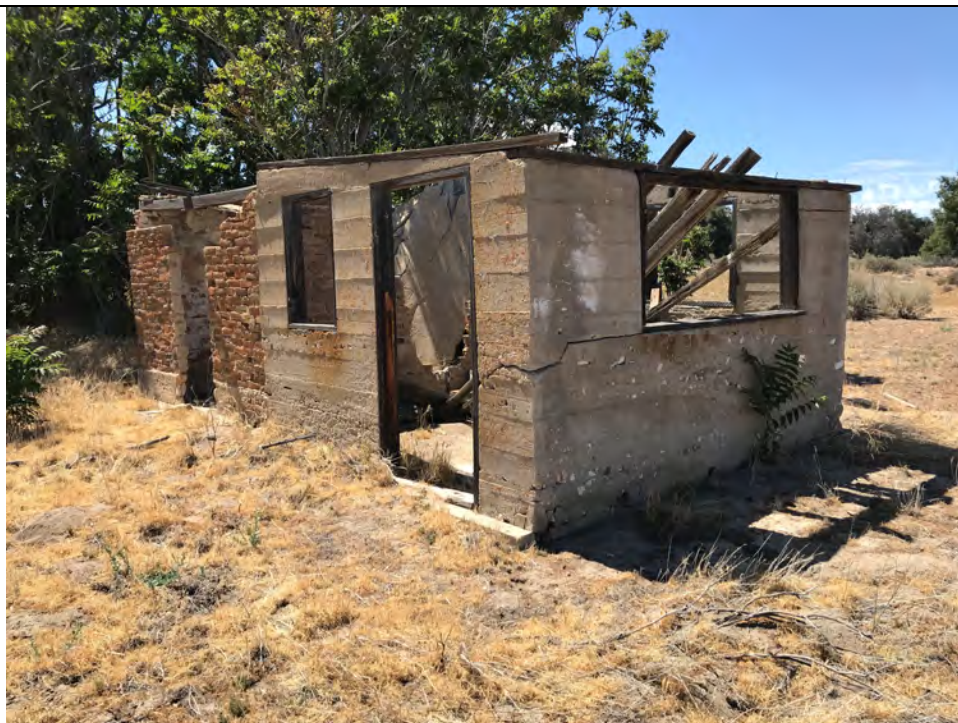
Photo 45. Old residence with collapsed roof. No utilities found.
