Subject: Memo—Proposed revisions to the Camp Lockett Master Plan and Overlay Zone

**CAMP LOCKETT CULTURAL LANDSCAPE TECHNICAL
REPORT, SAN DIEGO COUNTY, CALIFORNIA**

December 2019

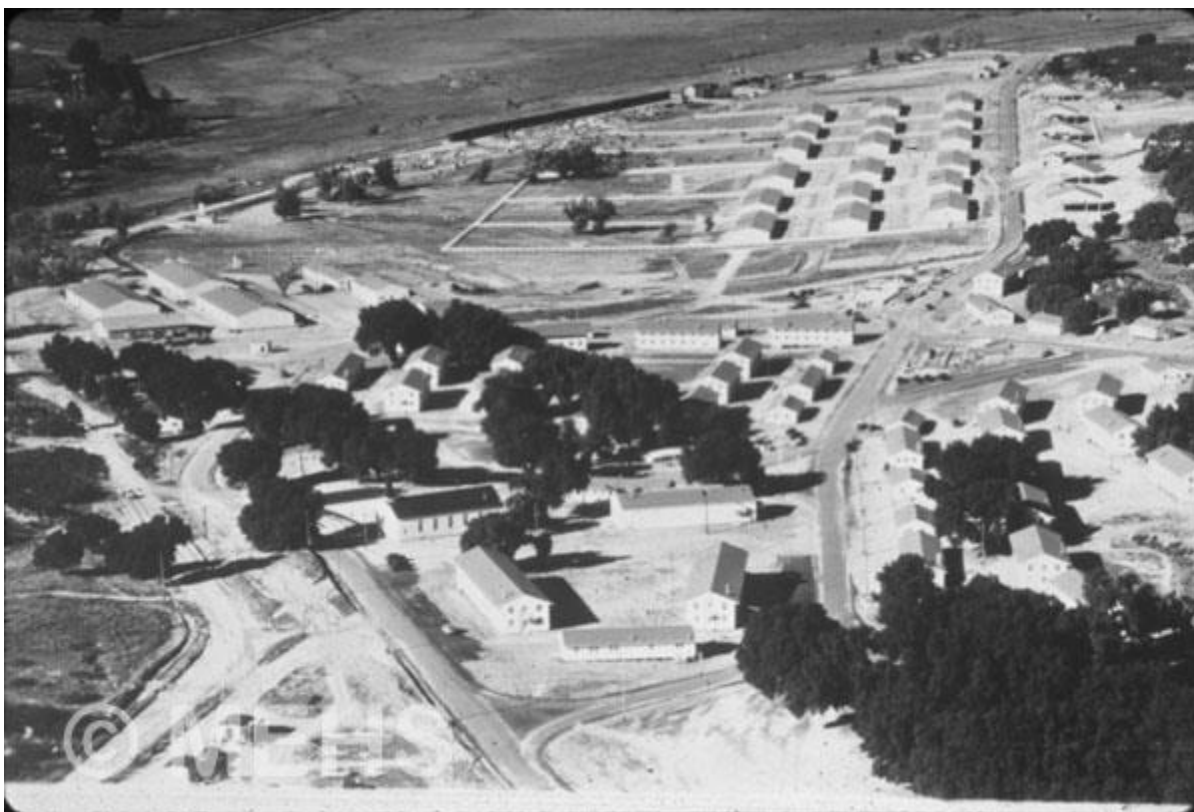
Figure 3. Chaffee Park – 1940

This 1940s image shows the coast live oak trees in Chaffee Park and their extension into the Main Post on the left of the photo. Source: MEHS Archives..

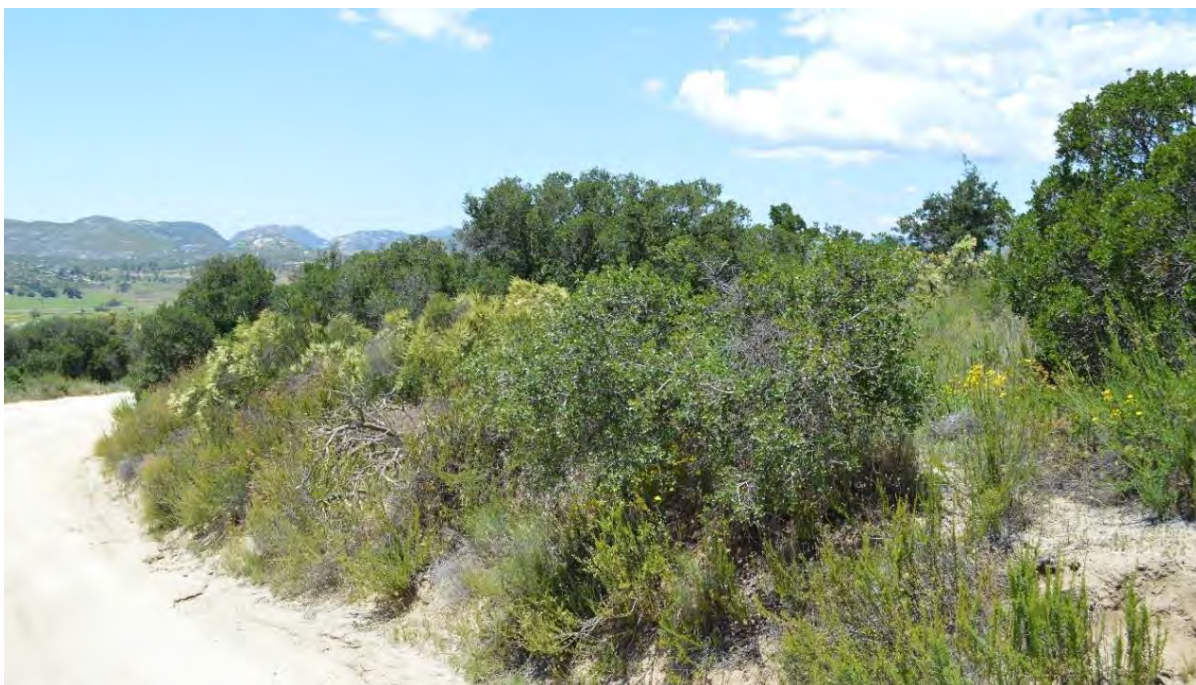
Figure 4. Chaparral Communities Located on the Hillsides Surrounding the Developed Core.
This photo represents the vegetation near the water tanks east of the historic stables area. Source: ICF
June 2019.

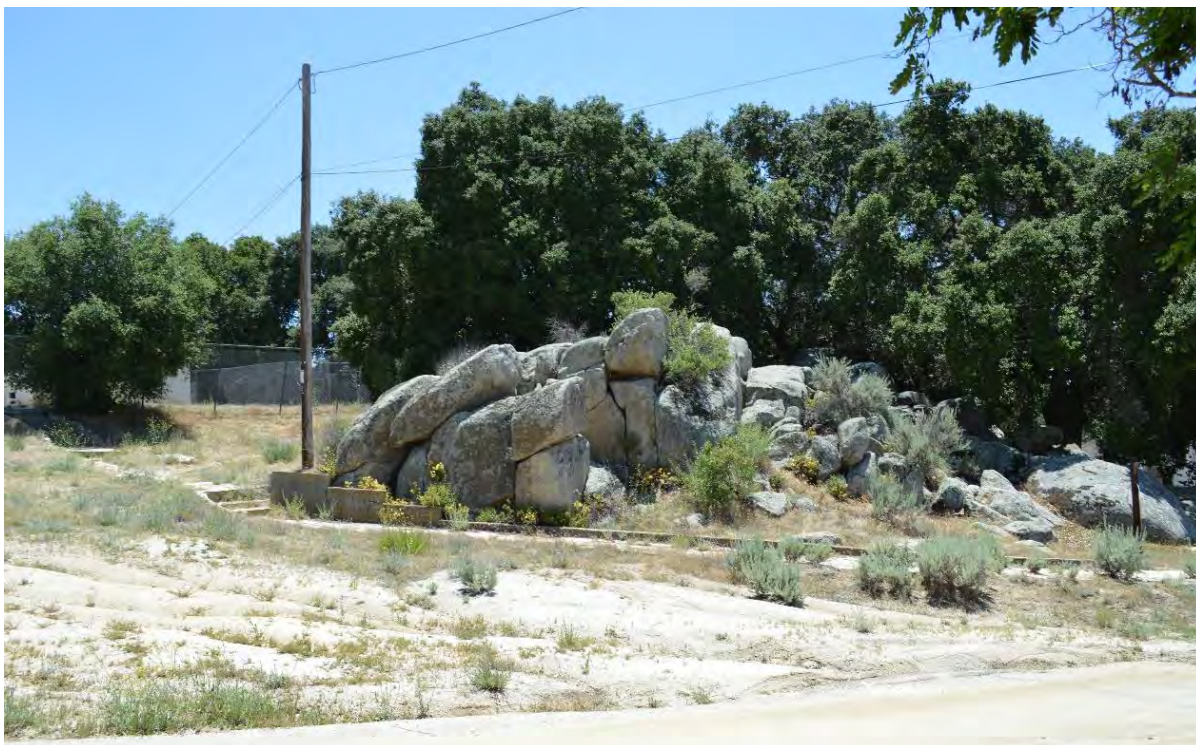
Figure 6. View Looking East from Sheridan Road
Toward natural boulder outcropping adjacent to swimming pool. Source: ICF June 2019.

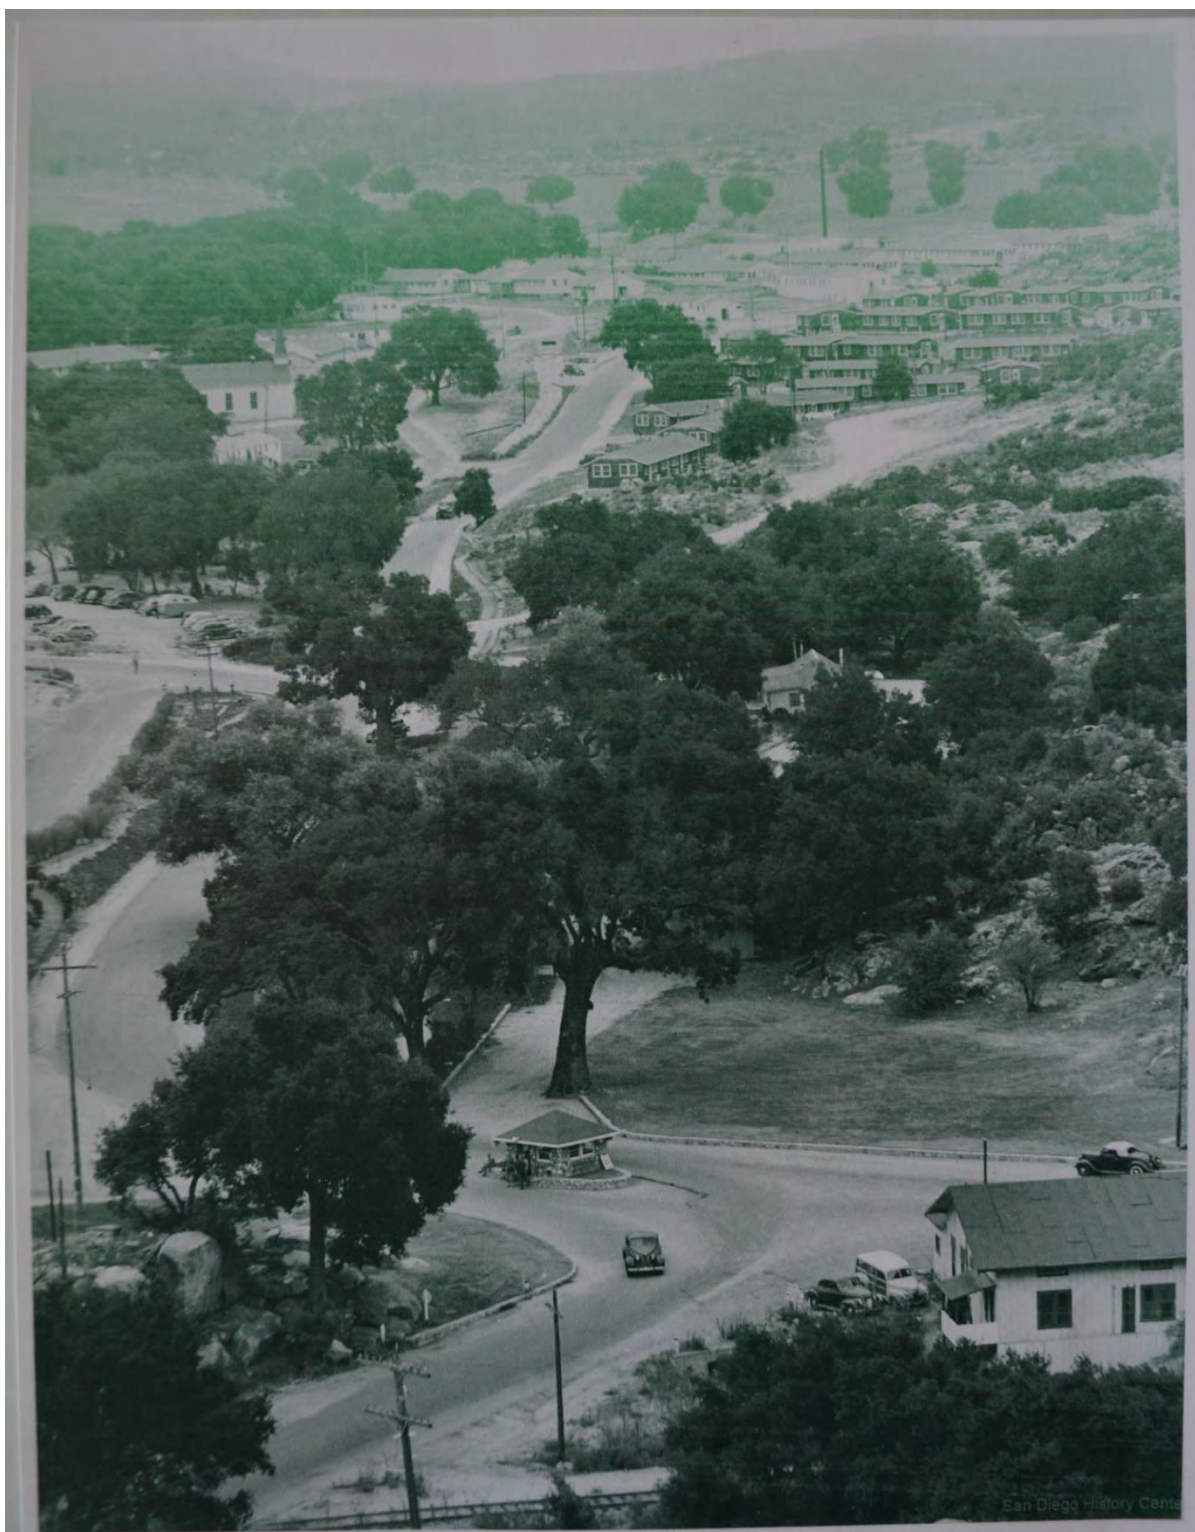
Figure 10. Civilian Housing, Main Post

This image, looking south from the entrance area, shows the civilian workers housing complex on the right side of the photo and the Main Post area to the left of the photo. Source: MEHS Archives.

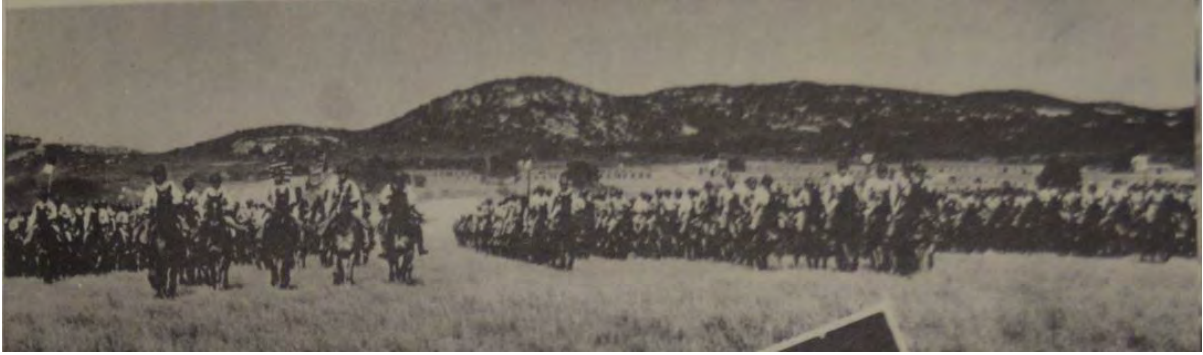
Figure 13. Mounted Troops at Parade Grounds

This photo shows mounted troops during a review at one of the mounted parade grounds in pre-World War II ranchlands. Source: MEHS Archives 1988.

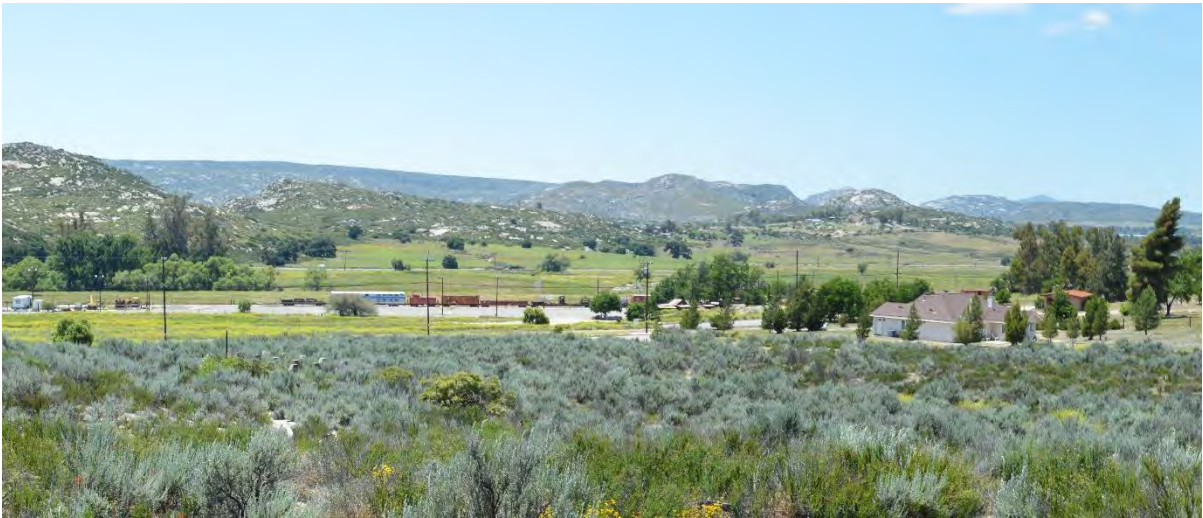
Figure 14. Flat, Cleared, Generally Open Character of Ranch lands Cluster

The ranch lands are shown in the middle of this picture, with the chaparral vegetation and railroad in the foreground and the mountains in the background. View looking west. Source: ICF June 2019.

- The flat, cleared, and generally open character of ranch lands cluster (Figure 14).
- The stables cluster is spatially understood through four extant buildings, and several foundation remnants, extant circulation features, and apparent grading/terracing.
- The western wing cluster.
- Southern developed core cluster:
 - Main Post area
 - Quartermaster area
 - Civilian Worker Housing area
 - Chaffee Park area
 - Hospital Complex area
 - Ferguson Ranch House area
- The generally flat, open character of the landscape in the Mounted Parade Ground/Mounted Obstacle Course cluster (Figure 15).

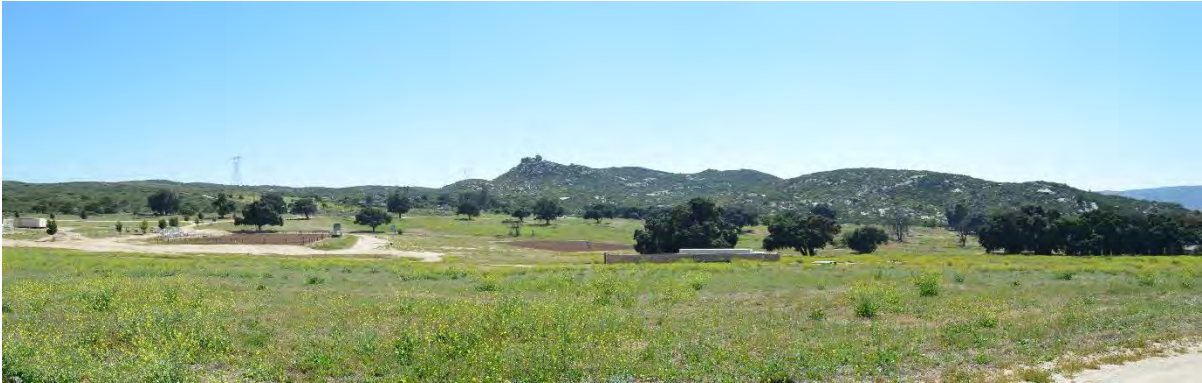
Figure 15. Generally Flat, Open Character of Mounted Parade Ground/Mounted Obstacle Course Cluster

The generally flat, open character of the landscape has been retained in the Mounted Parade Ground/Mounted Obstacle Course cluster, where CLEEF facilities are seen today. View looking west.
Source: ICF June 2019.

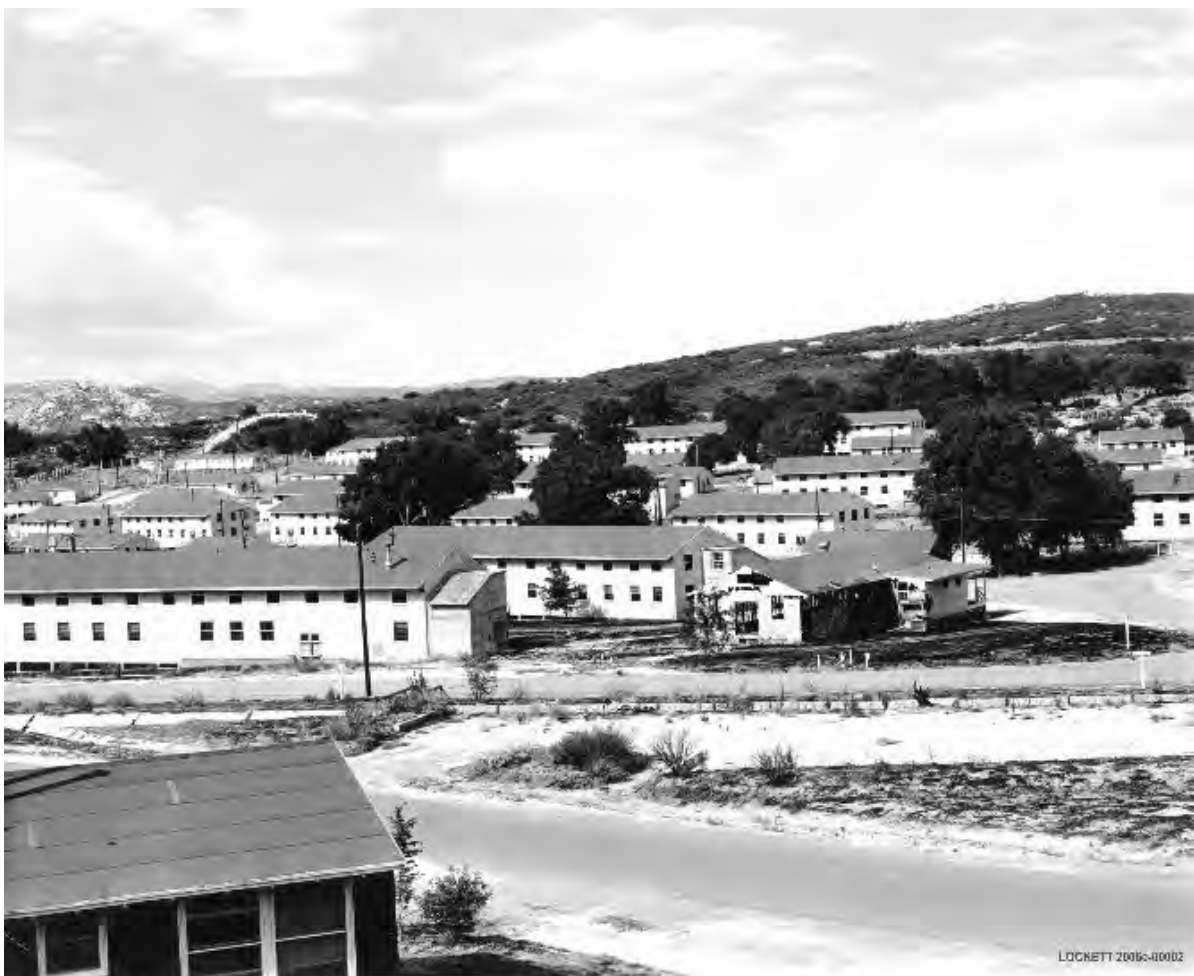
Figure 16. Lack of Ornamental Vegetation in the Barracks Area at Camp Lockett

This photo shows the lack of ornamental vegetation planted in the Barracks area at Camp Lockett. Taken after the decommission of the camp, and thus after the U.S. Army had left care of the grounds, the photo shows a scrub-like groundcover had naturalized. Source: MEHS Archives.

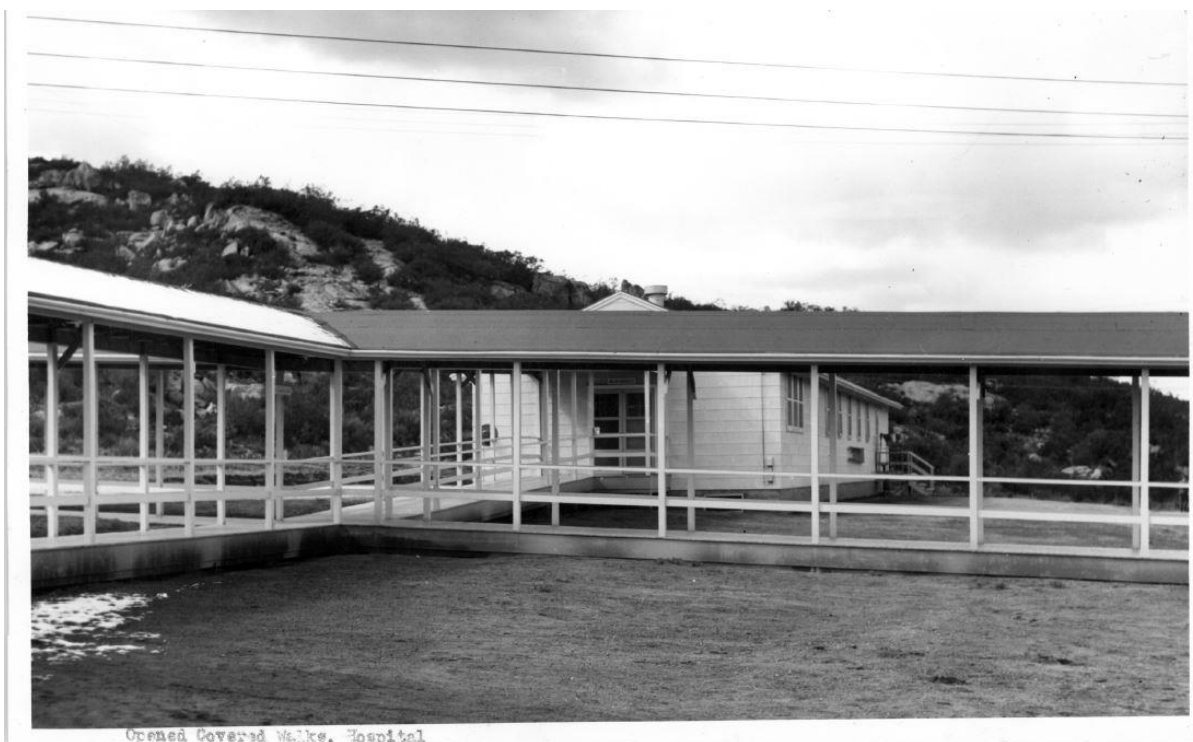
Opened Covered Walks, Hospital

Figure 24. Covered Open Walks in the Hospital Area

Covered open walks were built in the hospital area during the first phase of construction in 1941. Source: Tadlock 1941.

The hospital area was historically built with covered open walks and covered enclosed walks. Today, there is at least one extant covered enclosed walk in the hospital area that connects two buildings. The covered open walks are generally intact, although they have been modified since they were built (see Figure 19). Stairs from the covered open walks have been added and led to concrete sidewalks, which have been removed. The rails of the structure have been altered. When constructed in 1941, there were two central horizontal rails. At an unknown date, either during the Hospital Phase or during the Rancho Del Campo era, this portion of the structure was changed to provide greater safety, including vertical pickets between a top and bottom horizontal rail. See Figures 24 and 25 for a comparison of the 1941 construction with the structure after alterations were undertaken.

- Covered open walks and covered enclosed walks in the hospital area (Figure 25)
- Sheridan Road
- Forrest Gate Road
- Moore Road (Figure 27)
- Depot Street
- Custer Road
- Dodd Lane
- Wheeler Road (Figure 30)
- Shannon Road
- Parker Road
- Jeb Stewart Road
- Hampton Road
- Beauregard Road
- Old Highway 94 (Figure 29)
- Three road spurs in civilian workers housing complex (Figure 28)

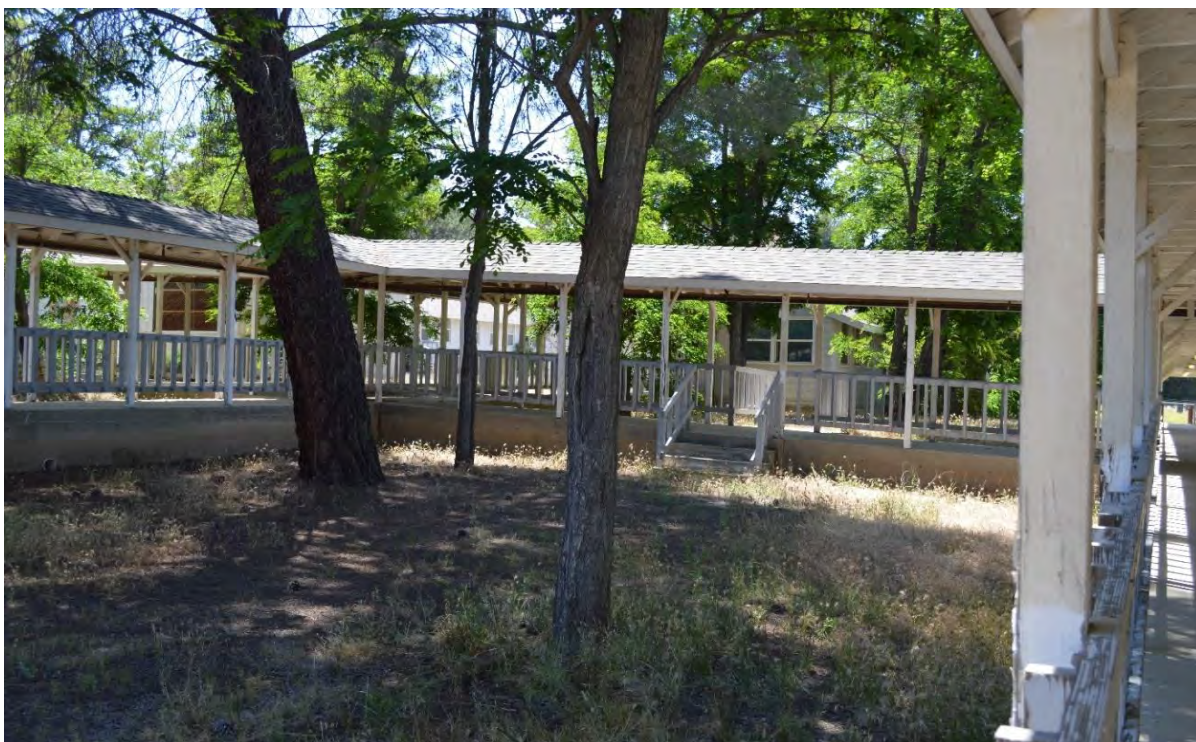
Figure 25. Vertical Pickets at Covered Open Walk

Vertical pickets were added to the covered open walk structures and the railings altered. Trees have also been planted within the open courtyards. Source: ICF June 2019

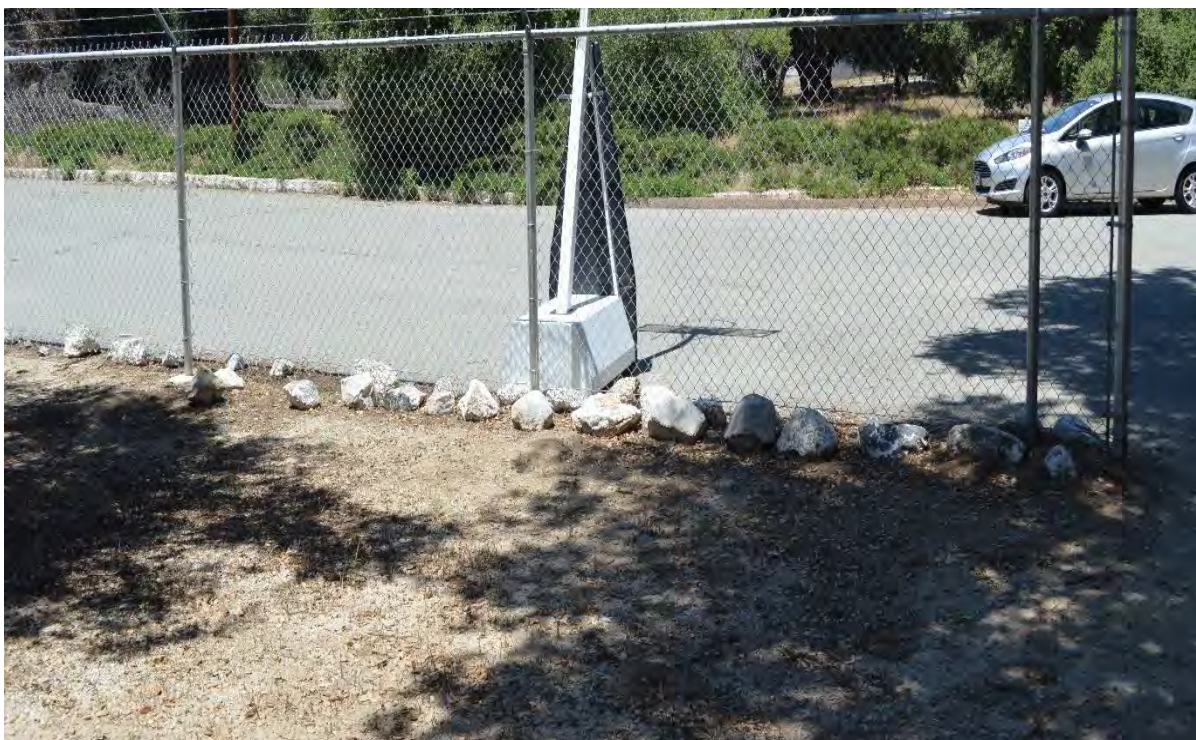
Figure 26. Unmortared Cobble Border in Hospital Area

Unmortared cobble border in the hospital area reminiscent of possibly Hospital Phase or Rancho Del Campo era. Source: ICF June 2019.

Today, unmortared cobble edging with white-painted cobbles is found lining a pedestrian pathway in Chaffee Park, the headquarters area, and throughout the hospital area (see Figure 20). Historic photos show a similar style of unmortared cobble edging along streets and pedestrian circulation within the hospital area during the Hospital Phase. The U.S. Army may have added the informal path through Chaffee Park and lined it with the unmortared cobble edging during the Hospital Phase; however, there is no photographic record. Residents of the Rancho Del Campo were known to care for the park and bring their visiting parents to that location and may have added the cobble edging as well. It is unknown if the U.S. Army painted the cobbles white, or if this was a new technique added during the Rancho Del Campo era. The cobble-edged pathway in the headquarters area is located near recreation fields dating to the Rancho Del Campo era. Nonetheless, the style of unmortared cobble edging in the Chaffee Park area, headquarters area, and hospital area is compatible with the Hospital Phase.

- San Diego–Arizona Eastern Railroad (see discussion of Railroad under Section 8: Recommendations)
- Unmortared cobble edging in Chaffee Park and hospital area (Figure 26)

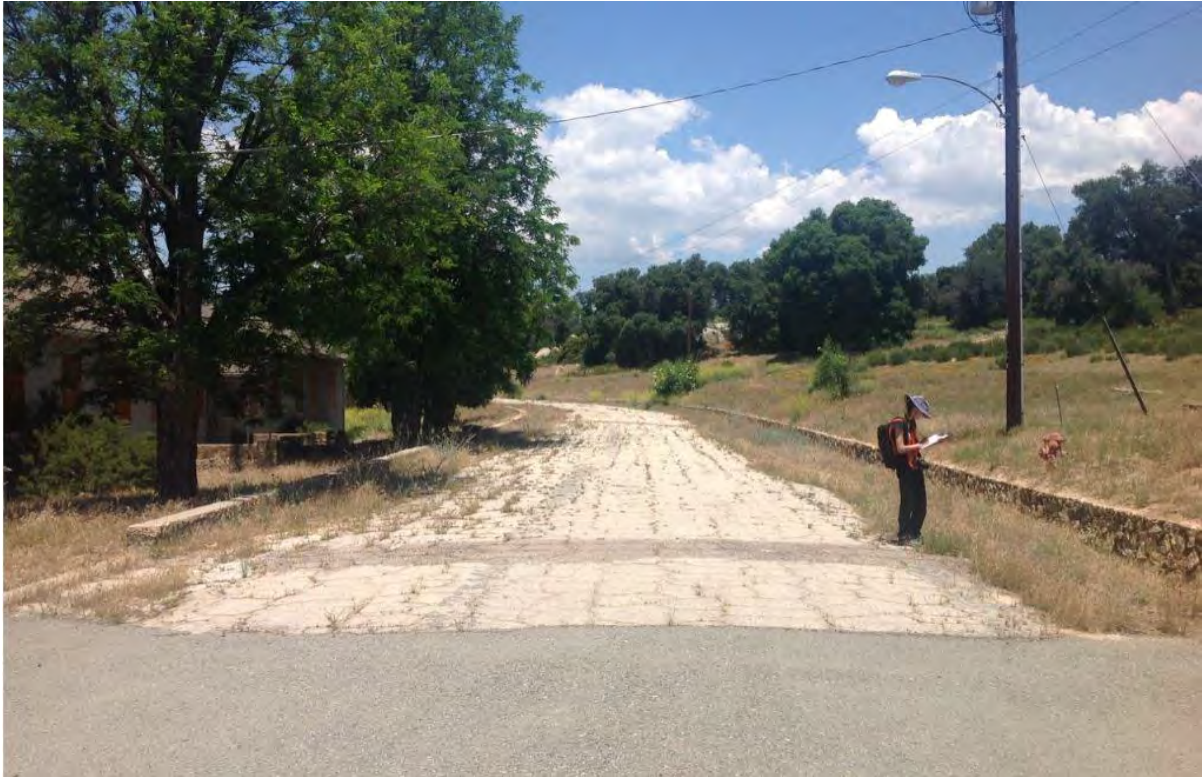
Figure 27. View Looking North on Moore Road at the North End of Chaffee Park

Note the change in road surface: the road encircling Chaffee Park has been resurfaced, while the section of road extending toward the historic barracks area is the original asphalt surfacing. Note the historic walls on either side of the road. Source: ICF June 2019.

The main roads that access currently utilized buildings have been repaved and maintained, while unused roads have lost varying amounts of paving or been reduced to dirt roads (see Figure 27). Some secondary roads that were never paved remain as dirt roads, such as the roads to access the water tanks east of the historic stables area. Some asphalt roads have the original surfacing, although they are in poor condition.

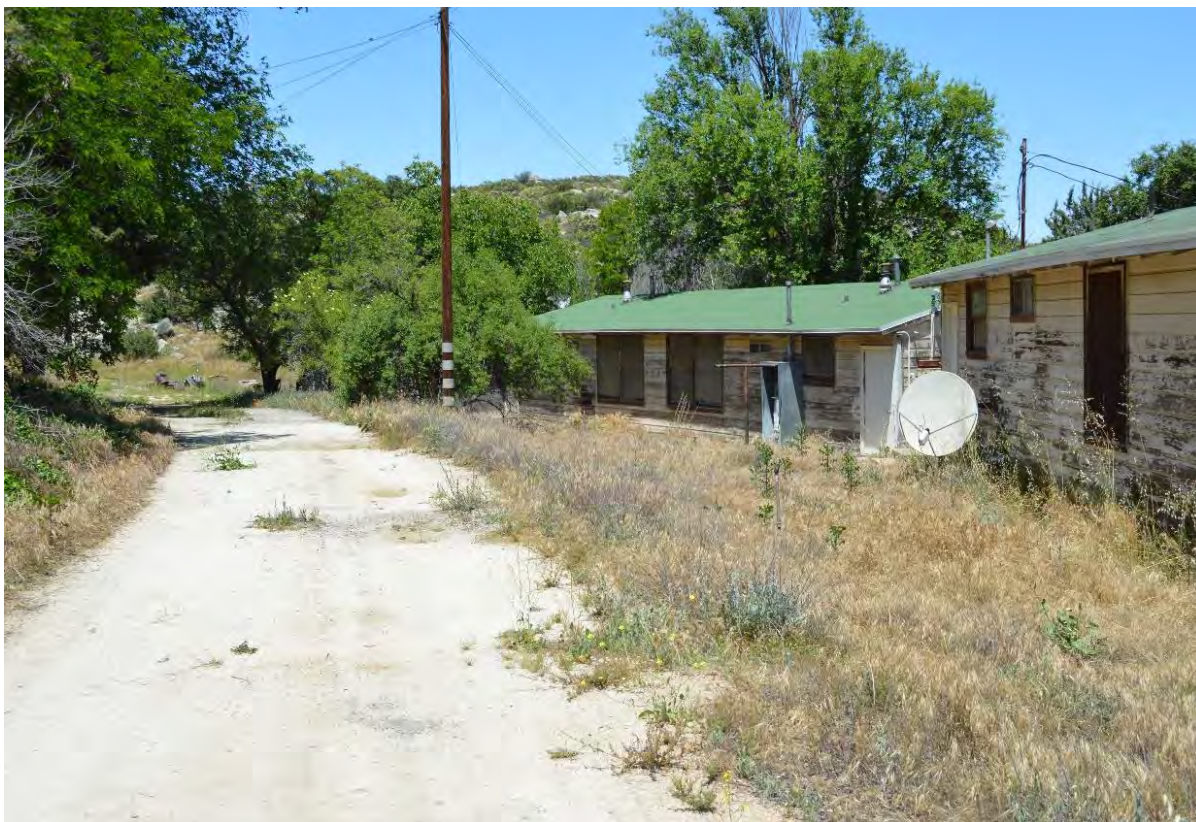
Figure 28. Spur Road in Civilian Housing Complex

This image shows one of the three spur roads in the civilian workers housing complex. Source: ICF June 2019.

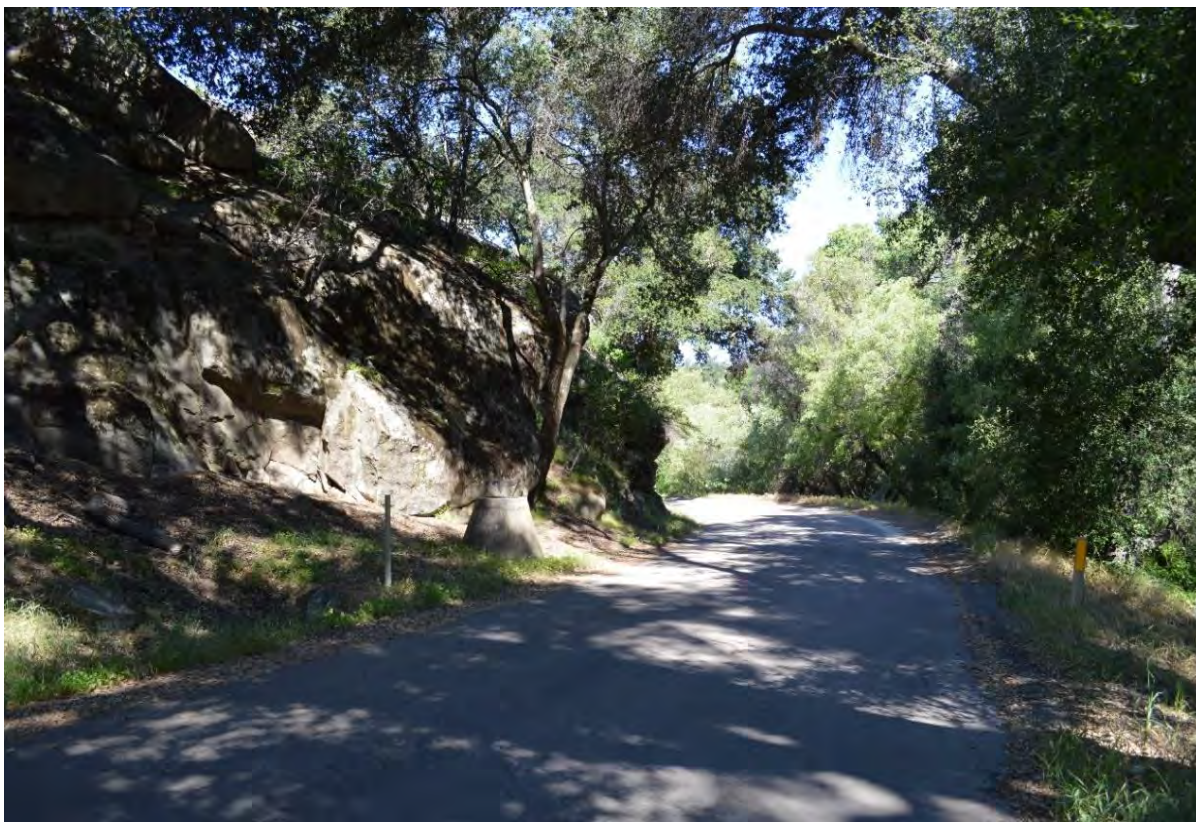
Figure 29. Old Highway 94

Old Highway 94 was built near boulder outcroppings and winded around them. The incinerator and sewage treatment plant are located along its alignment in the western wing cluster. Source: ICF June 2019.

- SR 94 remains a primary transportation route to and from Campo. Since the Historic Period, SR 94 has been altered to create a straighter alignment near the developed core. Beginning at the Camp Lockett entrance area near the Gaskill Brothers Stone Store, SR 94 was extended southward, turning west at the Campo Green Store through the rock outcroppings and connected to the historic alignment in about one mile. The Old Highway 94 alignment in this area is extant and services the incinerator and sewage treatment plan (Figure 29).

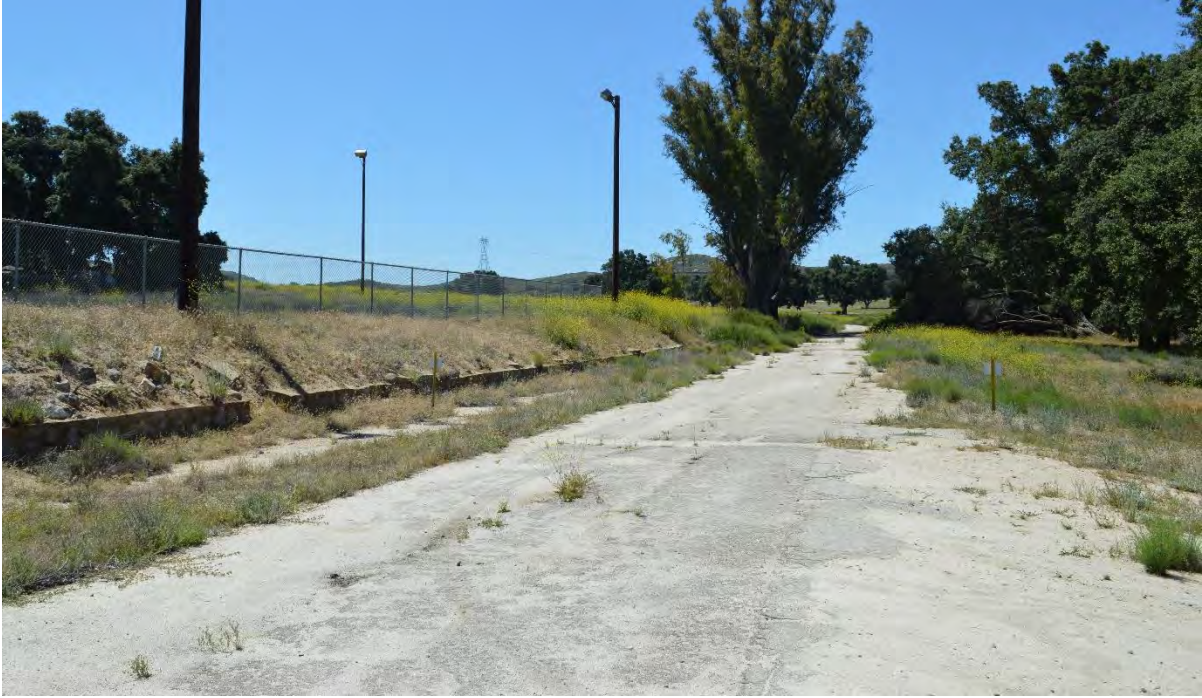
Figure 30. Wheeler Road

This photo shows an unmaintained Wheeler Road with encroaching vegetation. View looking south, near the 1970s era building to the right of the photo. Source: ICF June 2019.

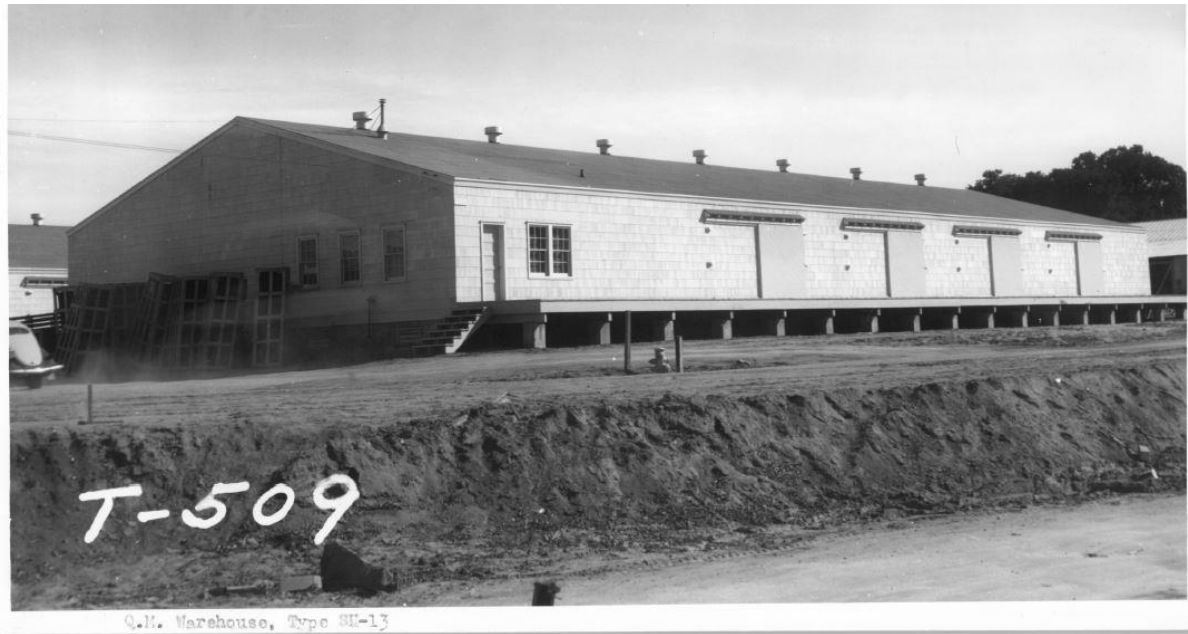
Figure 31. Historic Grading in Quartermaster Warehouse

The grading in the Quartermaster Warehouse area, in order to create a level ground for the buildings, is seen in this photo. Source: Tadlock 1941.

- Historic terracing of landscape to create even ground plane for buildings:
 - Barracks area
 - Quartermaster area (Figures 31, 32)
 - Stables area
 - Southern Land Frontier Sector /Headquarters area/4th Cavalry Brigade area
 - Dormitories area associated with the civilian workers housing complex west of Forrest Gate Road (Figure 33)

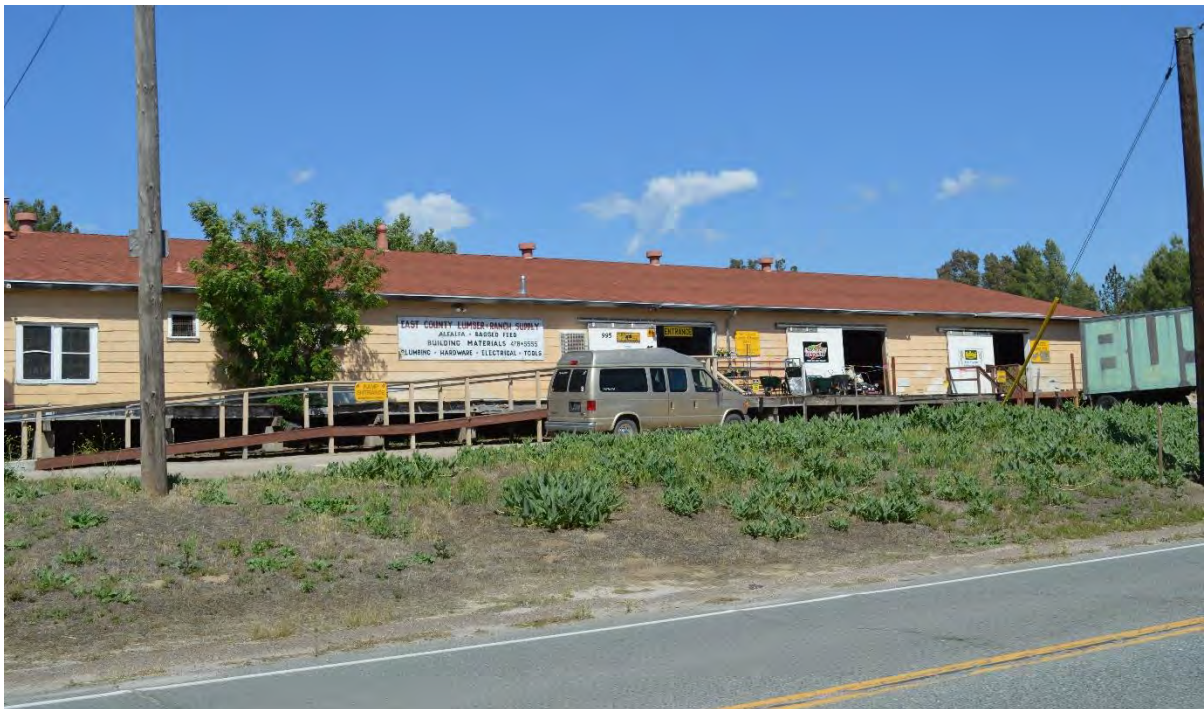
Figure 32. Existing Grading in Quartermaster Warehouse

The historic grading in the Quartermaster Warehouse area can still be seen in this photo, taken from Forrest Gate Road looking southeast. Source: ICF June 2019.

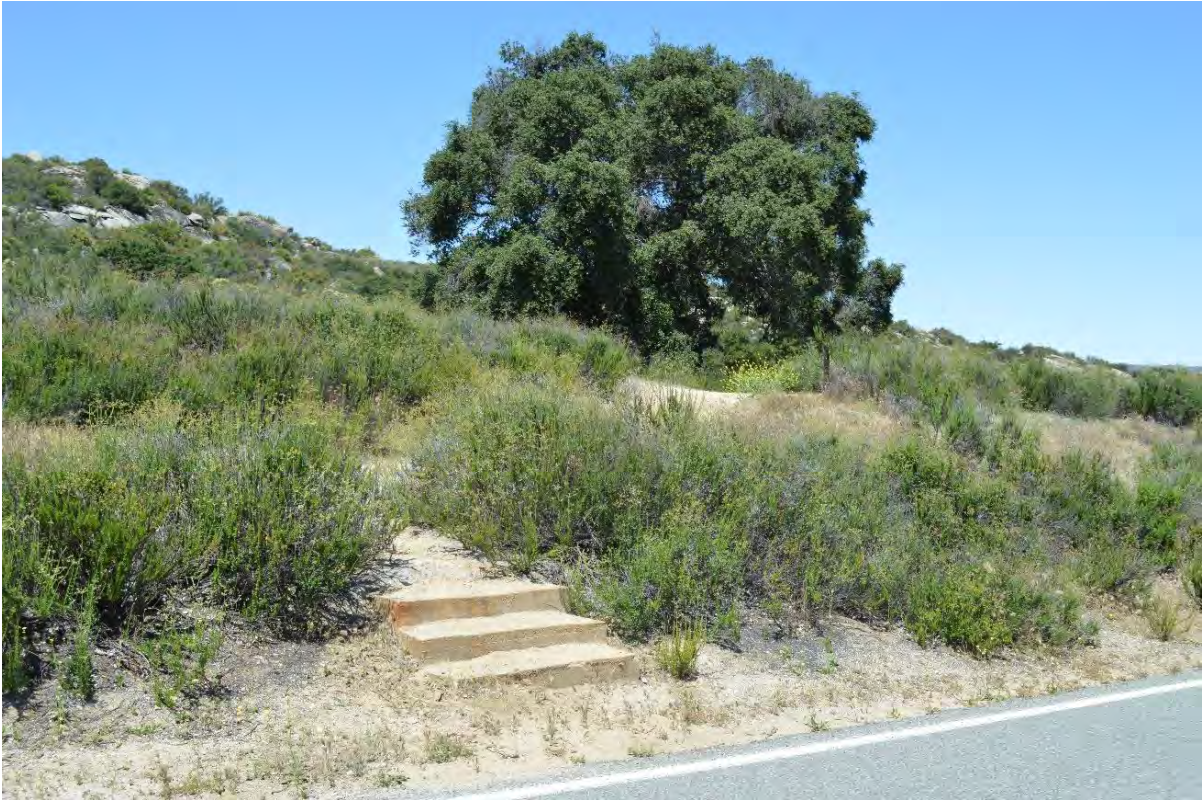
Figure 33. View Northwest from Forrest Gate Road

Looking northwest from Forrest Gate Road, toward the historic dormitories area associated with the civilian workers housing complex. The historic grading associated with the building is still evident, although the building has been demolished. Source: ICF June 2019.

- The terracing in the hillsides north of the civilian workers housing complex is extant. Although the dormitories have been demolished, the grade manipulation is evident in the landscape (see Figure 33).

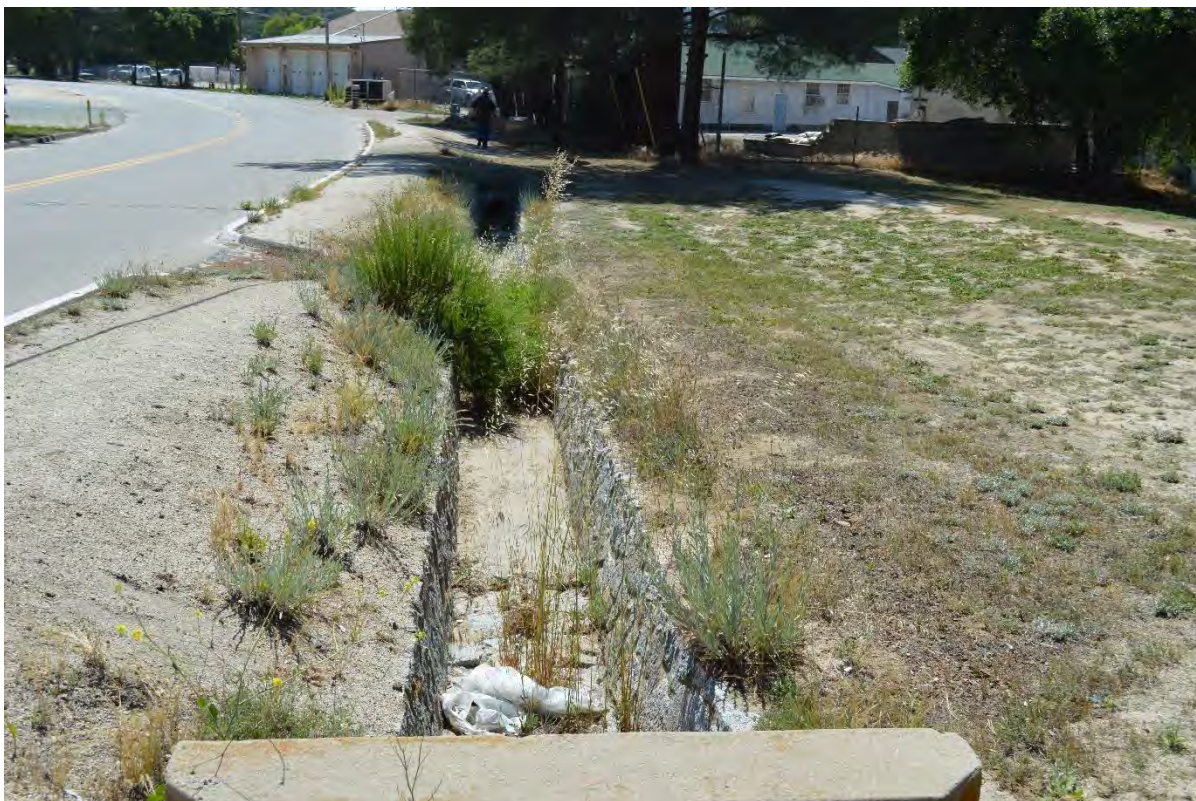
Figure 34. Stone-Lined Drainage Ditch along Jeb Stuart Road

A stone-lined drainage ditch with concrete headwalls follows the alignment along Jeb Stuart Road, from the south side of the Auditorium. This is a historic connector ditch. Source: ICF June 2019.

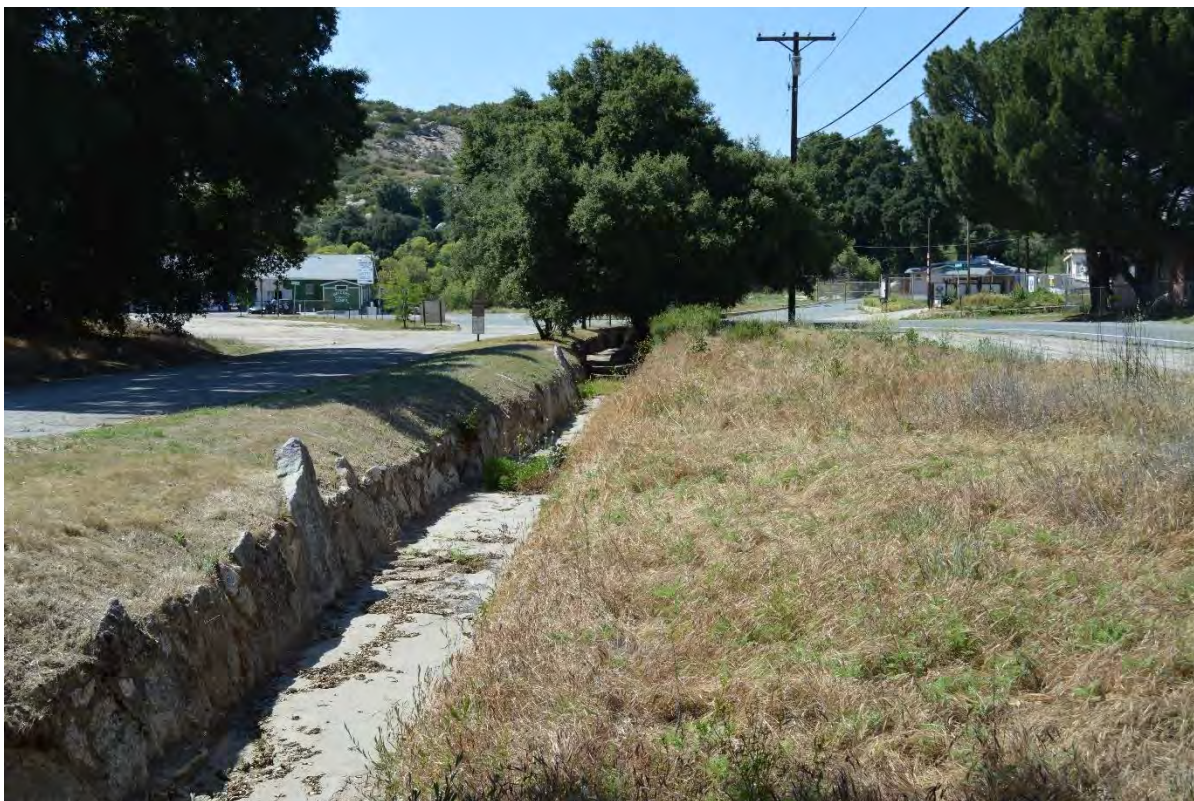
Figure 35. Stone-Lined Portion of Main Ditch near Entrance Area

The stone-lined portion of the main ditch is seen here near the entrance area, along the west side of Forrest Gate Road. Source: ICF June 2019.

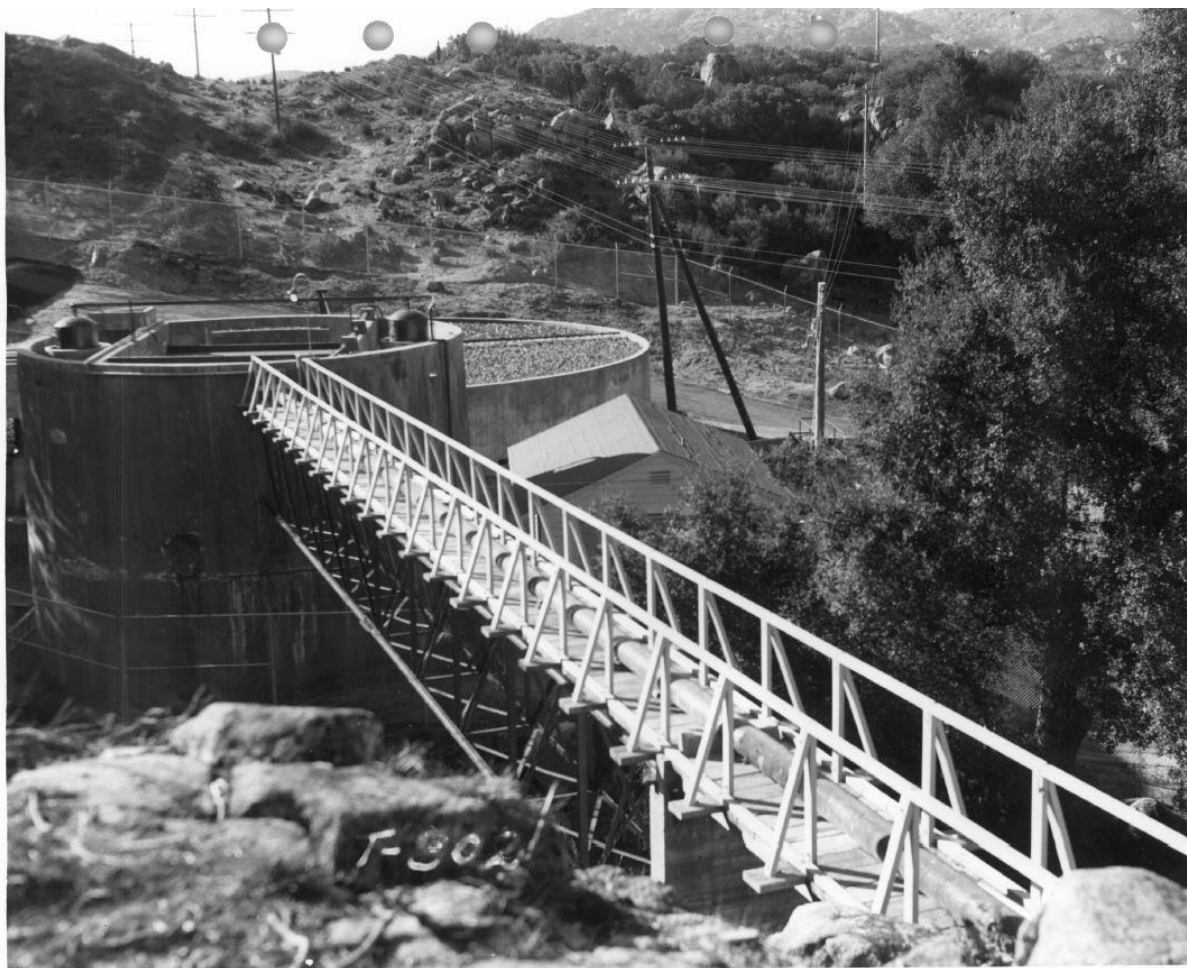
Figure 36. Trestle and Flume Connecting Sewage Treatment Plant and Camp

The trestle and flume to the tank of the sewage treatment plant connected the treatment plant and the camp. Source: Tadlock 1941.

December 1941 and included considerable rock excavation necessary to run the sewer lines from the camp to the plant (see Figure 36).

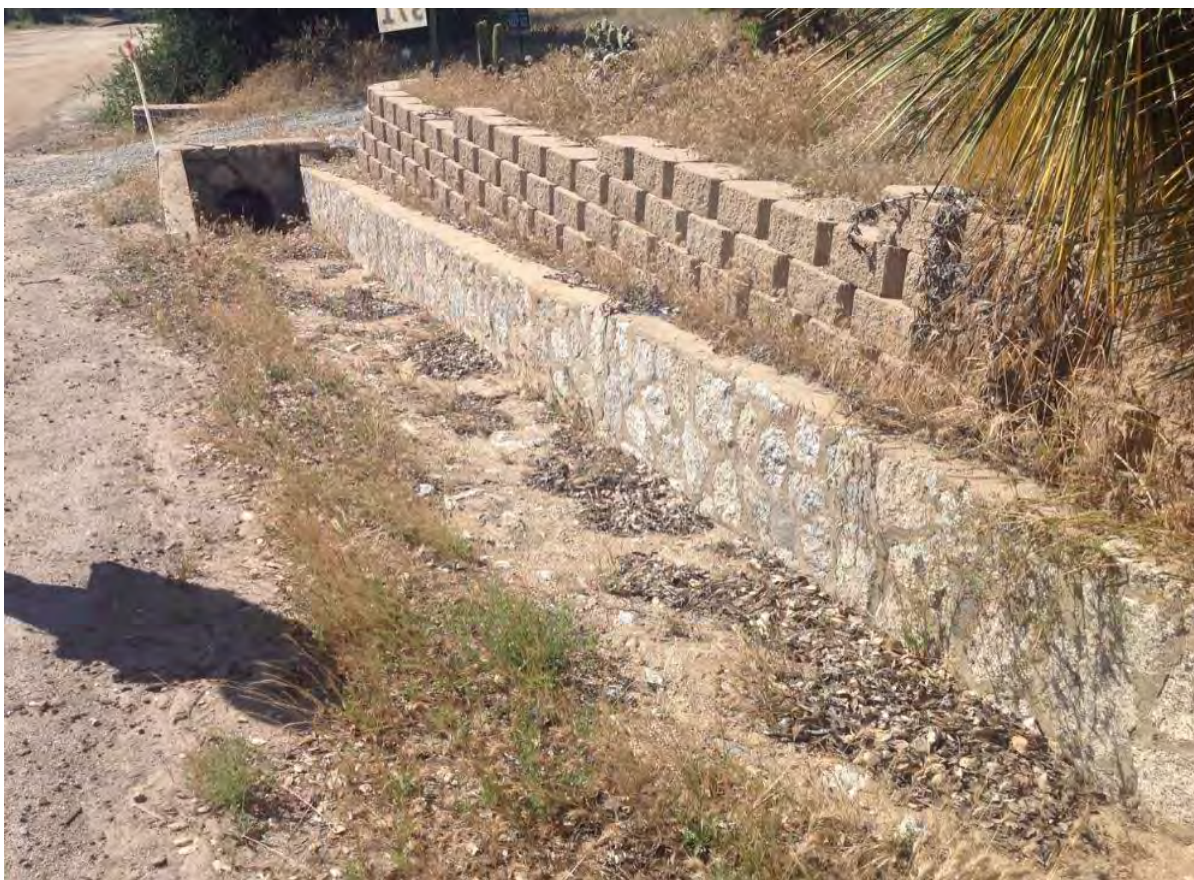
Figure 37. Mortared Rock Walls and Ditches, North Side of Moore Road

An extensive system of mortared rock walls with ditches lines the north side of Moore Road, abutting private residences (historic barracks). Note that concrete blocks have been added to the top of this historic wall. Source: ICF June 2019.
