Subject: Memo—Proposed revisions to the Camp Lockett Master Plan and Overlay Zone

**CAMP LOCKETT CULTURAL LANDSCAPE TECHNICAL
REPORT, SAN DIEGO COUNTY, CALIFORNIA**

December 2019

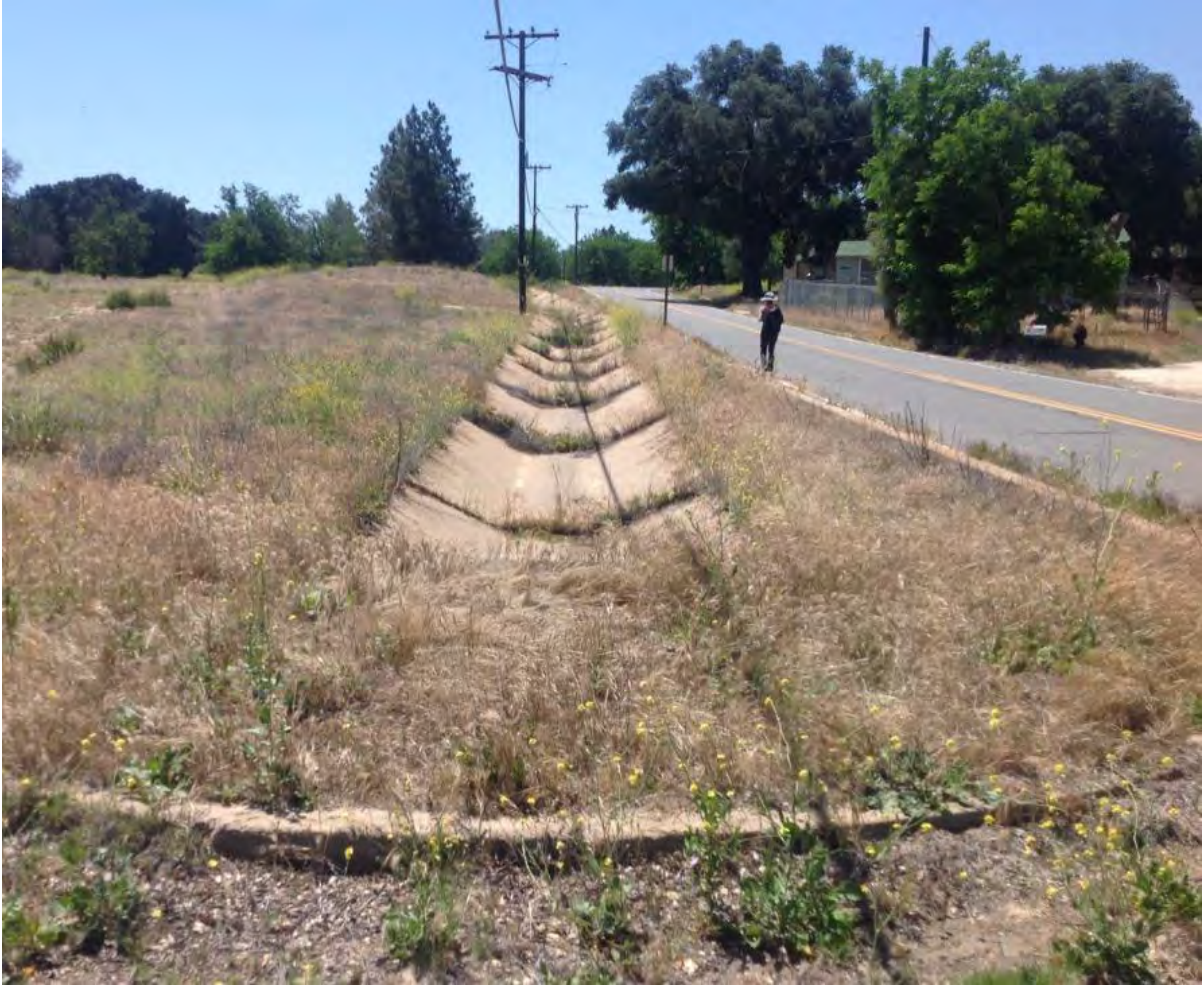
Figure 38. Historic Alignment of Main Ditch, East Side of Forrest Gate Road

This photo shows the historic alignment and materiality of the concrete lined portion of the main ditch along the east side of Forrest Gate Road. View looking south with overgrown vegetation. Source: ICF June 2019.

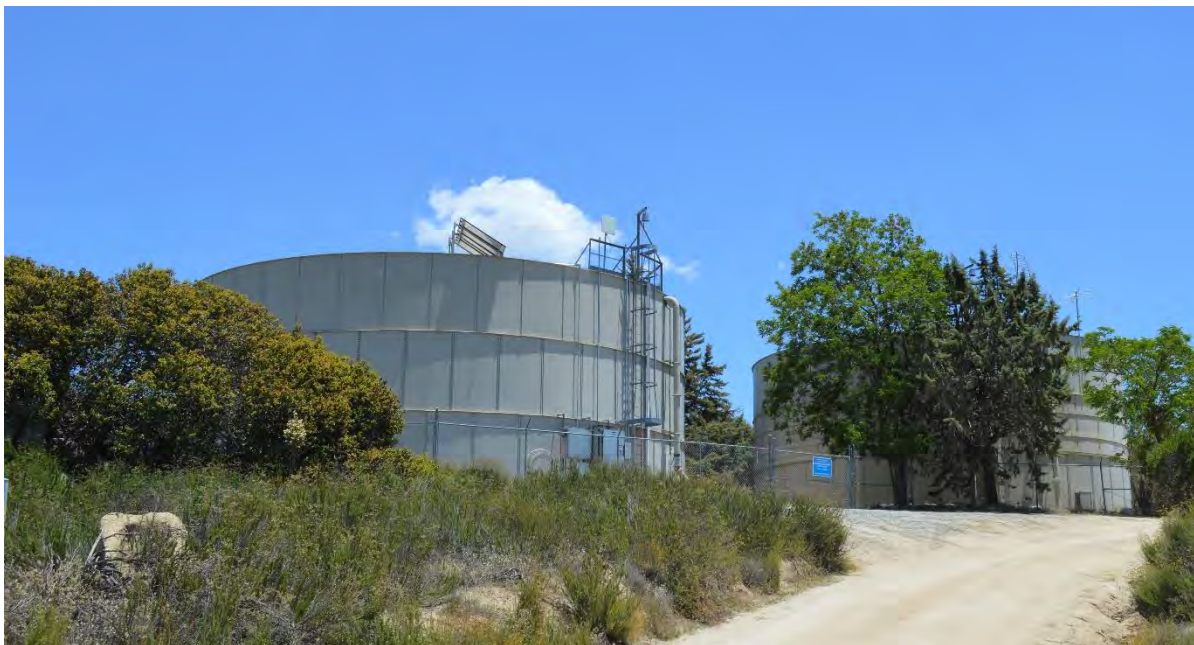
Figure 39. Water Tanks, East Side of Sheridan Road

This photo shows the two water tanks located on the knoll east of the Community Building on Sheridan Road. View looking east. Source: ICF June 2019.

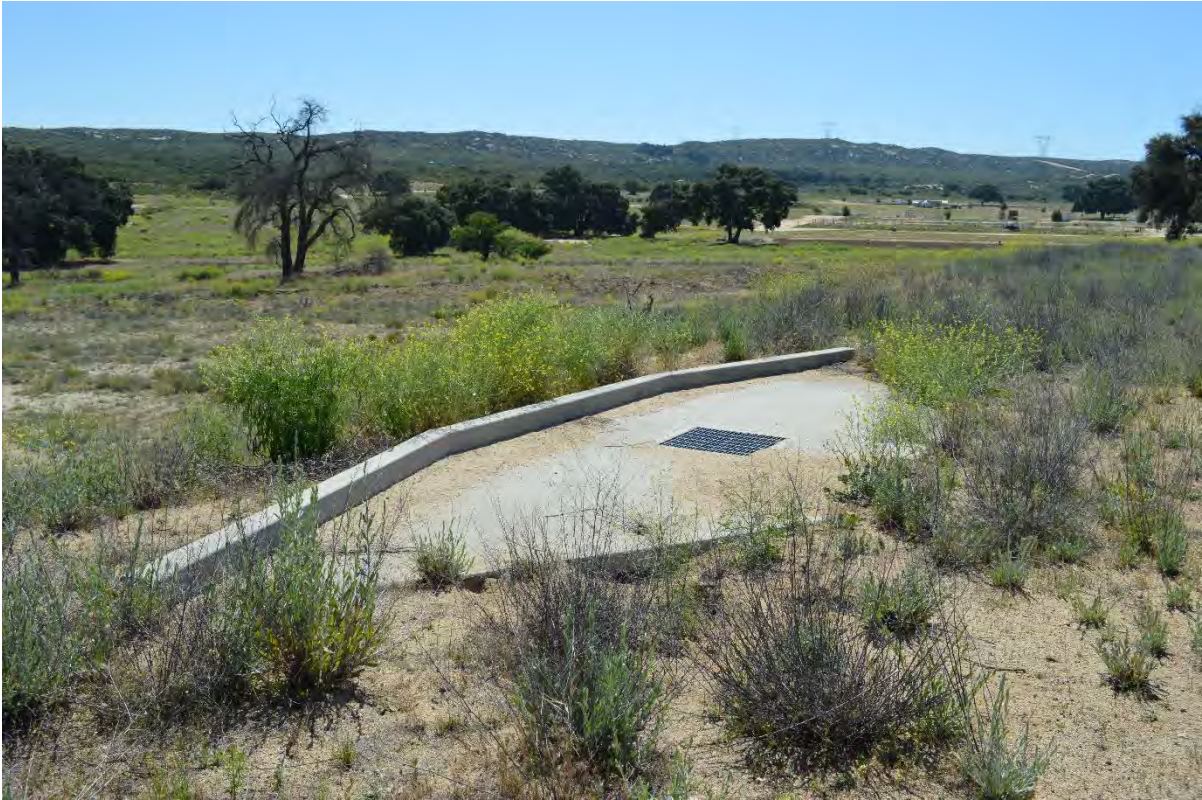
Figure 40. Concrete Drainage Structure, Center of Running Track

A contemporary drainage structure is located on the northeast edge of the running track near the Hospital Complex. View looking east. Source: ICF June 2019.

- Asphalt-lined swale near entrance area.
- Concrete drainage structures in center of running track (Figure 40).
- Water tank near CLEEF equestrian camping.

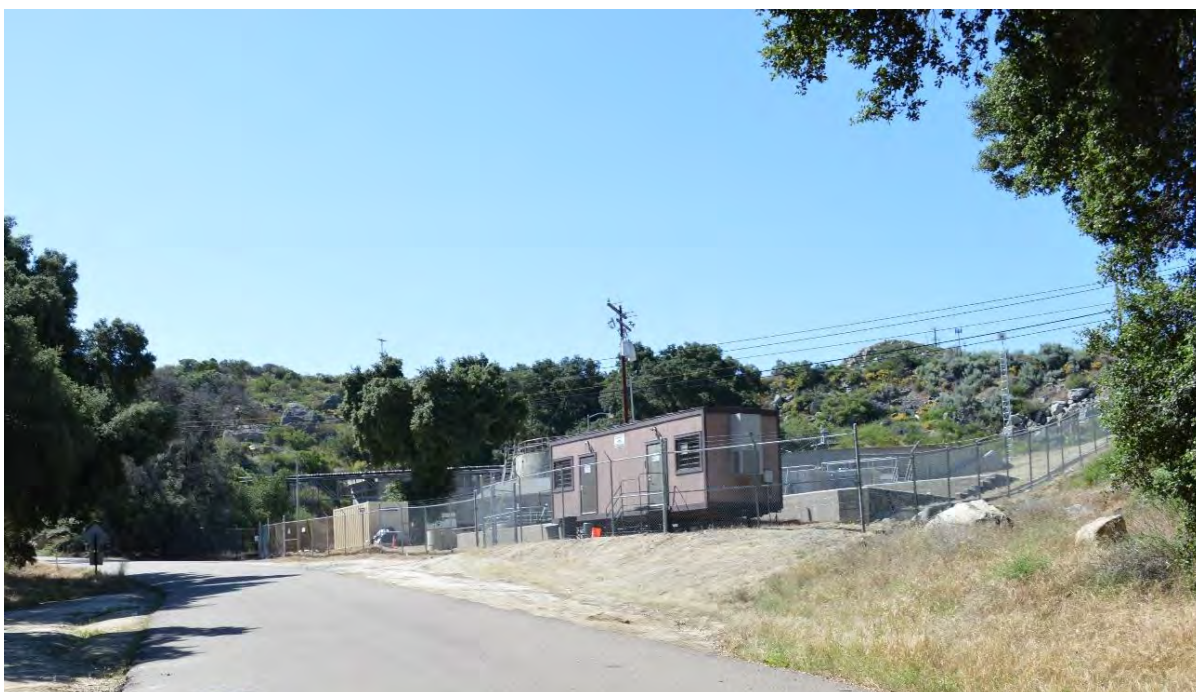
Figure 41. Sewage Treatment Plant

The sewage treatment plant has been an active land use since the war era. Source: ICF June 2019.

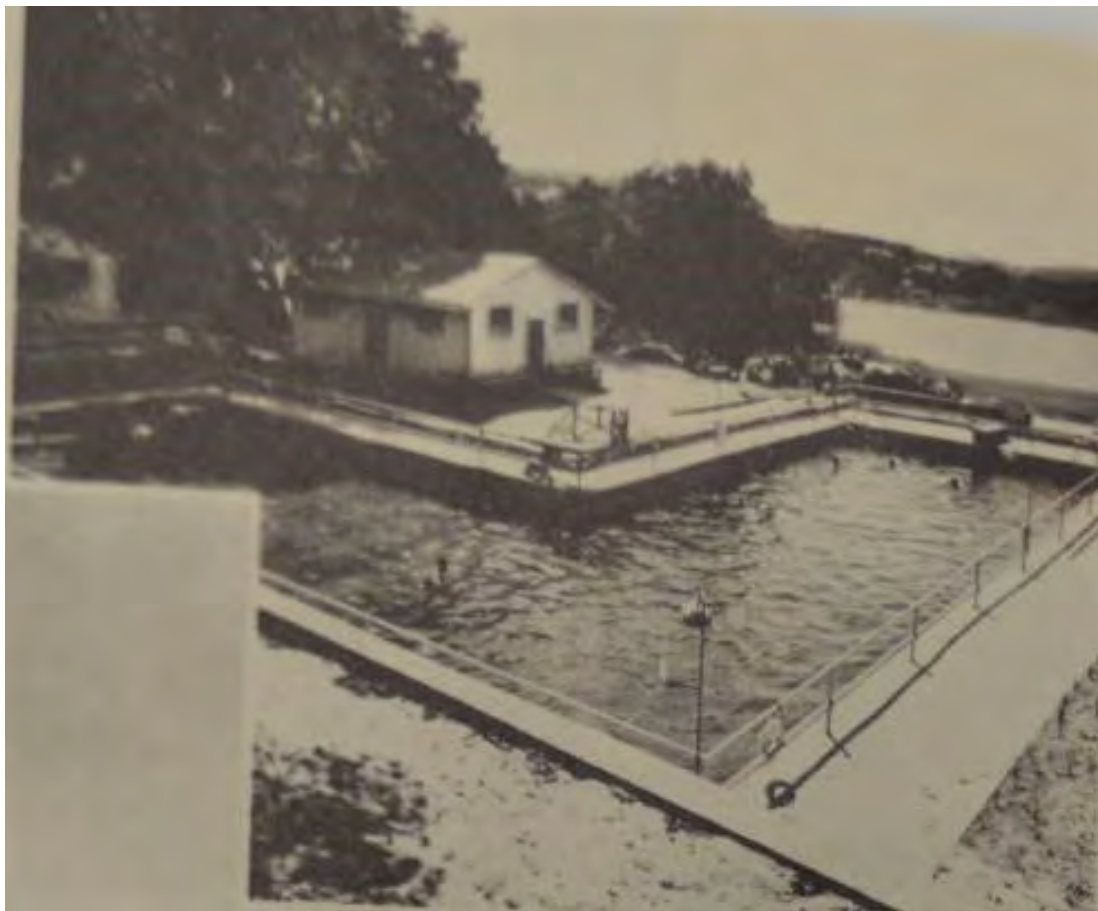
Figure 44. Pool Across from Community Building, 1998

This photo shows the original construction of the L-shaped pool across from the Community Building.
Source: MEHS Archives 1988.

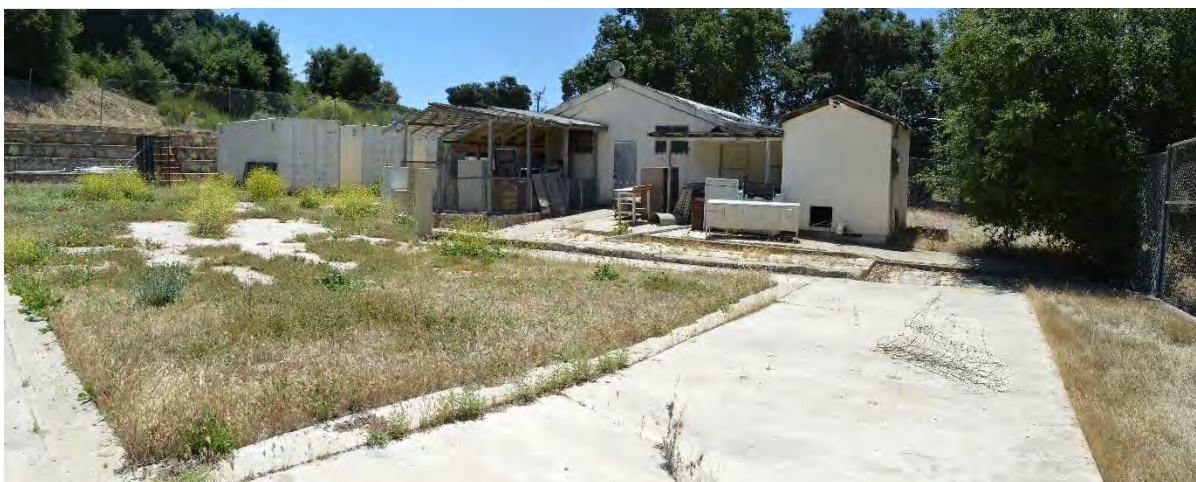
Figure 45. Pool Across from Community Building, 2019

The L-shaped pool has been filled in with soil. Storage containers are stored in the area. Stonework from both the POW era and Rancho Del Campo era surrounds the buildings and pool site. Source: ICF June 2019.

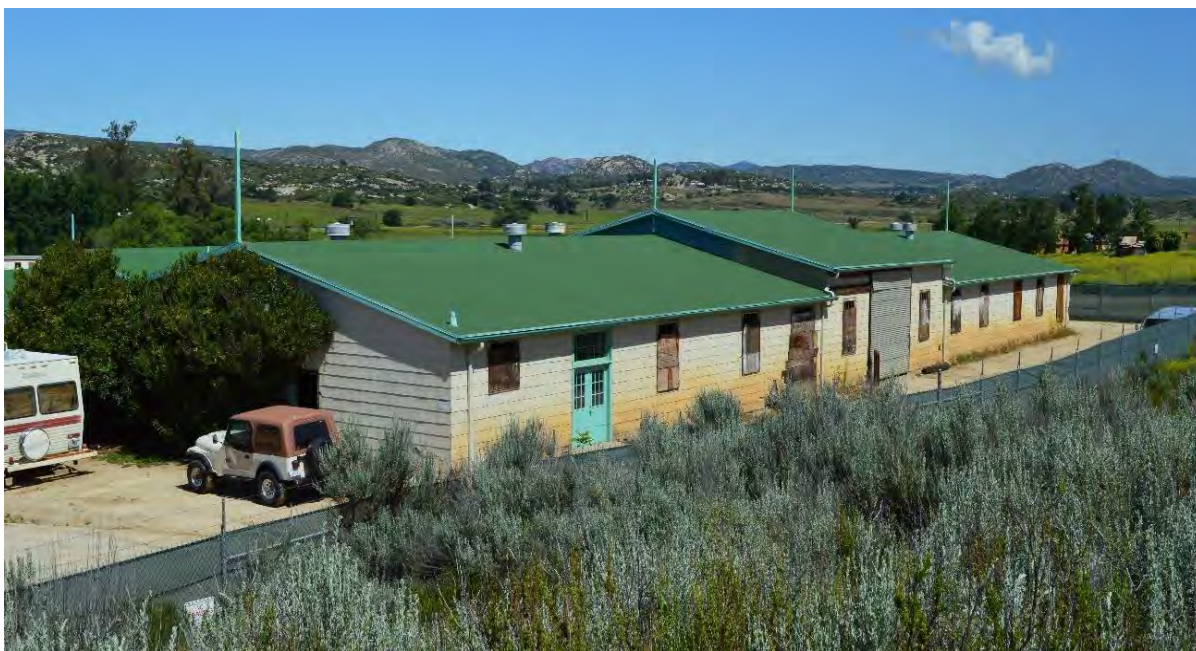
Figure 48. Updated Stable Building

This photo shows one of the four remaining stables that have been improved in the extant stables cluster.
Source: ICF June 2019.

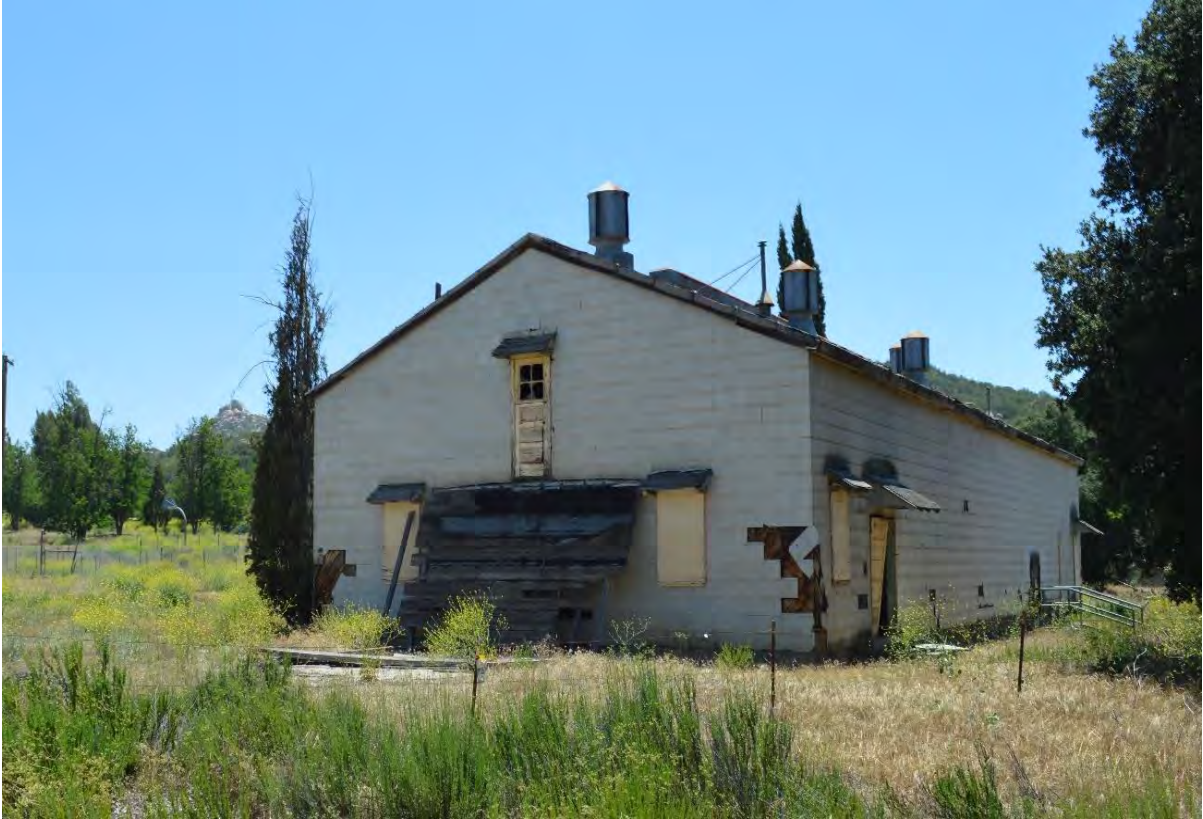
Figure 49. Historic Theater Building

The historic theater building retains its historic design, materials, location, but is currently vacant.
Source: ICF June 2019.

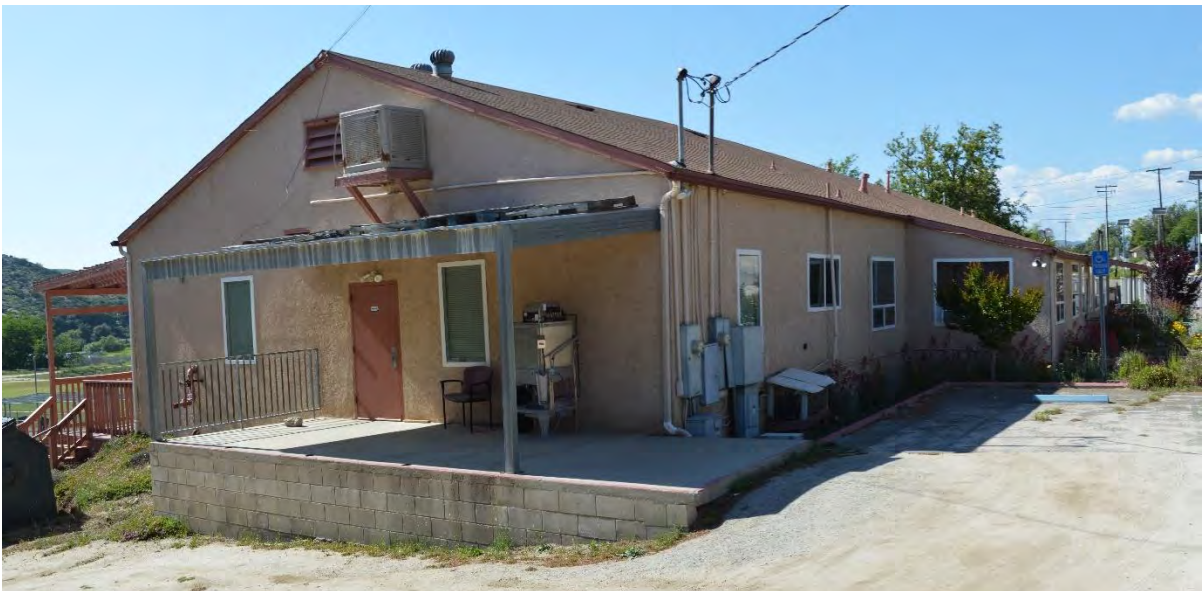
Figure 50. Historic Community Building

The historic community building has been rehabilitated and houses the local community center, a compatible use of the building. Source: ICF June 2019.

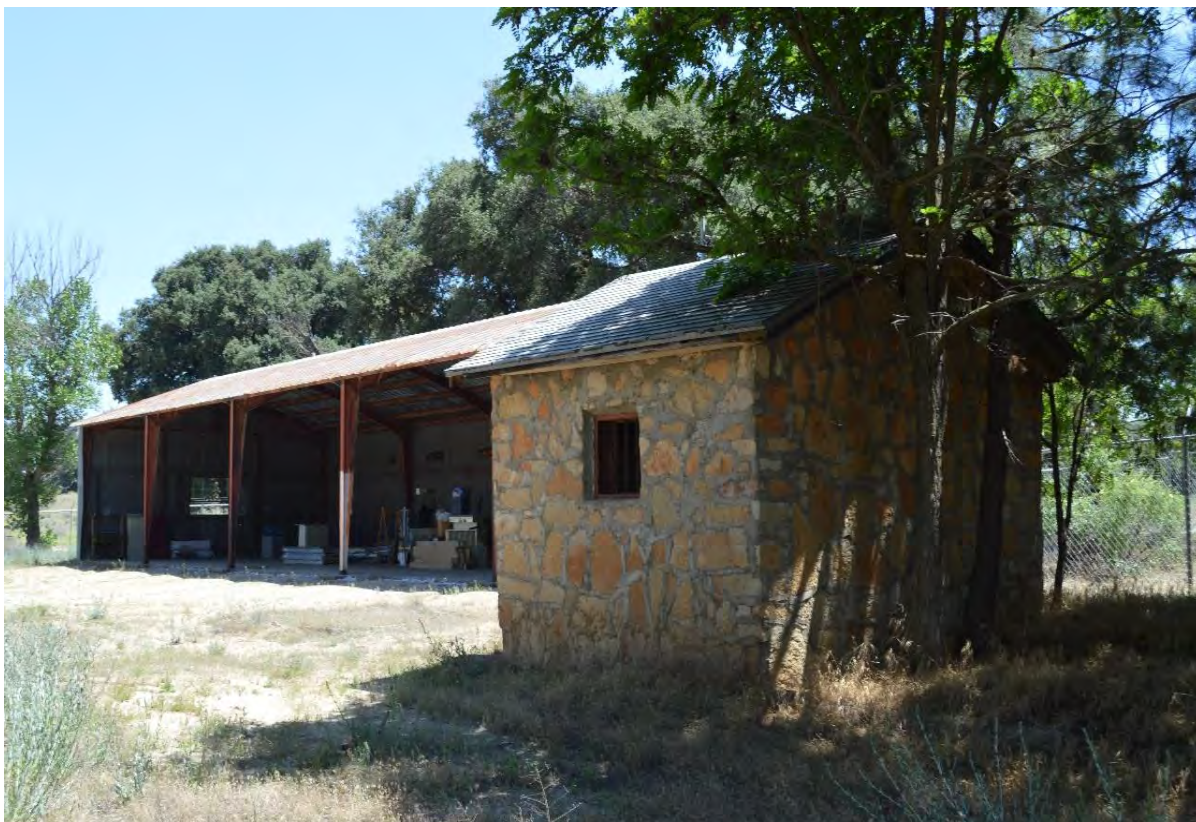
Figure 51. Historic Stone Dispensary

The historic stone dispensary is located in the rear of the hospital complex. Source: ICF June 2019.

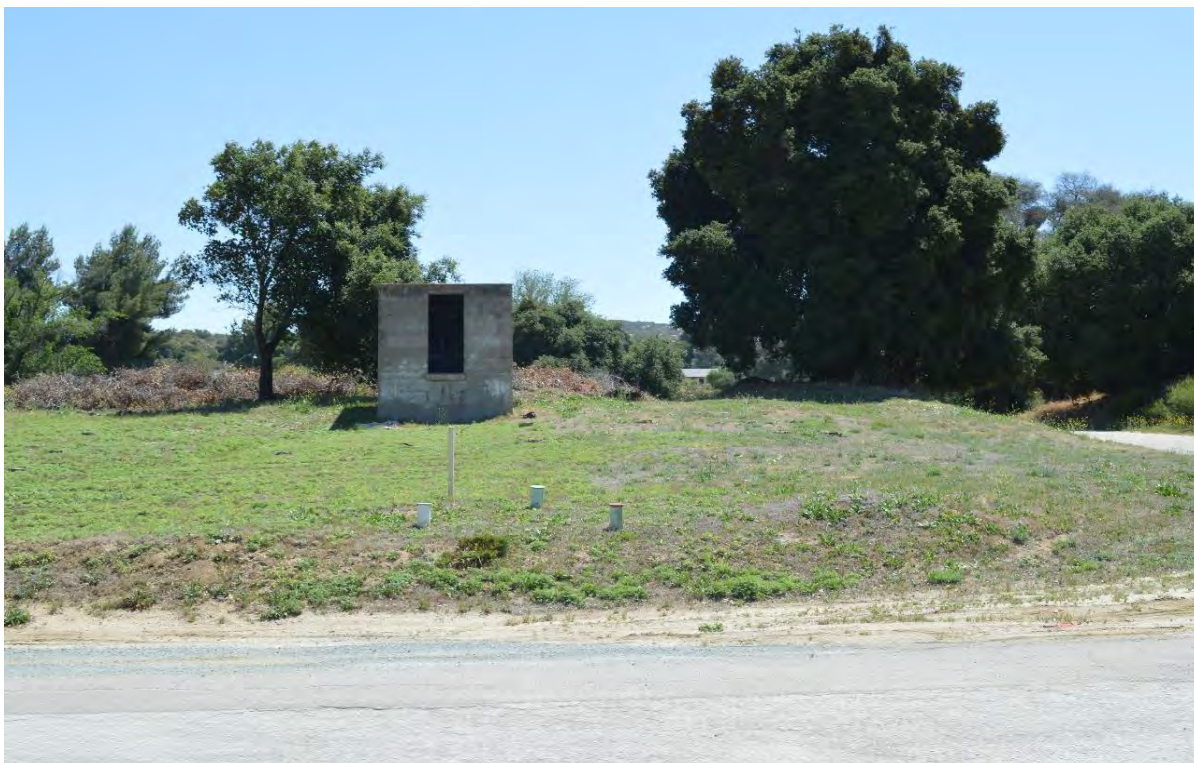
Figure 52. Concrete Block Structures near Main Post

Concrete block structures are located near the Main Post area. This photo was taken from Forrest Gate Road, looking east near the Border Patrol Facilities. Source: ICF June 2019.

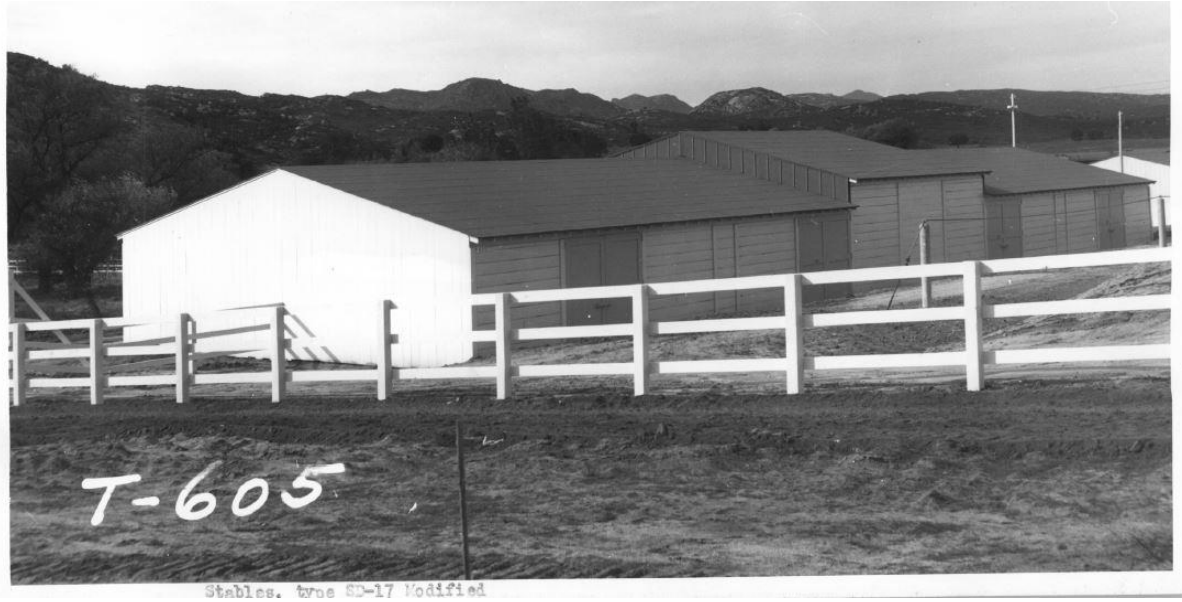
Figure 54. Three-Rail Corral Fences Near Stables

This photo shows three-rail corral fences in the historic stables area. Source: 1941 completion report.

- At least three types of fencing were constructed to create boundaries or to provide security or safety purposes. Wooden picket fences, made of wooden posts with three horizontal rails, were built around the stables and veterinary ward (see Figure 57). The 1941 completion report includes reference to a standard drawing for chain-link fences. There are historic photos of chain-link fences surrounding the incinerator and sewage treatment plant, but they were perhaps located in additional locations surrounding utilities. Finally, metal pole fencing was built within the swimming pool, area across from the community building.

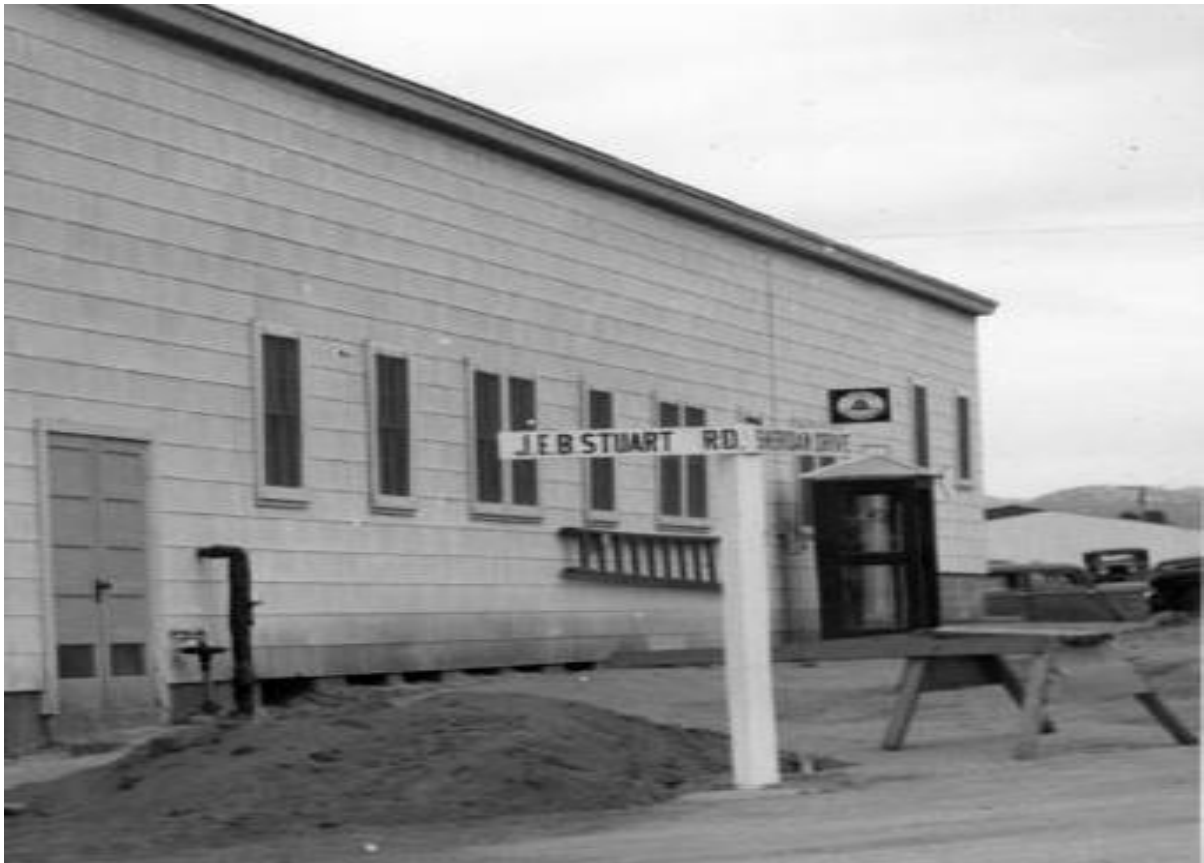
Figure 55. Historic-Period Directional Road Signs

This photo shows the standard directional road signs used during the Historic Period. Source: 1941 completion report.

- Standard street signs were erected during the first phase of construction. White-painted wooden signs with dark lettering were placed on street corners (see Figure 55).

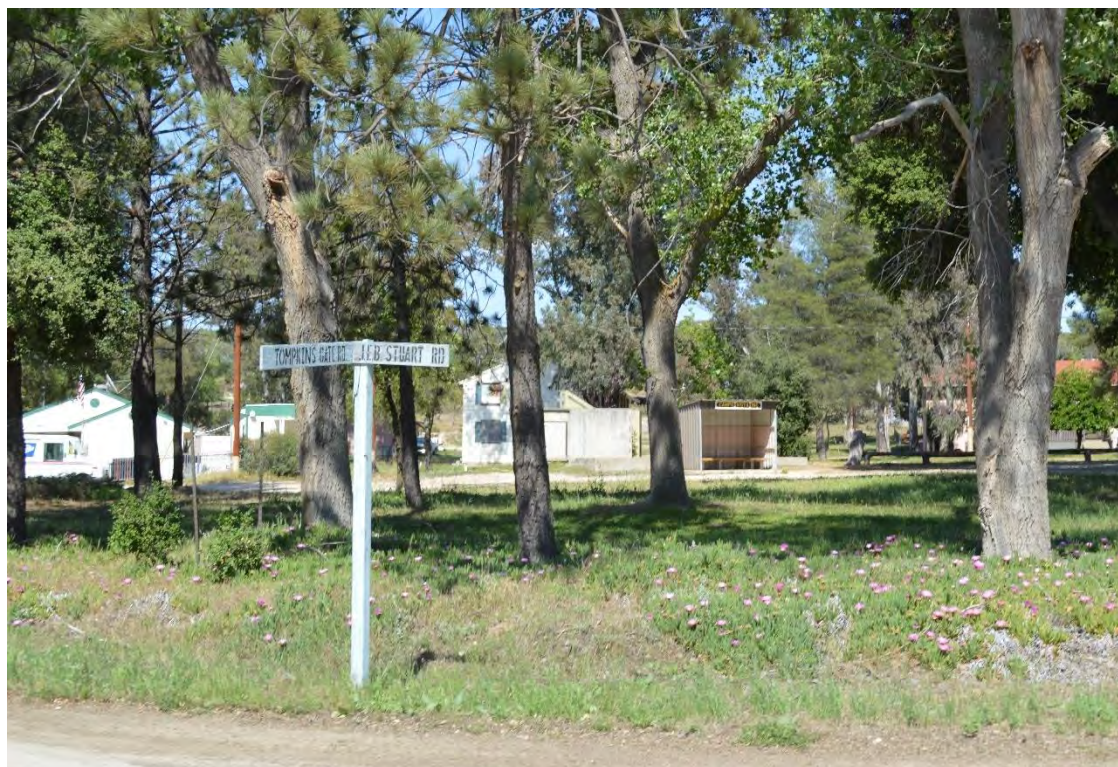
Figure 56. Original Street Sign, Main Post Area

An original street sign is located in the historic Main Post area. Source: ICF June 2019.

- Various styles of signage are found throughout Camp Lockett. Within the Main Post area (under private ownership), historic street signs are extant (see Figure 56). The entrance area is cluttered with an array of safety, directional, and destination type signs.

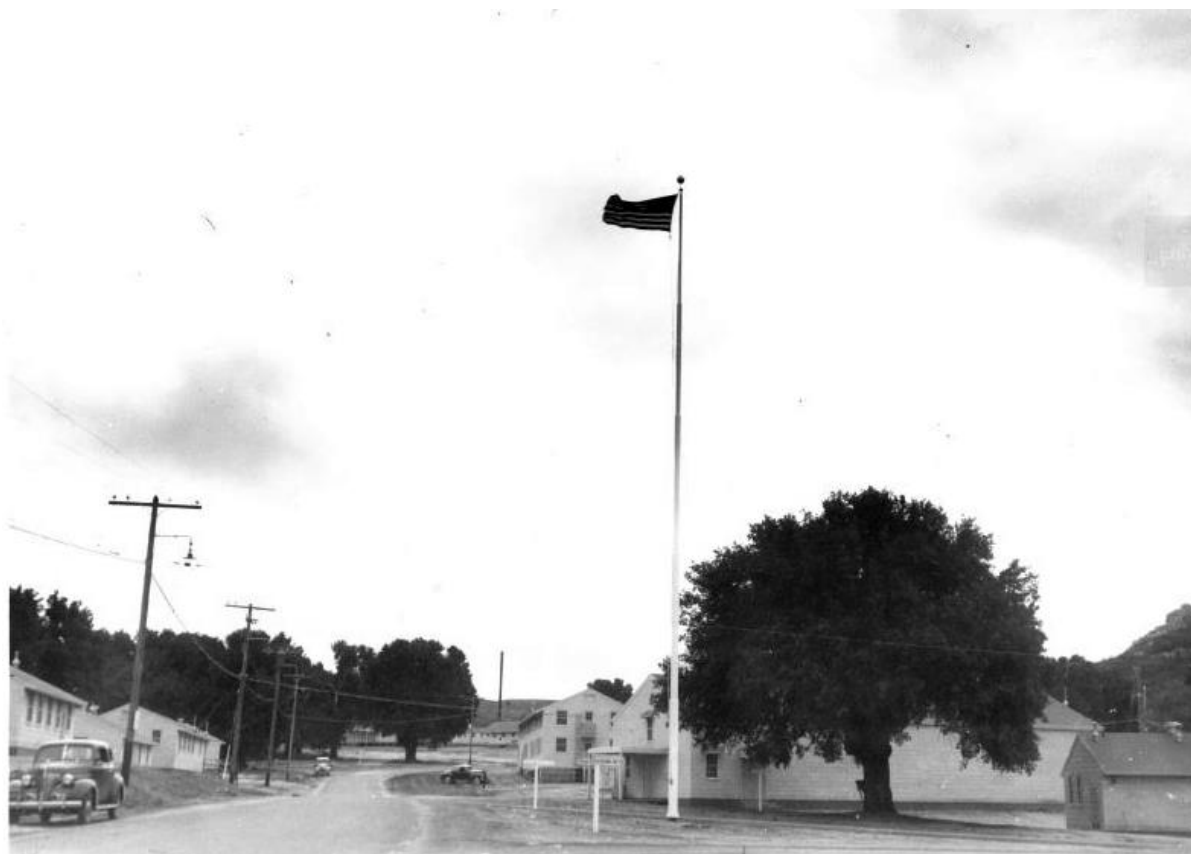
Figure 57. Original Flagpole

This 1941 image shows the original flagpole prior to the rock walls were built; note the the utility poles with street lights. Source: 1941 Completion Report.

- The 1941 completion report included reference to standard drawings for flagpoles and their associated revolving cleats. Known historic locations are at the entrance area and one sited prominently in the center of the road, near the 10th Cavalry Headquarters building and within the center area of the developed core (see Figure 57). There were likely more flagpoles, but their locations are unknown at this time.

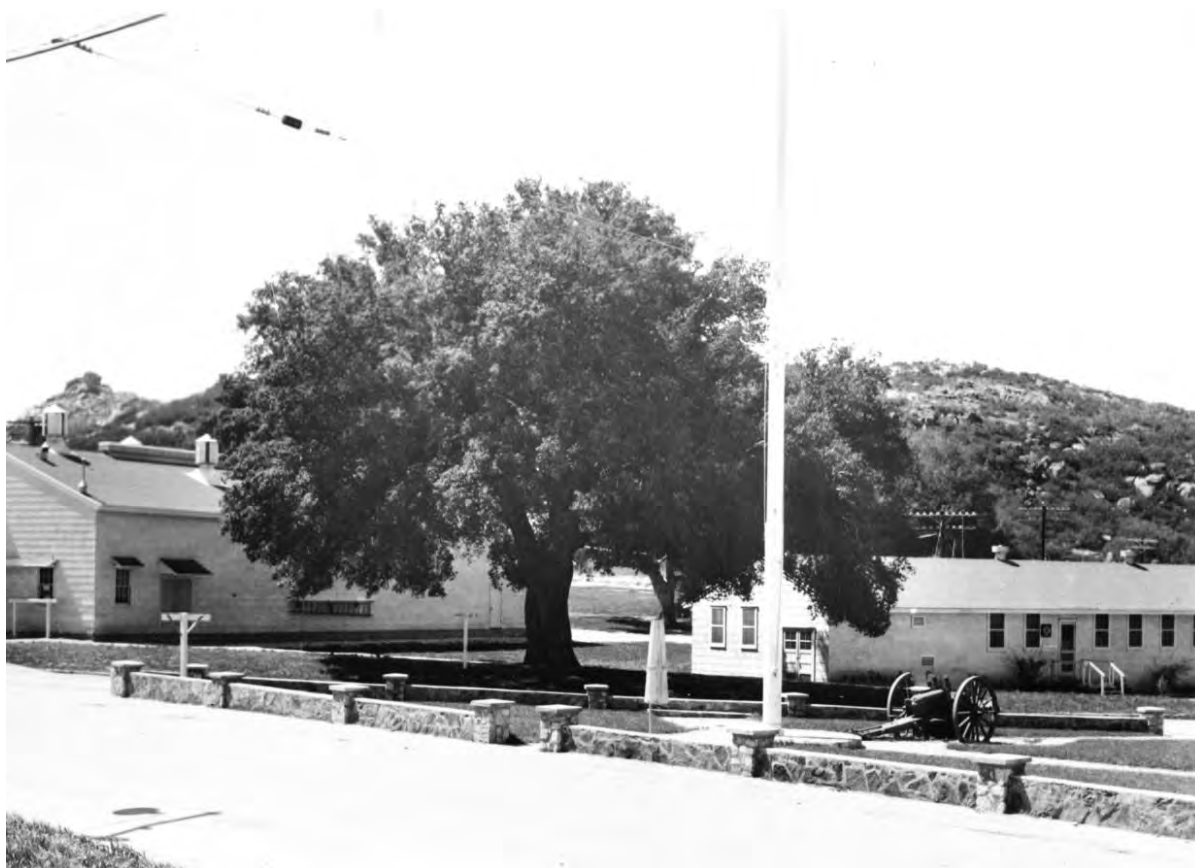
Figure 58. Flagpole Triangle, Main Post

The flagpole triangle area near the Main Post is seen here with the mortared stone walls built by the POWs. Source: MEHS Archives.

- Although the original flagpole in the Main Post area has been replaced, a new flagpole has been installed in the same location. The low rock wall built by the POWs that creates a triangular-shaped area surrounding the flagpole is extant. The flagpole from the entrance area has been removed. An existing flagpole is located on the north side of Jeb Stuart Road, adjacent to the fire station.

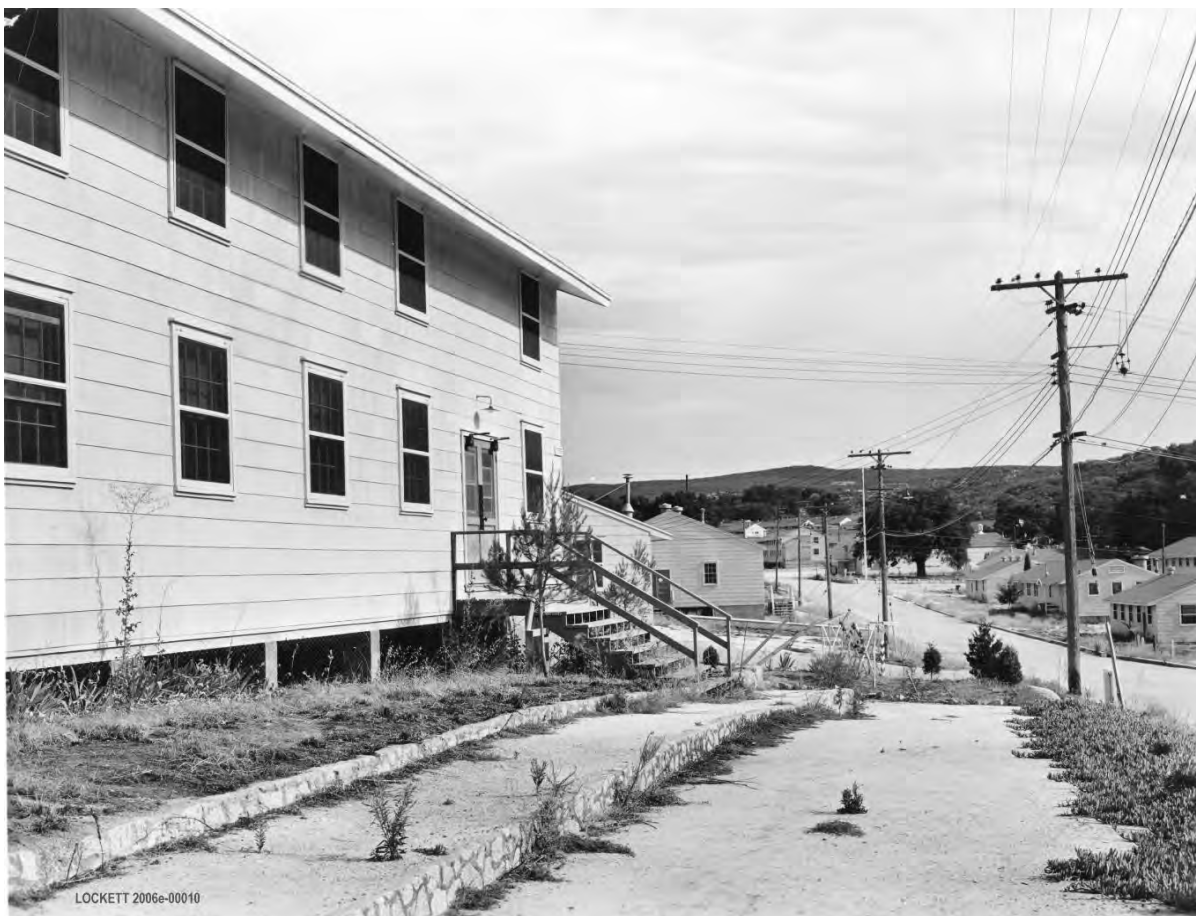
Figure 59. Mortared Retaining Walls, Moore Road

Mortared curb height retaining walls that appear to be near Moore Road. Photo taken after camp was decommissioned. Source: MEHS Archives.

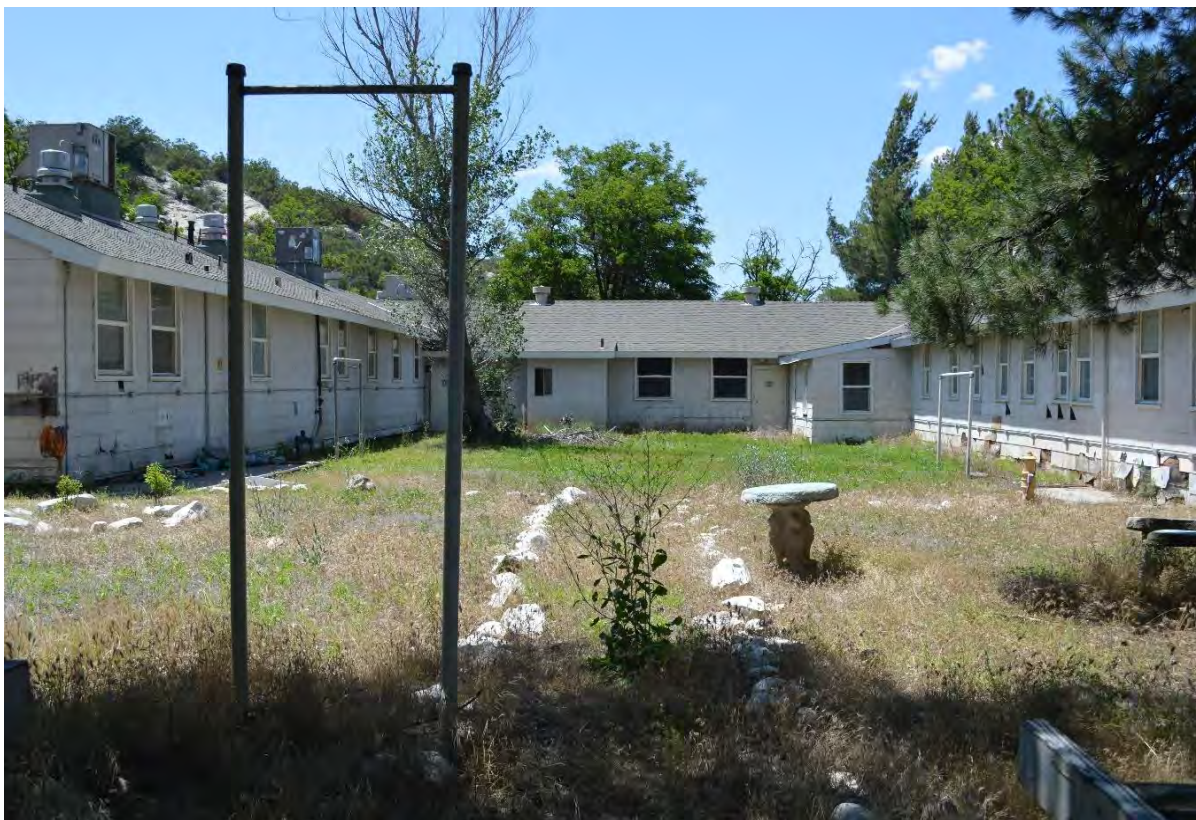
Figure 60. Open Courtyard, Hospital Complex

Various small scale features in one of the open courtyards in the hospital complex includes hose wheel, birdbath, pull-up bars. Source: ICF June 2019.

- Civilian workers housing features (clothes lines, fences, rock borders, retaining walls)
- Hospital area features (stone retaining wall lining front building, birdbath, hose wheel, pull-up bars, volleyball net)(Figure 60)
- Open concrete basin in stables area (Figure 65)
- Unidentified square concrete basins/footings

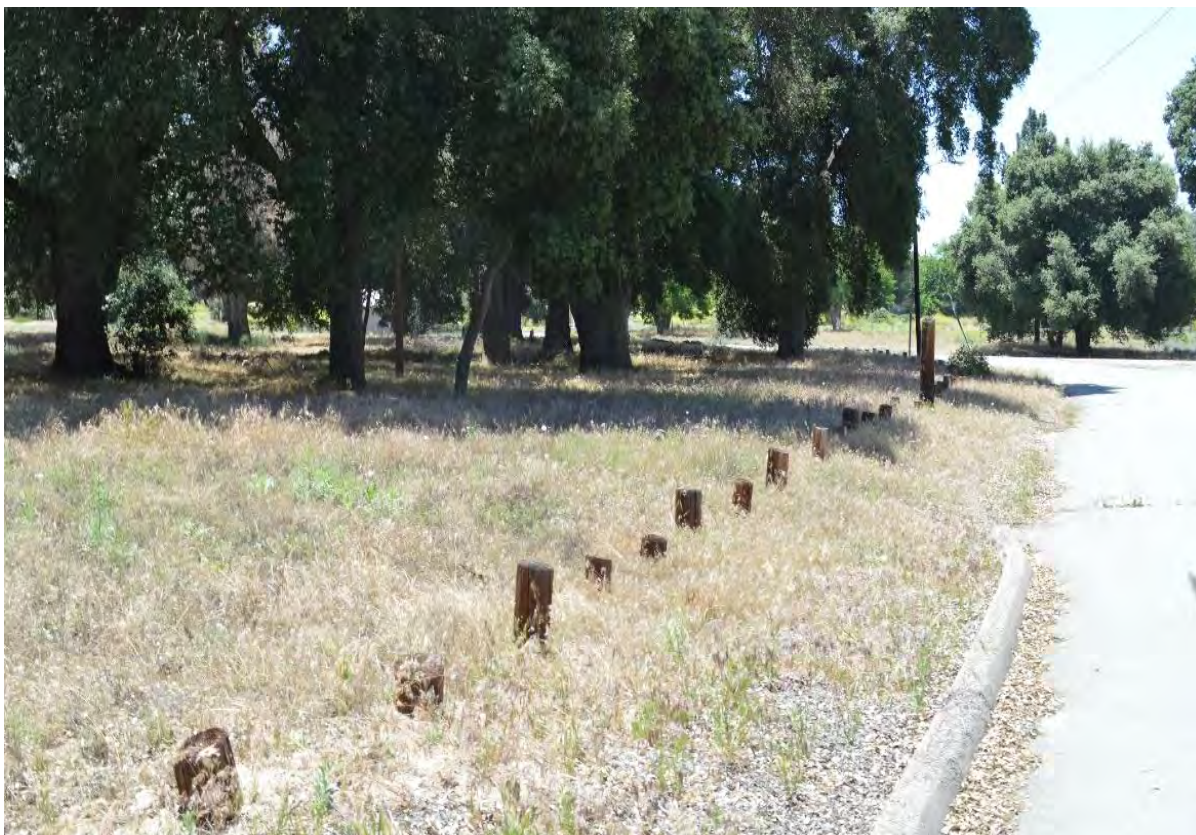
Figure 61. Creosote Logs, Chaffee Park

Creosote logs border Chaffee Park and nearby circulation features. Source: ICF June 2019.

- Creosote logs have been placed as a border around Chaffee Park and along the east side of Forrest Gate Road in the from the area near Chaffee Park south, near the entrance to CLEEF (see Figure 61). These are associated with the Rancho Del Campo era and are not compatible with the historic character of the site in materiality or style.

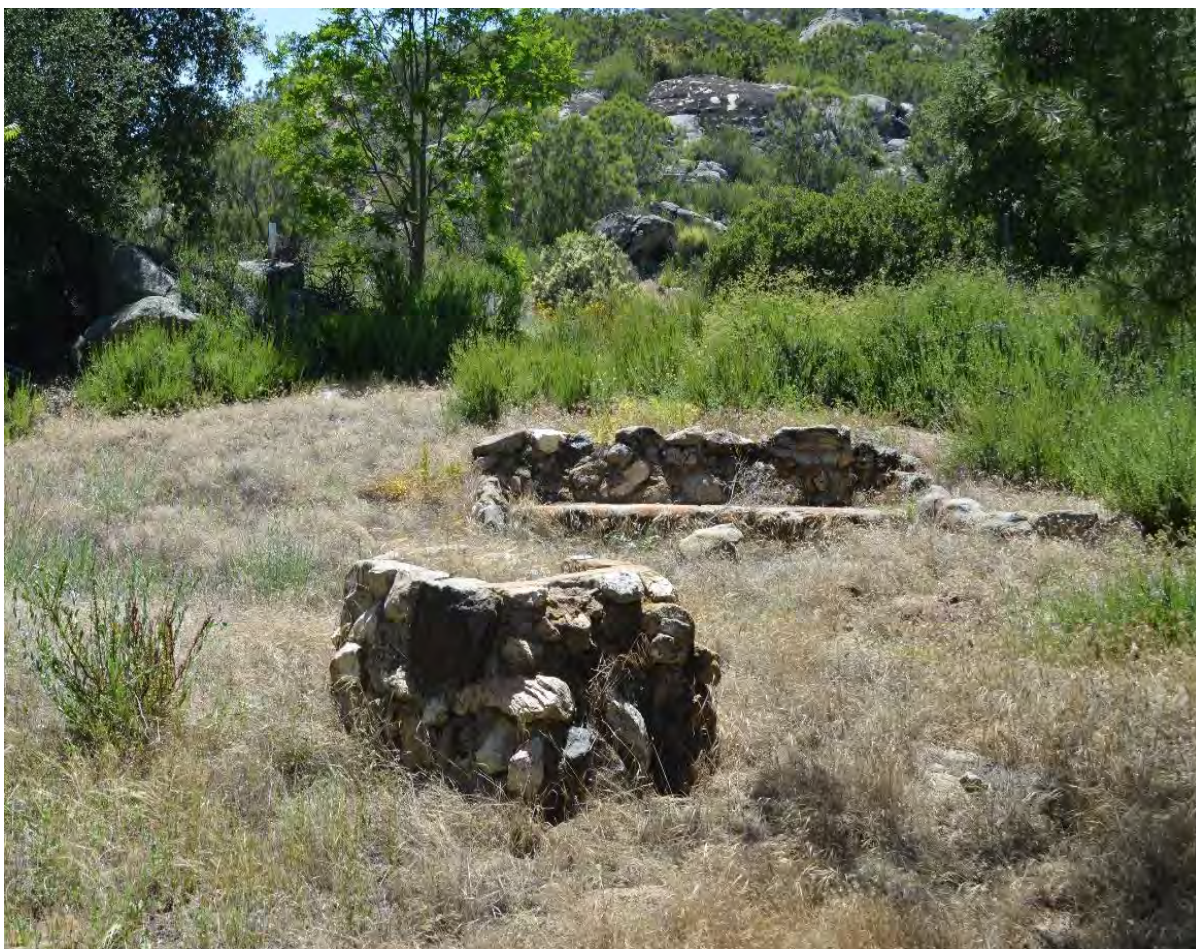
Figure 62. Bench and Grill

A bench and grill constructed of local stone is located near the south side of the hospital with an inscribed date of 1971. Source: ICF June 2019.

- The center of Chaffee Park contains small scale features constructed during the Rancho Del Campo era, including a grill inscribed with a 1970 date, a fountain, and a bridge structure built using local stone in a compatible style to the historic character of the site. Prior to World War II, local round stone was used for small scale features in the landscape, but during the war period, the POWs used faced local granite (see Figures 62 & 63).

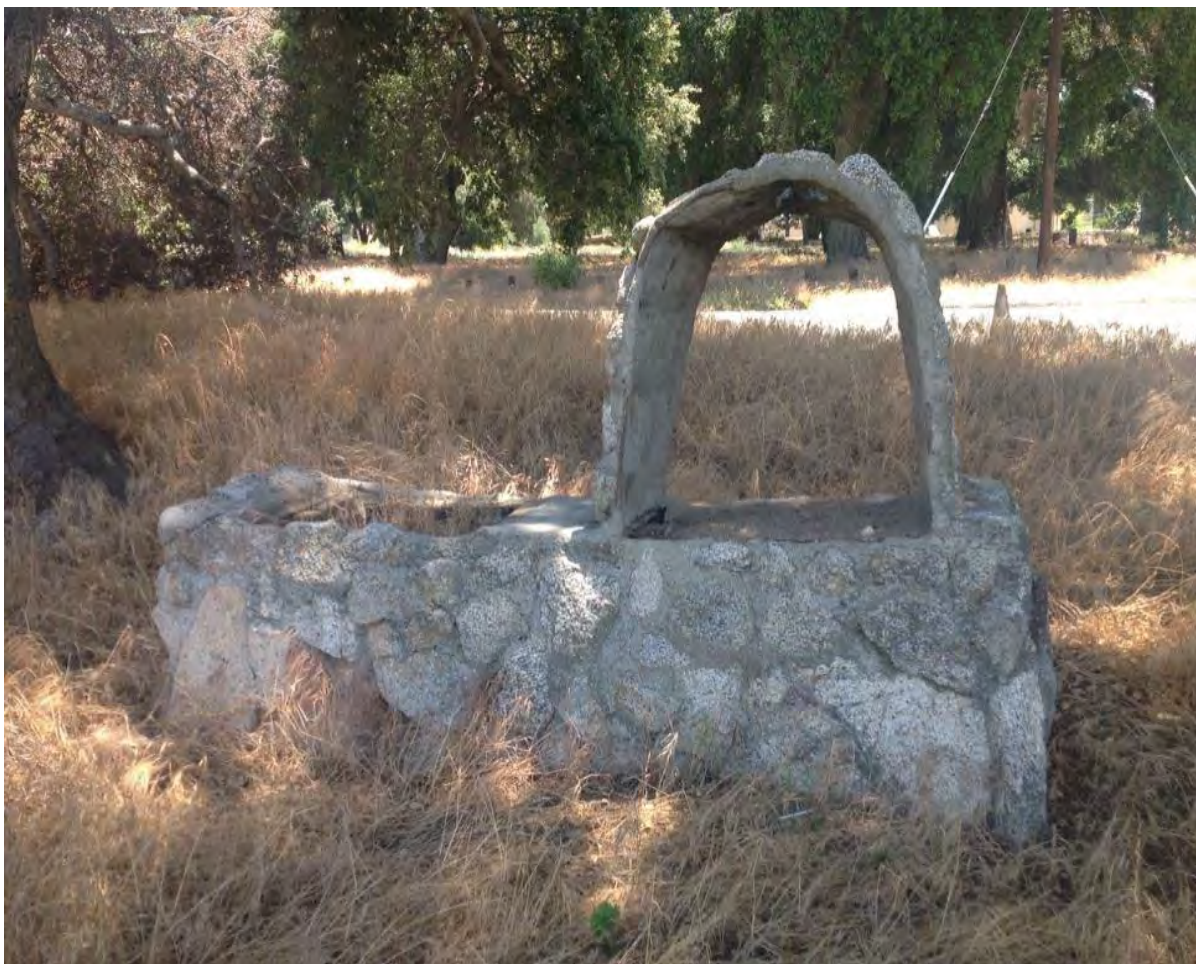
Figure 63. Stone Feature, Chaffee Park North

Stone feature north of Chaffee Park constructed by Rancho Del Campo with date inscription of 1970.
Source: ICF June 2019.

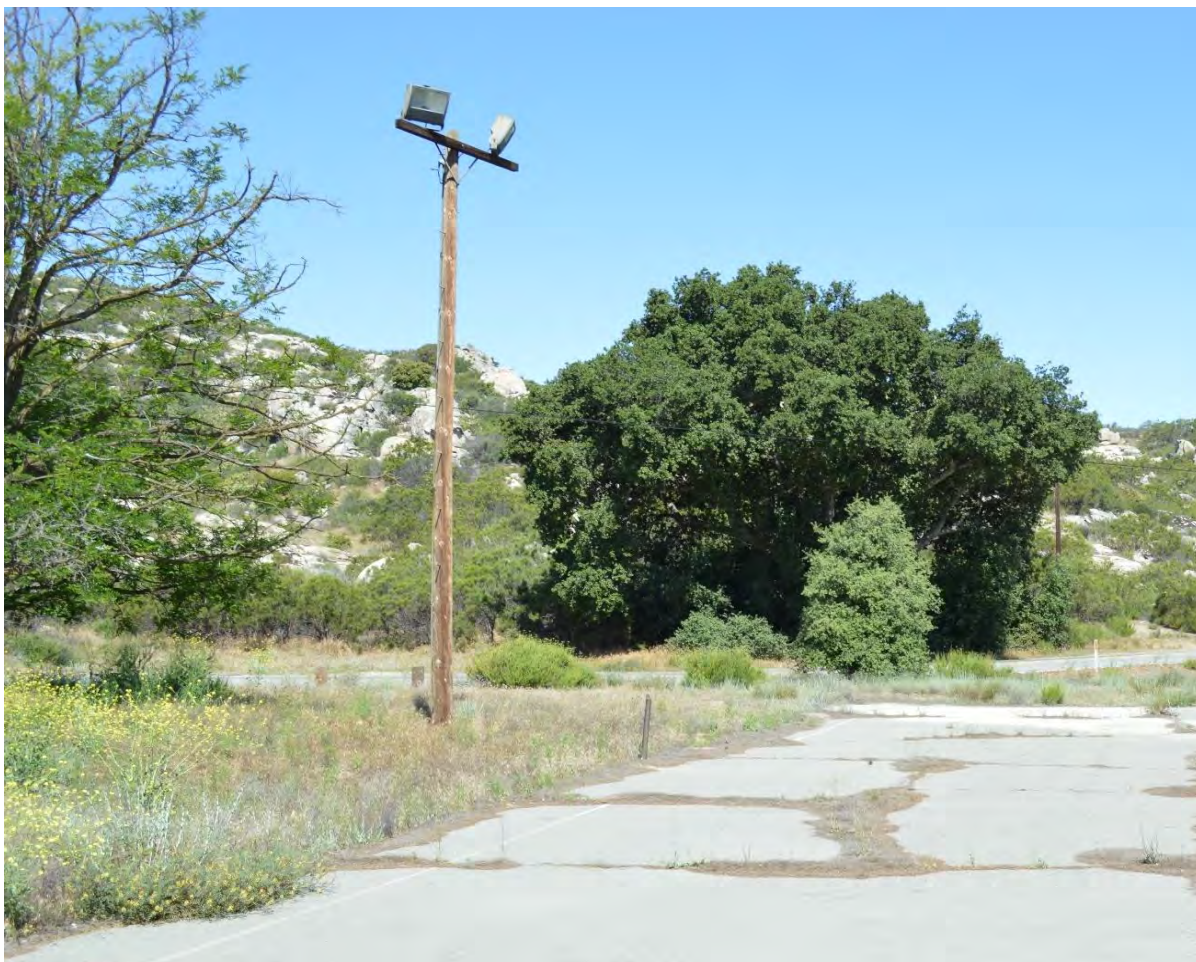
Figure 64. Rancho Del Campo Lighting Standards

This photo shows the Rancho Del Campo era lighting standards. This photo was taken at the handball court southeast of the hospital complex. Source: ICF June 2019.

- During the Historic Period, recreation fields were created at Camp Lockett, especially during the Hospital Phase. During the Rancho Del Campo era, several additional recreational fields were added to the site that maintained the rural character of the Historic Period and setting. New concrete has been poured over building foundation slabs to create basketball courts throughout the site. In other areas where World War II-era buildings have been demolished, the open fields have been used for baseball diamonds, such as the historic headquarters area. South of the hospital complex, a cluster of recreational fields has been built, including two basketball courts, a handball court, a baseball diamond with two single benches and a foul-ball fence, and a running track on a terrace above the other features. Concrete steps lead from the handball court to the running track. The recreational fields used by the Rancho Del Campo era consistently use the same style of lighting standards (see Figure 64).
