Subject: Memo—Proposed revisions to the Camp Lockett Master Plan and Overlay Zone

**CAMP LOCKETT CULTURAL LANDSCAPE TECHNICAL
REPORT, SAN DIEGO COUNTY, CALIFORNIA**

December 2019

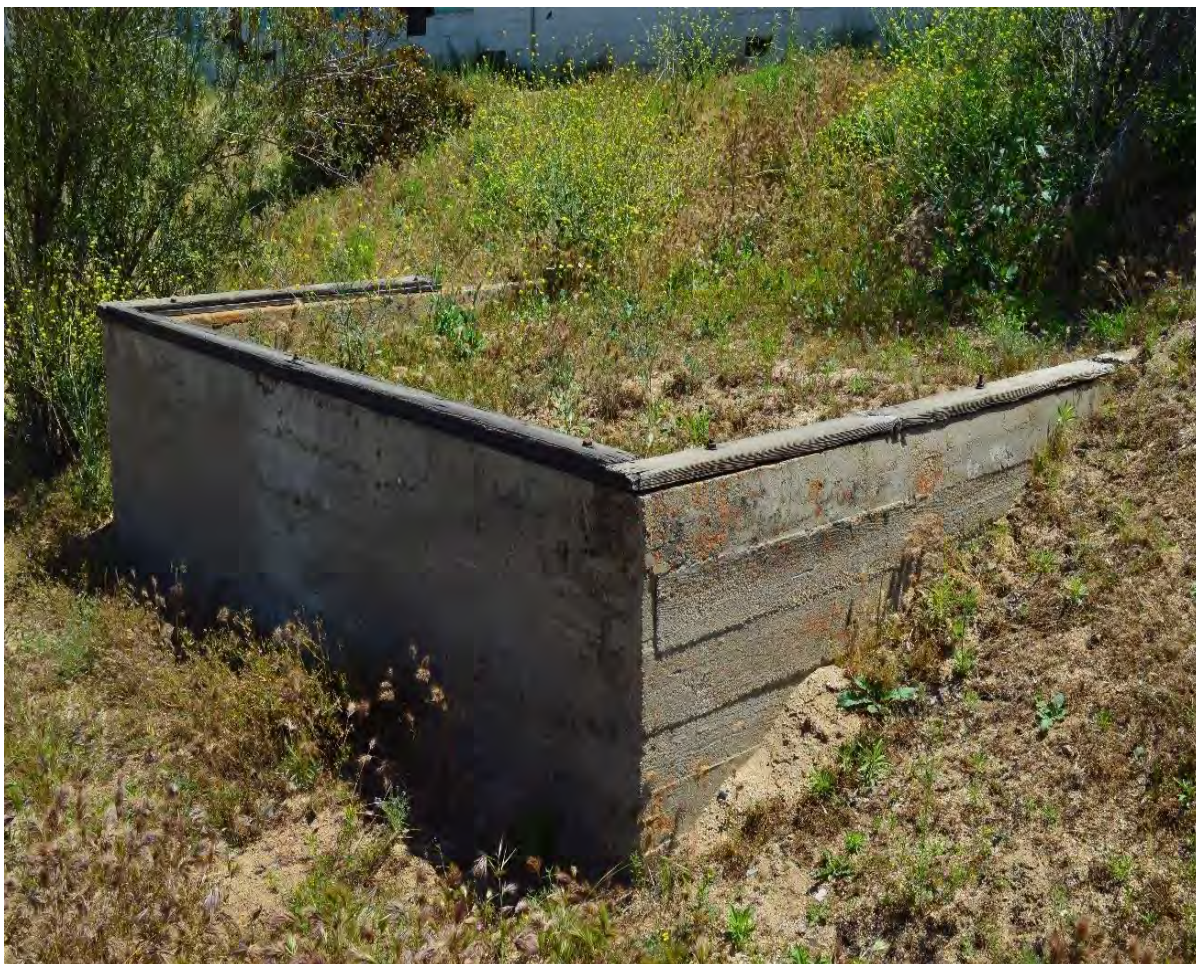
Figure 65. Concrete Basin at Stables Area, North

A concrete basin built into the slope located on the north side of the stables area. Source: ICF June 2019.

- Civilian workers housing features (clothes lines, fences, rock borders, retaining walls)
- Hospital area features (stone retaining wall lining front building, birdbath, hose wheel, pull-up bars, volleyball net)(Figure 60)
- Open concrete basin in stables area (Figure 65)
- Unidentified square concrete basins/footings

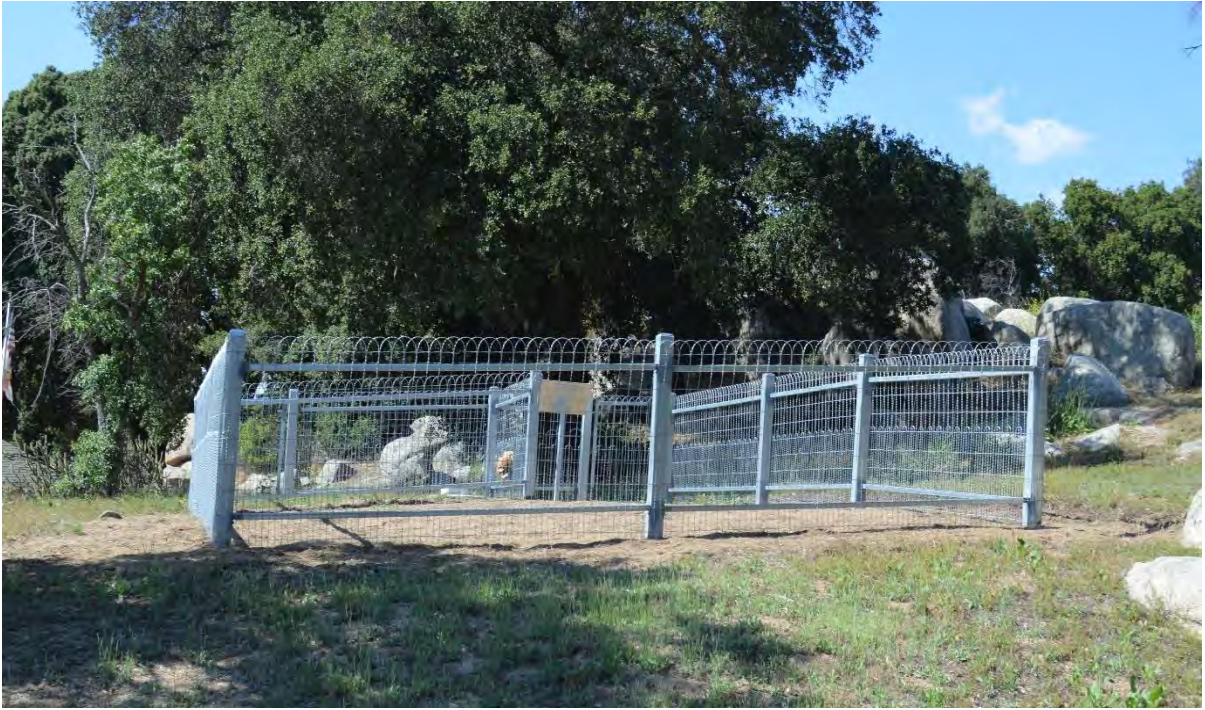
Figure 66. Pioneer Cemetery Fence and Markers

This photo shows the markings and fence that surround the 30-foot x 20-foot cemetery. View looking north. Source: ICF June 2019.

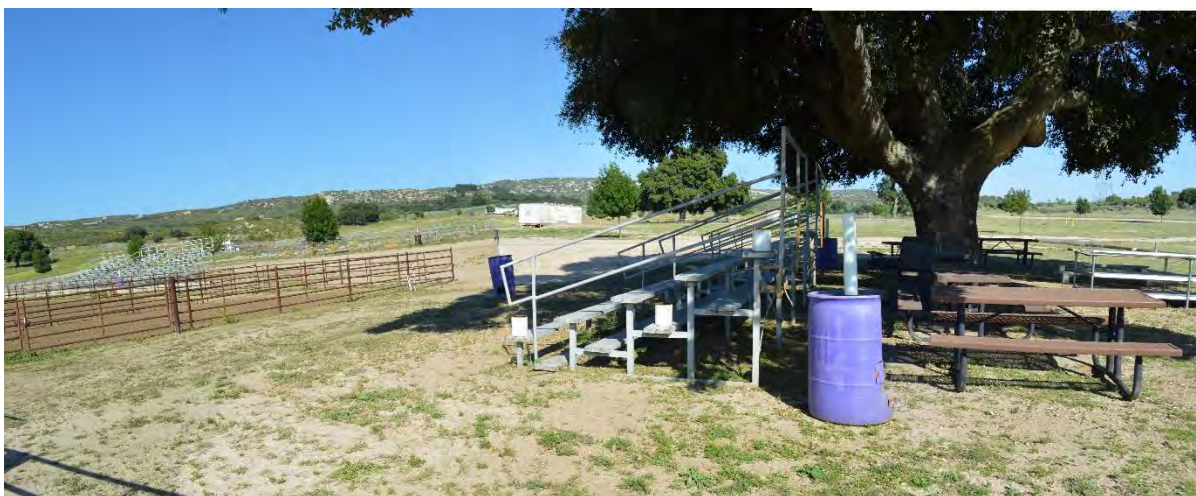
Figure 69. CLEEF Small Scale Features

Equestrian facilities at CLEEF include numerous small scale features, such as bleachers, paddocks, picnic tables, and more. Source: ICF June 2019.

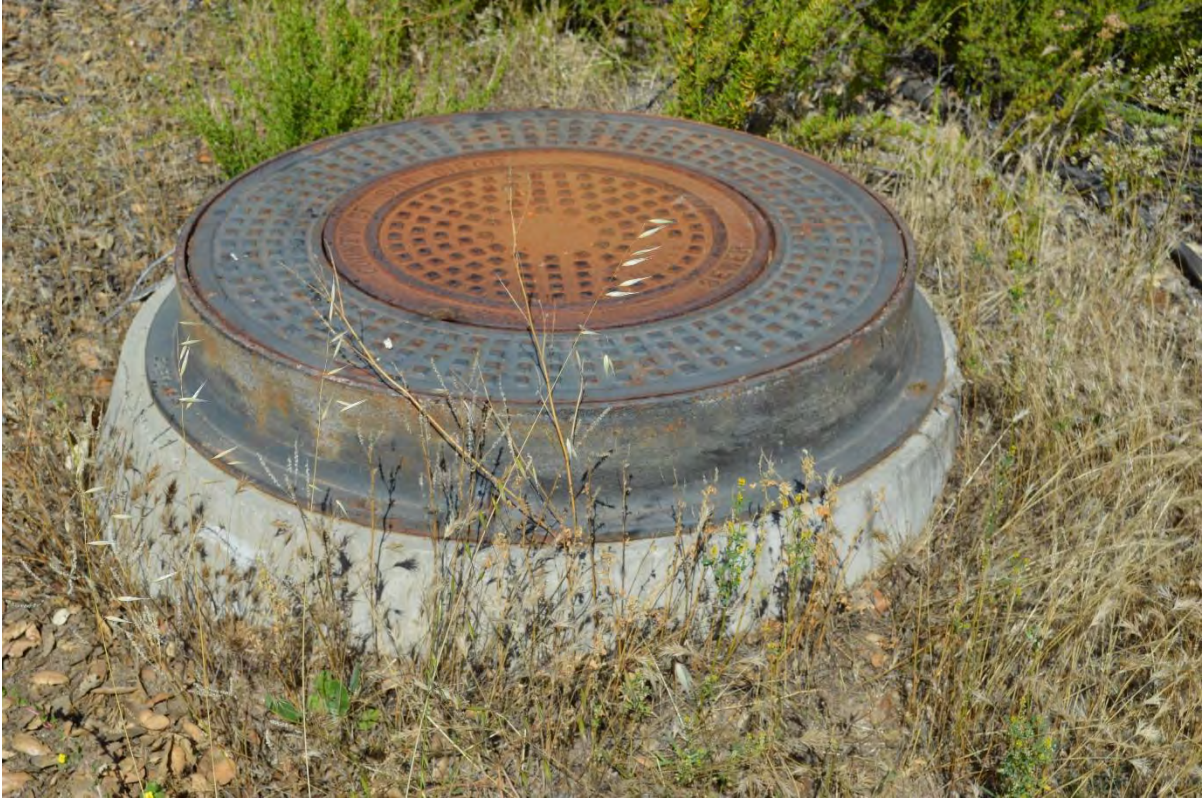
Figure 70. County of San Diego Manhole Cover

The San Diego County Sanitation District serves the community of Campo with sewer sanitation facilities located throughout the site. Source: ICF June 2019.

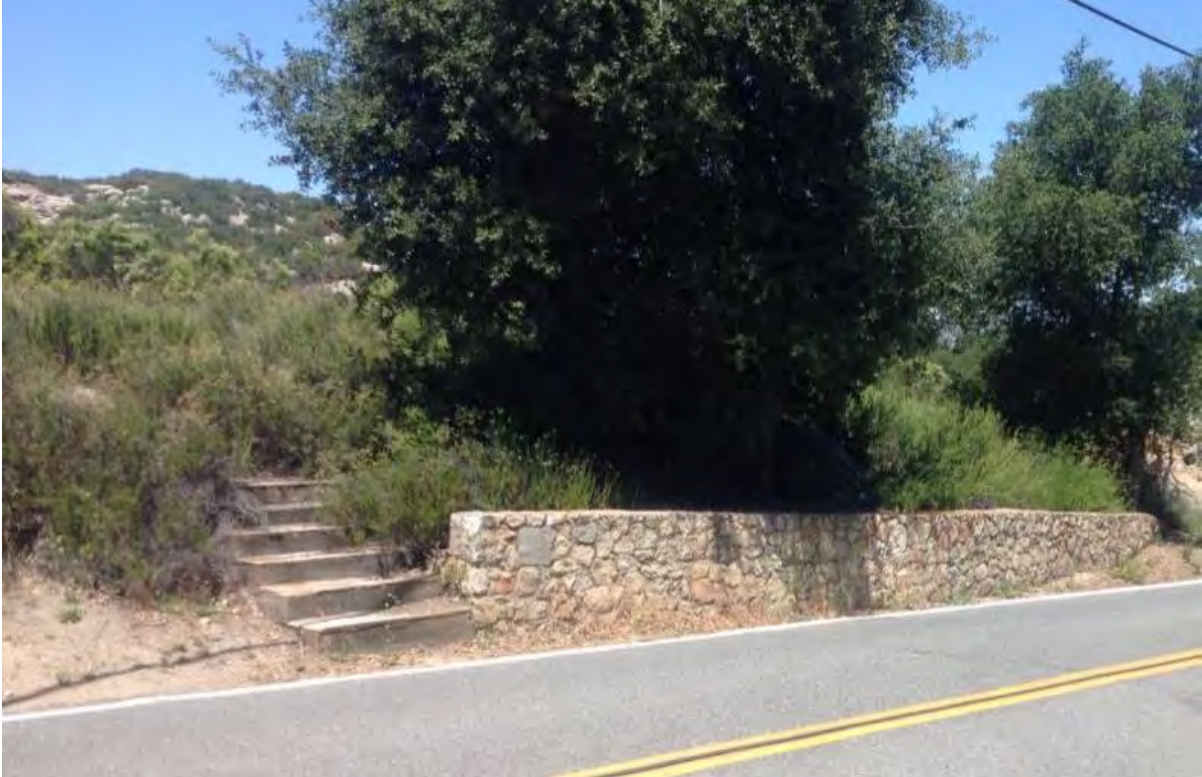
Figure 71. Mortared Granite Wall

A coursed mortared granite wall and stairs (covered in concrete) leads to the historic area of the dormitories north of the civilian workers housing complex, west of Forrest Gate Road. Source: ICF June 2019.

- A retaining wall and two stairways along Forrest Gate Road indicate that the historic location of the civilian worker dormitories that were built during the Expansion Phase (see Figure 71).

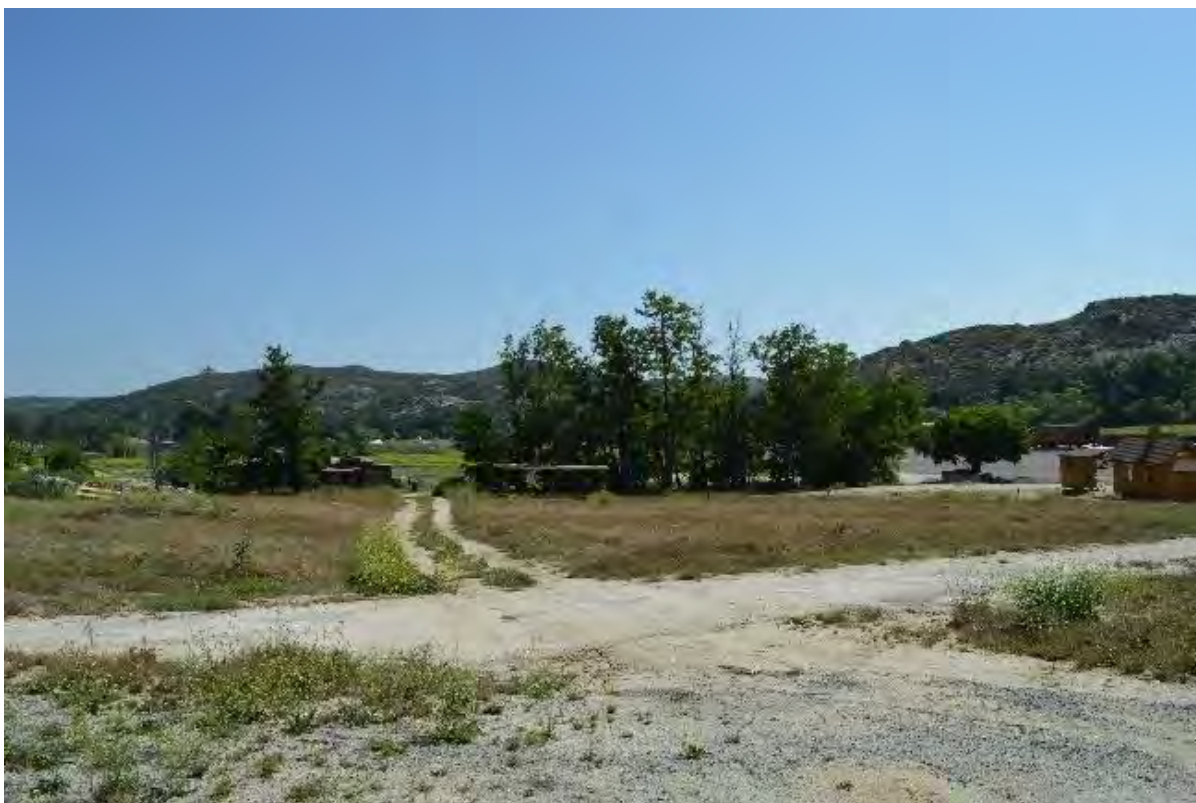
Figure 72. Two Road Traces Pictured Near the Railroad Depot Building.

The trace in the foreground crossing from left to right of photo is the historic Nicholson Road with remnant asphalt. Source: ICF 2019.

- Several road traces are evident in both north-south and east-west alignments between the PSRM parking lot/depot building and Sheridan Road. The Nicholson Road trace extending eastward toward the historic stables area from the railroad has remnants of World War II era asphalt (see Figure 72).

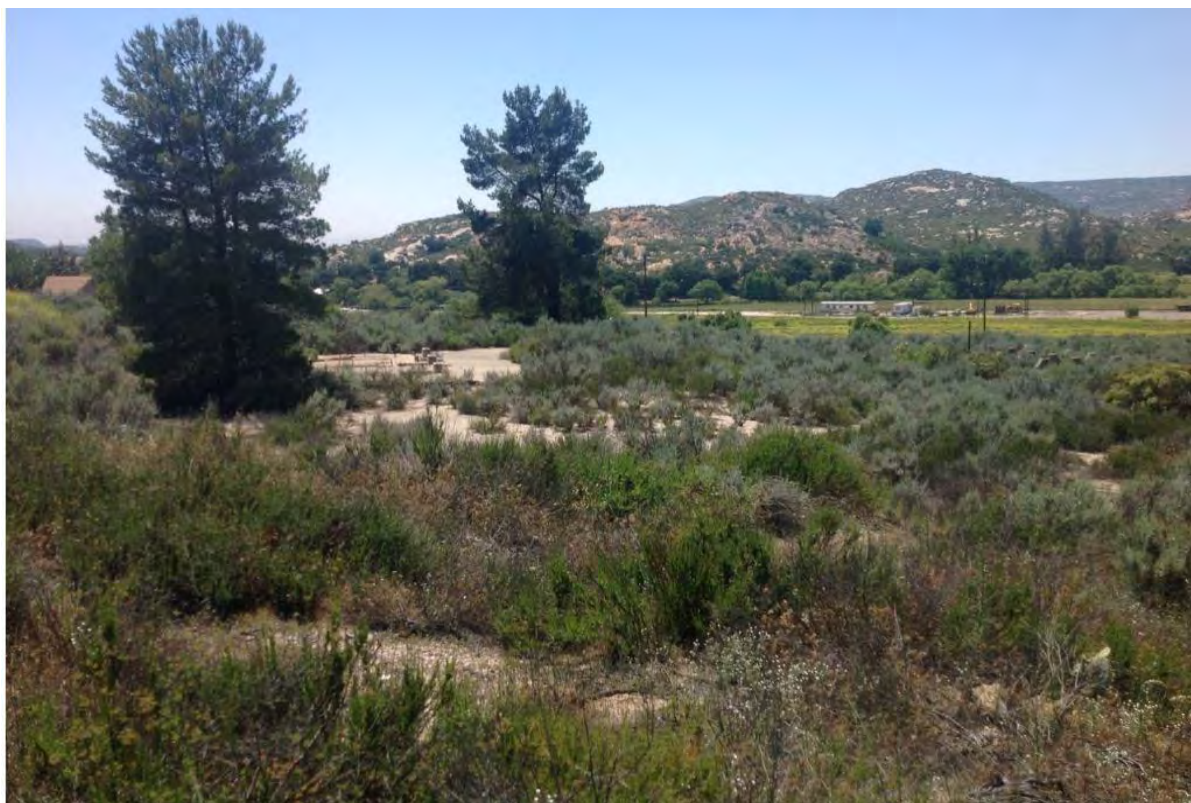
Figure 73. Foundation Slabs and Piers East of Sheridan Road

Foundation slabs and piers are seen under overgrown vegetation east of Sheridan Road in the historic stables area. Piers to the right of the photo in the sage. Source: ICF June 2019.

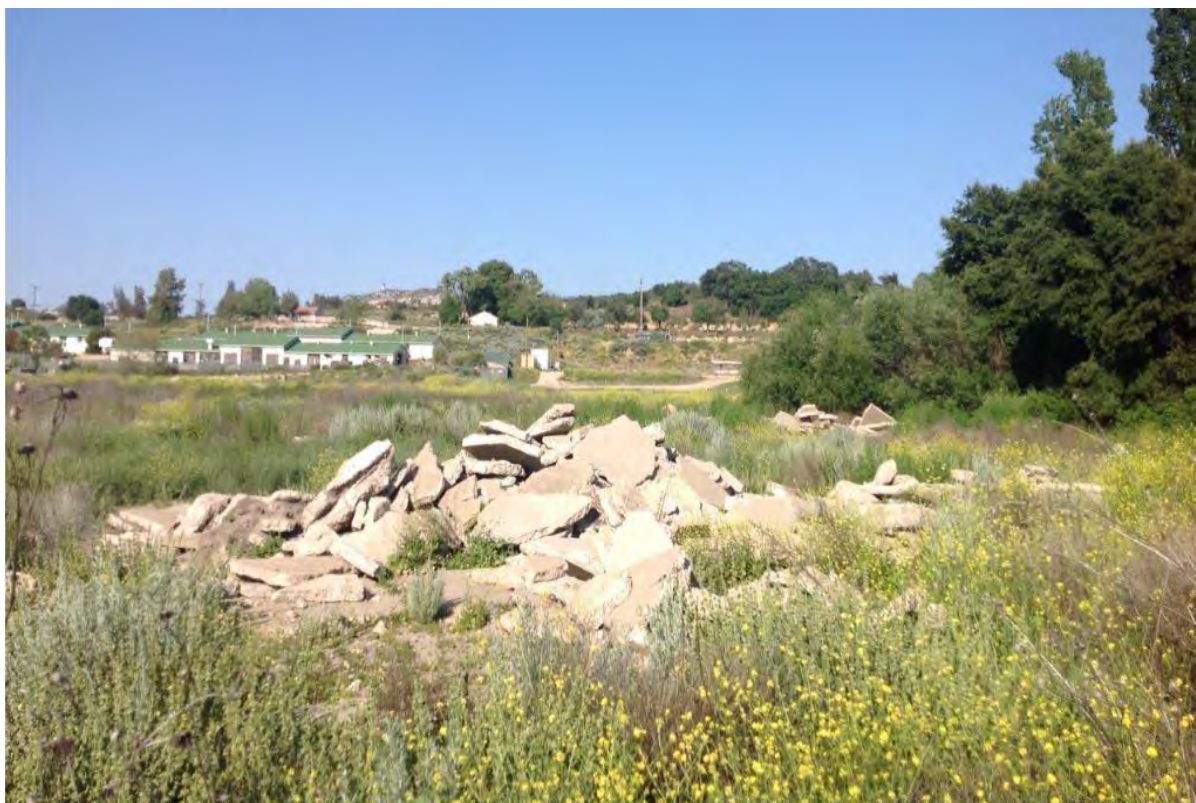
Figure 74. Four Concrete Foundations of the Warehouse Buildings

Four concrete foundations of the warehouse buildings in the Quartermaster area are in piles of rubble.

- The historic Quartermaster area is today occupied by U.S. Border Patrol facilities, a feed store, and private ownership occupying historic buildings. The Quartermaster warehouses foundation slabs are in rubble form.

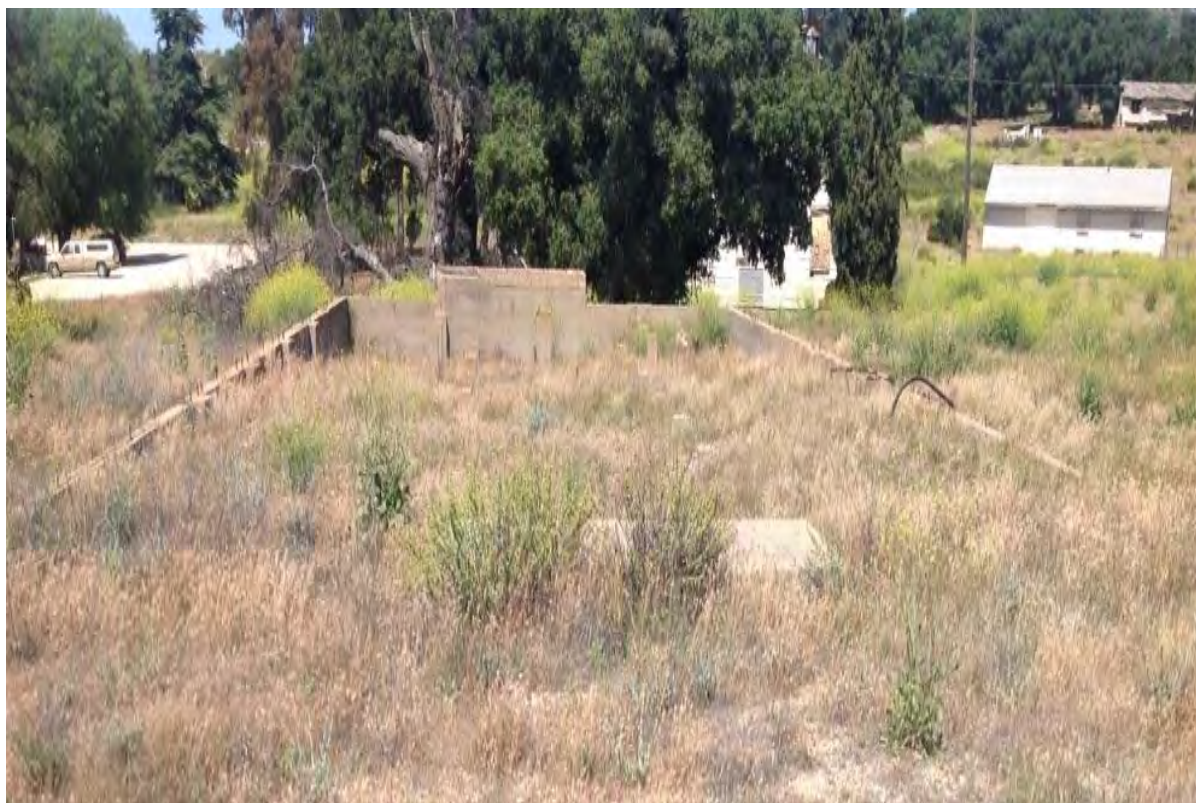
Figure 75. Chapel Foundation West of Theater with Concrete Piers
Chapel foundation west of theater with concrete piers in the center. Source: ICF June 2019.

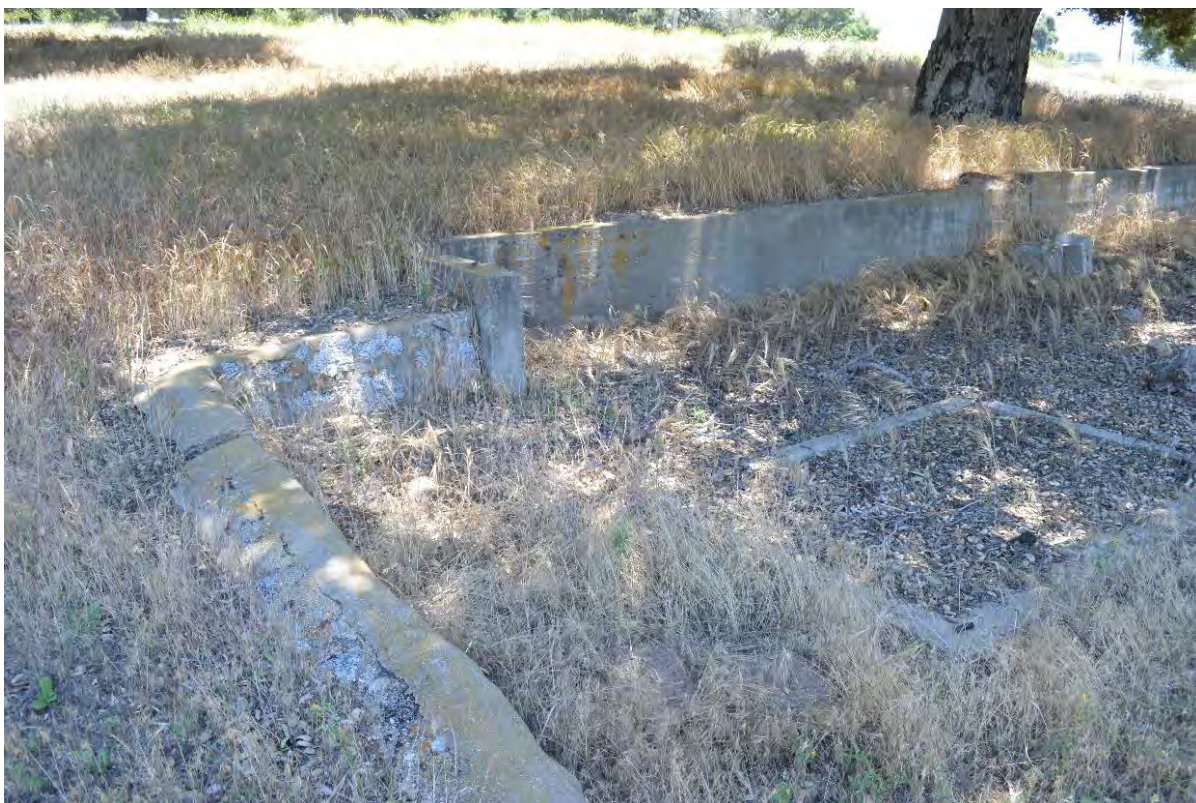
Figure 76. Terraces and Foundation Slabs East of Wheeler Road and Chaffee Park

East of Wheeler Road and Chaffee Park are terraces with foundation slabs, piers, and walls remnants. Pictured here is a concrete foundation wall and mortared stone wall. Source: ICF June 2019.

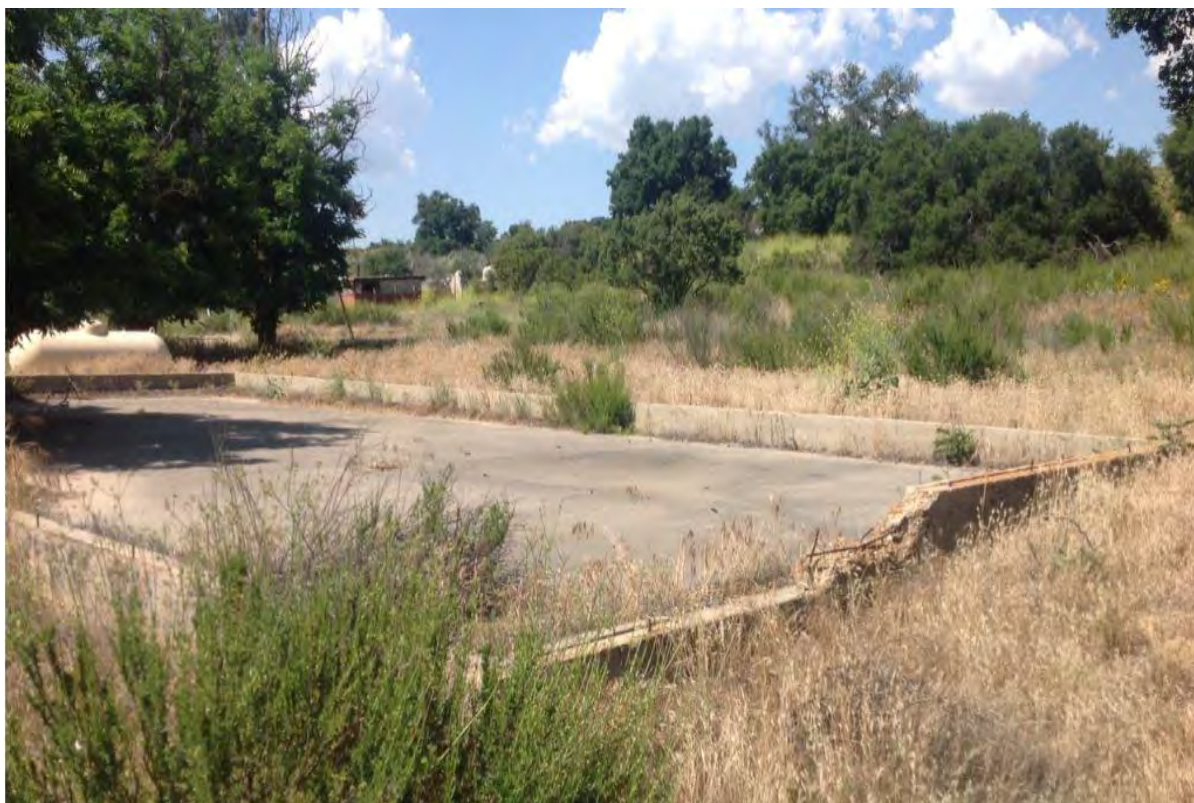
Figure 77. Historic Foundation Slab with New Poured Concrete

Historic foundation slab with new poured concrete in center is pictured here east of Moore Road. Source: ICF June 2019.

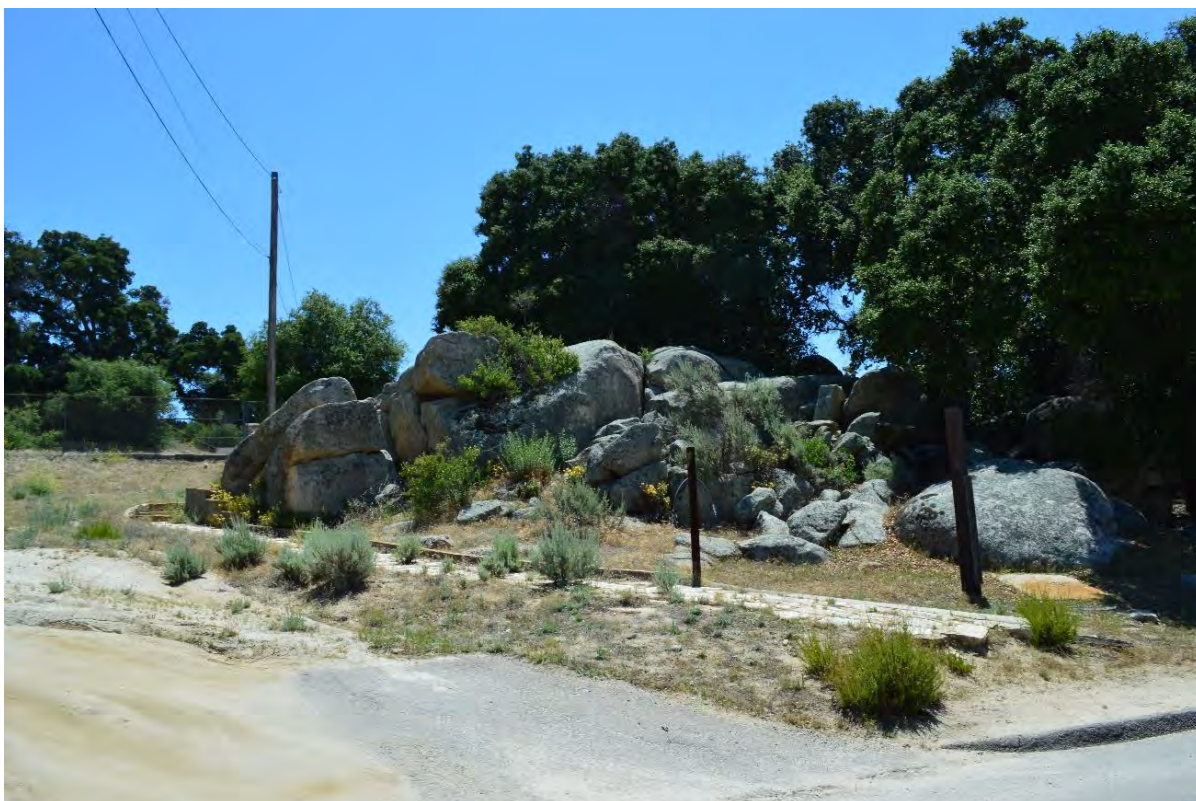
Figure 79. Stone Pathway Leading to Pool

A stone pathway with low walls originally built by the POW leads to the pool, across from the Community Building. Source: ICF June 2019.

- The mortared stone pathway leading to the swimming pool east of the community building on Sheridan Road includes a combination of concrete and masonry wall, with a concrete open culvert on the south side of the pathway (see Figure 79). The workmanship of the mortar and concrete patchwork reveals that improvement projects have occurred since it was first constructed, likely during the Rancho Del Campo era.

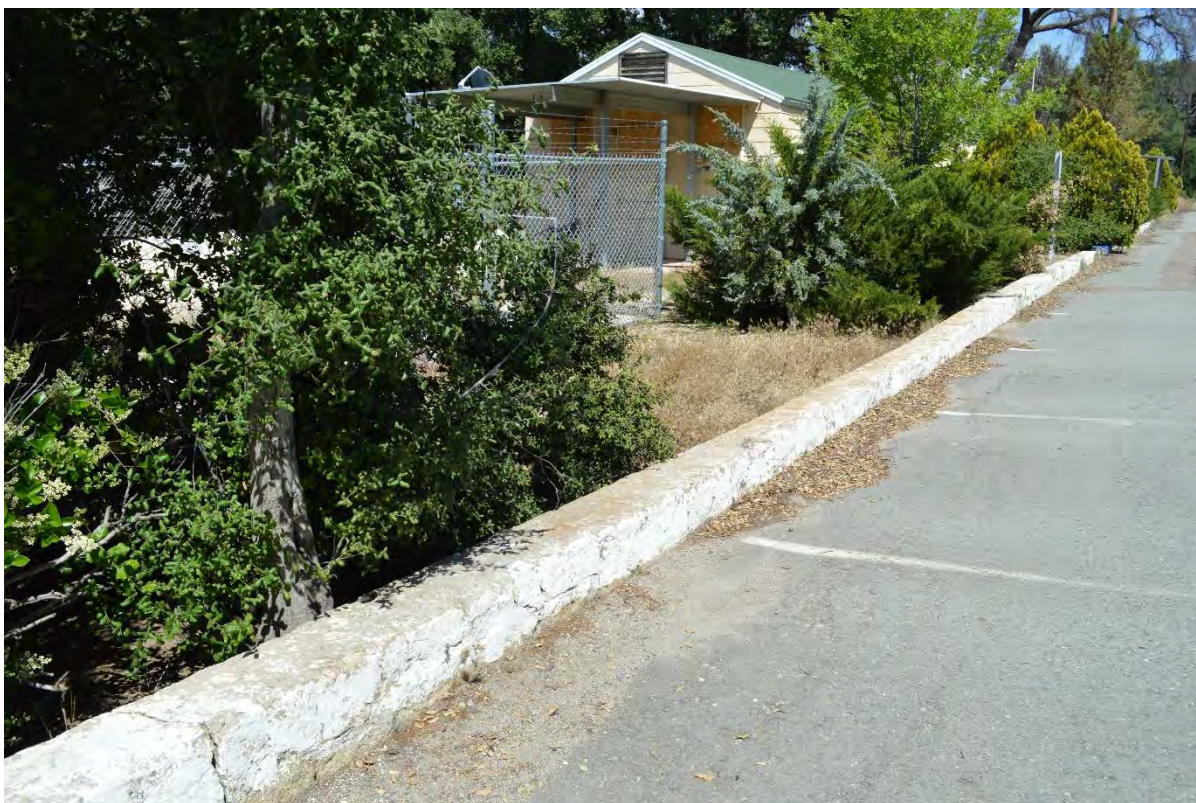
Figure 80. Low Rock Wall, Painted

A low rock wall on the western edge of Chaffee Park facing the Hospital Complex has been painted white. View looking east. Source: ICF June 2019.
