# Desert Habitat Restoration on SCE's Eldorado-Ivanpah Transmission Project

Scott McMillan\* and Linda Robb, AECOM

# The Eldorado-Ivanpah Transmission Project

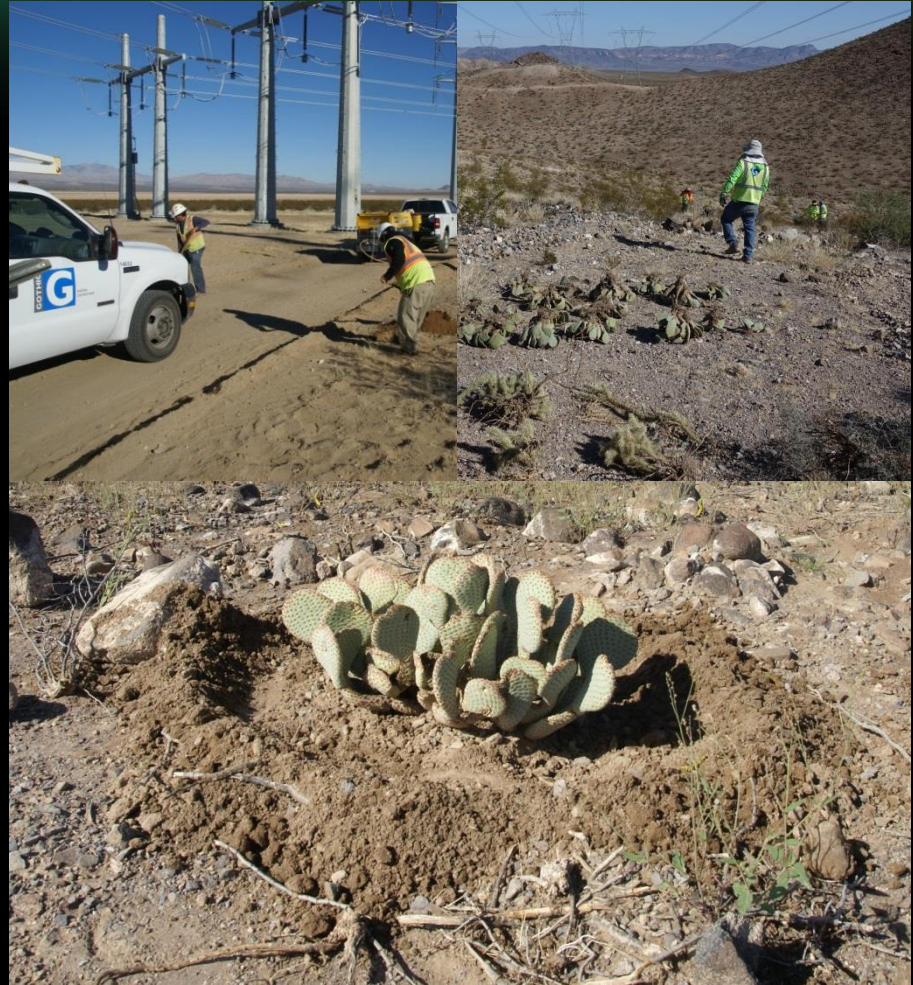
# Succulent Transplantation

- 223 nurseries across EITP
- BLM approved leaving 50 percent of succulents *in situ*
- Approximately 4,700 succulent individuals transplanted back to restoration areas
- Prioritized healthy plants for transplanting
- Special-status succulent species left *in situ*

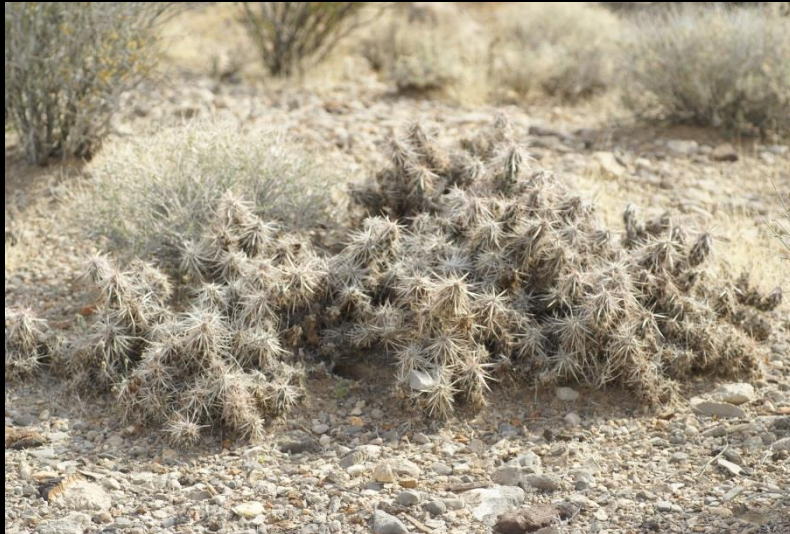
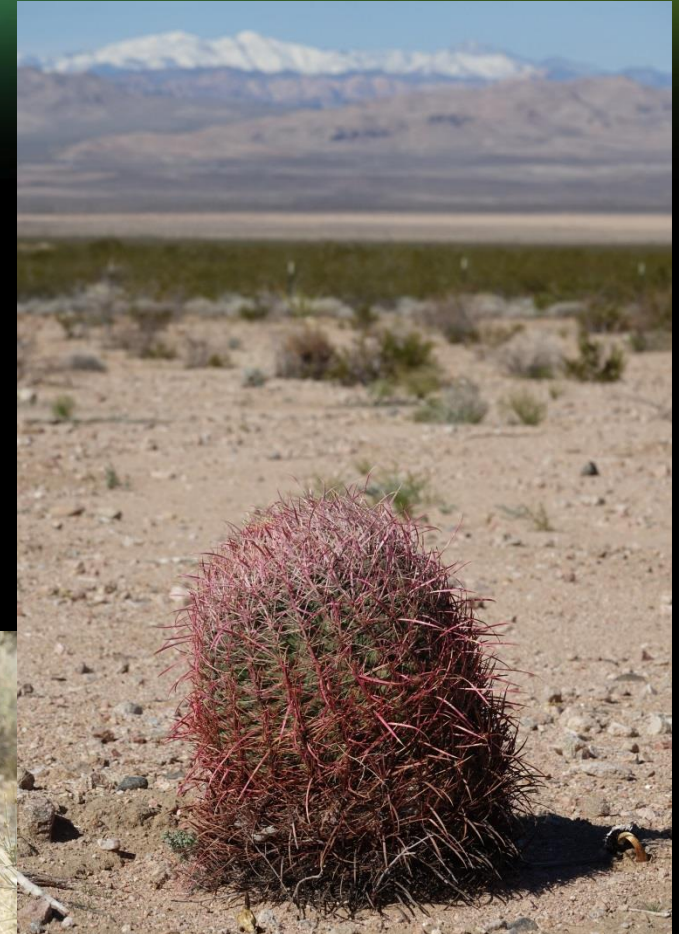
- Matted cholla (*Grusonia parishii*) – photo
- California barrel cactus (*Ferocactus cylindraceus*) –photo
- Desert pincushion (*Coryphantha* spp.) - 2 species both sensitive

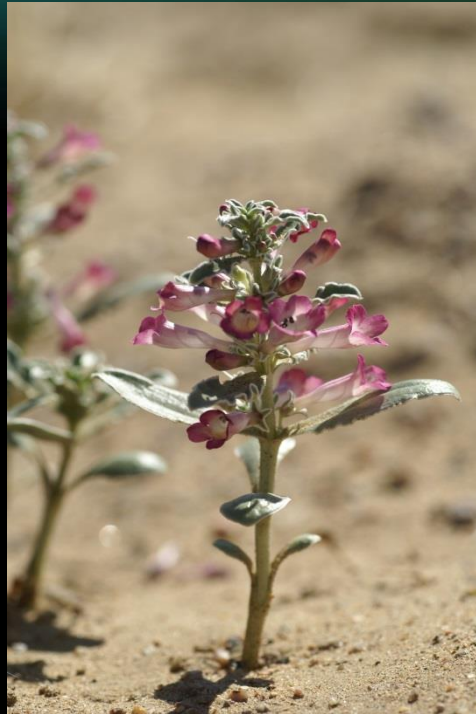
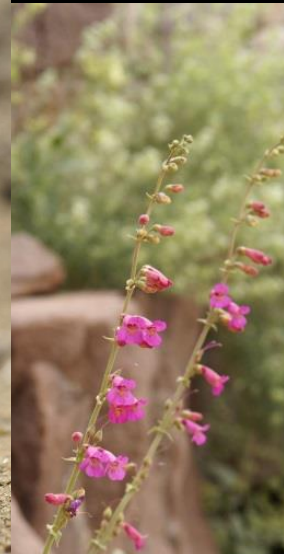
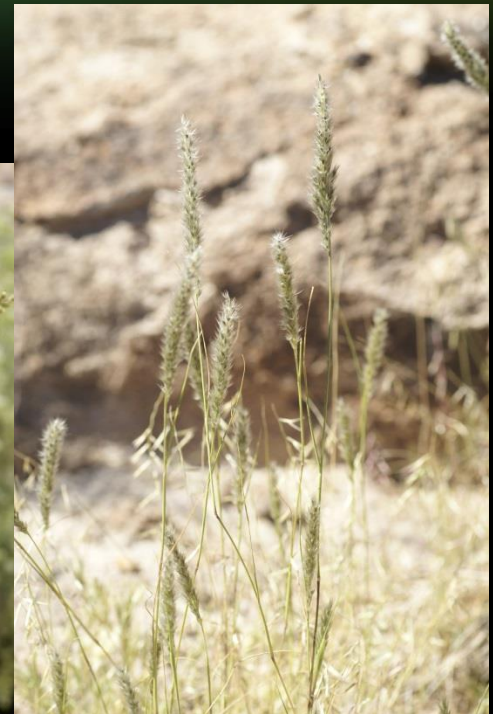
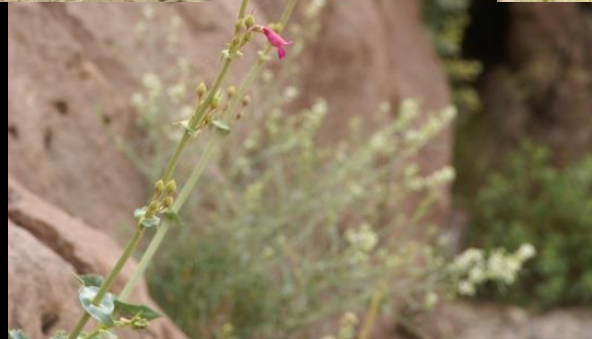
- Rosy two-toned beardtongue (*Penstemon bicolor* ssp. *roseus*) – photo
- White-margined beardtongue (*Penstemon albomarginatus*) – photo
- Nine-awned pappus grass (*Enneapogon desvauxi*) - photo

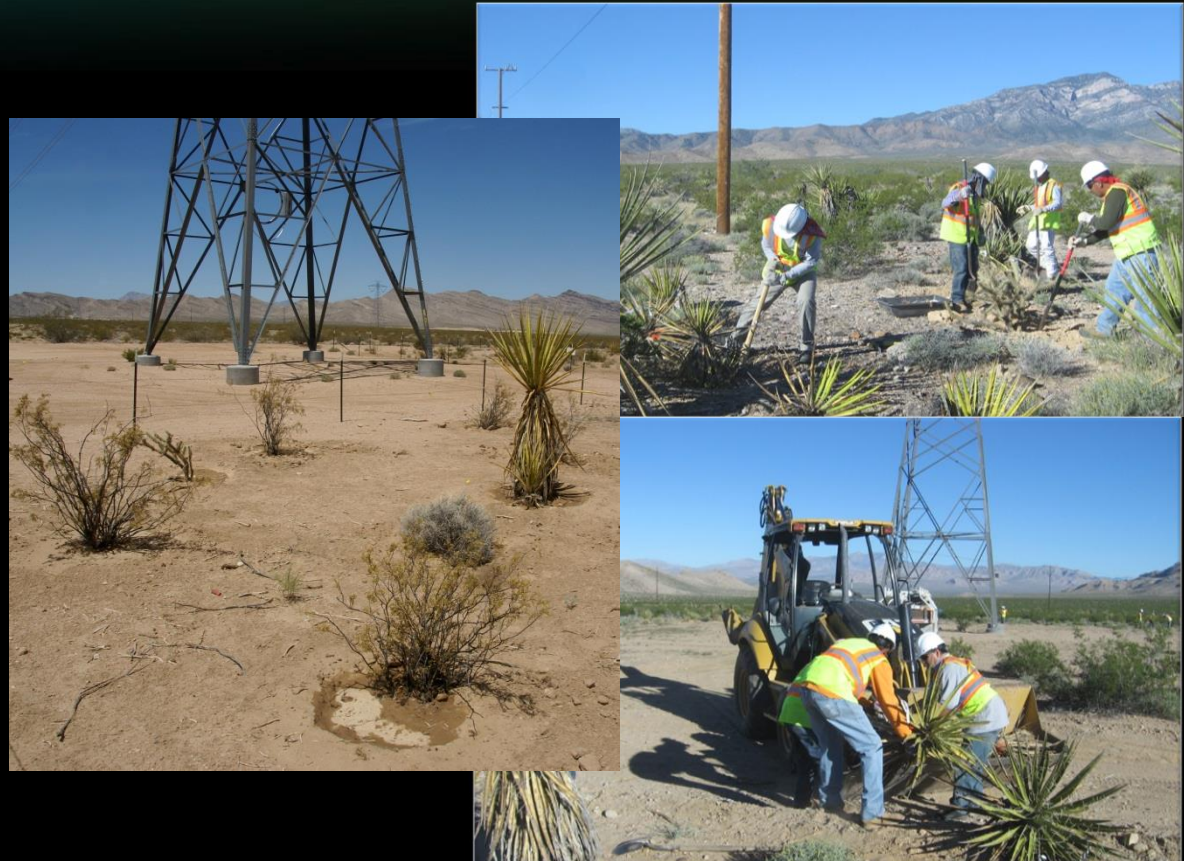
# Shrub and Succulent Transplantation

- Transplantation of over 3,000 additional succulents and shrubs to enhance cover
- Have transplanted straight from adjacent Project sites, from plants transplanted into nurseries, and from plants transplanted into containers
- Have transplanted in the summer

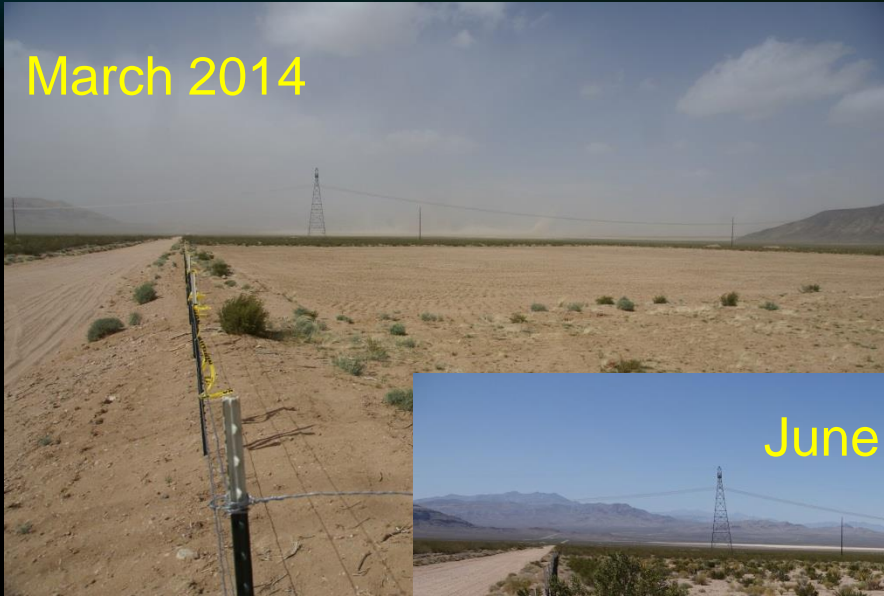
March 2014

- Plants excavated and planted with equipment within same day of salvage

- Small to medium plants
- Plants bare rooted
- Water!

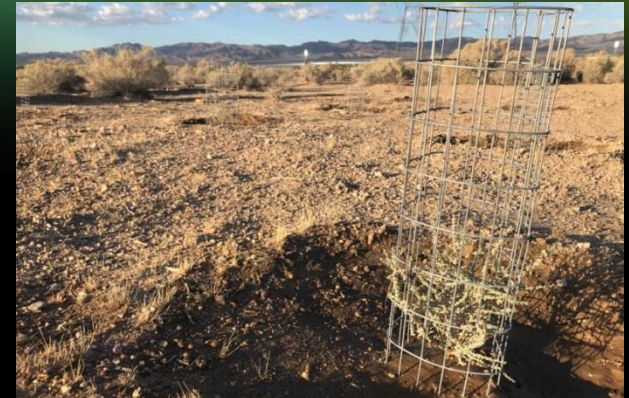
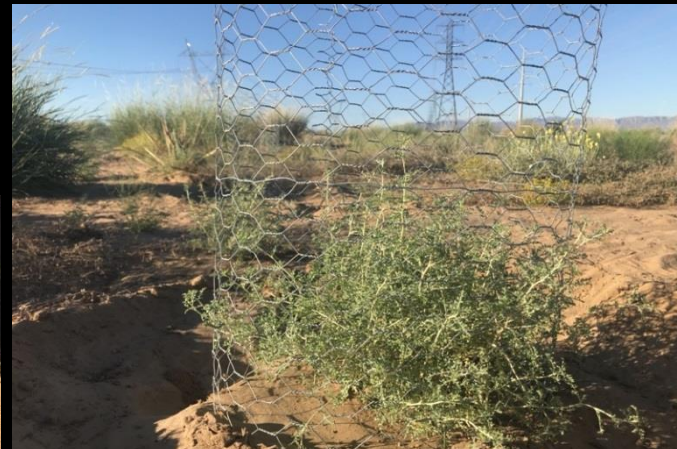
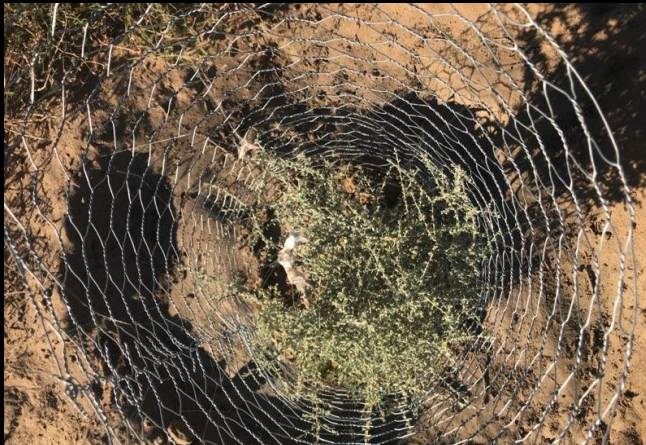
# Remedial Efforts in 2018

- Over 3,000 container plants, mostly salt bush (*Atriplex polycarpa*), installed at the 7 sites not meeting Final Success Standards
- Currently watering them in an effort to bring native shrub cover to 60% at the 7 sites.
