## High Desert Lore and Hydrogeology of the Jacumba Valley, Jacumba Hot Springs, San Diego County, California

CHARLES E. HOUSER, [chouserscsengineers.com](http://chouserscsengineers.com), and MONTE L. MURBACH, [mmurbach@murbachgeotech.com](mailto:mmurbach@murbachgeotech.com)

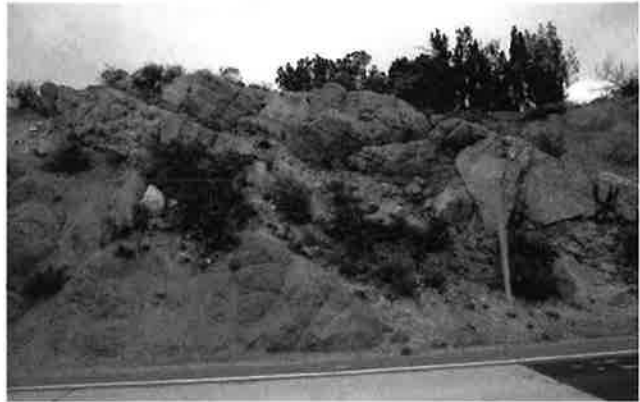
Figure 6. Granitic pegmatite dike in road cut in the western portion of Jacumba Hot Springs

secondary preferred fracture set, orthogonal to the primary set, also strikes north-northwest and dips steeply northeast. Fractures associated with the primary fracture set are commonly intruded by aplite and pegmatite dikes of granite composition. These dikes range from a few centimeters up to approximately four meters or more as exposed in the study area and encountered in borings. The aplite and pegmatite dikes are generally highly internally fractured. Figure 6 is a photograph showing pegmatite dikes exposed in the road cut along Old Highway 80 in the western portion of town.

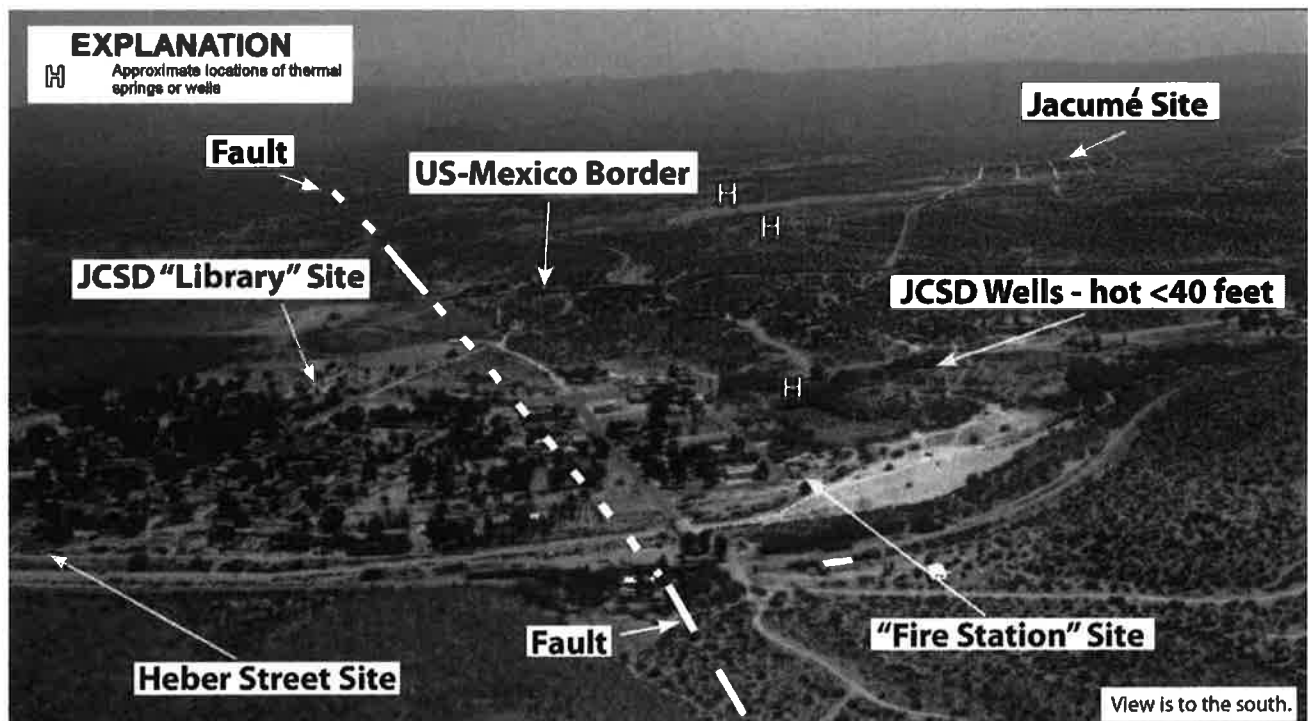
Figure 8. Oblique aerial photograph of the Jacumba area showing thermal springs and wells

of the US-Mexico border. The fault, as well as the approximate locations of several known thermal springs and wells, are depicted on this figure. Research by the authors has indicated that wells east of the interpreted location of this fault have not encountered hot water, and wells west of the fault and deeper than approximately 50 feet generally have encountered hot water.

As mapped by Dibblee (2008), Weber (1963), Brooks and Roberts (1954), and Todd (2004), a fault extends northwest/southeast just east of and roughly parallel to Railroad Street in the central portion of the town (Figure 5). Dibblee (2008) and Todd (2004) also place a second parallel fault to the west of Railroad Street. It is thought that the fault or faults influence the distribution of thermal (warm or hot) water in the Jacumba area. Swenson (1981) indicates that groundwater in the Table Mountain aquifer, located east of this fault, does not show any thermal contamination, and suggests that the fault restricts movement of thermal water by acting as a groundwater barrier. Figure 8 is an oblique aerial photograph of Jacumba Valley and the region south
