### Aquatic Resources Delineation Report

**To:** South Coast Branch, Regulatory Division, U.S. Army Corps of Engineers  
**From:** Callie Amoaku, Dudek  
**Subject:** Aquatic Resources Delineation Report for Jacumba Valley Ranch Energy Park; SPL-2019-00339  
**Date:** December 2, 2019, Revised March 27, 2020  
**cc:** George Gunmoe, BayWa  
Patricia Schuyler, Dudek  
**Attachment(s):** Attachment A, Appendix 1 of Regulatory Guidance Letter 16-1, Request for Corps Jurisdictional Determination  
Attachment B, Preliminary Jurisdictional Determination Form  
Attachment C, Figures  
Attachment D, Data Station Forms and OHWM Datasheets  
Attachment E, WETS Table  
Attachment F, Review Area Photos

This memo provides the 20 items listed in the Minimum Standards for Acceptance of Aquatic Resources Delineation Reports in support of a preliminary jurisdictional determination for the proposed Jacumba Valley Ranch Energy Park (project) in San Diego County, California.

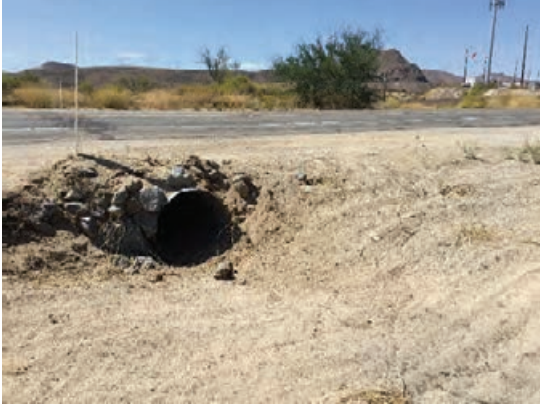
Culvert connected to Feature A, facing northwest	Transect C

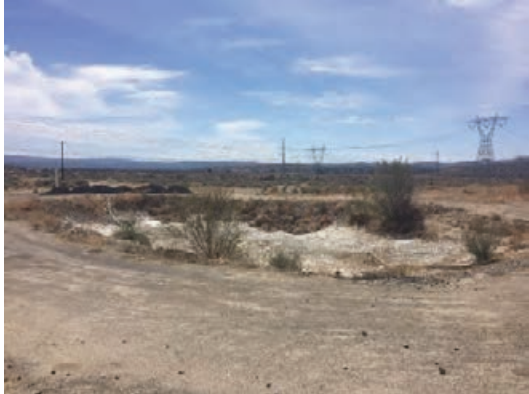
Transect D	Borrow pit 1

Additionally, there are two borrow pits located near the eastern side of the site that were constructed in 2013/2014 in an upland area associated with a temporary sand and gravel mine. It appears water was stored and/or drained into the borrow pit as part of the mining activities. The borrow pits were dry with little to no vegetation during the January 2019 and February 2020 site visits. The borrow pits support sparse tamarisk and cracked soil as a result of the pit's inundation from mining activities. Two sample points were taken in borrow pit 1: one next to the tamarisk and one outside of the tamarisk. While one of the sample points resulted in positive indicators of a three-parameter wetland, this human-made basin was constructed in an upland area, is considered an artificial wetland, and does not connect to waters of the United States. Borrow pit 2 had even sparser tamarisk with minimal evidence of cracked soil.
