APPENDIX E
Cultural Resources Report
Part 2

HISTORICAL RESOURCES TECHNICAL REPORT FOR JVR ENERGY PARK

Mountain Meadow Dairy Complex

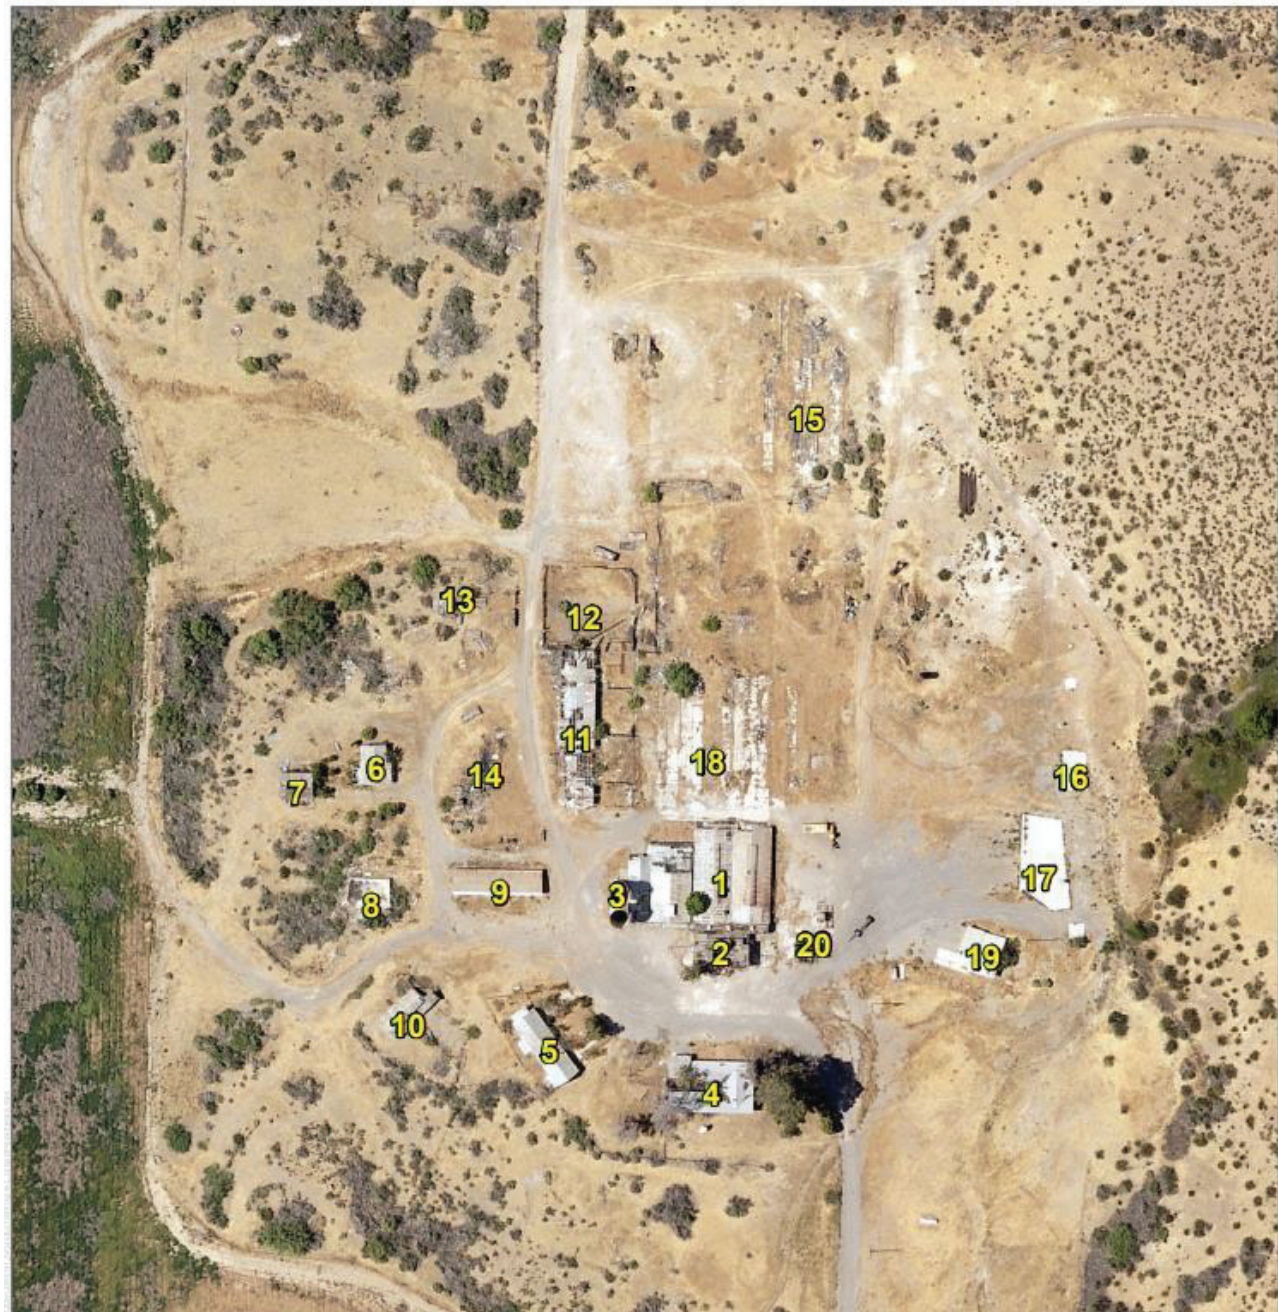
- 1 - Milking Barn
- 2 - Tank Room
- 3 - Silos
- 4 - Dwelling A

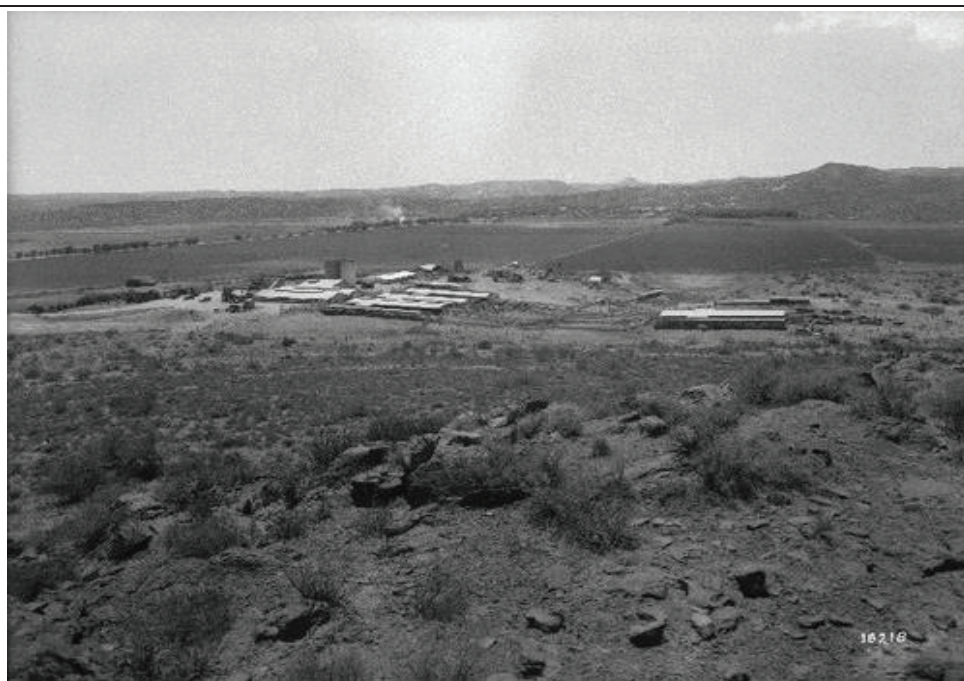
Figure 3. View of Mountain Meadow Creamery in the Jacumba Valley, c. 1934,
Courtesy San Diego Historical Society

The Mountain Meadow Dairy and Creamery's Sunshine Ranch totaled 750-acres in size and was one of the only large dairy products organizations in San Diego County's southeast region that both produced its own milk and then distributed it (Figure 3) (ET 1933). This was possible by several innovations made by the company. The first being the presence of an urban creamery located in Mission Valley, San Diego, constructed in 1933 with the latest technologies in pasteurizing, cooling, testing, and bottling milk under sanitary conditions (ET 1933). The second being the fleet of 80 employees working at the two locations, which helped operate twelve retail and three wholesale routes. Two early morning deliveries were made daily before 6 a.m. and after 8 a.m. by a fleet of milk deliverymen driving motorized trucks (Figure 4) (SDU 1934b). The aluminum painted delivery trucks serviced thousands of homes in San Diego, La Jolla, and Coronado every morning due in part to the company's third innovation of a specialized metal bottle cap. In 1933, Mountain Meadow introduced a 100-percent sanitary metal bottle cap and a new type of milk bottle that would better protect the milk inside. In 1934, this earned the company a gold medal for the highest testing Grade "A" raw milk at the California State Fair in Sacramento (SDU 1934e).

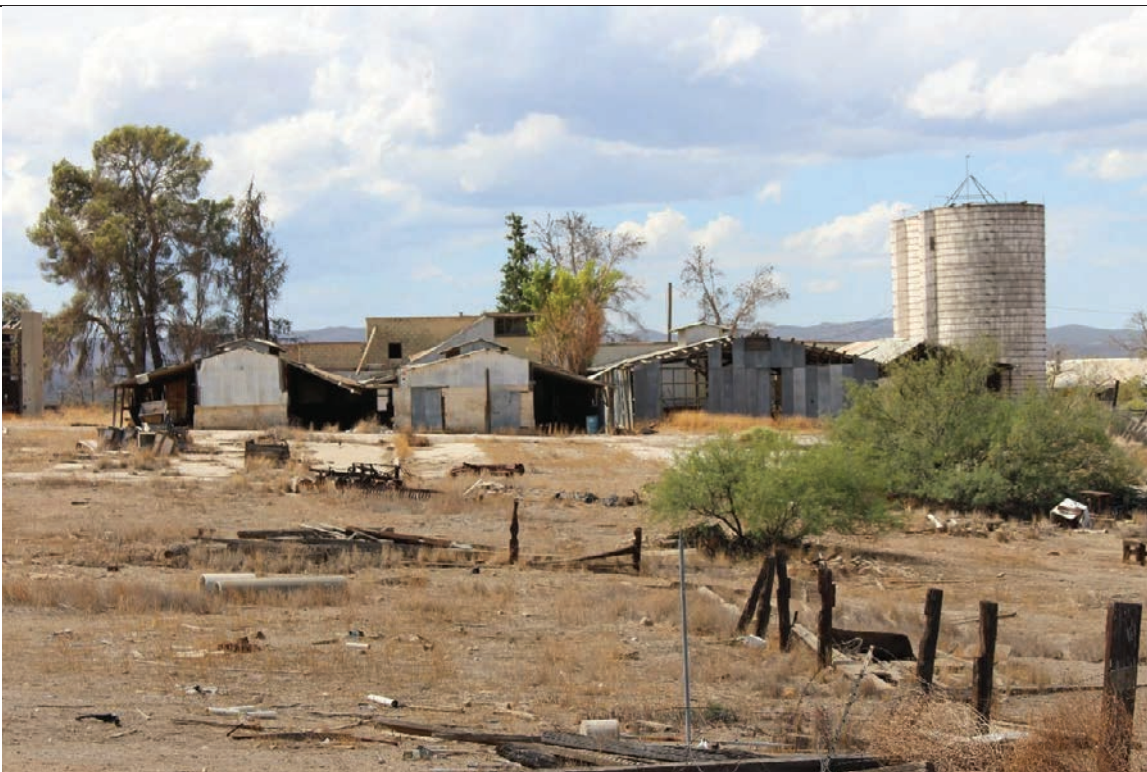
The Milking Barn is located at the center of the dairy complex, with the long axis running north-south. The building is comprised of four wood-framed barn forms under a contiguous roof with front-facing gables. The two barn forms to the east are monitor-style barns approximately 15 feet shorter than the third gable-roofed barn form, with the fourth eastern-most barn form being approximately half the width of the other three and recessed a further 10 feet. Exterior walls are clad in wood and corrugated metal with the roof sheathed in corrugated metal. Along the north elevation are two sliding metal doors. Areas of roofing and exterior cladding are missing (Figure 6).

Figure 6. Milking Barn, view to south, IMG_3501

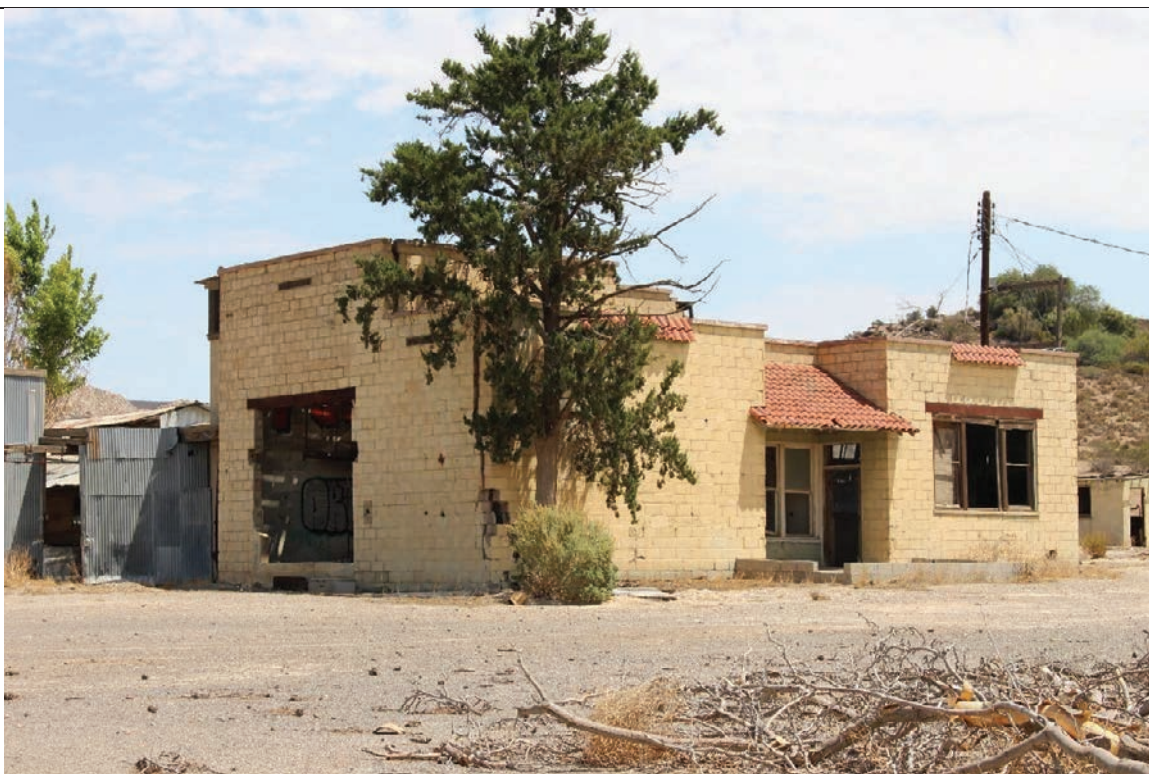
The Tank Room is located at the center of the dairy complex, to the direct south of the Milking Barn. The building is one-and-a-half stories tall and rectangular in plan. Exterior walls are made up of concrete masonry units (CMUs) and the roof is flat with a surrounding parapet. The primary entrance is located on the south elevation and is approached by a single concrete landing. Two pent roofs clad in red half-barrel clay tiles project from the front on either side of a shed roof extension over the primary entry door, also clad in red half-barrel clay tiles. The windows no longer have glass but retain their wooden frames. The west elevation displays a large square opening, possibly a loading dock of some sort (Figure 7).

Figure 7. Tank Room, view to northeast, IMG_3728

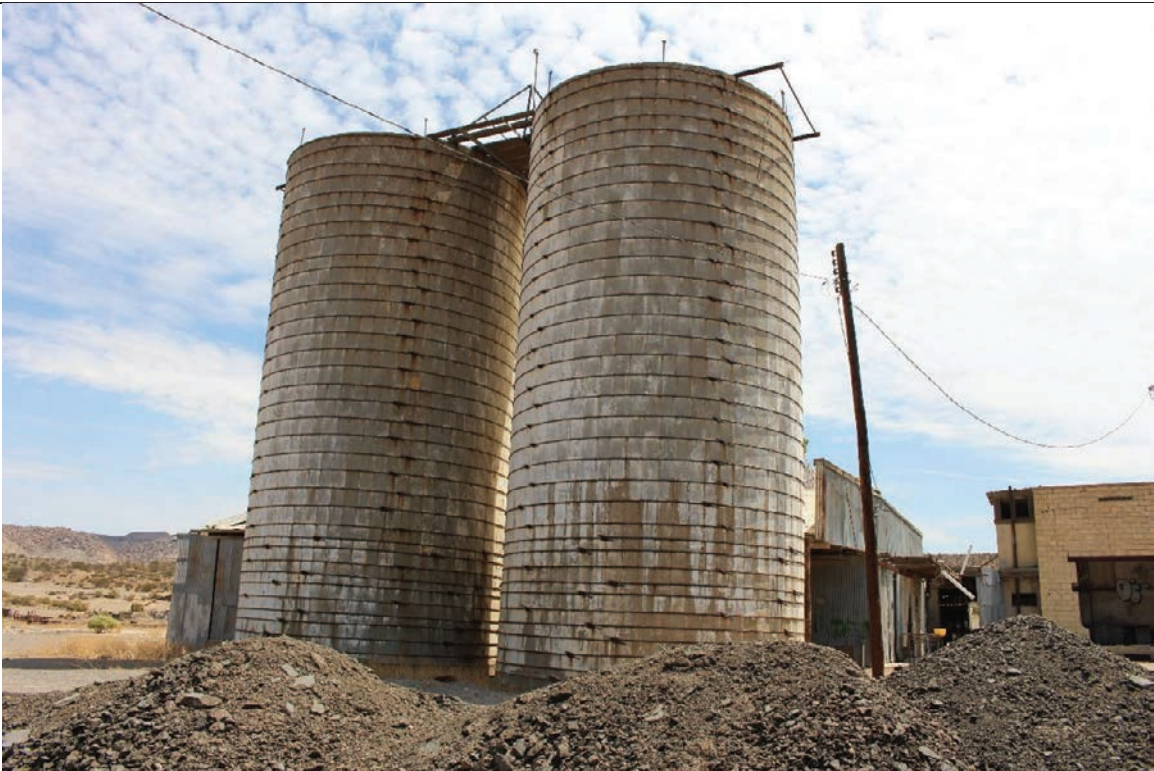
The Silos are located at the center of the dairy complex, to the west of the Milking Barn. They are two-story vertical concrete stave silos connected at the top by a wooden board walkway. The exterior is composed of concrete with round metal bands closed with metal turnbuckles at approximately every foot. On both silo's eastern elevation are small semicircular additions with ladders inside (Figure 8).

Figure 8. Silos, view to east, IMG_3672

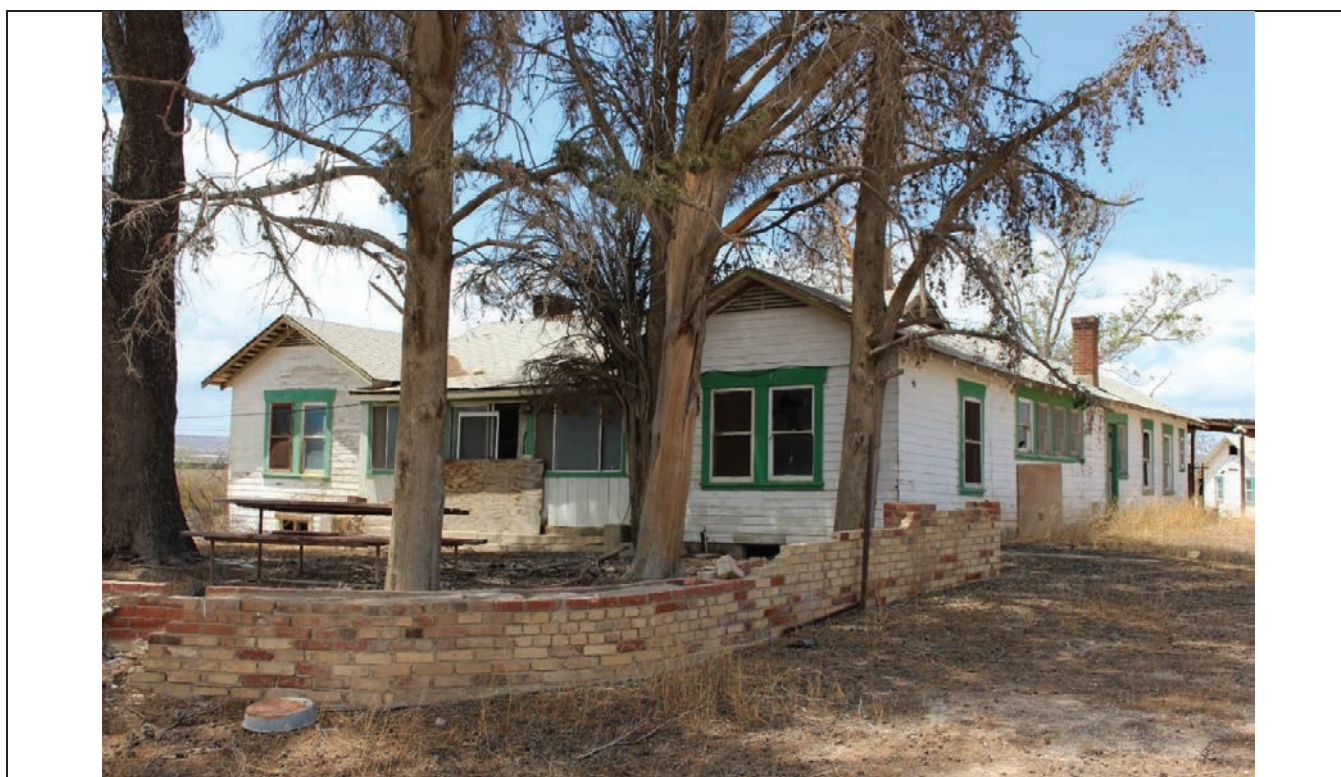
Dwelling A is located at the southern end of the dairy complex. The building is a one-story rural vernacular Craftsman style residence that is U-shaped in plan. The central section faces east, is side-gabled, and has a central entry door and enclosed front porch. The two wings are front-gabled. The roofs are clad with composition shingle and have overhanging eaves with exposed rafter tails (Figure 9). The exterior walls are clad predominantly with horizontal wood boards, with some vertical wood boards. Fenestration is irregular, with window styles including double-hung, sliding, single-hung, and fixed windows in wood, vinyl, or metal frames, bordered by wood casings and aprons. Two chimneys jut from the roof: one on the southern end of the central section and the second off-center on the northern wing.

Figure 9. Dwelling A, view to southwest, IMG_3767

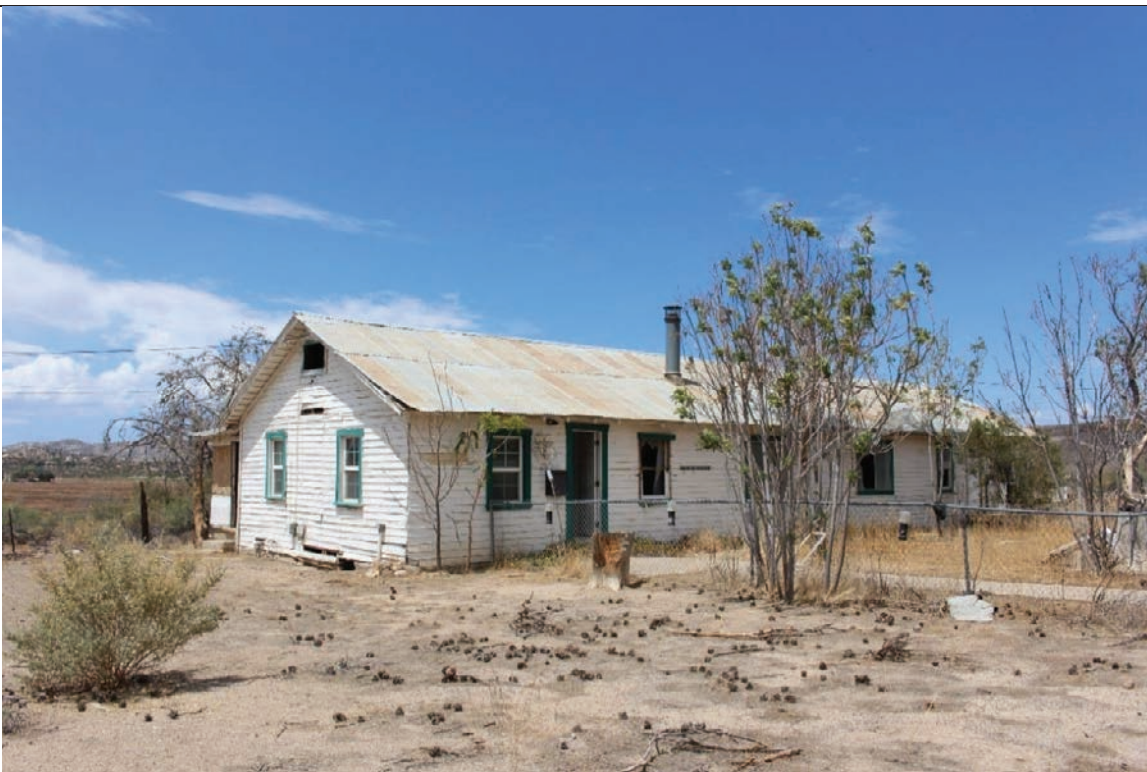
Dwelling B is a one-story rural vernacular Craftsman style duplex located near the southwest corner of the dairy complex (Figure 10). The building is rectangular in plan with a side-gabled roof clad in corrugated metal with open eaves and exposed rafter tails. Exterior walls are sheathed in horizontal wood boards. Two single-leaf entry doors are located on the main (northeast) elevation. Fenestration is irregular, with window styles including double-hung, sliding, single-hung, and fixed windows in wood, vinyl, or metal frames, bordered by wood casings and aprons. The rear (southwest) elevation displays two shed-roofed additions clad with a mixture of wood siding, vertical boards, and plywood.

Figure 10. Dwelling B, view to southwest, IMG_ 3722

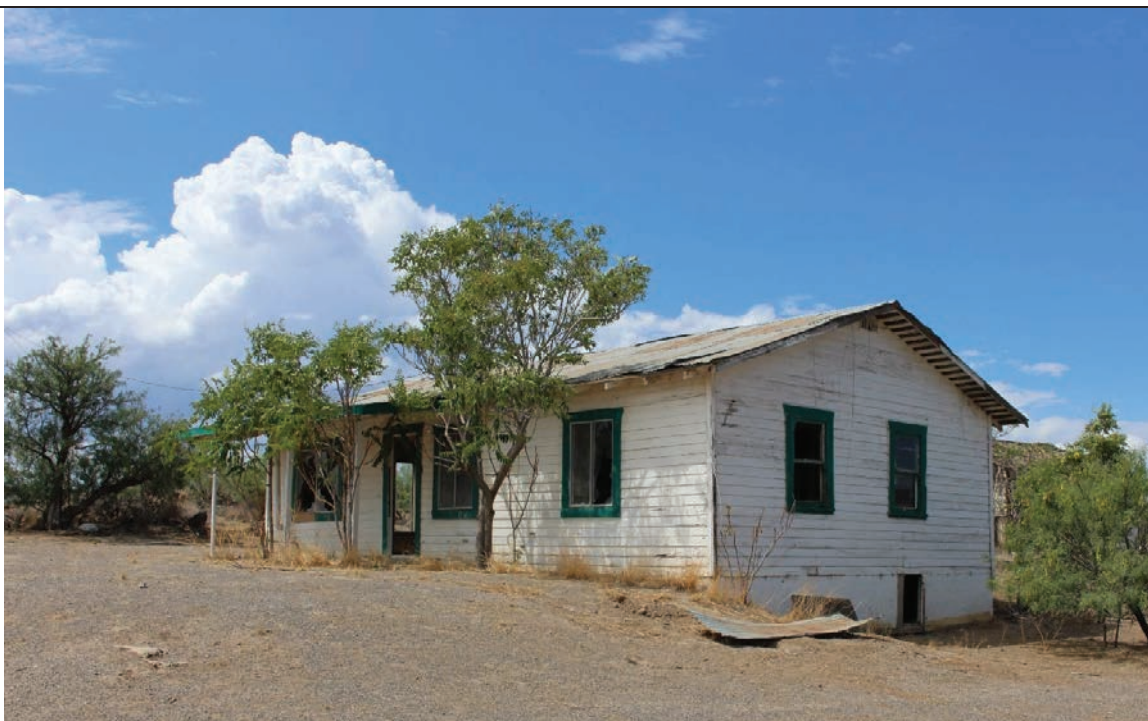
Dwelling C is a one-story rural vernacular Craftsman style single-family residence located near the western edge of the dairy complex. The building is rectangular in plan with a side-gabled roof clad in corrugated metal with overhanging eaves and exposed rafter tails (Figure 11). The exterior is clad in horizontal wood boards. Fenestration is irregular and includes double-hung, sliding, and fixed windows in wood or metal frames. The main (east) elevation has a single main entry left of center, sheltered by a partial-width flat roof supported by three posts. A shed-roofed addition projects from the southern end of the rear (west) elevation.

Figure 11. Dwelling C, view to southwest, IMG_3580

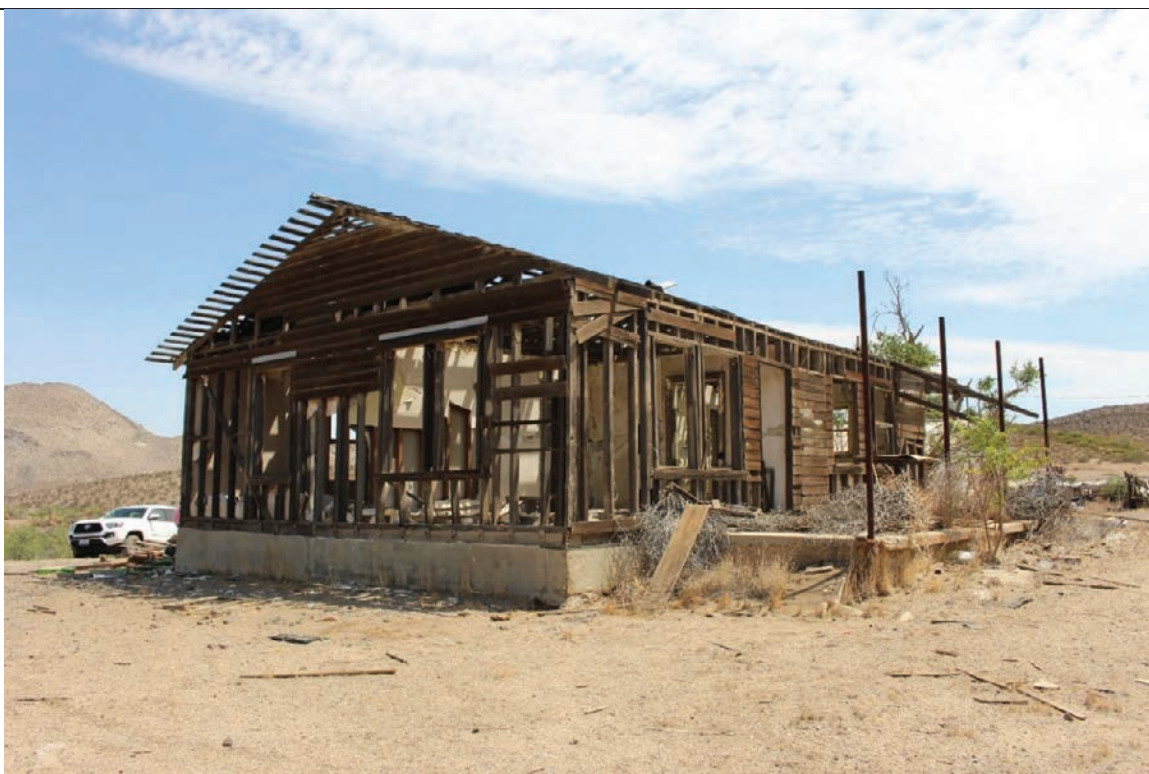
Dwelling D is a one-story single-family house located at the western end of the dairy complex. Resting on a concrete foundation, the building is rectangular in plan with a side-gabled roof. The majority of the building's exterior walls and roofing materials are no longer existent, leaving exposed areas of horizontal wood boards and wood framing (Figure 12).

Figure 12. Dwelling D, view to southwest, IMG_3626

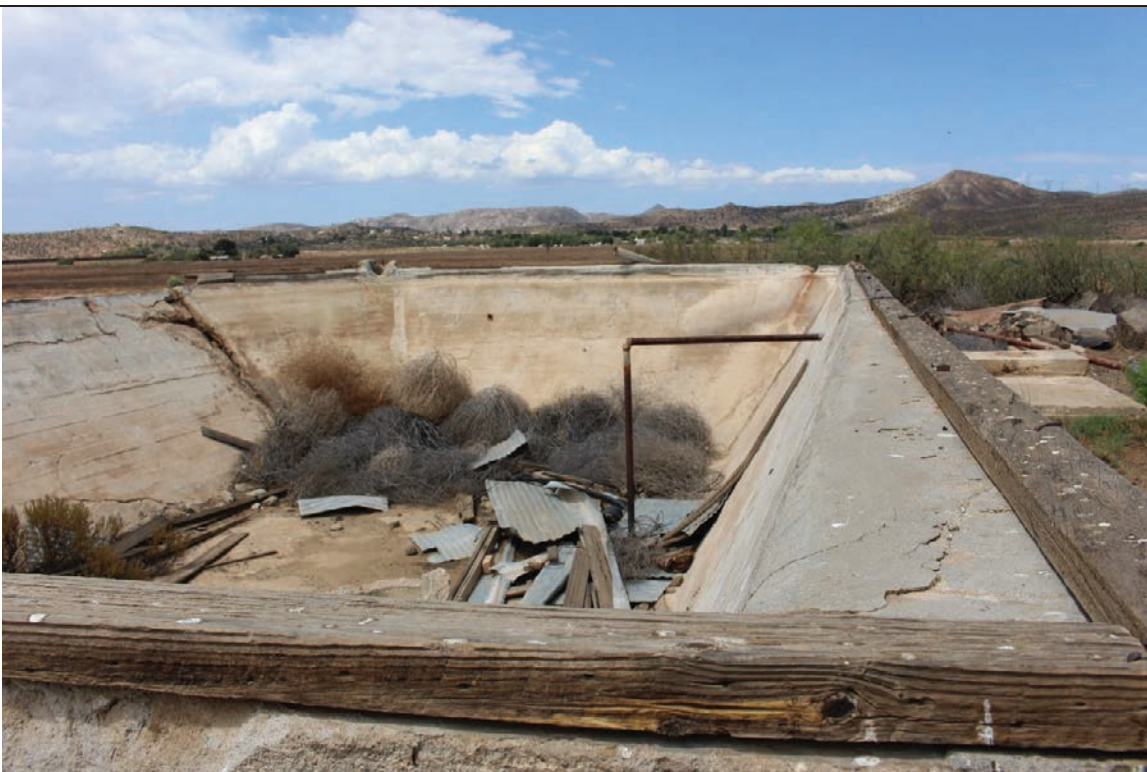
The Reservoir is located near the southwestern corner of the dairy complex, south of Dwellings C and D. It is a rectangular structure that is partially below grade and constructed of board-formed reinforced concrete (Figure 13). The interior walls slope inwards towards the bottom, while the above-grade exterior walls are vertical. Around the reservoir's edge is a wood sole plate held in place by large metal bolts. A metal pipe rises up from the floor of the reservoir, and then bends at a right angle before piercing through the north wall of the reservoir. The concrete is in poor condition, with spalled areas, exposed rebar and multiple cracks indicating issues with rust jacking. To the north of the reservoir are eight board-formed concrete foundation blocks of different sizes, typically with battered sides and metal protrusions (bolts, flattened pipes, rectangular bars, etc.).

Figure 13. Reservoir, view to north, IMG_3651

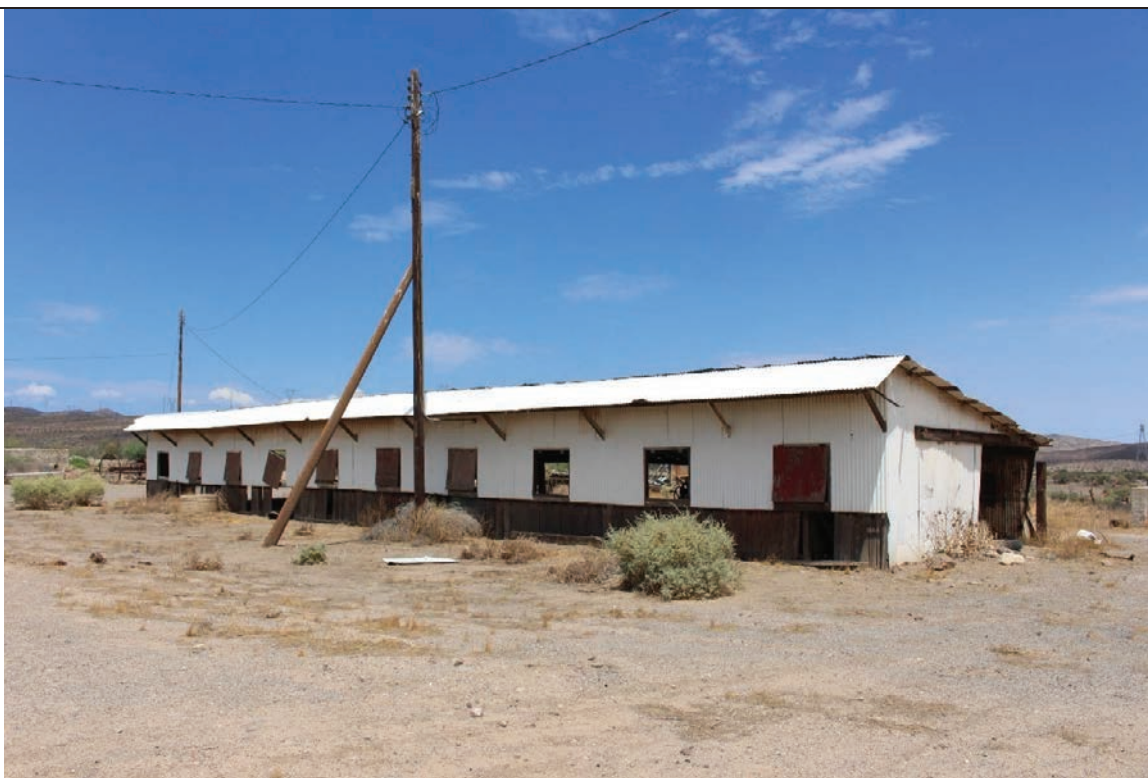
Barn A is located on the western side of the dairy complex, directly west of the Silos. The building is rectangular in plan with a shed roof clad in corrugated metal. The main (north) elevation is open to the elements, with the last bay on either end clad in corrugated metal, and the wood timber-frame structure is revealed. The remaining elevations are fully clad with corrugated metal. The south elevation has a full-length pent roof clad with corrugated metal, evenly spaced rectangular openings, and the lower third of the wall is clad with vertical wood boards instead of the corrugated metal. The east and west elevations each have a large square opening with evidence of a metal track above it, indicating there were sliding doors attached at one time (Figure 14). The exterior and interior characteristics of the building indicate it was likely a horse barn originally, that was converted at some point to a workshop and mechanical repair function.

Figure 14. Barn A, view to southwest, IMG_3669

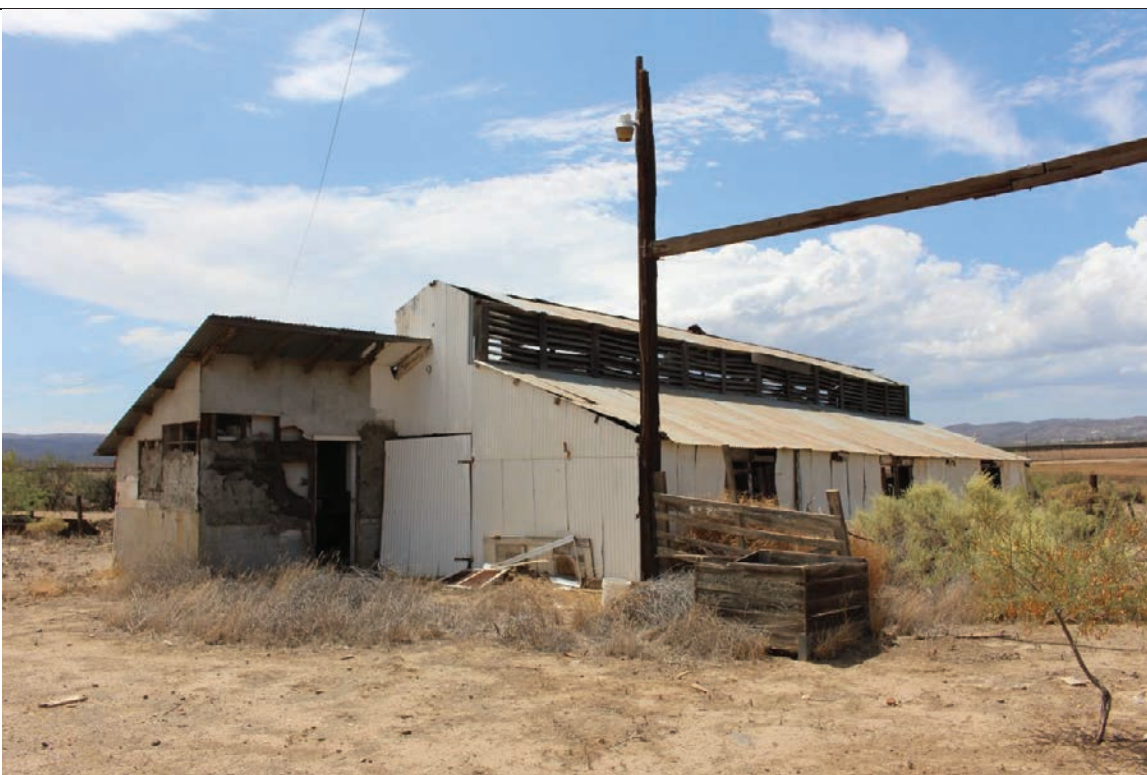
Barn B is located on the southwestern corner of the dairy complex, to the direct northwest of Dwelling B. The one-and-a-half story tall building is irregular in plan with a combination monitor-style barn roof and a shed roof with exposed wooden rafters; both are sheathed in corrugated metal. Exterior walls are primarily clad in corrugated metal, with the lower half of the walls forming the shed-roofed section being rendered CMUs and the upper half being wood-framed and clad in rendered drywall. The main entry is located on the building's northeast elevation and displays as a wide, single corrugated metal entry door. On the southwest and northeast elevations are openings exposed to the elements revealing the timber framing. Along the barn's raised center aisle are horizontal wooden vents (Figure 15).

Figure 15. Barn B, view to southwest, IMG_3686

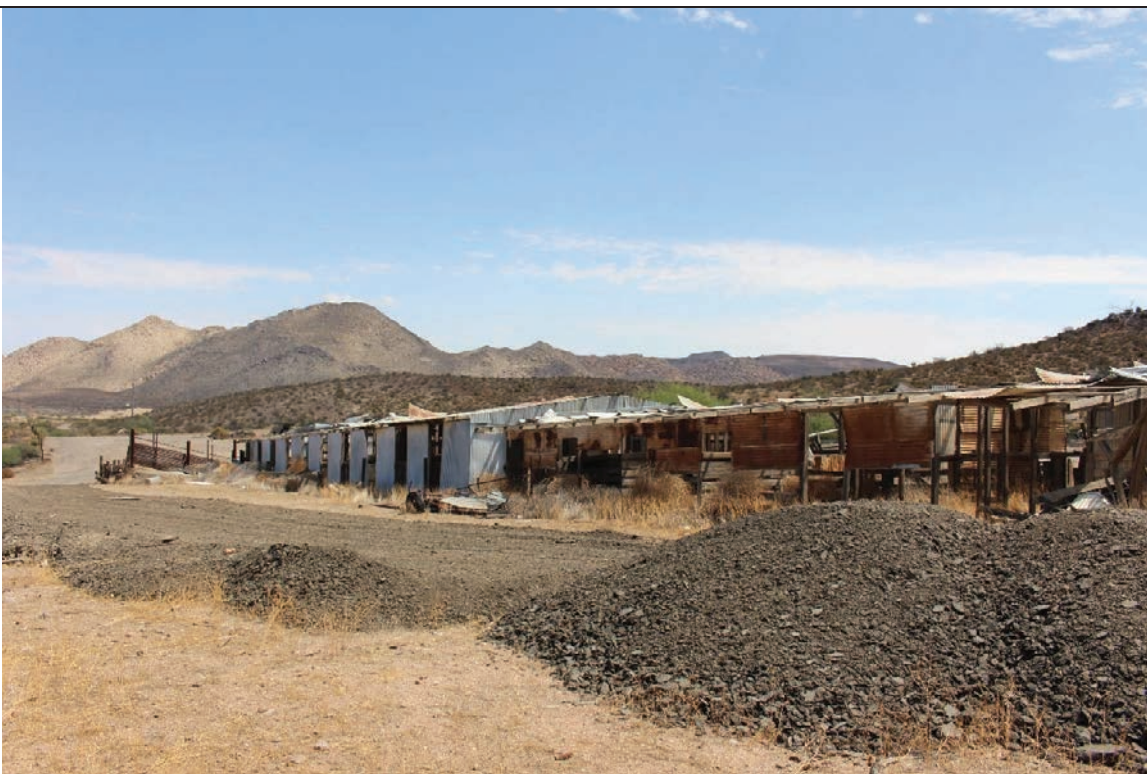
Barn C is located in the northern section of the dairy complex, to the direct south of the Cow Pens. The building is rectangular in plan with the long axis running north-south and is comprised of two wood-framed barn forms with front-facing gables. The majority of the exterior walls are clad in corrugated metal with sections of vertical wood boards. Areas of roofing and exterior cladding are missing leaving the building's wooden frame exposed. Along the east and west elevations are a series of nine openings with corrugated metal between each (Figure 16).

Figure 16. Barn C, view to northeast, IMG_3564

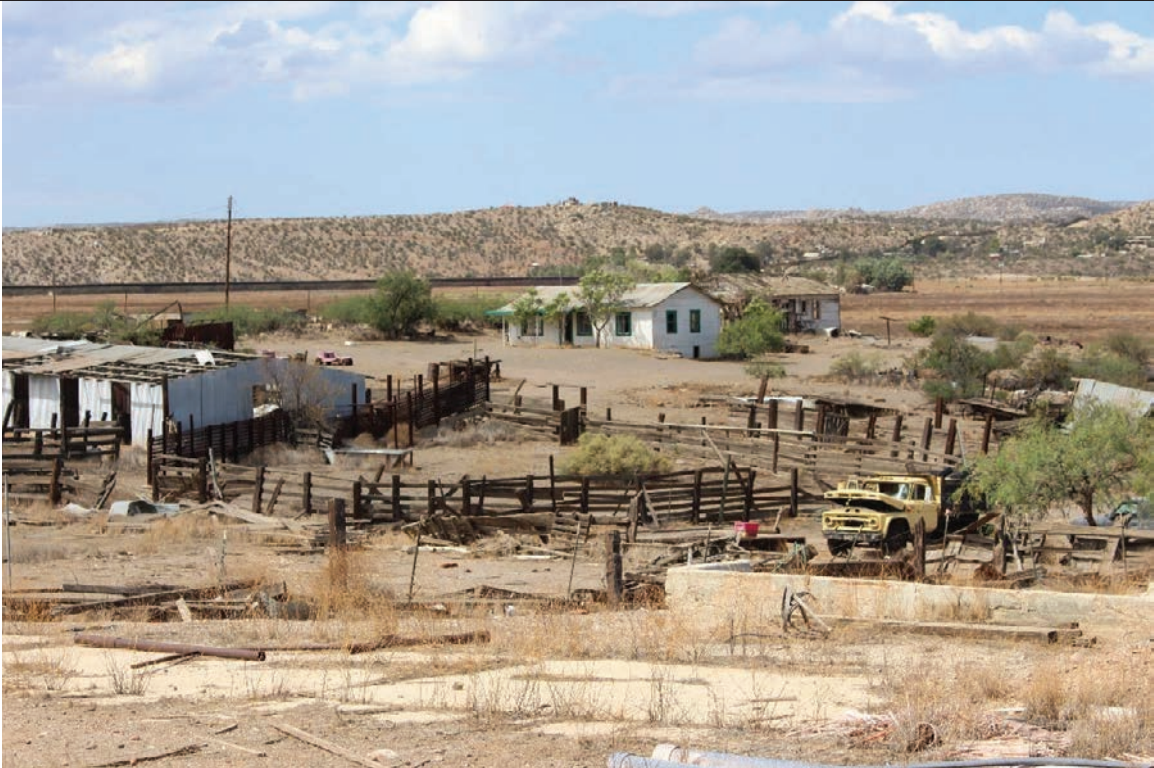
The Cow Pens are located at the northern end of the dairy complex and directly north of Barn C. The pens are square and comprised of post-and-rail wood fencing approximately measuring 90 feet by 90 feet (Figure 17). A majority of the fence is still standing with some sections either missing or having fallen down over time.

Figure 17. Cow Pens, view to southwest, IMG_3477

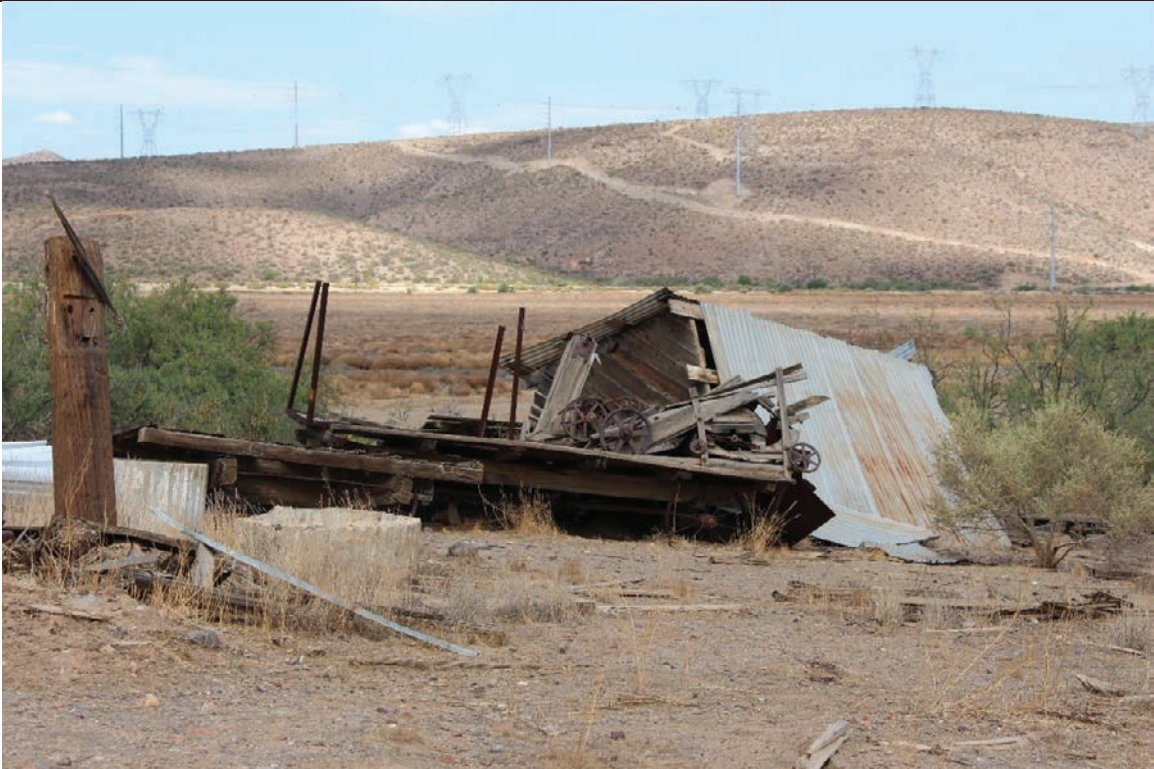
The Collapsed Shed is located at the southwest corner of the dairy complex and is to the direct west of the Cow Pens. The building appears to have had a front-gable roof sheathed in corrugated metal with exterior walls clad in horizontal wood. Currently the materials that made up the majority of the building are still present but the building is no longer standing (Figure 18).

Figure 18. Collapsed Shed, view to west, IMG_3522

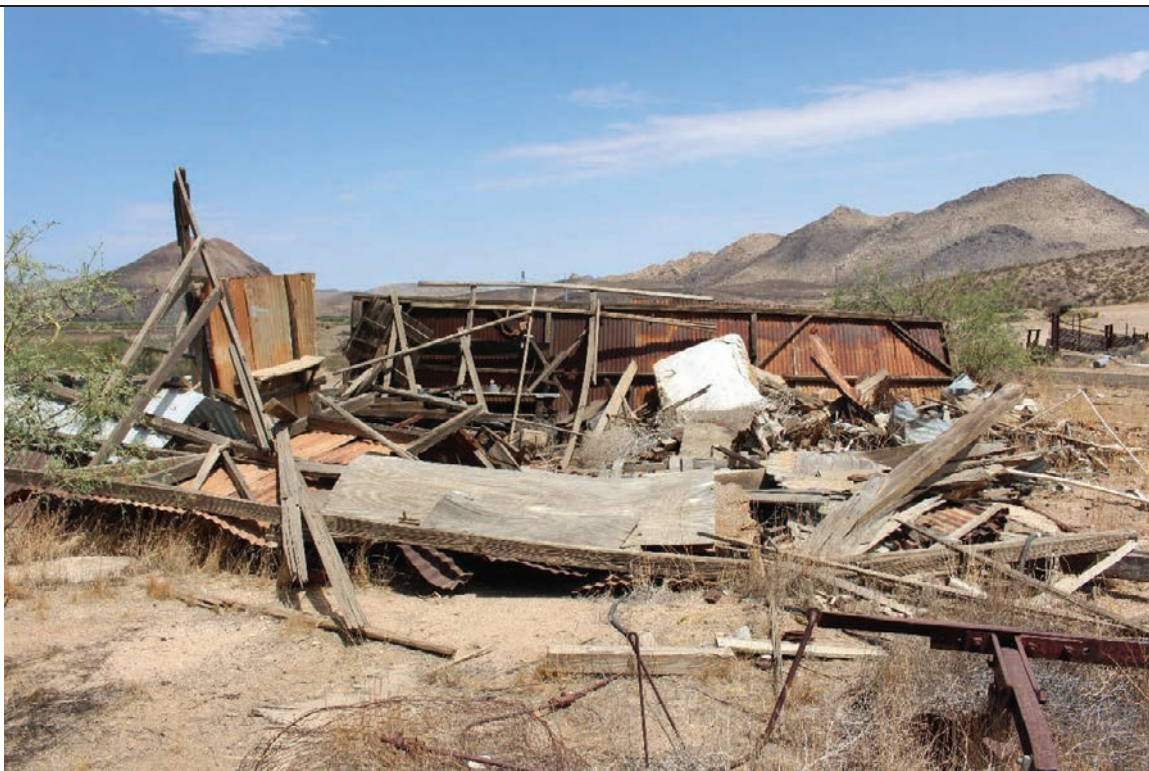
Collapsed Barn A is located on the western end of the dairy complex to the direct west of Barn C. The building appears to have been constructed out of corrugated metal and wood framing. The building materials are still present but the building is no longer standing (Figure 19).

Figure 19. Collapsed Barn A, view to west, IMG_3658

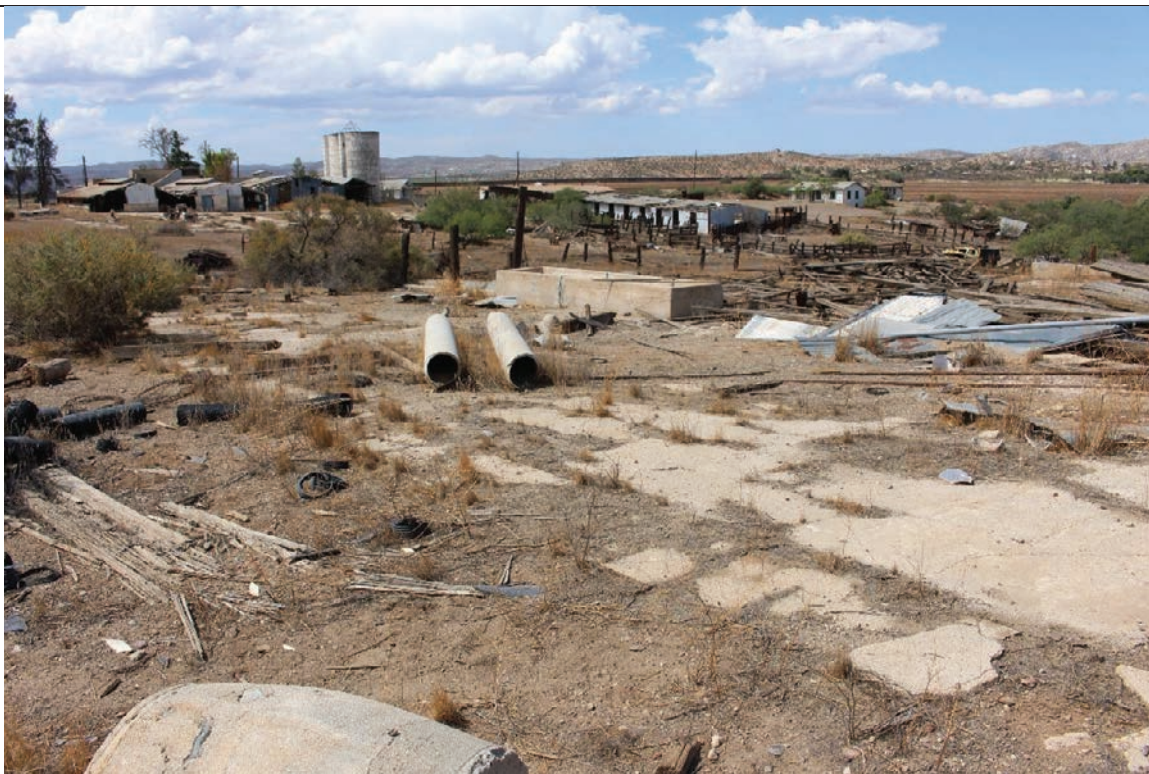
Building 15: Barn Foundation A

Barn Foundation A is located at the northeastern end of the dairy complex to the direct northeast of the Cow Pens. The building itself is no longer extant; only the concrete foundation remains (Figure 20).

Figure 20. Barn Foundation A, view to southwest, IMG_3472

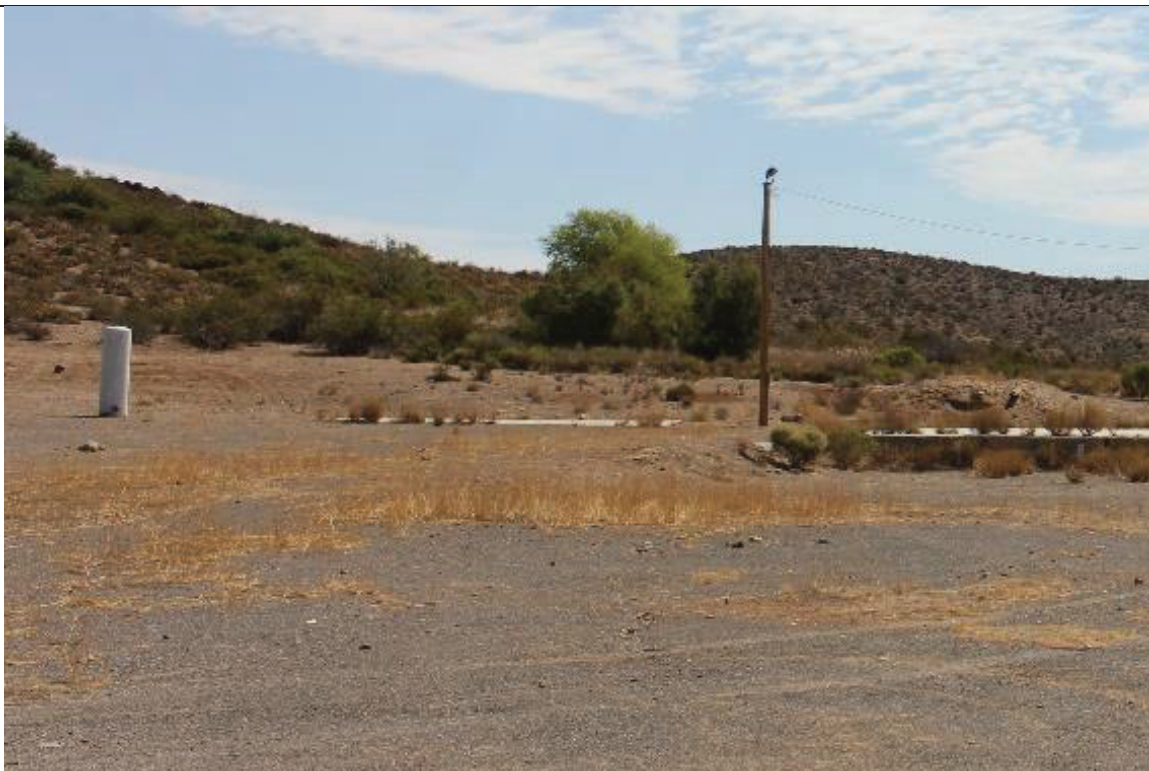
Building 16: Barn Foundation B

Barn Foundation B is located at the eastern end of the dairy complex. The building itself is no longer extant; only the concrete foundation remains (Figure 21).

Figure 21. Barn Foundation B, view to east, IMG_3427

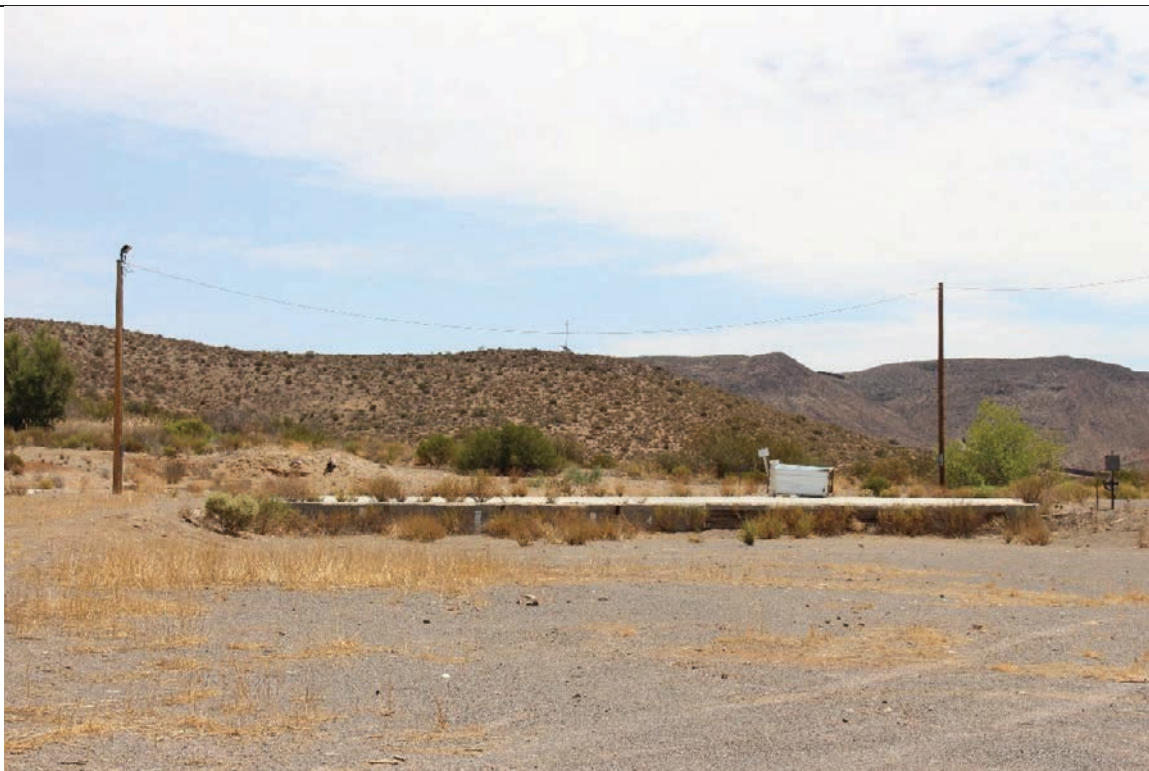
Building 17: Barn Foundation C

Barn Foundation C is located at the eastern end of the dairy complex to the direct south of Barn Foundation B. The building itself is no longer extant; only the concrete foundation remains (Figure 22).

Figure 22. Barn Foundation C, view to east, IMG_3880

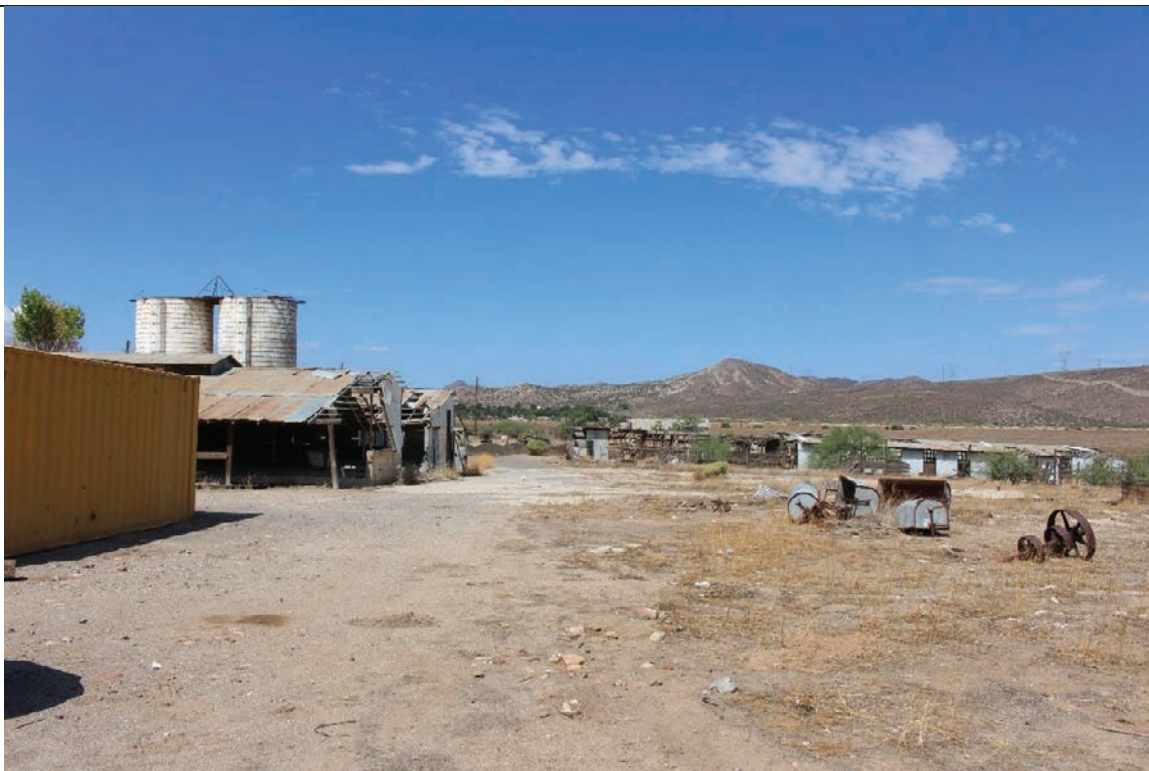
Building 18: Barn Foundation D

Barn Foundation D is located at the center of the dairy complex to the north of the Milking Barn. No building materials are extant, but the rectangular concrete foundation is still present (Figure 23).

Figure 23. Barn Foundation D, view to east, IMG_3435

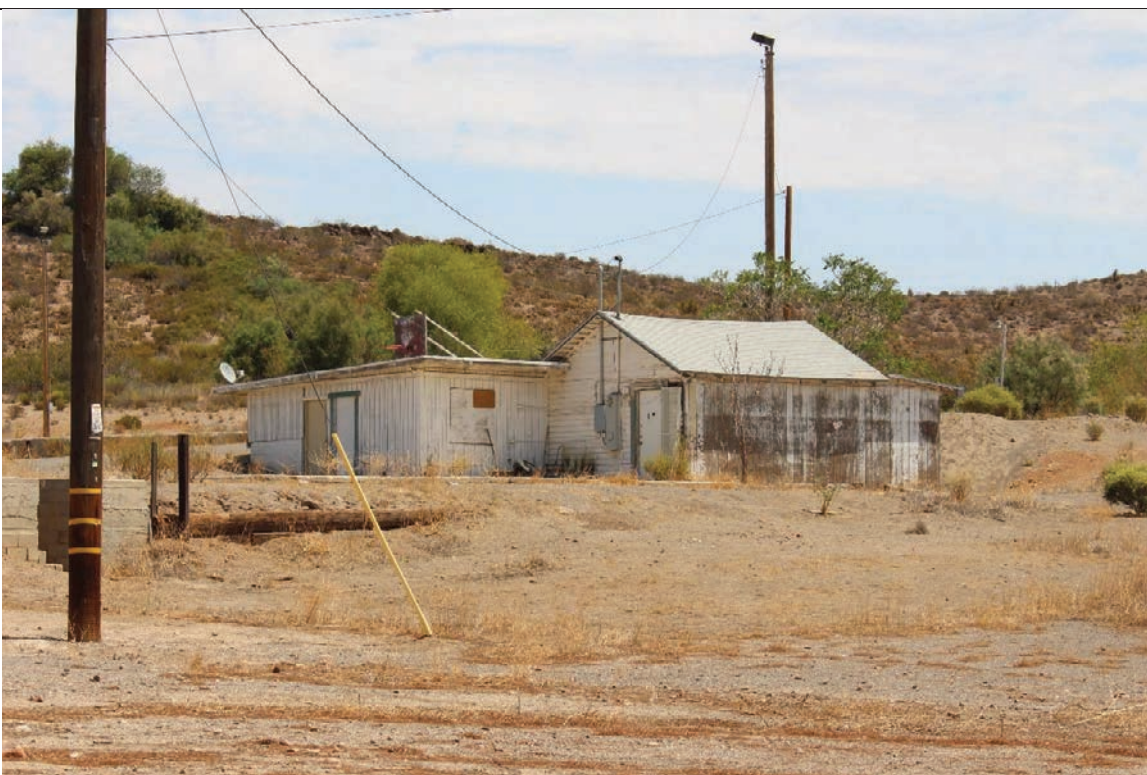
The Office is located at the southeast corner of the dairy complex to the southwest of Barn Foundation C. The building is one-story tall and irregular in plan, with a front-gabled roof section sheathed in composition shingles with exposed eaves and a flat roof section sheathed in rolled asphalt roofing material. Exterior walls are clad in vertical and horizontal wood siding. The main entry is located on the northeast elevation. Fenestration around the building includes single-leaf doors, sliding windows, and one-over-one windows. A flat-roofed addition extends off the west-northwest portion of the Office; it is clad in vertical boards and has two flush entry doors on the west elevation and a boarded-over window opening on the south elevation. (Figure 24).

Figure 24. Office, view to northeast, IMG_3761
