APPENDIX E
Cultural Resources Report
Part 2

HISTORICAL RESOURCES TECHNICAL REPORT FOR JVR ENERGY PARK

Mountain Meadow Dairy Complex

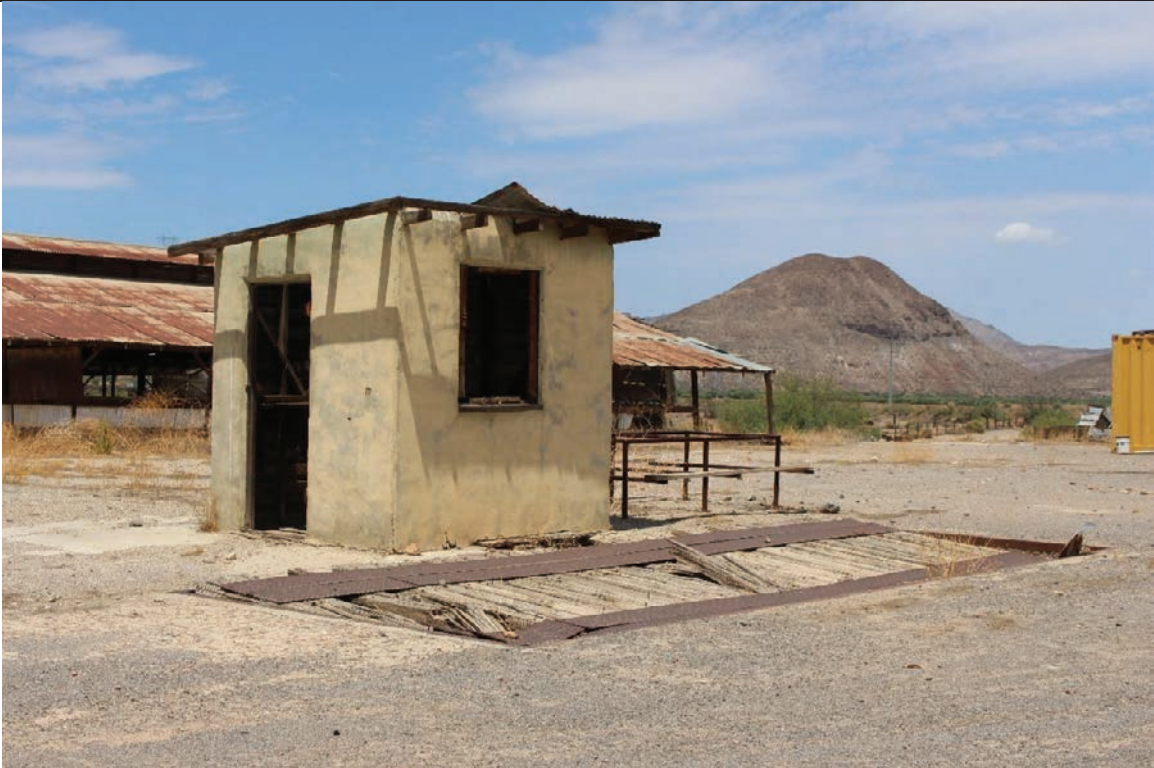
The Weigh Station is located at the center of the dairy complex to the east of the Tank Room. The building is utilitarian in style with a relatively square plan. The shed roof is sheathed in corrugated metal over a wood frame; below are a series of five projecting wood beams on the east and west elevations. Exterior walls are clad in smooth painted stucco. Fenestration around the building includes two window openings and one door opening (Figure 25).

Figure 25. Weight Station, view to north west, IMG_3868

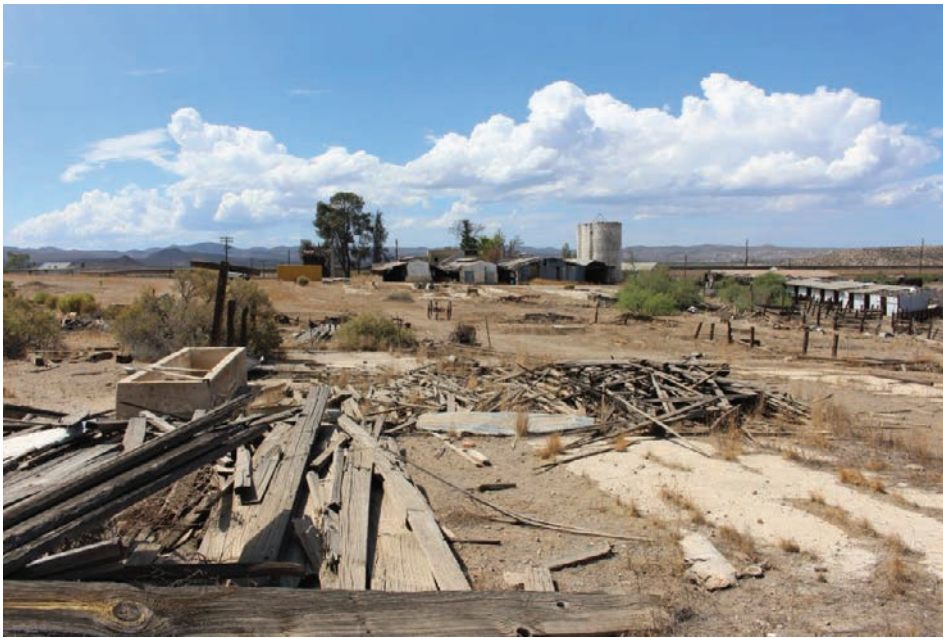
P5b. Description of Photo: (view, date, accession #) View to south, 8/10/2018, IMG_3474

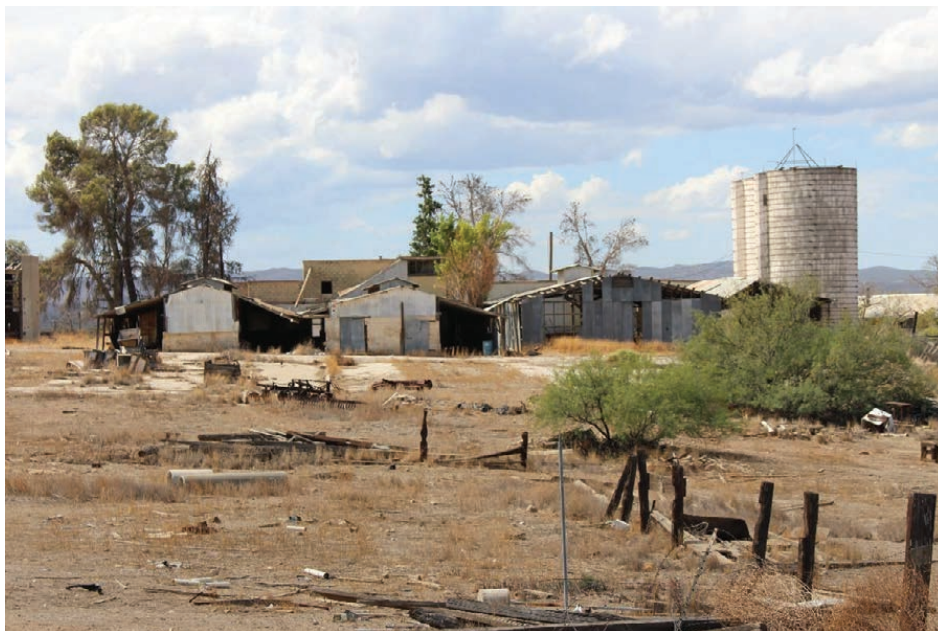
The Milking Barn is located at the center of the dairy complex, with the long axis running north-south. The building is comprised of four wood-framed barn forms under a contiguous roof with front-facing gables. The two barn forms to the east are monitor-style barns approximately 15 feet shorter than the third gable-roofed barn form, with the fourth eastern-most barn form being approximately half the width of the other three and recessed a further 10 feet. Exterior walls are clad in wood and corrugated metal with the roof sheathed in corrugated metal. Along the north elevation are two sliding metal doors. Areas of roofing and exterior cladding are missing (Figure 1).

Figure 1. Milking Barn, view to south, IMG_3501

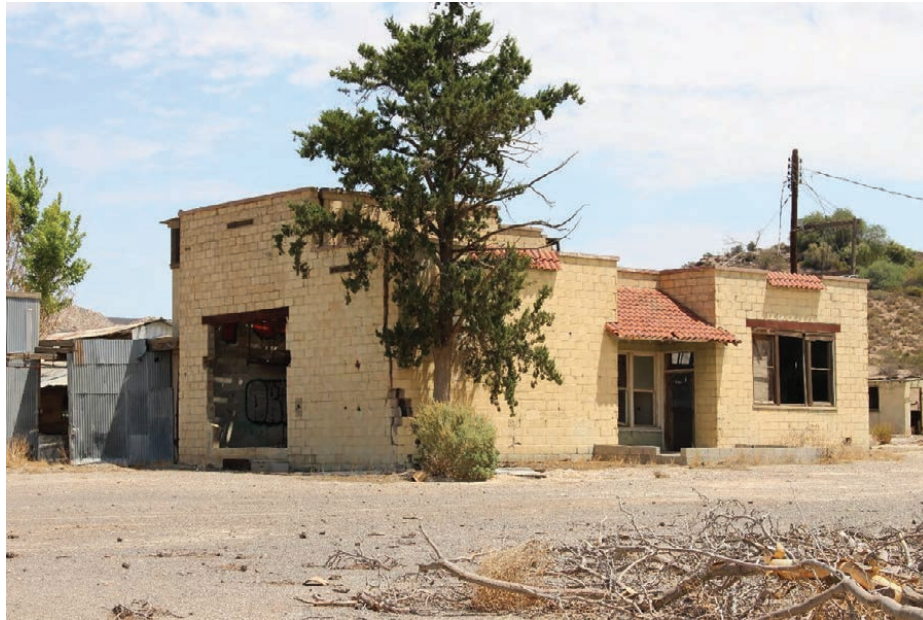
Figure 2. Tank Room, view to northeast, IMG_3728

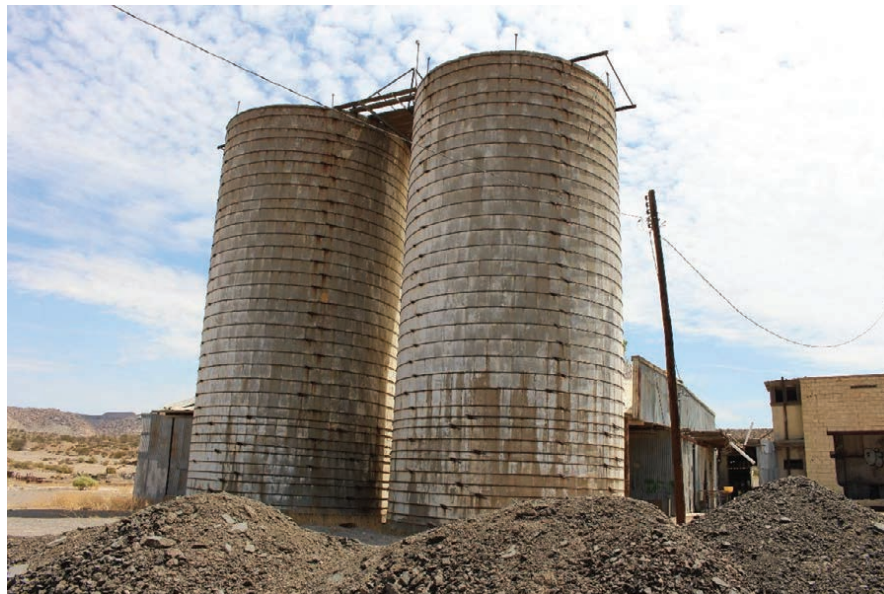
The Silos are located at the center of the dairy complex, to the west of the Milking Barn. They are two-story vertical concrete stave silos connected at the top by a wooden board walkway. The exterior is composed of concrete with round metal bands closed with metal turnbuckles at approximately every foot. On both silo's eastern elevation are small semicircular additions with ladders inside (Figure 3).

Figure 3. Silos, view to east, IMG_3672

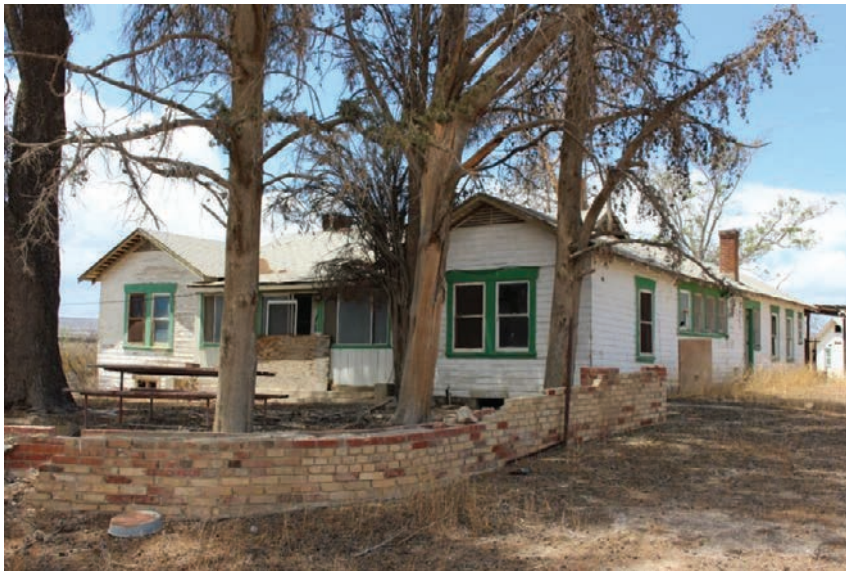
section faces east, is side-gabled, and has a central entry door and enclosed front porch. The two wings are front-gabled. The roofs are clad with composition shingle, and have overhanging eaves with exposed rafter tails (Figure 4). The exterior walls are clad predominantly with horizontal wood boards, with some vertical wood boards. Fenestration is irregular, with window styles including double-hung, sliding, single-hung, and fixed windows in wood, vinyl, or metal frames, bordered by wood casings and aprons. Two chimneys jut from the roof: one on the southern end of the central section and the second off-center on the northern wing.

Figure 4. 3672 Dwelling A, view to southwest, IMG_ 3767

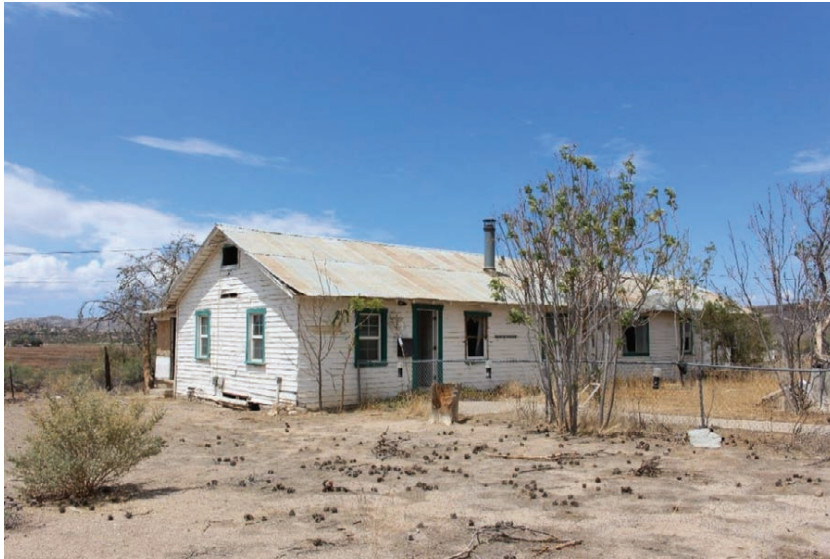
Figure 5. Dwelling B, view to southwest, IMG_3722

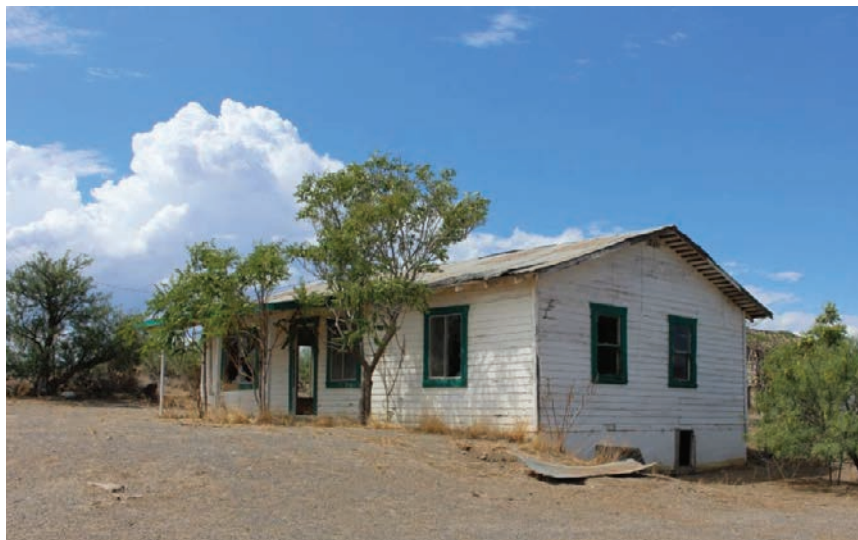
Dwelling C is a one-story rural vernacular and Craftsman style single-family residence located near the western edge of the dairy complex. The building is rectangular in plan with a side-gabled roof clad in corrugated metal with overhanging eaves and exposed rafter tails (Figure 6). The exterior is clad in horizontal wood boards. Fenestration is irregular and includes double-hung, sliding, and fixed windows in wood or metal frames. The main (east) elevation has a single main entry left of center, sheltered by a partial-width flat roof supported by three posts. A shed-roofed addition projects from the southern end of the rear (west) elevation.

Figure 6. Dwelling C, view to southwest, IMG_3580

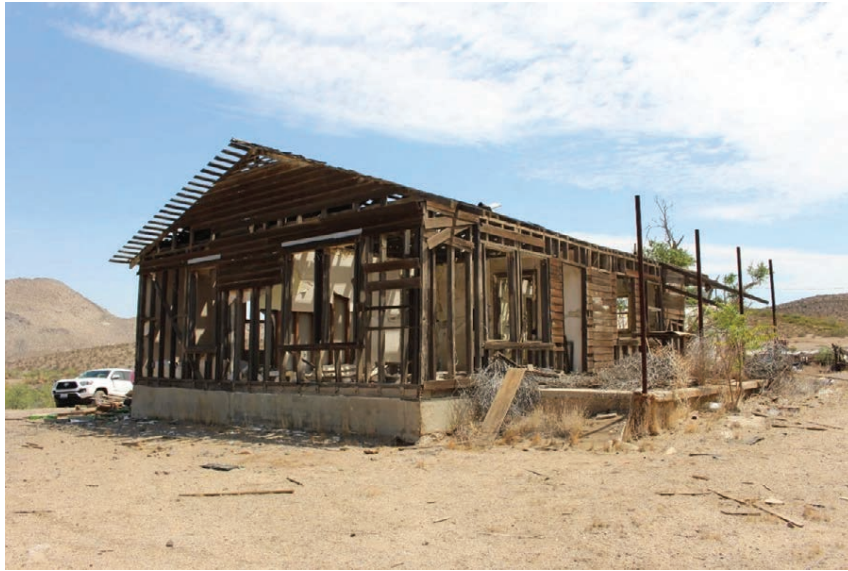
Dwelling D is a one-story single-family house located at the western end of the dairy complex. Resting on a concrete foundation, the building is rectangular in plan with a side-gabled roof. The majority of the building's exterior walls and roofing materials are

no longer existent, leaving areas of horizontal wood boards and exposed wood framing (Figure 7).

Figure 7. Dwelling D, view to southwest, IMG_3626

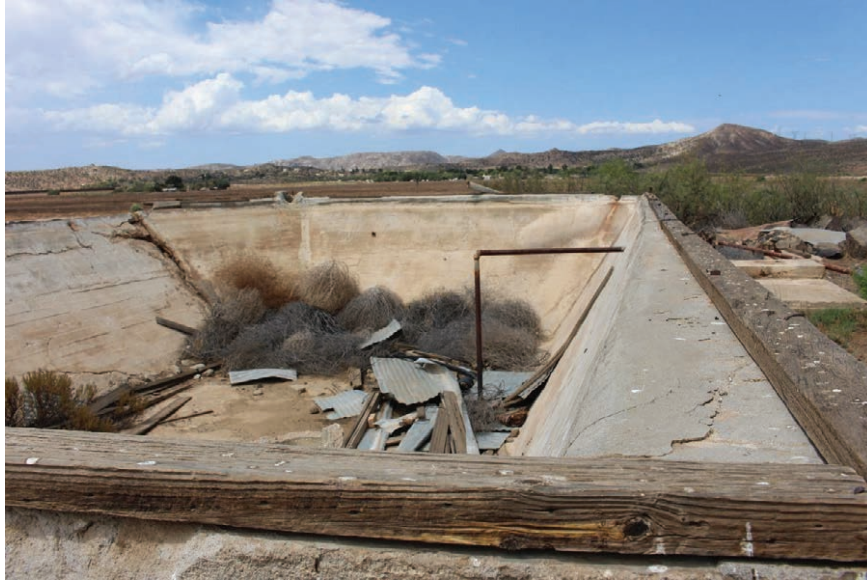
Figure 8. Reservoir, view to north, IMG_3651

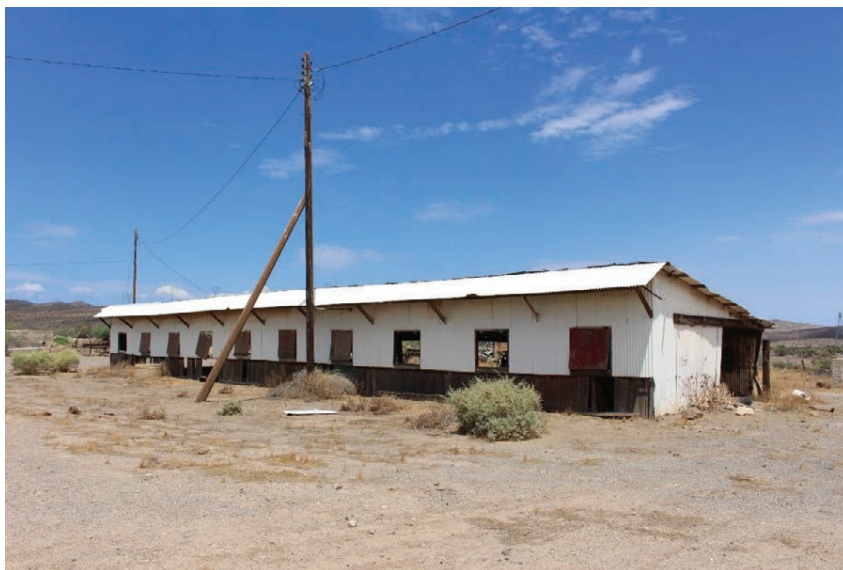
Barn A is located on the western side of the dairy complex, directly west of the Silos. The building is rectangular in plan with a shed roof clad in corrugated metal. The main (north) elevation is open to the elements, with the last bay on either end clad in corrugated metal, and reveals the wood timber-frame structure. The remaining elevations are fully clad with corrugated metal. The south elevation has a full-length pent roof clad with corrugated metal, evenly spaced rectangular openings, and the lower third of the wall is clad with vertical wood boards instead of the corrugated metal. The east and west elevations each have a large square opening with evidence of a metal track above it, indicating there were sliding doors attached at one time (Figure 9). The exterior and interior characteristics of the building indicate it was likely a horse barn originally, that was converted at some point to a workshop and mechanical repair function.

Figure 9. Barn A, view to southwest, IMG_3669

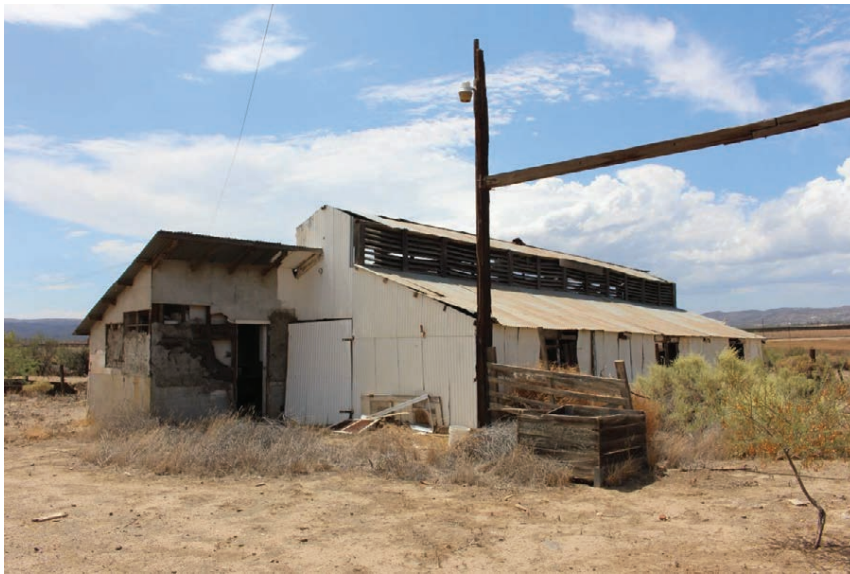
Barn B is located on the southwestern corner of the dairy complex, to the direct northwest of Dwelling B. The one-and-a-half story tall building is irregular in plan with a combination monitor-style barn roof and a shed roof with exposed wooden rafters; both are sheathed in corrugated metal. Exterior walls are primarily clad in corrugated metal, with the lower half of the shed roof section being rendered CMUs and the upper half wood-framed and clad in rendered drywall. The main entry is located on the building's northeast elevation and displays as a wide, single corrugated metal entry door. On the southwest and northeast elevations are openings exposed to the elements revealing the timber framing. Along the barn's raised center aisle are horizontal wooden vents (Figure 10).

Figure 10. Barn B, view to southwest, IMG_3686

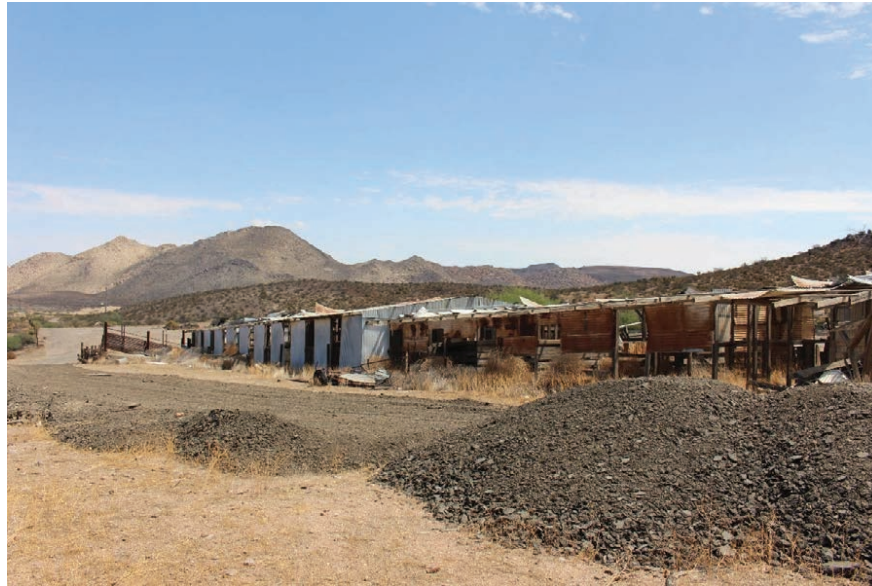
Figure 11. Barn C, view to northeast, IMG_3564

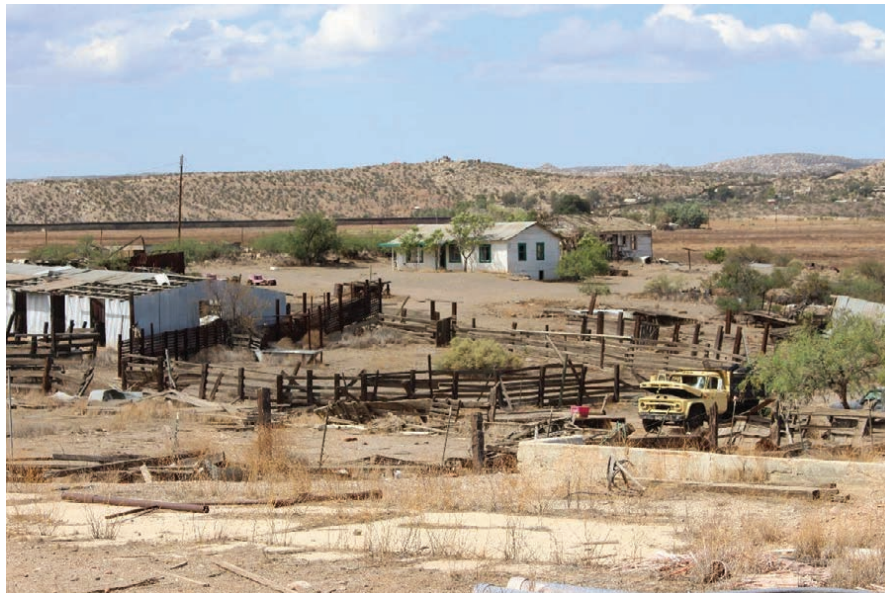
The Cow Pens are located at the northern end of the dairy complex and directly north of Barn C. The pens are square and comprised of post-and-rail wood fencing approximately measuring 90 feet by 90 feet (Figure 12). A majority of the fence is still standing with some sections either missing or having fallen down over time.

Figure 12. Cow Pens, view to southwest, IMG_3477

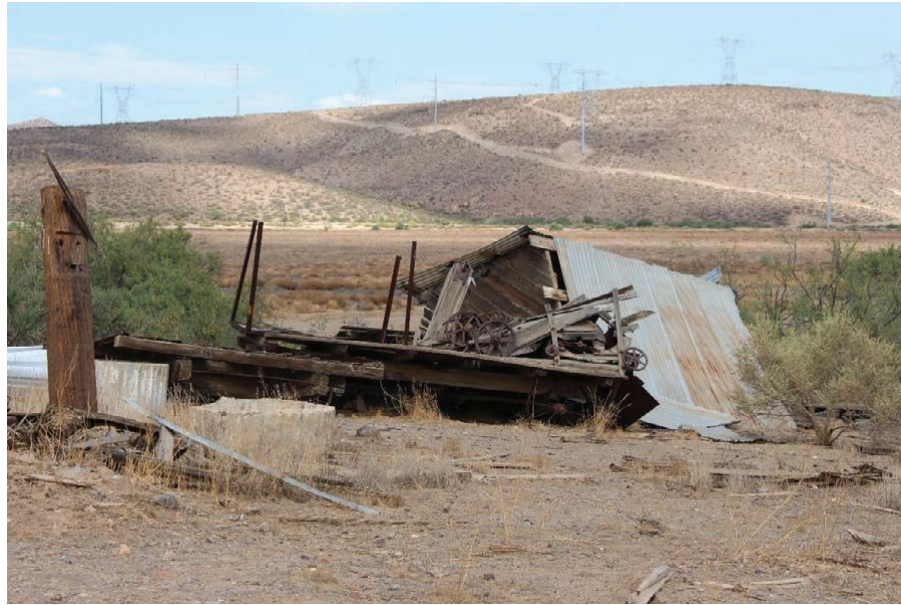
standing (Figure 13).

Figure 13. Collapsed Shed, view to west, IMG_3522

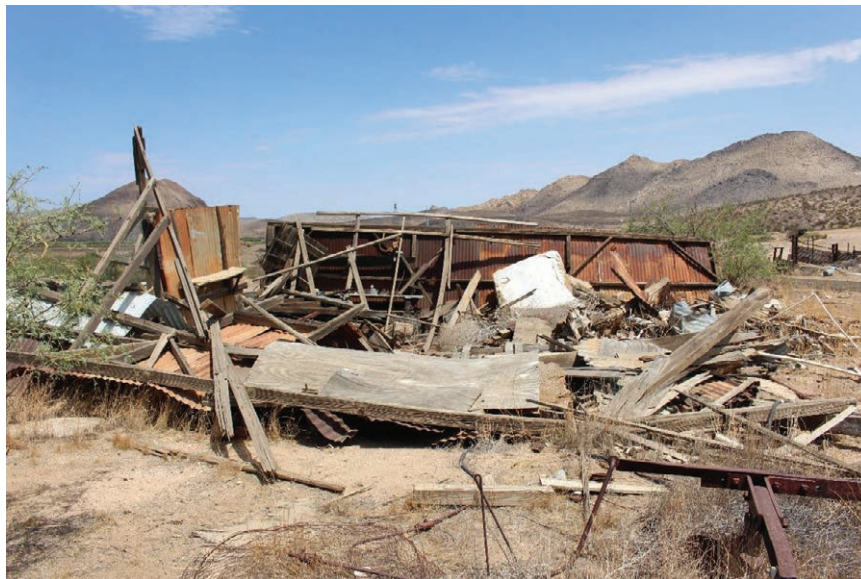
Collapsed Barn A is located on the western end of the dairy complex to the direct west of Barn C. The building appears to have been constructed out of corrugated metal and wood framing. The building materials are still present but the building is no longer standing (Figure 14).

Figure 14. Collapsed Barn A, view to west, IMG_3658

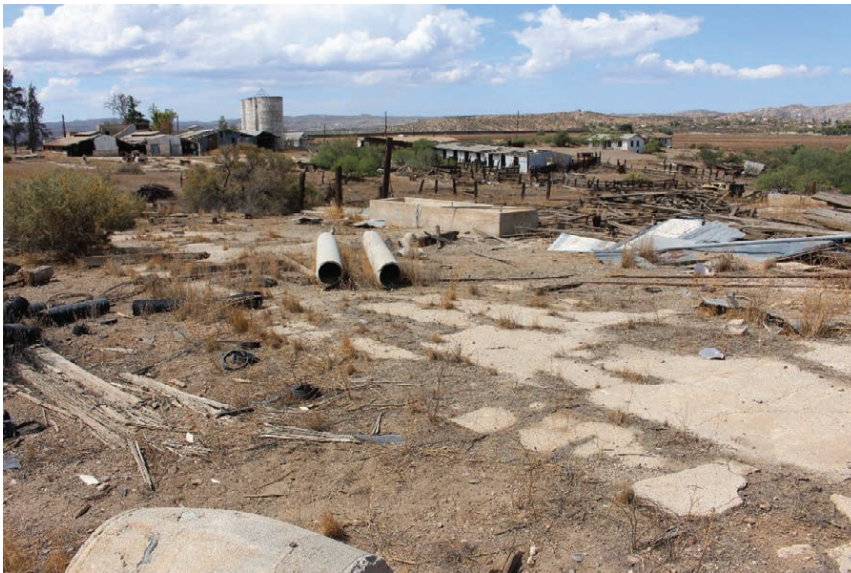
Building 15: Barn Foundation A

Barn Foundation A is located at the northeastern end of the dairy complex to the direct northeast of the Cow Pens. The building itself is no longer extant; only the concrete

foundation remains (Figure 15).

Figure 15. Barn Foundation A, view to southwest, IMG_3472

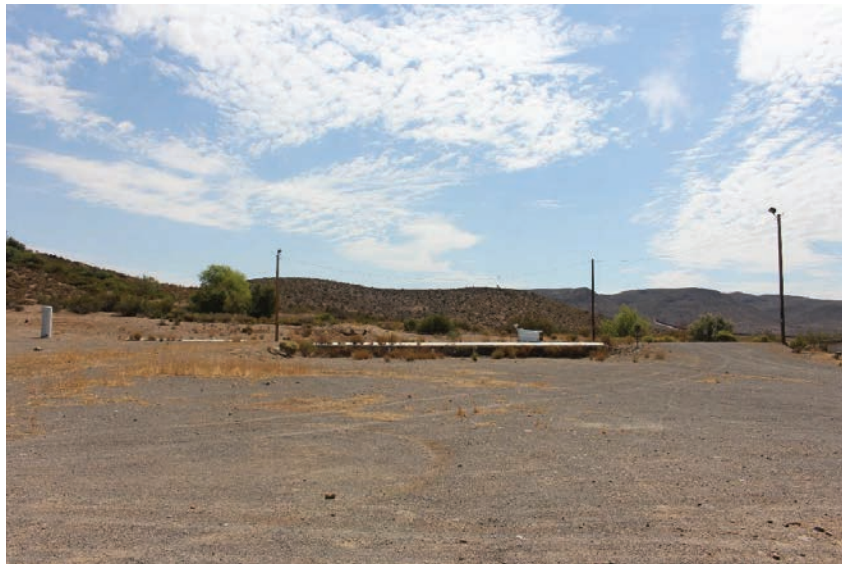
Building 16: Barn Foundation B

Barn Foundation B is located at the eastern end of the dairy complex. The building itself is no longer extant; only the concrete foundation remains (Figure 16).

Figure 16. Barn Foundation B, view to east, IMG_3427

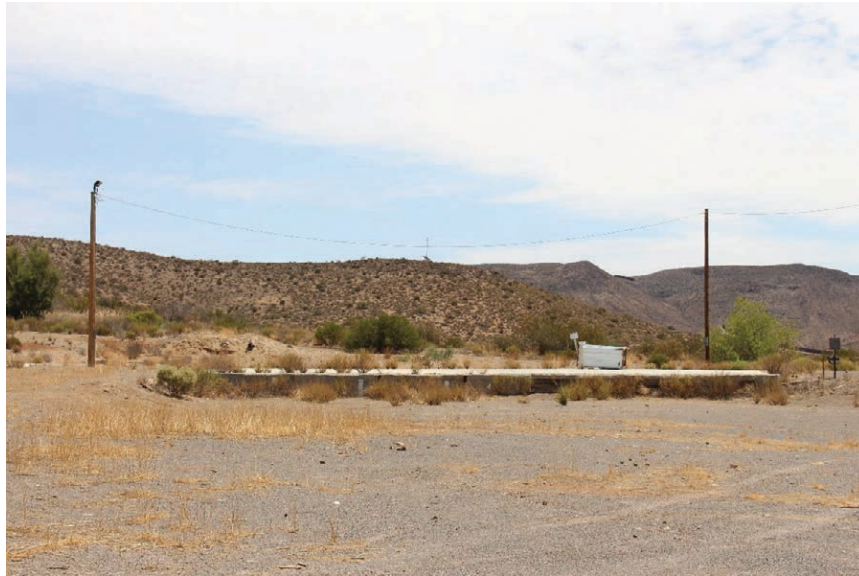
Figure 17. Barn Foundation C, view to east, IMG_3880

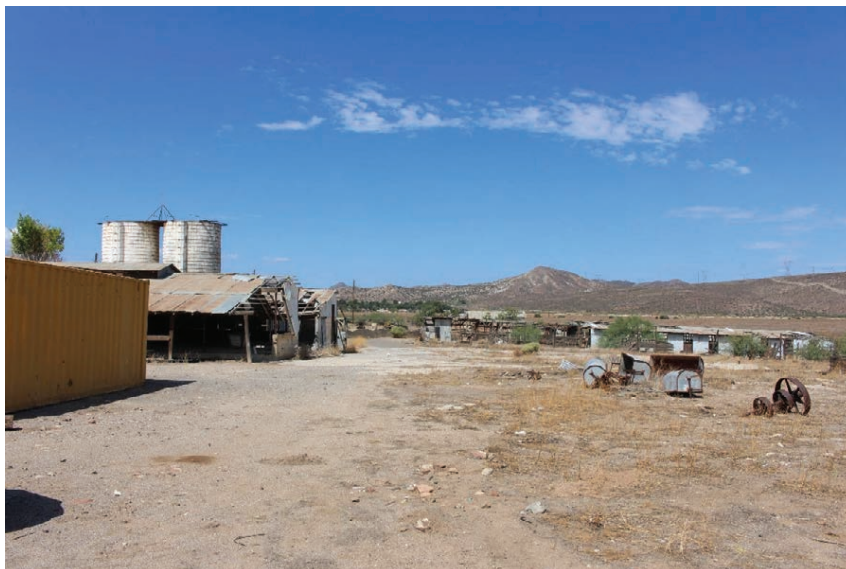
Figure 18. Barn Foundation D, view to east, IMG_3435

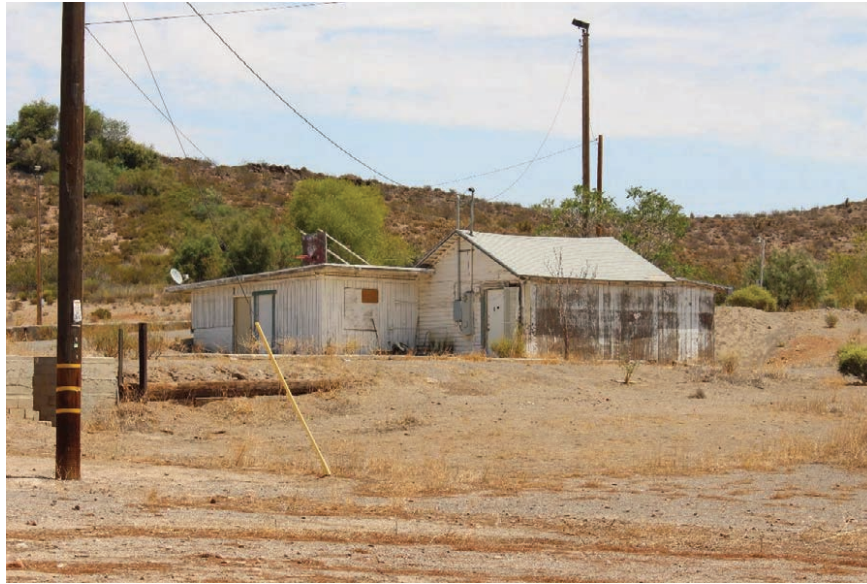
over-one windows (Figure 19).

Figure 19. Office, view to northeast, IMG_3761

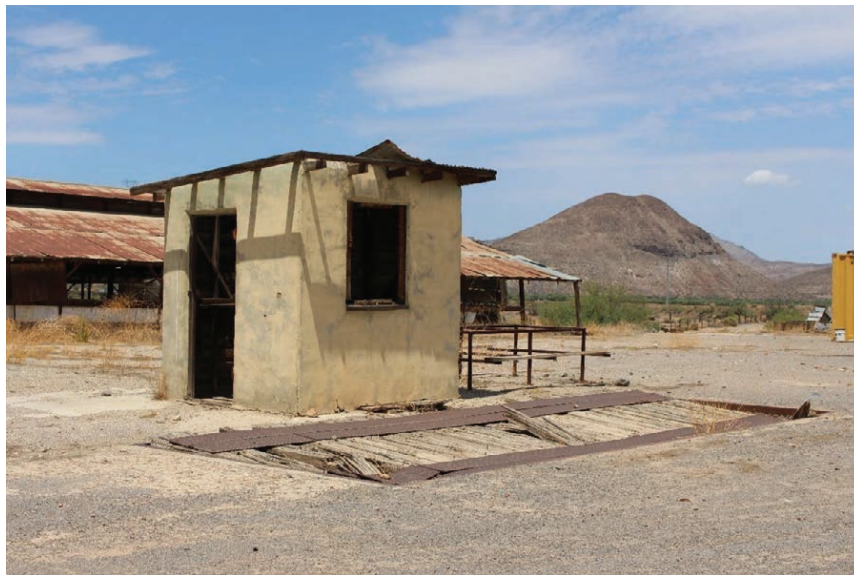
Figure 20. Weight Station, view to north west, IMG_3868

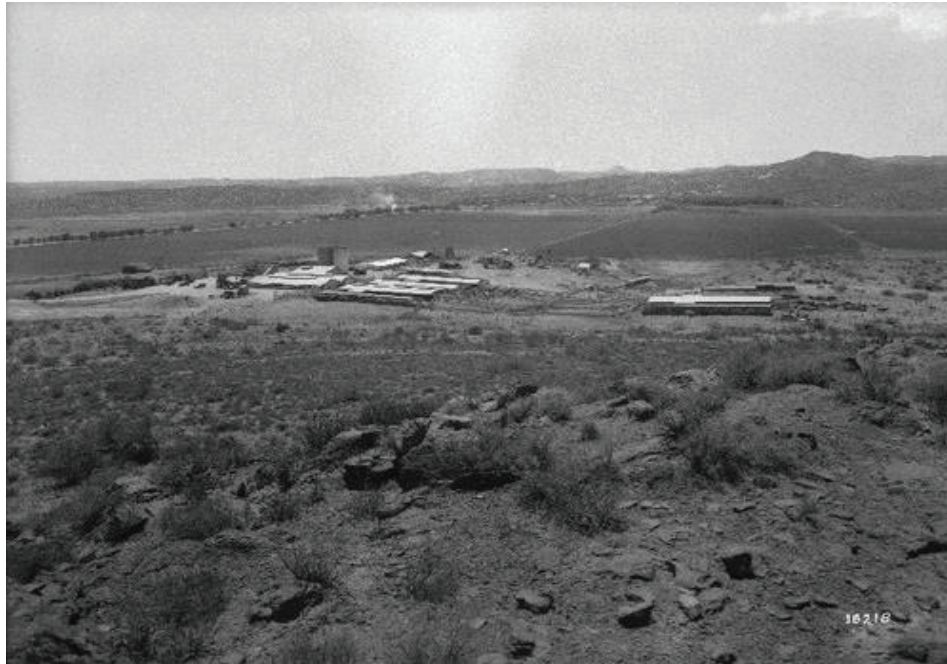
Figure 21. View of Mountain Meadow Creamery in the Jacumba Valley, c. 1934, Courtesy San Diego Historical Society

The Mountain Meadow Dairy and Creamery's Sunshine Ranch totaled 750-acres in size and was one of the only large dairy products organizations in San Diego's southwest region that both produced its own milk and then distributed it (Figure 21) (ET 1933). This was possible by several innovations made by the company. The first being the presence of an urban creamery located in Mission Valley, San Diego, constructed in 1933 with the latest technologies in pasteurizing, cooling, testing, and bottling milk under sanitary conditions (ET 1933). The second being the fleet of 80 employees working at the two locations, which helped operate twelve retail and three wholesale routes. Two early morning deliveries were made daily before 6 a.m. and after 8 a.m. by a fleet of milk deliverymen driving motorized trucks (Figure 22) (SDU 1934b). The aluminum painted delivery trucks serviced thousands of homes in San Diego, La Jolla, and Coronado every morning due in part to the company's third innovation of a specialized metal bottle cap. In 1933, Mountain Meadow introduced a 100-percent sanitary metal bottle cap and a new type of milk bottle that would better protect the milk inside. In 1934, this earned the company a gold medal for the highest testing Grade "A" raw milk at the California State Fair in Sacramento (SDU 1934e).

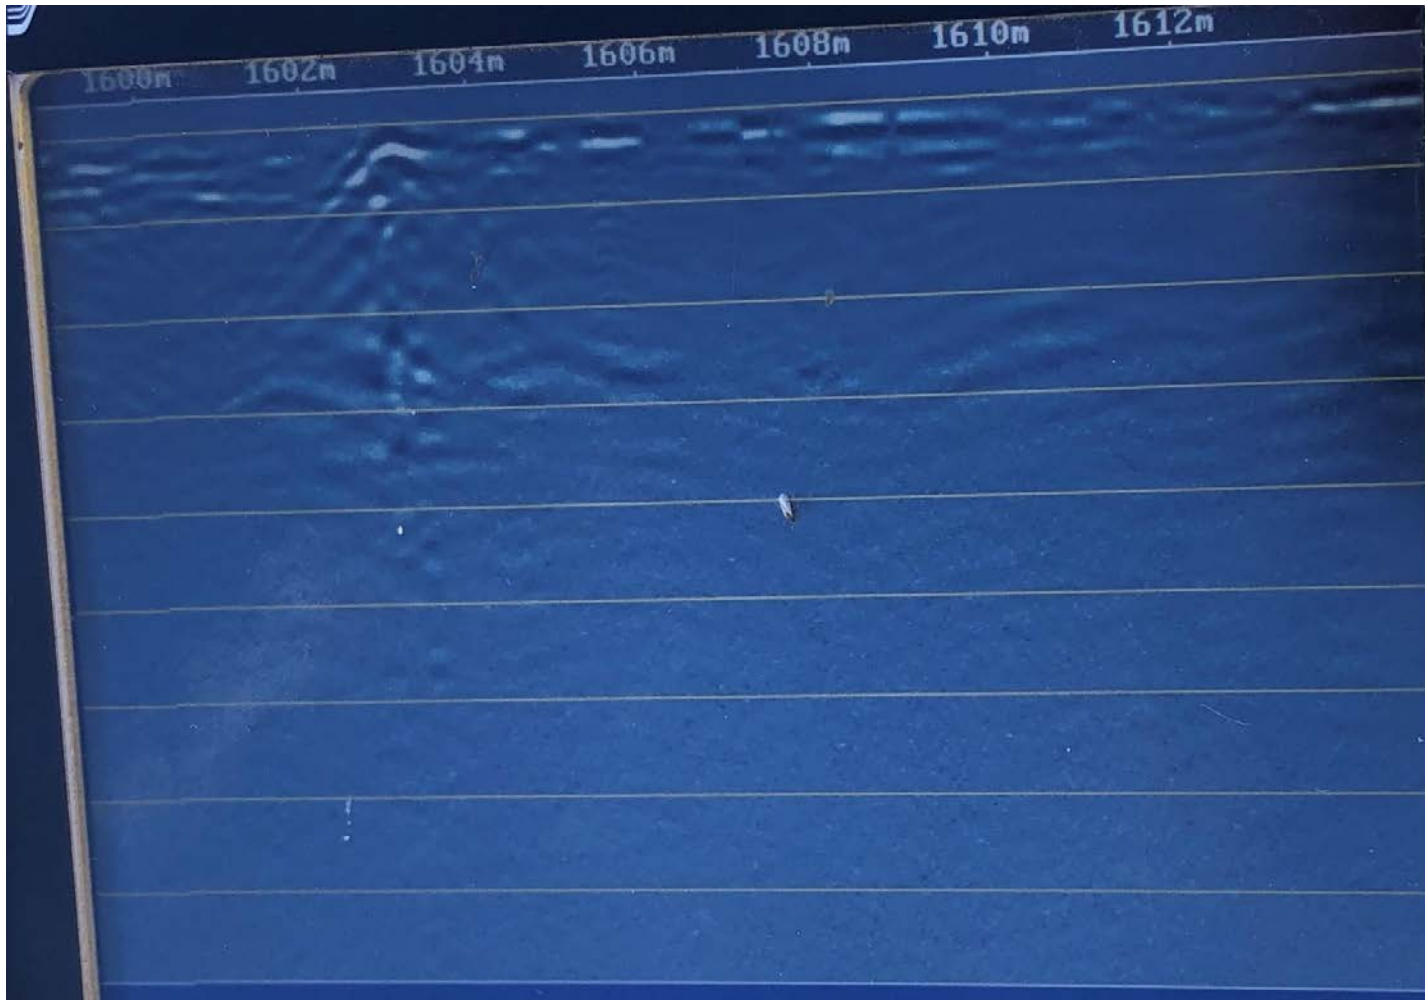
Figure 7: Anomaly 2 Metal Object Reverberations
