# APPENDIX G

*Phase 1 Environmental Site Assessment,  
JVR Energy Park Project (Jacumba Valley Ranch)*

## MEMORANDUM

*Subject: Technical Documents for Hazards and Hazardous Materials Chapter, JVR Energy Park Project  
Environmental Impact Report*

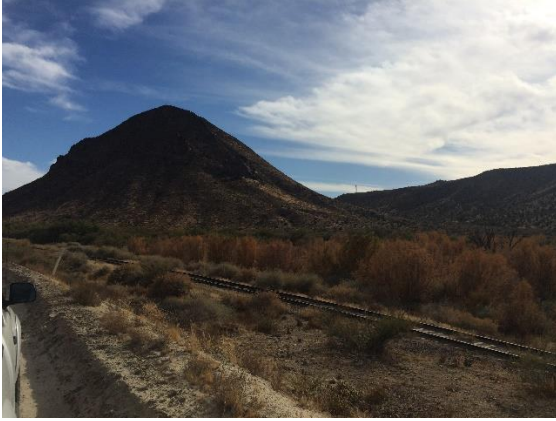
Photograph 5 – Railroad and Round Mountain in the northwestern portion of the subject property.

A dry stream runs from the northwest portion of the subject property down the western portion of the subject property. A railroad track runs along a similar path as the stream and turns west towards Jacumba Hot Springs (Photograph 5). The railroad is not located on the subject property but runs north to south in between the western parcels. The northeastern portion of the subject property has a former produce packing facility and an abandoned sand mine (Photographs 11 and 12). Piles of crushed asphalt were observed near the sand mine (Photograph 13). A dry pond was observed near the abandoned sand mine (Photograph 14). A desert dry wash was observed in the northeastern portion of the subject property (Photograph 15). A large area consisting primarily of wood debris was observed south of the desert dry wash (Photograph 16). Carrizo Gorge Road is not on the subject property but runs in between the north and northeastern parcels.

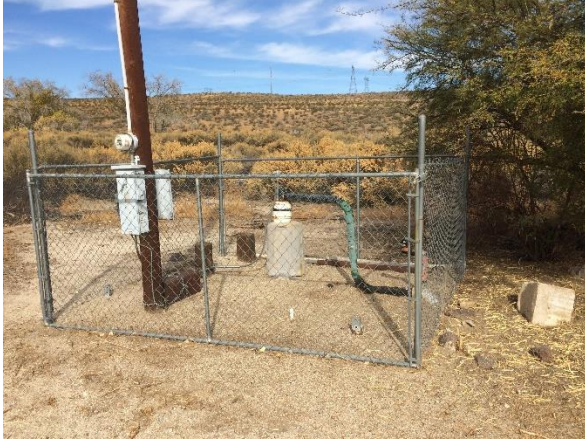
Photograph 9 – A production well on the subject property located just north of Jacumba Hot Springs.

As observed during the site reconnaissance, 12 water wells are present on the subject property. Two of the 12 wells are currently used as production wells. Seven additional water wells are located within Jacumba Hot Springs.

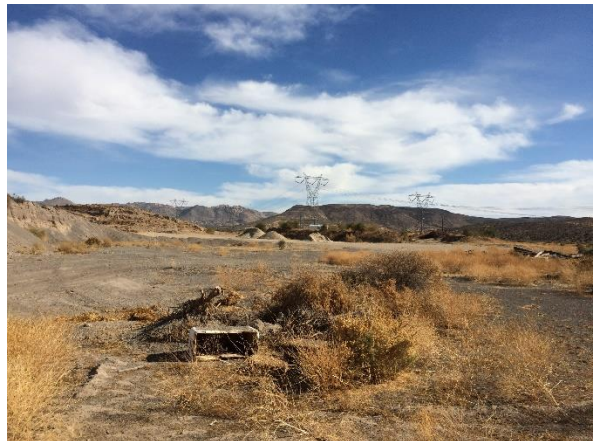
Photograph 12 – Abandoned sand mine located in the northeastern portion of the subject property.

Soil disturbances related to an abandoned sand mine were observed near the northeastern portion of the subject property.

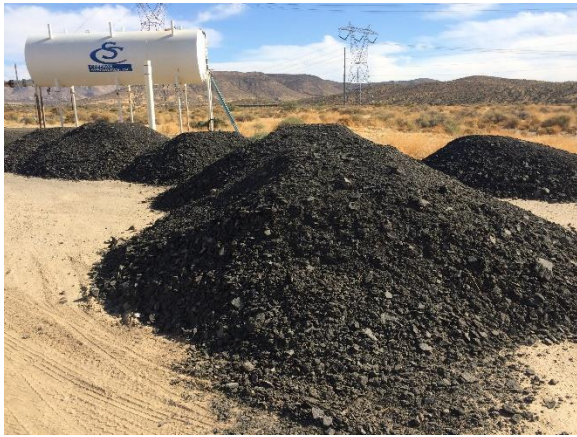
Photograph 13 – Piles of crushed asphalt and a water trailer on stilts located on the eastern portion of the abandoned sand mine.

- Large piles of crushed asphalt were observed near the former sand mine located in the northern portion of the subject property.
- Adjacent and nearby land uses are gas stations, an airport, residential, and undeveloped land.

A propane tank was observed on the ranch portion of the subject property, along with a large oval-shaped metal AST; the contents of the oval tank are not known, but no staining was observed during the site reconnaissance (Photograph 21). A raised water trailer was observed near the abandoned sand mine on the subject property (Photograph 13).

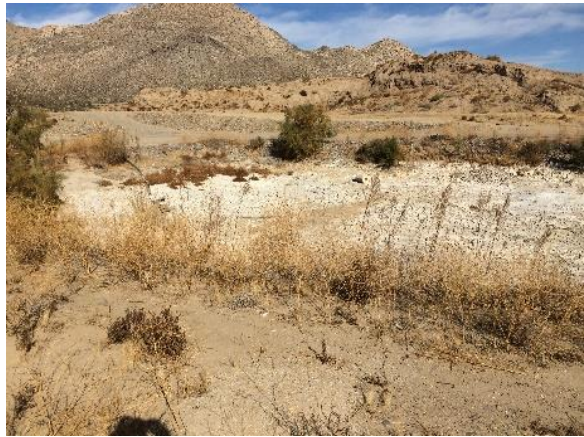
Photograph 14 – A former pond near the abandoned sand mine.

A dry pond area overgrown with vegetation was observed in the central region of the subject property. A dry pond was observed near the abandoned sand mine (Photograph 14).

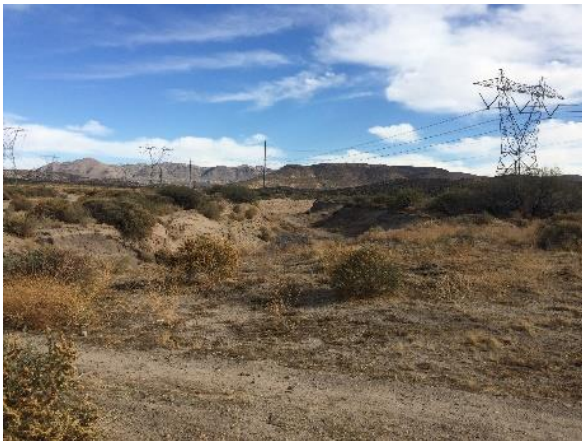
Photograph 15 – Desert dry wash located south of the abandoned sand mine.

A dry stream was observed along the western portion of the subject property. A desert dry wash was observed south of the abandoned sand mine (Photograph 15).

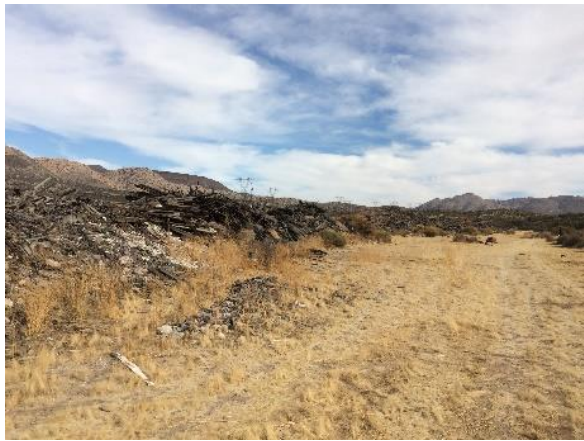
Photograph 16 – A large wood dump area, approximately 3 acres, is located north of the ranch.

- A sand mine or gravel pit was operated on the subject property from at least 1959 until sometime before 2015.
- A large dumping area, comprised primarily of wood debris, was observed during the site reconnaissance and appears to have been present since at least 2002.

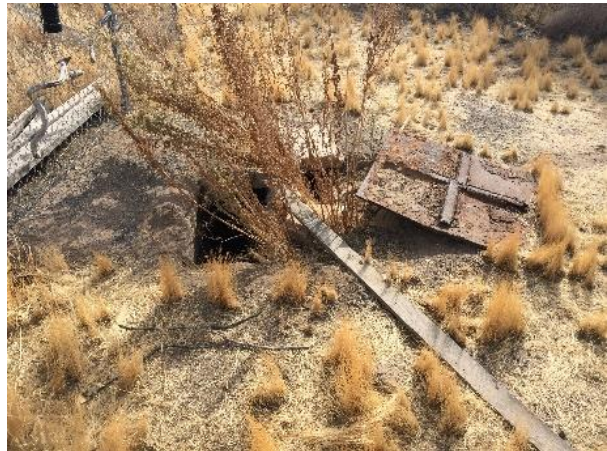
Photograph 20 – Possibly a location of an old septic tank located behind one of the residential house on the ranch.

Twelve groundwater wells were observed on the subject property. What appears to be a septic tank was observed on the ranch portion of the subject property (Photograph 20).

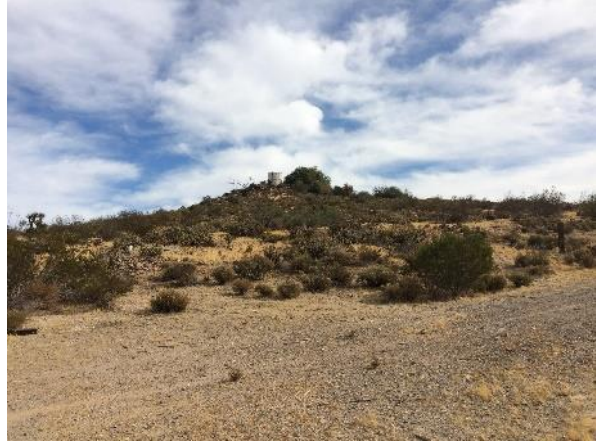
Photograph 22 – Three large water tanks are located just east of the ranch on a hill top.

the hill east of the ranch (Photograph 22). Pole-mounted transformers were observed on the ranch portion of the subject property (Photograph 23). Two vehicles were observed parked on the ranch, one of which had a bed full of tires (Photograph 24). Large piles of debris were observed on the ranch; the majority of the piles were scrap metal and wood (Photograph 25). Other debris observed included concrete, PVC pipe, crushed asphalt, I-beams, a steel drum, and farming equipment; no staining was observed beneath the steel drum (Photographs 26–28). A water supply line runs north–south west of the ranch area (Photograph 29).

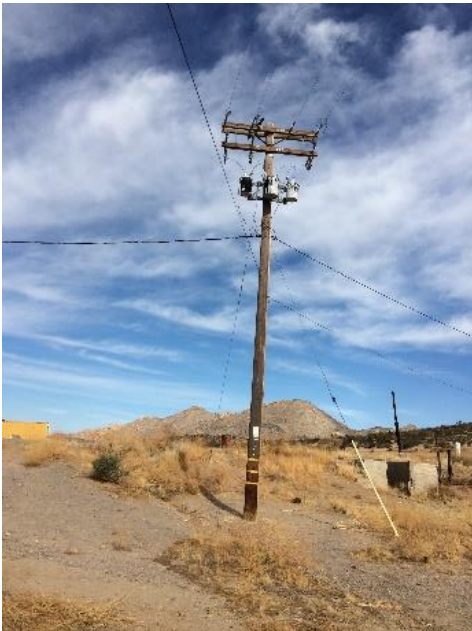
Photograph 23 – Three pole-mounted transformers located on the ranch.

Pole-mounted transformers were observed on the subject property. No visual indications of staining were observed (Photograph 23).

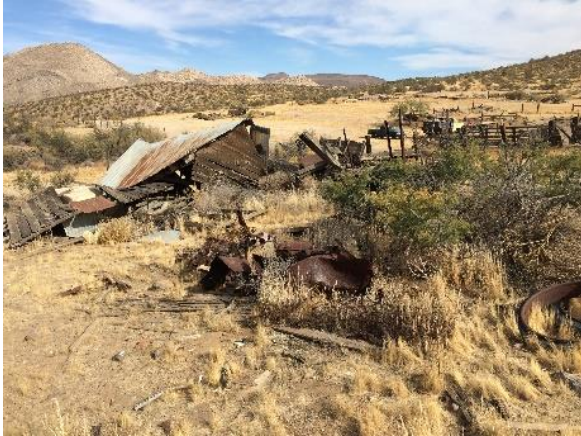
Photograph 25 – Piles of scrap metal and wood located on the ranch.

- Large piles of debris were observed on the ranch portion of the subject property including scrap metal, wood, concrete, PVC piping, a steel drum, and farming equipment.

Wood, metal scraps, tires, furniture, and trash debris were found throughout the subject property (Photographs 25 and 26).

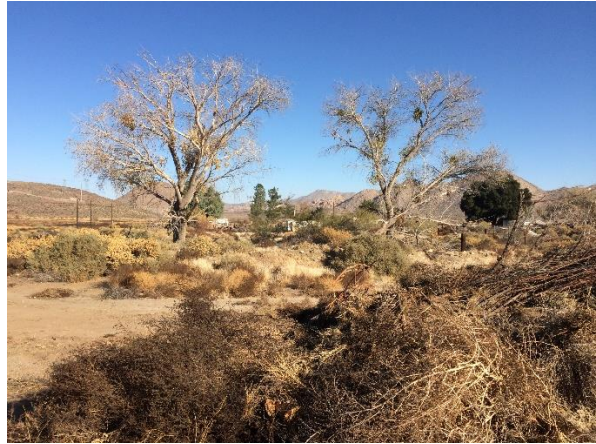
Photograph 30 – Distressed trees due to groundwater level decrease in the past.

Several dead trees were observed in the southwestern portion of the subject property, just north of Jacumba Hot Springs (Photograph 30). The trees were likely dead due to receding groundwater levels.

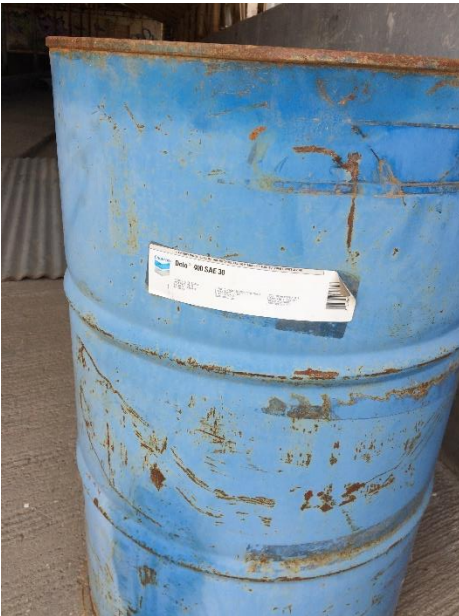
Photograph 31 – A 55-gallon drum labeled Delo 400 SAE 30 located on the ranch.

Chemical storage was observed on the ranch portion of the subject property. The chemicals observed include one bucket of hydraulic oil, one 55-gallon drum labeled Delo 400 SAE 30, some rusted aerosol cans, wood stain, and a 2.5-gallon container of fungicide (Photographs 31 and 32).
