Re: 2020 Updated Vegetation Communities of the Proposed Moosa Creek Riparian Restoration Project, Bonsall, San Diego County, California

Figure 2 - Vegetation

Figure 2
USACE Jurisdictional Resources

Figure 4
Vegetation in Relation to
Concept Design
Moosa Creek
San Diego County, CA

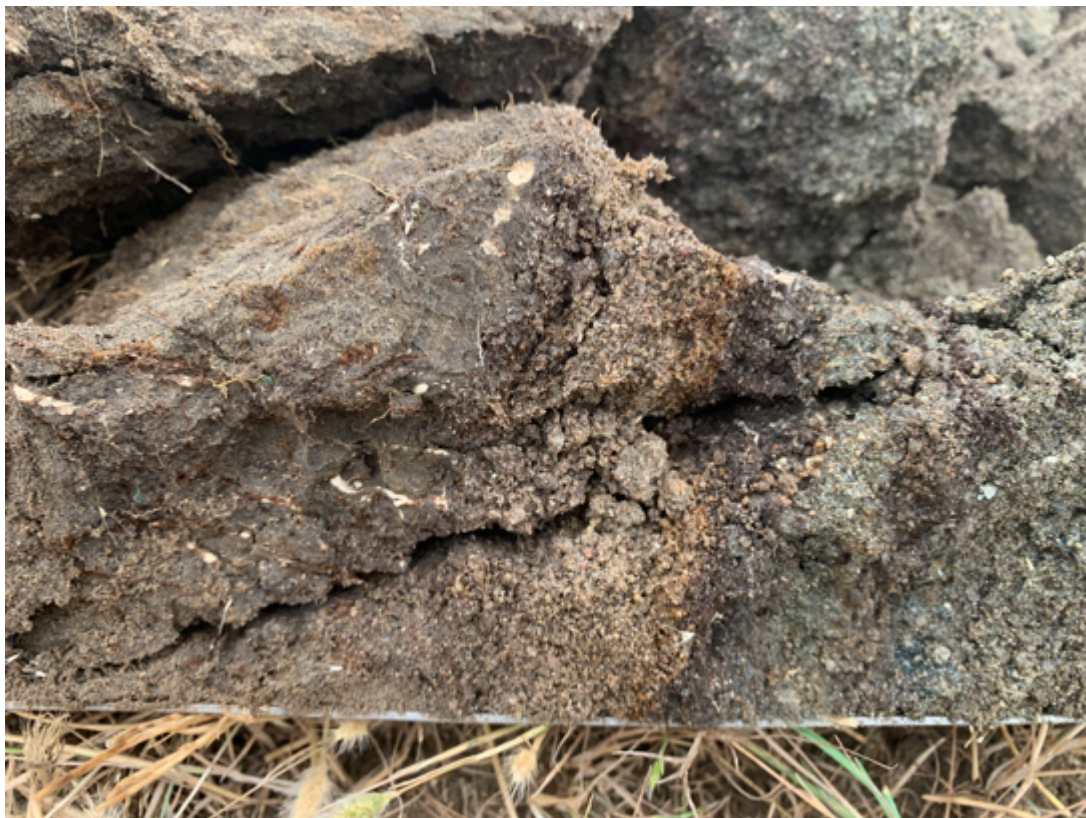
Photo 1: Sample Point 1 soil sample showing formation of stratified layers hydric soils indicator occurring within disturbed herbaceous wetland habitat within sampling location and adjacent test pits.

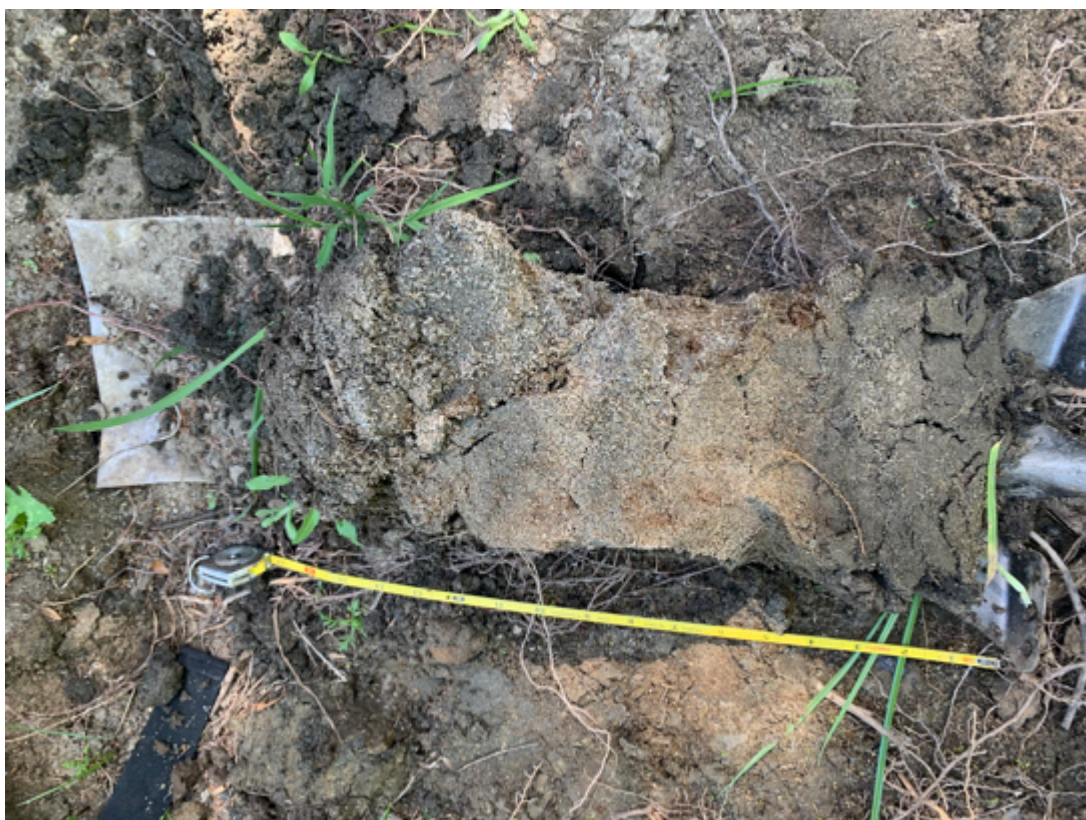
Photo 2: Sample Point 2 soil sample showing formation of redox dark surface hydric soils indicator occurring within disturbed herbaceous wetland habitat within sampling location and adjacent test pits.

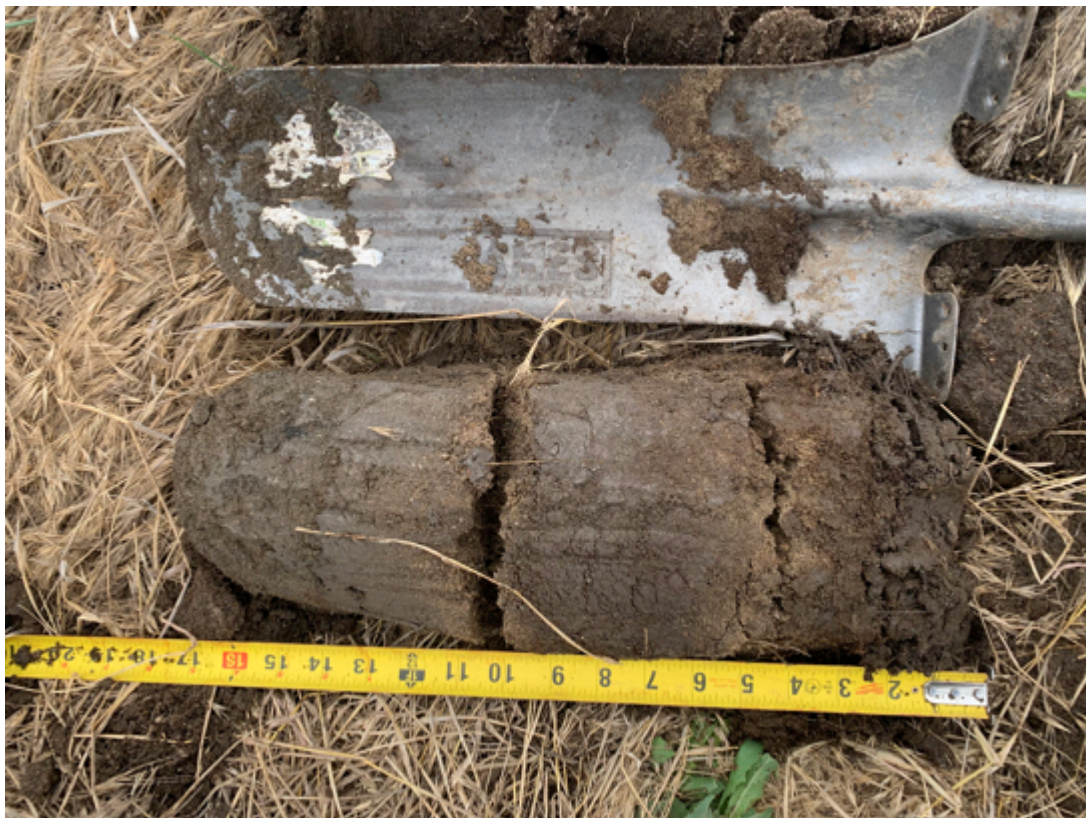
Photo 3: Sample Point 5 soil sample showing formation of redox dark surface hydric soils indicator occurring within disturbed herbaceous wetland habitat within sampling location and adjacent test pits.

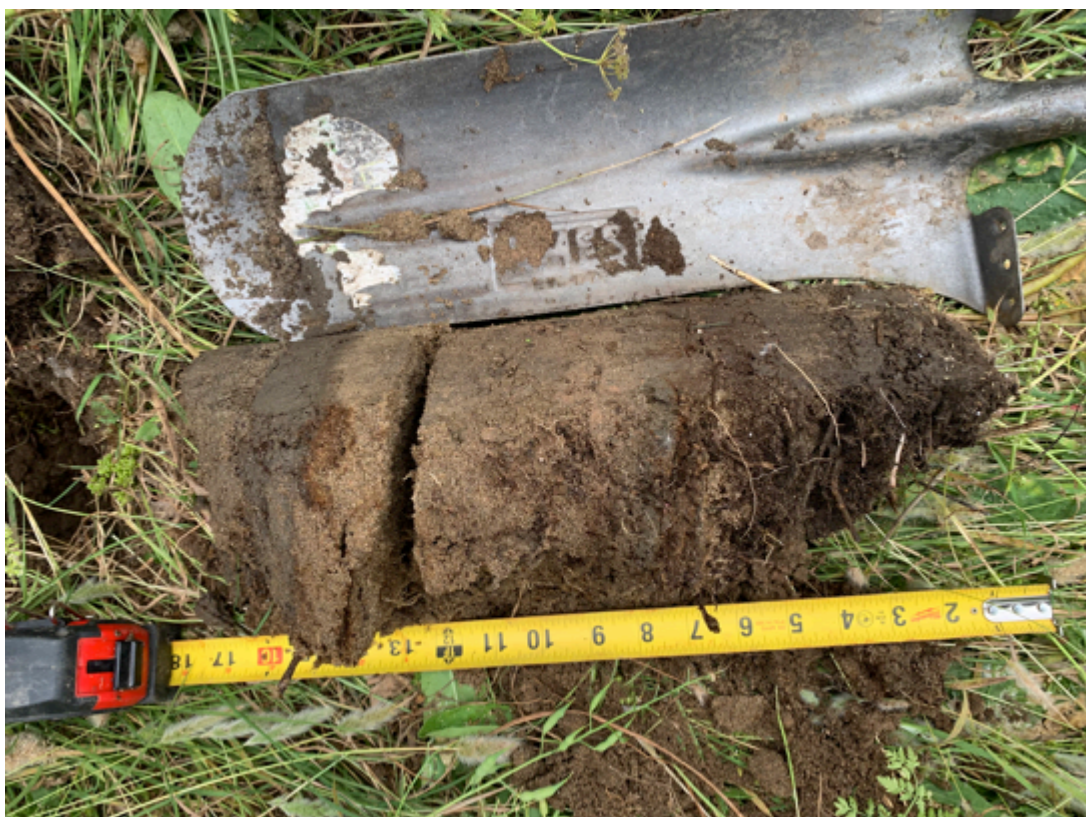
Photo 4: Sample Point 8 soil sample showing formation of depleted below dark surface hydric soils indicator occurring within disturbed herbaceous wetland north of Moosa Creek.

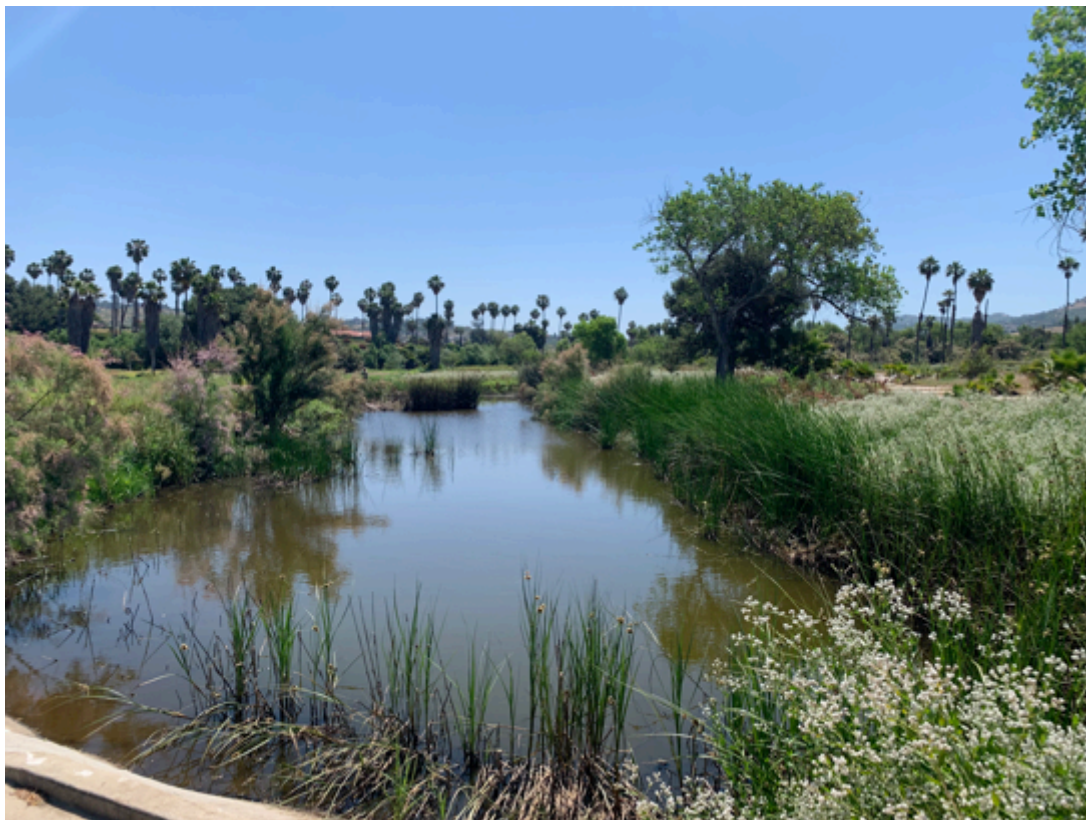
Photo 5: Representative photograph of open water habitat fringed by adjacent freshwater marsh and disturbed herbaceous wetland habitats occurring south of and adjacent to Moosa Creek. These areas were observed to have hydrological connectivity to Moosa Creek.

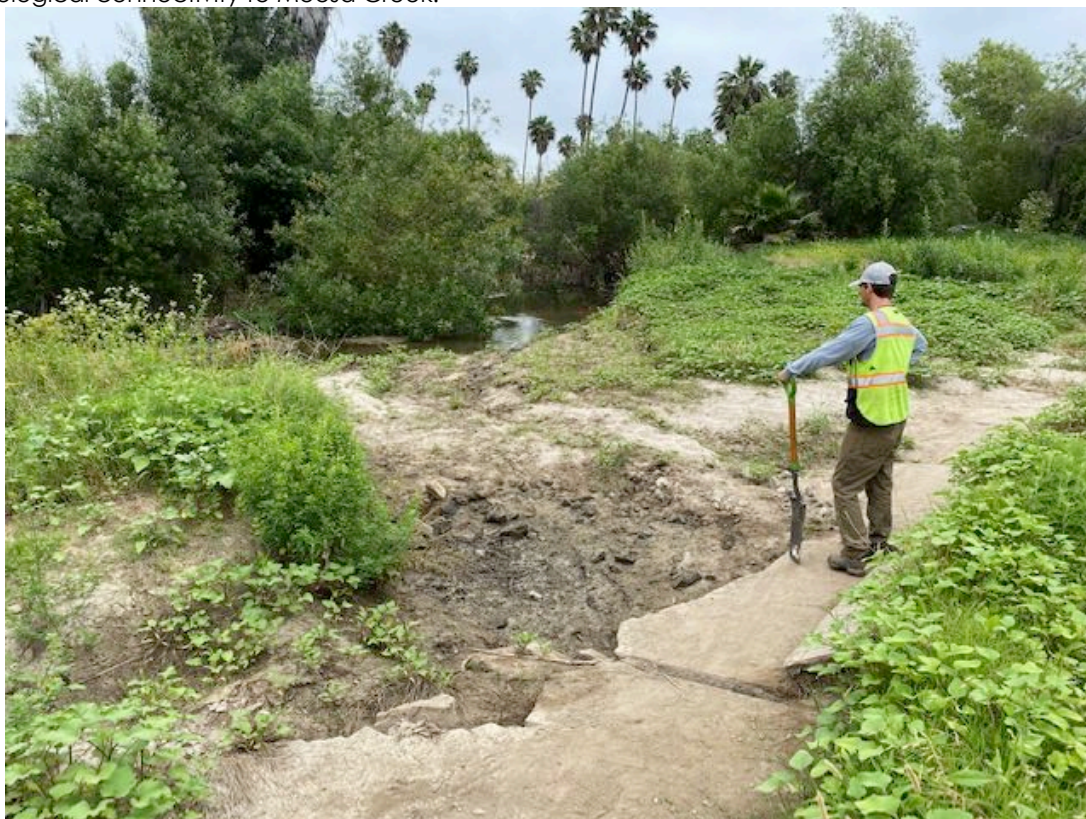
Photo 6: Representative photograph depicts arroyo willow association and scouring across the Moosa Creek flood plains where disturbed herbaceous wetland was mapped near the northeastern boundary of the old golf course.

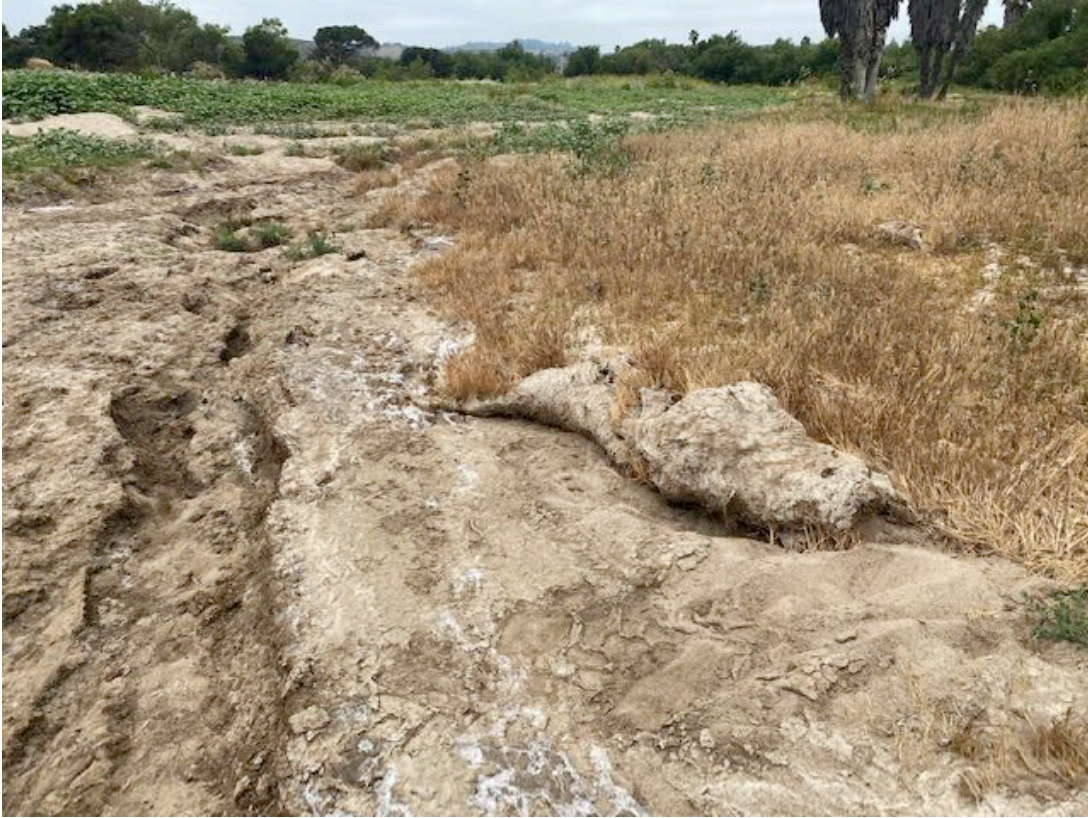
Photo 7: Representative photograph depicts downstream hydrological scouring and annual herbaceous vegetation from the area of Photo 6 across the flood plains of Moosa Creek where disturbed herbaceous wetland was mapped. This photo also shows the arroyo willow association in the background that is connected to this wetland.

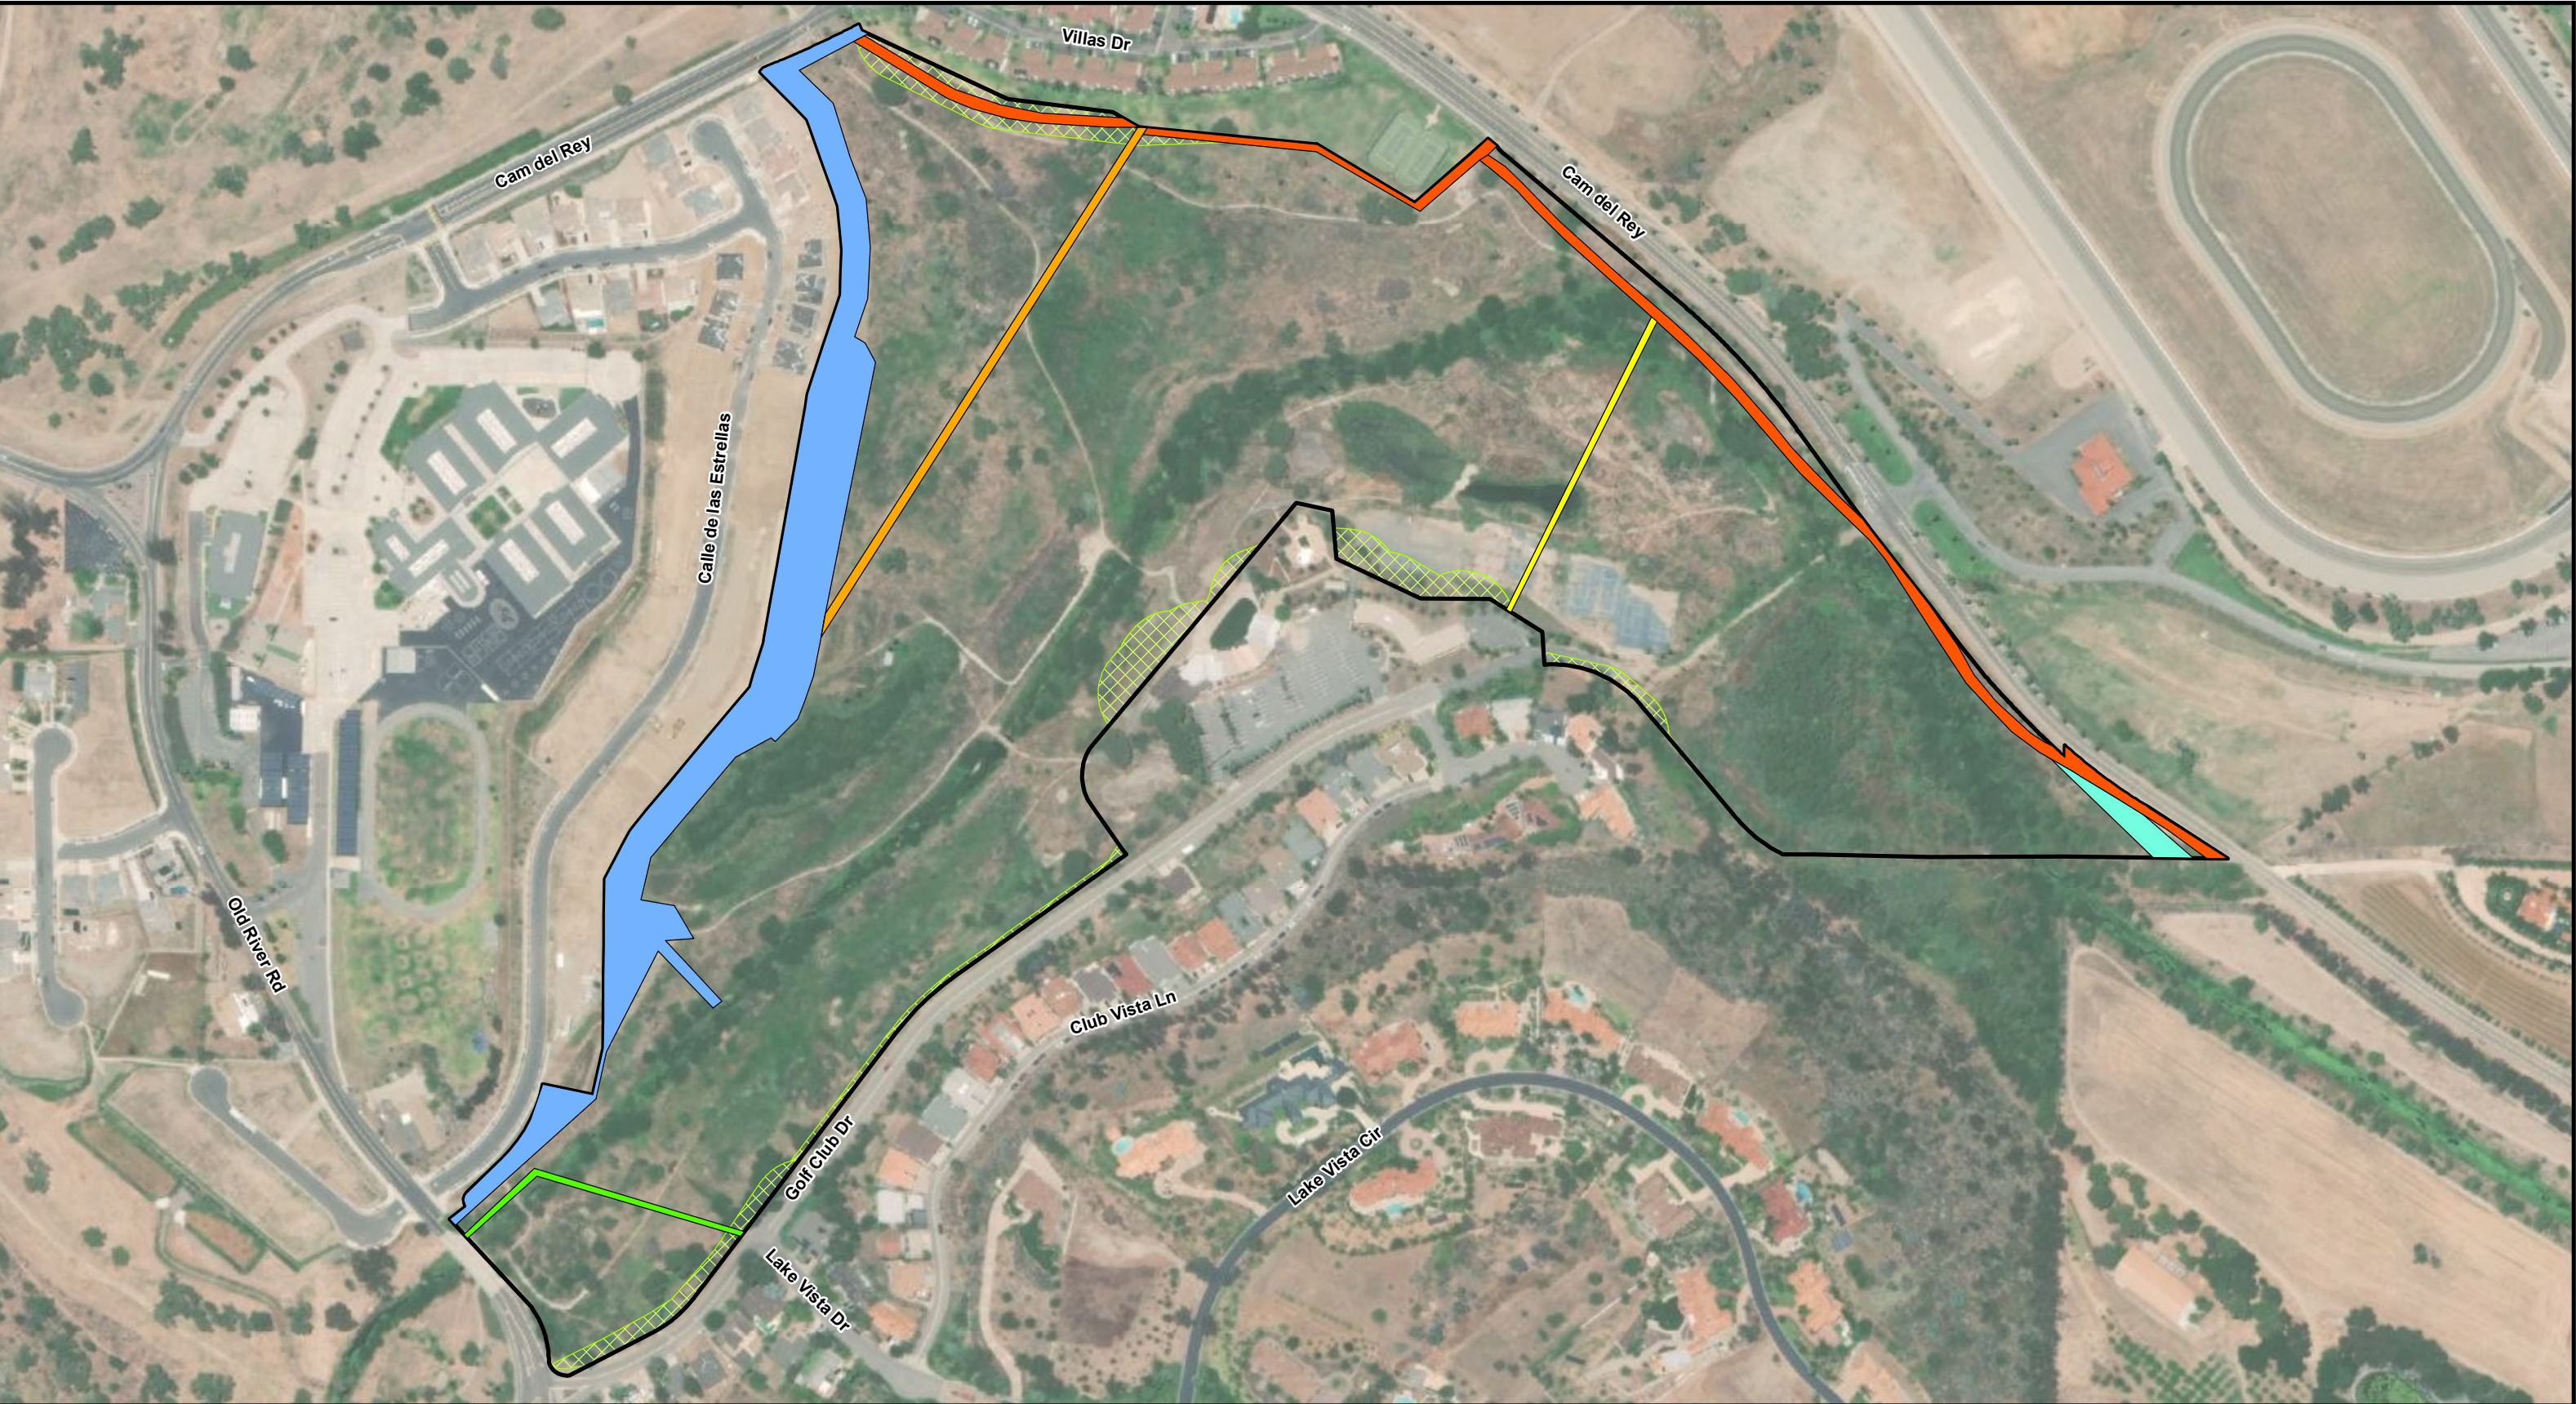
| <ul style="list-style-type: none">Site BoundaryFuel Modification Zones | Easements: Rainbow Municipal Water District <ul style="list-style-type: none">Pipelines (20 feet)Public Sewer (10 feet)Public Pipelines and Appurtenances (10 feet)Pipelines (15 feet) | <ul style="list-style-type: none">Slope, Utility, and IrrigationCounty ROW | <div><p>NORTH</p><p>0 150 300 600</p><p>Scale in Feet</p></div> | <p>BURNS & MCDONNELL</p> | <p>Figure 6 Fuel Modification Zones Moosa Creek San Diego County, CA</p> |

Fire management activities on this parcel will be conducted in accordance with the laws and regulations for fire management in conjunction with CalFire and the North Valley Fire Protection District. Fuel

modification zones will be excluded from restoration crediting and will be delineated in the field by markers to make the limits of fuel clearing distinct and prevent encroachment into the restoration site.
