PHASE I ENVIRONMENTAL SUBJECT SITE ASSESSMENT

**APN 4983303900,
southwest corner of Chase Avenue & Jamacha Road
near El Cajon, California**

DATE: March 15, 2016

PROJECT NUMBER: 16-0208

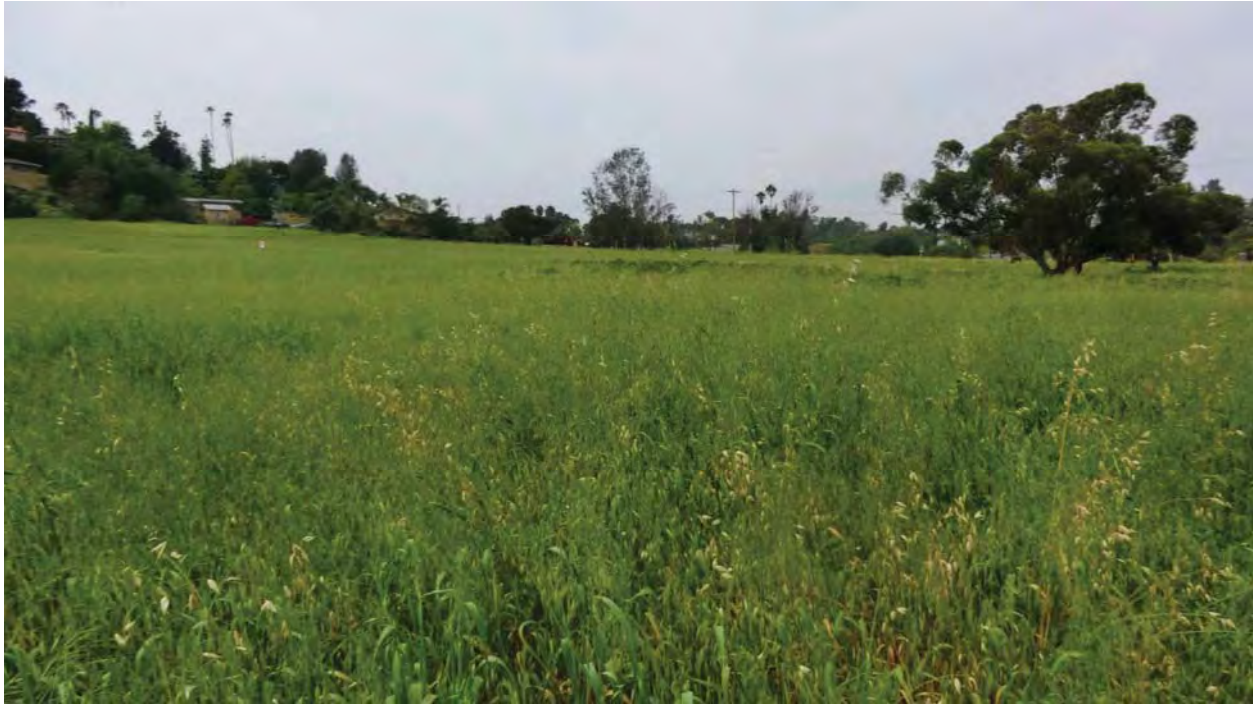
The subject site as seen from driveway along its south side, facing north.

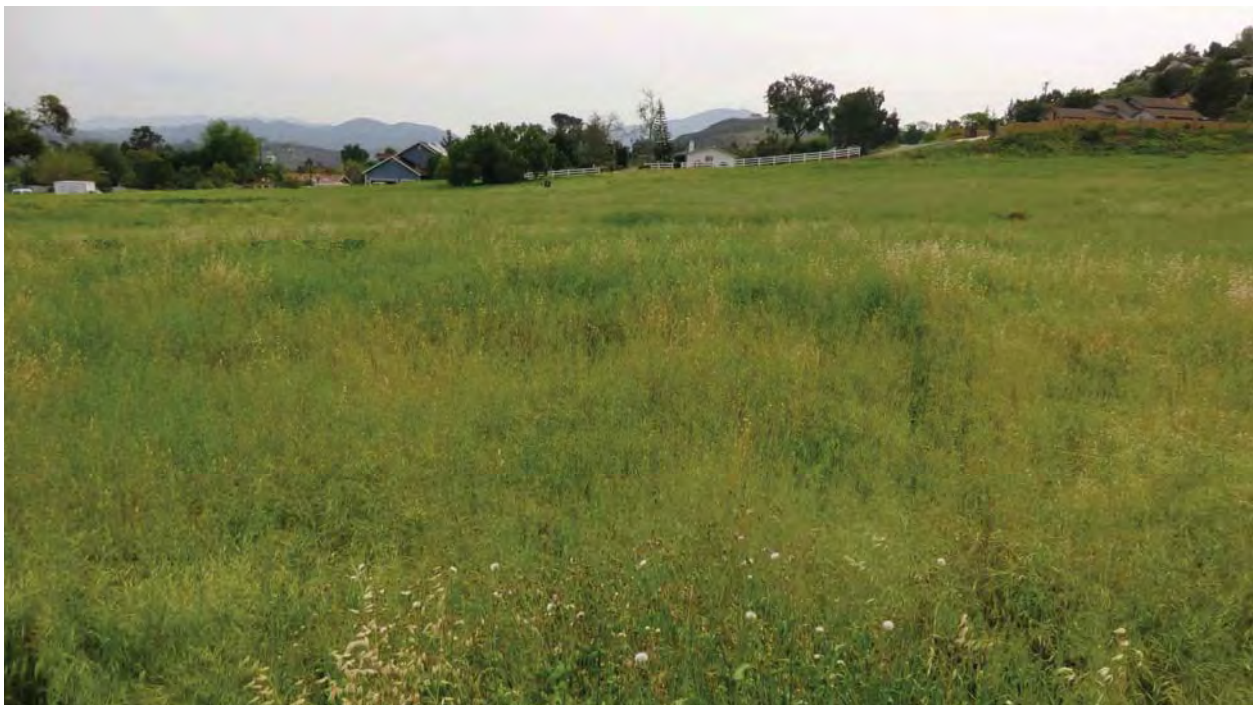
The subject site as seen from near its northeast corner, facing southwest; in background is adjoining residential usage.

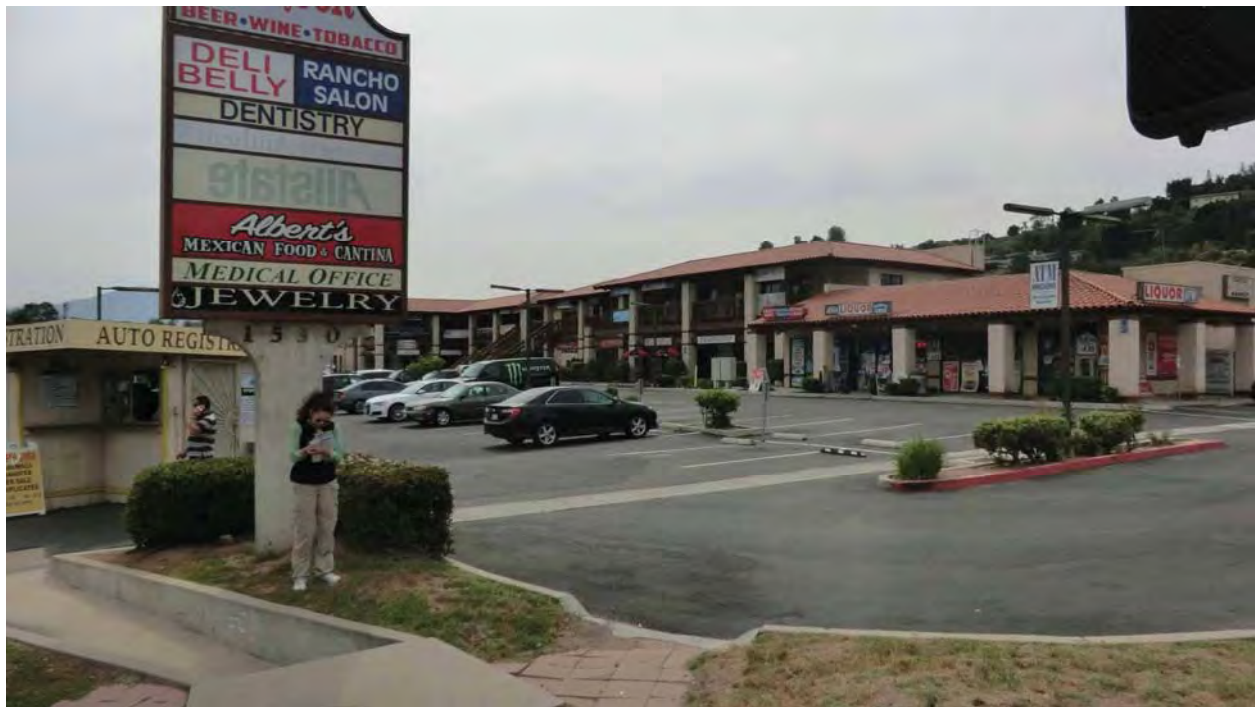
Adjoining usage; facing southwest from southwest corner, Jamacha Rd & E Chase Ave. In foreground, onsite paved strip; in background is adjoining shopping center at 1530 Jamacha Rd.

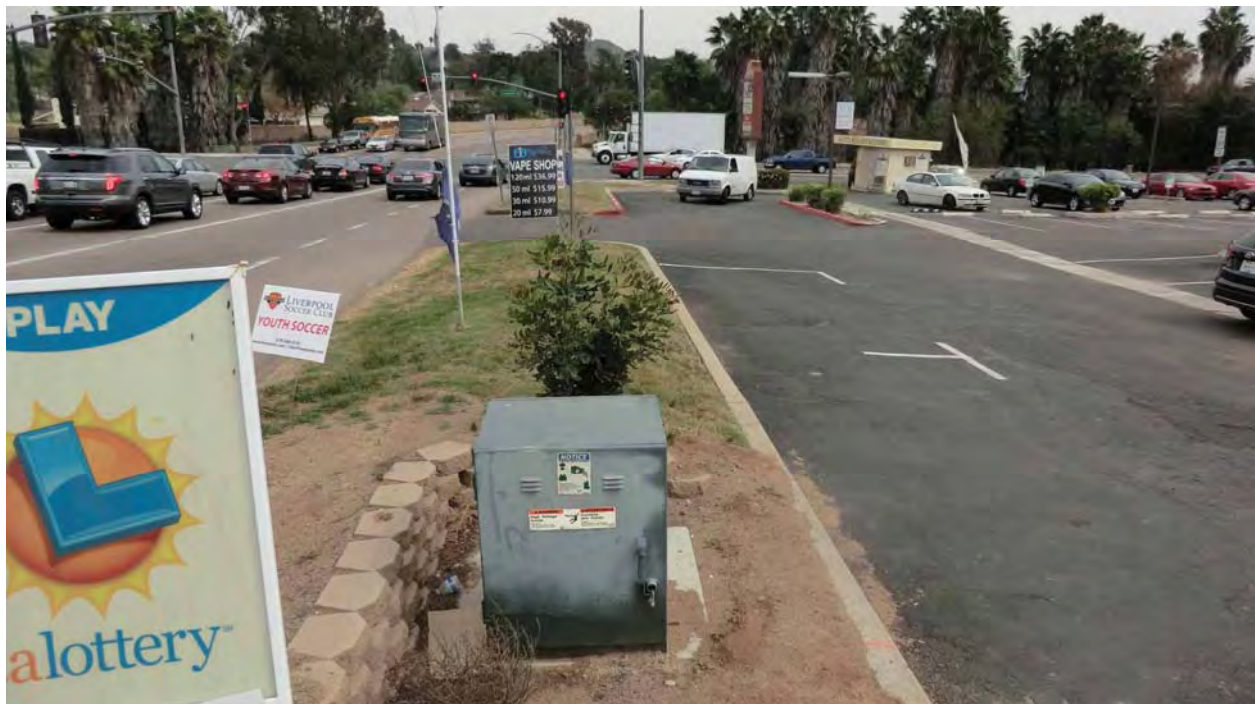
Facing east along strip extending at northeast corner of subject site; onsite transformer in foreground, onsite paved area and landscaping with Jamacha Road in background.

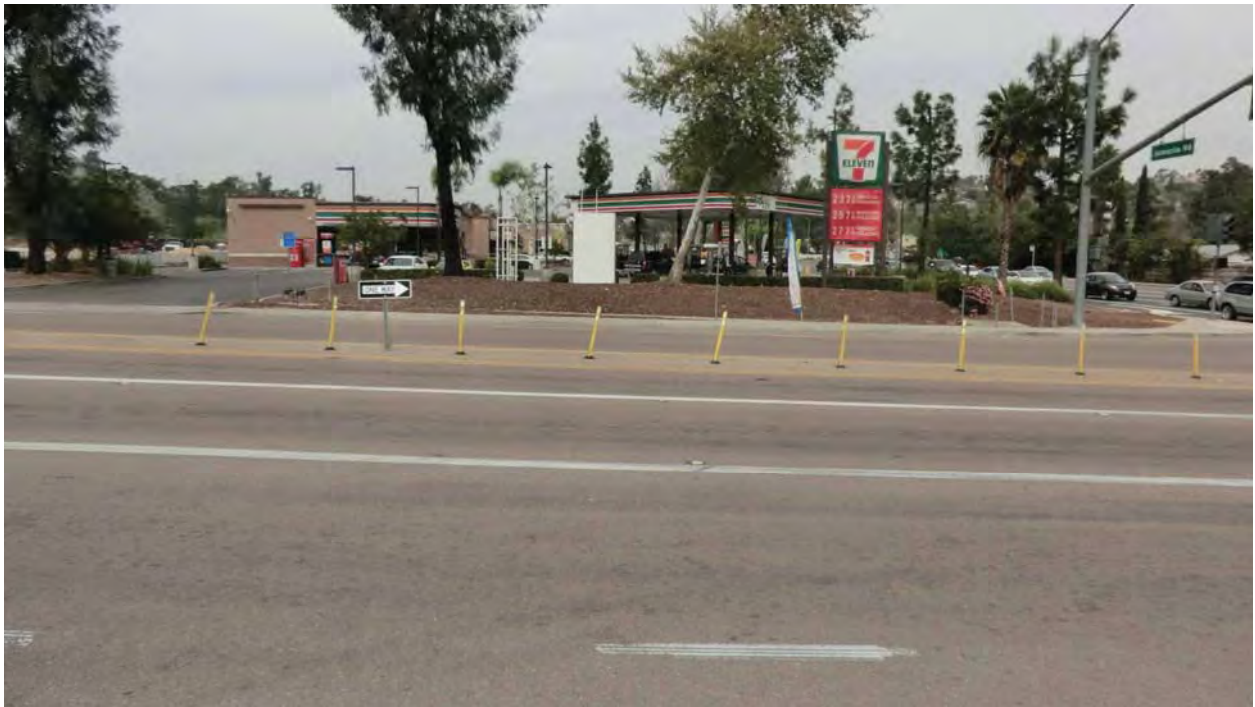
Neighboring usage: facing north across East Chase Avenue from southwest corner of Jamacha Rd & E Chase Ave; in background is 7-Eleven and gasoline station.

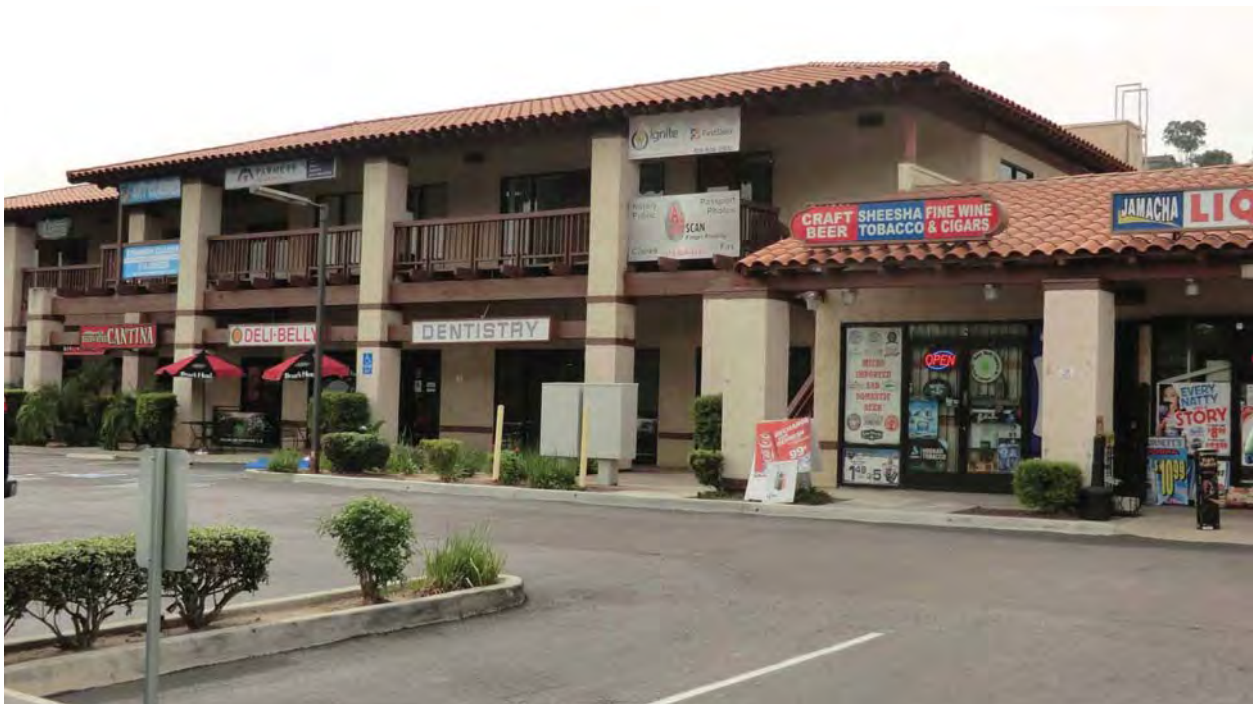
Detail of tenancies in building adjoining the subject site at 1530 Jamacha Road, facing southwest.

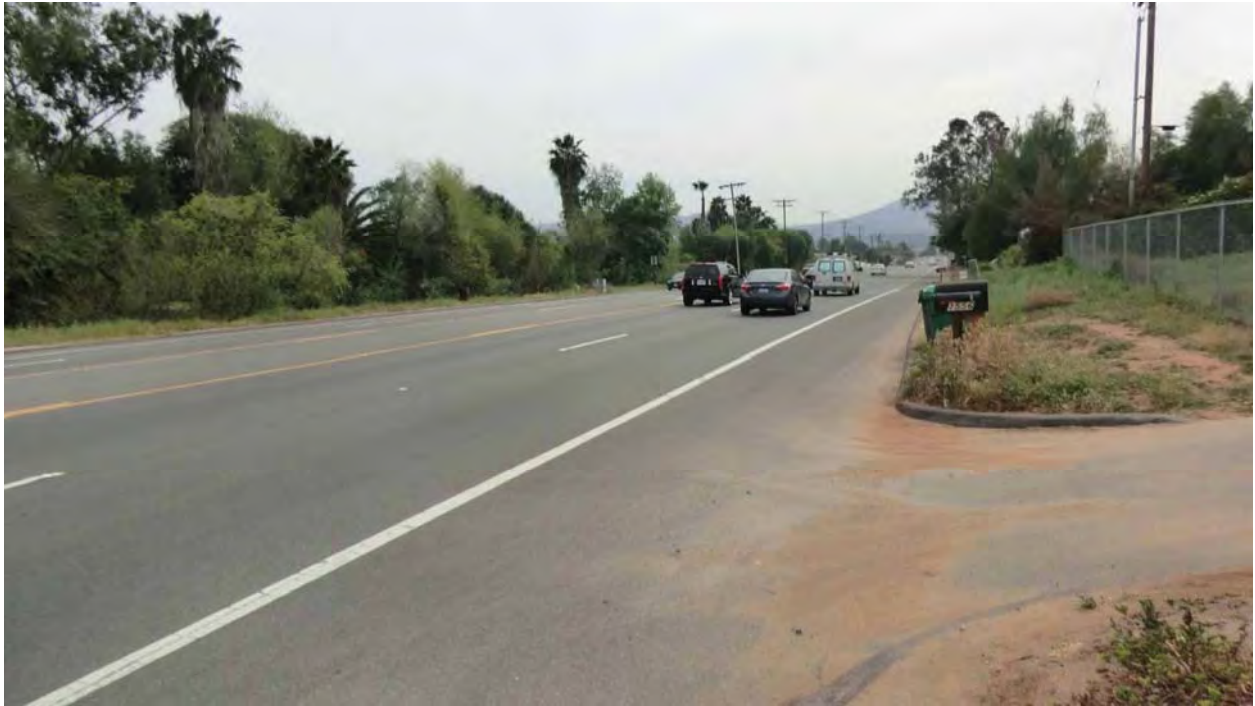
Subject site vicinity characterization; facing south along Jamacha Road from near its southeast corner.

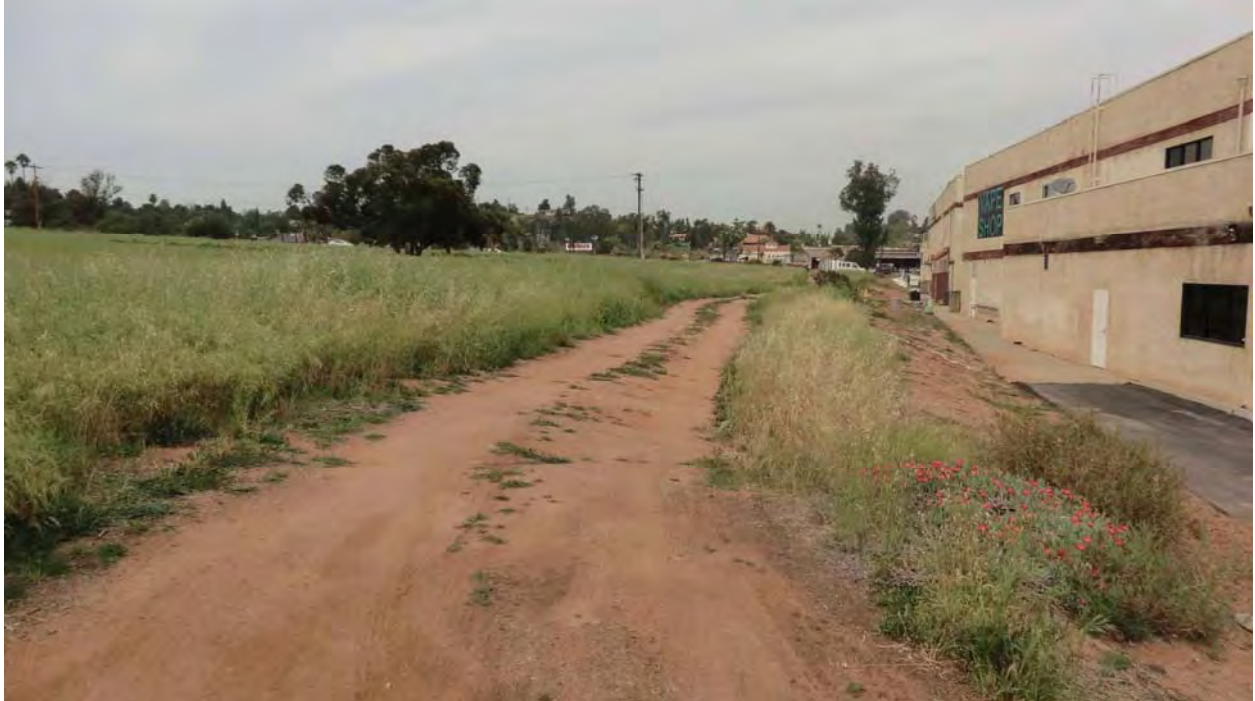
Facing north along eastern subject site boundary from near its southeast corner; at right is adjoining shopping center at 1530 Jamacha Road.

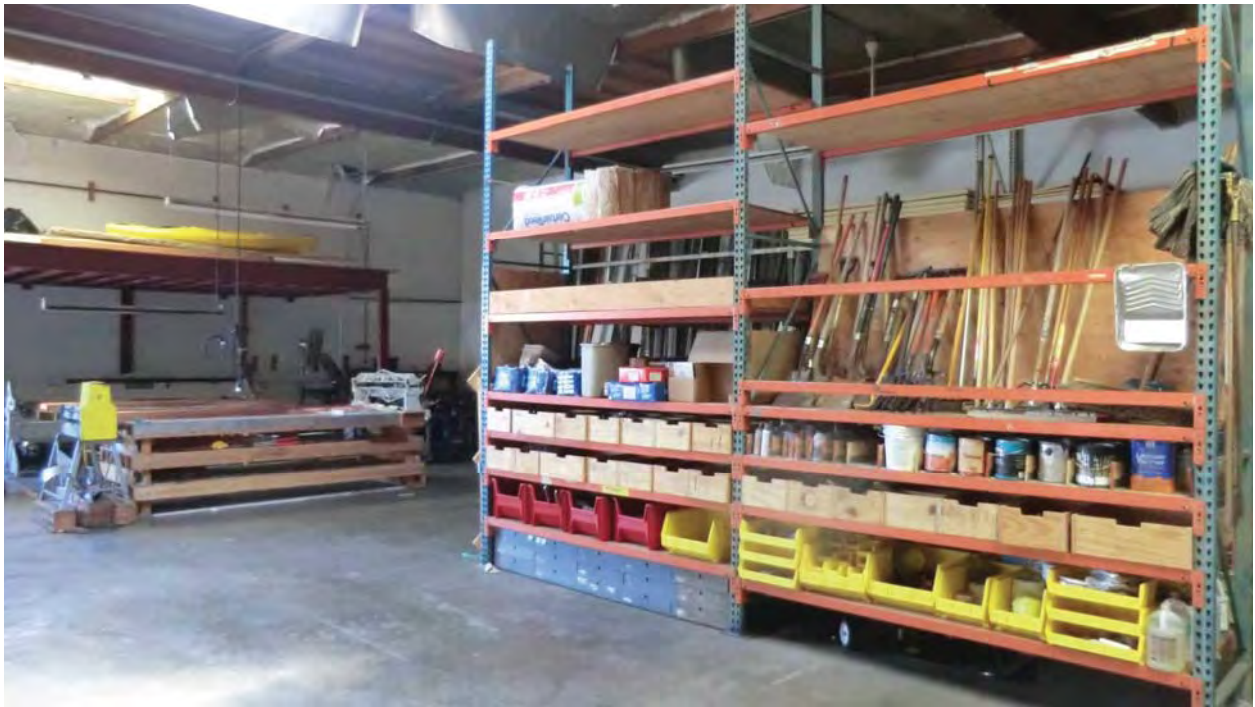
Interior of *Shadowcrest Roofing* operations area; supplies and hand-tools used in roof-related contracting. At rear are brakes for forming sheet metal flashings, etc.

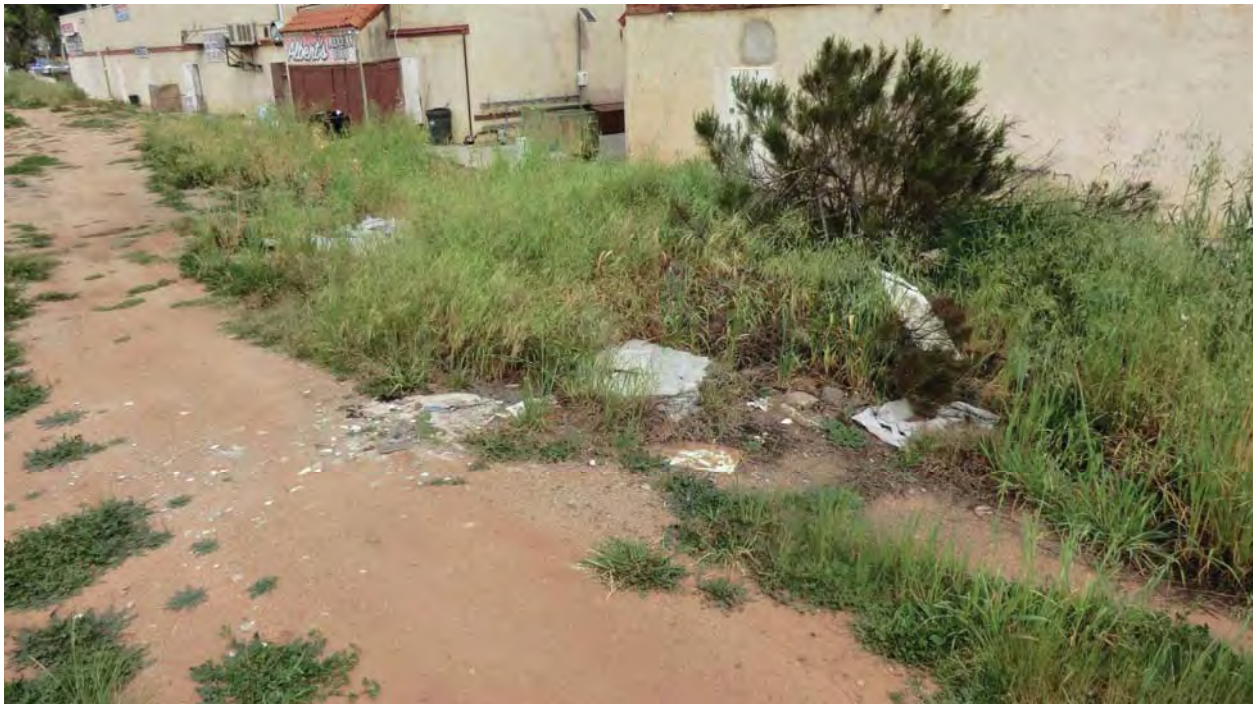
An unpaved roadway ran north-south along most of the eastern boundary, at the backside of the adjoining shopping center. Several small piles of waste were noted along this and included miscellaneous scrap from construction and packaging; these appeared to total less than a cubic yard. Also along the unpaved road, and presumed offsite were small steel outdoor tanks for waste food-oil in use by restaurants of the shopping center; minor release from one was noted in an adjoining puddle. A small pile of granular material, ca 1-cubic yard, appeared to have been dumped along northern edge of the subject site, at the edge of pavement for East Chase Avenue. A narrow onsite strip of land was indicated on the subject site’s parcel map as extending to Jamacha Road at its northeast extremity; this area appeared taken up by in part by a turn lane for East Chase Avenue and by a paved parking area for the adjoining shopping center.

Scrap along unpaved onsite road near southwest corner of subject site. Litter here includes minor quantities of packaging waste and building materials.

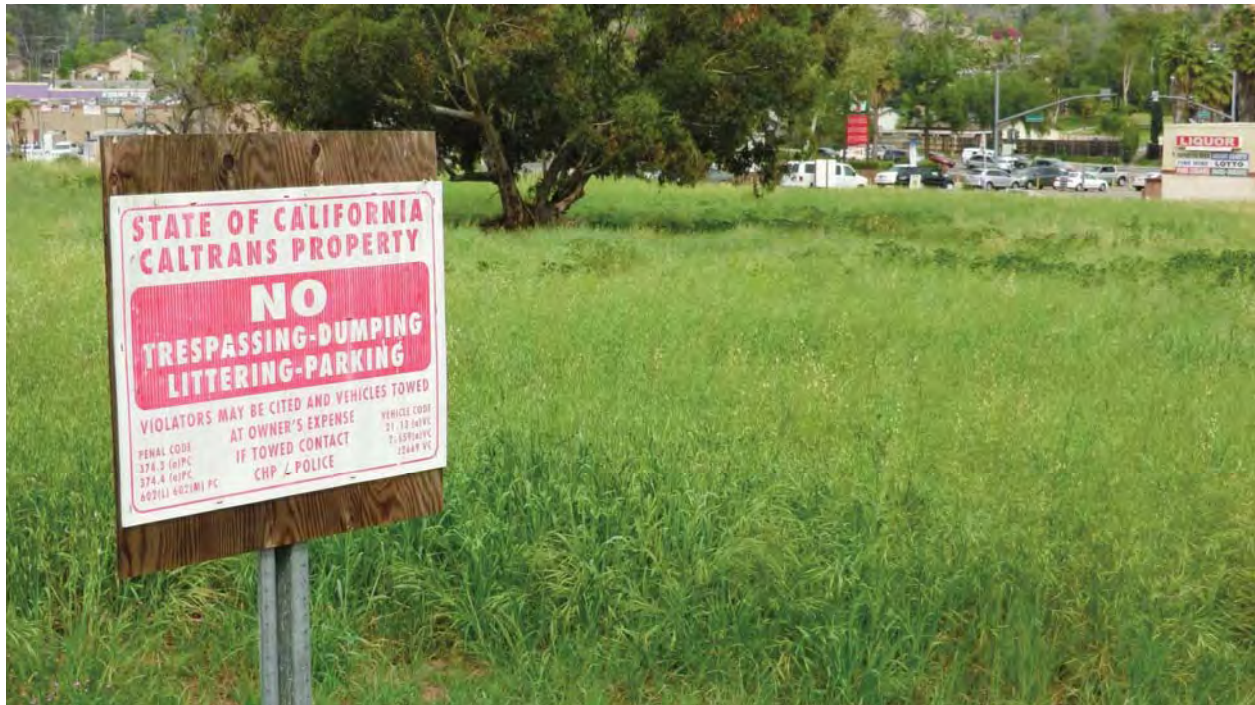
Facing northeast from near the center of the subject site; signage noting ownership by CALTRANS; tree in background shades area with small concrete slab.

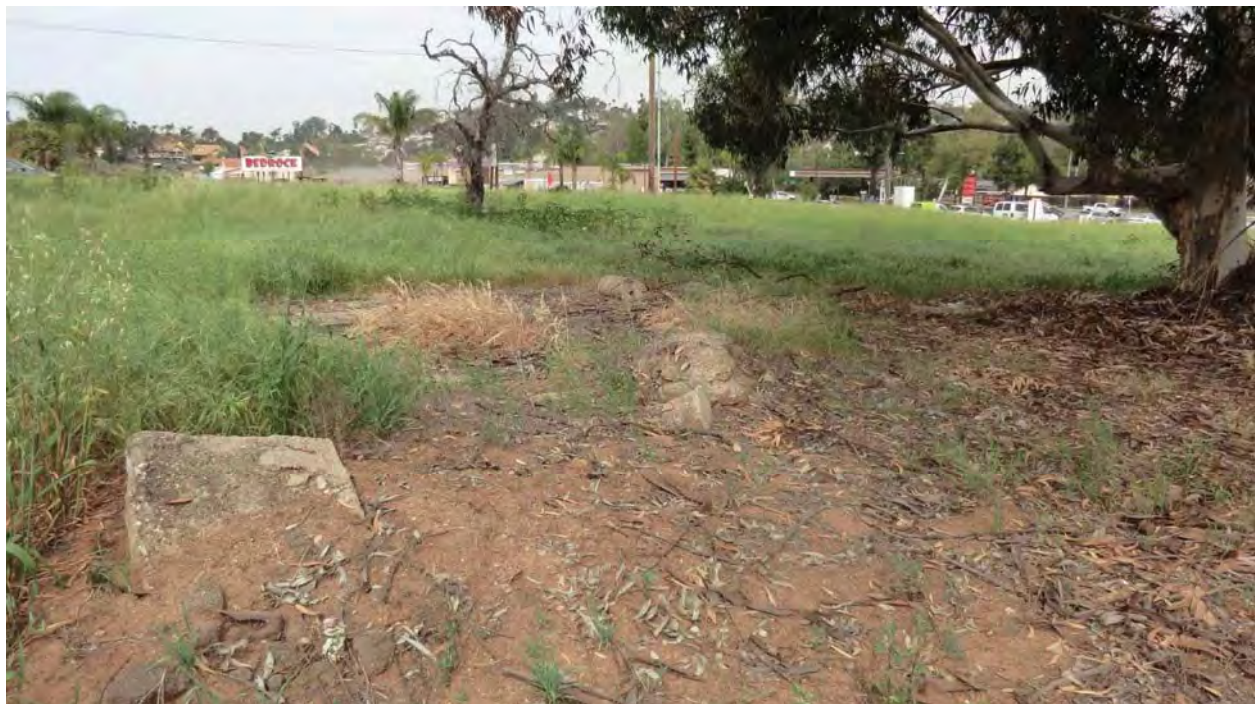
Observed Conditions – No threats were identified at the subject site; however, original activities involved with the onsite concrete slab were not identified and tall, weedy vegetation did not allow for a complete inspection for all surfaces of the subject site.

Area beneath tree shown above; remains of a possible floor slab, concrete scrap includes fencepost footings, rubble.

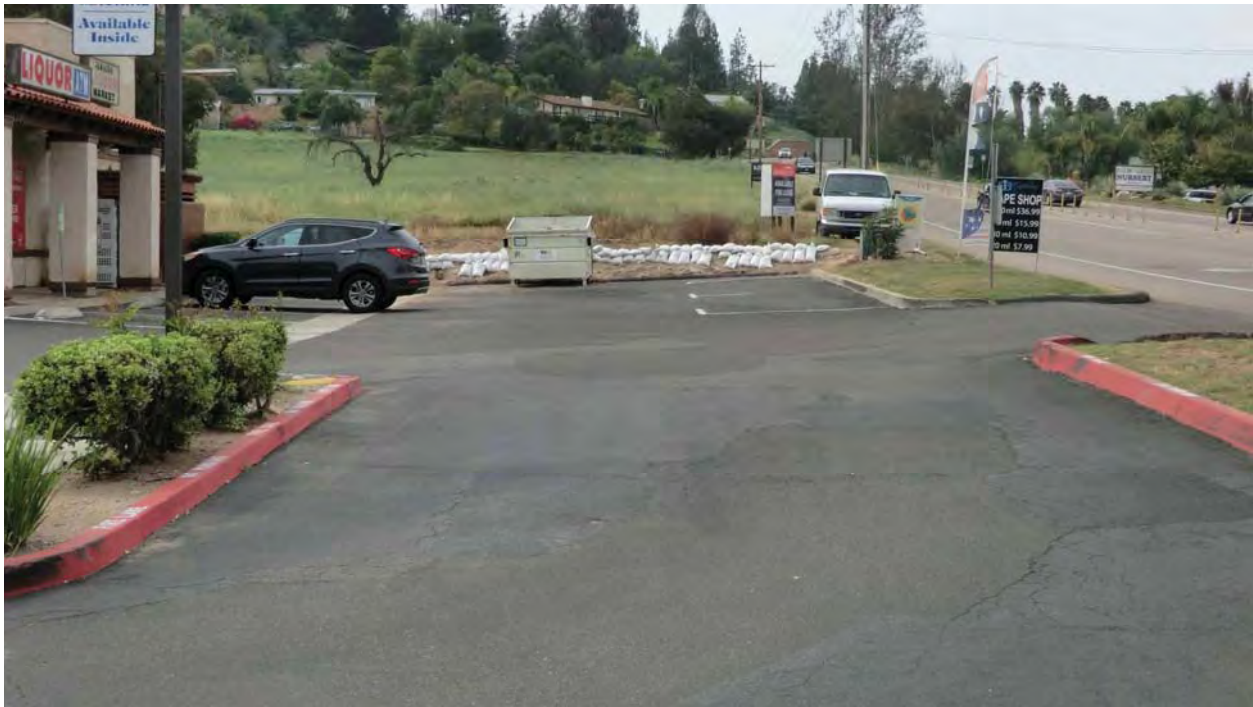
Facing west from northeast corner of subject site; onsite paved strip in foreground; East Chase Avenue at right; offsite shopping center of 1530 Jamacha Road at left.

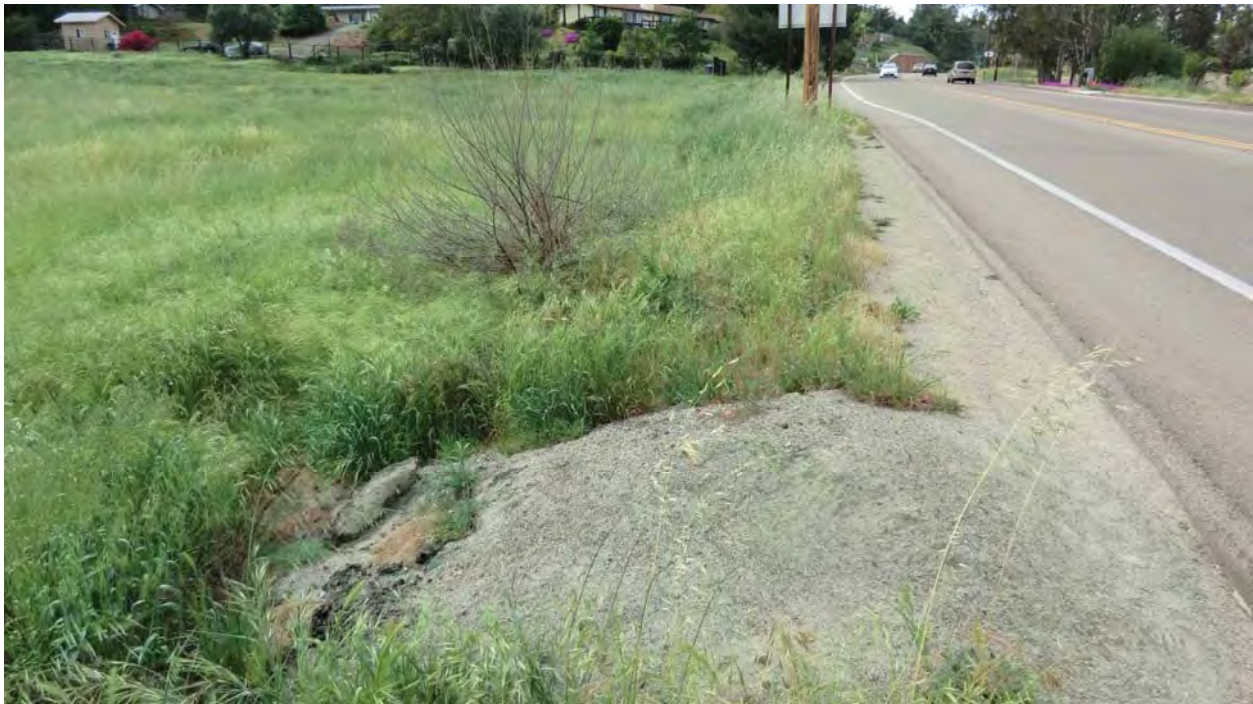
Small pile of granular material along northern boundary of subject site, the edge of pavement with East Chase Avenue.

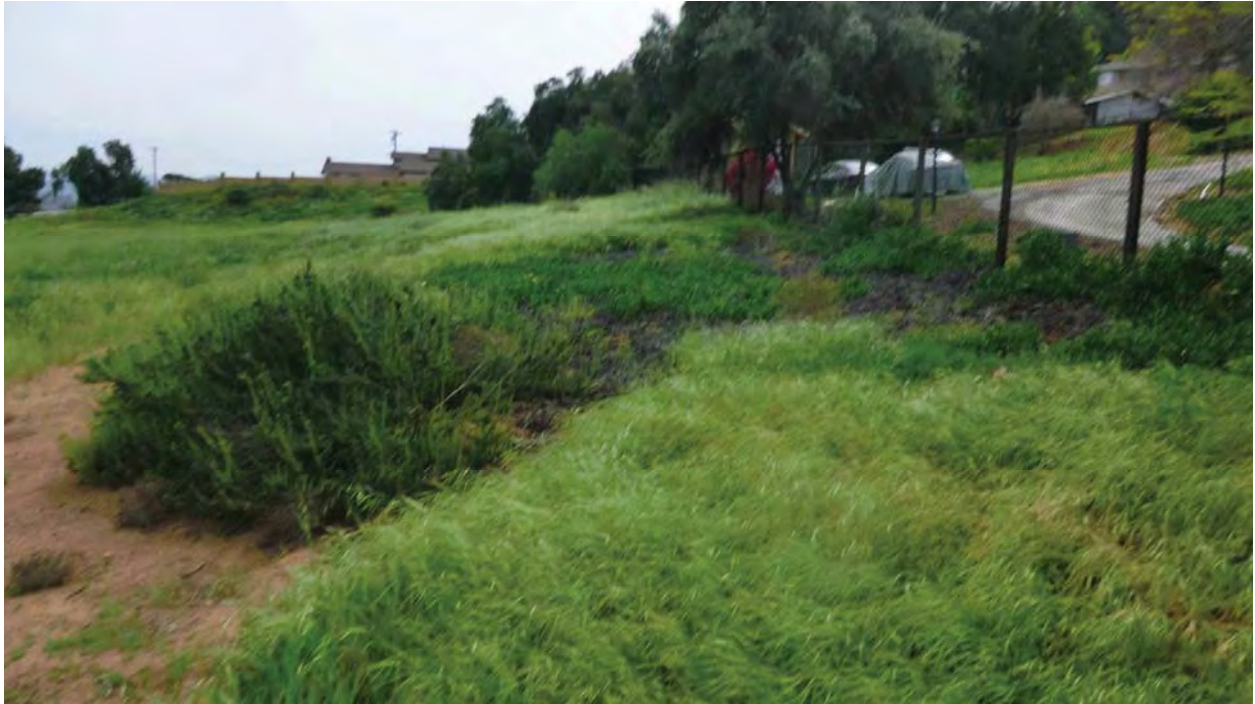
Facing south along western subject site boundary fence; at right is offsite 1903 East Chase Avenue residence.

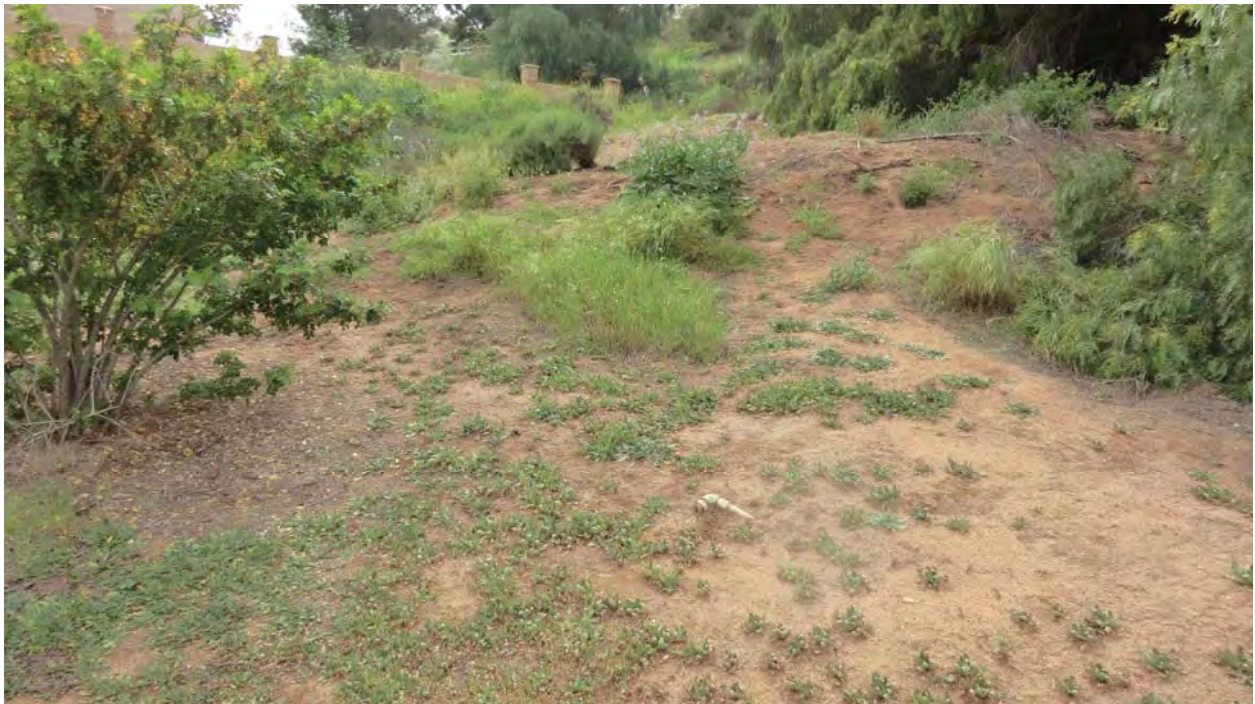
The subject site comprised sloping and level terrain covered by heavy, weedy growth, mostly grasses, with a few individual trees and clumps of trees along its western boundary. Near the center of the subject site was a “no trespassing” sign identifying it as property of the State of California and CALTRANS. A few small clearings were present and some small pieces of inert waste material, e.g., wood scrap or concrete rubble were noted. Beneath a tree about 150-feet south of East Chase Avenue and 150-feet to the west of the shopping center adjoining the east side of the subject site was a clearing with remains of a small slab, ca. 20- x 30-feet in area; this was mostly covered by leaf-litter, but a few chunks of rubble and minor miscellaneous pieces of scrap were noted. A small (ca 1/2-in) capped steel pipe stub was noted inside the southwest corner of the subject site.

Facing southeast from onsite by southeast subject site corner; in background are walls with offsite residences, and in foreground is small pipe stub-up.
