## PHASE II SUBSURFACE INVESTIGATION REPORT

Gas Station Property  
8445 Los Coches Road  
El Cajon, California 92021

October 19, 2018  
Partner Project Number: 18-226305.2

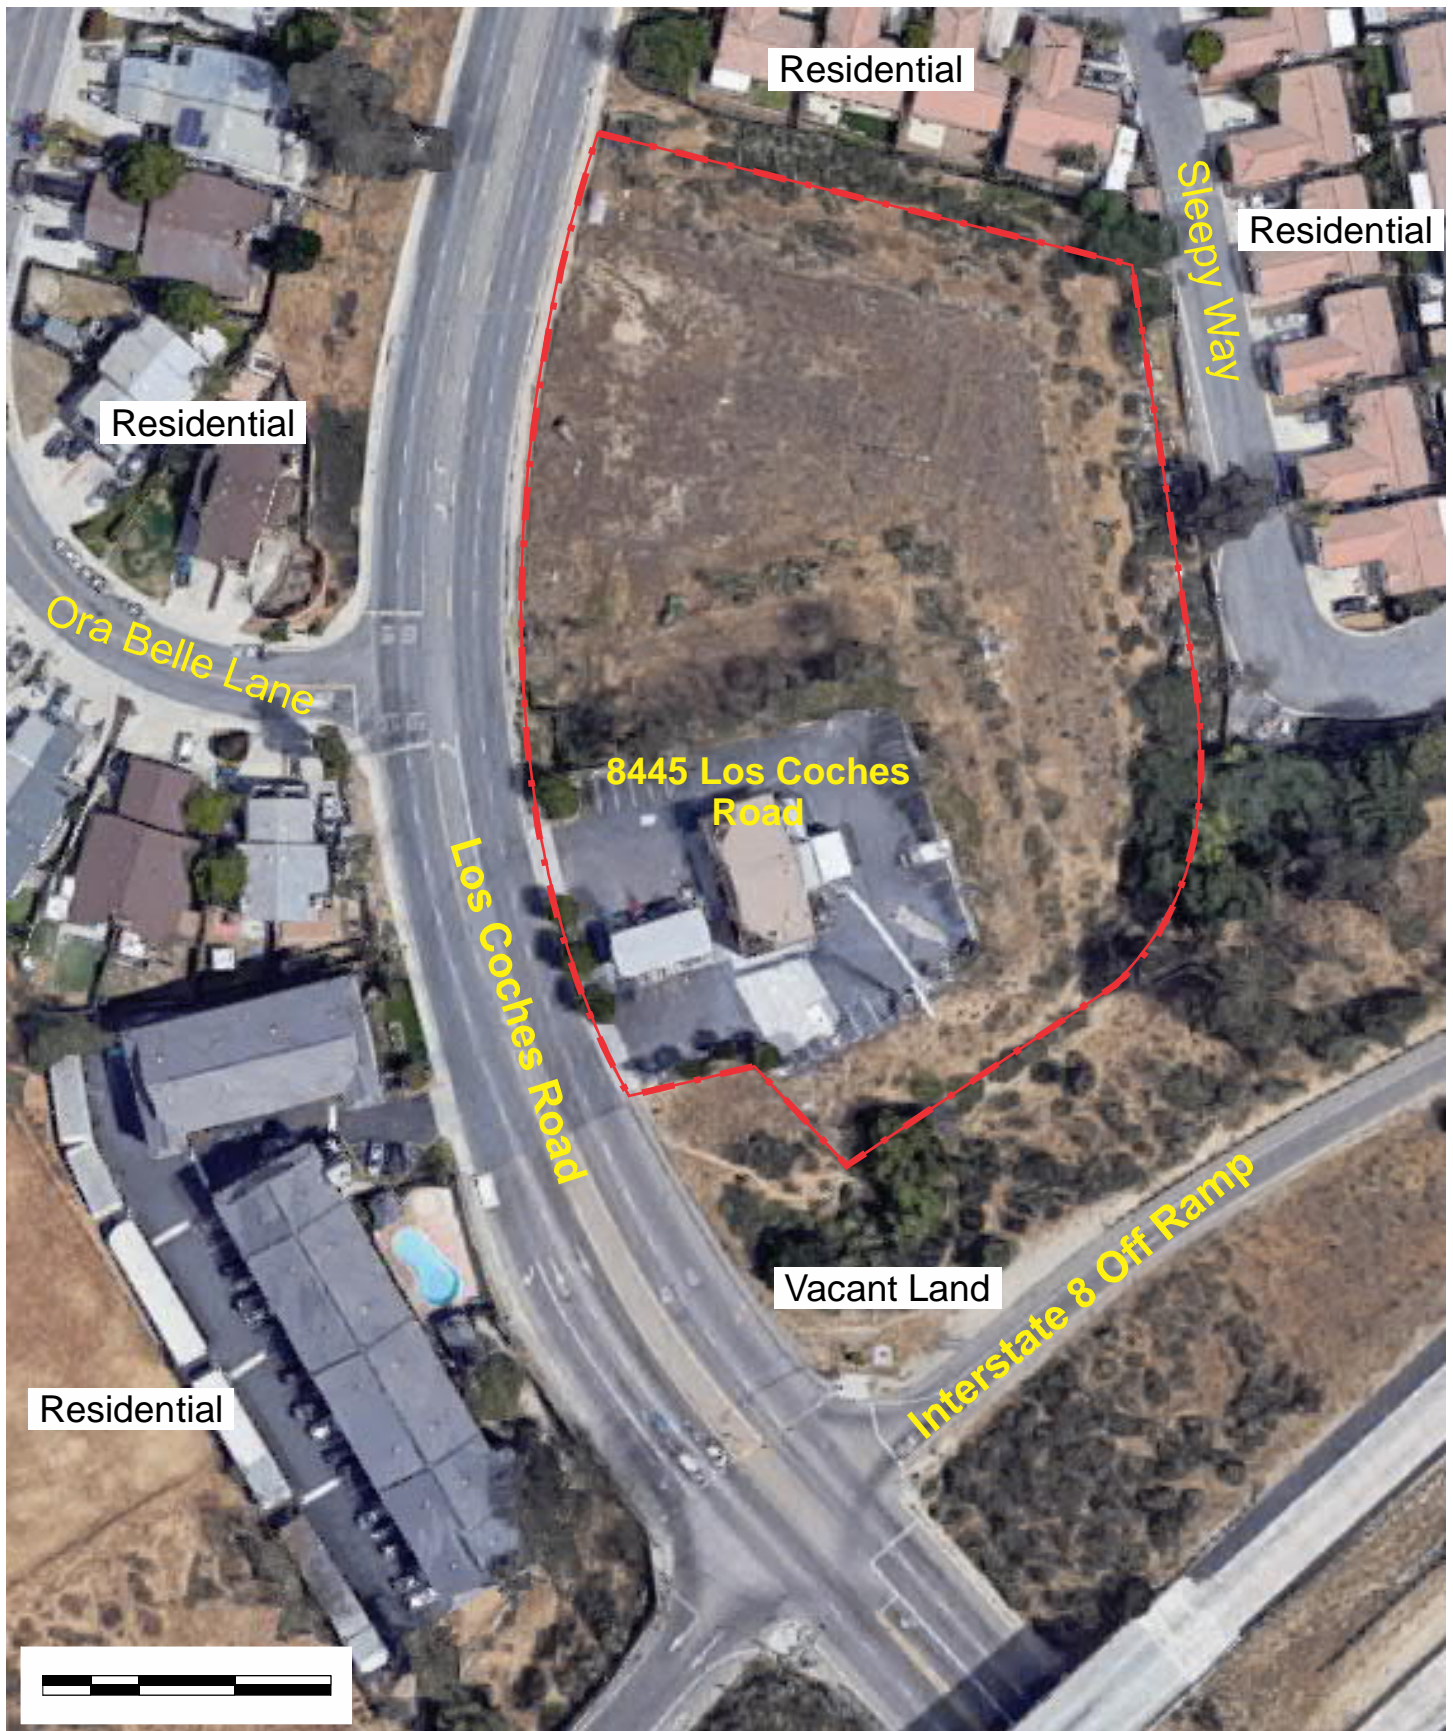
**Site Plan**

The subject property is bound by residential properties to the north and east, vacant land followed by Interstate 8 to the south, and single- and multi-family residential properties across Los Coches Road to the west. Refer to Figure 1 for a site plan showing site features and surrounding properties.

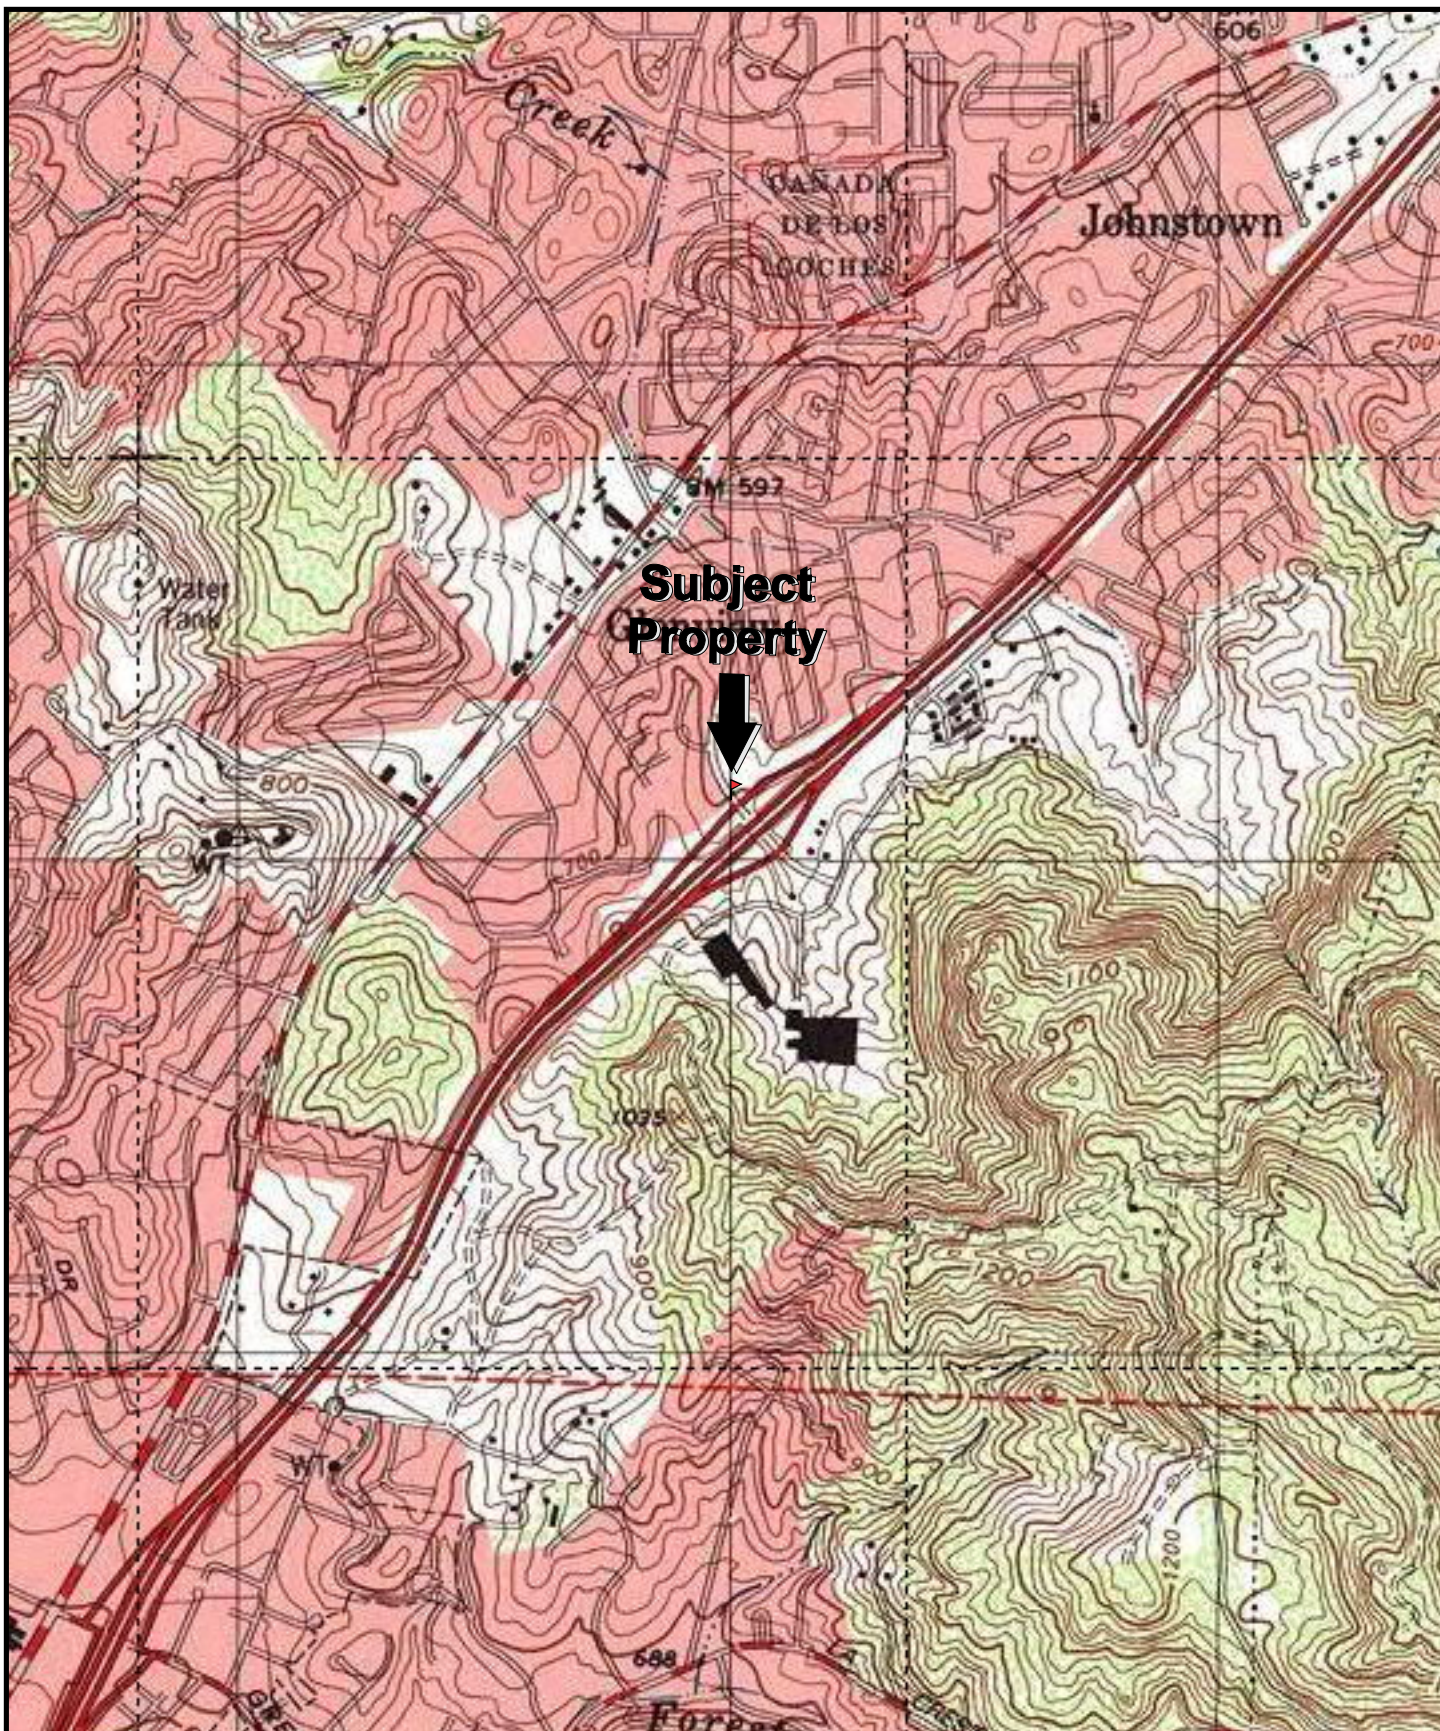
Figure	Prepared By	Date
2	J. Cain	October 2018

Based on a review of the United States Geological Survey (USGS) El Cajon, California Quadrangle topographic map, the subject property is situated at an elevation approximately 700 feet above mean sea level, and the local topography is sloping gently to the northeast. Refer to Figure 2 for a topographic map of the site vicinity.

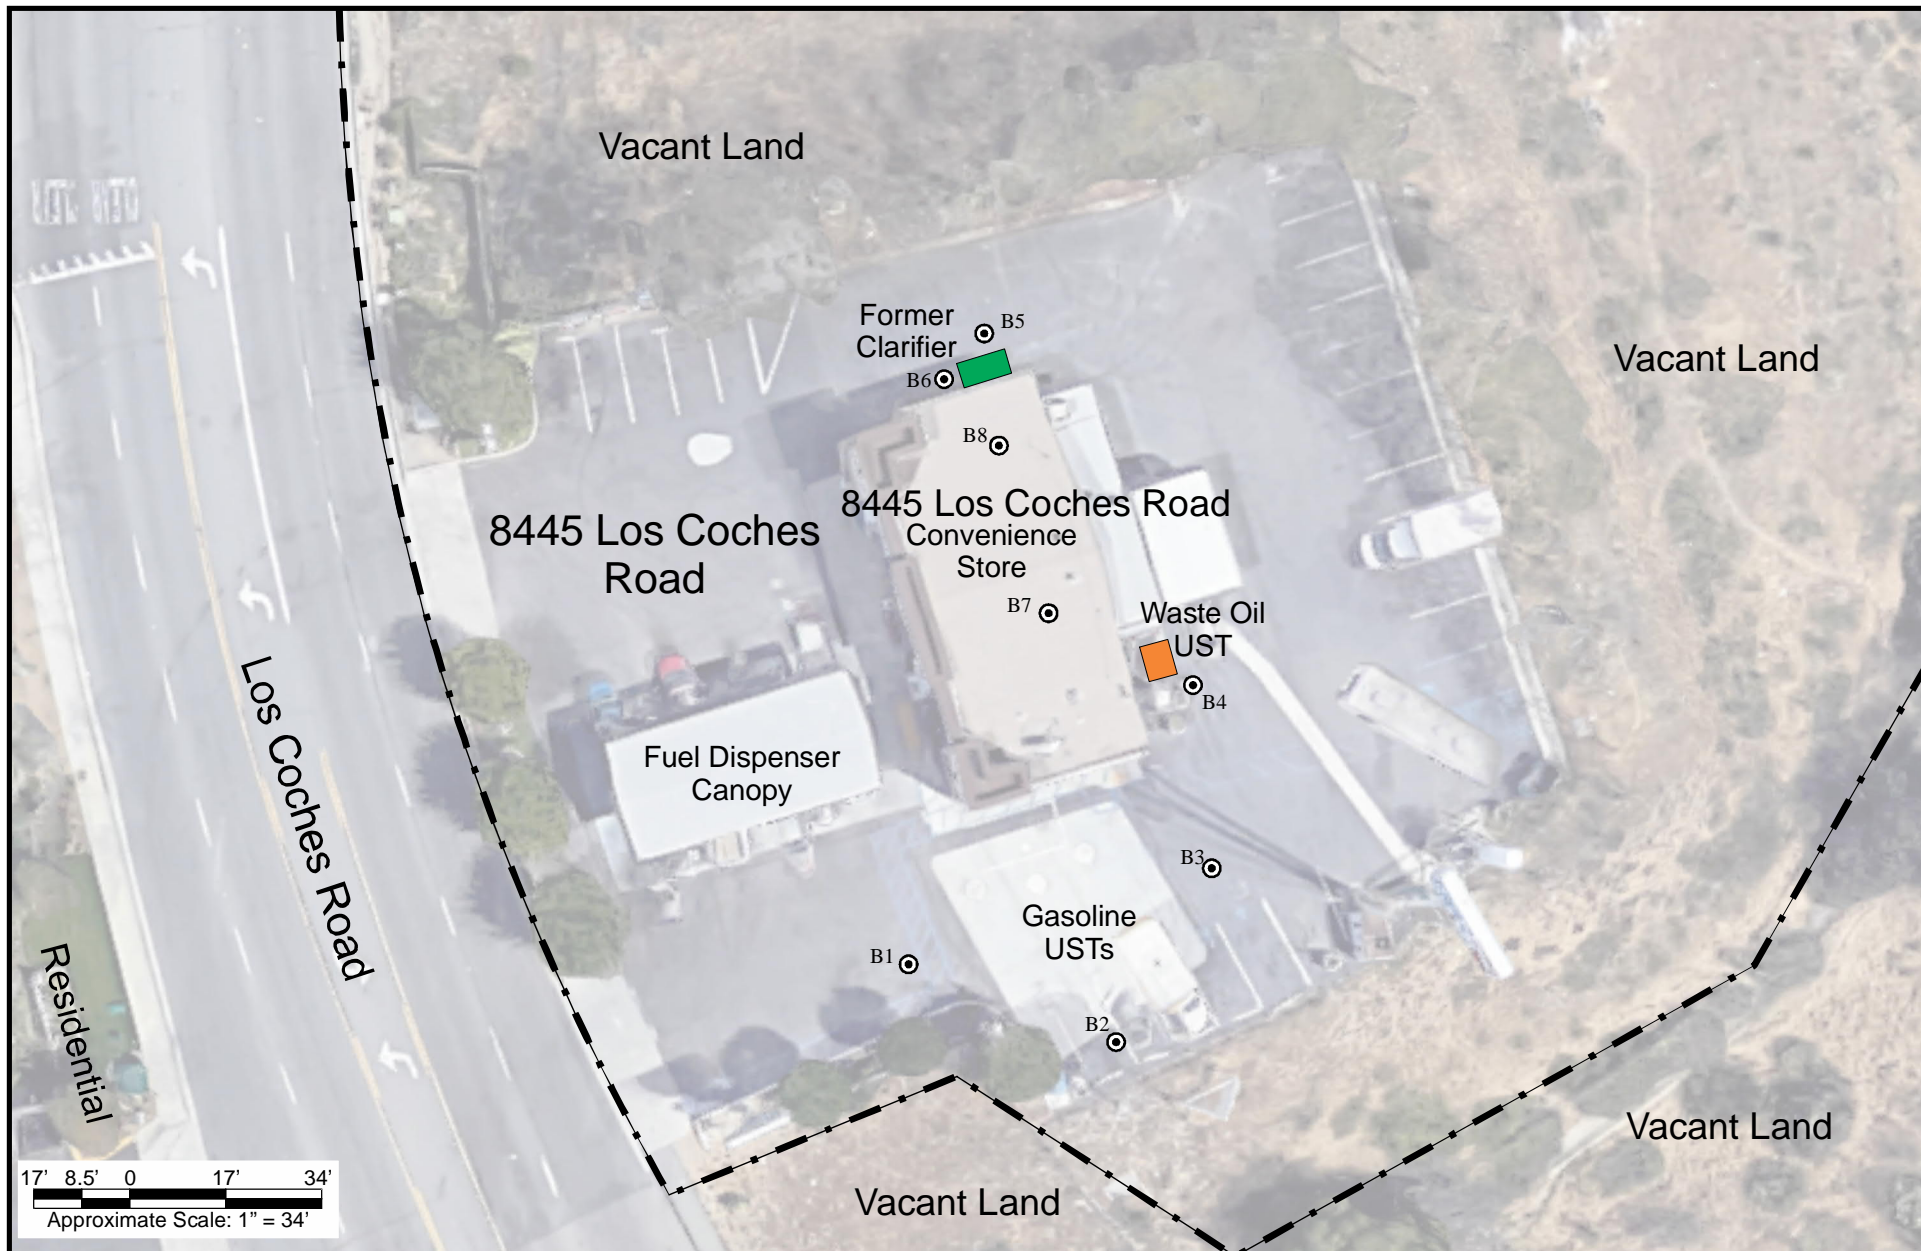
Borings B1 through B3 were advanced to the west, south, and east of the current USTS in the southern portion of the subject property, respectively. Boring B4 was advanced to the southeast of the waste oil UST. Borings B5 and B6 were advanced to the northeast and west of the former clarifier, respectively. Borings B7 and B8 were advanced in the central and northeast interior areas of the former automotive repair shop, respectively, in areas of the former hydraulic lifts. Refer to Figure 3 for a map indicating boring locations.

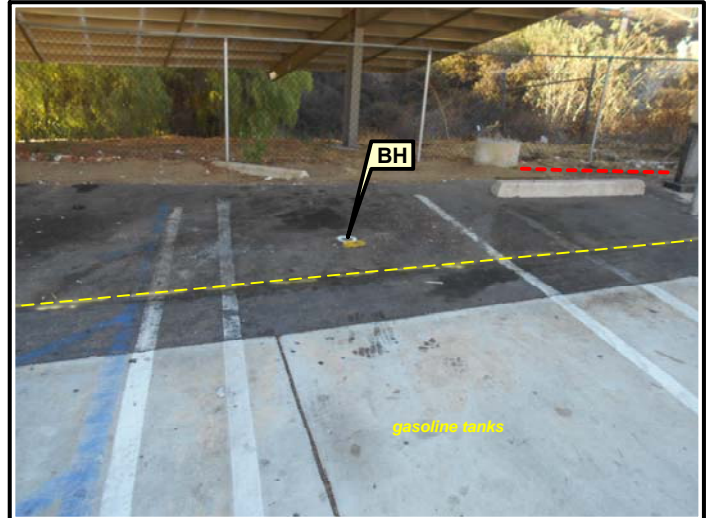
**Figure 3**

Refer to Figure 3 for a map of the boring locations, UST locations, and the anomaly detected during the geophysical survey. Refer to Appendix C for a copy of the geophysical survey report, which provides additional details regarding the geophysical survey equipment and methodology.
