# AEI Consultants

## PHASE I ENVIRONMENTAL SITE ASSESSMENT

14906 Via De La Valle  
Del Mar, San Diego County, California 92014

AEI Project No. 415303

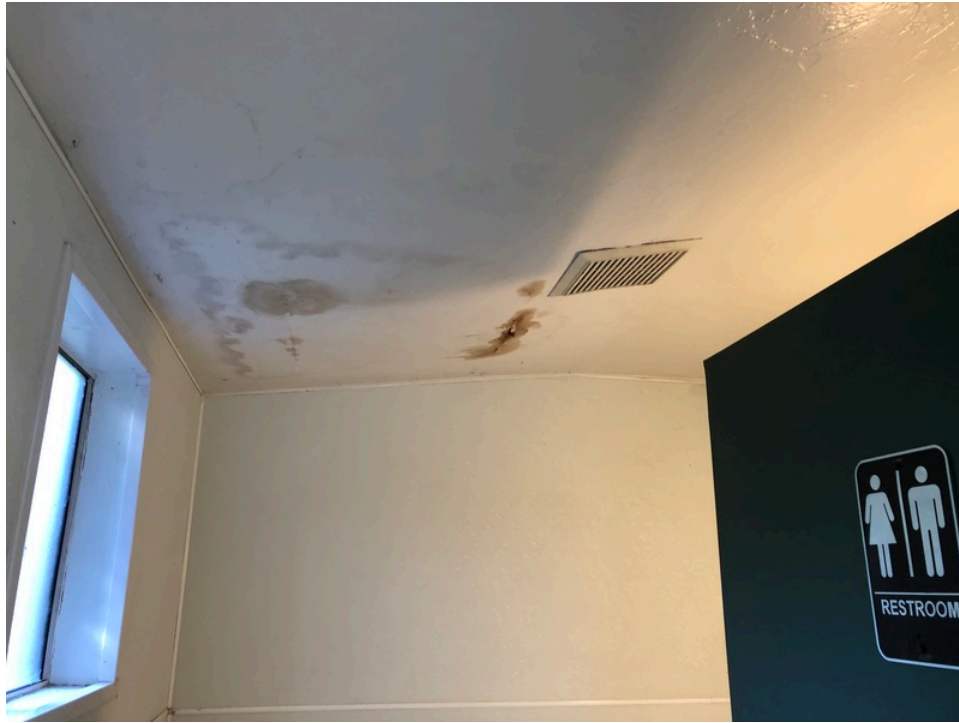
- AEI observed interior areas of the subject property buildings in order to identify the presence of mold. AEI did not note obvious visual or olfactory indications of the presence of mold, nor did AEI observe obvious indications of significant water damage. However, a water stained ceiling area was observed in the candle shop restroom. Based upon our observations, AEI recommends confirming that the source of water intrusion has been addressed.

17. Past moisture intrusion observed in the restroom

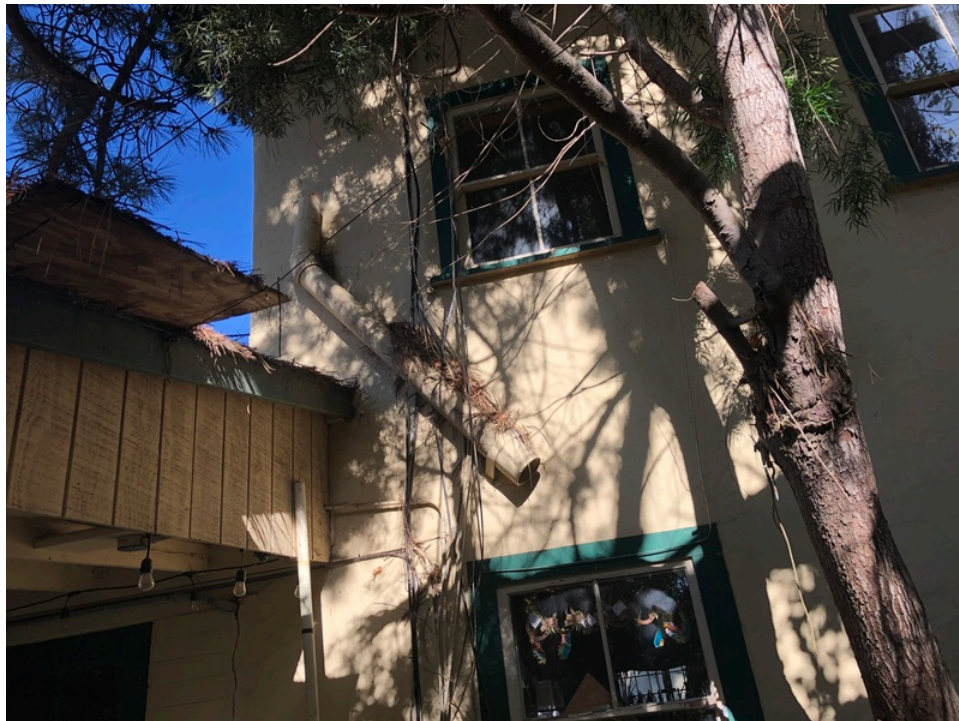
- Due to the age of the subject property buildings, there is a potential that ACMs are present. The observed suspect ACMs at the subject property were in good condition at the time of the site reconnaissance and are not expected to pose a health and safety concern to the occupants of the subject property at this time. Based on the potential presence of ACMs, AEI recommends the implementation of an O&M Plan which stipulates that the repair and maintenance of damaged materials should be performed to protect the health and safety of the building occupants. In the event that building renovation or demolition activities are planned, a thorough asbestos survey to identify asbestos-containing building materials is required in accordance with the EPA NESHAP 40 CFR Part 61 prior to demolition or renovation activities that may disturb suspect ACMs.

18. Suspect ACM piping on the south elevation of the retail candle store

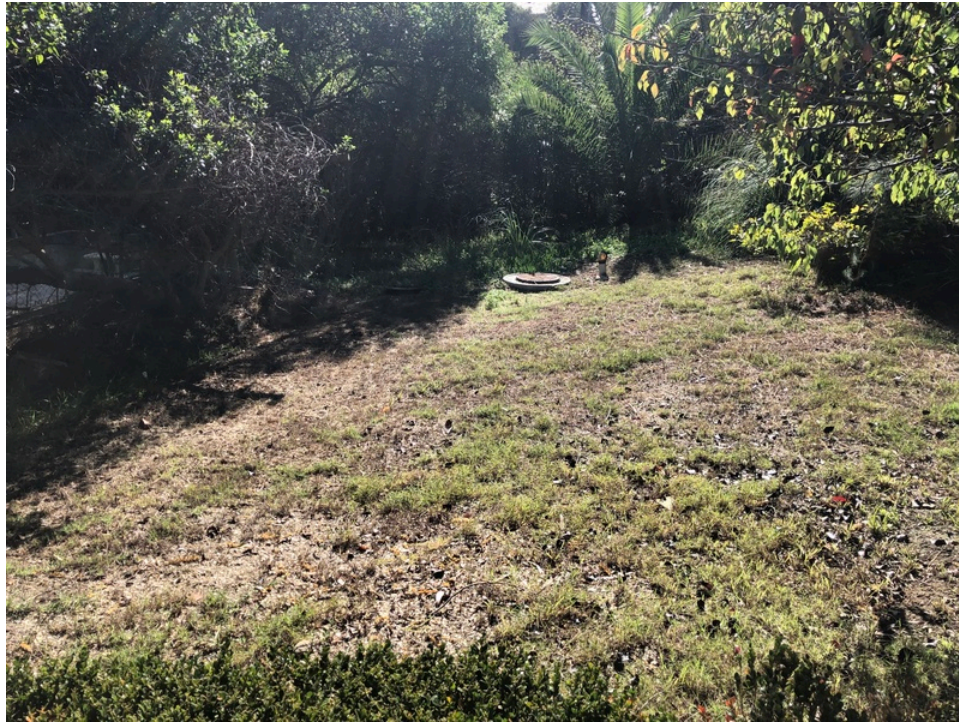
- Two 1,000 gallon septic tanks are provided for the subject property according to DEH records. One septic tank was identified south of the retail candle shop (1,000 gallon) and one between the two residential homes (1,000 gallon). The tanks were reportedly installed in 1992 and replaced/upgraded former septic tanks. There are no floor drains in the subject property building or garage; nor are there any shop use sinks. Based on the use of the septic system solely for domestic waste, the presence of the septic system is not expected to represent a significant environmental concern.

37. View of the septic tank cover and leach field
