## Conceptual Wetlands Mitigation and Monitoring Plan for the Otay Ranch Resort Village

## **Conceptual Vernal Pool Mitigation Plan for the Otay Ranch Resort Village**

## **Quino Checkerspot Butterfly Management/Enhancement Plan for the Otay Ranch Resort Village**

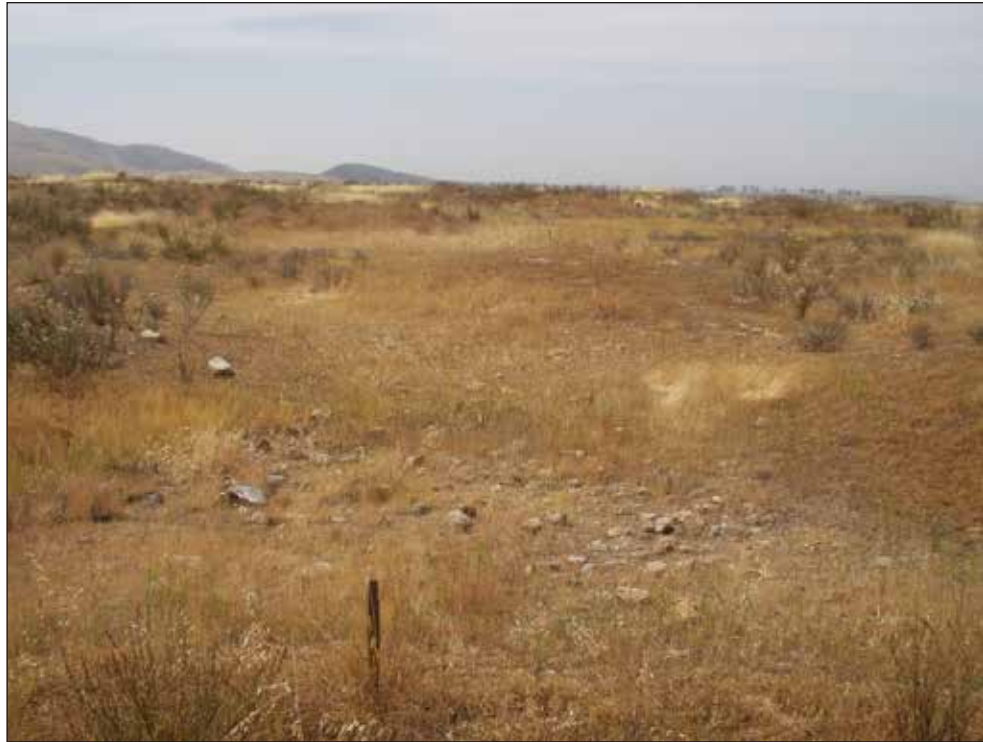
1 - View of K6 Vernal Pool Complex looking south (May 2009)

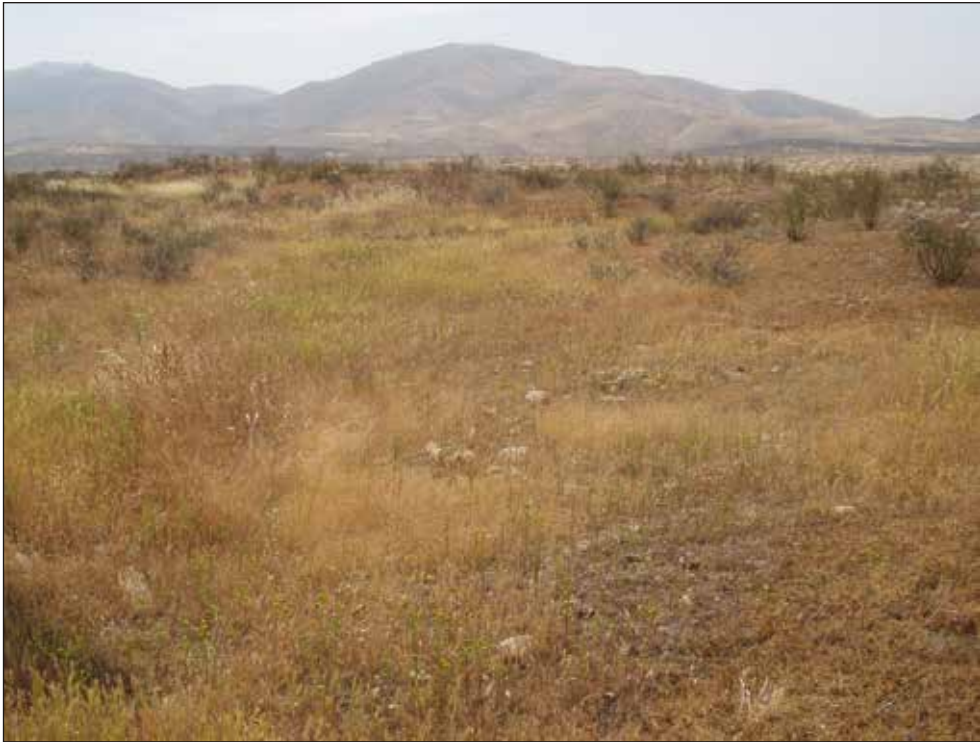
2 - View of K6 Vernal Pool Complex looking southeast (May 2009)

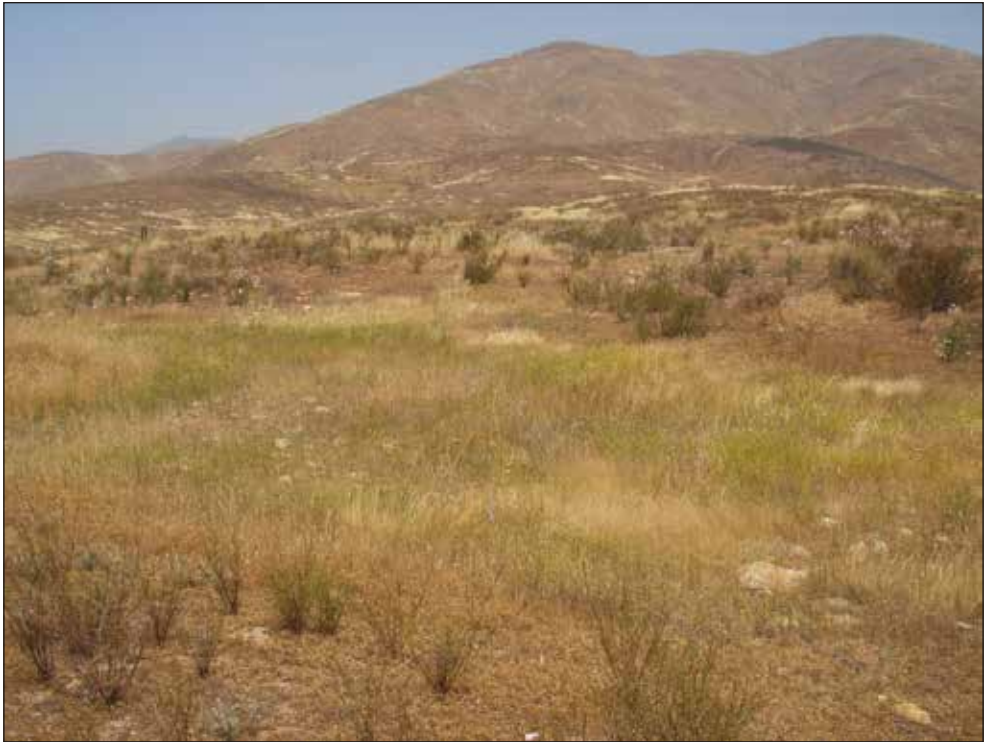
3 - View of K8 Vernal Pool Complex near Vernal Pool 8 looking northeast (May 2009)

The preliminary plan view layout for the vernal pool restoration area with details of basin locations is shown on Figure 5. This plan shows the locations of the proposed vernal pool restoration areas in relation to the existing pools in the K8 Group area. The exact locations, sizes, and shapes of the restored vernal pools will be further analyzed during field review during the design phase. The site encompasses sufficient area to support the intended restoration effort, and has adequate watershed area to support the expanded vernal pool basin, without adversely affecting the adjacent vernal pools. The site would also be protected from future disturbance by the existing fenced boundaries of this portion of the preserve, through the abandonment of the existing road, and through new exclusionary fencing to permanently block-off the area. Photographs of the existing site conditions at the proposed vernal pool mitigation area are shown on Figure 6 (Photos 3–6).

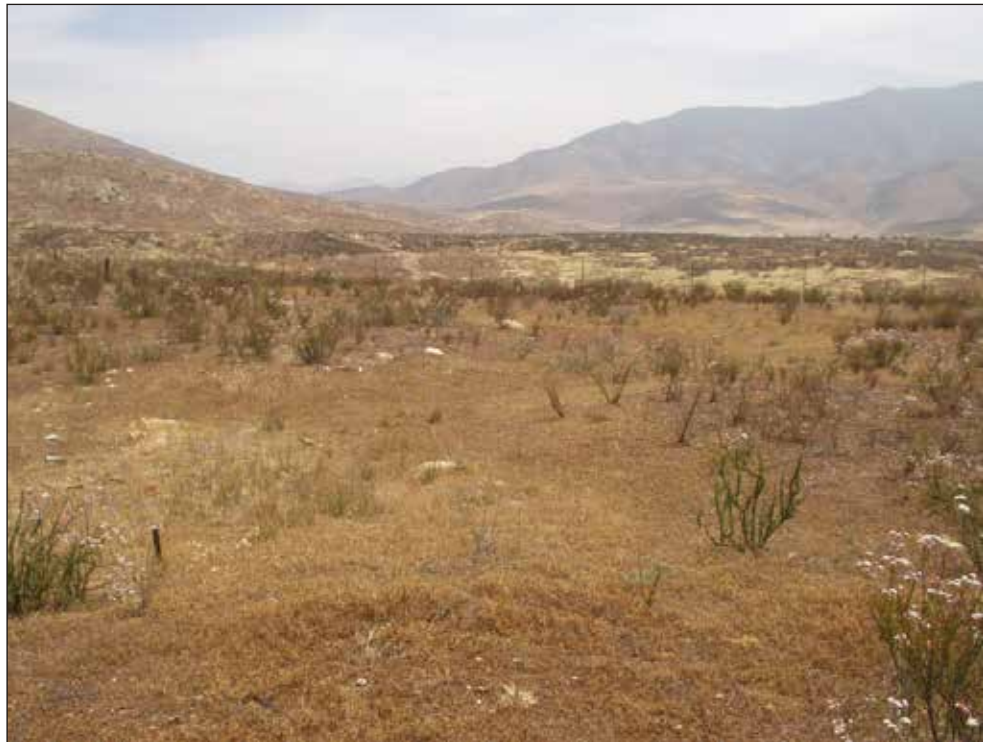
4 - View of K8 Vernal Pool Complex near Vernal Pool 11 looking southeast (May 2009)

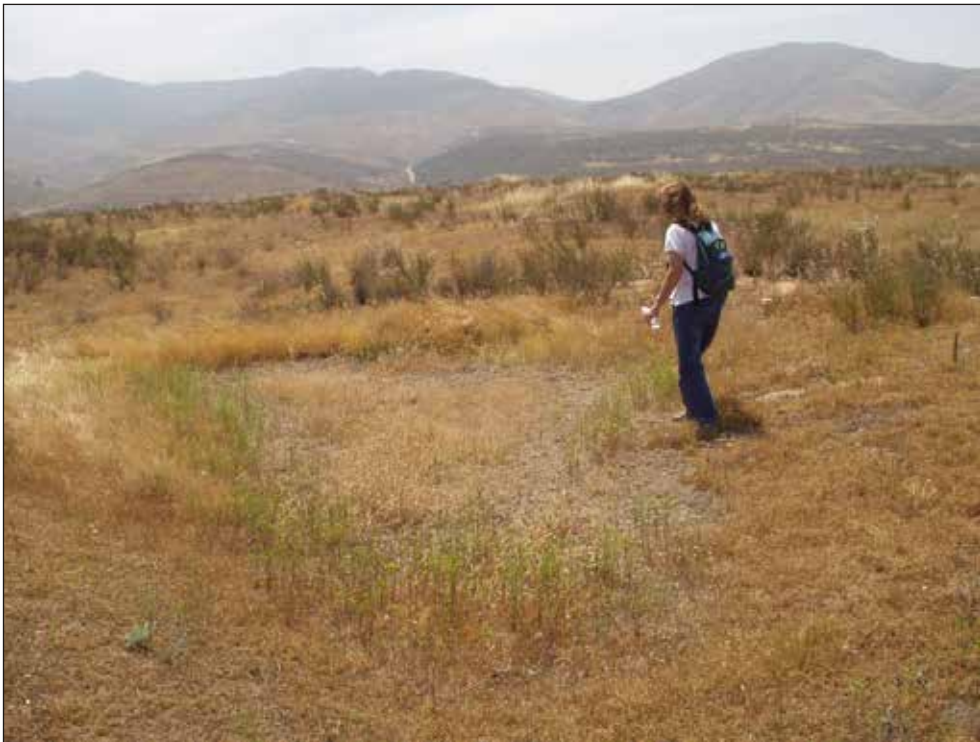
5 - View of K8 Vernal Pool Complex near Vernal Pool 6 looking south (May 2009)

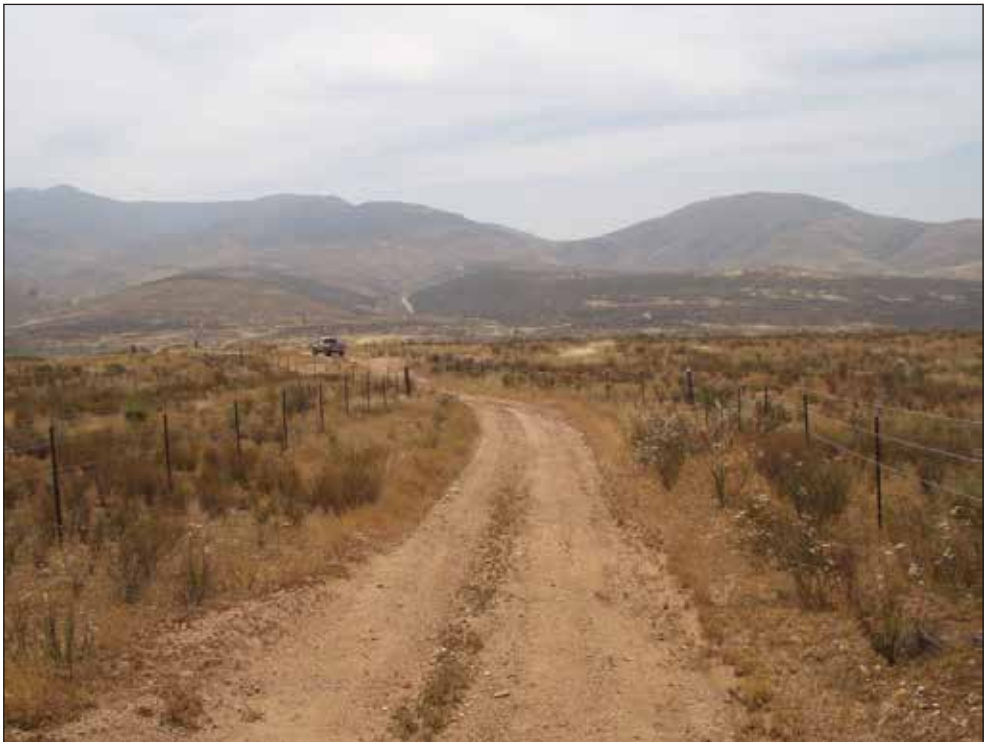
6 - View looking south of existing access road to be restored (May 2009)

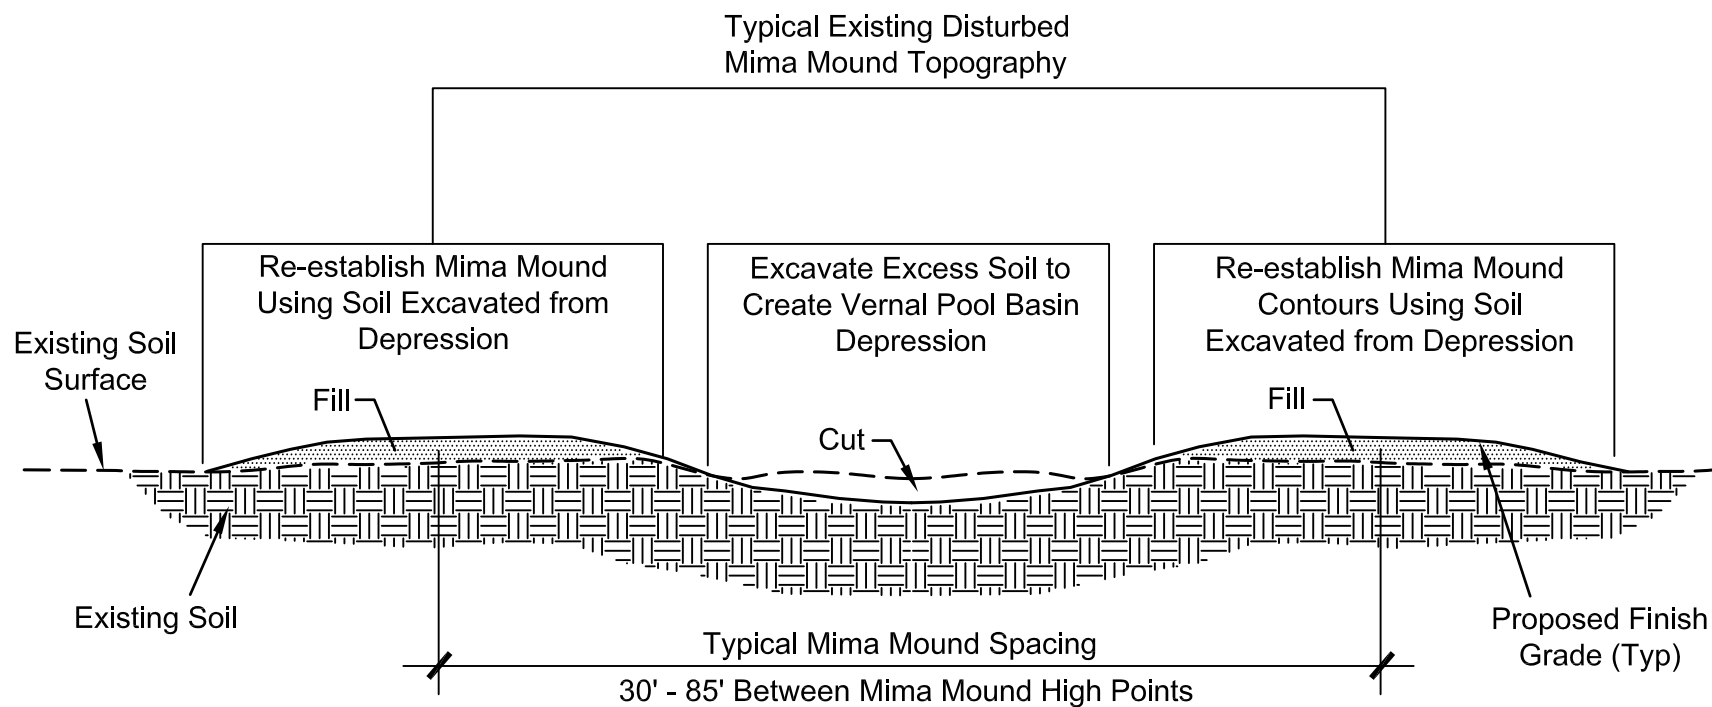
1. Height of mima mound fill soil will be directly proportional to the depth & area of excavation.

Existing mima mounds between the proposed vernal pool restoration areas may be heightened with the excavated material from the basin bottoms. If not already present, new mima mounds may be created to frame the restored vernal pool locations. An important design consideration for the mima mound alterations is the presence of existing native plant resources. If existing mima mound vegetation is largely native and undisturbed, it will be unmodified. Mima mounds with an abundance of non-native plants and exhibiting a disturbed character may be modified.

Excavation (mechanical and/or hand) of the bottom of the vernal pool restoration areas will function to increase the water holding capacity of the individual basins. In addition, soil compaction analysis will be conducted on the existing pools and the restored pools to determine optimal soil conditions to facilitate the long-term water retention to support the desired vernal pool habitat. In order to restore the water holding capacity of the restored pools to that of the existing pools, the soils within the restored pool may need to be compacted, or sub-grade modification made to create an impervious sub-surface layer, in order to match the soil compaction within the existing pools.
