CONCEPTUAL UPLAND RESTORATION PLAN for the OTAY RANCH RESORT VILLAGE – ALTERNATIVE H GPA 04-003; SPA 04-002; R04-009; TM 5361RPL; S08-028; fTER#04-19-005; KIVA#03-1004387

Prepared for the County of San Diego

### **CONCEPTUAL RESOURCE MANAGEMENT PLAN for**

Otay Ranch Resort Village – Alternative H
Conserved Open Space Areas
San Diego County, California
GPA 04-003, SP 04-002, TM5361RPL, REZ 04-009; S08-028
Environmental Log Number ER 04-19-005; KIVA 03-1004387

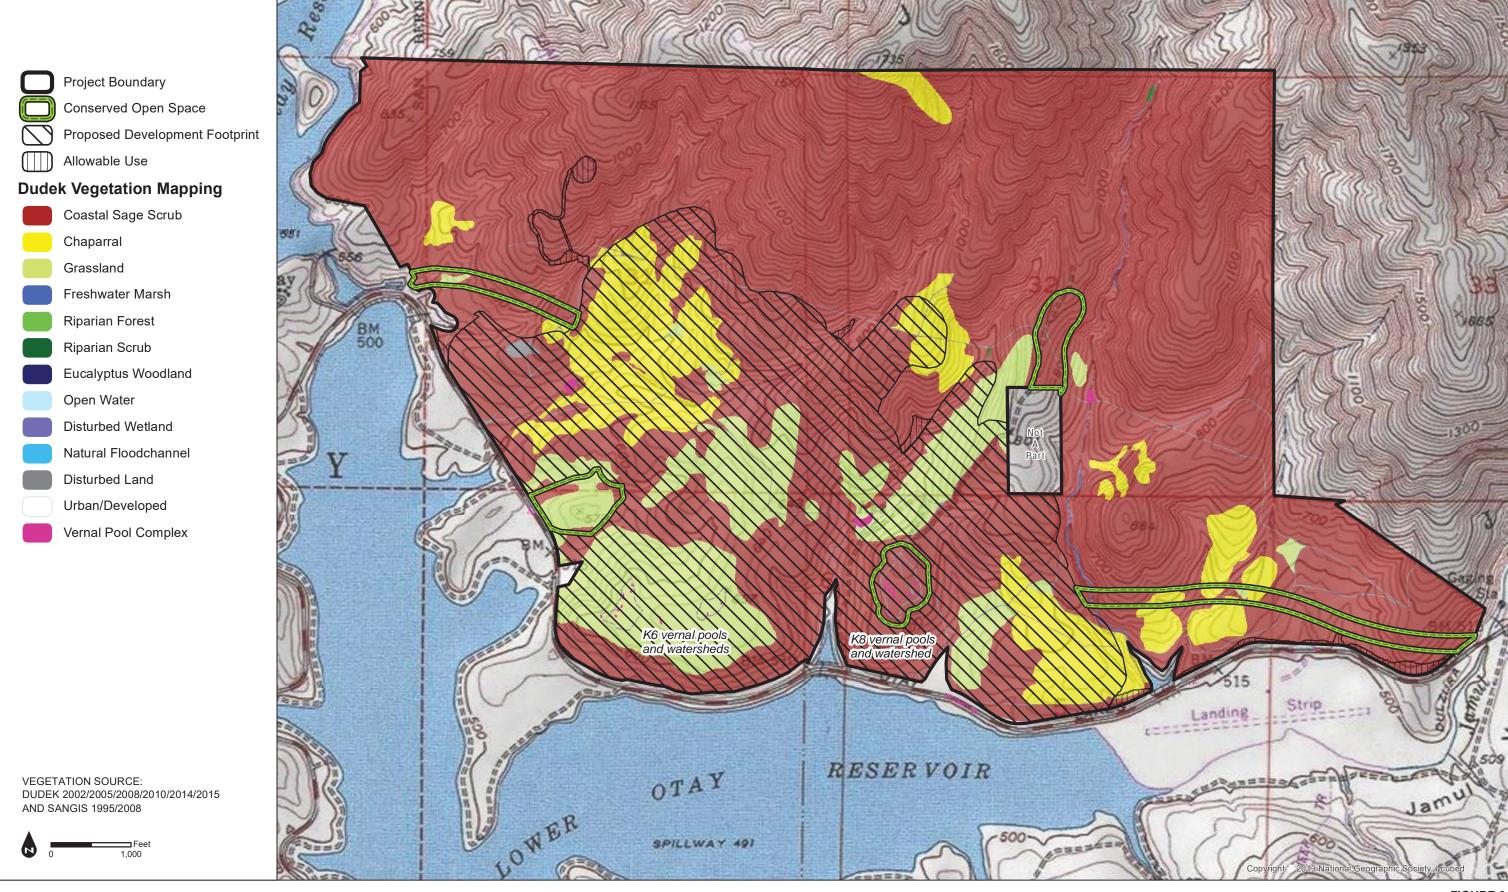
FIGURE 3

The vegetation communities/habitats that will be preserved and managed are described in Table 2. The Conserved Open Space preserve is shown on Figure 3.
