**GEOTECHNICAL SLOPE STABILITY EVALUATION
MANUFACTURED SLOPE
RESCUE RANCH
EAST OF PASEO PENASCO AND NORTH OF HIGHLAND VALLEY ROAD
COUNTY OF SAN DIEGO, CALIFORNIA
APN 276-030-48 AND APN 276-030-49**

CTE JOB NO.: 10-13290G

OCTOBER 5, 2016

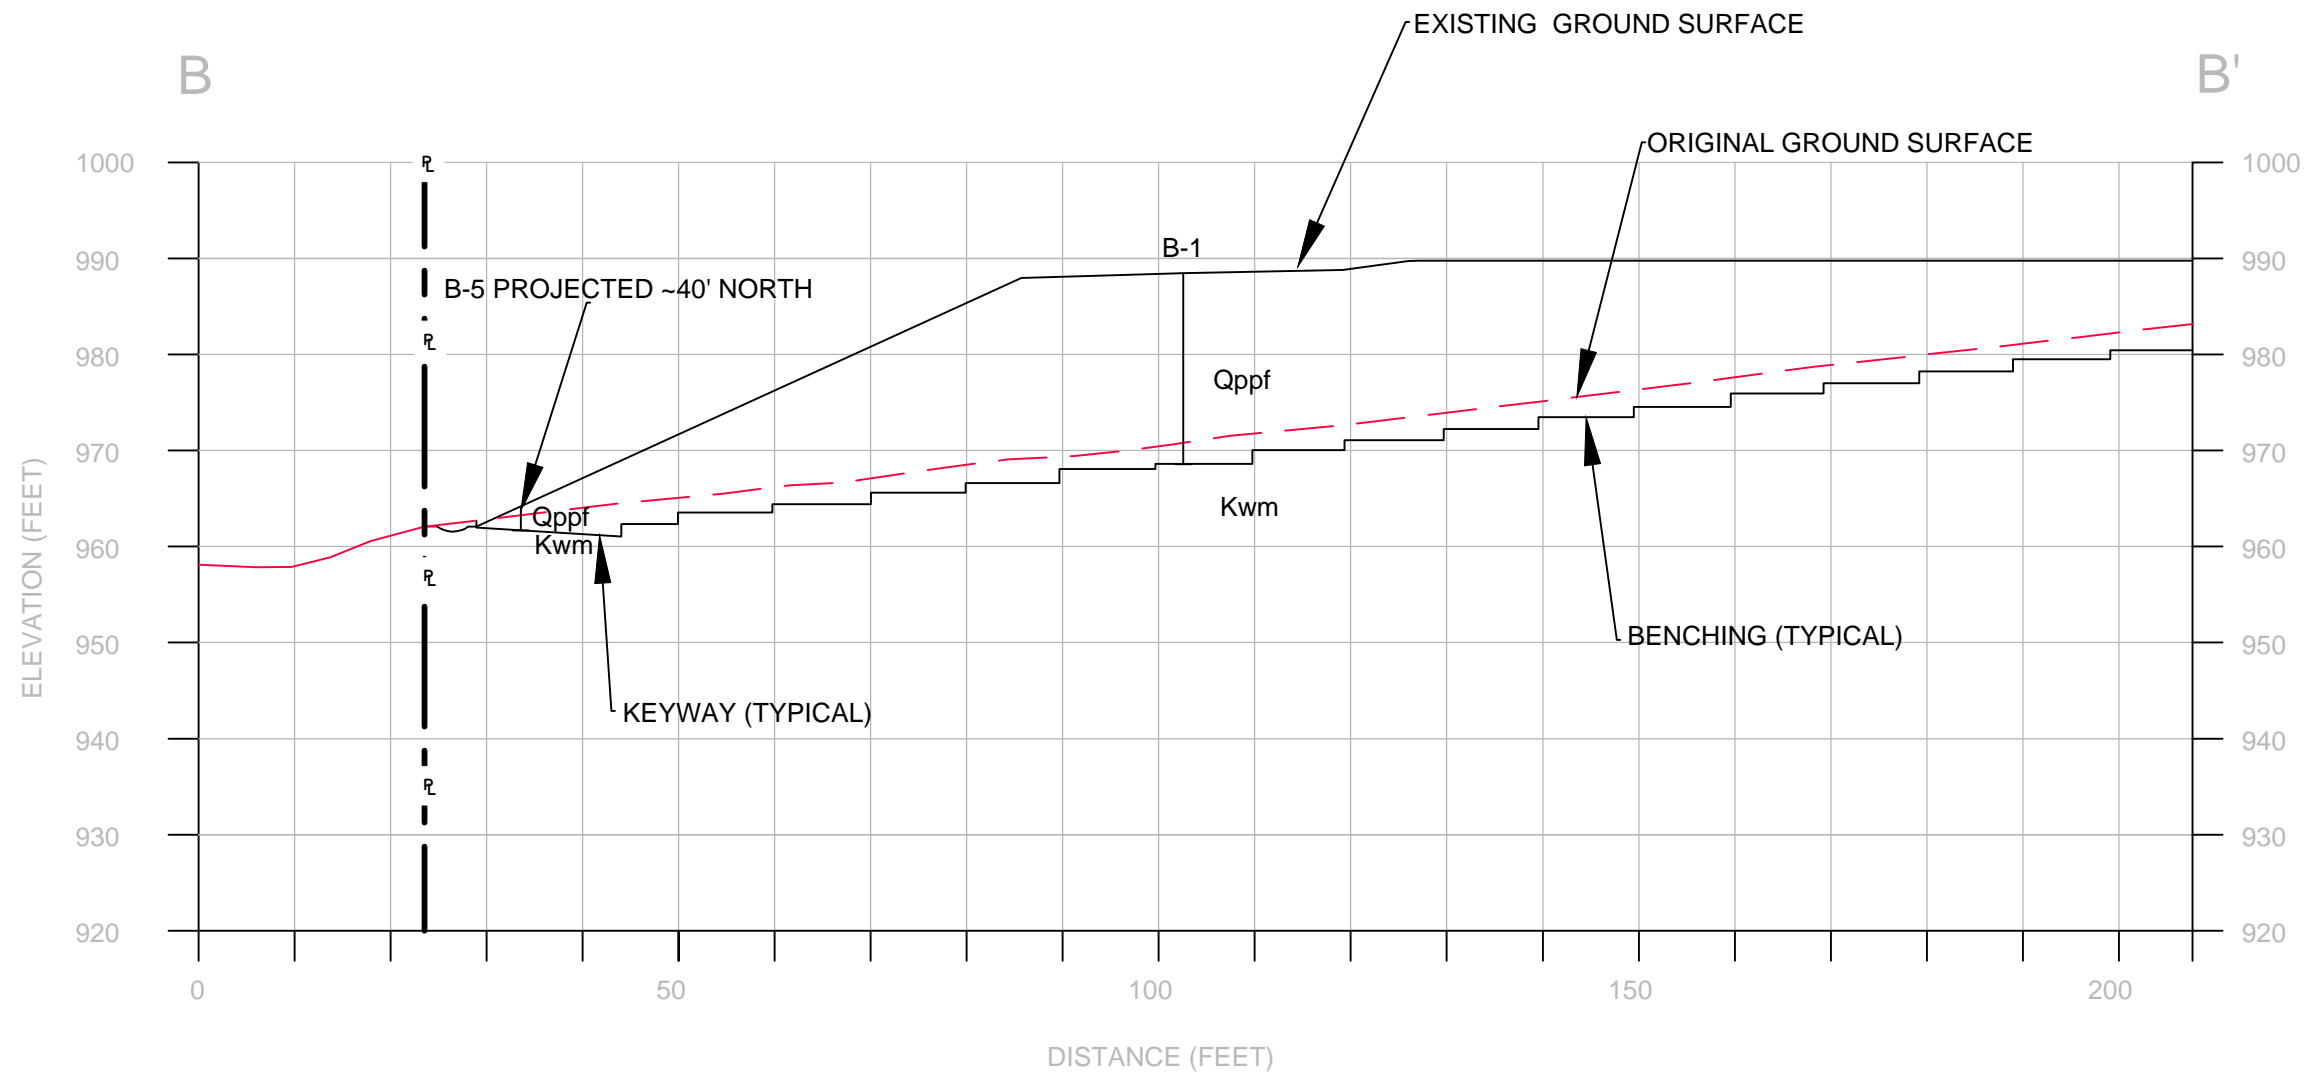
CTE JOB NO:
10-13290G
SCALE:
1" = 20'
DATE:
10/16
FIGURE:
2B

GEOLOGIC CROSS SECTION B-B'
RESQUE RANCH
APN: 276-030-48-00
NORTH OF HIGHLAND VALLEY ROAD, SAN DIEGO, CALIFORNIA

Analyses were performed on two lines of sections to evaluate the most likely direction of hypothetical failure as: 1) Section A-A' located on the south margin of the property through bio-retention Basin O, associated retaining walls, and near bio-retention Basin B and, 2) Section B-B' located on the north margin of the manufactured slope along the highest portion of the subject slope. The cross sections were oriented perpendicular to the major axis of slope surface topographic

contours. These two lines of section were analyzed for hypothetical gross failures through the entire slope. Section B-B' was analyzed for surficial stability assuming saturated soil within three feet of the finished face. Hypothetical groundwater surfaces were conservatively modelled by assuming hypothetical saturation of soils associated with Basin B and Basin O in Section A-A' and hypothetical saturation of soils within five feet of Cretaceous Woodson Mountain granodiorite residual soil in Section B-B'. The calculated critical surface and pertinent input factors are provided on figures attached in Appendix D. A summary of the calculated safety factor for these conditions is provided on the following Table 7.5.

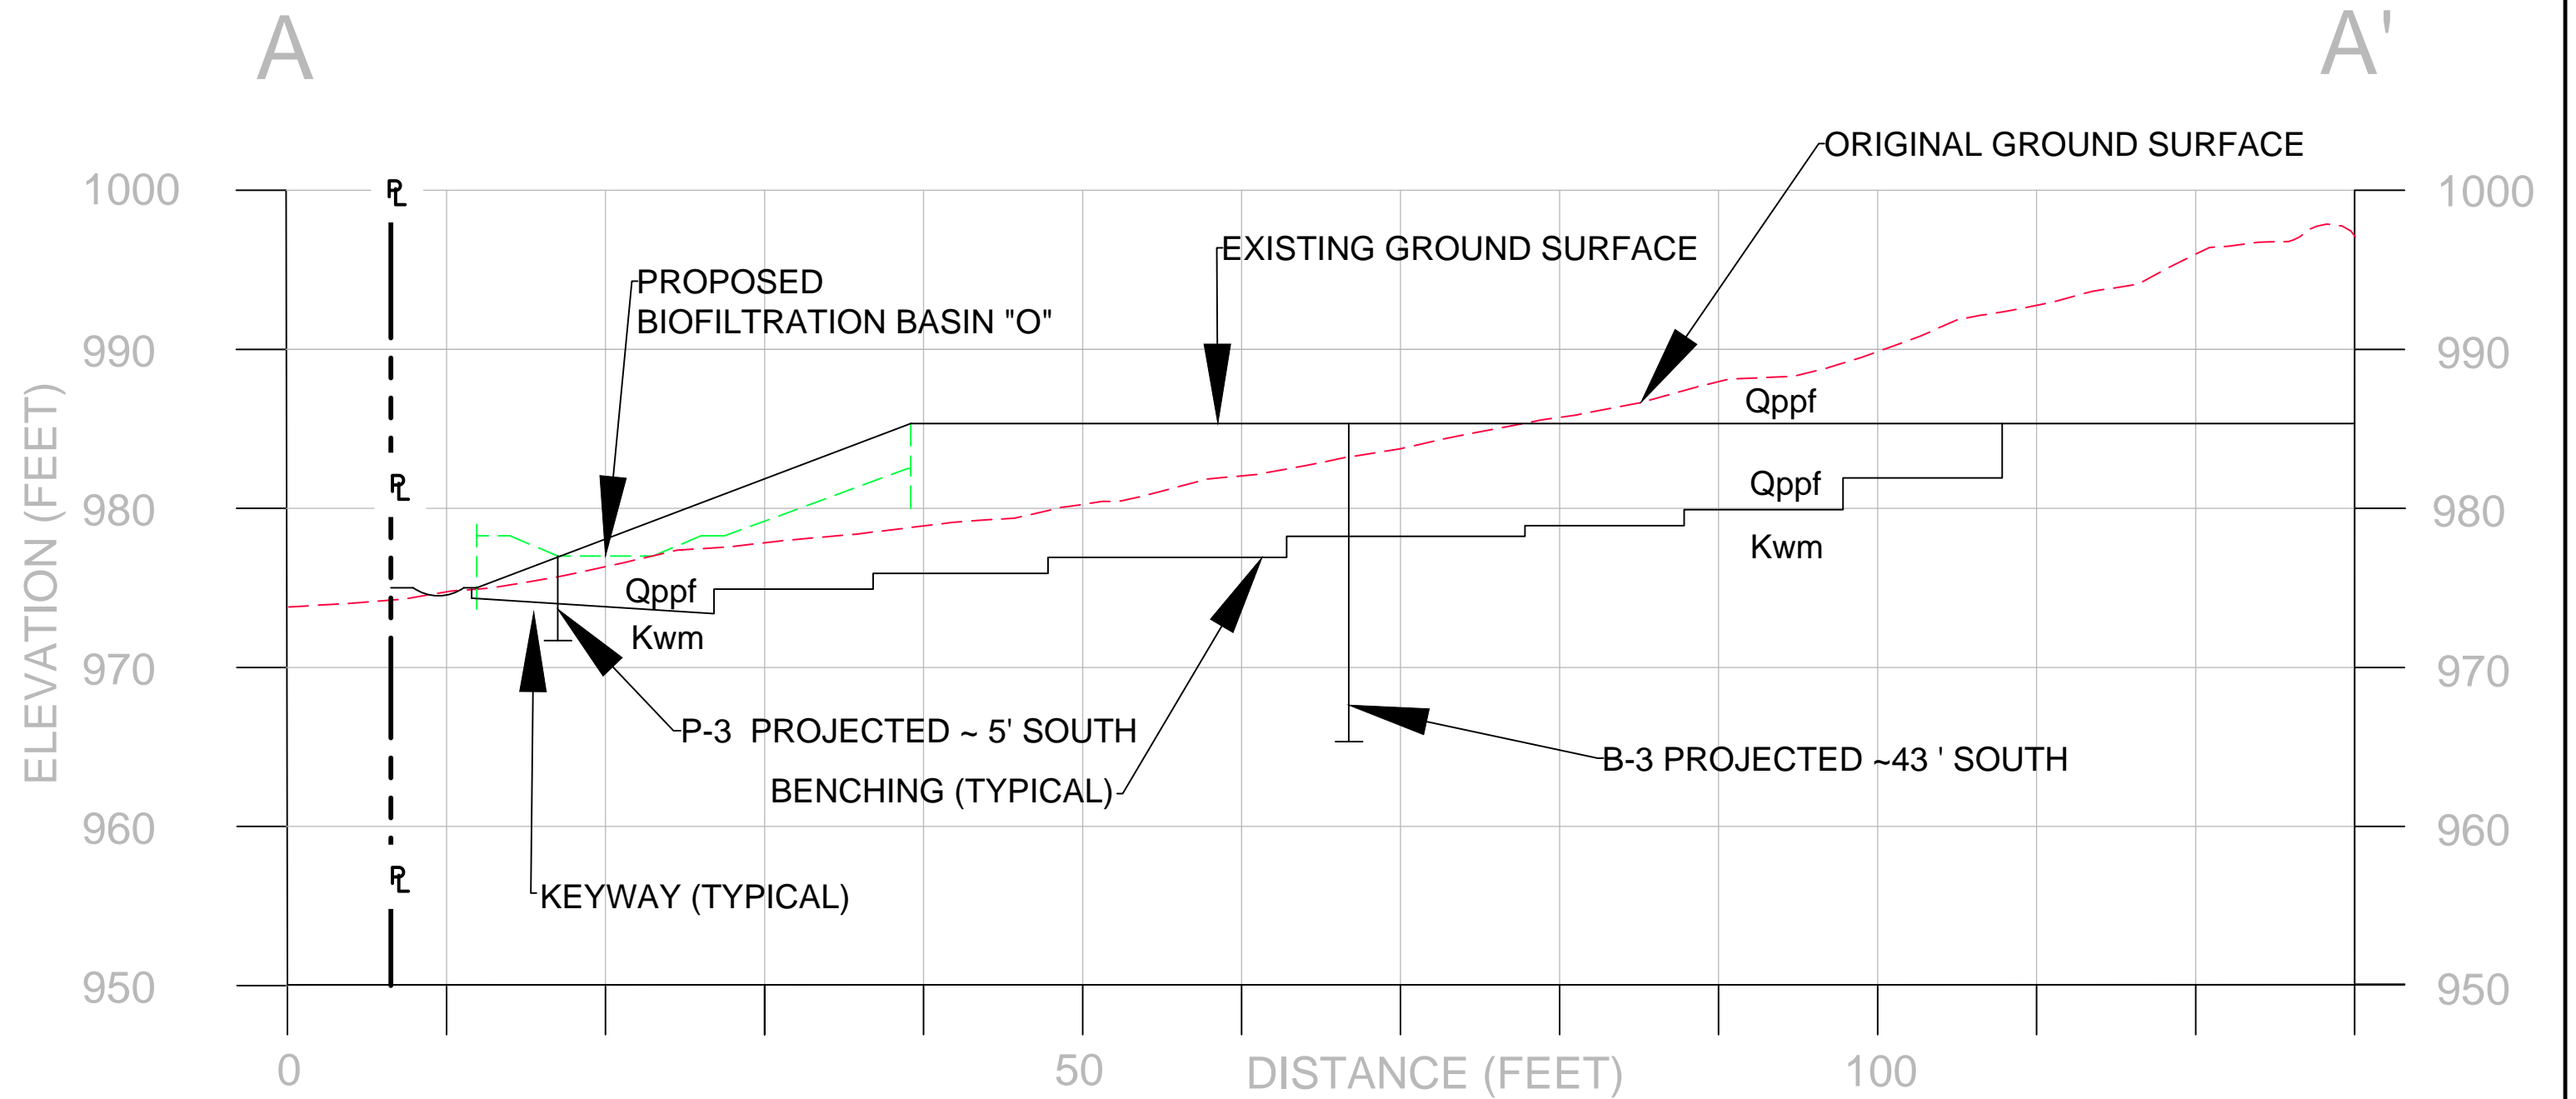
CTE JOB NO: 10-13290G
SCALE: 1" = 10'
DATE: 10/16 FIGURE: 2A

GEOLOGIC CROSS SECTION A-A'
RESQUE RANCH
APN: 276-030-48-00
NORTH OF HIGHLAND VALLEY ROAD, SAN DIEGO, CALIFORNIA

The computer program feature termed “Auto Search” was utilized for Cross Section A-A’; this feature, as the title implies, automatically searches the section geometry for the composite failure surface with the lowest factor of safety. Upon locating the lowest factor of safety (using 1000 computer generated composite failure surfaces), the program optimizes the critical failure surface using up to an additional 2000 “optimized” surfaces. A grid and radius was utilized to constrain the hypothetical failure at the toe of the slope depicted on Section B-B’. The grid and radius locates the most critical hypothetical failure path through the section to find the critical radius within specified grid boundaries.

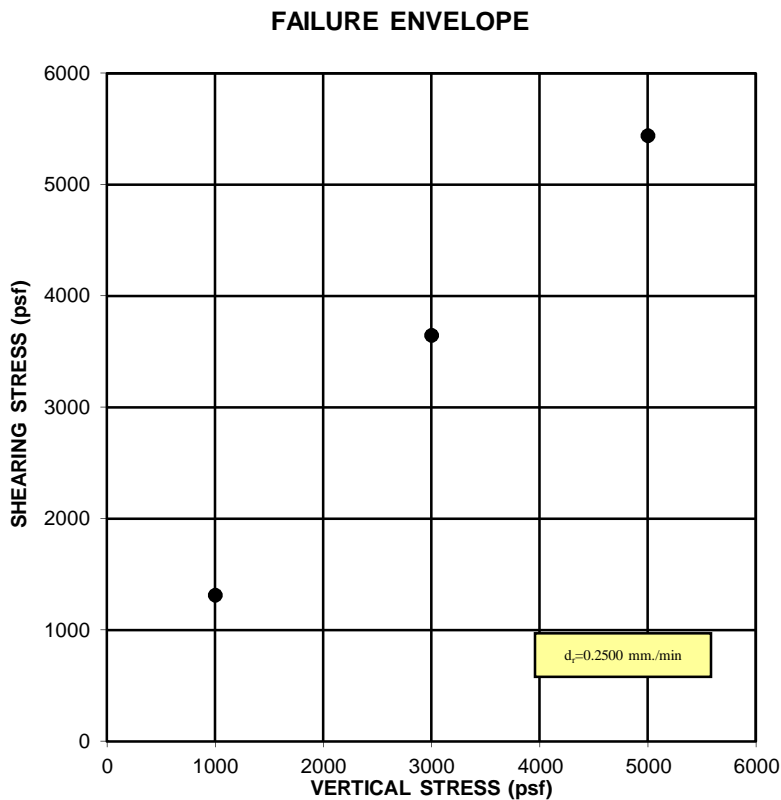
SHEAR STRENGTH TEST - ASTM D3080

Job Name: <u>ResQue Ranch Manufactured Slope</u>	Initial Dry Density (pcf): <u>106.2</u>
Project Number: <u>10-13290G</u>	Sample Date: <u>8/30/2016</u>
Lab Number: <u>26609</u>	Test Date: <u>9/8/2016</u>
Sample Location: <u>B-1 @ 10'</u>	Tested by: <u>Julian Carmona</u>
Sample Description: <u>Brown SW</u>	
	Initial Moisture (%): <u>6.3</u>
	Final Moisture (%): <u>16.8</u>
	Cohesion: <u>360 psf</u>
	Angle Of Friction: <u>45.9</u>

Direct shear tests were performed on selected drive samples collected from the field exploration. Direct shear testing was performed in accordance with ASTM D 3080. The samples were inundated during shearing to represent adverse field conditions.

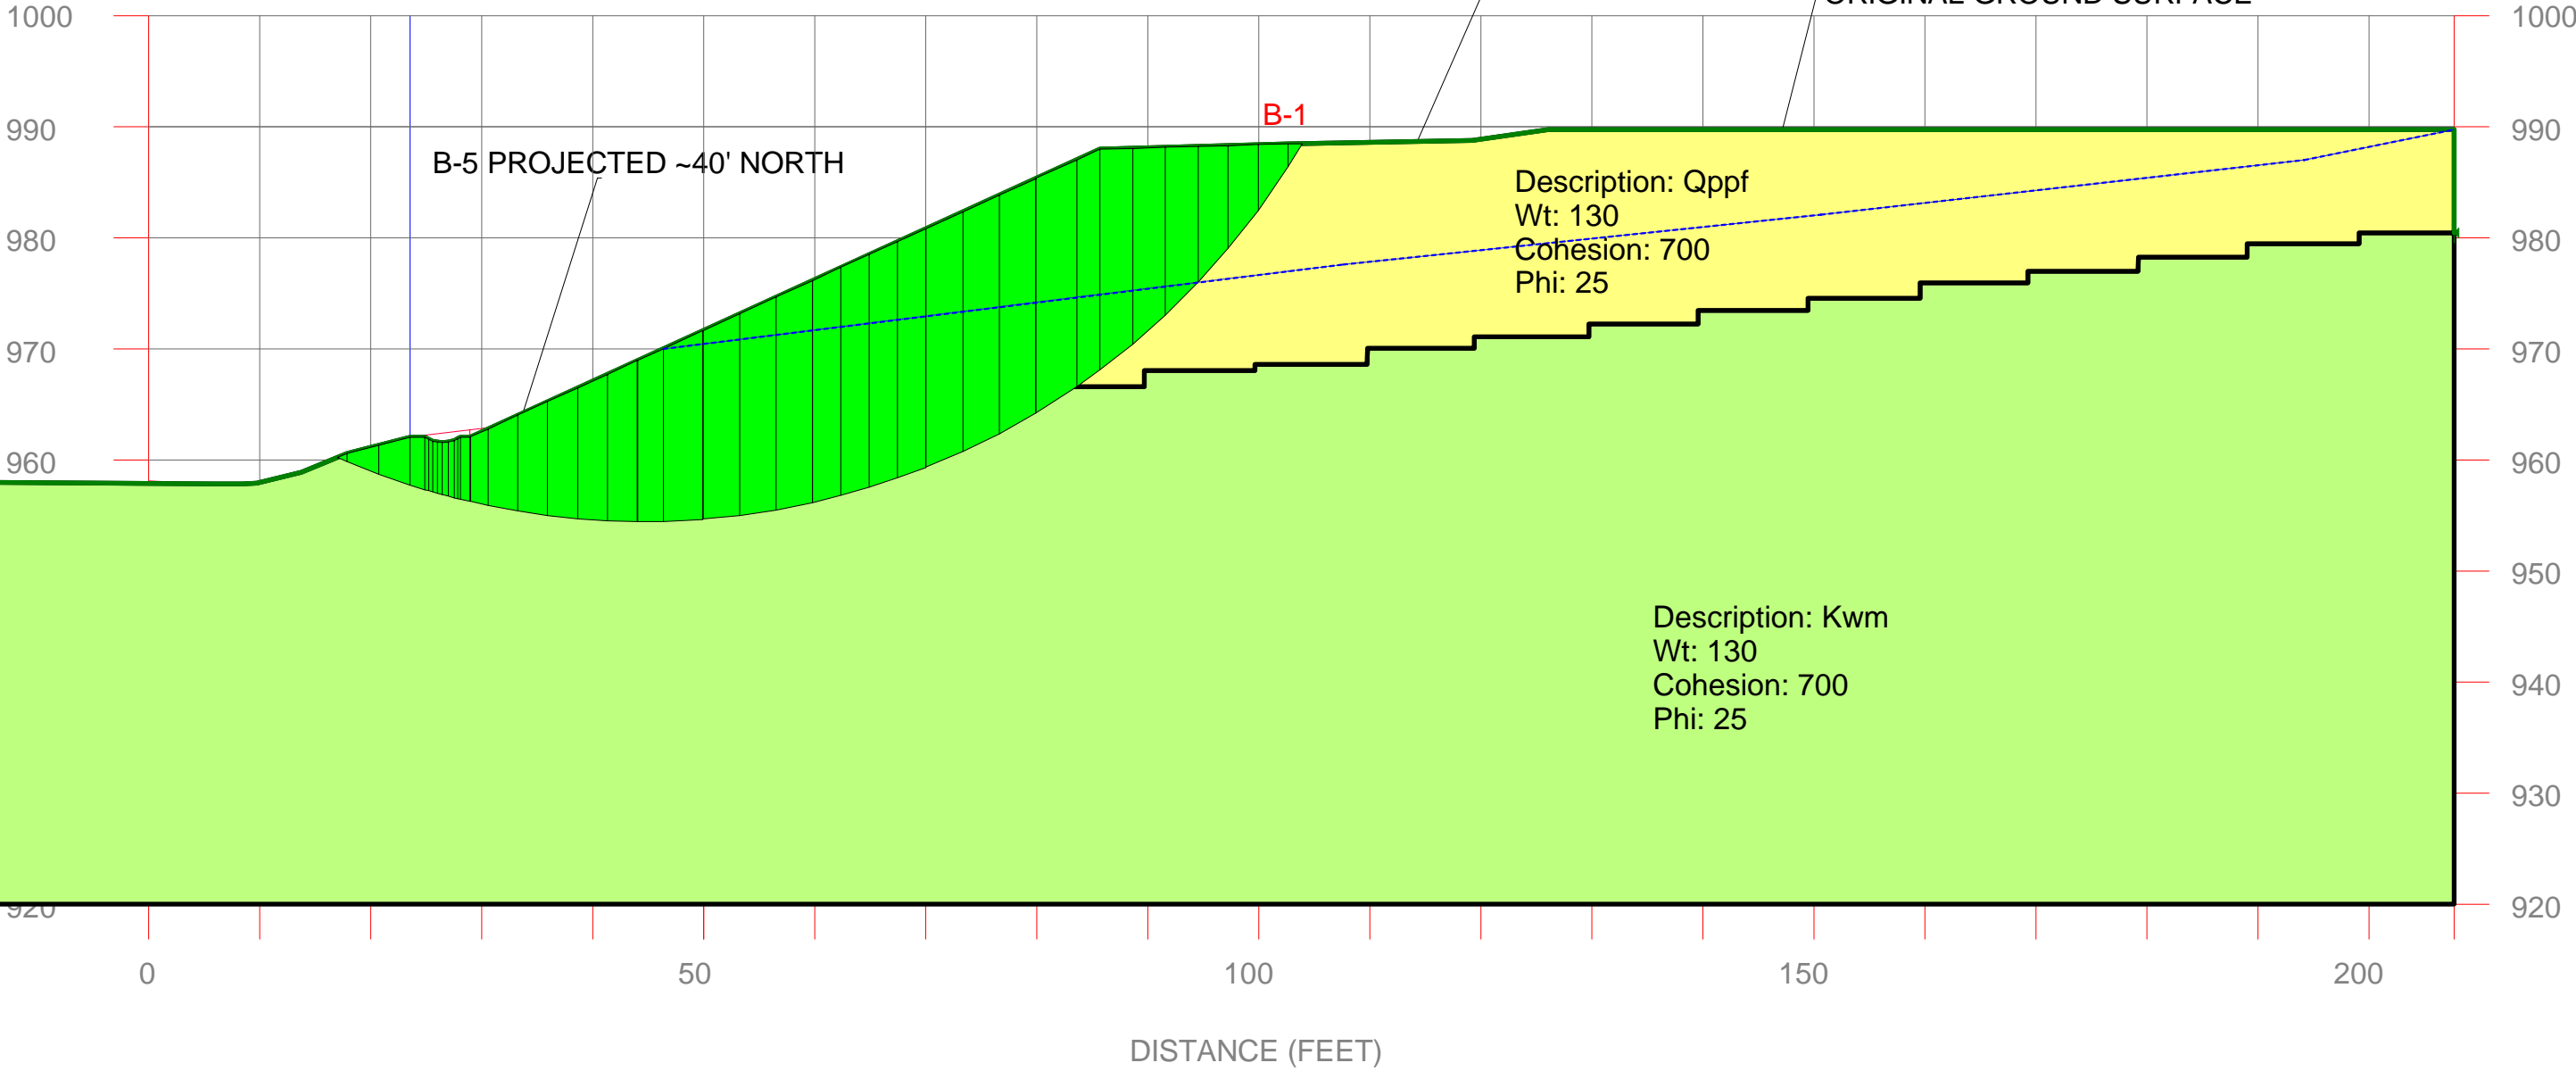
Name: B_Base.gsz
Method: Spencer
Direction of movement: RightToLeft
Slip Surface Option: GridAndRadius
Horz Seismic Load: 0
Vert Seismic Load: 0
Factor of Safety: 2.649

TABLE 7.5 CALCULATED SAFETY FACTORS	
Condition Analyzed	Calculated Safety Factor
Section A, Static, Auto Search for Critical Deep Hypothetical Failure	4.642
Section B, Static, Grid and Radius Search for Critical Deep Failure	2.649
Surficial Failure, Three Feet Saturated Profile	5.00
