# Groundwater Resources Investigation Report Tierra del Sol Solar Farm Project

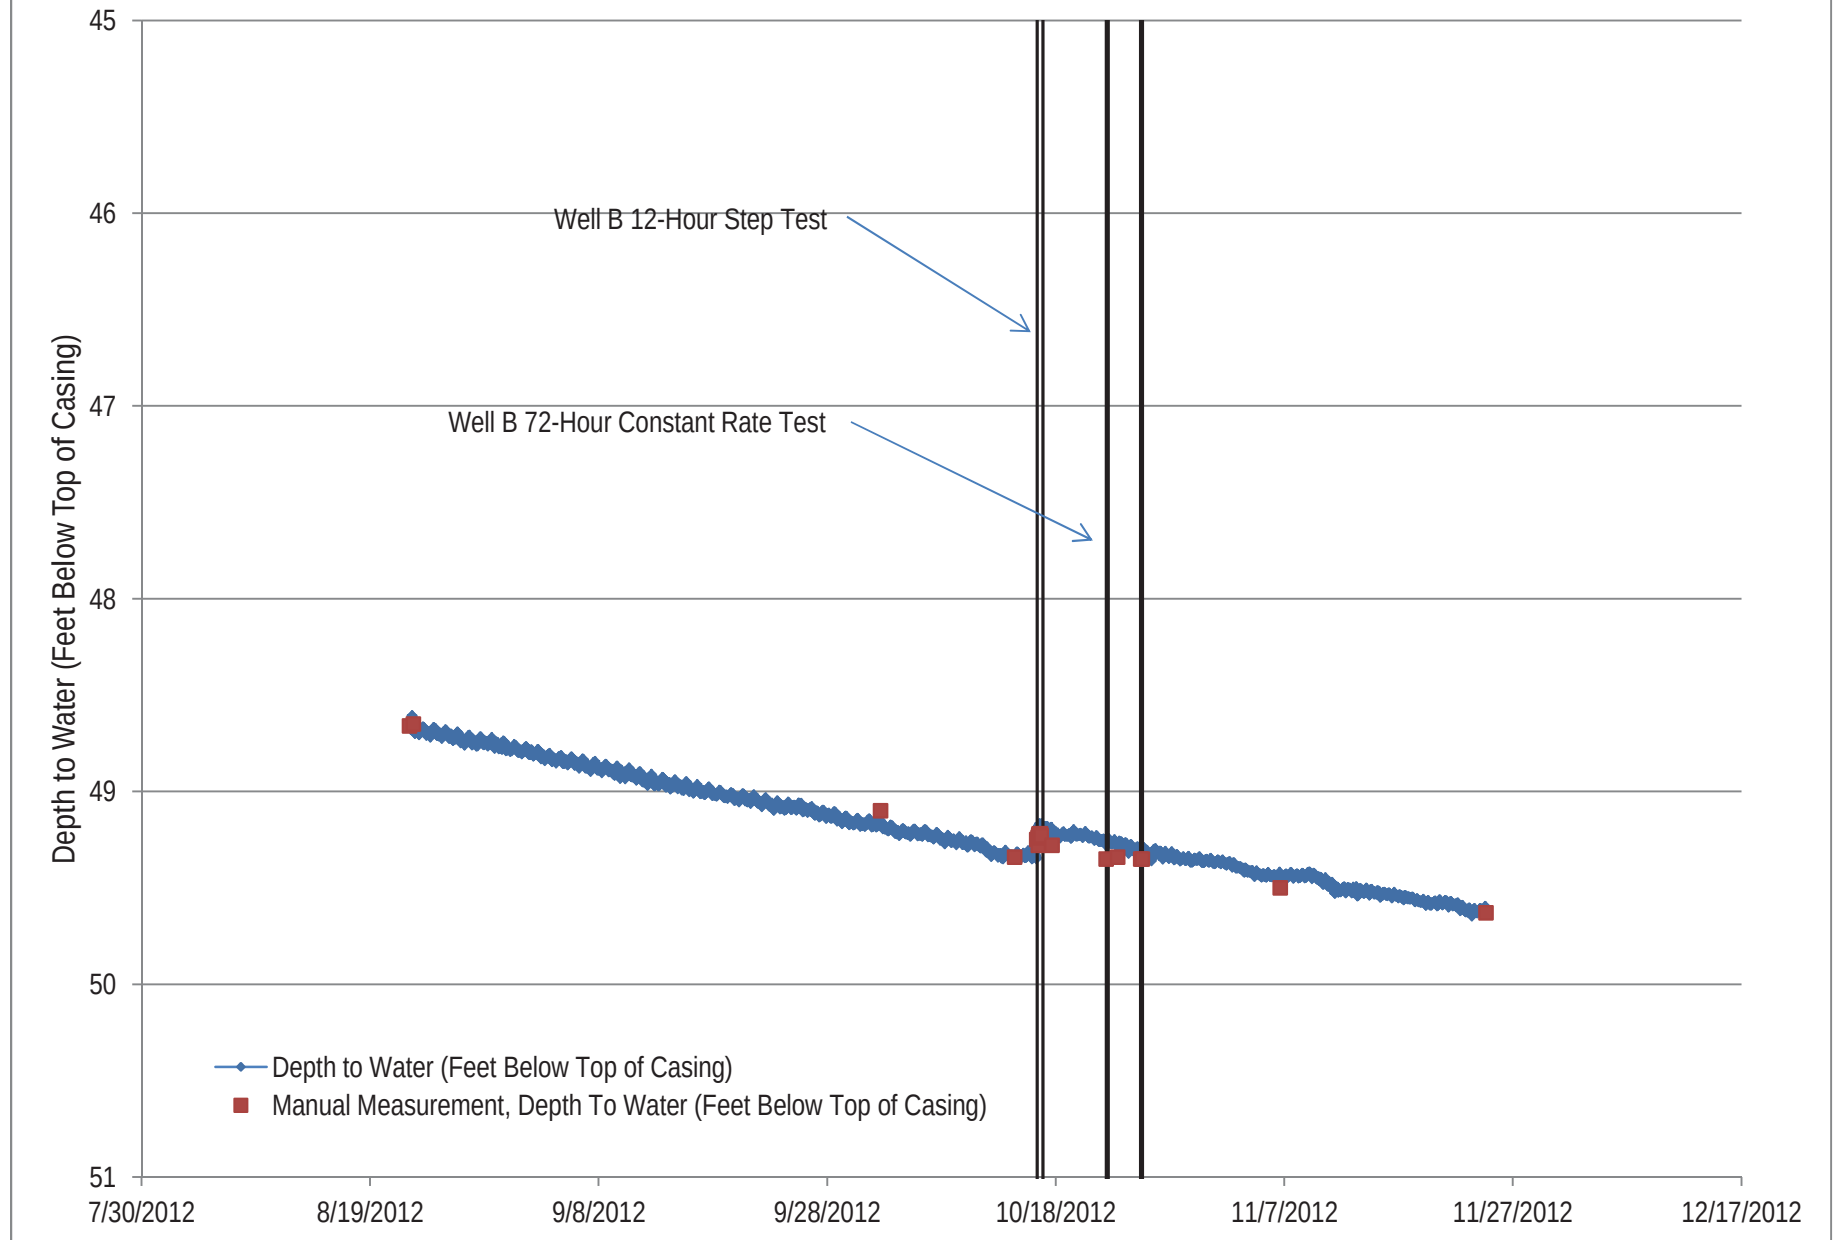
Figure 17. On-site Well A Water Level Data

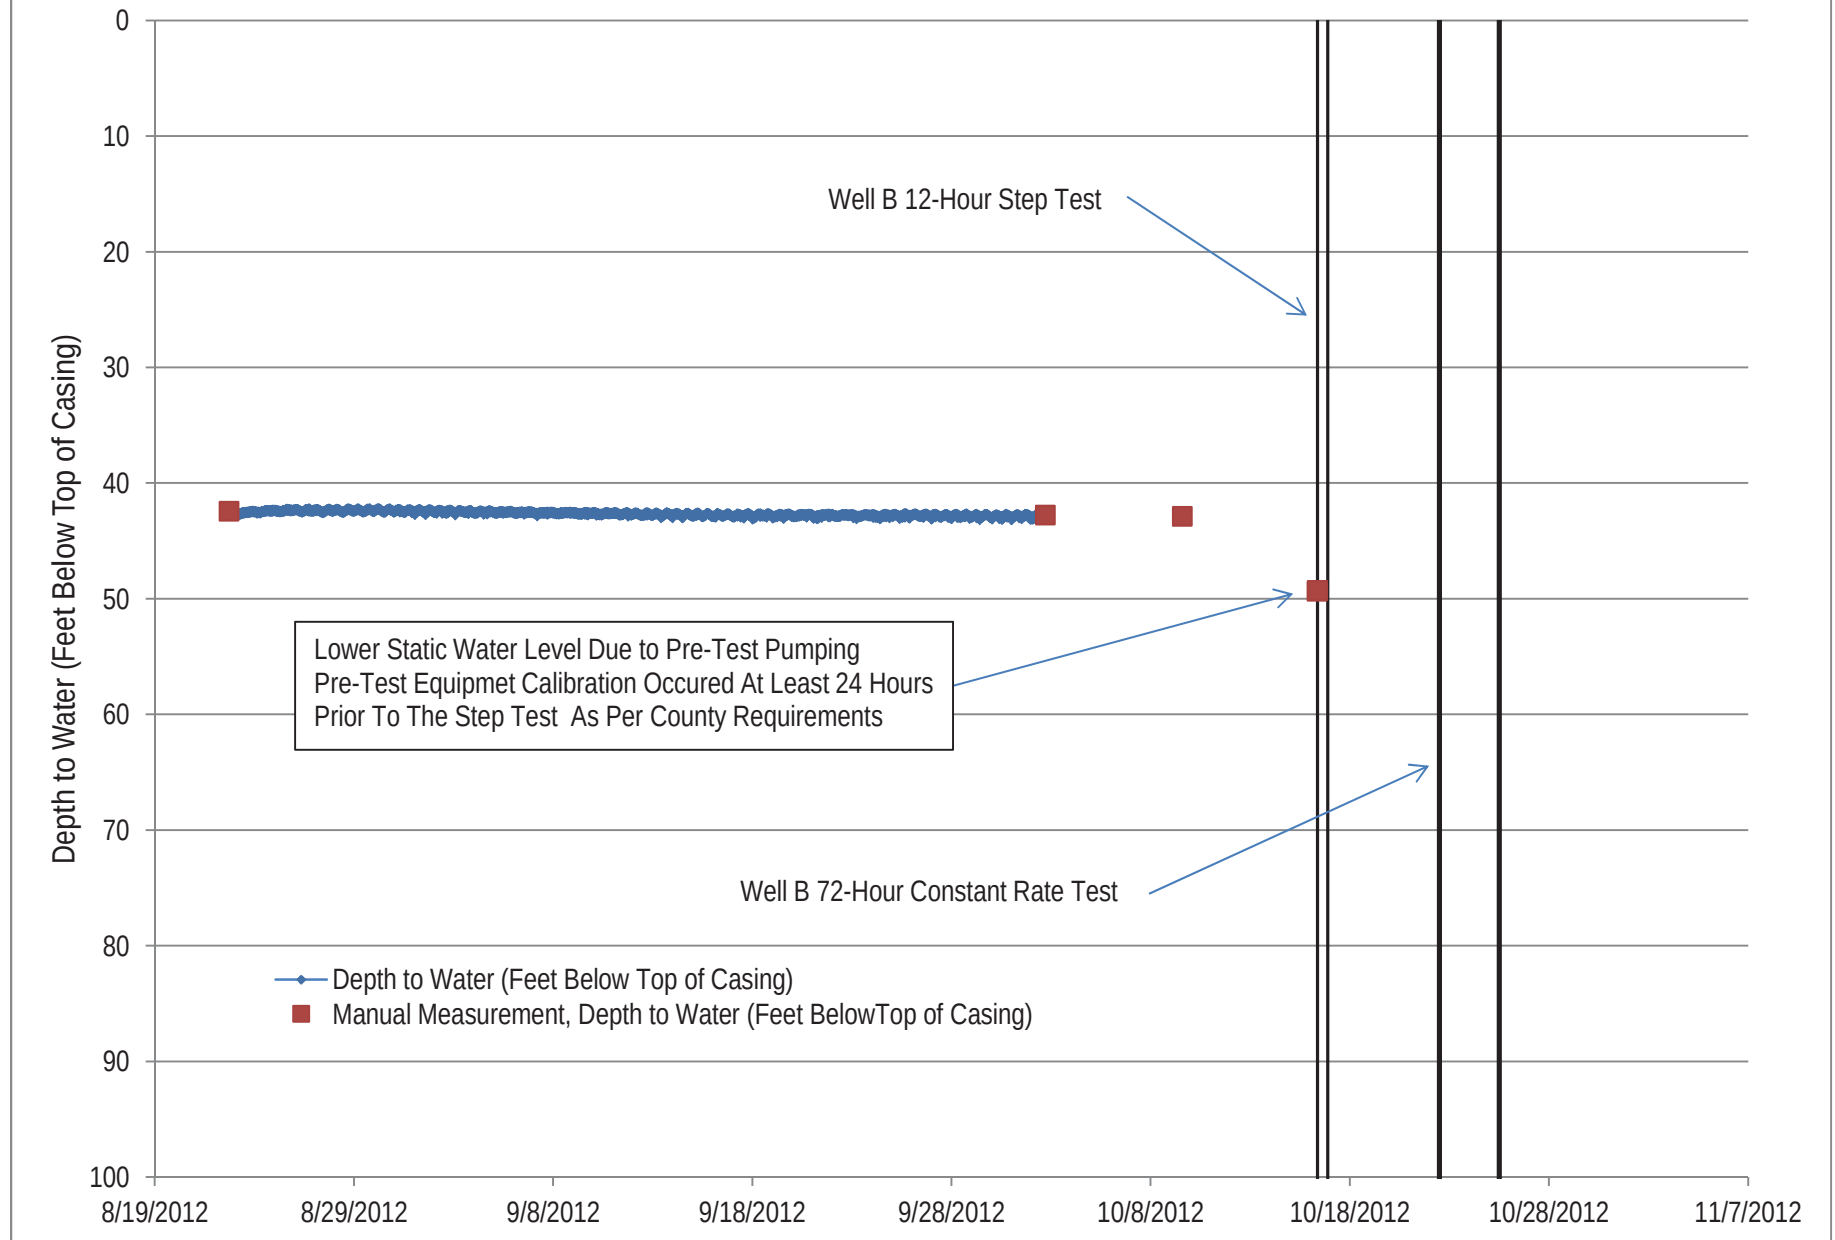
**Figure 18. On-site Well B Pre-Test Water Level Data**

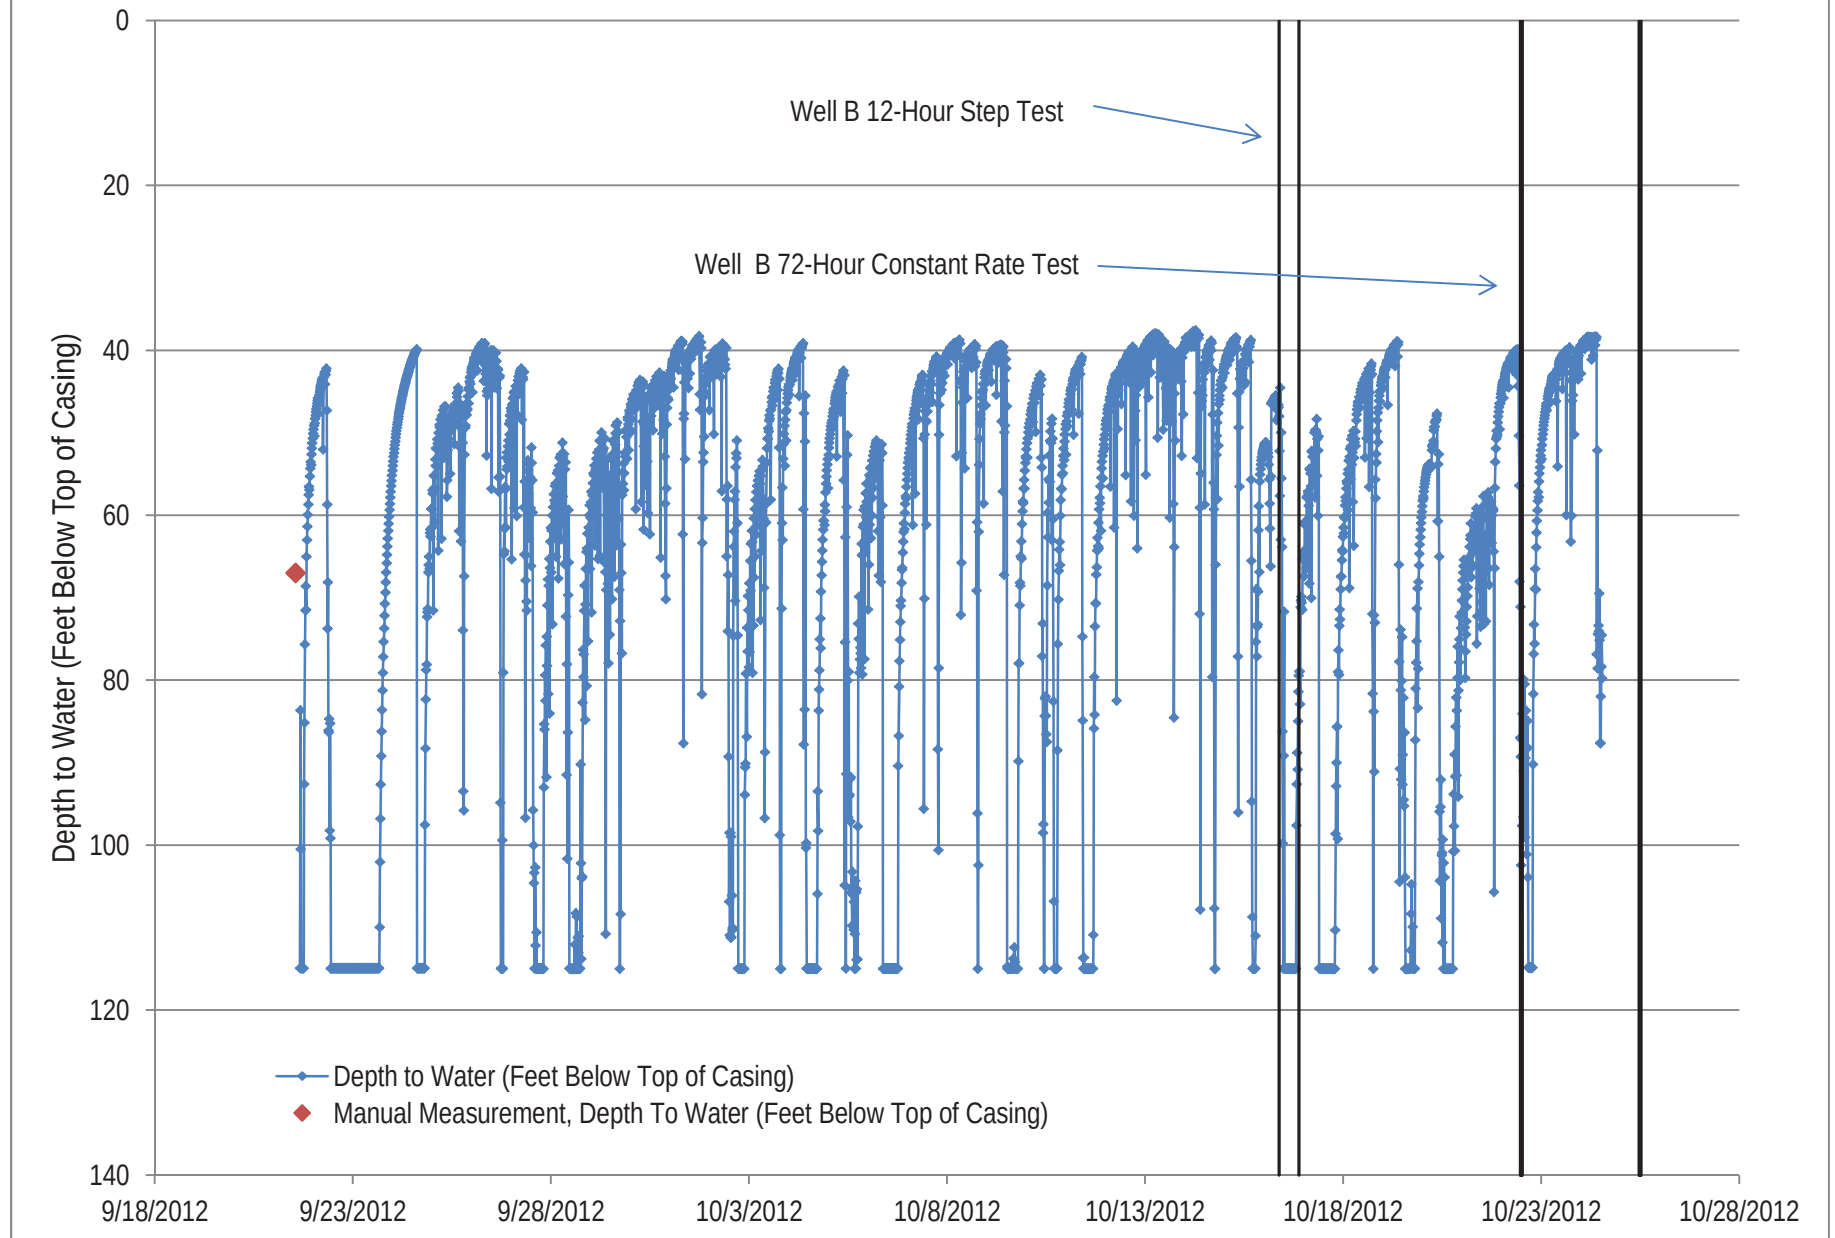
Figure 19. Off-site Well GR-1 Water Level Data

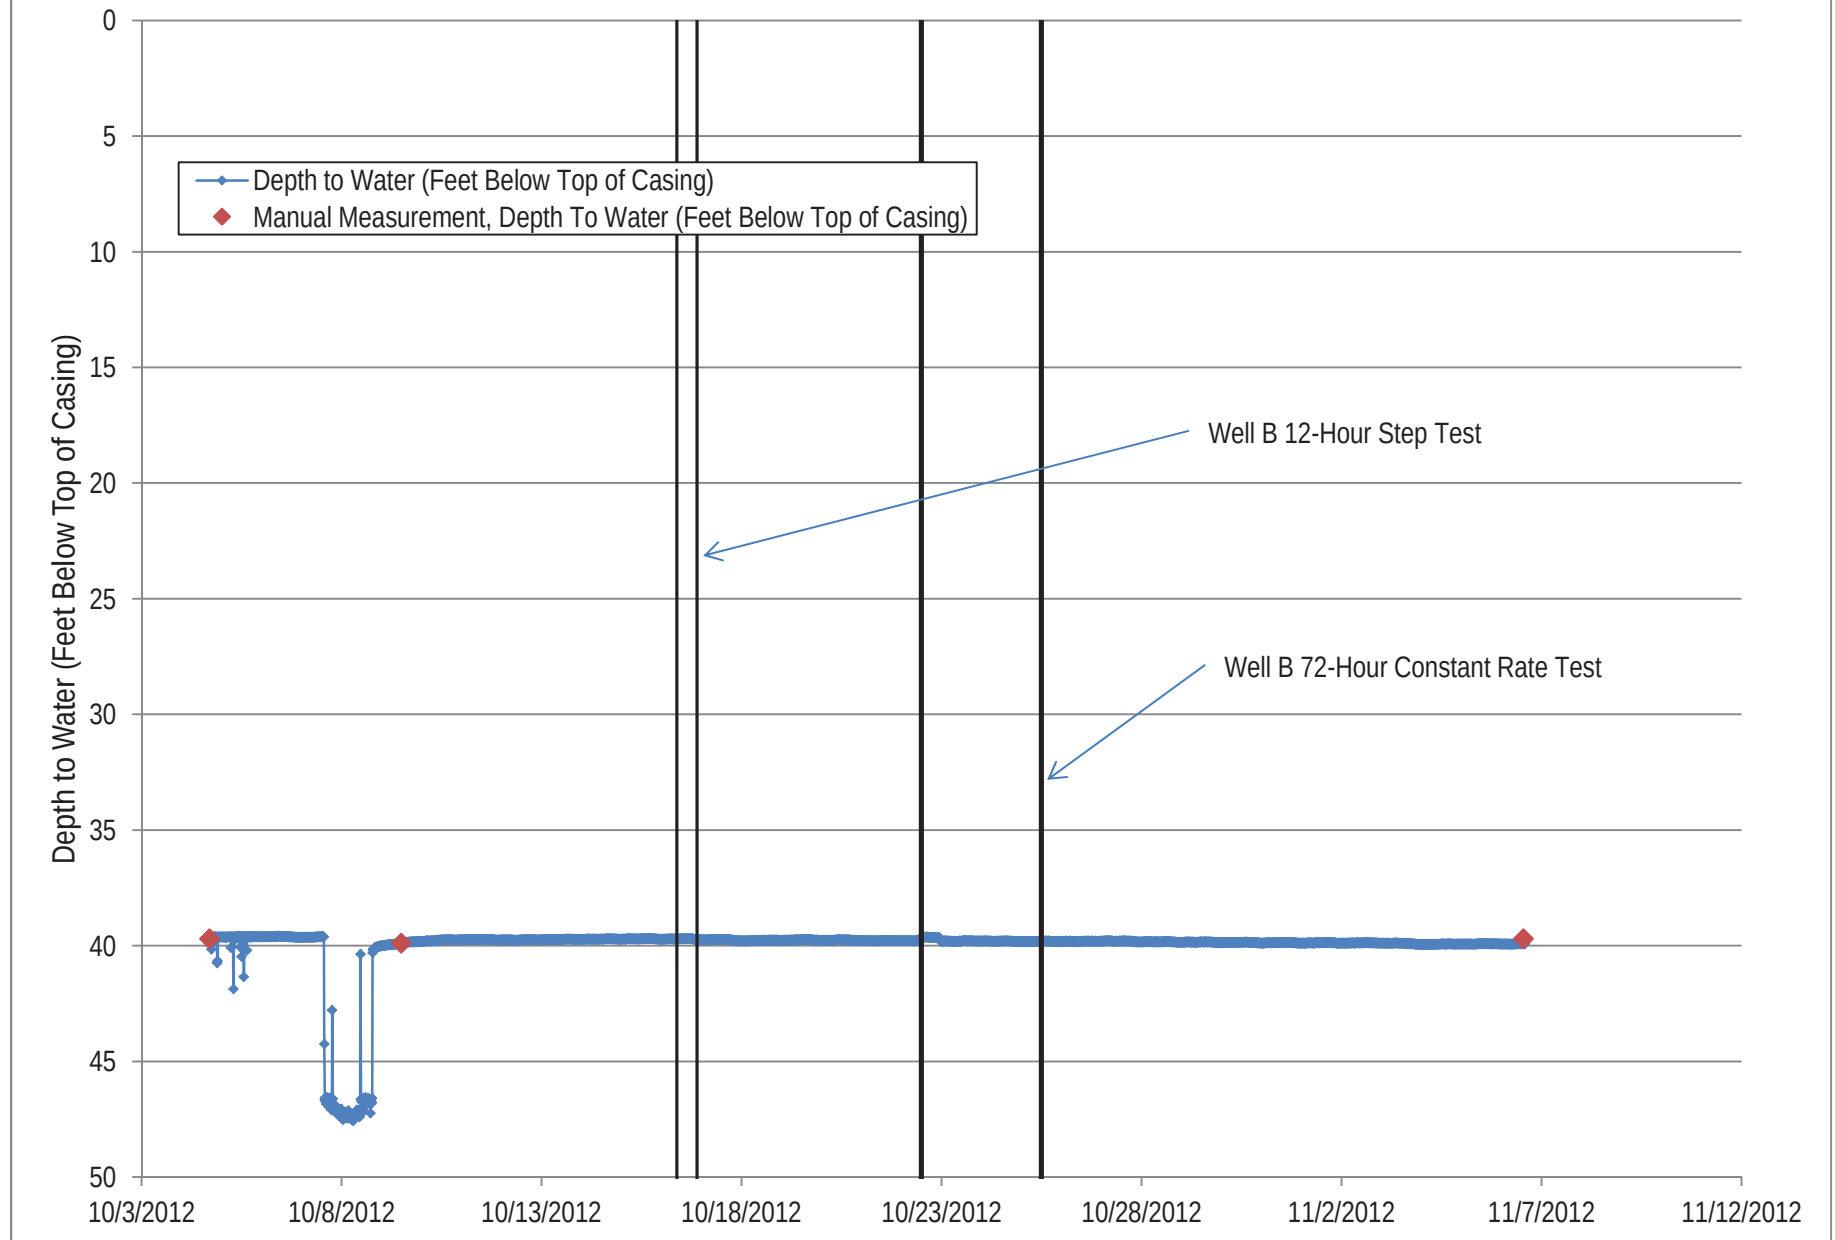
Figure 20. Off-site Well GS-1 Water Level Data

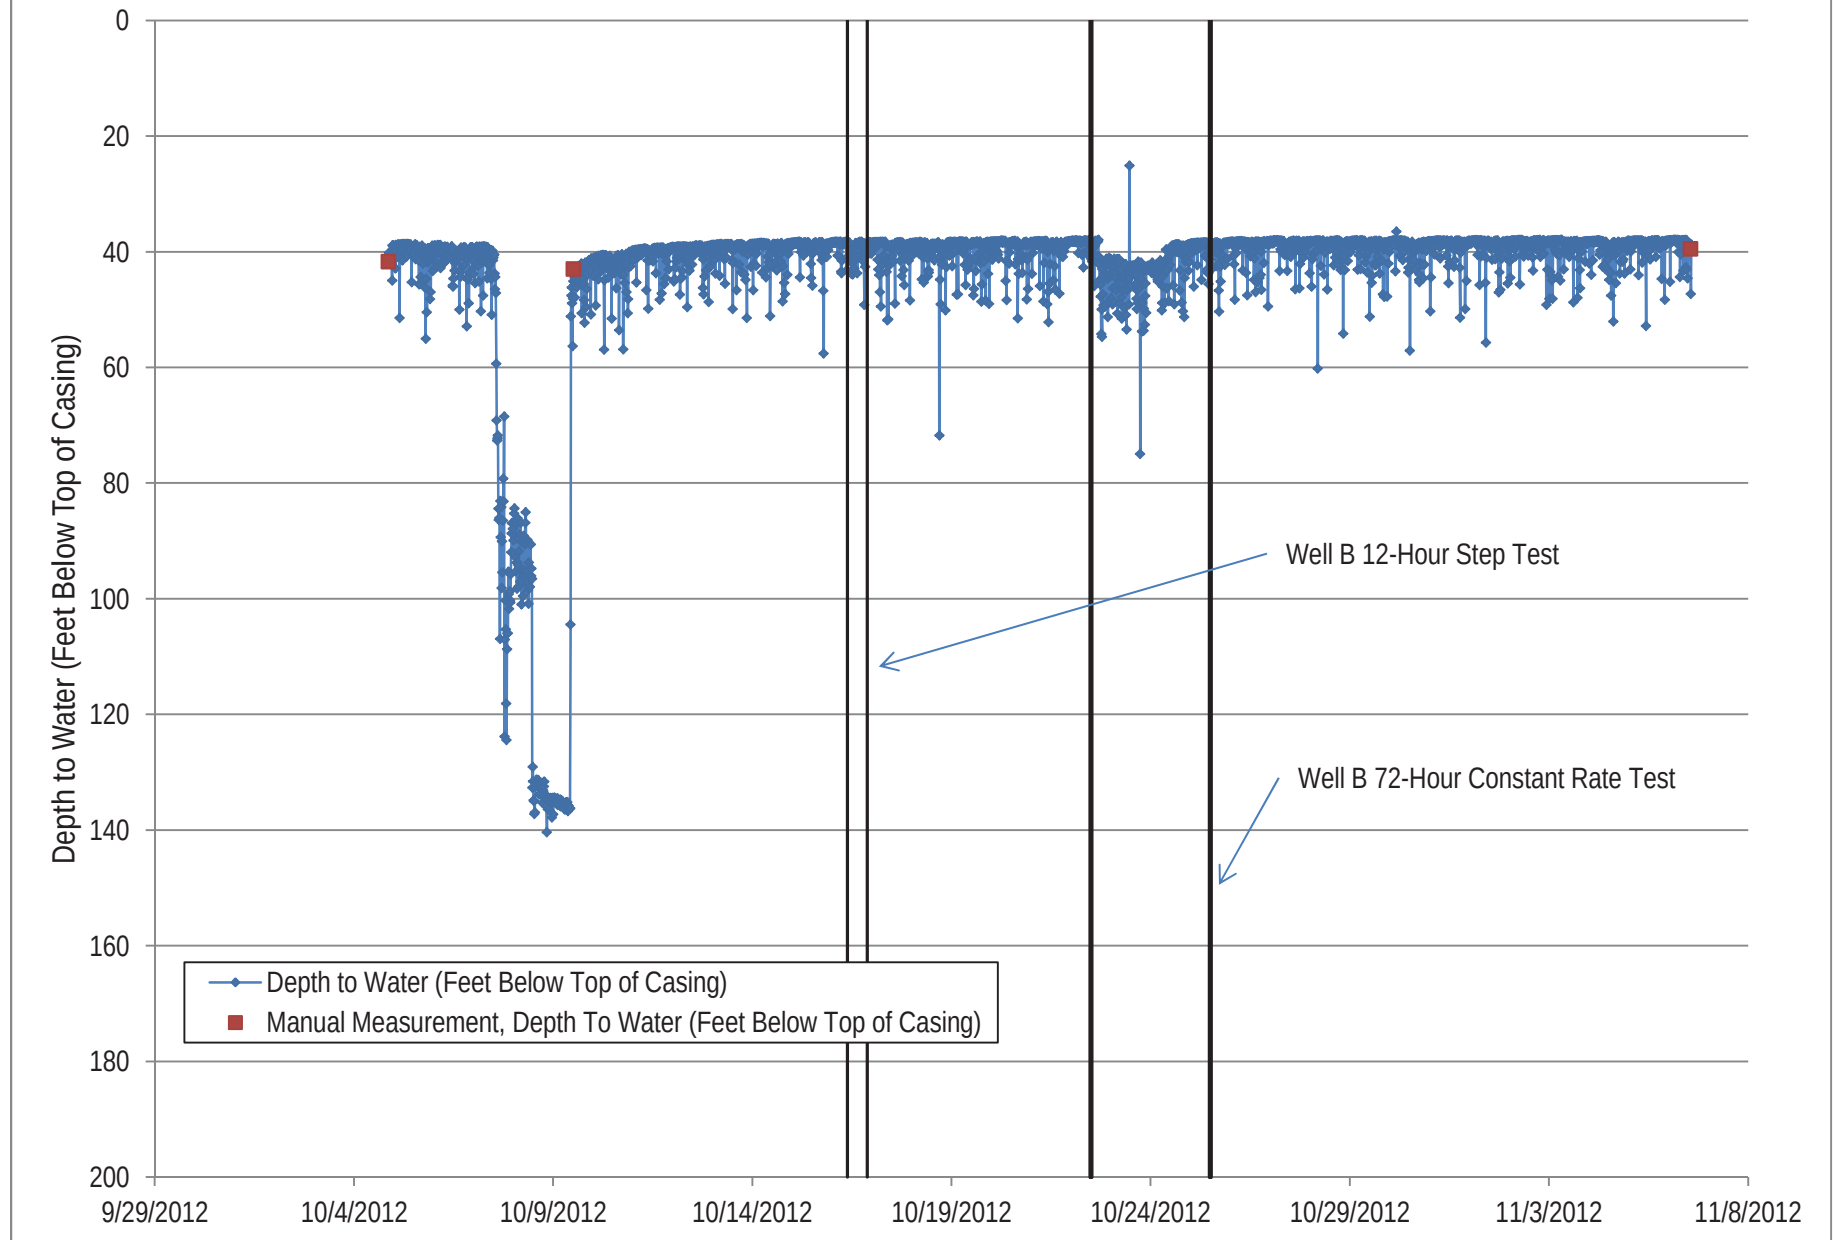
Figure 21. Off-site Well GS-2 Water Level Data

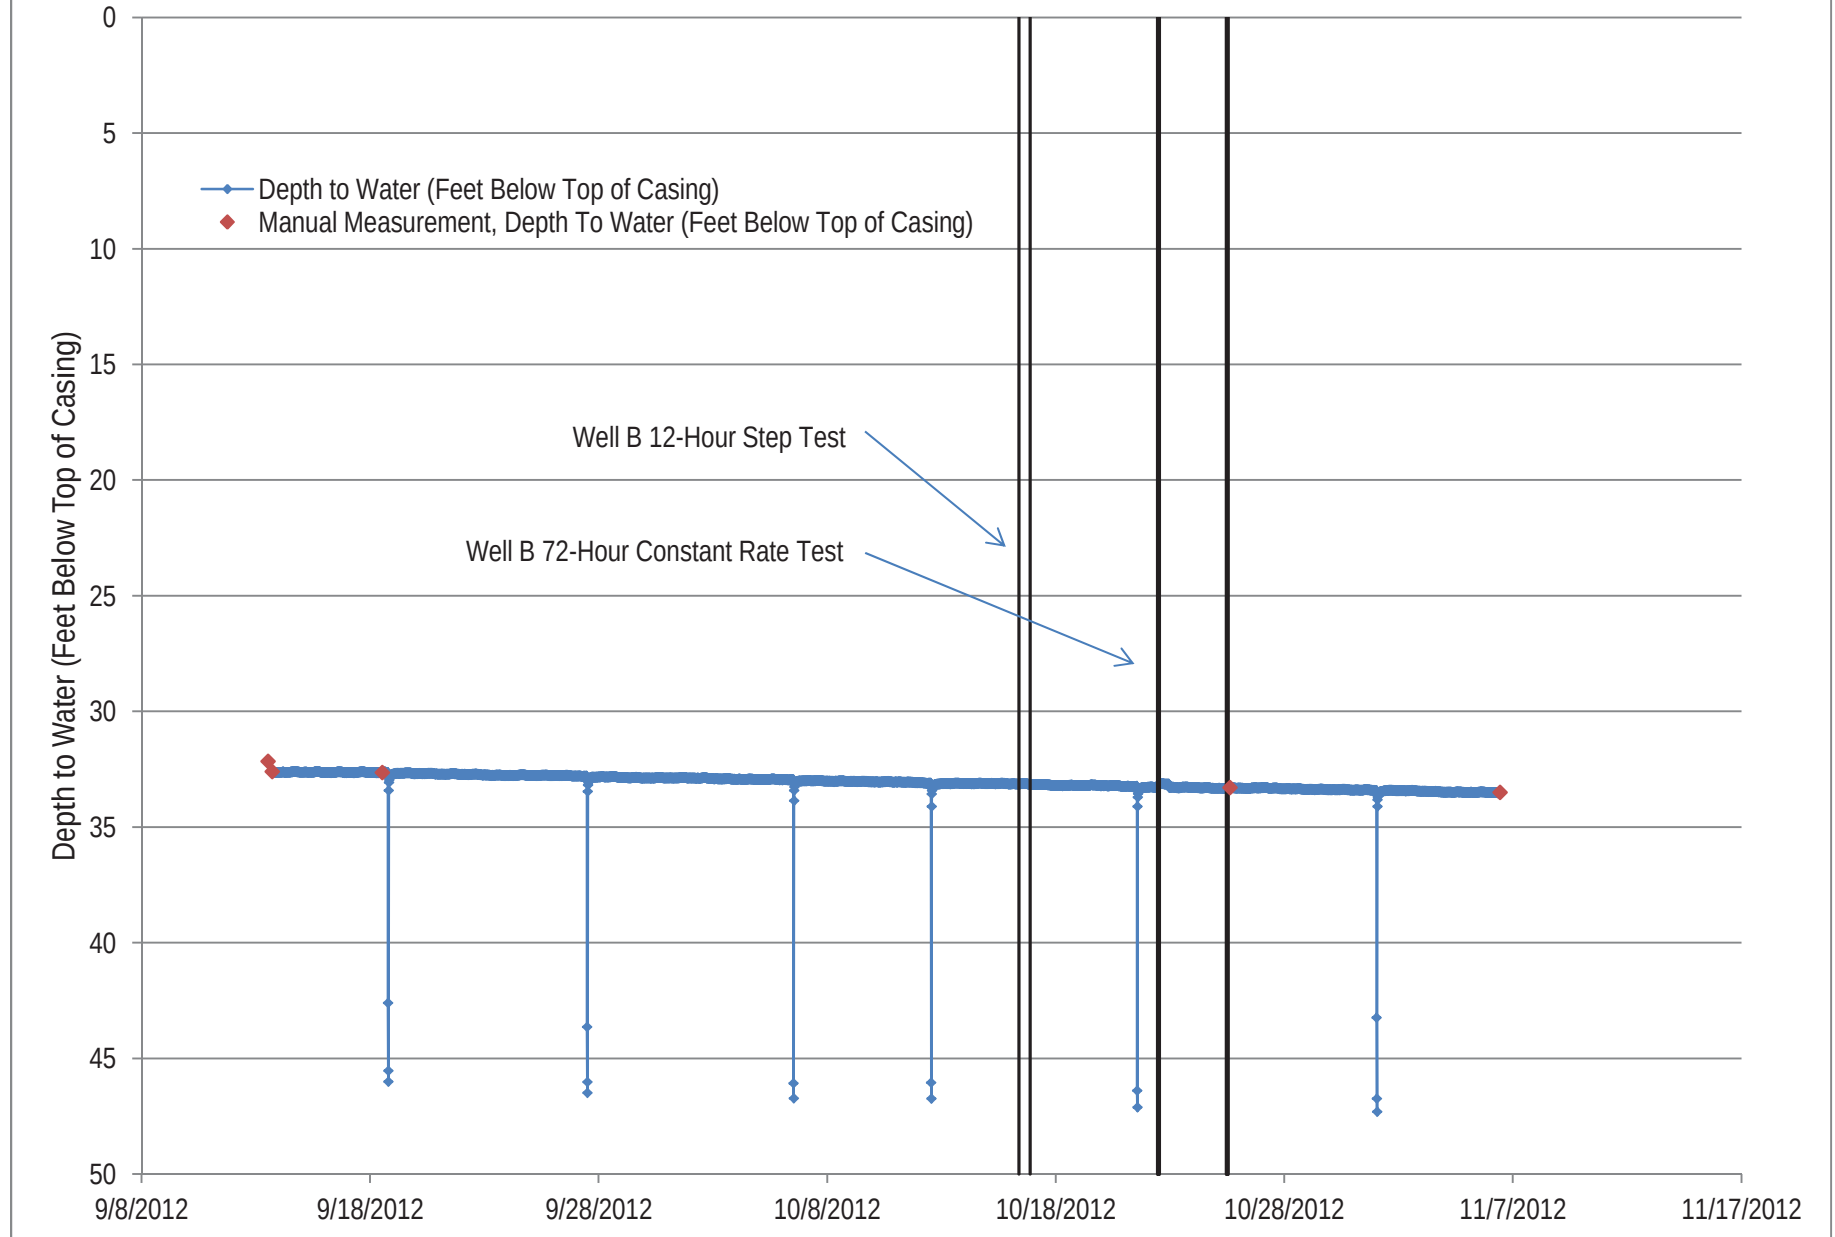
Figure 22. Off-site Well LK-1 Water Level Data

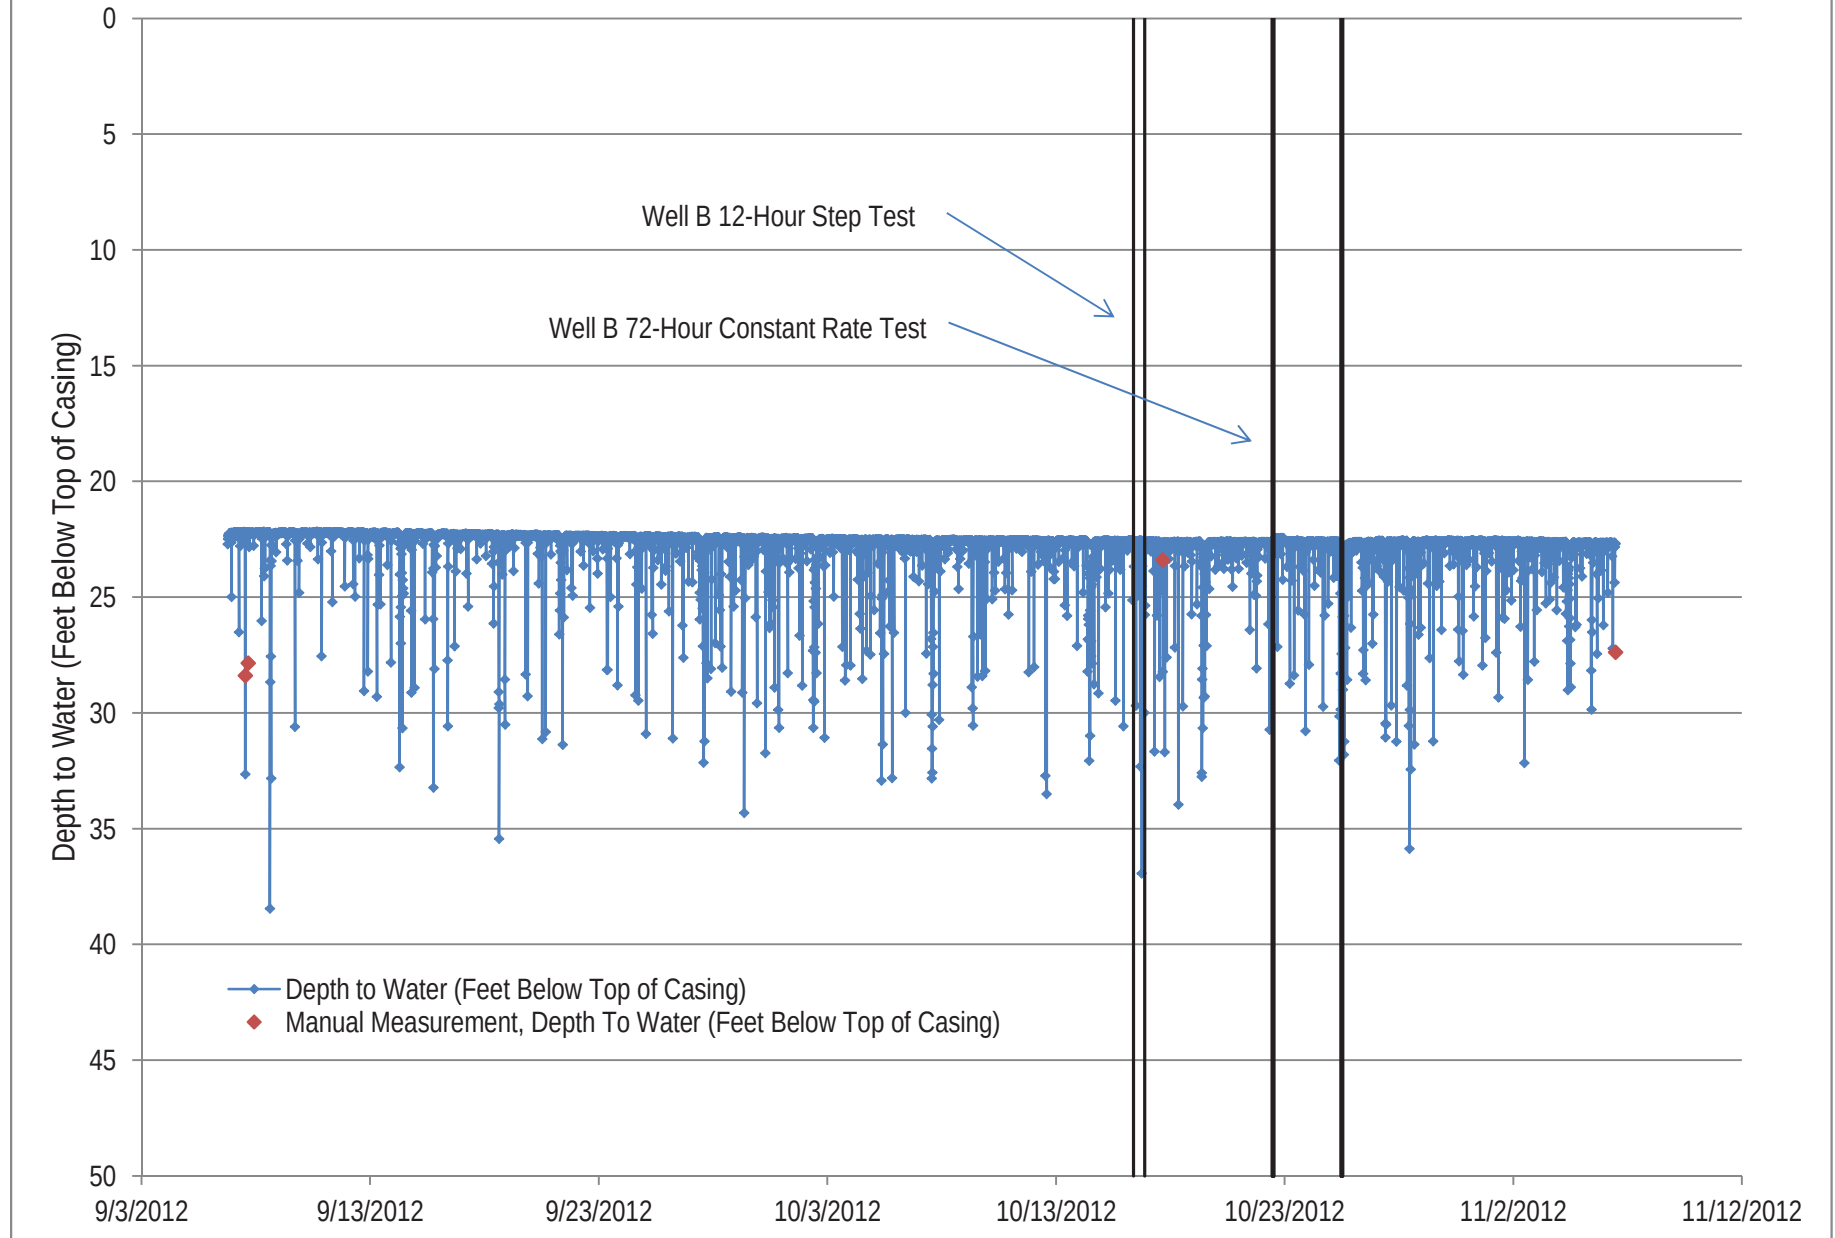
Figure 23. Off-site Well RM-1 Water Level Data

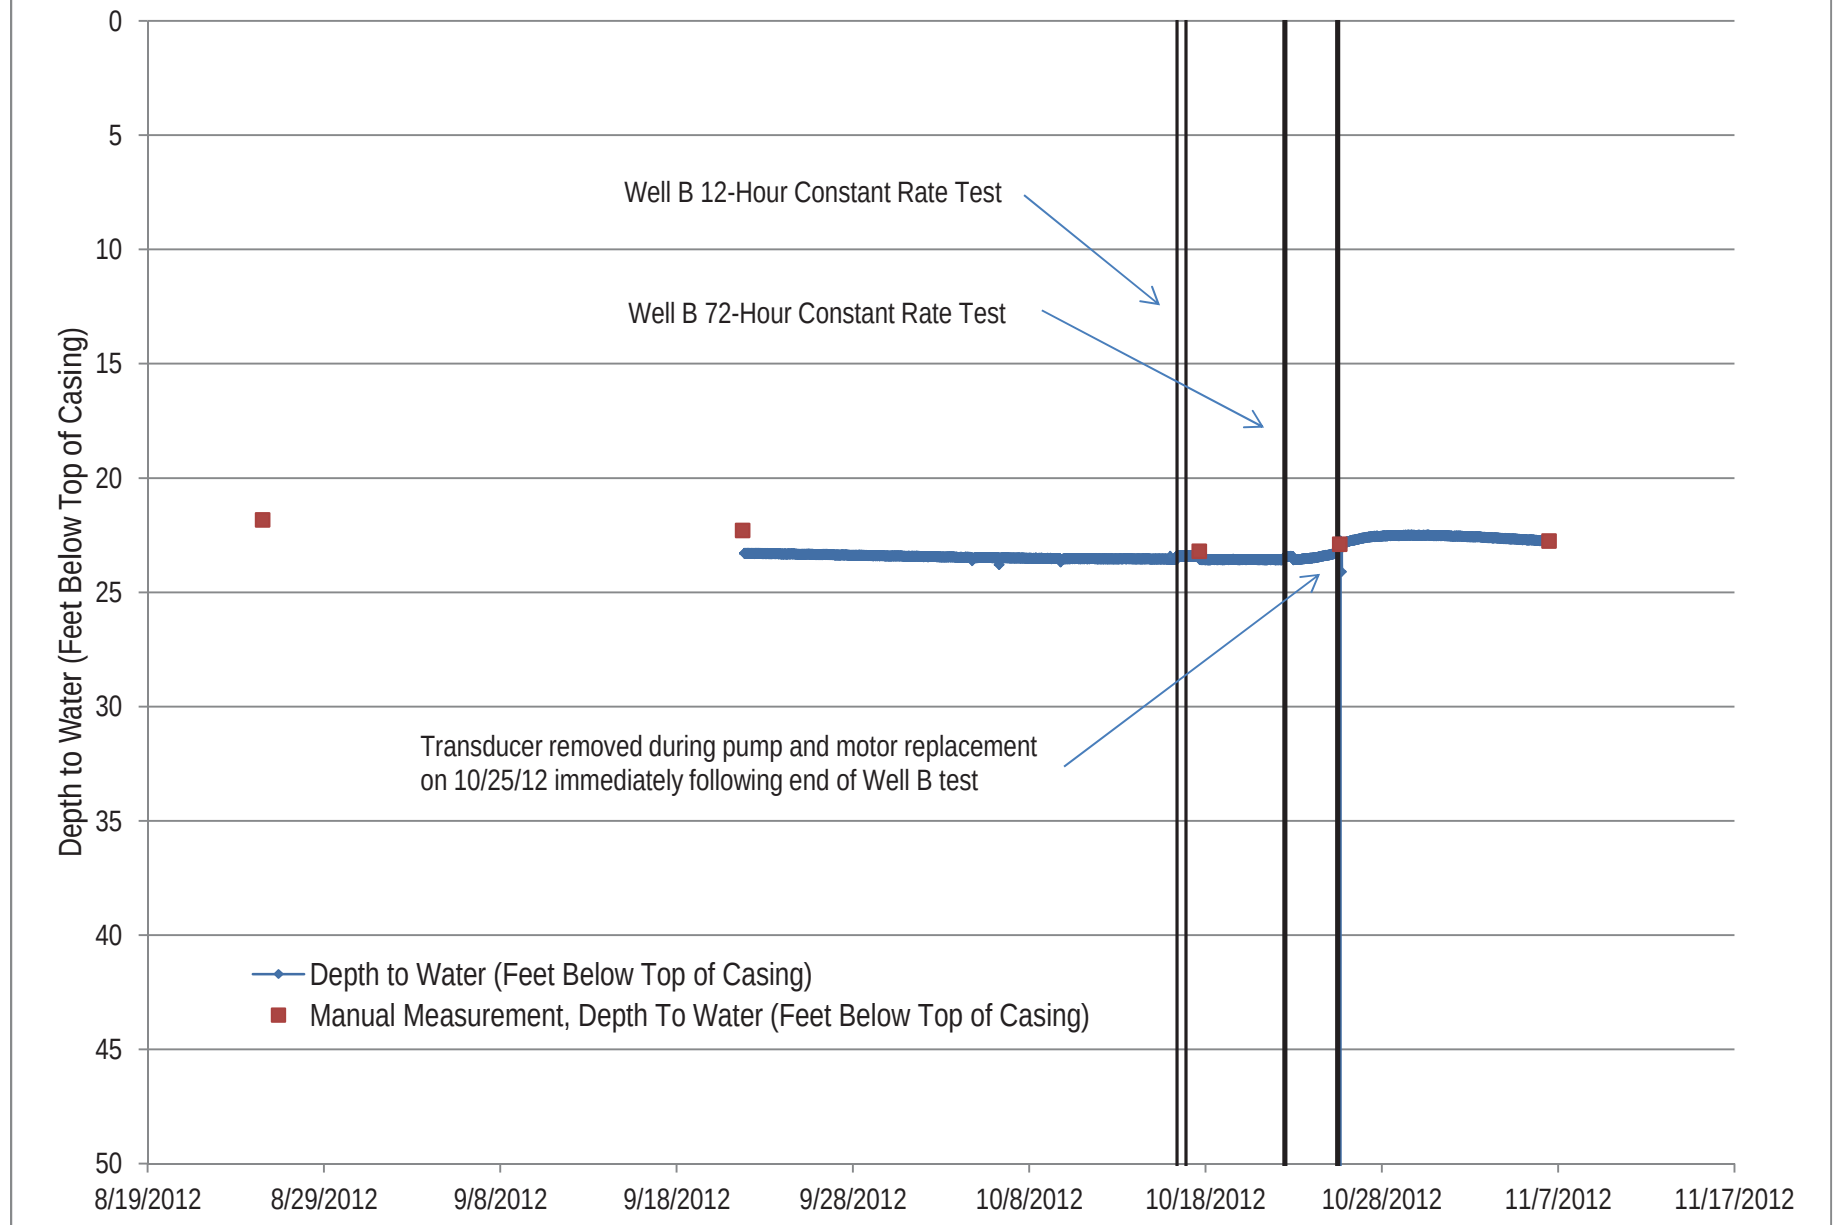
**Figure 24. Off-site Well RM-3 Water Level Data**

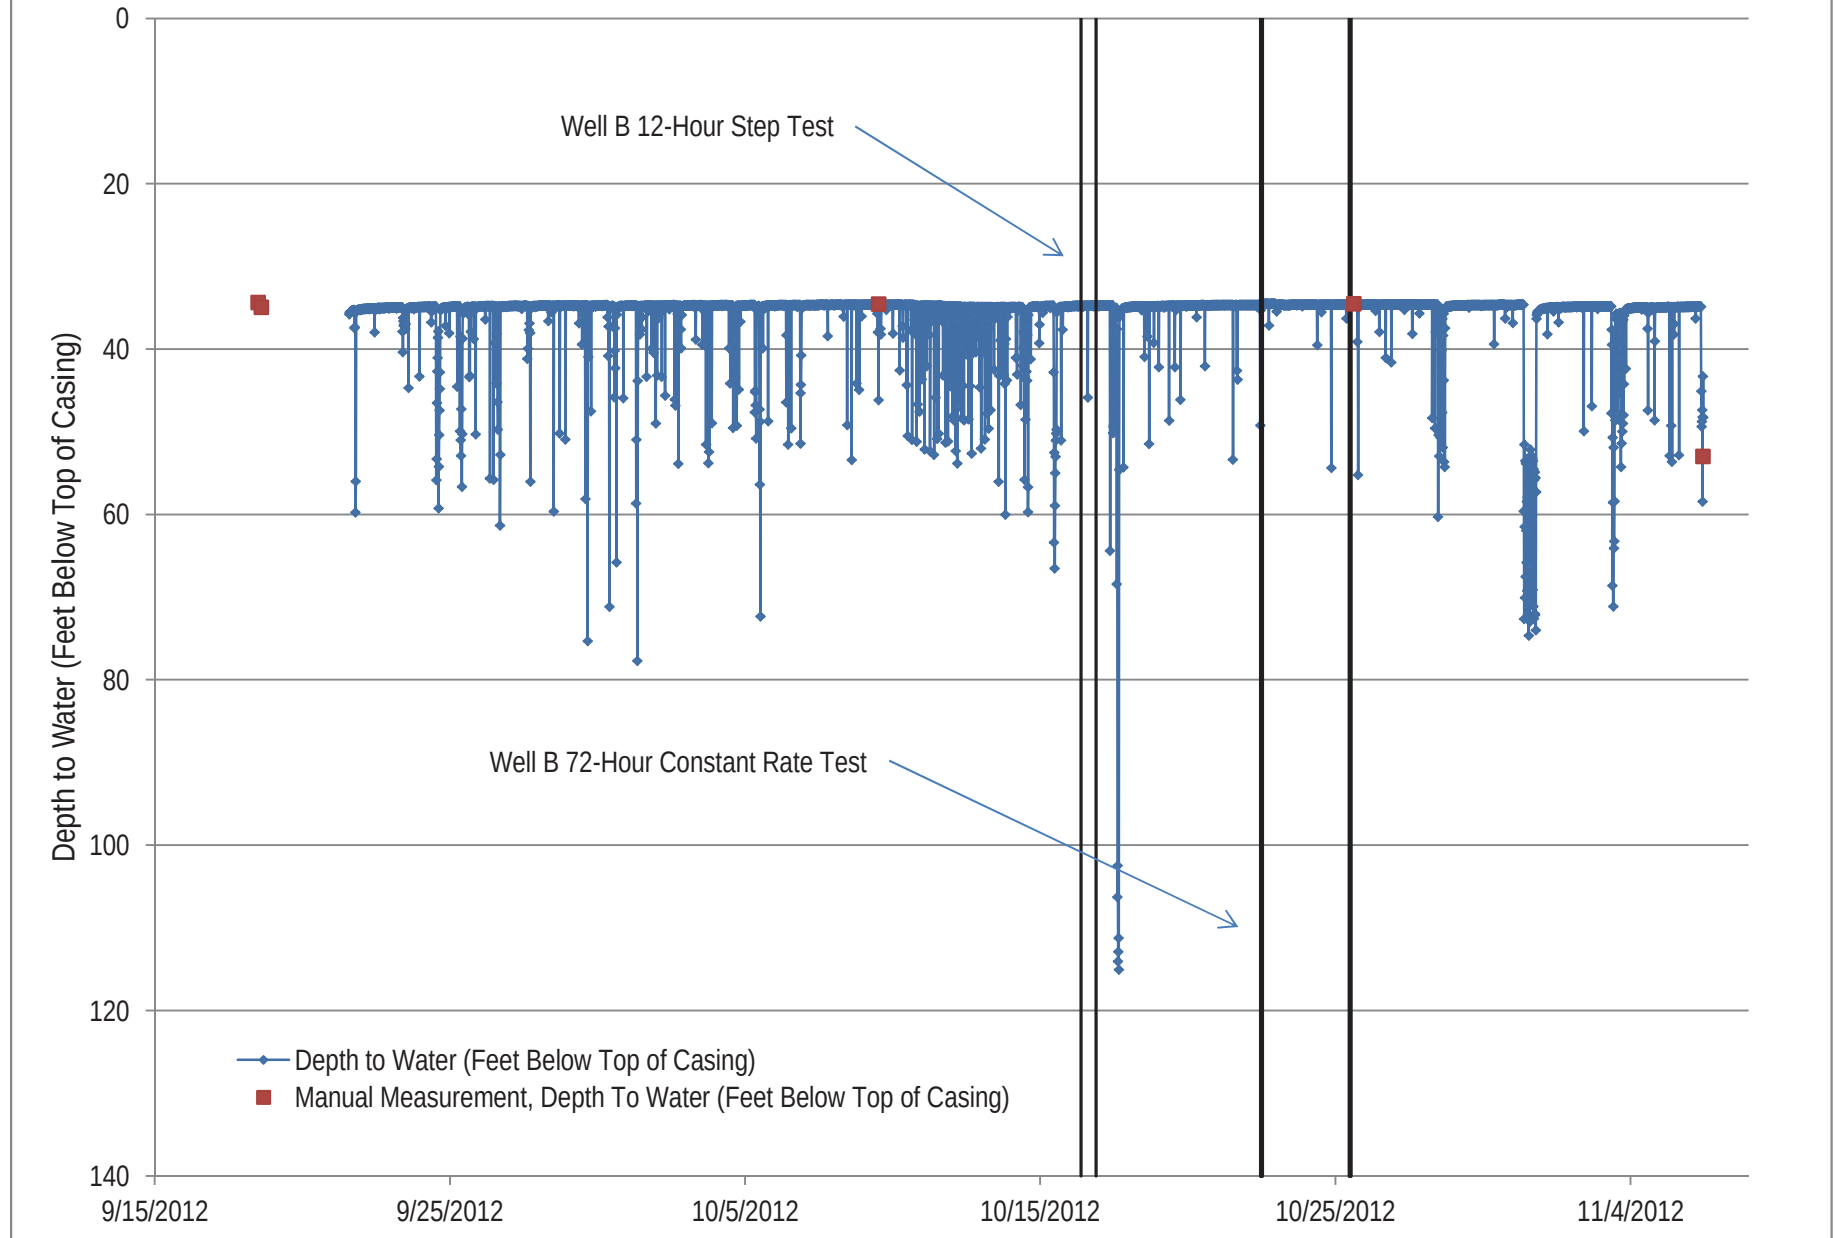
**Figure 25. Off-site Well RSD-1 Water Level Data**

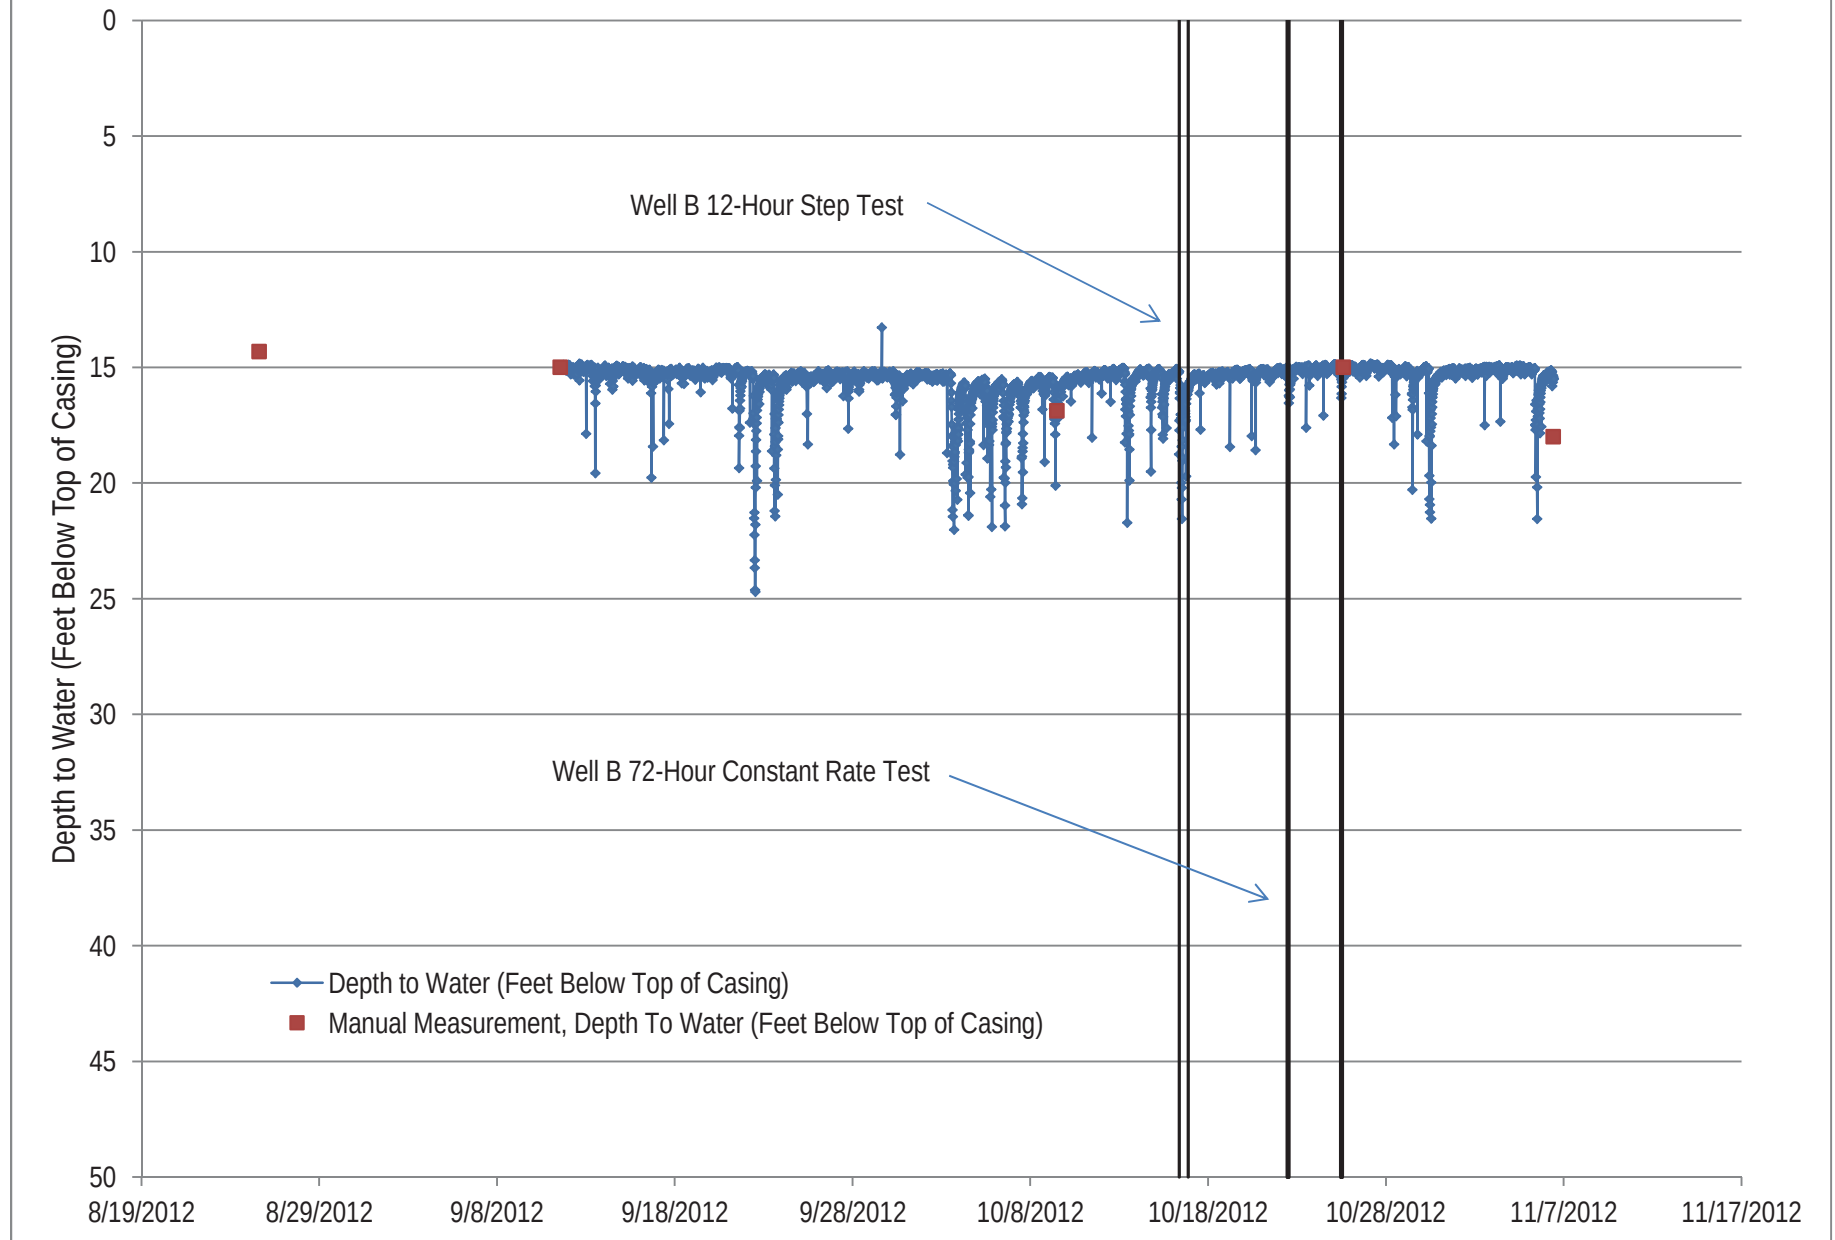
**Figure 26. Off-site Well RSH-1 Water Level Data**
