# Groundwater Resources Investigation Report Tierra del Sol Solar Farm Project

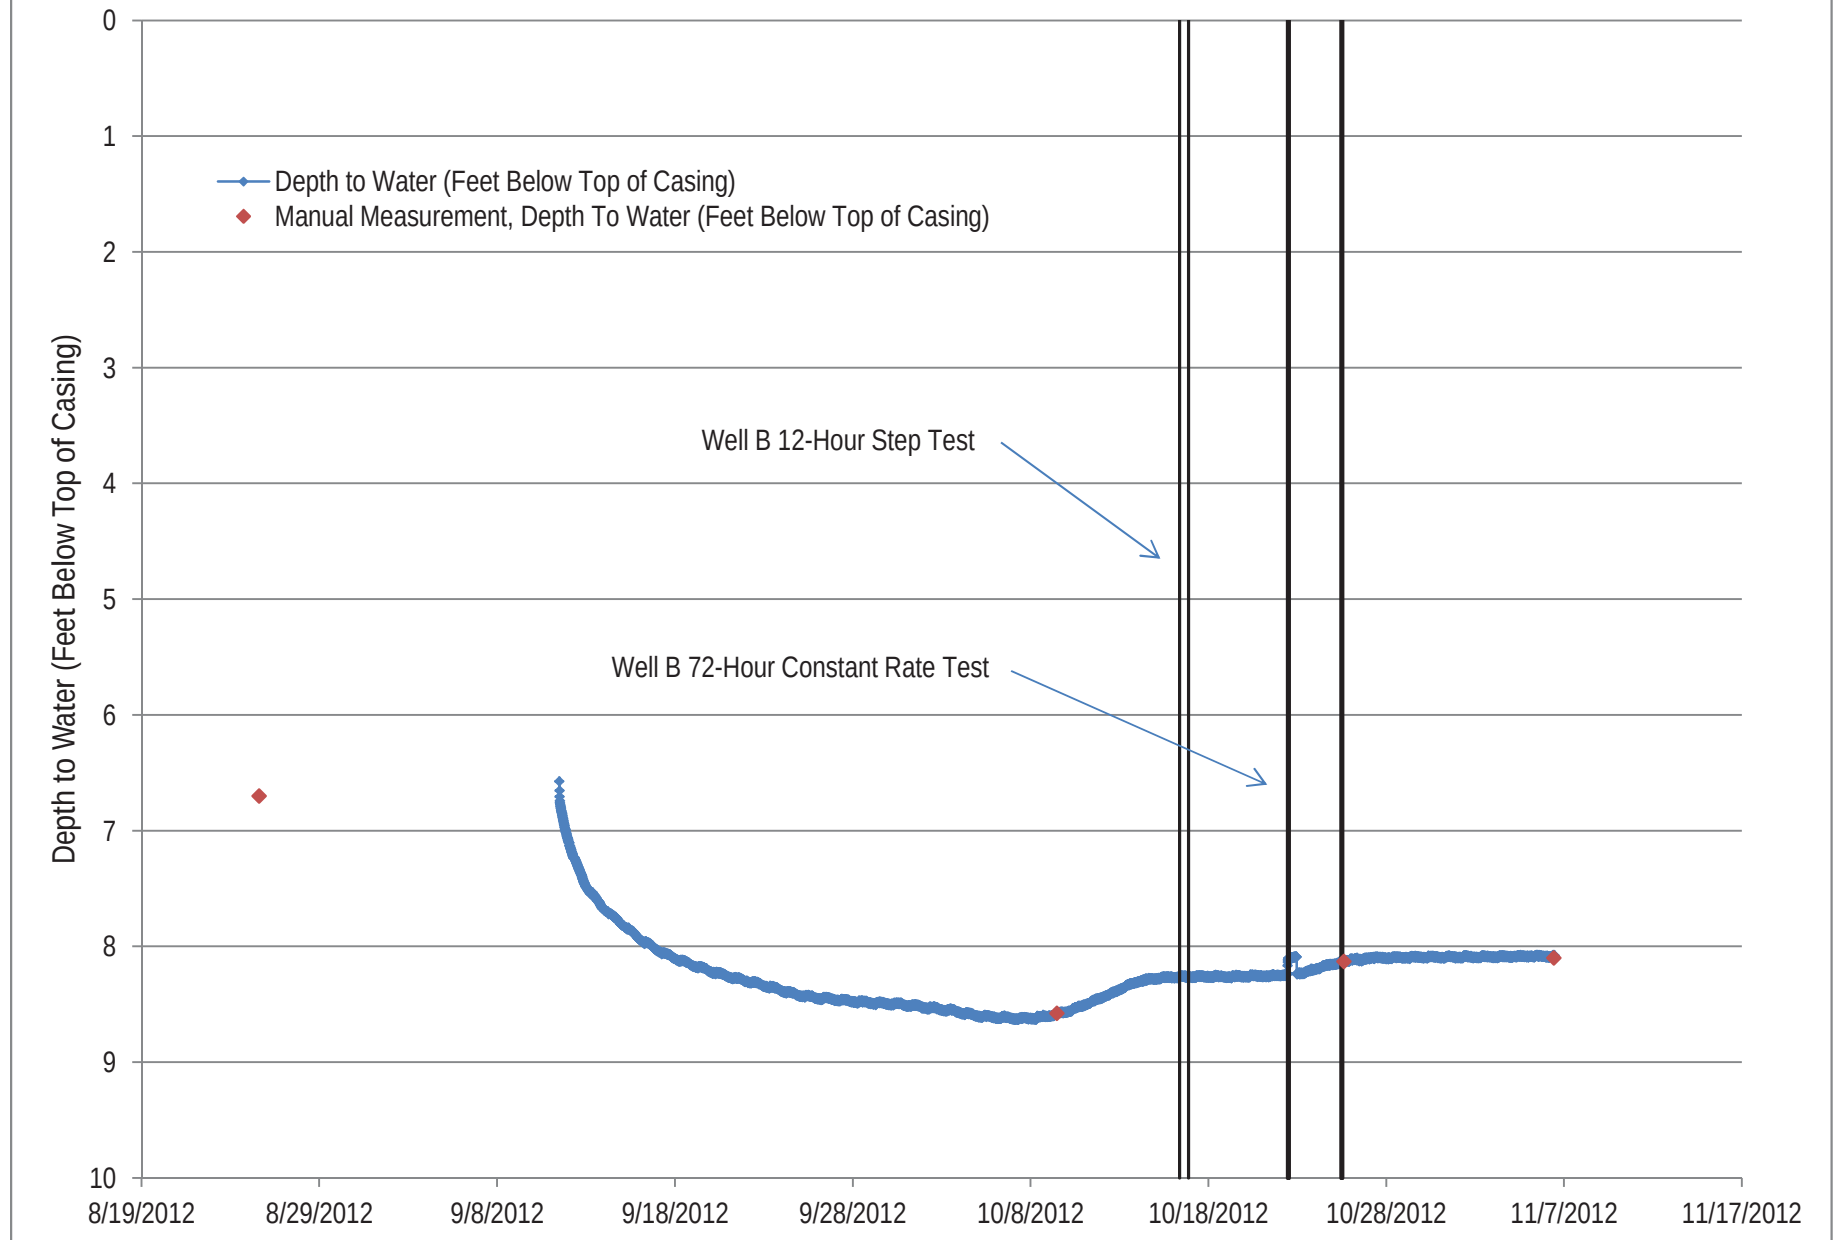
**Figure 27. Off-site Well RSH-2 Water Level Data**

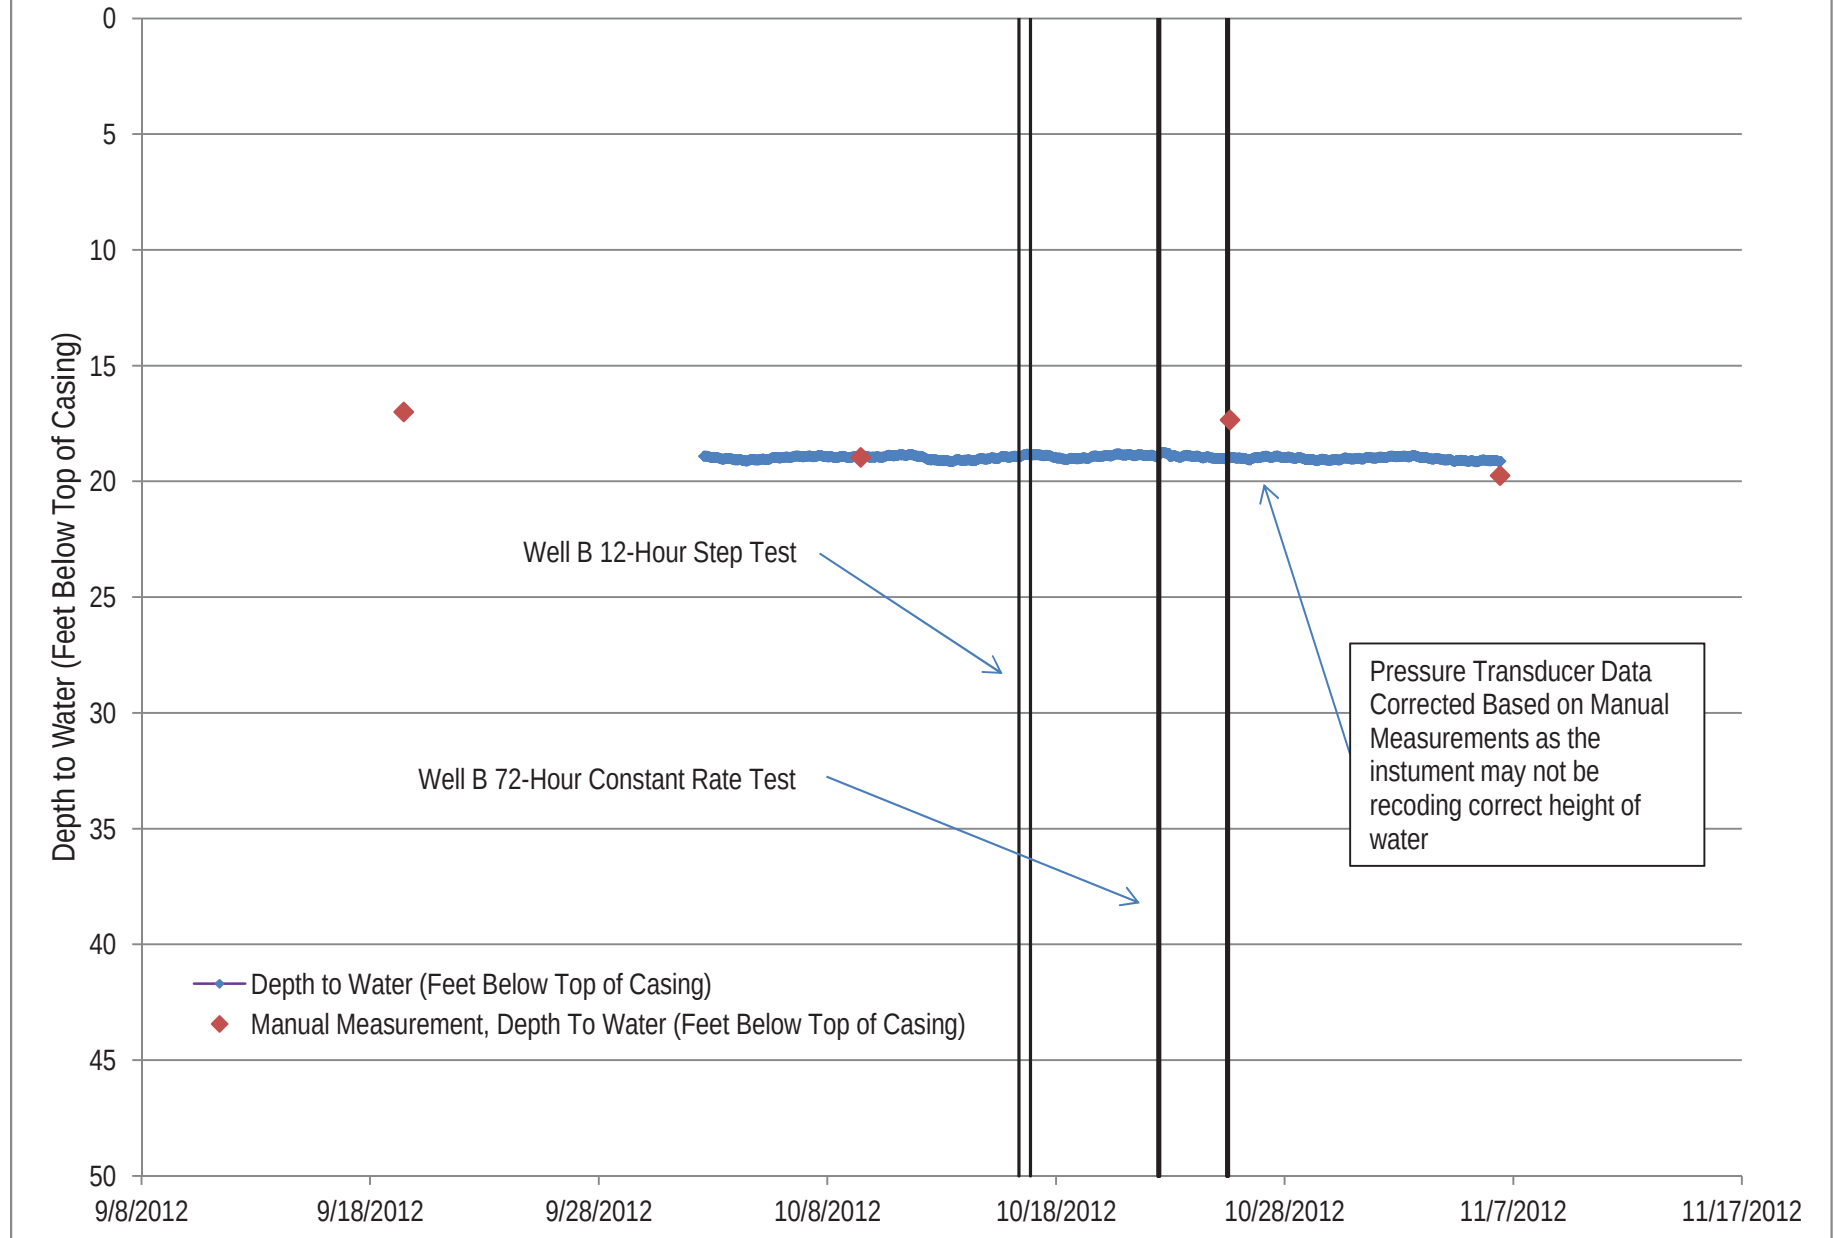
**Figure 28. Off-site Well RSH-3 Water Level Data**

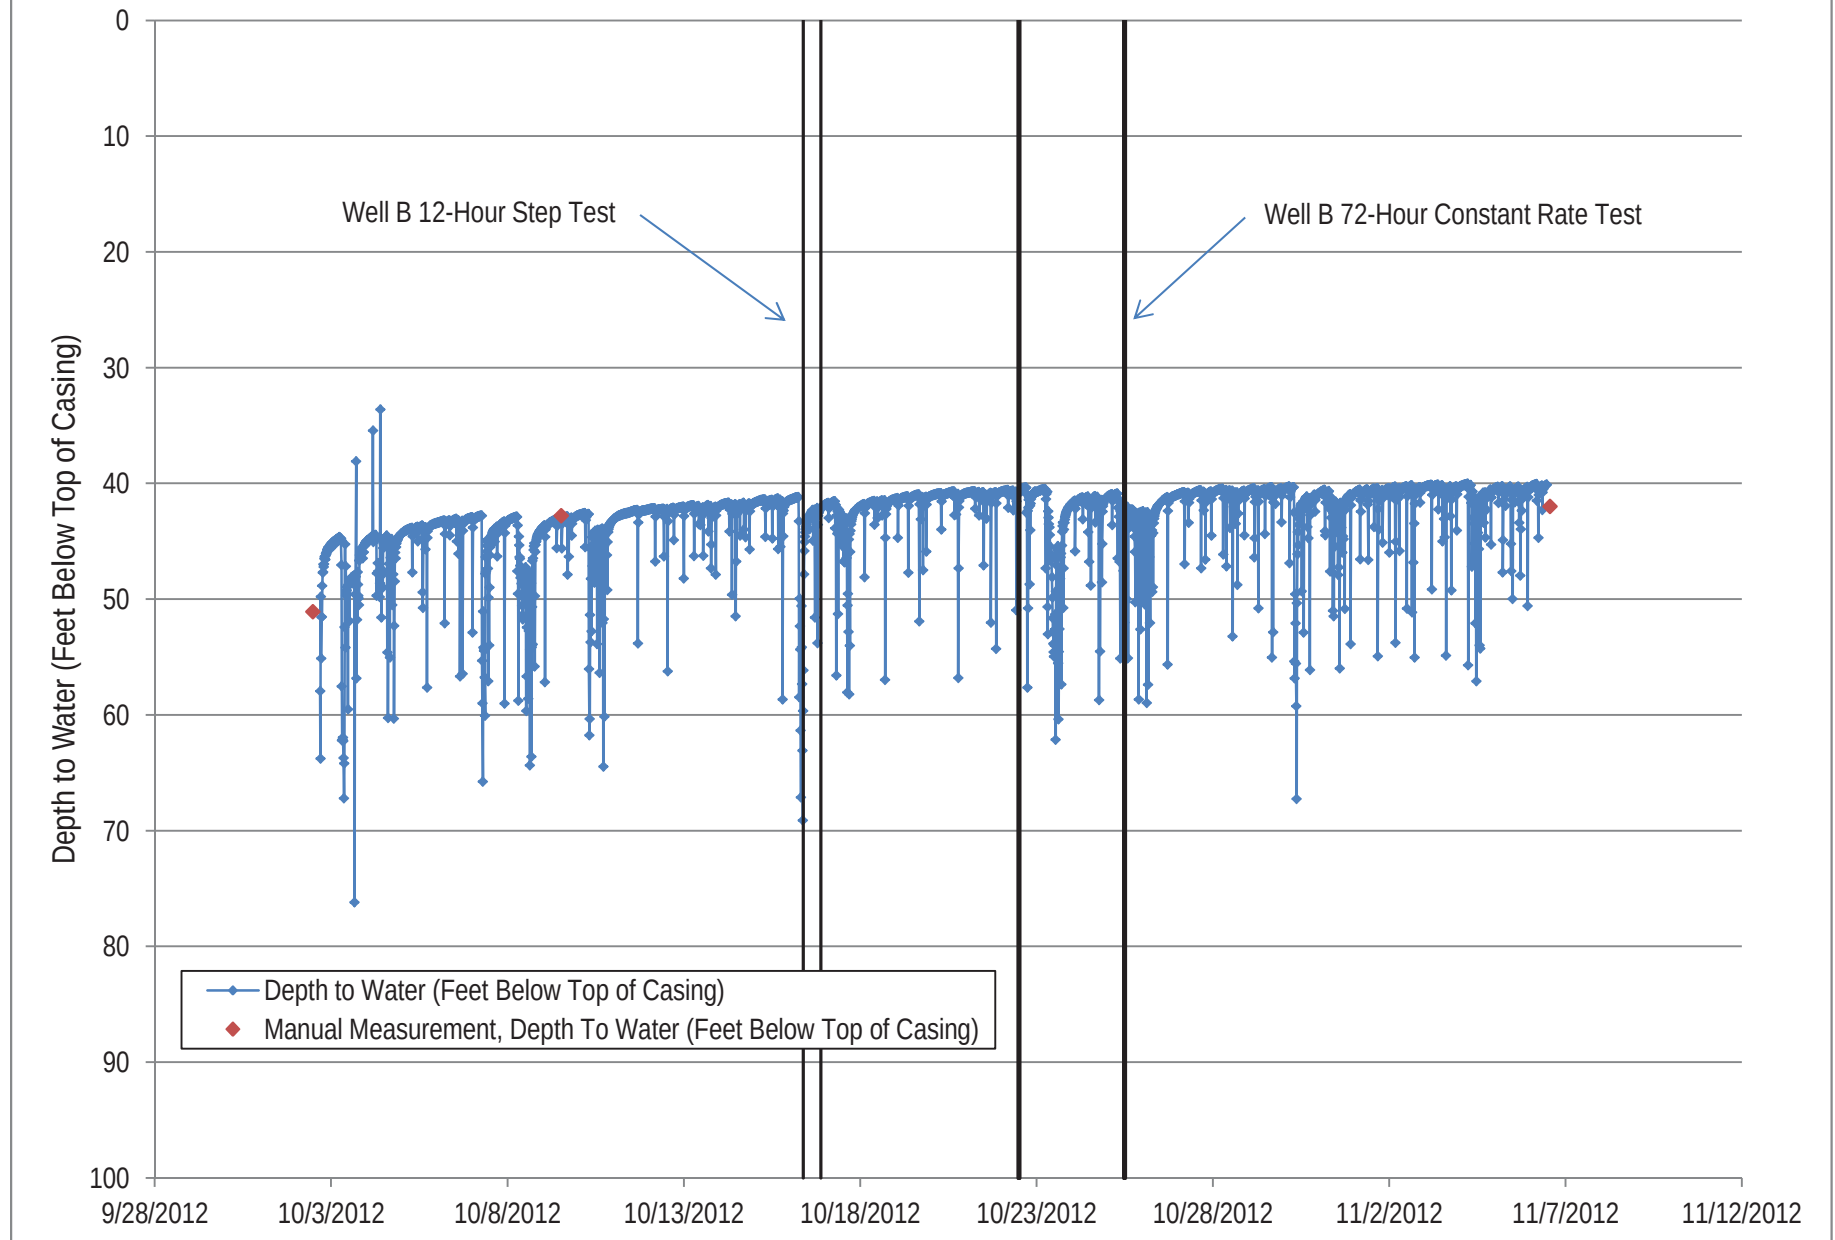
Figure 29. Off-site Well WHH-1 Water Level Data

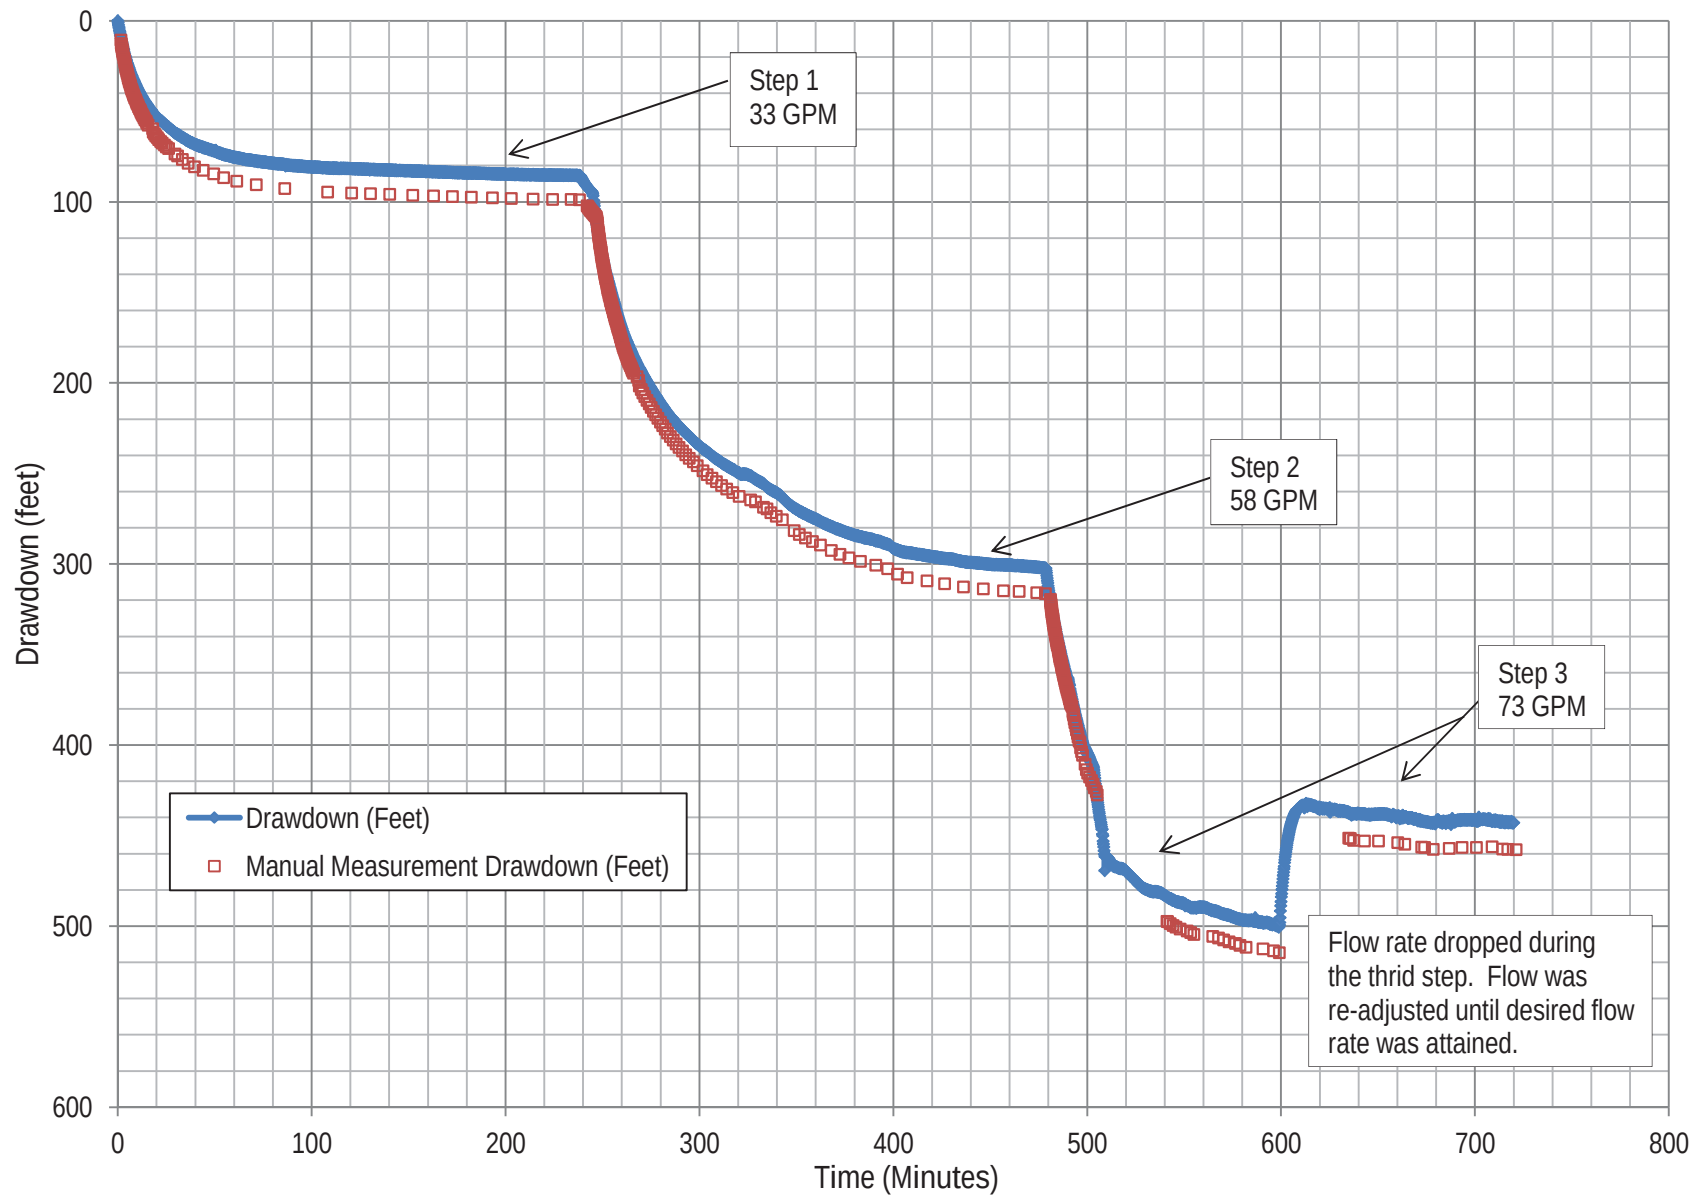
**Figure 30. Onsite Well B Step Test Water Level Drawdown**

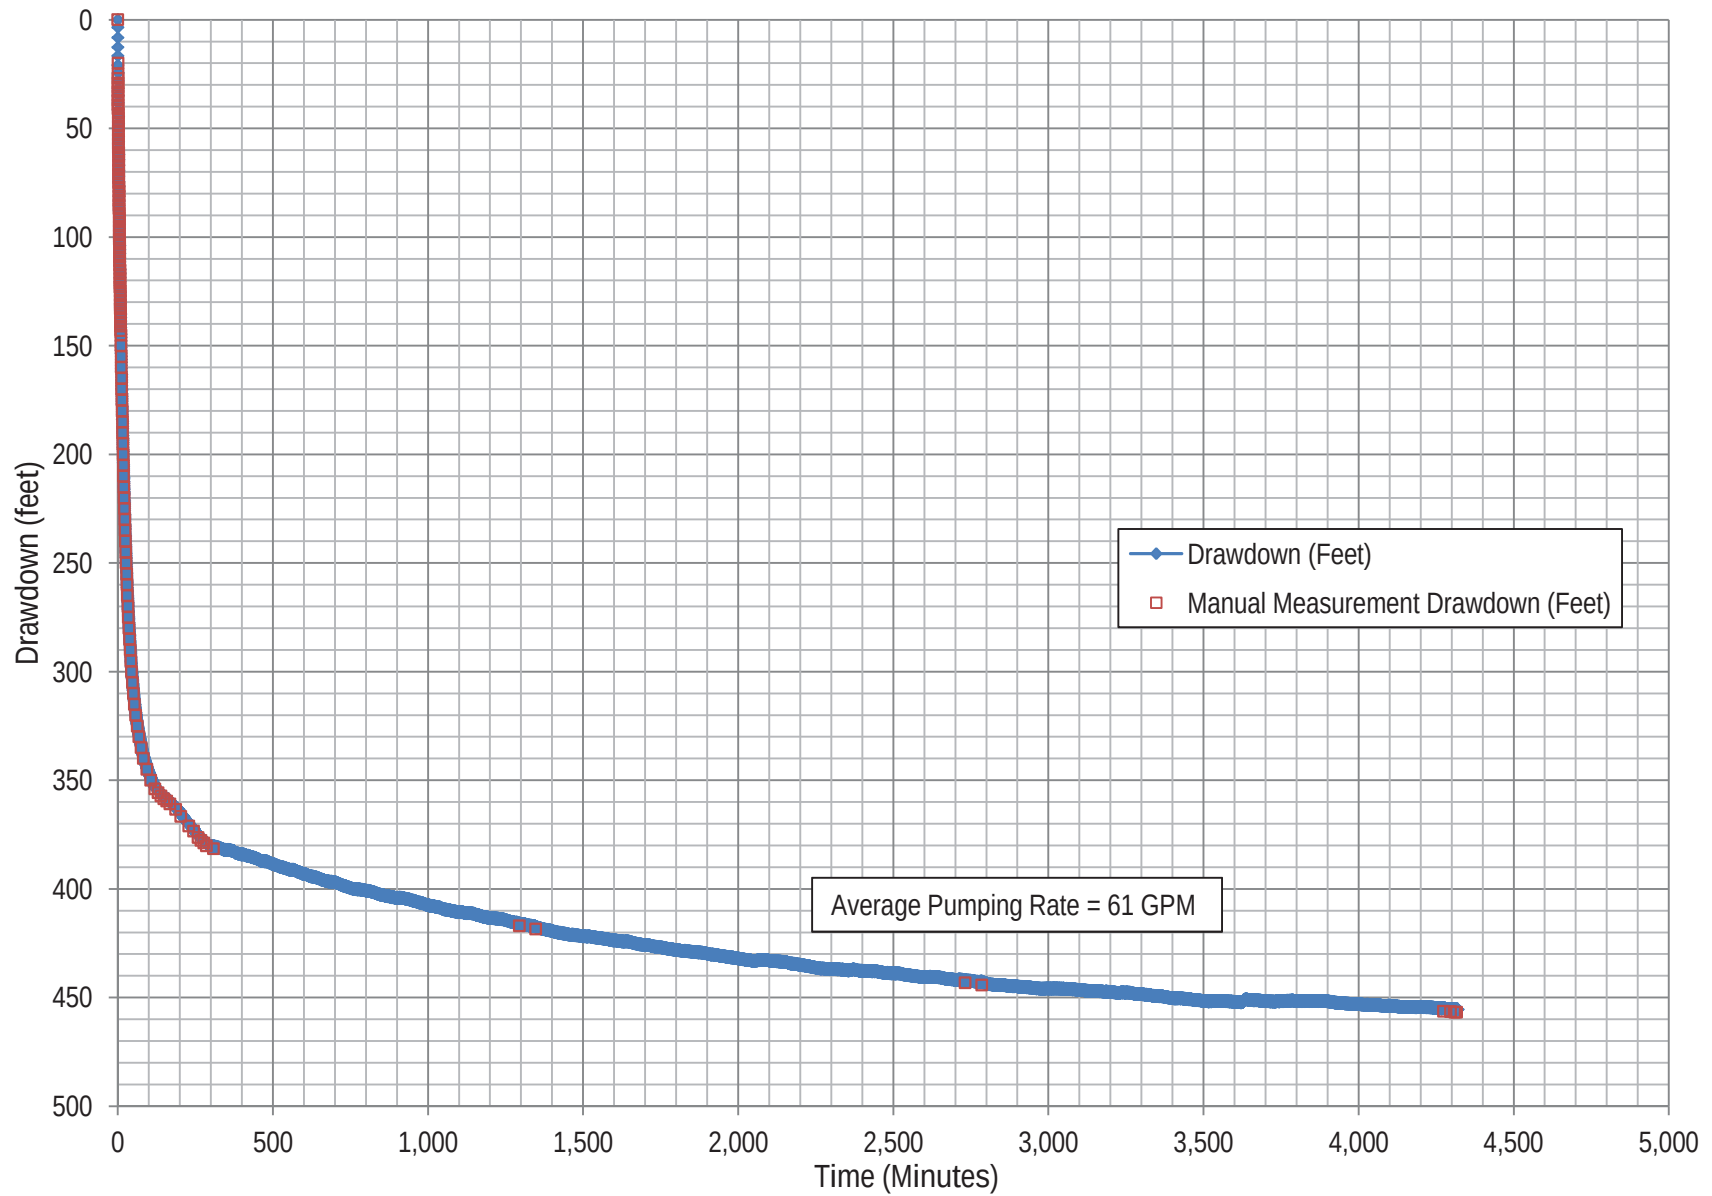
Figure 31. Onsite Well B Constant Rate Test Water Level Drawdown

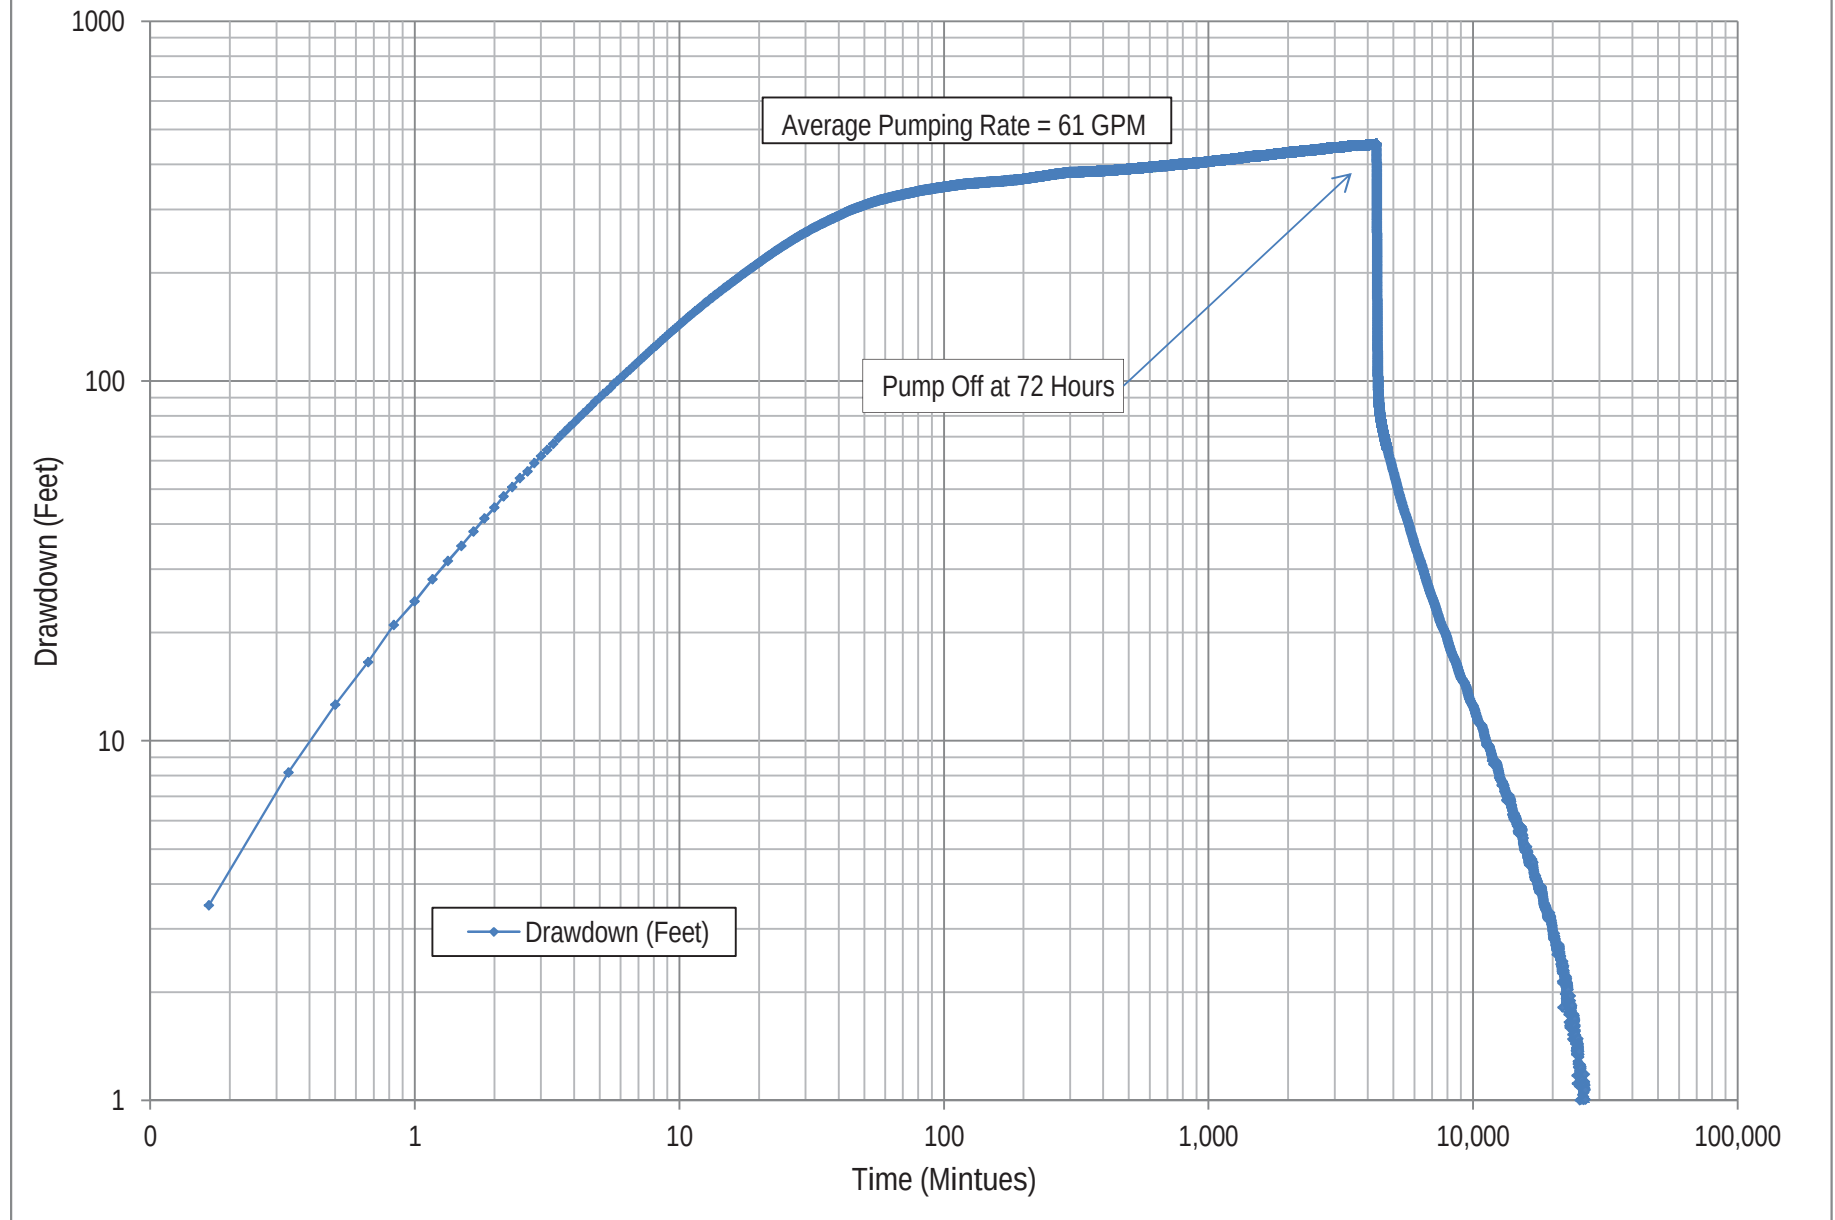
Figure 32. Onsite Well B Constant Rate Test Log Water Level Drawdown

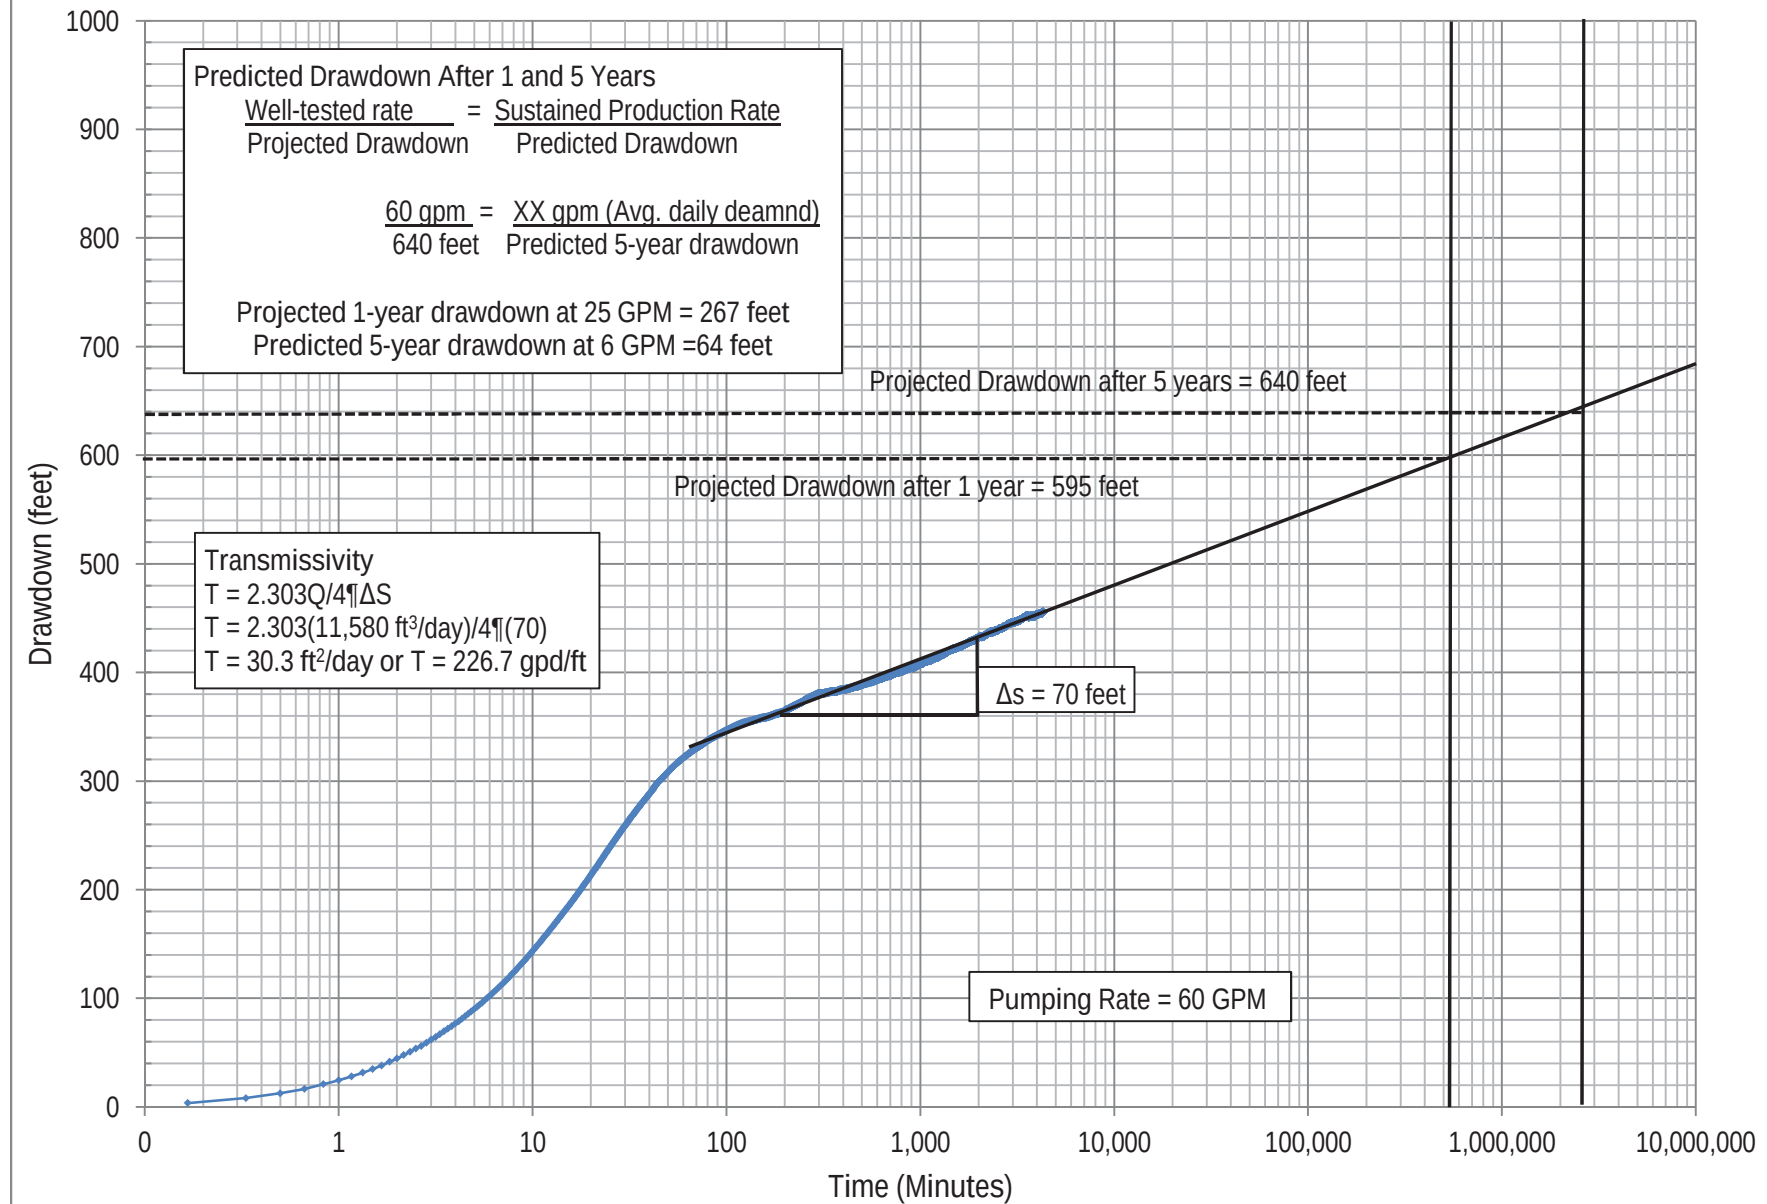
**Figure 33. Onsite Well B Constant Rate Test Jacob Straight Line Analysis**

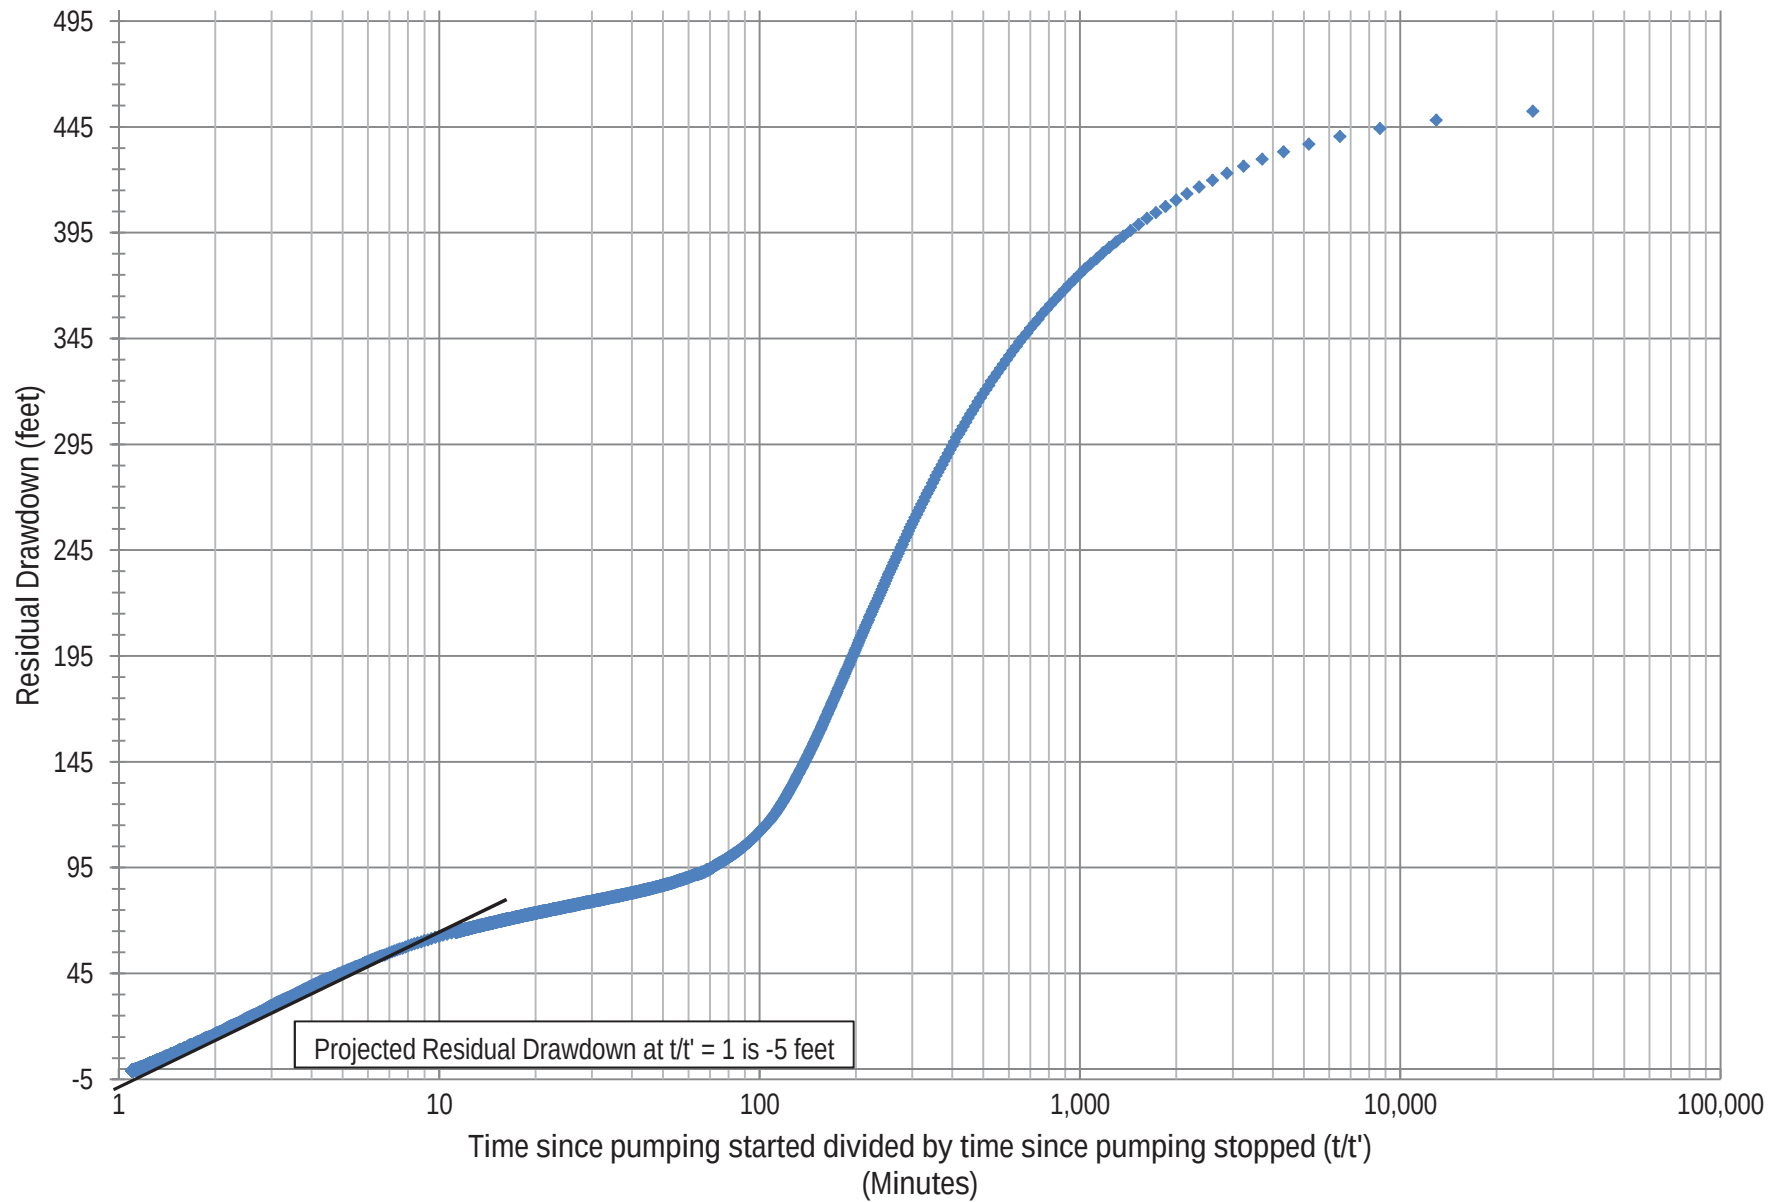
**Figure 34. Onsite Well B Constant Rate Test Recovery Analysis**
