## **APPENDIX C**

### **Datasheets**

**WETLAND DETERMINATION DATA FORM – Arid West Region**

Project/Site: Starlight Solar City/County: Boulevard/San Diego Sampling Date: 1/14/2022  
 Applicant/Owner: Empire II, LLC State: CA Sampling Point: SP05  
 Investigator(s): Luis Aguilar and Lauren Strong (SWCA) Section, Township, Range: S8, T18S, R7E  
 Landform (hillslope, terrace, etc.): Isolated Shallow Depression Local relief (concave, convex, none): Concave Slope (%): <1  
 Subregion (LRR): C Lat: 32.619912 Long: -116.282329 Datum: WGS-84  
 Soil Map Unit Name: Mottsville loamy coarse sand, 2 to 9 percent slopes (MvC) NWI classification: NA  
 Are climatic / hydrologic conditions on the site typical for this time of year? Yes ☒ No ☐ (If no, explain in Remarks.)  
 Are Vegetation ☒, Soil ☐, or Hydrology ☐ significantly disturbed? Are "Normal Circumstances" present? Yes ☒ No ☐  
 Are Vegetation ☐, Soil ☐, or Hydrology ☐ naturally problematic? (If needed, explain any answers in Remarks.)

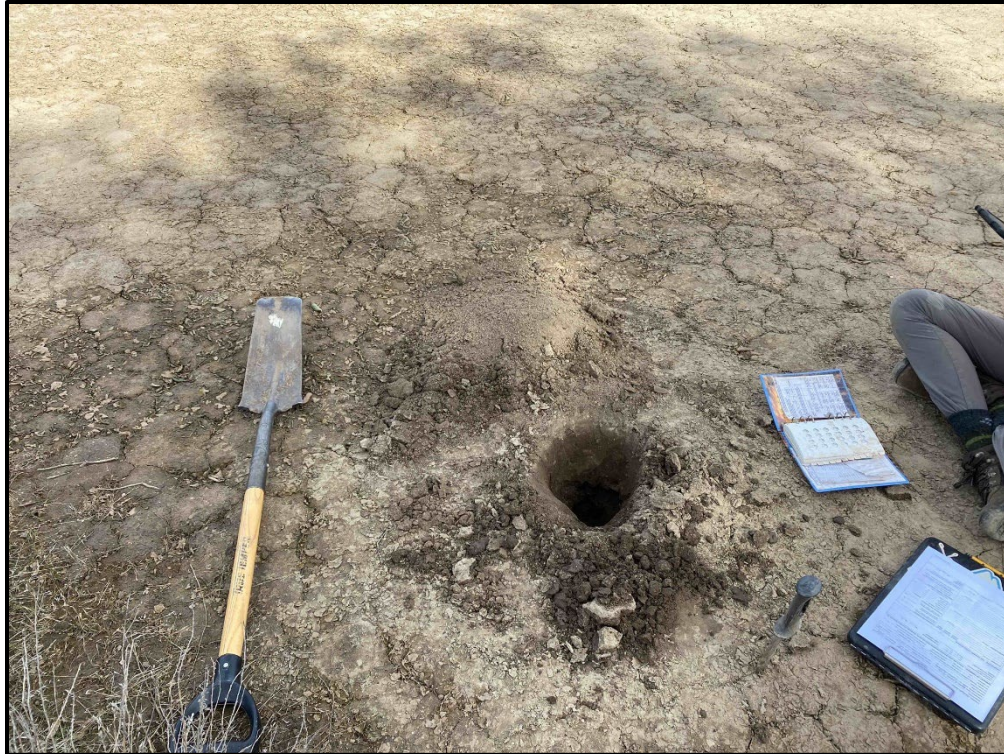
**Photograph B57. SP04 examined within isolated unvegetated area. Surface hydrology indicators were observed; however, hydric soils were not present, and the area was determined to lack potentially regulated aquatic resources.**

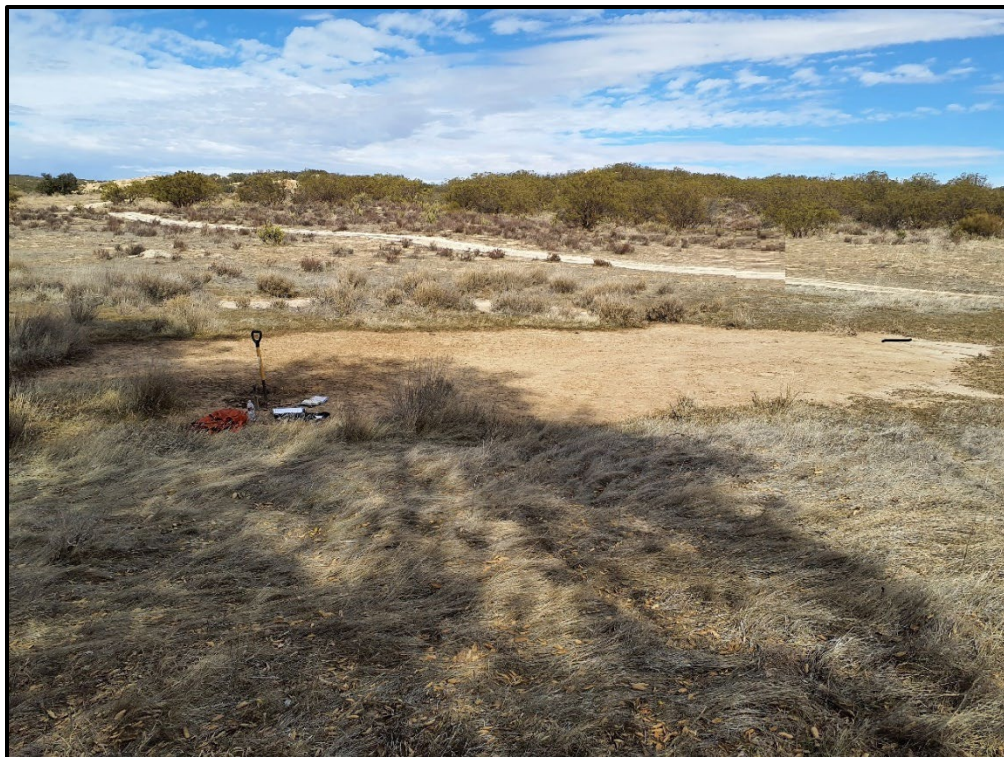
**Photograph B58. SP04 overview, facing northeast.**

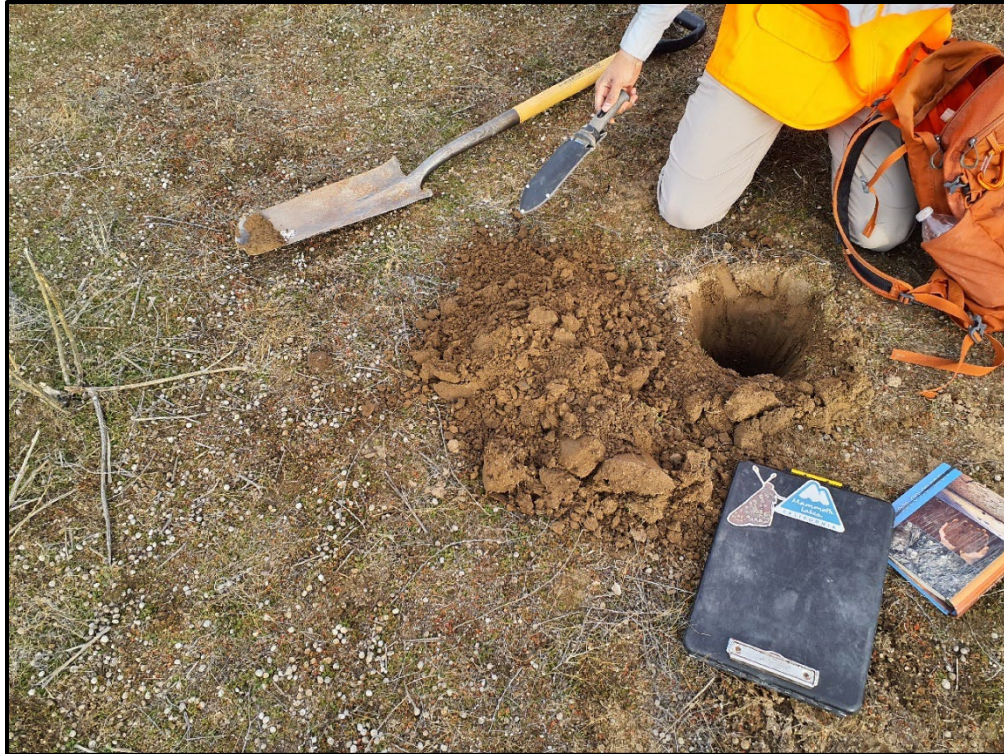
**Photograph B59. SP05 examined within isolated depression for potential wetland indicators. No indicators observed. Area determined to lack potentially regulated aquatic resources.**

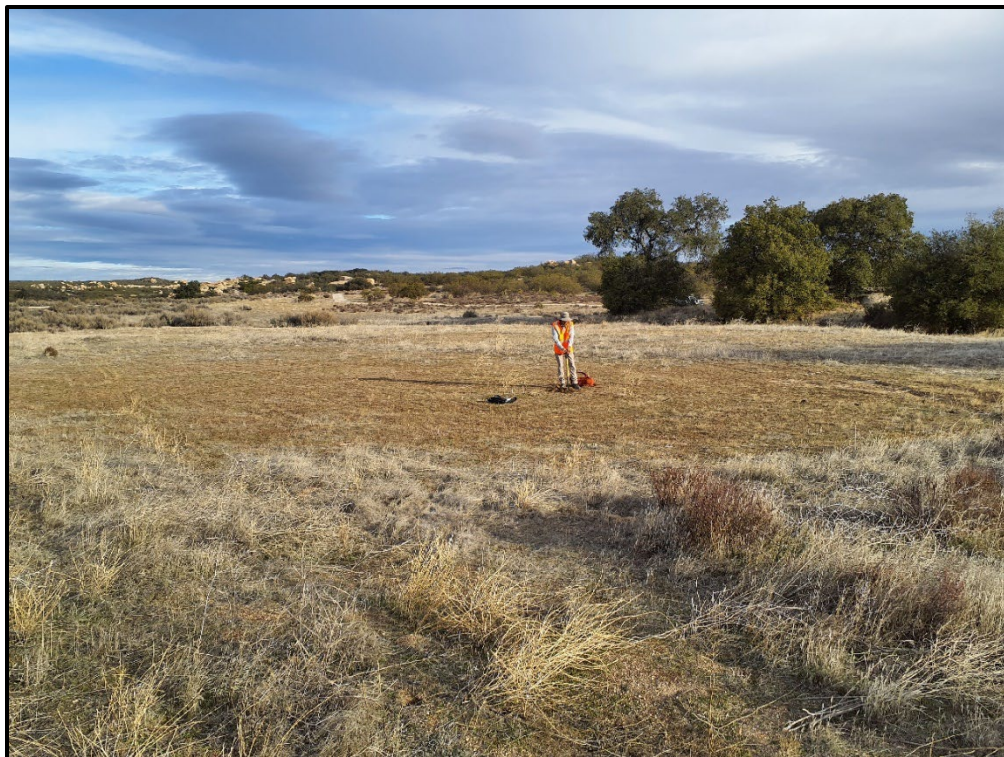
**Photograph B60. SP05 overview, facing northeast.**

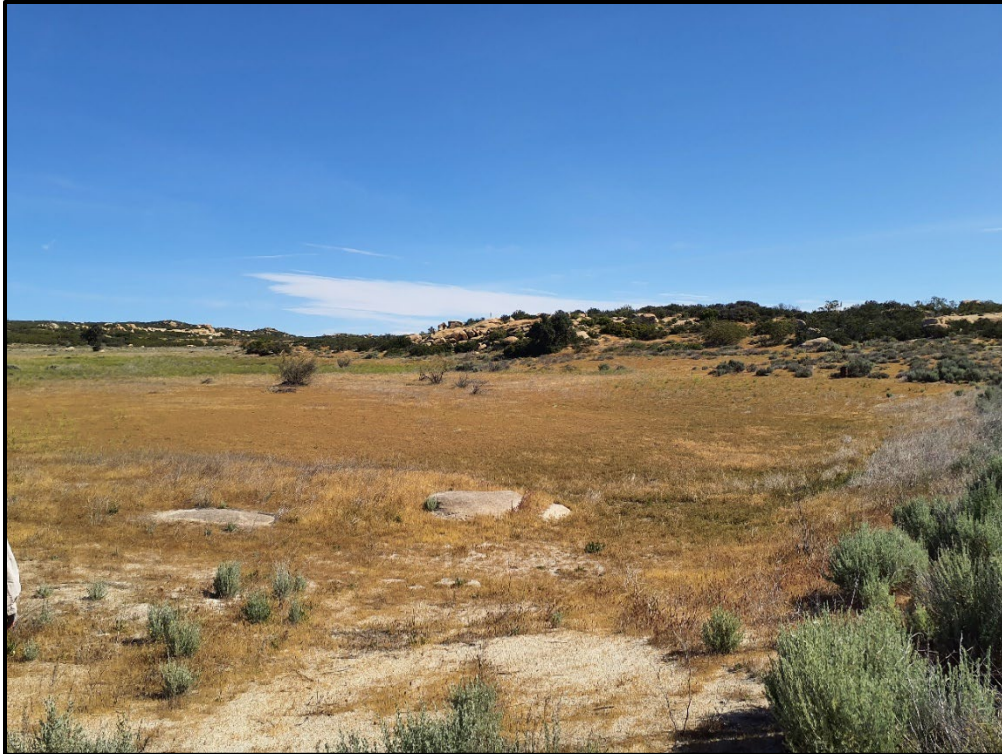
**Photograph B61. FP01 overview. View facing north–northeast, captured during other biological surveys on May 10, 2022.**

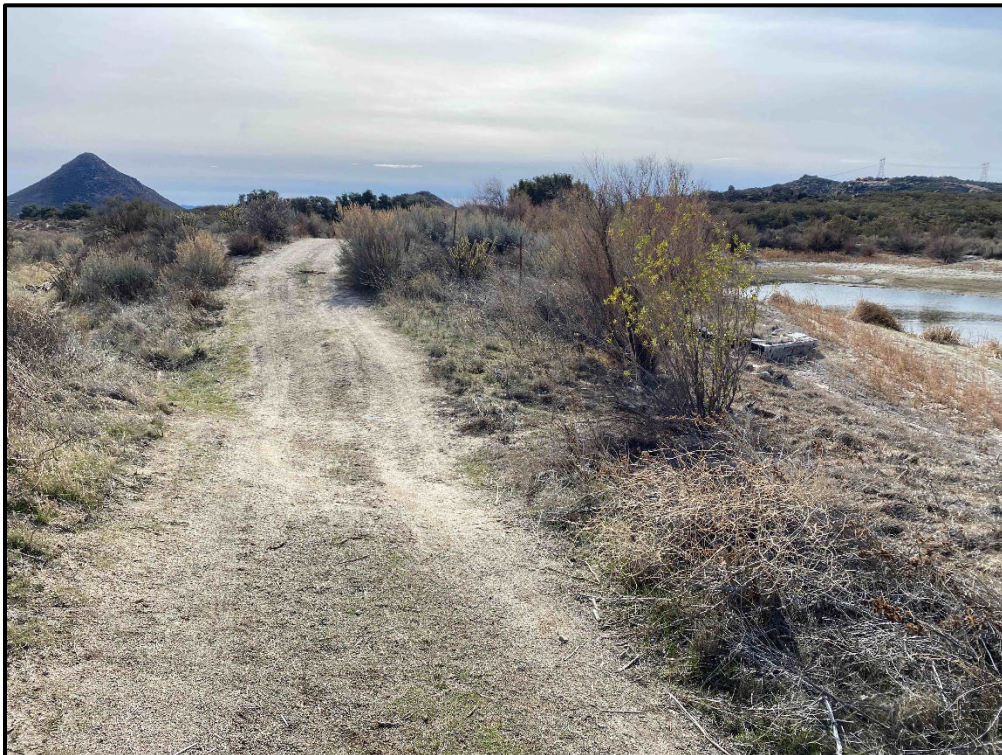
**Photograph B62. FP02 (right) and start of S64 as it conveys flow across the dirt access road in overflow periods. Flow is conveyed to left of image when flowing. View facing south–southeast.**

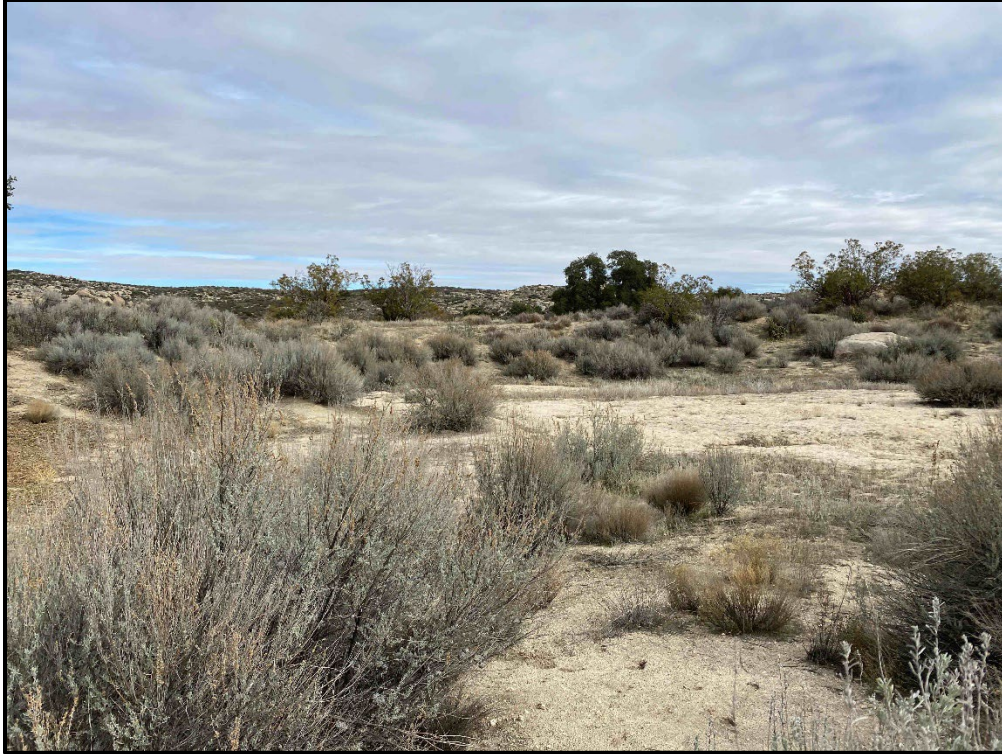
**Photograph B63. FP03 functioning as sedimentation basin without hydrologic outlet. Feature lacks hydrologic output. View facing northeast.**

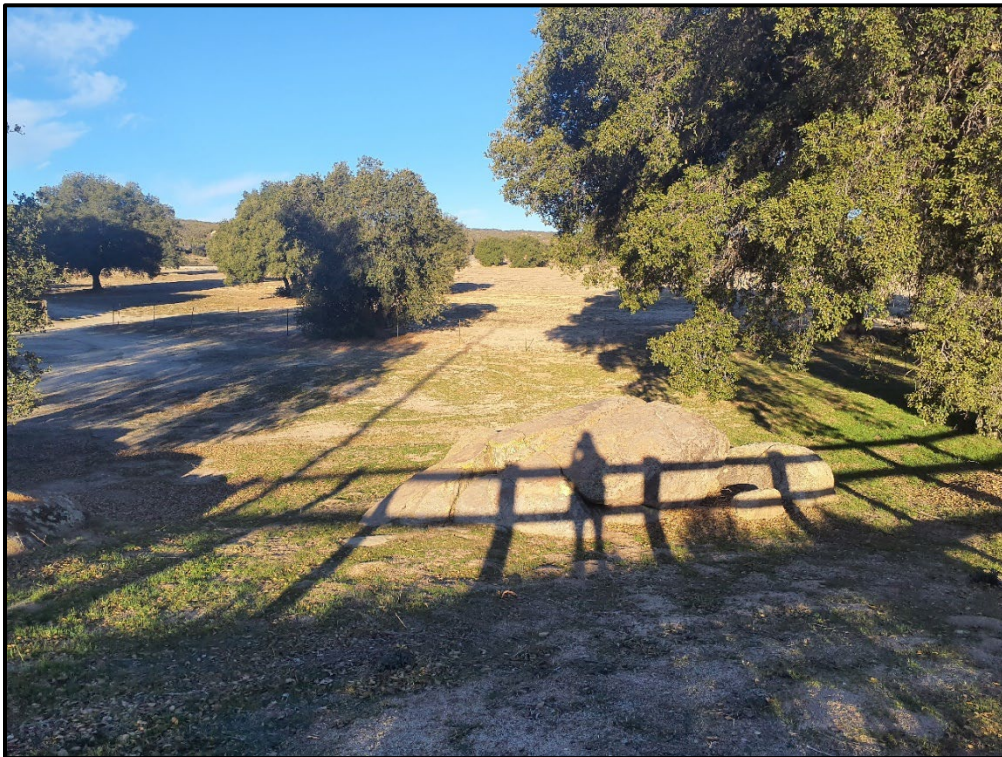
**Photograph B64. NWI-mapped Boundary Creek. No hydrology indicators. View facing west.**

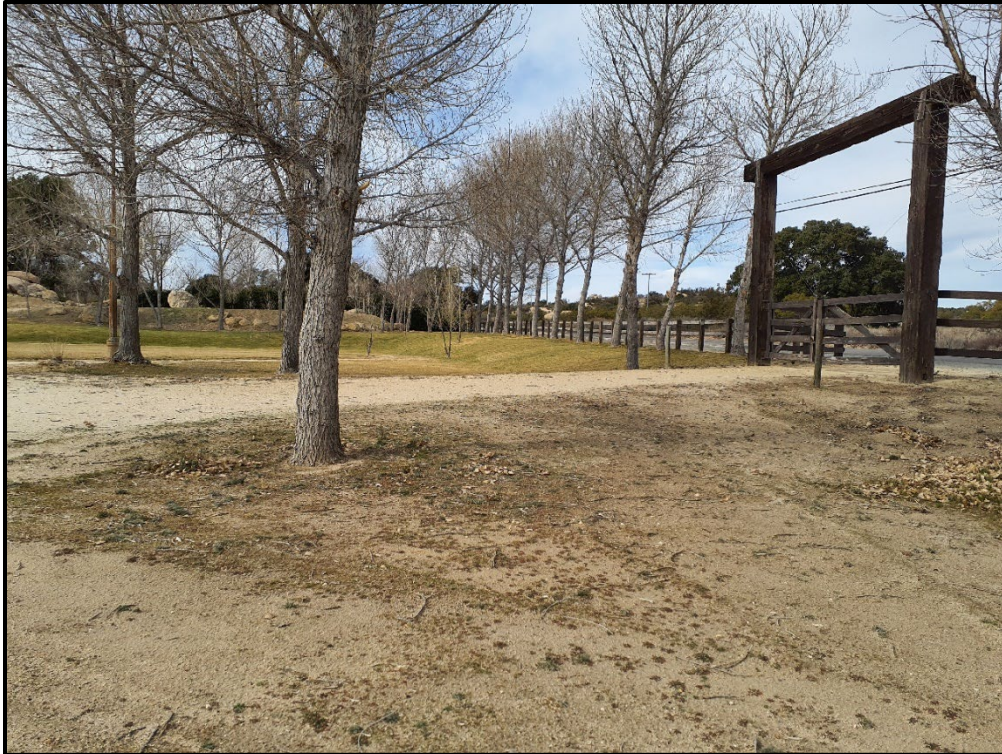
**Photograph B65. NWI-mapped Boundary Creek. No hydrology indicators.  
View facing northwest.**

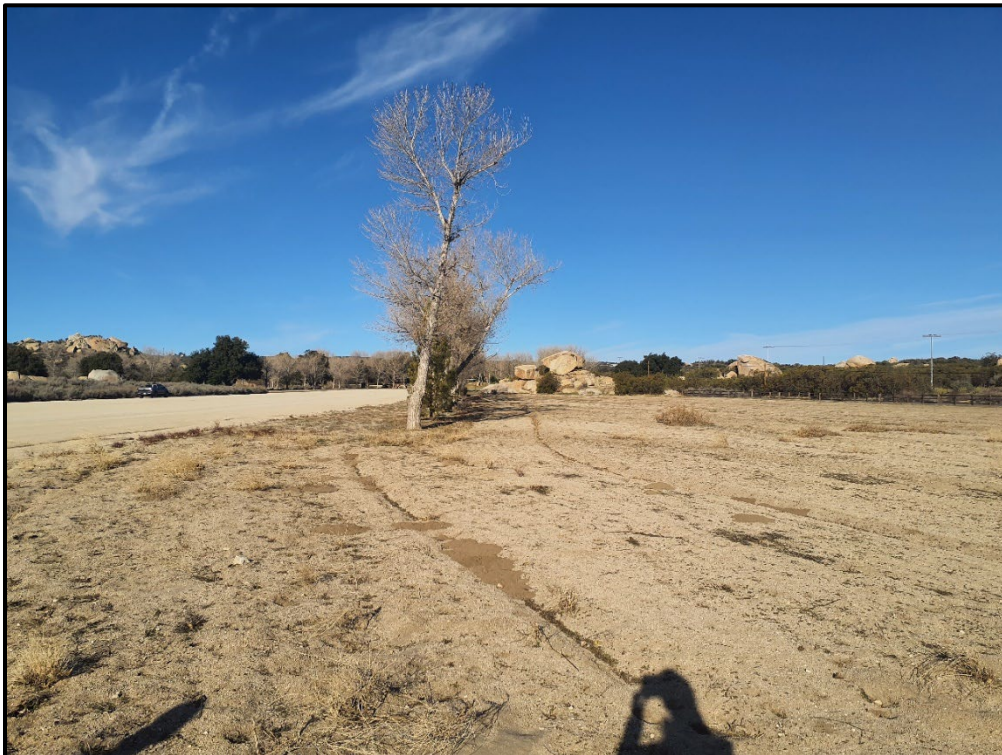
**Photograph B66. NWI-mapped Boundary Creek. No hydrology indicators.  
View facing west-northwest.**

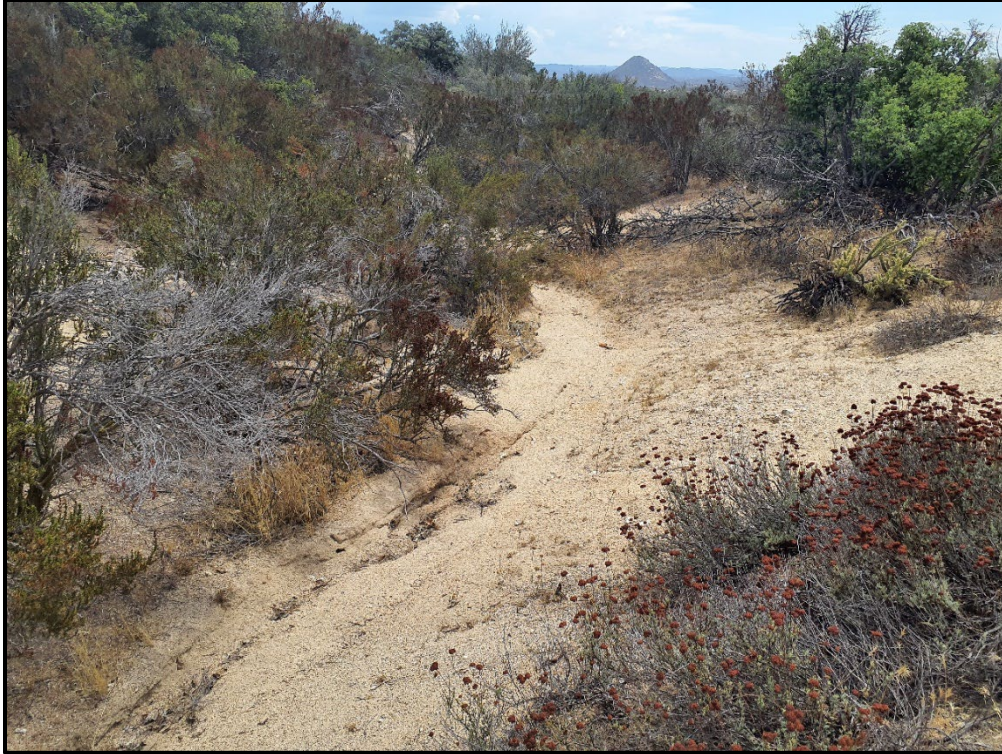
**Photograph B67. Feature 68, view facing south/downstream.**

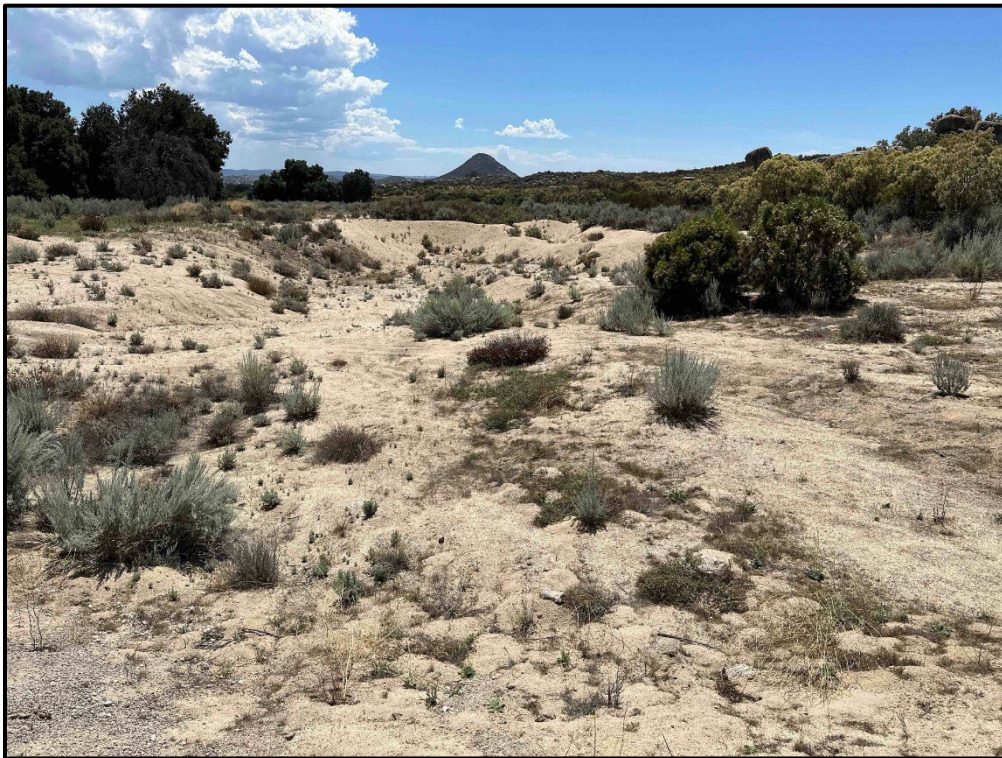
**Photograph B68. Freshwater Pond 08. Not an NWI-mapped feature. View facing southeast/downslope.**

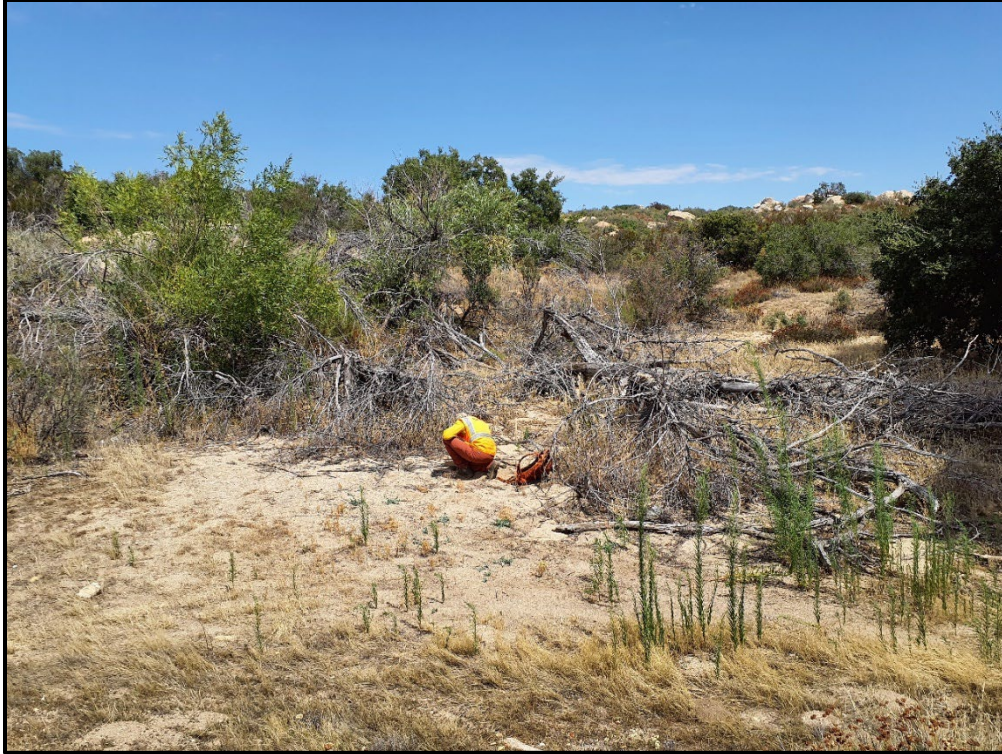
**Photograph B69. Wetland determination sampling plot 06. Delineator examining the wetland determination sampling plot. View facing north/upslope.**

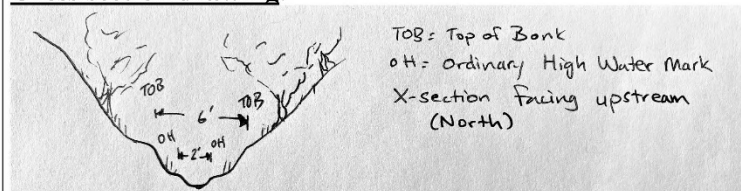
**Cross section drawing:**

**OHWM**

| <input checked="" type="checkbox"/> Change in average sediment texture | <input checked="" type="checkbox"/> Break in bank slope |
| <input checked="" type="checkbox"/> Change in vegetation cover | <input type="checkbox"/> Other: _____ |

Unvegetated with granule texture.

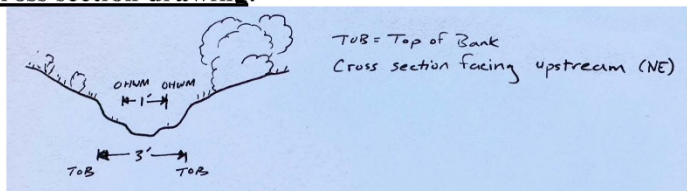
**Cross section drawing:**

**OHWM**

| <input checked="" type="checkbox"/> Change in average sediment texture | <input checked="" type="checkbox"/> Break in bank slope |
| <input checked="" type="checkbox"/> Change in vegetation cover | <input type="checkbox"/> Other: _____ |

Unvegetated with granule texture.
