# **PRELIMINARY GEOTECHNICAL SITE EVALUATION REPORT**

**Prepared For  
The AES Corporation**

**Proposed  
Starlight Solar Project  
Sand Diego County, California**

**Job No: 22-137  
June 20, 2022**

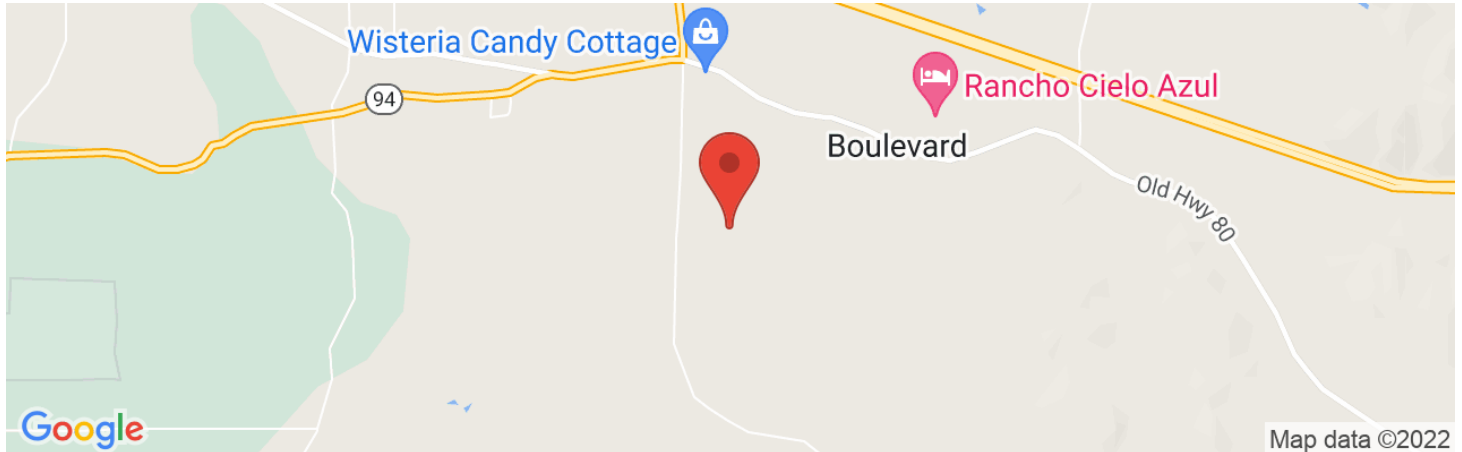
## 22-137 AES Starlight Solar

Latitude, Longitude: 32.658339, -116.286564

| <b>Date</b> | 6/13/2022, 1:31:09 PM |
| <b>Design Code Reference Document</b> | ASCE7-16 |
