This Preliminary Geotechnical Evaluation report presents the results of the limited geotechnical investigation performed by Bruin Geotechnical Services, Inc., for the potential Photovoltaic Generation or Battery Storage Facility based on the assessor's parcel maps and the Site Plan (google KMZ file) provided by the client. This report is specific to the potential developments and is intended to provide preliminary information to aid in determining if driven piles and/or conventional concrete foundations are feasible at the subject site.

AES-Starlight – San Diego County, CA

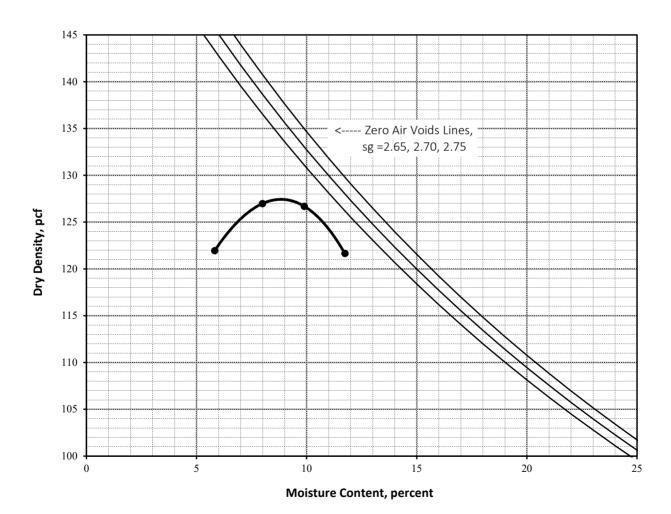
Description: (SP/SM) Moderate brown slightly silty fine to medium sand w/ coarse sand & occ #4-1/2" grav

Maximum Density: 127.5 pcf
Optimum Moisture: 9%

#### Maximum Density/Optimum Moisture Proctor ASTM D698/D1557

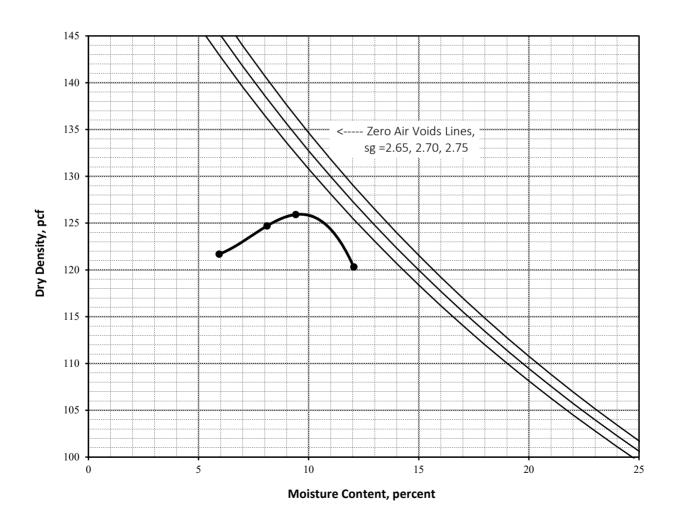
Description: (SP/SM) Brown slightly silty fine to medium sand w/ coarse sand

Maximum Density: 126 pcf
Optimum Moisture: 9.5%

#### Maximum Density/Optimum Moisture Proctor ASTM D698/D1557

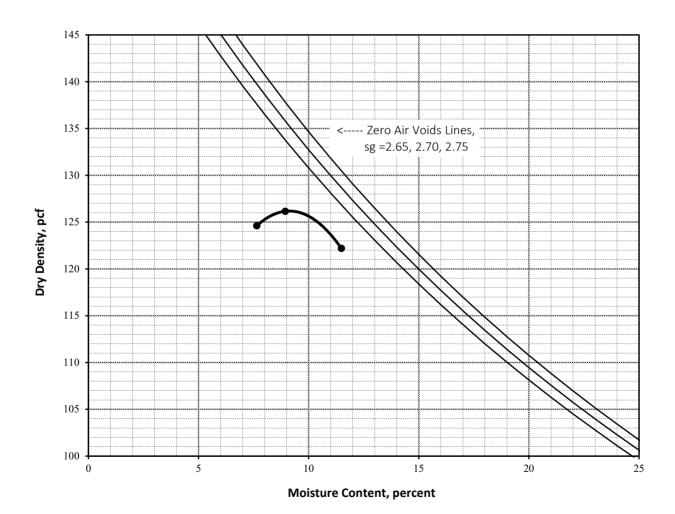
Description: (SP) Light brown slightly silty medium to coarse sand w/ fine sand & occ #4-1/2" gravel

Maximum Density: 126 pcf
Optimum Moisture: 9%

#### Maximum Density/Optimum Moisture Proctor ASTM D698/D1557

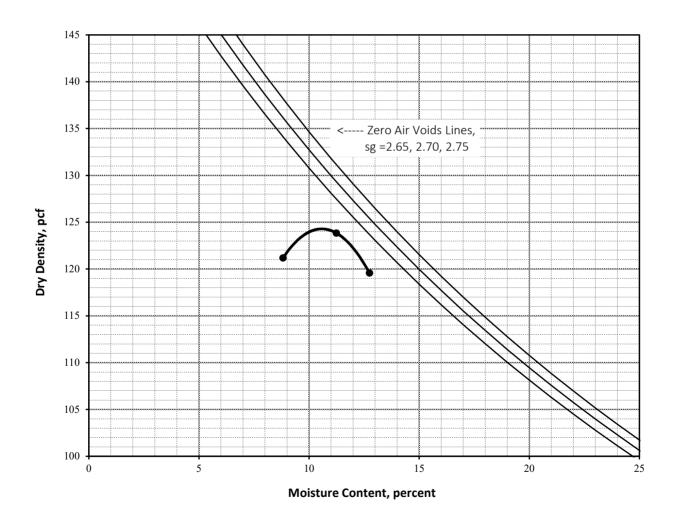
Description: (SP) Light brown slightly silty medium to coarse sand w/ fine sand & occ #4-1/2" gravel

Maximum Density: 124.5 pcf
Optimum Moisture: 10.5%

#### Maximum Density/Optimum Moisture Proctor ASTM D698/D1557

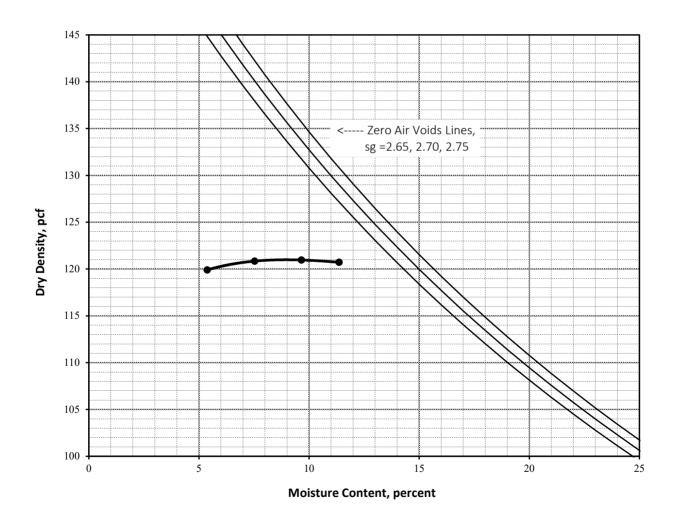
Description: (SP) Moderate brown slightly silty fine to medium sand w/ coarse sand & occ #4 gravel

Maximum Density: 121 pcf
Optimum Moisture: 9.5%

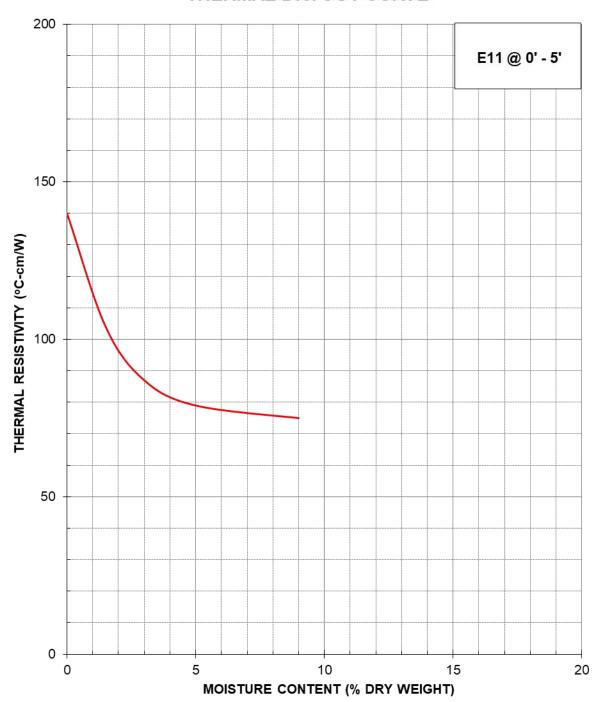
#### THERMAL DRYOUT CURVE

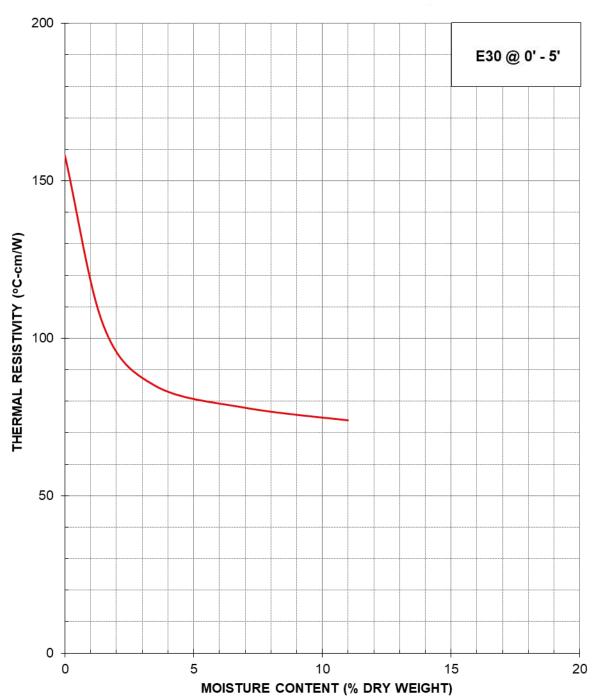
#### THERMAL DRYOUT CURVE

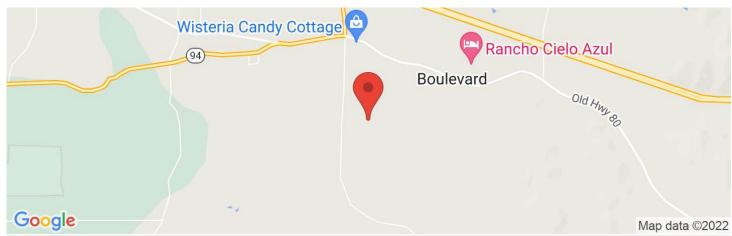
Date	6/13/2022, 1:31:09 PM			
Design Code Reference Document	ASCE7-16			
Risk Category	1			
Site Class	D - Stiff Soil

Туре	Value	Description
S <sub>S</sub>	1.061	MCE <sub>R</sub> ground motion. (for 0.2 second period)
S <sub>1</sub>	0.358	MCE <sub>R</sub> ground motion. (for 1.0s period)
S <sub>MS</sub>	1.142	Site-modified spectral acceleration value
S <sub>M1</sub>	null -See Section 11.4.8	Site-modified spectral acceleration value
S <sub>DS</sub>	0.761	Numeric seismic design value at 0.2 second SA
S <sub>D1</sub>	null -See Section 11.4.8	Numeric seismic design value at 1.0 second SA
