**Subject: Biological Resources Letter Report for the Vista II Residential Project (PDS2022-MPA-22-008)**

Regional Location  
Vista II Residential Project

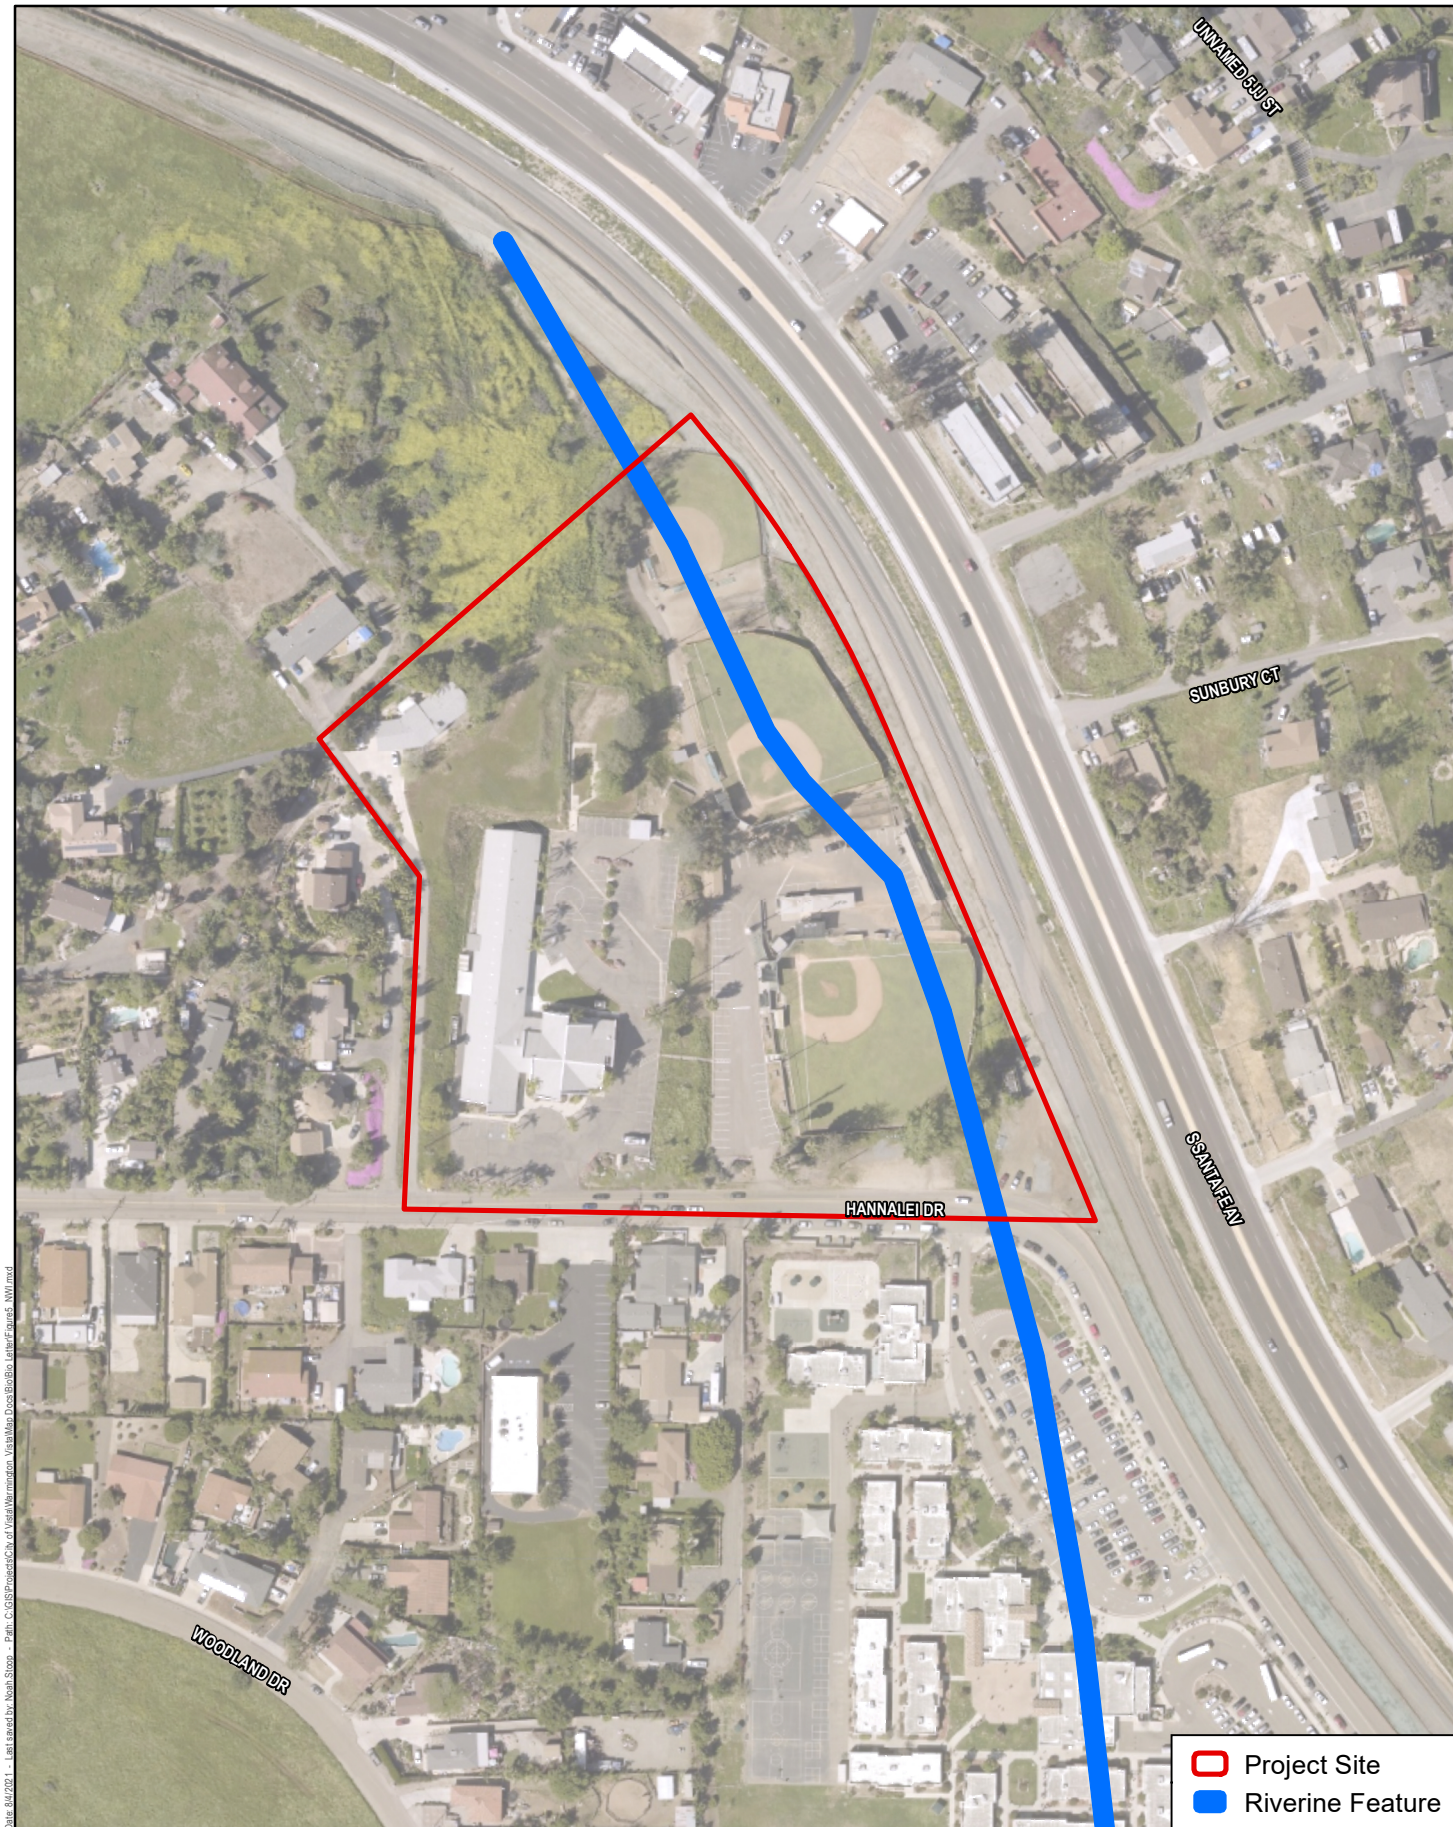
Source: USFWS 2021; SanGIS Imagery 2017.

The National Wetlands Inventory (NWI) shows an unnamed riverine feature running through the eastern portion of the project site (Figure 5, National Wetlands Inventory Results). The unnamed riverine feature identified on the NWI mapping results was observed on the project site and identified as Channel 1. The flow path of the riverine feature shown on the NWI mapping results (NWI flow path) was not observed during the aquatic resources delineation investigation on the project site. The NWI flow path is west of what was observed on the project site during the survey but could have occurred historically on the project site before development of the baseball fields, surrounding residential community, and train transportation corridor to the east. The concrete channelization and shifting of portions of Channel 1 to the east likely occurred as a result of the baseball fields. No other aquatic resources were identified in the NWI mapping results or observed on the project site.

The NWI shows an unnamed riverine feature running through the eastern portion of the project site (Figure 5). The unnamed riverine feature identified on the NWI mapping results was observed on the project site as Channel 1. The flow path of the riverine feature shown on the NWI mapping results was not observed during the aquatic resources delineation investigation on the project site. This flow path could have occurred historically on the project site before the development of the baseball fields, surrounding residential community, and train transportation corridor to the east. The concrete channelization of portions of Channel 1 likely occurred as a result of the baseball fields. No other aquatic resources were identified on the NWI mapping results or observed on the project site.

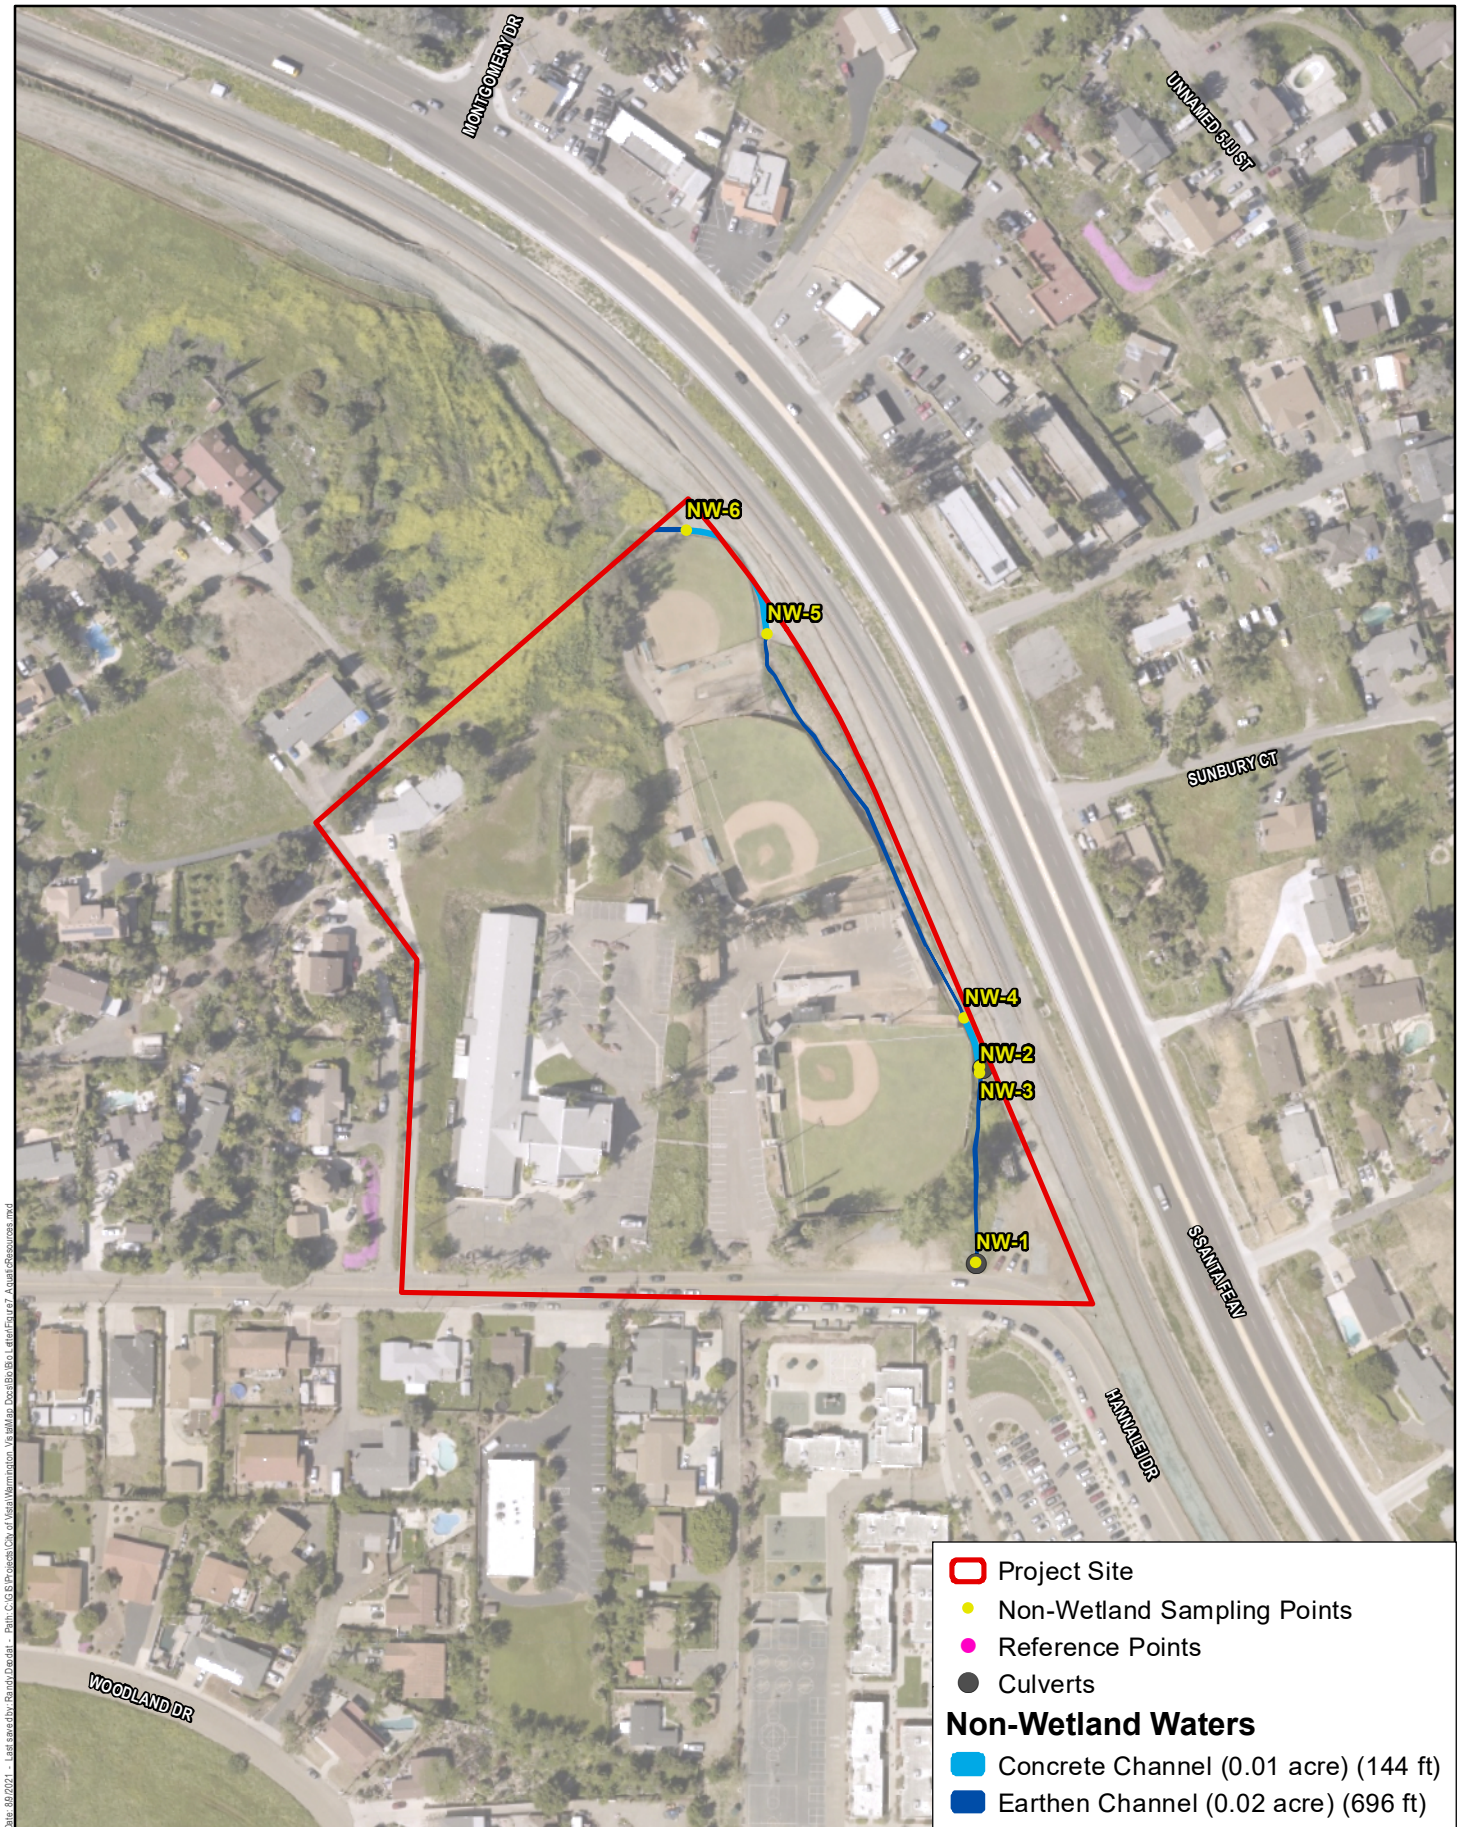
**Aquatic Resources**

Source: Latitude 33 2019; SanGIS Imagery 2017.

One approximately 0.03-acre (840 linear feet) aquatic resource, Channel 1, was observed running along the eastern and northeastern edge of the project site (Figure 7, Aquatic Resources). Two portions of Channel 1 are lined with concrete, accounting for approximately 0.01 acre (144 linear feet) of the channel. The earthen-bottom portions of Channel 1 are approximately 0.02 acre (696 linear feet). Channel 1 was determined to be an ephemeral non-wetland water based on the USACE and County of San Diego RPO definitions described in the Regional Context section (USACE 1987; County of San Diego 2012). Channel 1 does not meet the USACE three-parameter wetland definition because it is unvegetated, lacks hydrophytic vegetation growing in hydric (wetland) soils, and meets only one of the hydrologic indicators of a defined bed and bank. Similarly, Channel 1 does not meet the RPO definition of a wetland because it does not support hydrophytic vegetation, the substrate is not undrained hydric soil, and it does not contribute to values and functions of wetlands in the drainage system.

As discussed in the Results section, one approximately 0.03-acre (840-linear-foot) aquatic resource, Channel 1, was observed on the project site (Figure 7). Channel 1 was determined to be an ephemeral non-wetland water that does not meet the USACE and County definitions of what constitutes a wetland (USACE 1987; County of San Diego 2012). Based on the NWI and NHD results, Channel 1 is connected to Buena Creek, which is a tributary to Agua Hedionda Creek, a TNW as defined by the USACE. Based on the direct connectivity to a TNW, Channel 1 is likely under the jurisdiction of the USACE, RWQCB, and CDFW pursuant to Sections 404 and 401 of the CWA and Section 1600 of the California Fish and Game Code.

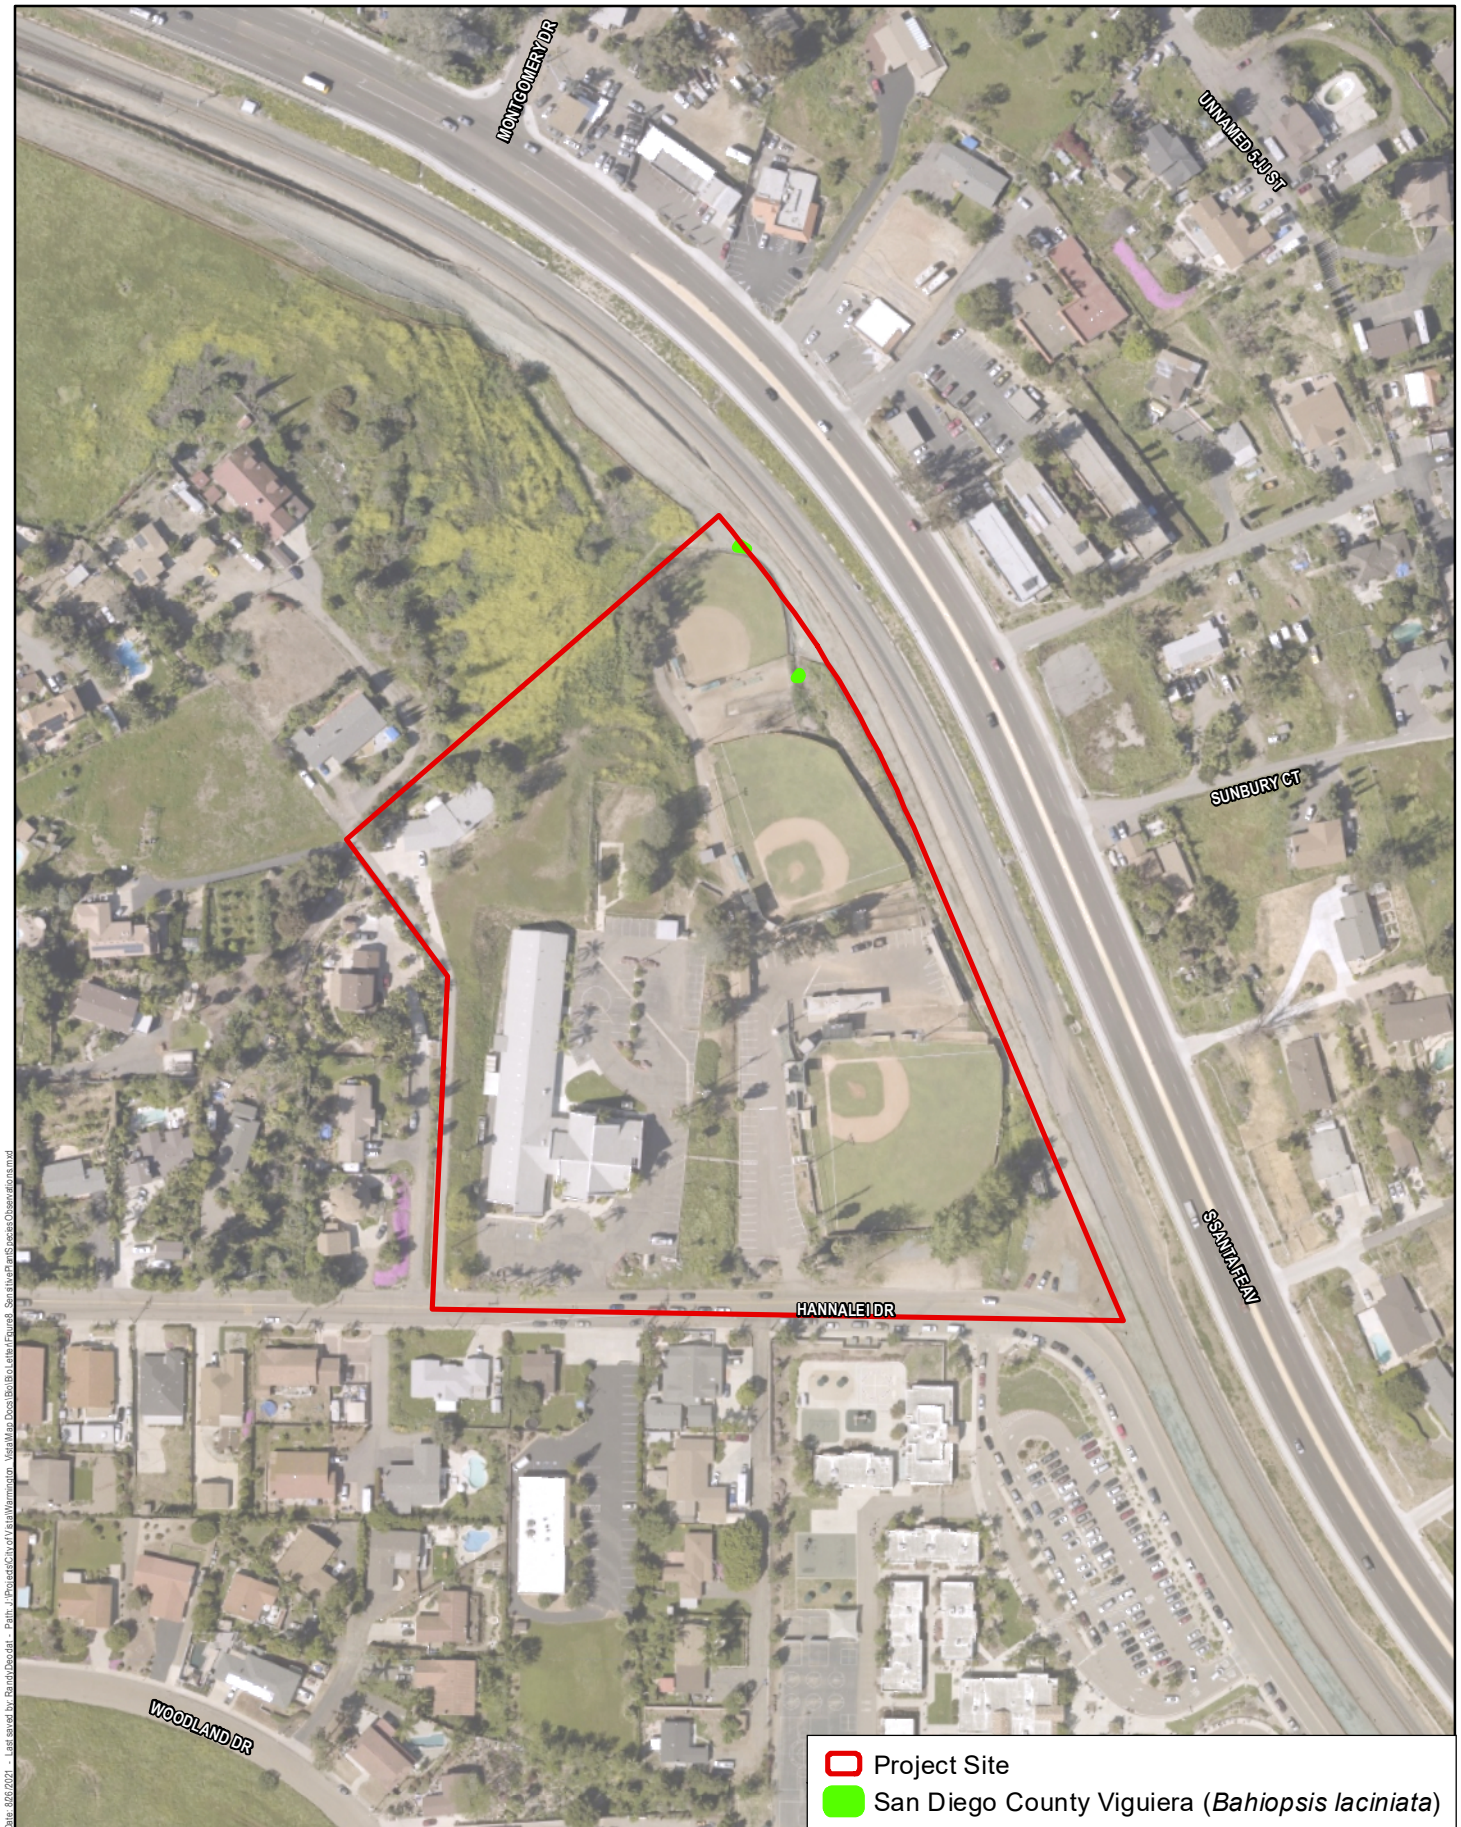
Sensitive Plant Species Observations

Source: SanGIS Imagery 2017.

Approximately 13 San Diego County viguiera individuals (approximately 0.0008 acre) were observed in two patches on the eastern and northern edges of Channel 1 in the northeastern corner of the project site (Figure 8).

Approximately 13 San Diego County viguiera individuals (approximately 0.0008 acre) were observed surrounding the concrete and earthen portions of Channel 1 in the northeastern corner of the project site (Figure 8). As discussed in the Project Description and Location section, the project is designed to avoid impacts to Channel 1. Avoidance of Channel 1 includes the banks of the channel where the approximately 13 San Diego County viguiera individuals occur. Project design features for avoidance of these sensitive resources would include temporary fencing during construction and permanent signage for operation of the project. Therefore, no direct impacts to San Diego County viguiera would occur and no mitigation is required.

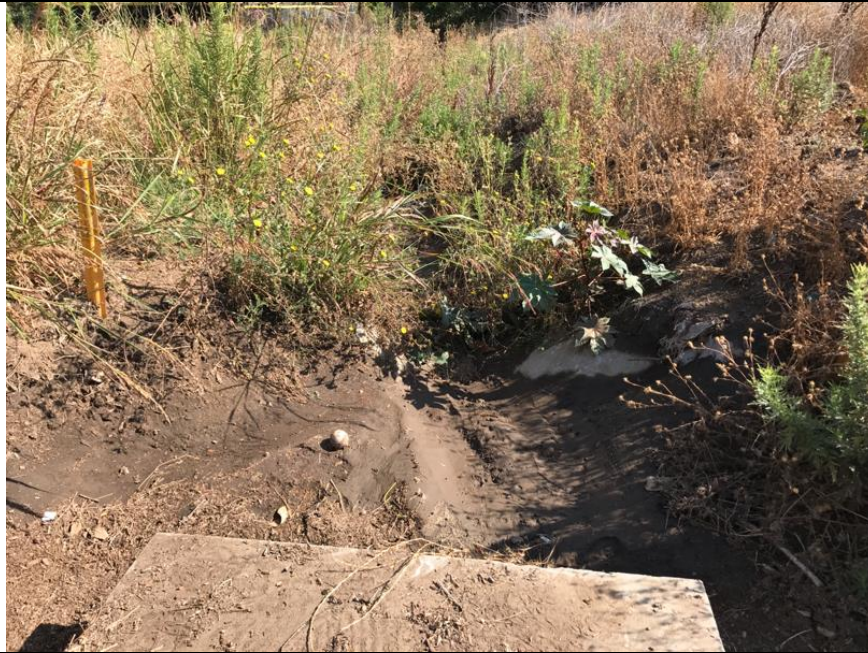
**Photograph 1:** (33.179, -117.216) North-facing view of the southern reach of the 2-foot-wide earthen-bottom channel on the southern portion of the project site. This photo shows where sampling point NW-1 was taken to determine the presence of OHWM indicators. This photo also shows the approximately 5-foot-diameter concrete culvert that runs south under Hannalei Drive.

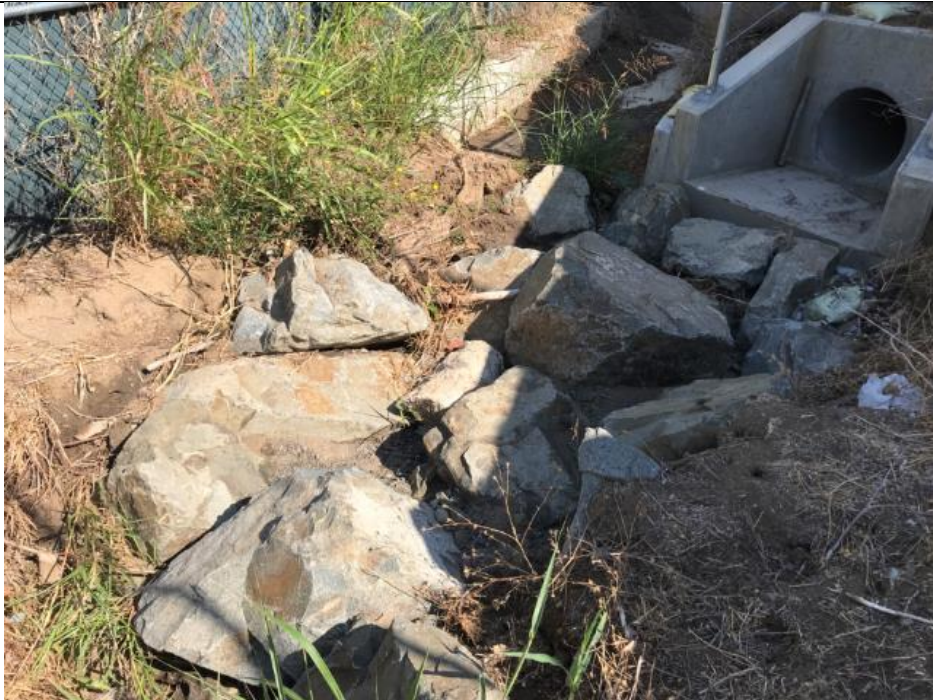
**Photograph 2:** (33.179, -117.216) North-facing view of the 4-foot-wide earthen-bottom channel on the eastern edge of the project site. This photo shows where sampling point NW-2 was taken to determine the presence of OHWM indicators. This photo also shows the approximately 3-foot-diameter concrete culvert that runs east under the train transportation corridor east of the project site and the concrete and rock riprap in the center of the earthen-bottom channel.

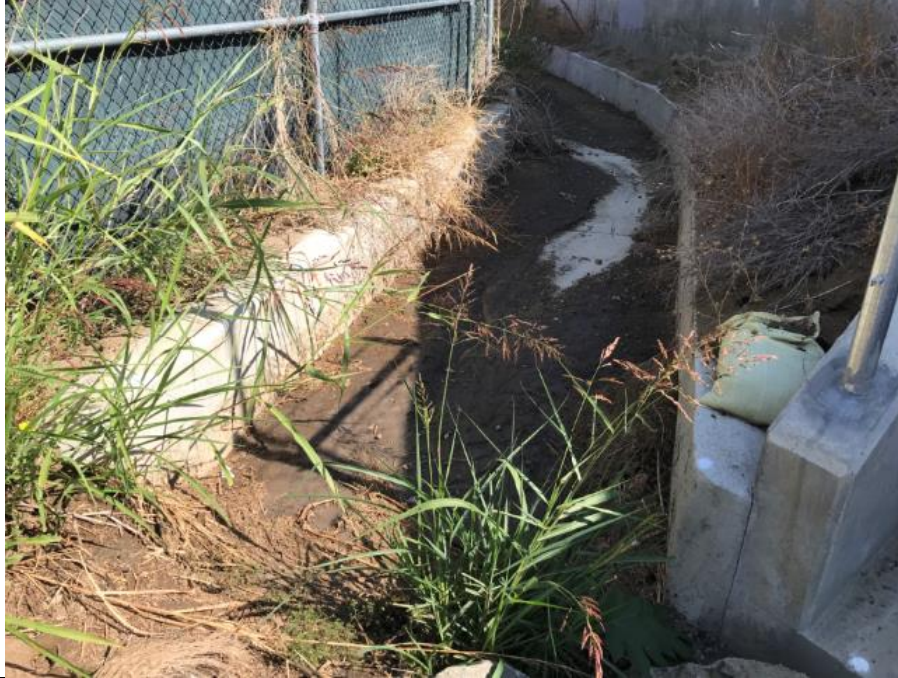
**Photograph 3:** (33.179, -117.216) North-facing view of the 4-foot-wide concrete-lined portion of the channel on the eastern edge of the project site. This photo shows where sampling point NW-3 was taken to determine the presence of OHWM indicators. The approximately 3-foot-diameter concrete culvert that runs east under the train transportation corridor east of the project site is shown on the right side of the photo.

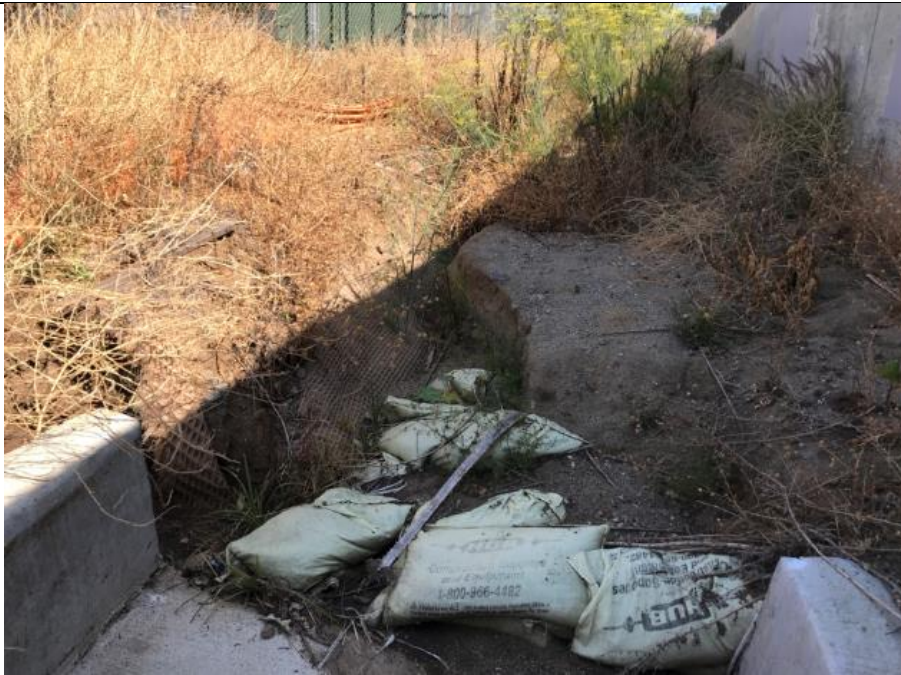
**Photograph 4:** (33.179, -117.216) Northwest-facing view of the 1-foot-wide earthen-bottom channel on the eastern edge of the project site. This photo shows where sampling point NW-4 was taken to determine the presence of OHWM indicators. This photo also shows the end of the concrete-lined portion of the channel that occurs south of sampling point NW-4.

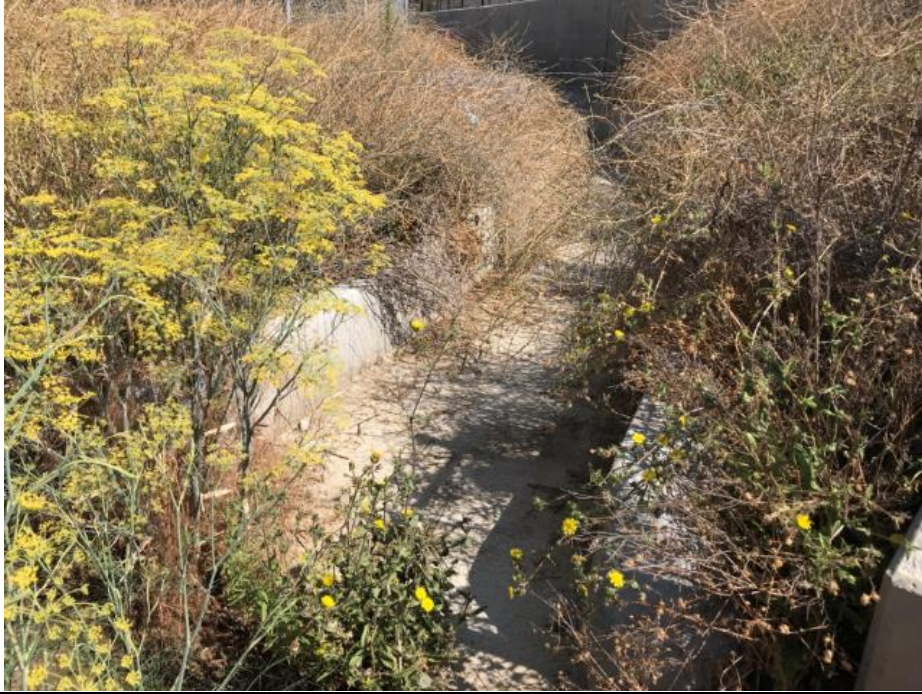
**Photograph 5:** (33.179, -117.216) North-facing view of the 5-foot-wide concrete-lined portion of the channel on the northeastern edge of the project site. This photo shows where sampling point NW-5 was taken to determine the presence of OHWM indicators.

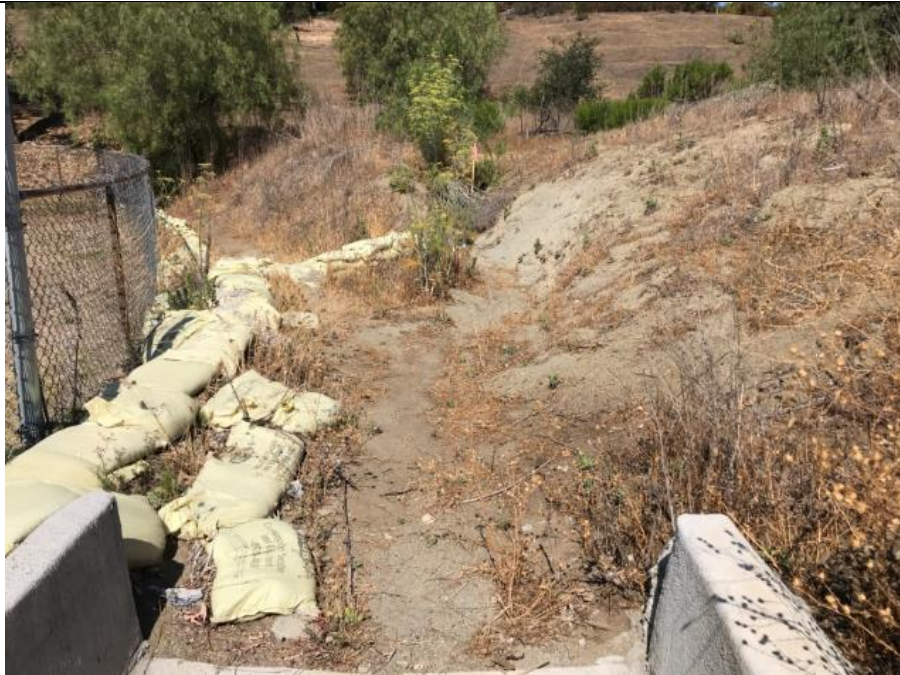
**Photograph 6:** (33.179, -117.216) West-facing view of the 3-foot-wide earthen-bottom channel on the northeastern edge of the project site. This photo shows where sampling point NW-6 was taken to determine the presence of OHWM indicators. This photo also shows the end of the concrete-lined portion of the channel that occurs south of sampling point NW-6.
