PHASE I AND LIMITED PHASE II ENVIRONMENTAL SITE ASSESSMENT APNS 181-180-84, 181-180-86, AND 181-180-56 BLUEBIRD CANYON ROAD AND HOLLYBERRY DRIVE VISTA AREA, SAN DIEGO COUNTY, CALIFORNIA 92084

W.O. E6814-SC DECEMBER 30, 2014

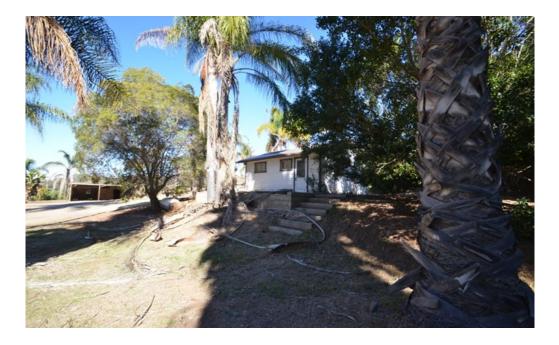
1. House and covered parking area on south side of property. View is to the north.

- Based upon the age of the subject property buildings, it is likely that ACMs and LBP are present. Prior to demolition, ACM and LBP surveys should be conducted. If ACMs and LBPs are found to be present, special handling and disposal techniques will be necessary under the oversight of a qualified consultant.

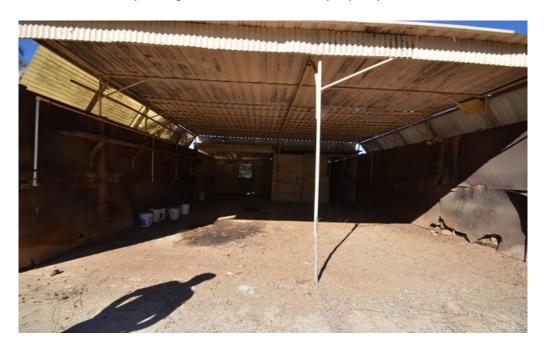
- Hydraulic Lifts GSI did not observe readily visible evidence of hydraulic lifts on the subject property.
- Use, Storage, and Disposal of Petroleum Products GSI observed seven 5-gallon buckets labeled hydraulic oil stored on concrete in a covered parking area onsite; however, the subject property owner indicated that the buckets contained used oil. Staining was observed on the concrete in the vicinity of the buckets, however, it did not appear that the buckets were leaking. The presence of used oil and stained concrete is an environmental concern, however, based on the small volume and presence of concrete, the used oil does not currently represent a REC.

2. Covered parking area on south side of property. Note 5-gallon buckets filled with used oil and stained concrete.

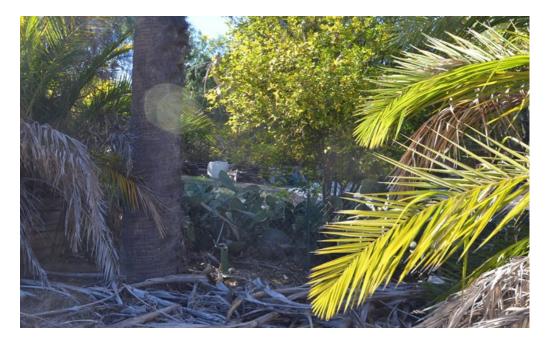
4. Residential property on west side of subject site. Note unidentified AST.

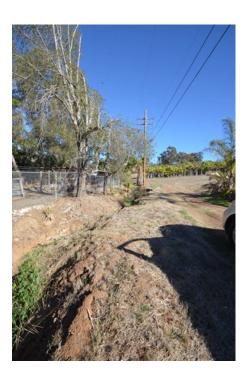
8. Looking east along drainage ditch on north side of site.

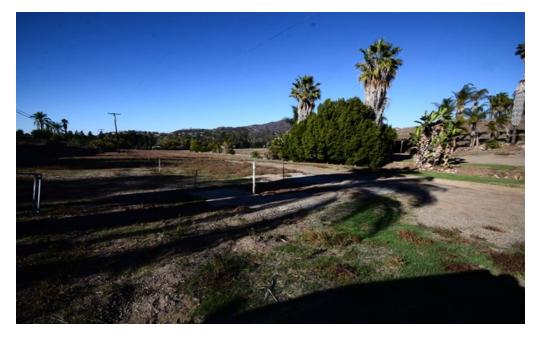
- Storage Tanks No above ground storage tanks (AST)s or evidence of underground storage tanks (USTs) were observed on the subject property. Therefore, storage tanks are not considered an REC at this time. However, according to the property owner's representative, a 1,000-gallon diesel fuel AST was previously located on a concrete slab in the southern portion of the property, near the onsite structures. Soil samples were collected in this area, and the results are discussed herein.

9. Former AST and pesticide mixing area. View is to the northwest.

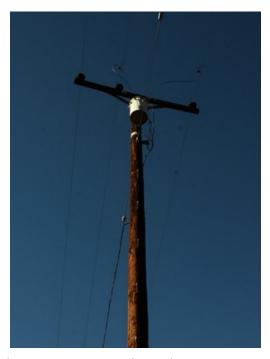
10. Transformer on southwestern property boundary.
