The Secretary of the Interior's Standards  
for the Treatment of Historic Properties

with Guidelines for  
Preserving, Rehabilitating  
Restoring & Reconstructing  
Historic Buildings

Kay D. Weeks and Anne E. Grimmer

U.S. Department of the Interior  
National Park Service  
Cultural Resource Stewardship and Partnerships  
Heritage Preservation Services  
Washington, D.C.  
1995

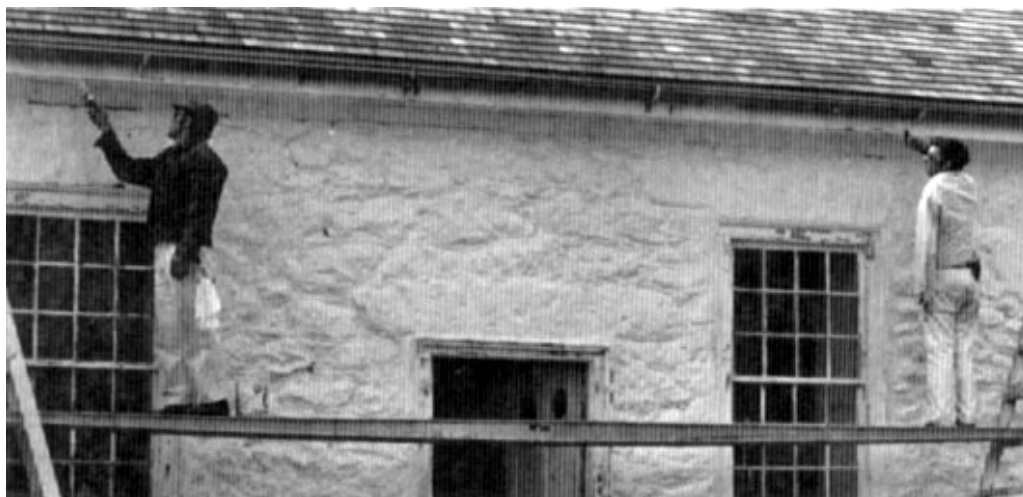
*Adequate protection and maintenance of a historic building is an ongoing commitment. Here, two workers are priming and repainting exterior stone and wood trim. If surface treatments are neglected, more extensive repair and replacement will be required. Each loss further undermines a building's historic integrity.*

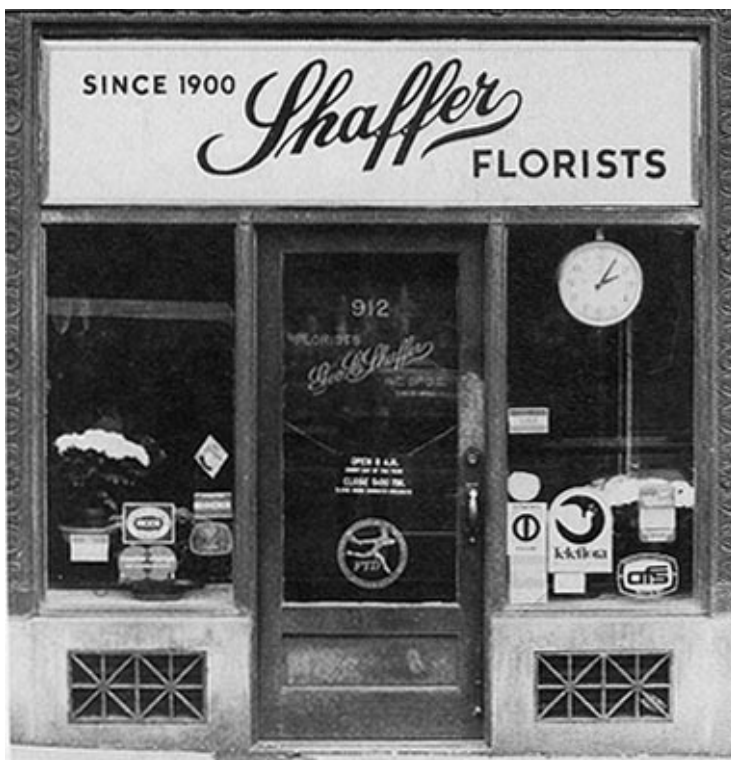
*The original form and features of this 1920s storefront have been retained through Preservation. Photo: David W. Look, AIA.*

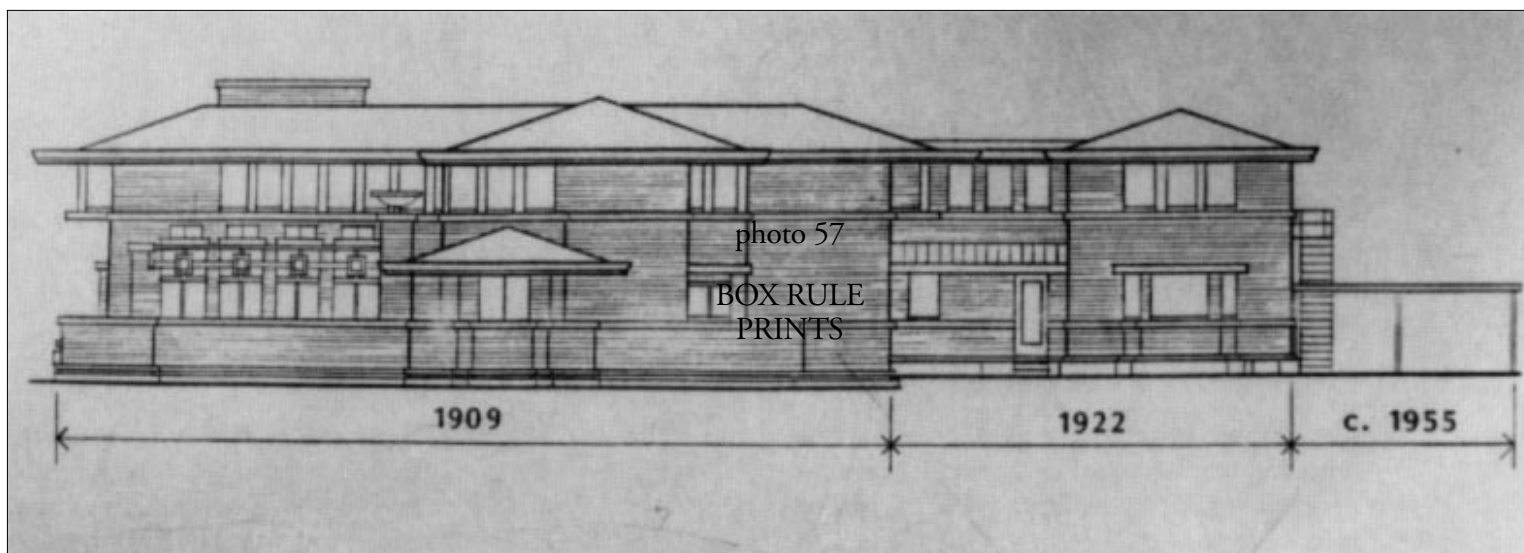
*The Meyer May House in Grand Rapids, Michigan, was designed by Frank Lloyd Wright and built in 1909. In 1922, May added to the house for an expanding family. After the May occupancy, the house was altered for use as apartments, with a carport added in 1955. In the 1980s restoration, the Wright's original design was deemed more significant than May's later changes, and, as a result, the additions were removed and the house returned to its 1909 appearance. Drawing: Martha L. Werenfels, AIA.*

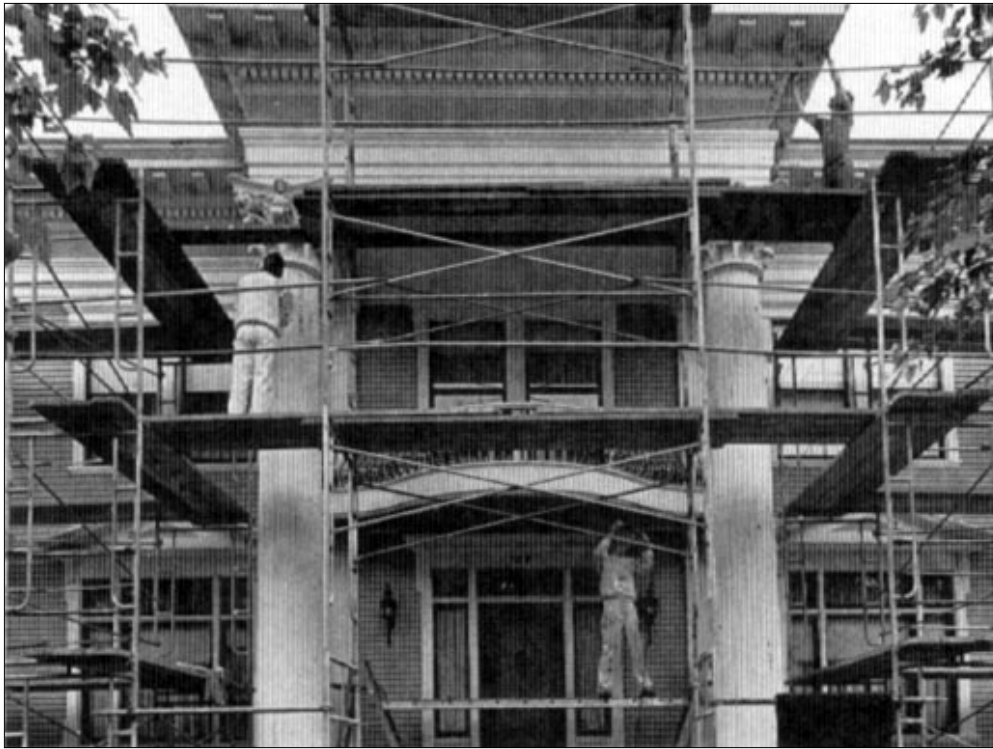
*Ongoing work at this house focuses on the maintenance and repair of exterior wood features from the restoration period. After scraping and sanding, the wood was painted in colors documented to the Restoration period. Photo: ©Mary Randlett, 1992.*

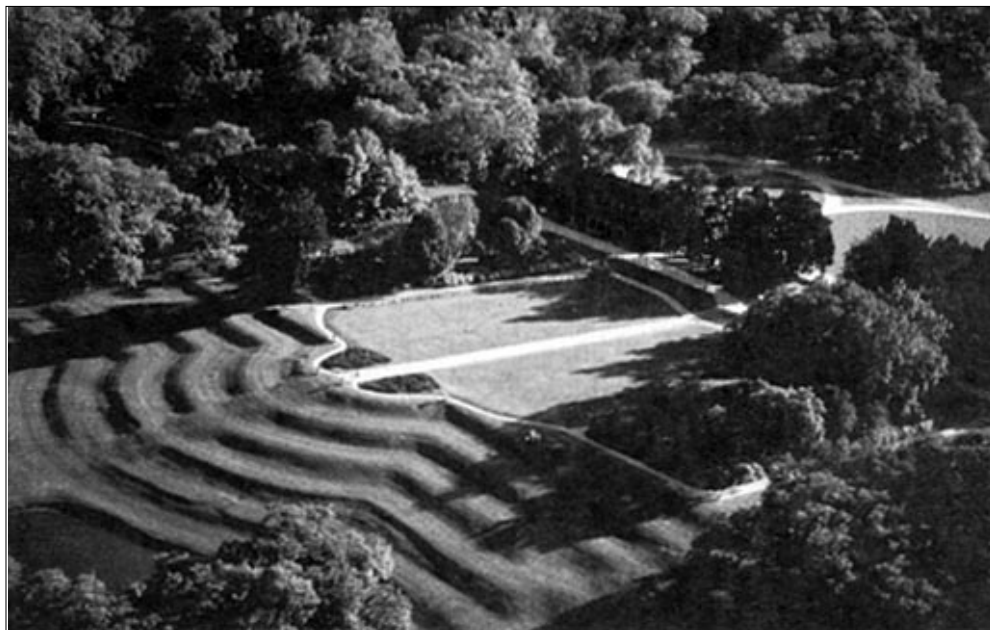
*The spacious grounds at Middleton Place, near Charleston, South Carolina, constitute the first landscaped garden in America. The molded terraces, originally constructed in the 18th century, were largely reconstructed in the early 20th century based on extant remains and other documentary evidence. Photo: Middleton Place.*

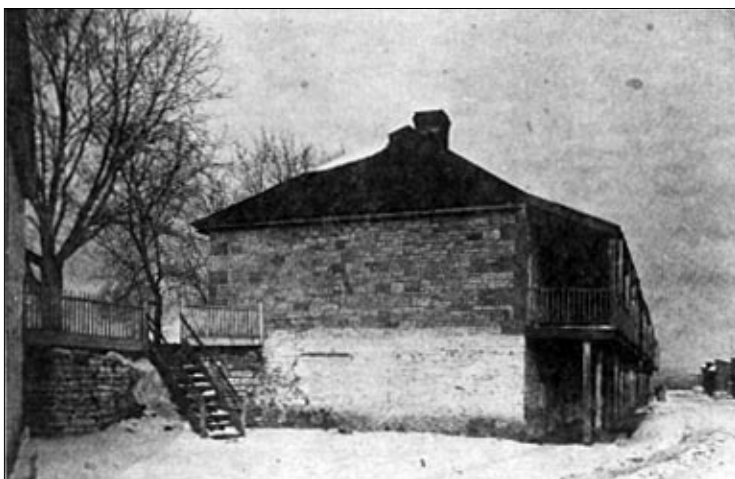
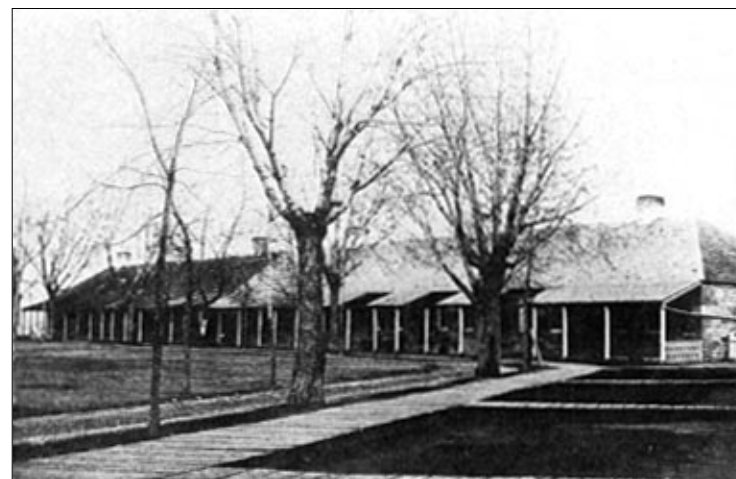
*(a) and (b). Two views of the Officers' Quarters at Fort Snelling (ca. 1885 to 1900) not only provide information on the materials and form of the historic block, they document the wooden walkways and other landscape features such as stairs, railings, and tree placement. Historical and pictorial evidence would need to be combined with specific physical evidence in order to make the case for Reconstruction as a treatment.*

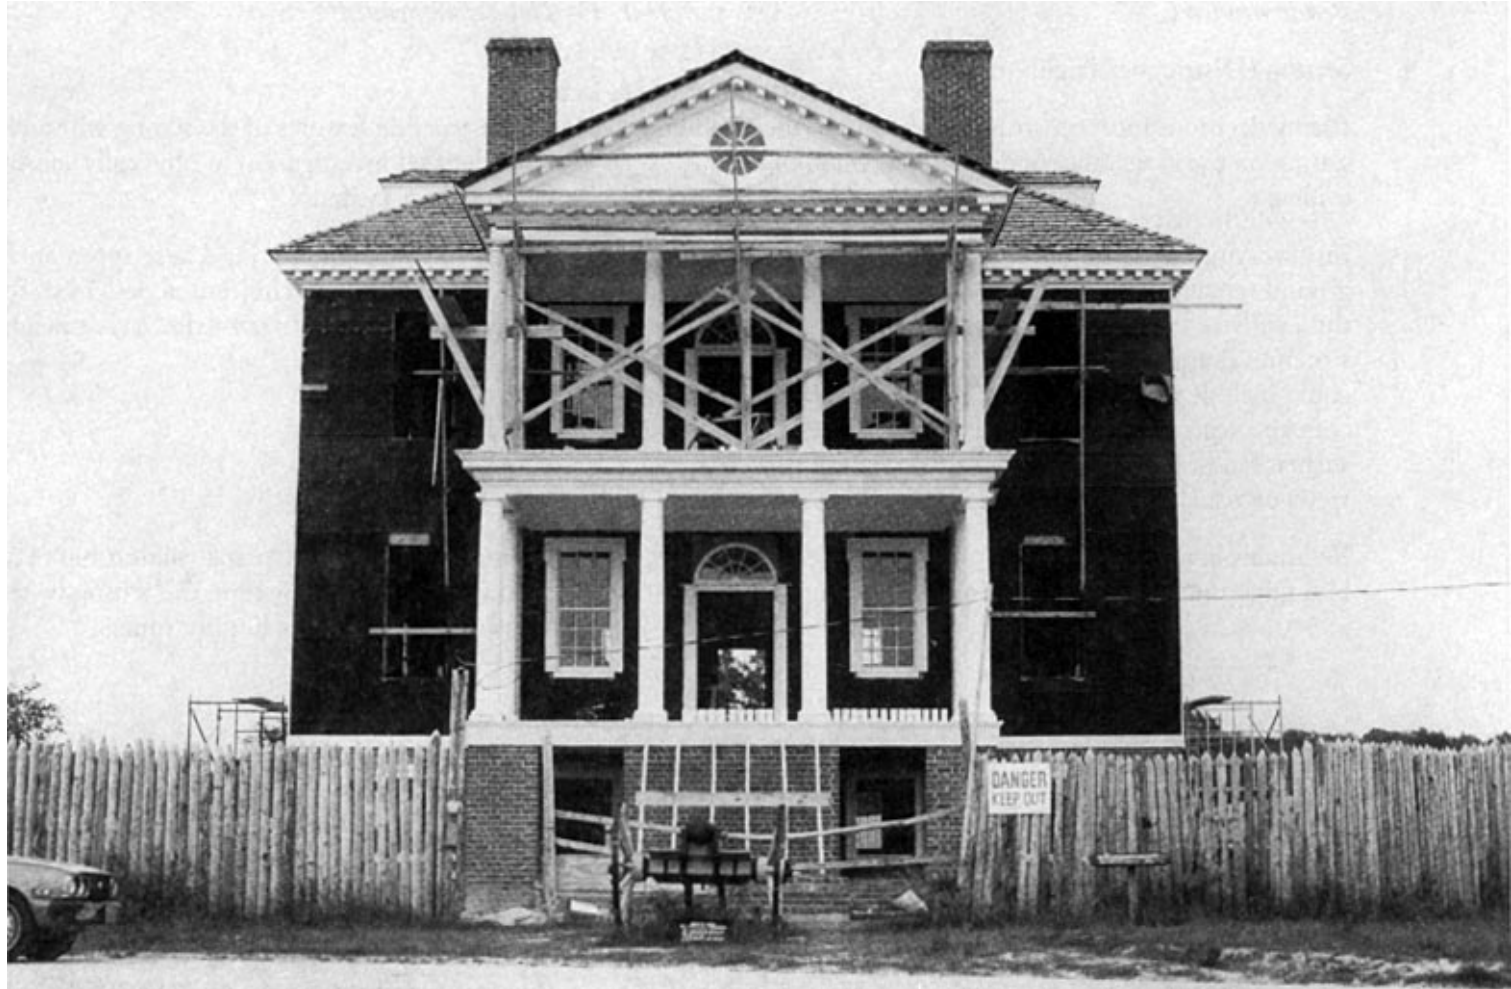
*The 1778 Kershaw House, which served as British Headquarters during the Revolutionary War, was burned by Union troops in 1865. In the early 1970s, the house was reconstructed as part of Camden Battlefield, Camden, South Carolina. Built expressly for interpretive purposes, it serves as an illustrative reminder of a past event of national significance. The Standards for Reconstruction call for any re-created building to be clearly identified as a contemporary depiction. This is most often done by means of an exterior sign or plaque, or through an explanatory brochure or exhibit. A guide may inform visitors as well. Photo: Richard Frear.*
