# **PHASE I ENVIRONMENTAL SITE ASSESSMENT and LIMITED SOIL INVESTIGATION**

**Accretive Investments, Inc.  
Lilac Hills Ranch Development  
Roadway Expansion Property**

**Gopher Canyon Road and Interstate 15 Intersections;  
Old Highway 395 from Gopher Canyon Road  
North to Circle R Drive, Escondido, California 92026**

**EEI Project Number ACR-71497.2a**

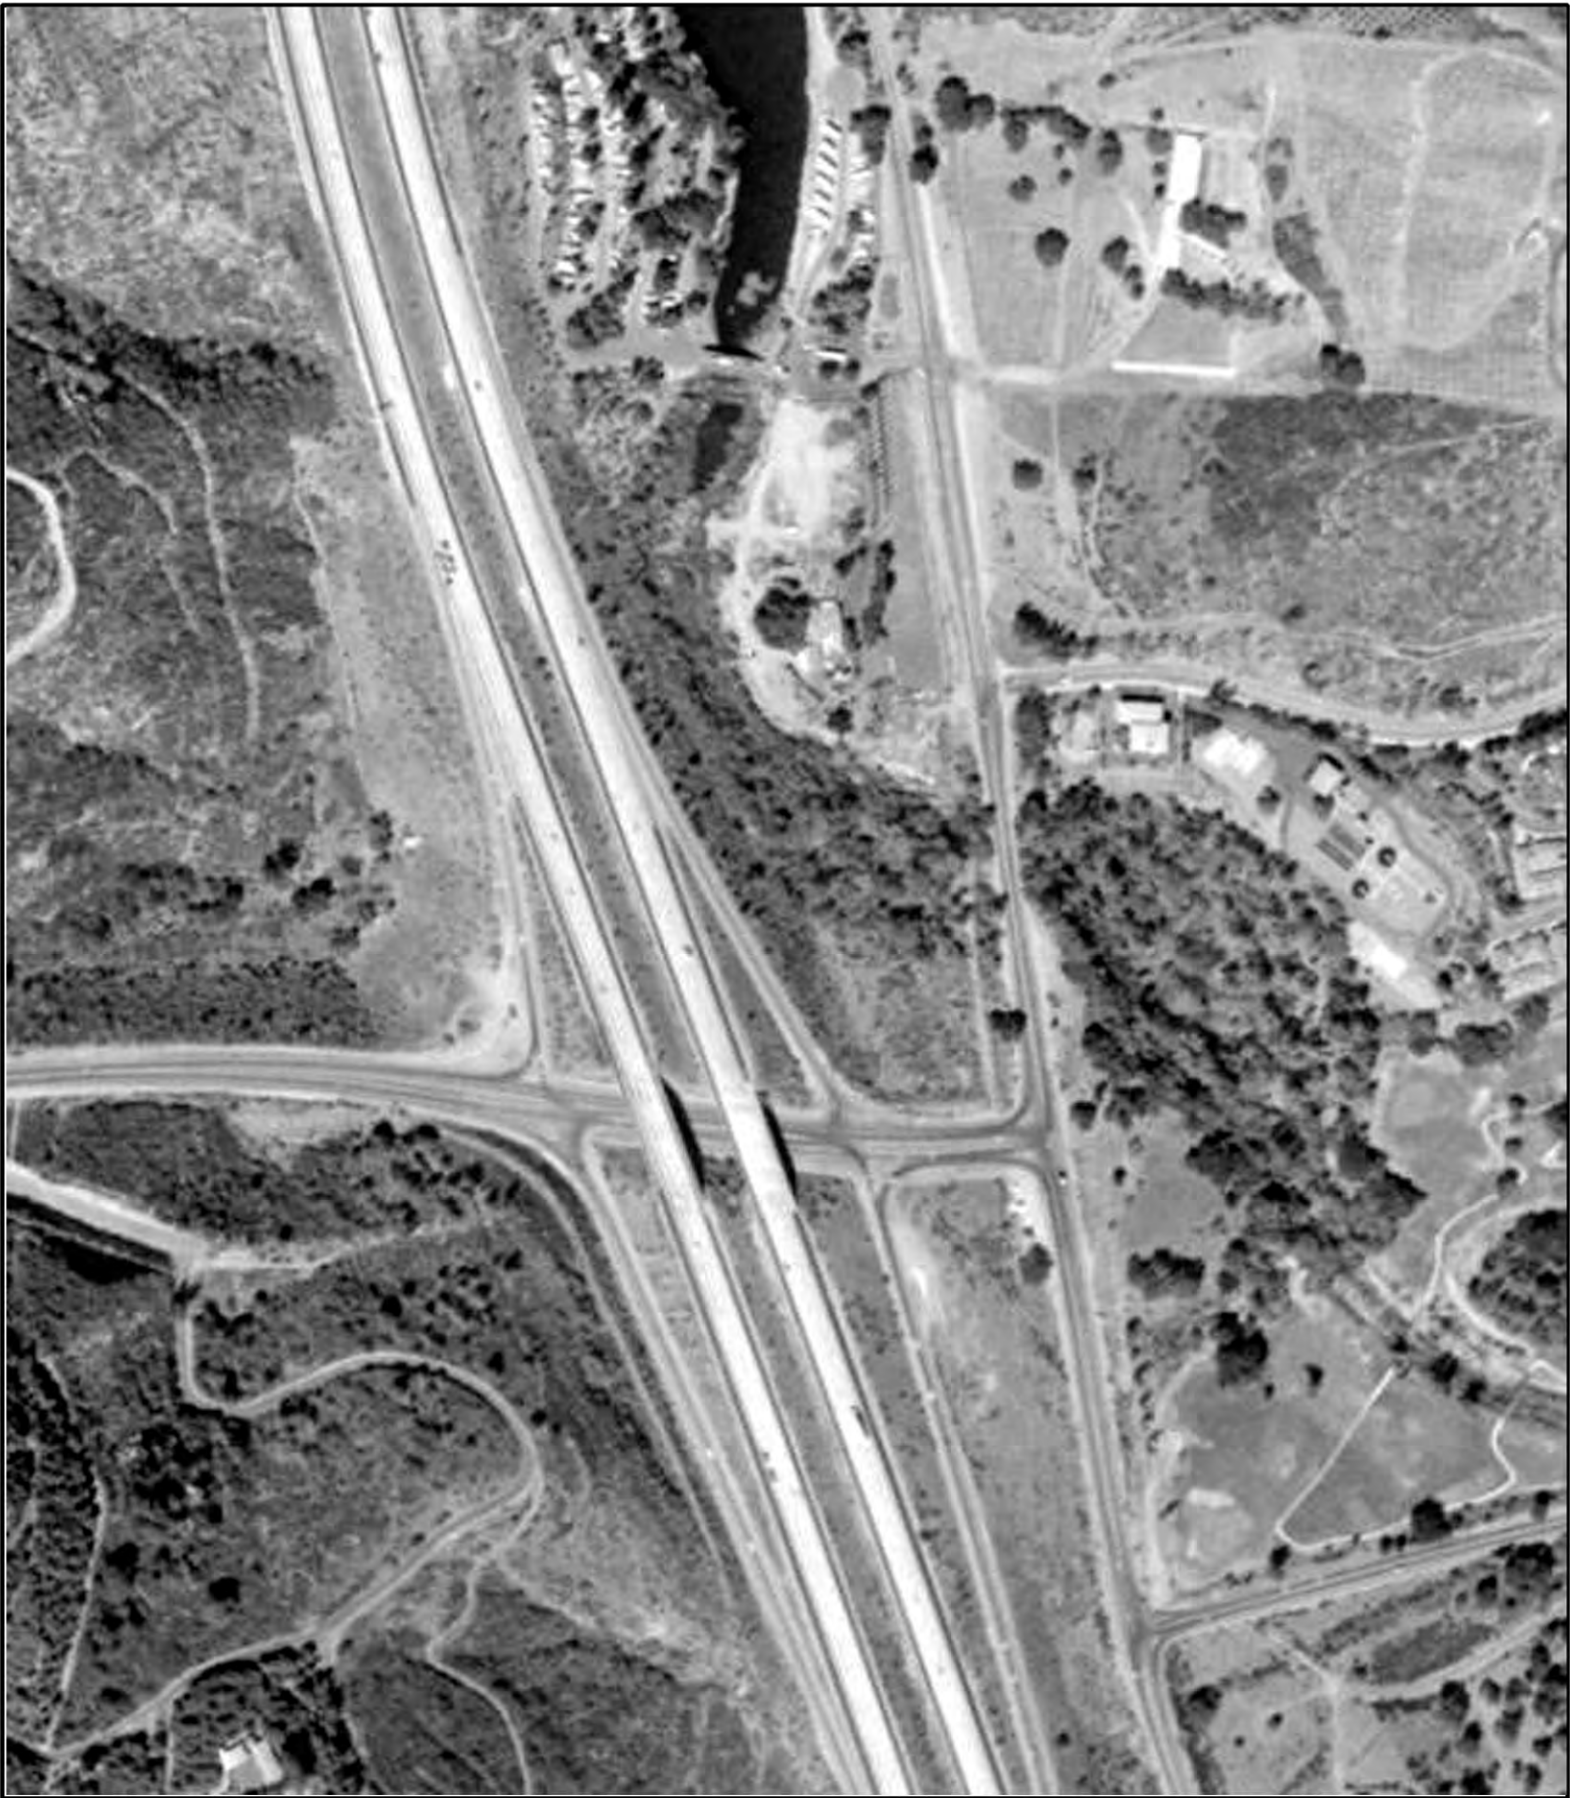
Historical Aerial Photo  
1990-1991

1990and 1991	Aerial Photograph 1:340	Circle R Drive now extended west and intersected with Old Highway 395. I-15 now appeared completed. Additional structures now present at the northwest and southeast corner of Circle R Drive and Old Highway 395.
2002/2008	Aerial Photograph 1:340	No apparent changes were noted in the site vicinity. Additional development appeared to the north along Old Highway 395.

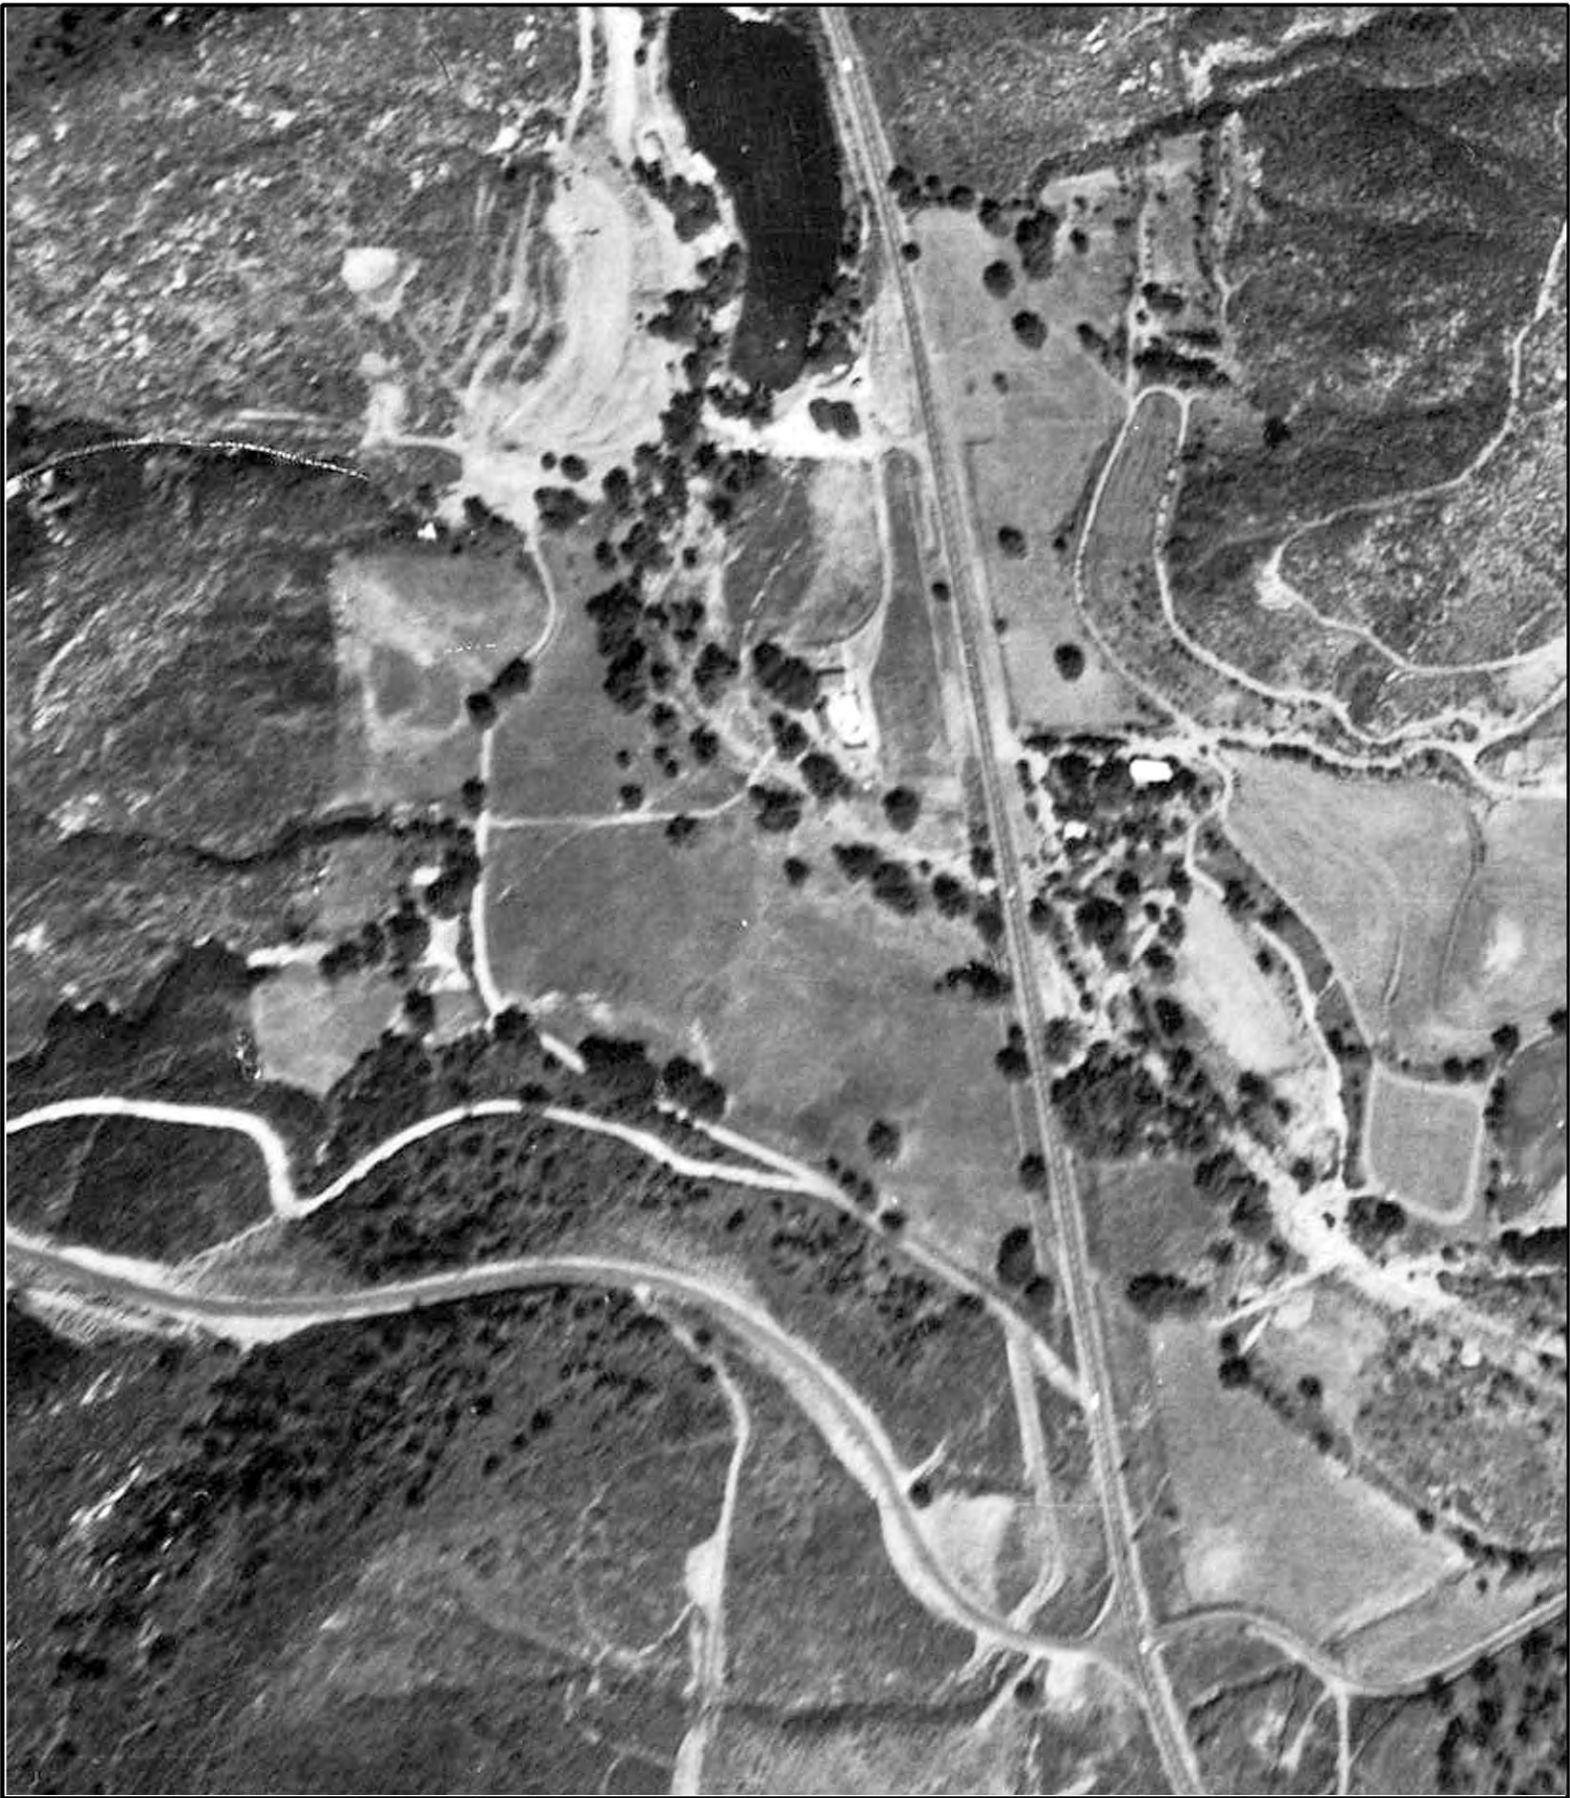
Historical Aerial Photo  
1963

1963	Aerial Photograph 1:340	No apparent changes were noted on the site vicinity; with the exception of increased rural residential and agricultural development in the area. Structural development appeared at the northwest and southeast corners of Old Highway 395 and Circle R Drive. A golf course also appeared to the east along Circle R Drive.
1968/1975	Topographic Map 1: 24,000	No apparent changes were noted on the subject property or adjacent property. Old Castle Road was preset to the south. A golf course was present east of Circle R Drive and Old Highway 395.
1976	Aerial Photograph 1:340	No apparent changes were noted on the site vicinity. Moosa Canyon WTF appeared along Circle R Drive to the east.
1980	Aerial Photograph 1:340	I-15 appeared under construction to the west of Old Highway 395. Gopher Canyon Road appeared in its current configuration. Portions of the subject property along the west side of Old Highway 395 appeared cleared of vegetation.

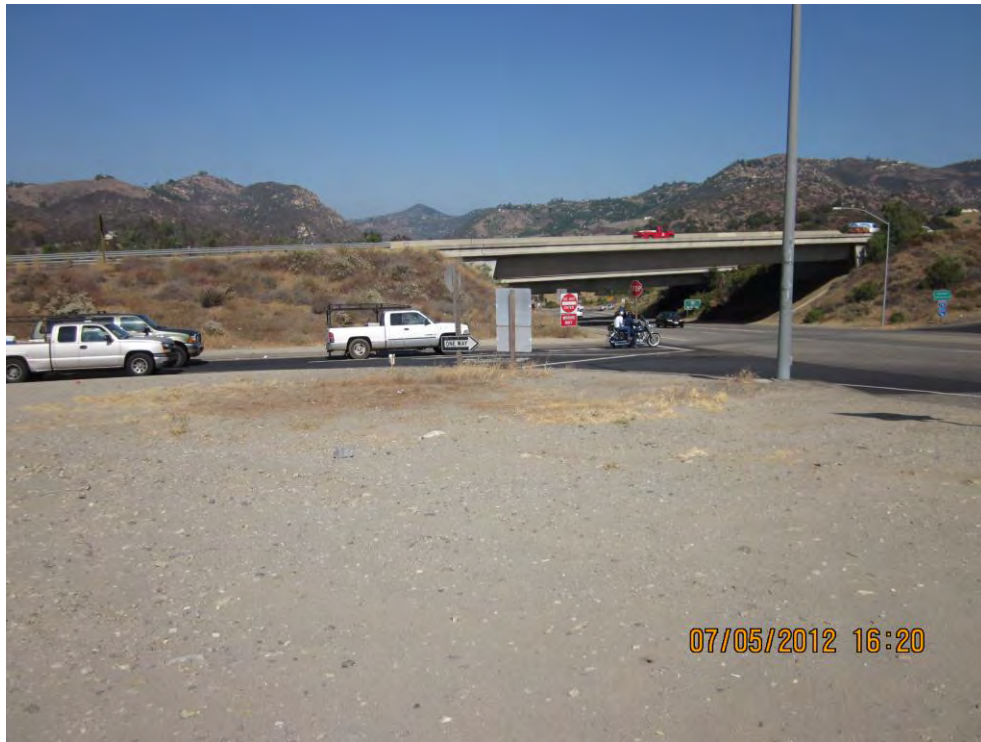
**Photograph 1** – Easterly view of Gopher Canyon Road off ramp to southbound I-15.

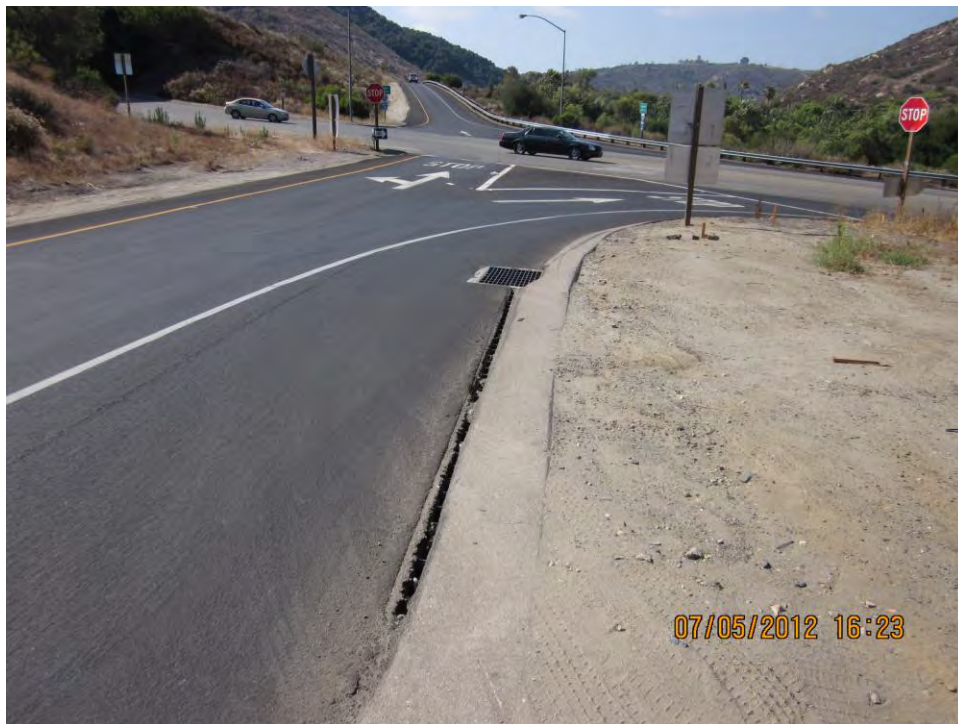
**Photograph 2** – North view of Gopher Canyon Road off ramp to north bound I-15.

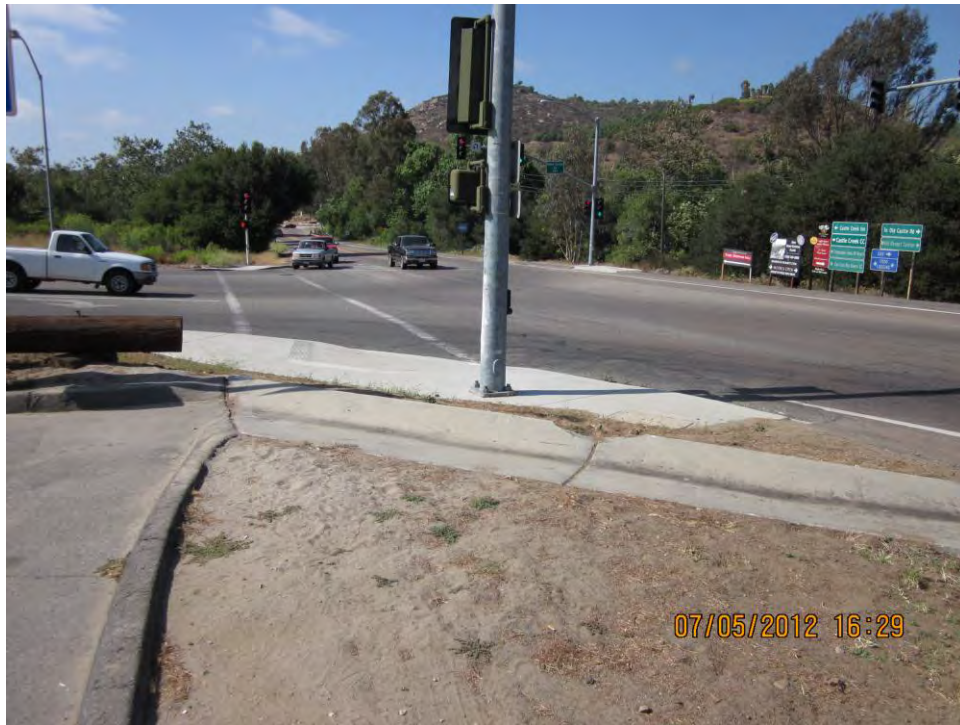
**Photograph 3** – Northerly view of intersection of Gopher Canyon Road (left photo) and Old Highway 395. Photo taken from adjacent Car Pool parking lot.

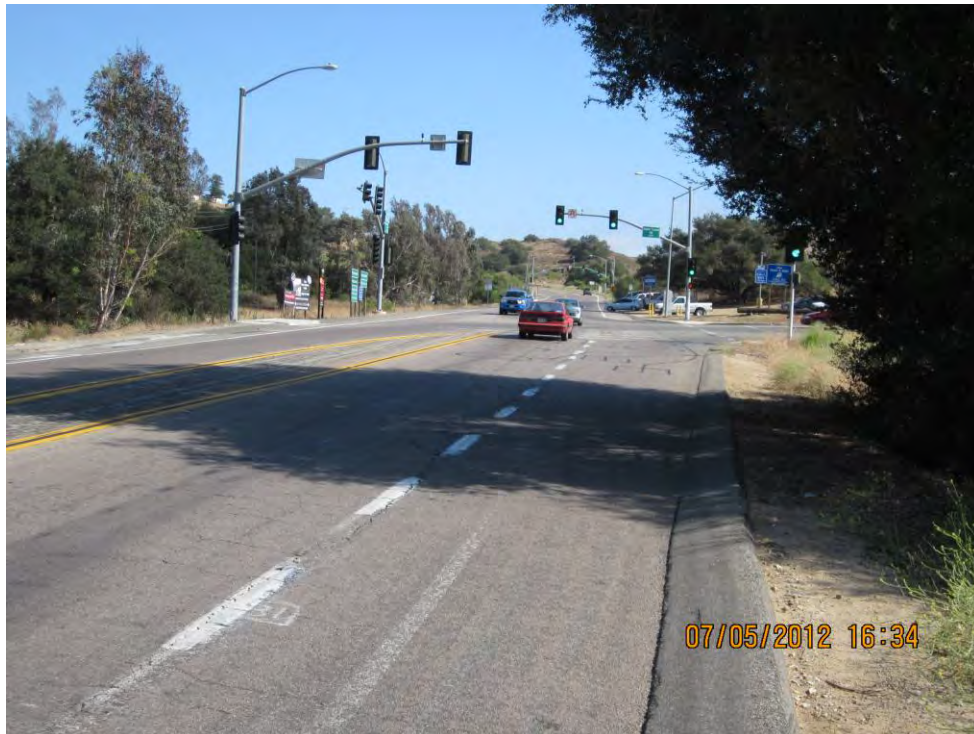
**Photograph 4** – Southerly view along Old Highway 395 toward intersection with Gopher Canyon Road (right background).

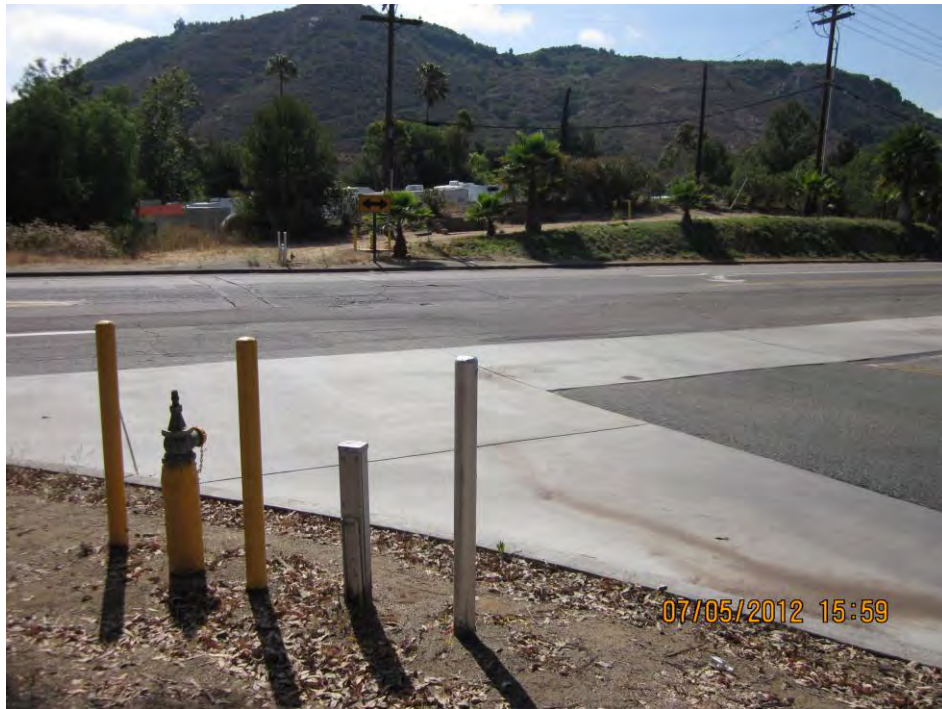
**Photograph 5** – Northwesterly view of the intersection of Circle R Drive (right foreground) and Old Highway 395. Note water utilities on both edges of roadways.

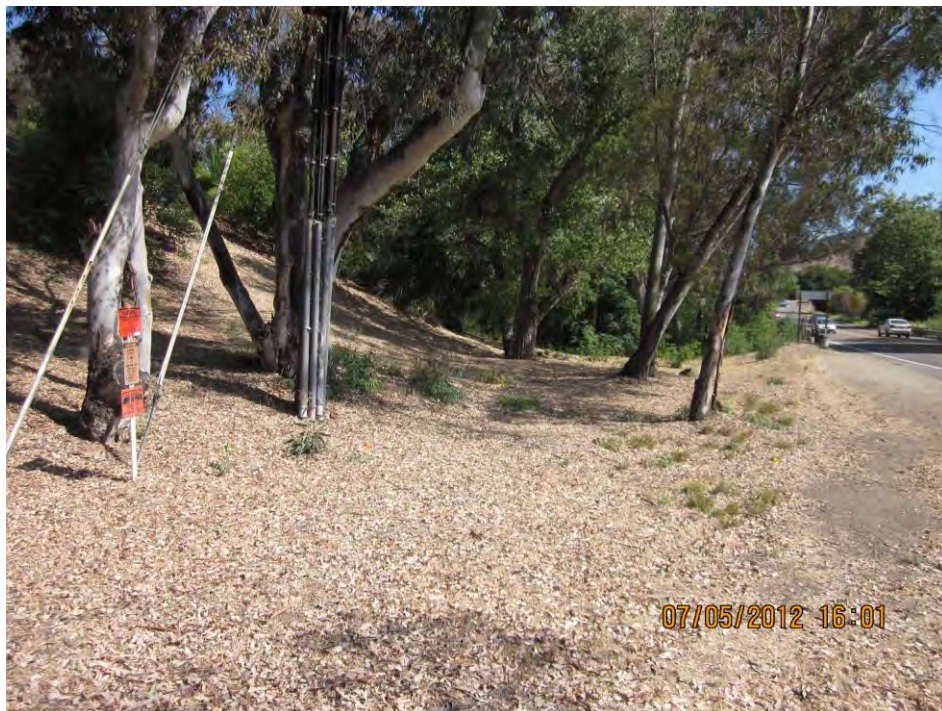
**Photograph 6** – South view along northeast side of Old Highway 395 south of Circle R Drive. Note orange signage in left photo delineating buried fiber optic cable.

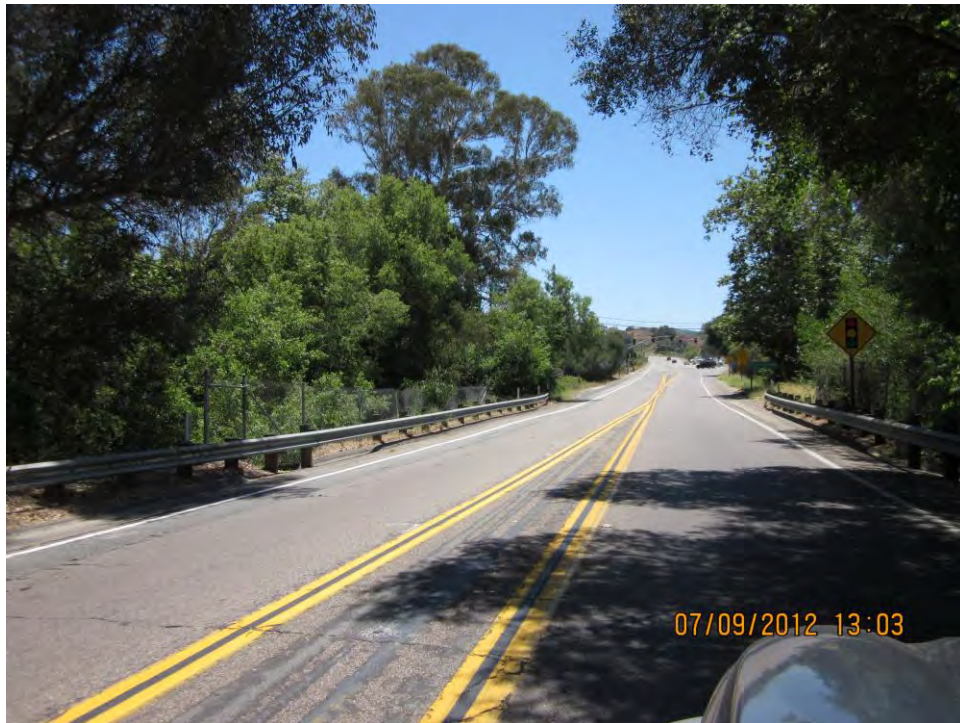
**Photograph 7** – south view along central section of Old Highway 395 at culvert under-crossing, delineated by guard railing.

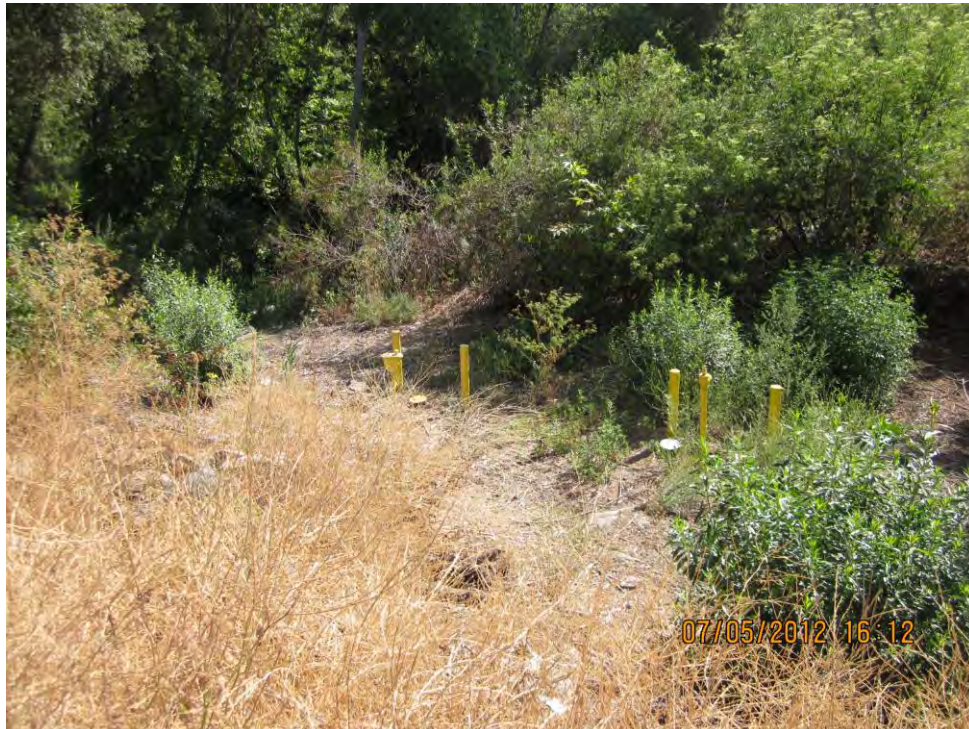
**Photograph 8** – Southwesterly view of water utilities in drainage (easement?) area along west side of Old Highway 395, north of culvert under-crossing.

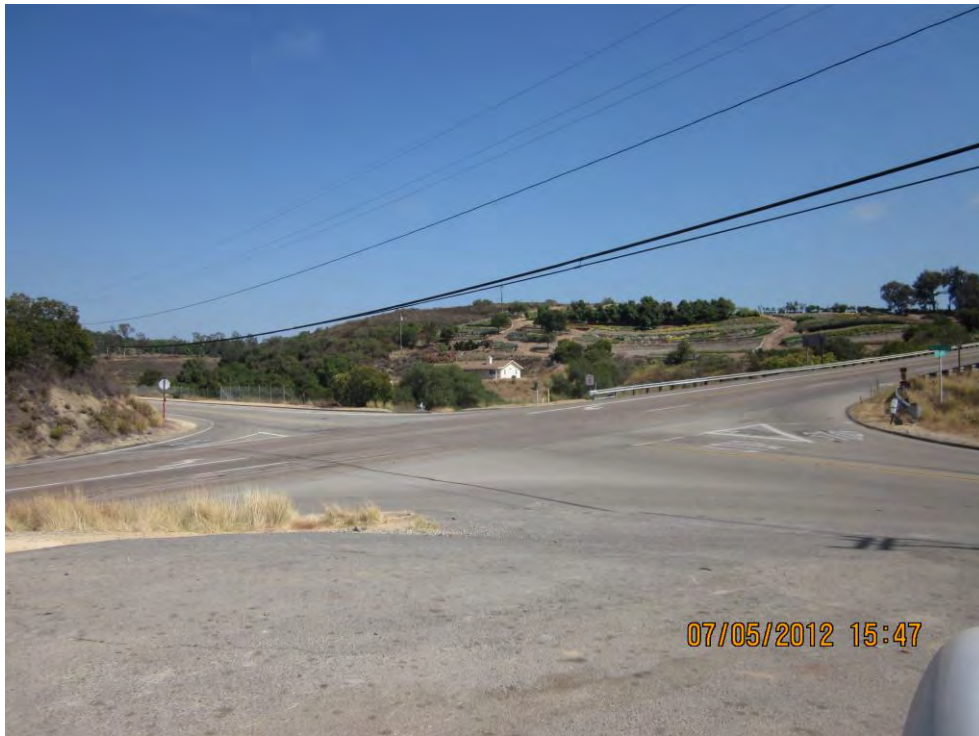
**Photograph 1** – Southeasterly view of intersection of West Lilac Road and Old Highway 395 (i.e., sloping roadway right to left).

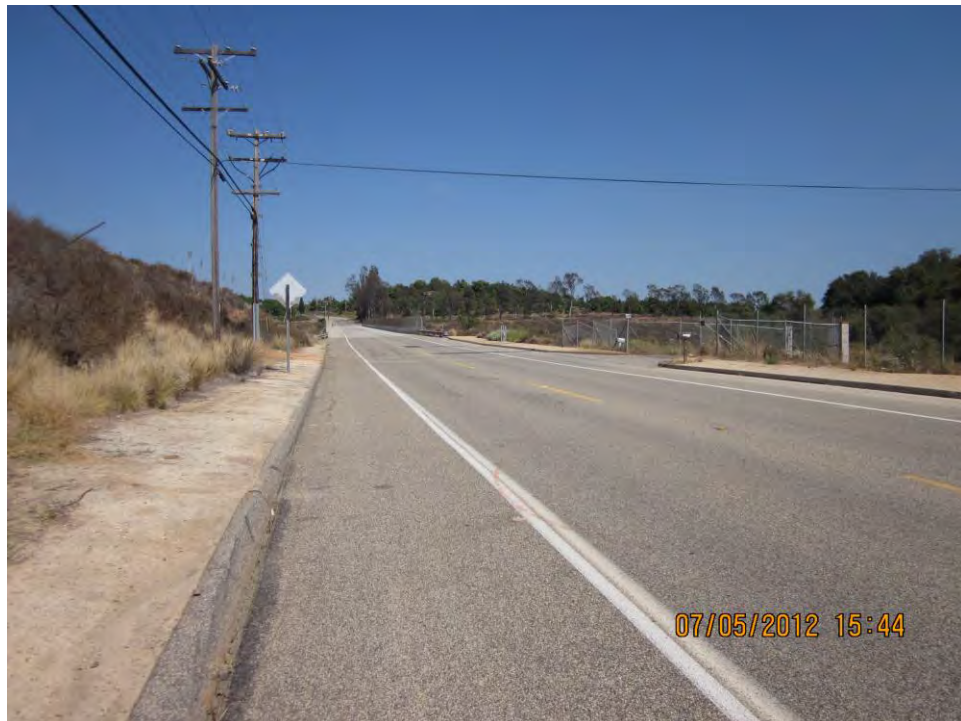
**Photograph 2** – East view along the northern edge of West Lilac Road. Concrete pavement in background is the I-15 overpass. Note strip storm drain inlet inside of asphalt curb in left foreground.

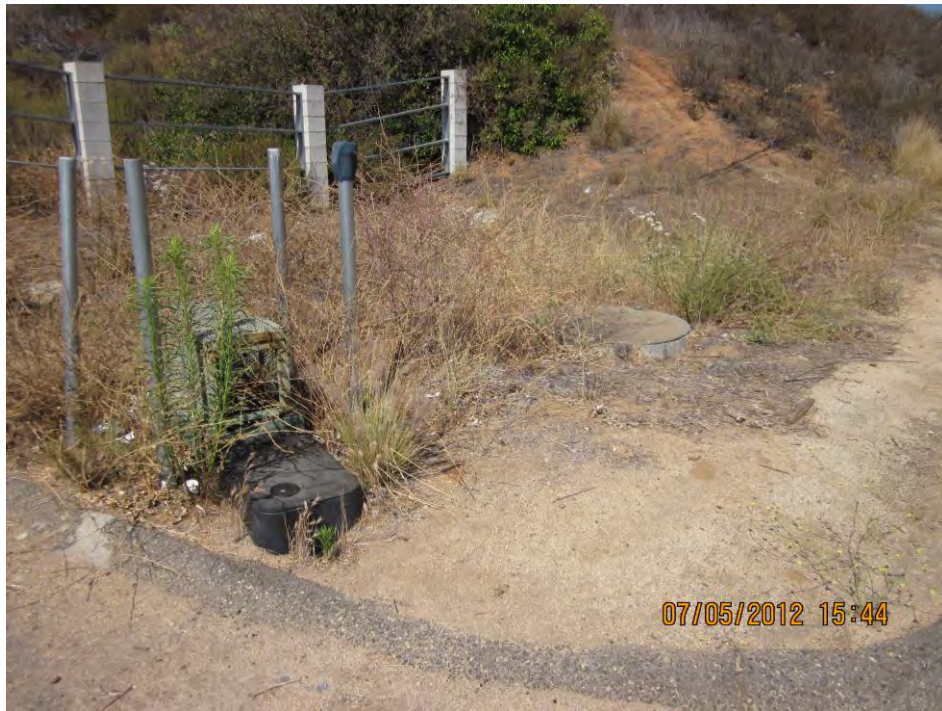
**Photograph 3** – Northeasterly view of utilities situated at the east edge of the driveway to 8268 W. Lilac Road. Note unmarked manhole to the right of the water valve box.

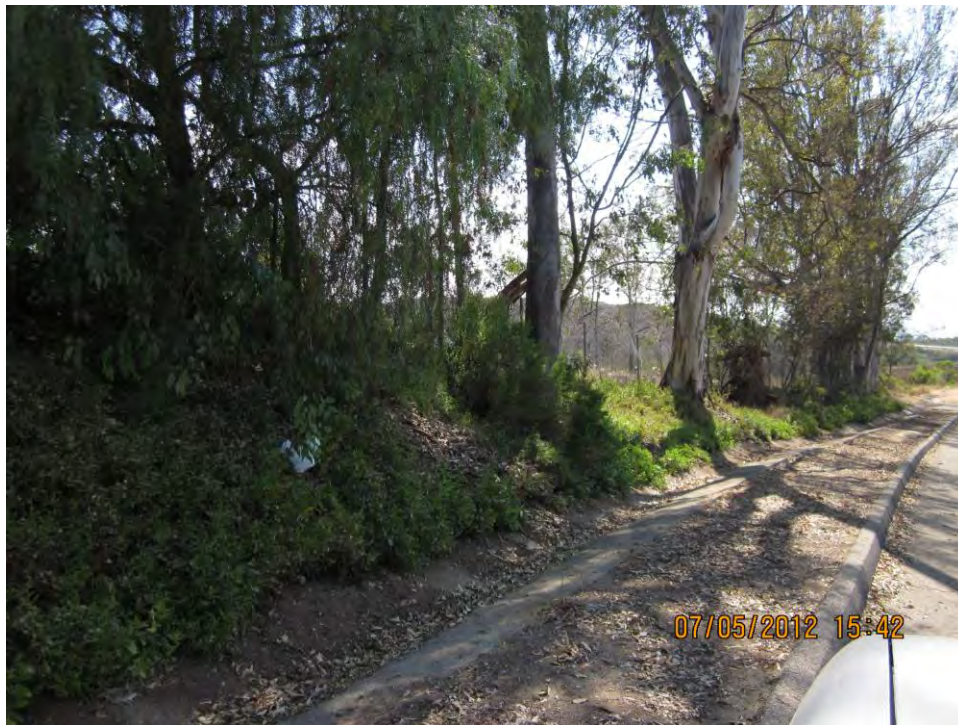
**Photograph 4** – Westerly view of concrete drainage swale along the south edge of W. Lilac Road east of I-15.

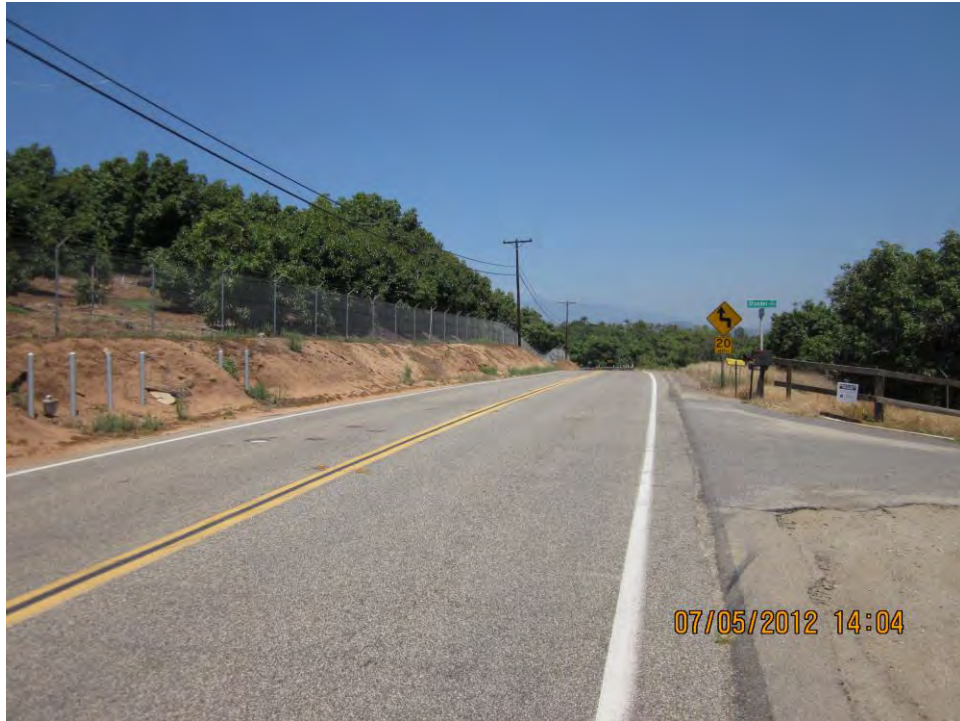
**Photograph 5** – Easterly view along the southern edge of W. Lilac Road with Standel Lane visible in right photo. Note water utilities along north (left) side of roadway.

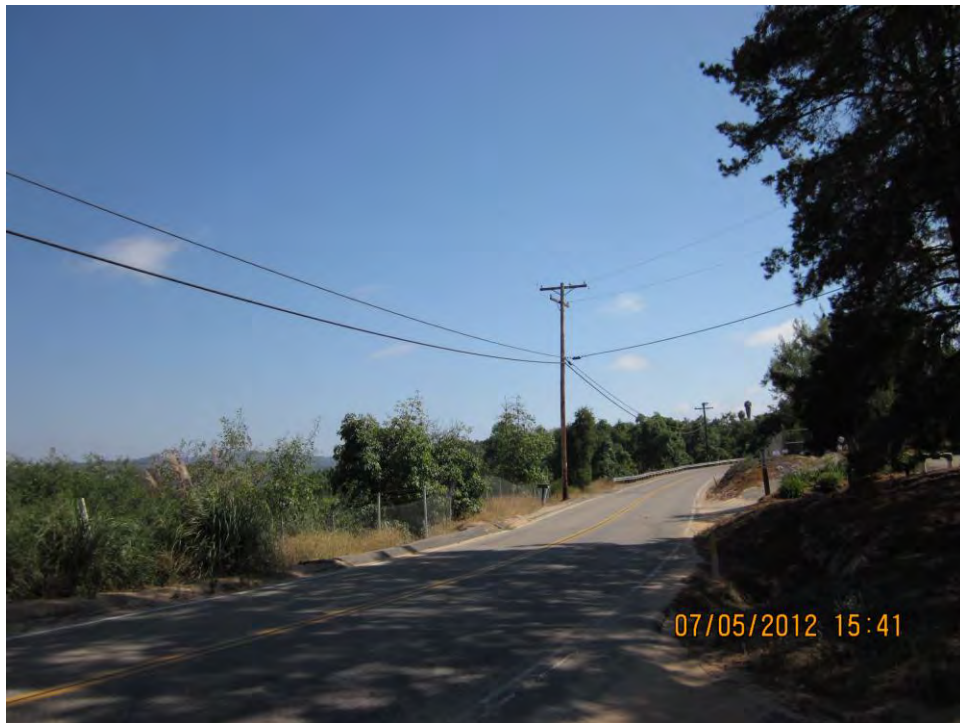
**Photograph 6** – Southerly view of West Lilac Road towards the easterly end of the project near guard rail in background.

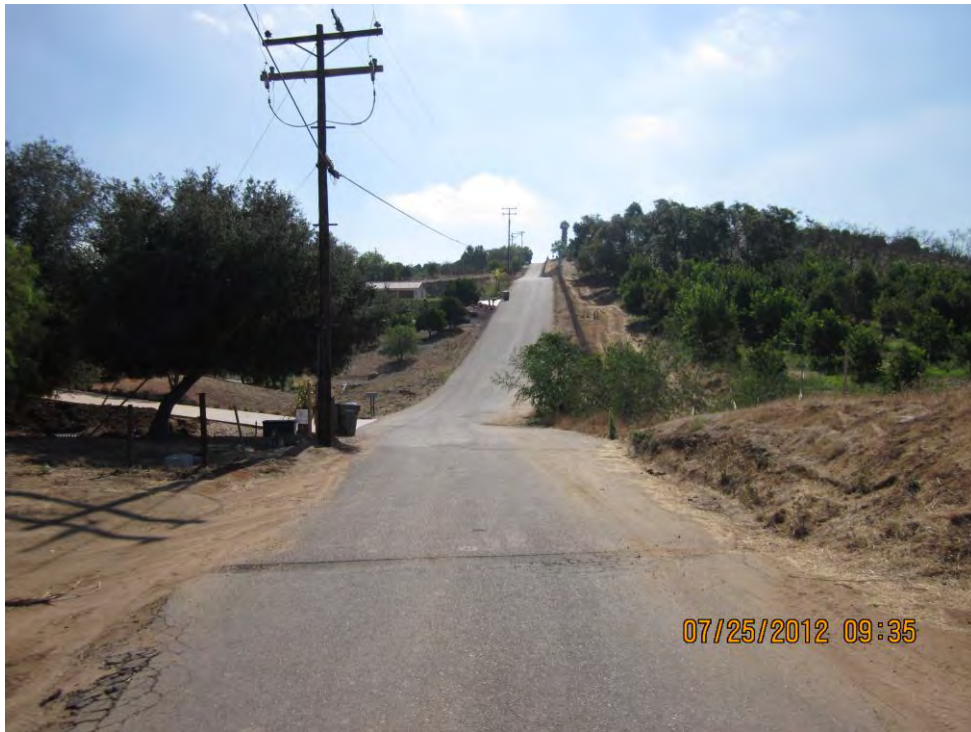
**Photograph 1** – East view along Covey Lane showing the western limits of the subject property. Concrete driveway to 9542 Covey Lane visible in left photo.

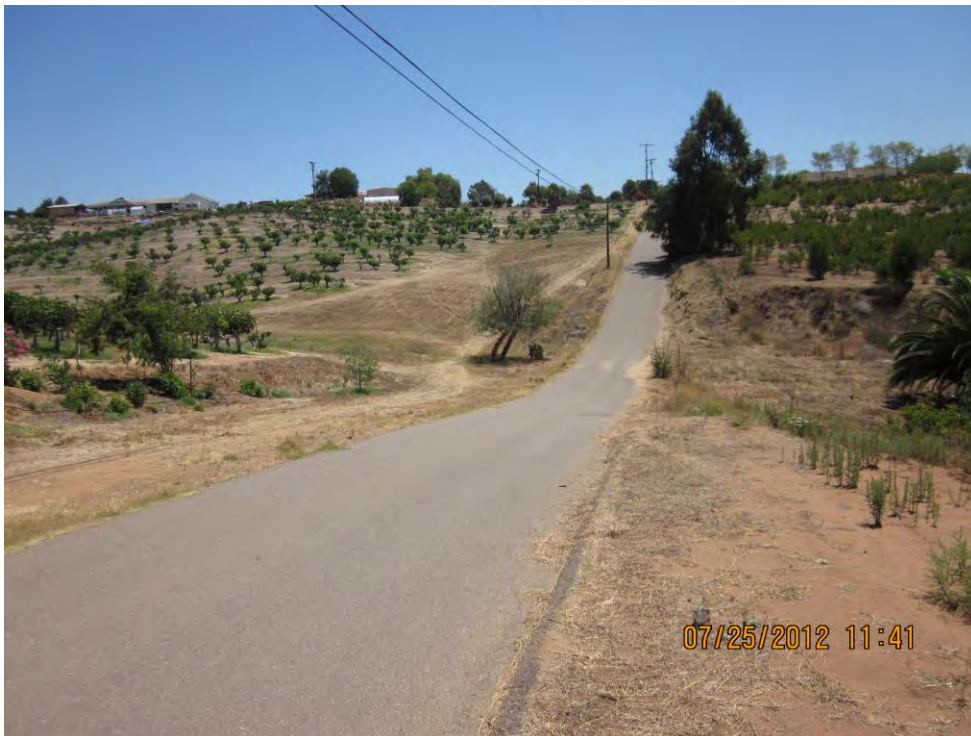
**Photograph 2** – Northeasterly view of the east central canyon area on Covey Lane.

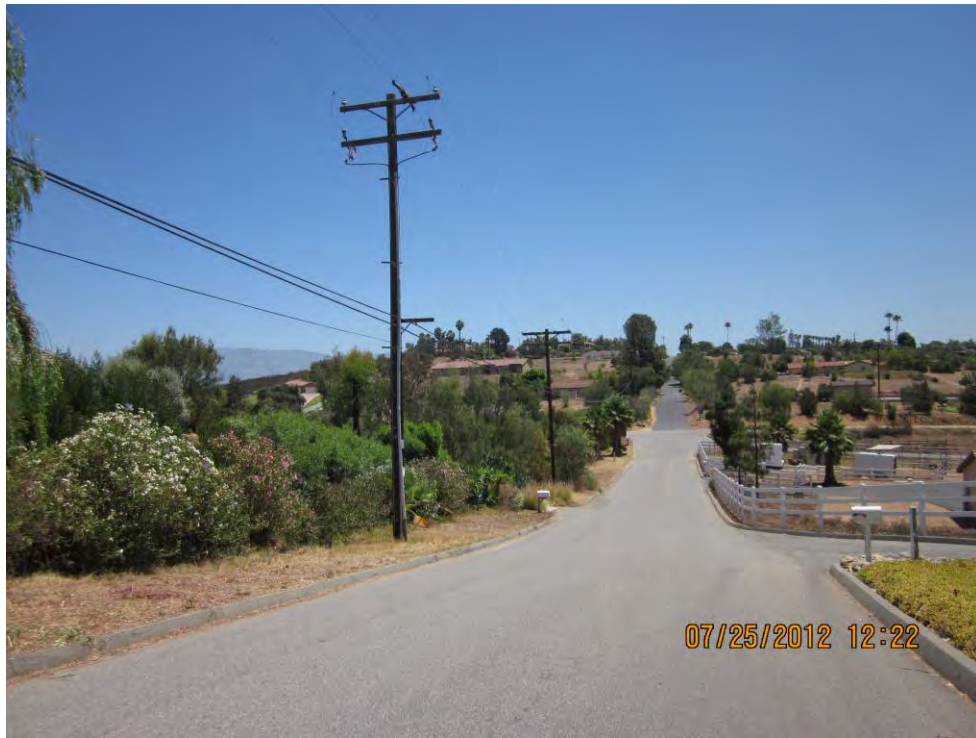
**Photograph 3** – East view of the eastern portion of Covey Lane. Driveway to 9825 Covey Lane visible in right photo. Intersection with Lilac Road visible in background.

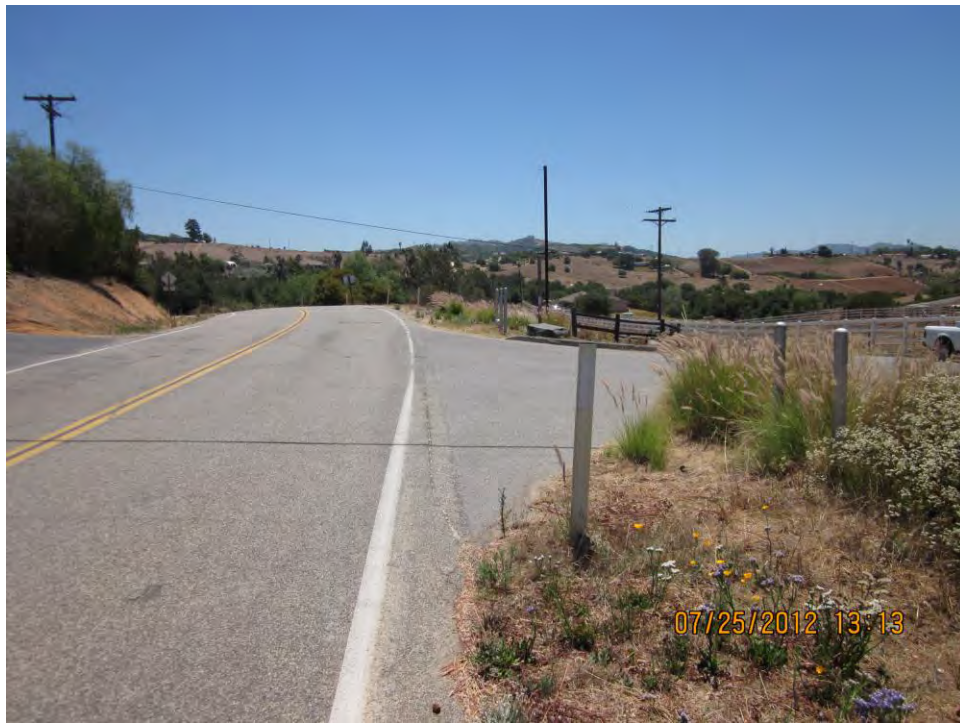
**Photograph 4** – South view along west edge of Lilac Road showing Covey Lane in right photo.

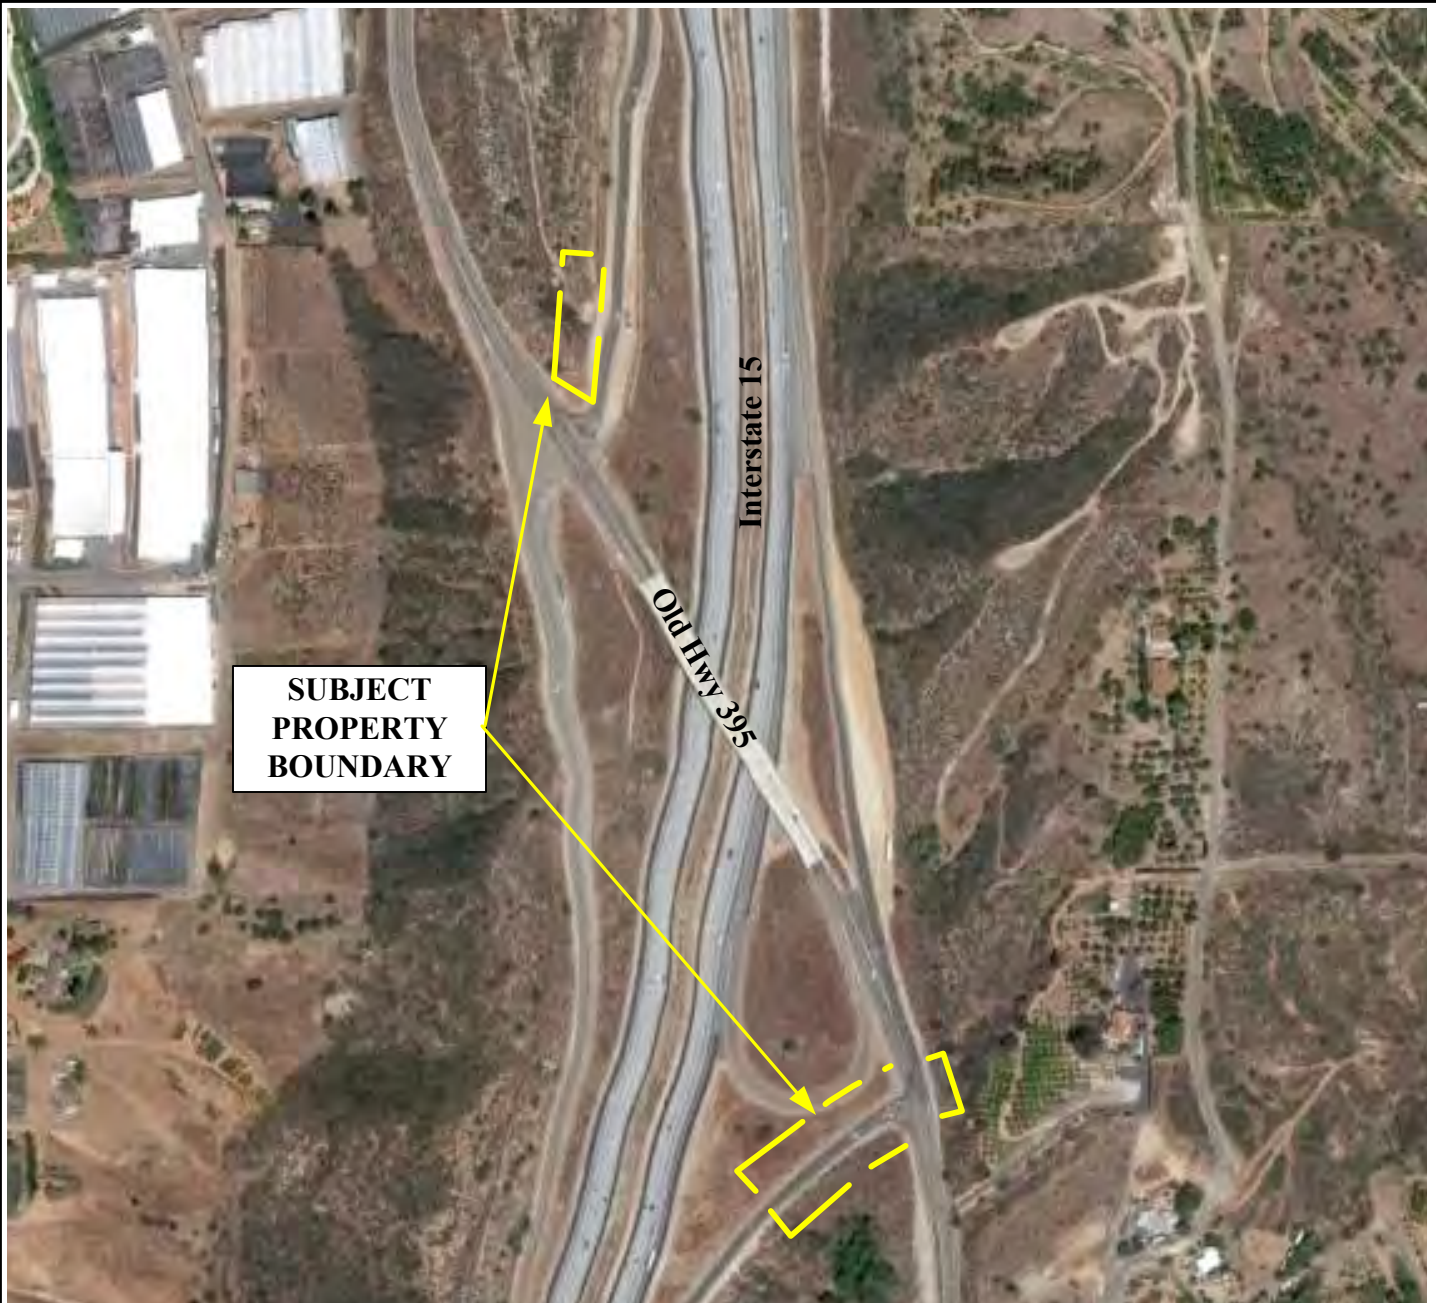
**FIGURE 2**

Aerial photographs and historical topographical maps were reviewed to identify historical land development and any surface conditions which may have impacted the subject property. Photographs and historical topographic maps dating 1946, 1948, 1951, 1953, 1963, 1968, 1975, 1976, 1980, 1990/91, 2002, 2008, and 2012 were obtained and reviewed from Track Info Services/FirstSearch®, an environmental information/database retrieval service. A 2010 aerial photograph was obtained from Google Earth®. and reviewed, a copy of which is included herein (**Figure 2**).

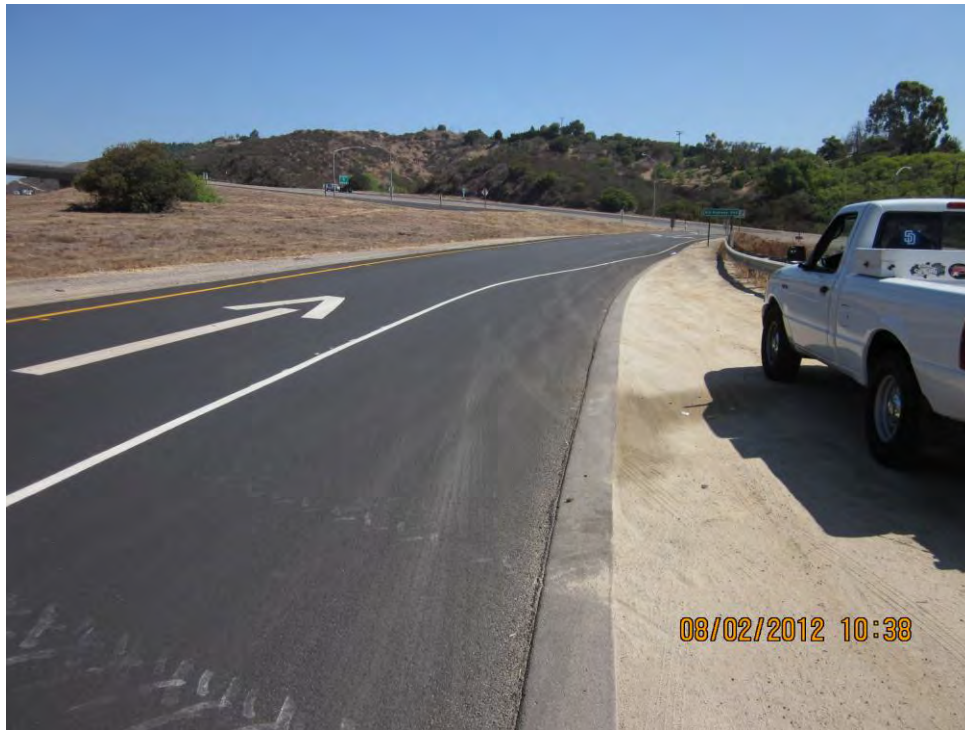
**Photograph 1** – East view along the southern edge of the northbound I-15 off ramp to Old highway 395.

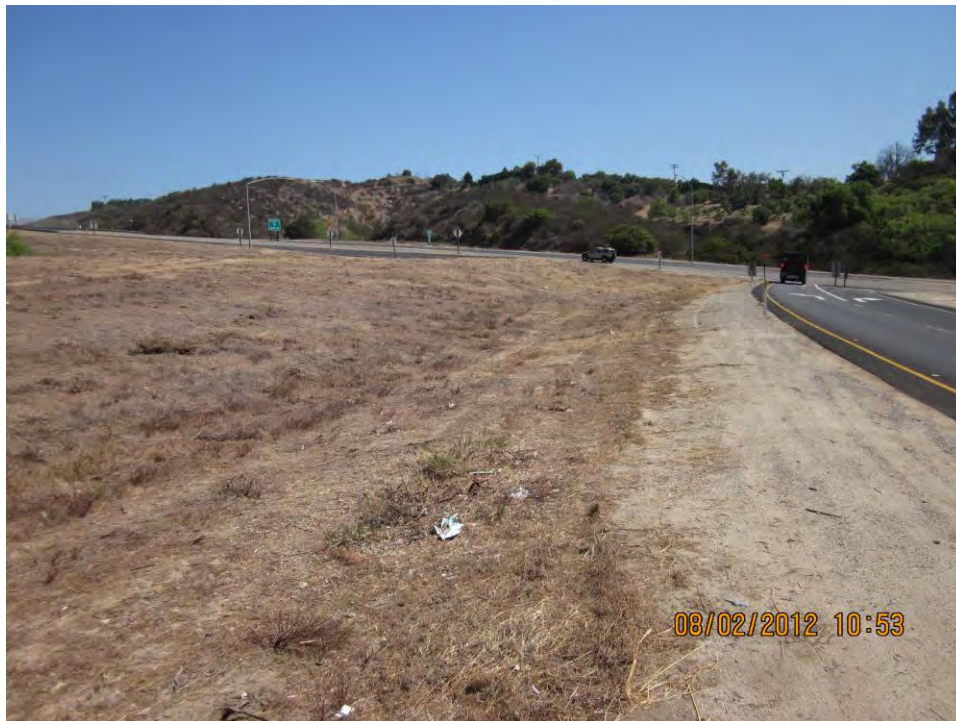
**Photograph 2** – East view along the northern edge of the northbound I-15 off ramp to Old Highway 395 showing drainage swale.
