# **PHASE I ENVIRONMENTAL SITE ASSESSMENT and LIMITED SOIL INVESTIGATION**

**Accretive Investments, Inc.  
Lilac Hills Ranch Development  
Roadway Expansion Property**

**Gopher Canyon Road and Interstate 15 Intersections;  
Old Highway 395 from Gopher Canyon Road  
North to Circle R Drive, Escondido, California 92026**

**EEI Project Number ACR-71497.2a**

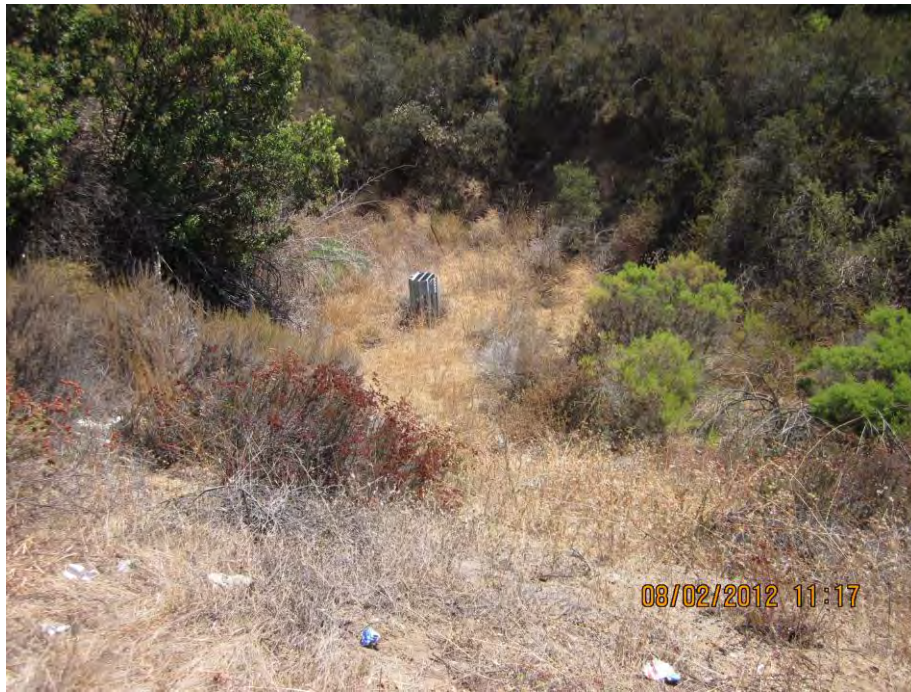
**Photograph 3** – Northeasterly view of stormdrain riser inlet situated east of the eastern edge Old Highway 395 opposite the northbound I-15 off ramp to Old Highway 395.

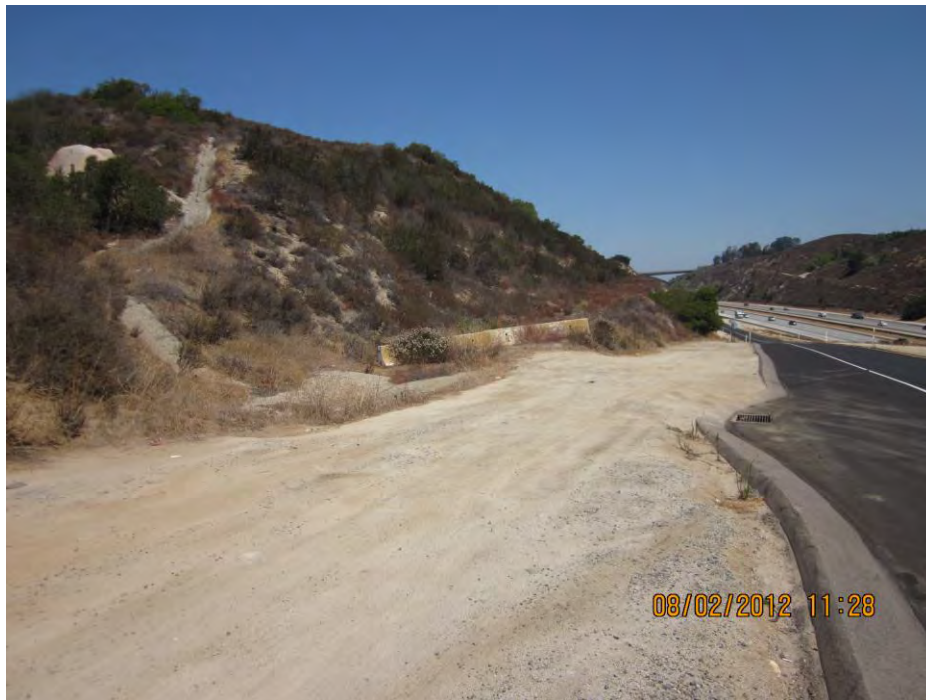
**Photograph 4** – North view along the southbound I-15 off ramp for Old Highway 395. Note 3 drainage structures (i.e., grate inlet; concrete-pave inlet basin; and concrete-paved swale) near northerly end of proposed improvement area.
