# WETLAND DETERMINATION DATA FORM – Arid West Region

Project/Site: Las Lilas City/County: San Diego County Sampling Date: 3/10/11  
 Applicant/Owner: Acres-Live State: CA Sampling Point: 30  
 Investigator(s): G. Schindler Section, Township, Range: \_\_\_\_\_  
 Landform (hillslope, terrace, etc.): Valley bottom Local relief (concave, convex, none): Concave Slope (%): 0-5  
 Subregion (LRR): LRR-C Lat: \_\_\_\_\_ Long: \_\_\_\_\_ Datum: \_\_\_\_\_  
 Soil Map Unit Name: Steep gullied land / fine to coarse sandy loam NWI classification: \_\_\_\_\_

**RPO Wetland Crossing Findings Analysis**

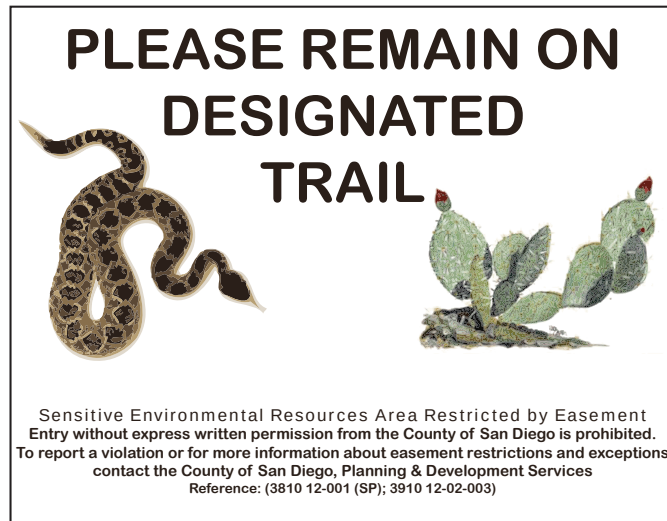
SIGN 'A'

1. SIGNS SHALL BE MANUFACTURED OF ALUMINUM SHEET, THICKNESS 0.08" MIN.
2. SIGNS WILL INCORPORATE BACKGROUND TO MATCH FRAZEE 8200W BLEACHED SAND. GRAPHIC AND LETTERING COLOR TO BE VERIFIED WITH OWNER.
3. SIGNS SHALL BE MOUNTED ON 4"x4" POSTS WITH BOTTOM EDGE 36" ABOVE GRADE.
4. ATTACHMENT TO POSTS USING 1/4" X 2-1/2" ANODIZED LAG SCREWS AND WASHERS (2 EA.)
5. SIGNAGE WILL BE SPACED @ 200' O.C. (MAX.) ALONG TRAIL
