At the request and authorization of Accretive Investments, Inc. (“Client”), EEI conducted a Phase I Environmental Site Assessment (ESA) for the property located at 9151 and 9153 West Lilac Road, and 32444 Birdsong Drive, Escondido, California. The purpose of this Phase I ESA was to assess the presence or likely presence of an existing, historical, or threatened release of any hazardous substances or petroleum products into structures, soil, and/or groundwater beneath the subject property, to the extent practical (i.e., *recognized environmental conditions* as delineated in ASTM E1527-05).

The purpose of this Phase I Environmental Site Assessment (ESA) was to assess the possible presence of *recognized environmental conditions* at the property located at 9151 and 9153 West Lilac Road, and 32444 Birdsong Drive, Escondido, California (**Figure 1**). *Recognized environmental conditions* include those property uses that may indicate the presence or likely presence of an existing, historical, or threatened release of any hazardous substances or petroleum products into structures, soil, and/or groundwater beneath the property. The term *recognized environmental conditions* are not inten

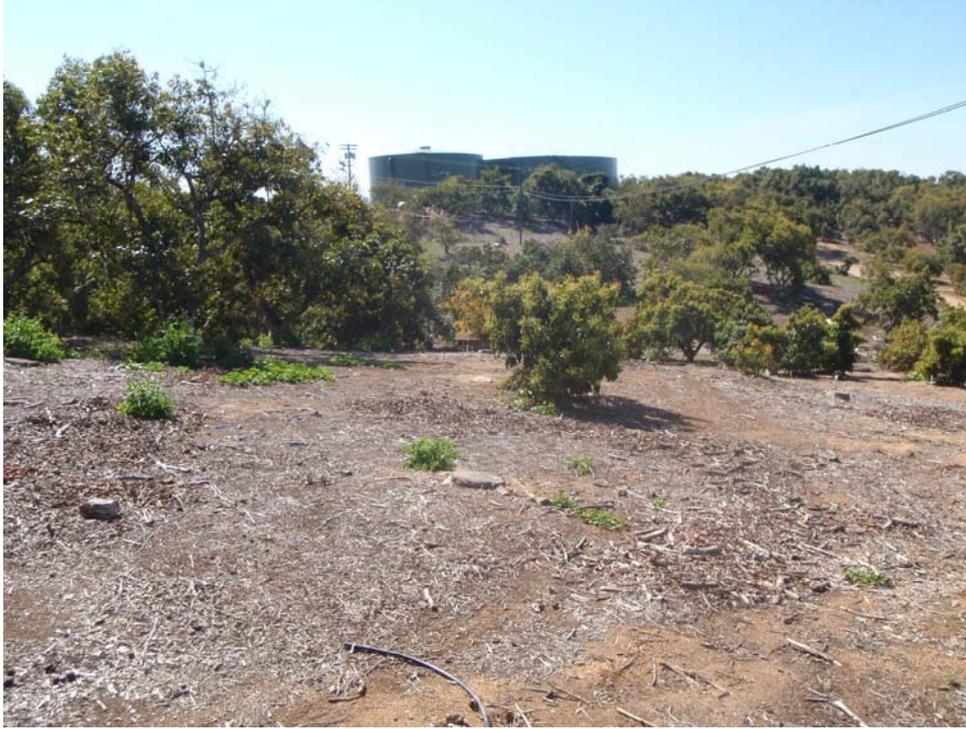
**Photograph 1** – View of the subject property looking south. View is from the northwest corner of the property. Overhead power lines are in view.

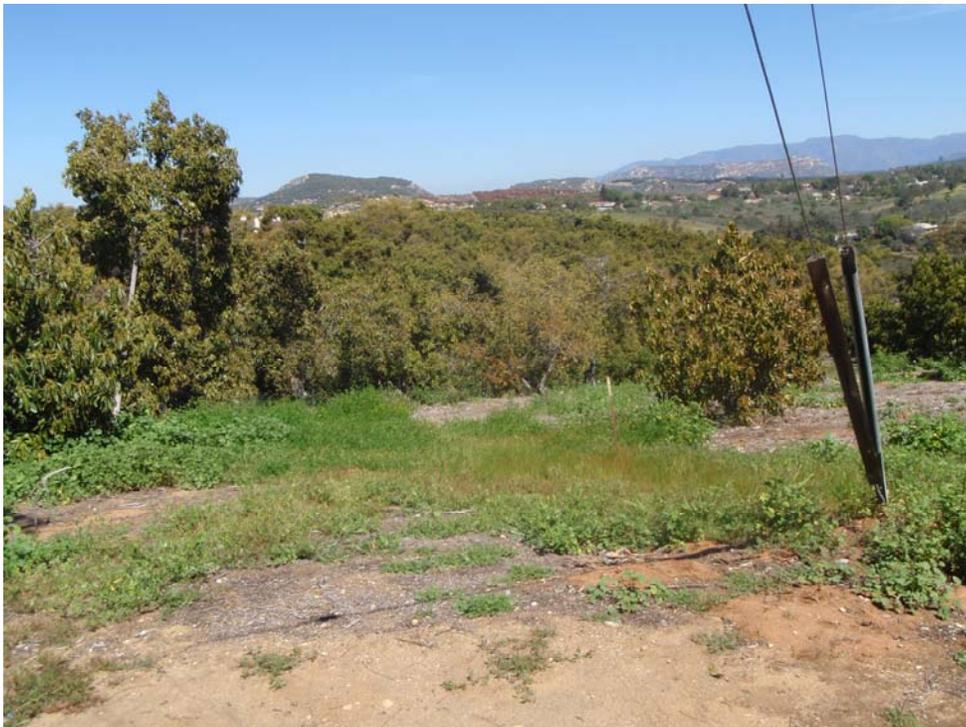
**Photograph 2** – View of the subject property looking northeast. View is from the southwest corner of the property.

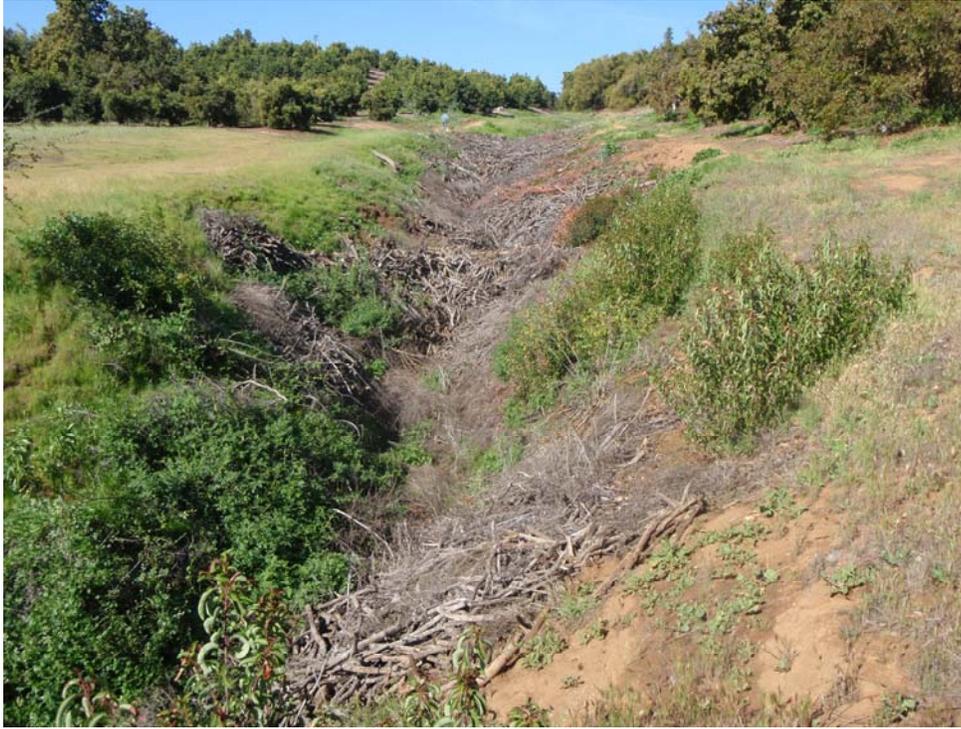
**Photograph 3** – View looking west towards the central drainage from the eastern edge of the property.

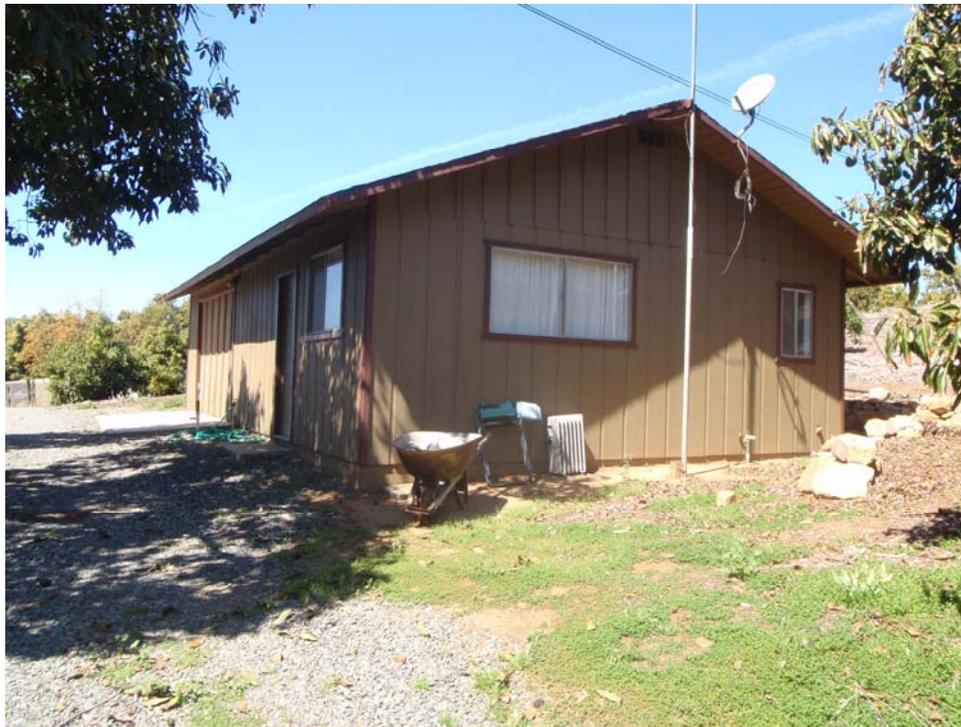
**Photograph 4** – View of a structure utilized as a staging area for agricultural workers located on the west-central portion of the property.

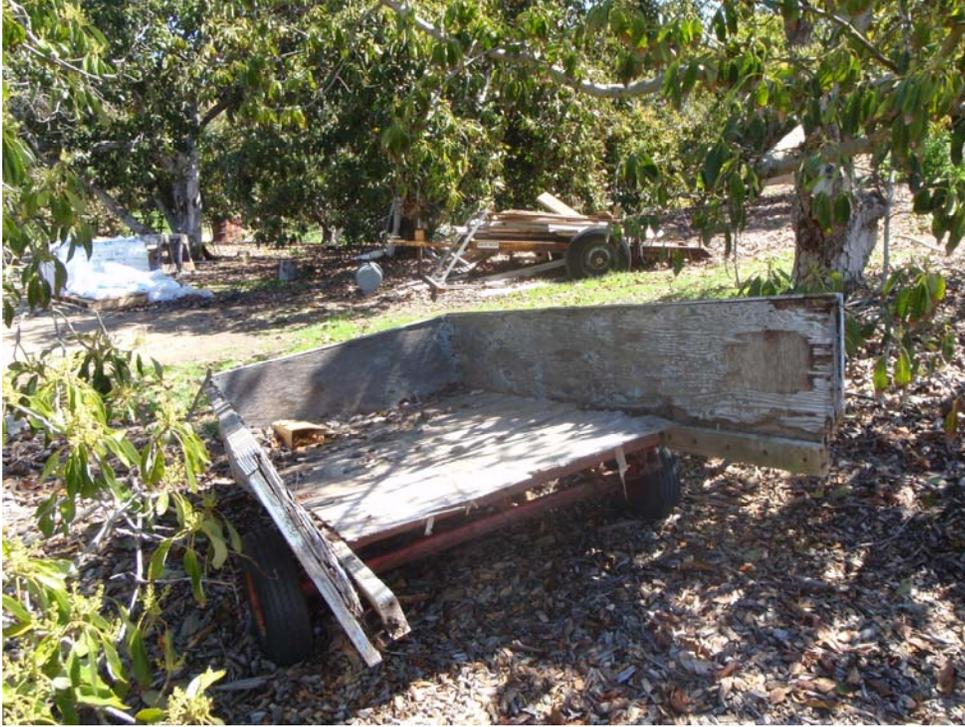
**Photograph 5** – View of a trailer and construction materials in the western central portion of the property.

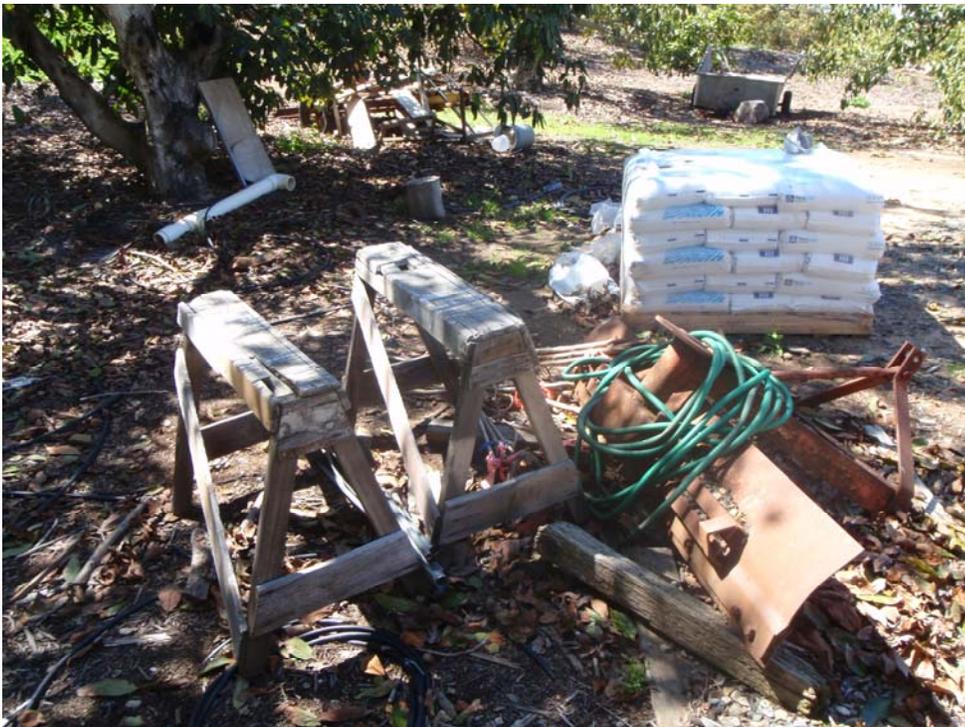
**Photograph 6** – View of construction equipment and a pallet of calcium nitrate fertilizer on the western central portion of the site.

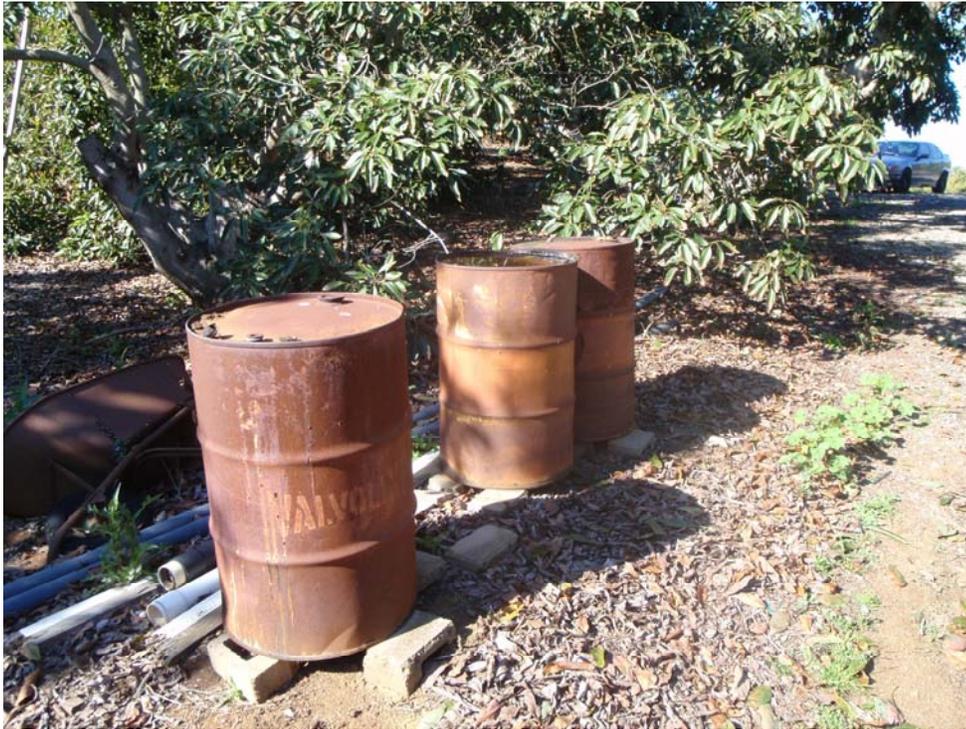
**Photograph 7** – View of 55-gallon storage drums (two full) and piping located on the western central portion of the property. Drums are labeled “Valvoline.”

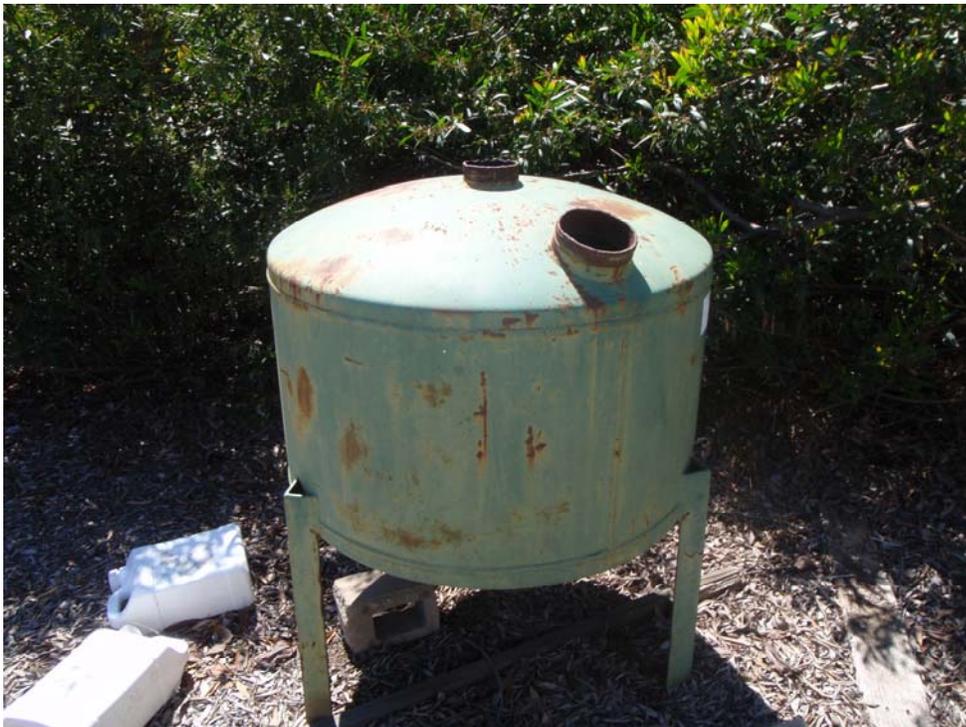
**Photograph 8** – View of metal AST (filled with sand) located on the southwestern portion of the site. Empty phosphorous acid fertilizer containers are in view.

- An AST, currently empty, is present along the central portion of the subject property. No signs of leakage or staining were noted on the tank or on the ground surface below; therefore, no further investigation appears to be warranted. EEI recommends that the AST be removed from the property and properly disposed of off-site.
- Portions of the subject property have and continue to be utilized for agricultural purposes. Based on the future planned property use (residential), additional investigation efforts (i.e., soil sampling and analysis) were performed to further evaluate site soils for restricted agriculture chemical residues. EEI conducted limited soil sampling in areas not previously investigated. The results of EEI's sampling did not reveal concentrations of arsenic, lead, or organochlorine concentrations in excess of residential screening levels.

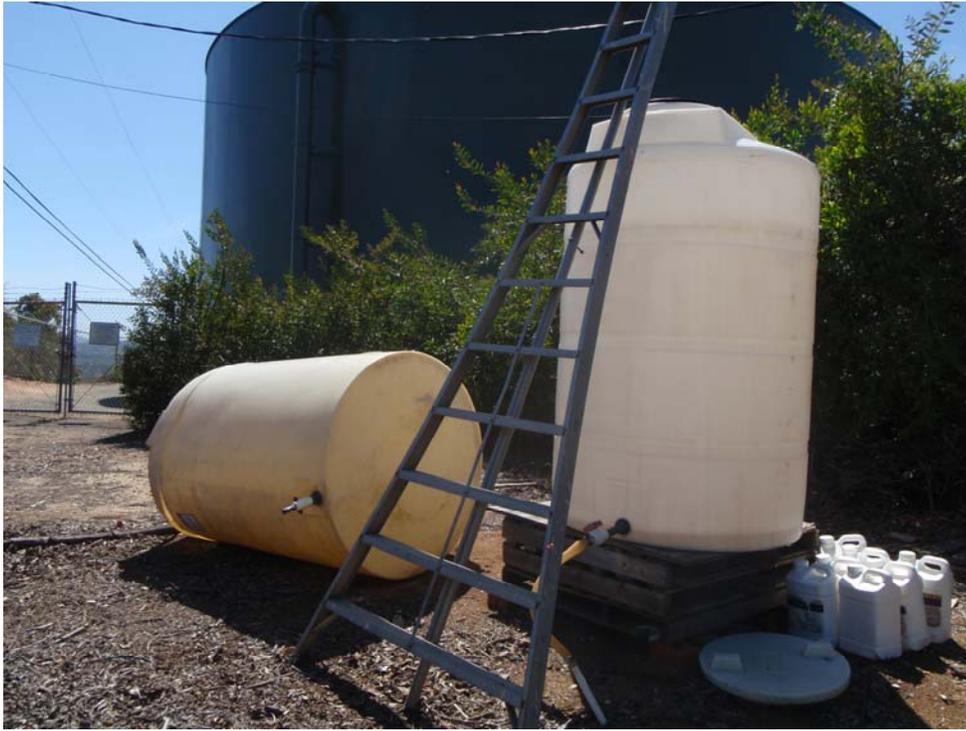
**Photograph 9** – View of plastic ASTs and phosphorous acid fertilizer located on the southwestern portion of the property. Water tanks in the background are not part of the Phase I ESA.

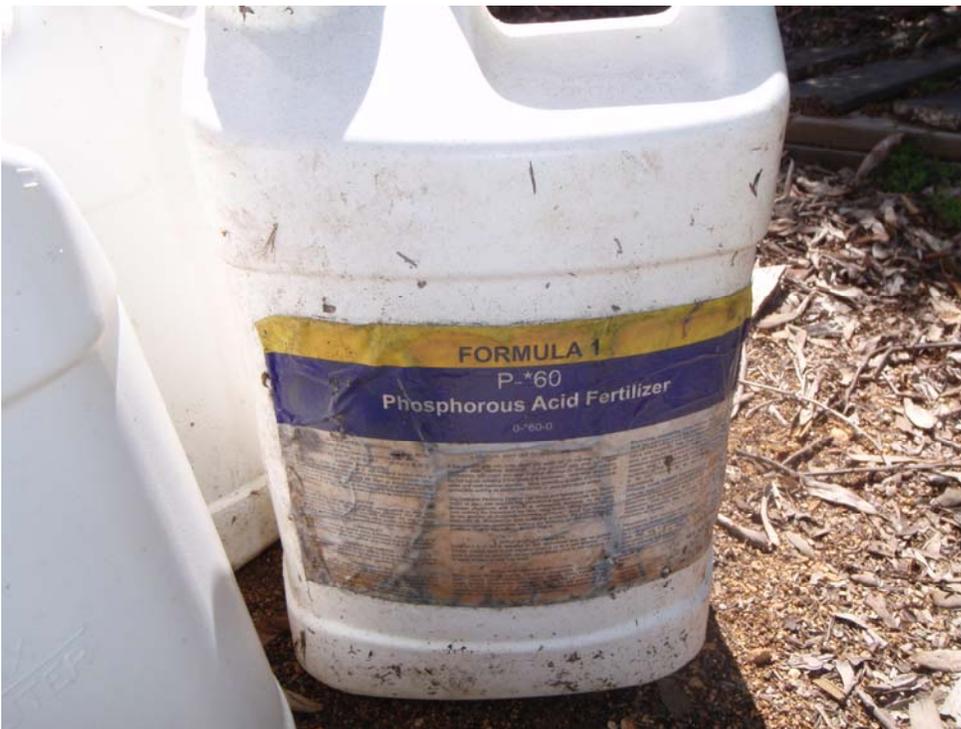
**Photograph 10** – Phosphorous acid fertilizer located on the southwestern portion of the property.
