We have performed a Phase I Environmental Site Assessment (ESA) in conformance with the scope and limitations of ASTM Designation E1527-05 for the subject property located at 9007 West Lilac Road, Escondido, California. Any exceptions to, or deletions from, this practice are described in Section 6.0 of this report. Phase I ESA has revealed no evidence of *recognized environmental conditions* in connection with the property, except for the following:

1.0 INTRODUCTION

The purpose of this Phase I Environmental Site Assessment (ESA) was to assess the possible presence of *recognized environmental conditions* at the property located at 9167 West Lilac Road, Escondido, California (**Figure 1**). *Recognized environmental conditions* include those property uses that may indicate the presence or likely presence of an existing, historical, or threatened release of any hazardous substances or petroleum products into structures, soil, and/or groundwater beneath the property. The term *recognized environmental conditions* are not intended to include *de minimis* conditions that generally do not present a material risk of harm to public health or the environment and that would not be subject

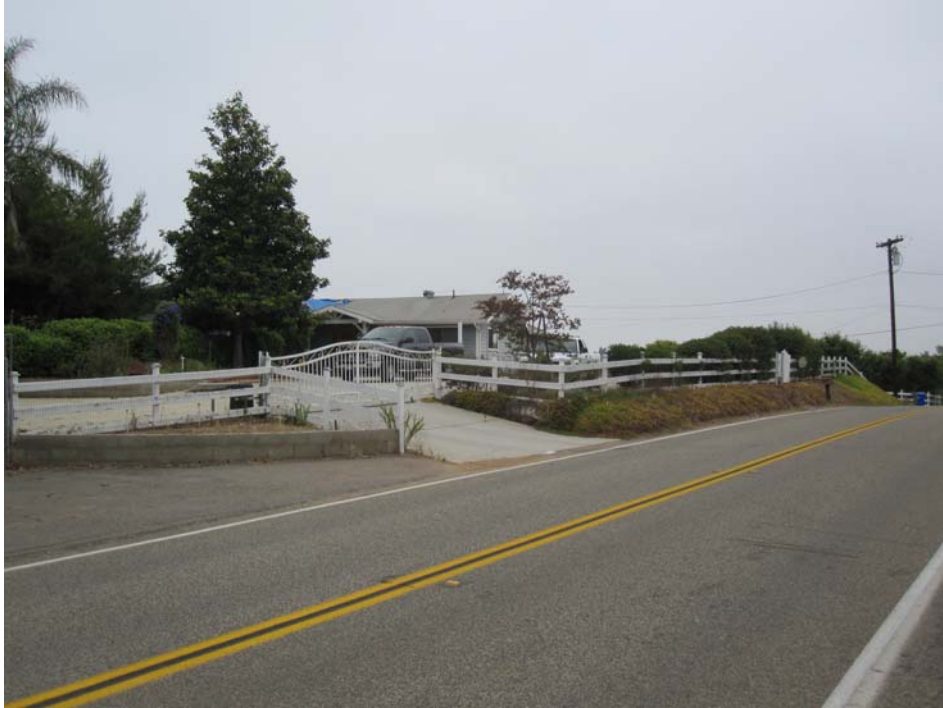
The northern portion of the subject property is currently developed with three (3) structures that consist of a single story residence, detached garage, and detached shop. The structures are constructed of stucco and wood-framed. A swimming pool is located along the southeast portion of the main residence. A total of five (5) vehicles were observed in the area of the residence. All of the vehicles, except for a truck located along the northeast corner of the subject property appeared to be in good operating condition. Small quantities of trash and debris were noted along the south side of the detached garage and shop buildings. Additionally, EEI observed small quantities of household cleaning products, anti-freeze, paint, tires, and construction debris.

Photograph 1 – View of the subject property residence located on the north-central portion of the subject property. View is to the southwest.

An ACM survey was not conducted at the subject property as part of this Phase I ESA. Based on aerial photograph data, the structures located along the northern portion of the subject property appeared to have been constructed circa-1975. Therefore, it is likely that ACM is present within materials such as floor tiles, wallboard, and roofing. If future improvements or demolition activities are conducted on the subject property structures, EEI recommends ACM testing of building materials prior to improvements.

Based on the age (circa-1975) of the structures located along the northern portion of the subject property, the potential presence of lead-based paint may exist. Painted surfaces, however, appeared to be intact and in good condition at the time of our most recent subject property reconnaissance. If future improvements or demolition activities are conducted on the subject property structures, EEI recommends lead-based paint testing of building materials prior to improvements.

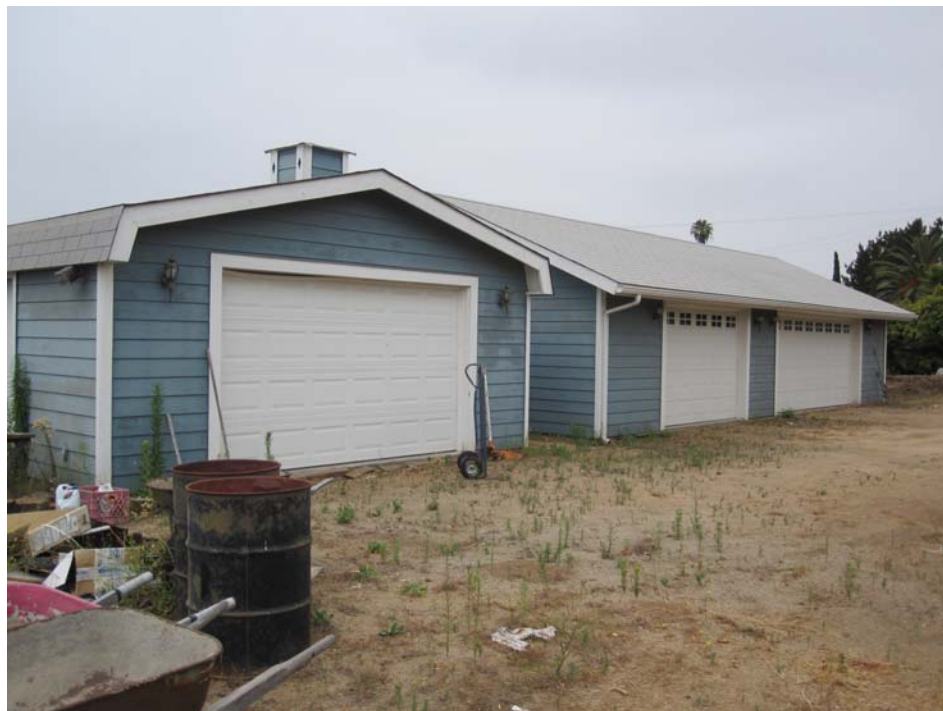
Photograph 2 – View of the detached garage and shop buildings located southwest of the residence.

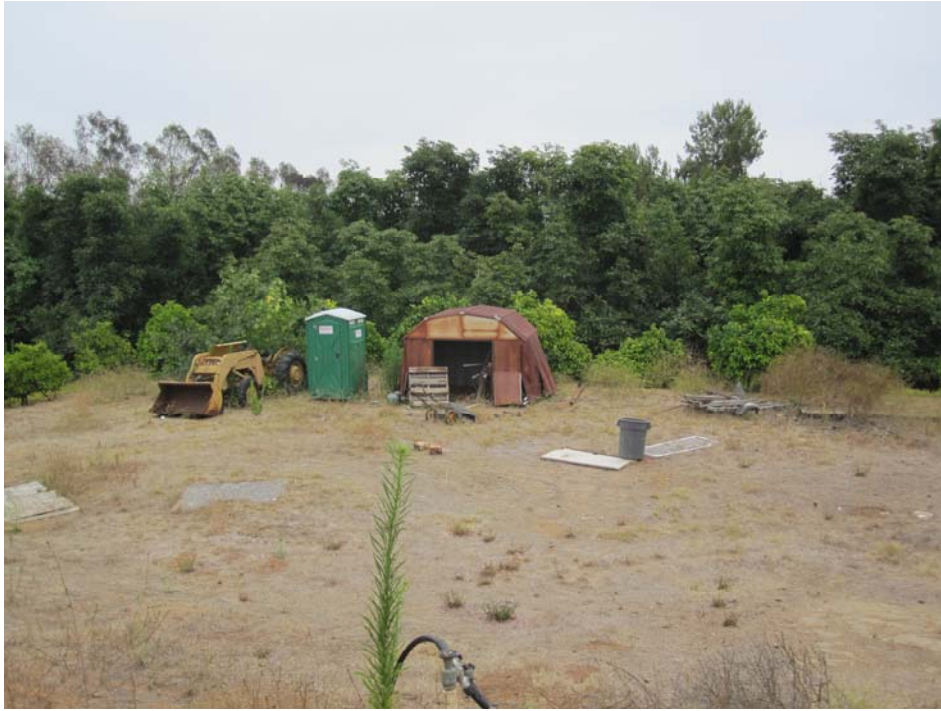
Immediately south of the residence is a terraced area. A small tractor was observed in this area. No signs of fuel or oil leakage were observed beneath the tractor. To the west of the tractor are a fiberglass port-a-potty and a metal storage shed. The storage shed contained two (2) empty metal fuel cans (no stained soils were observed) and various irrigation parts (e.g., piping and valves). Two (2) additional fuel containers were noted to the north of the shed. The containers were empty and no stained soils were observed beneath of them.

Photograph 3 – View of a tractor, fiberglass port-a-potty, and metal storage shed located south of the residence. View is to the south.

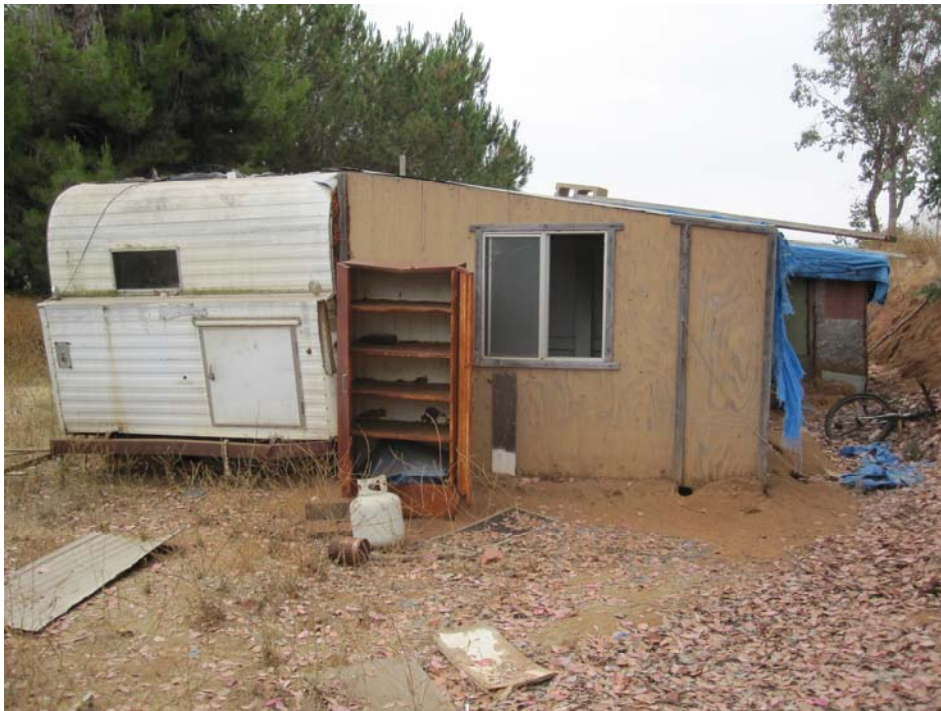
A small travel trailer that has been added on to is situated along the western property boundary. The trailer was unoccupied and appeared to be used as a residence for agricultural workers. EEI observed a sewer or gray line that exited the trailer on the east side and connected to an underground pipe.

Photograph 4 – View of the trailer and add-on located along the western property boundary. View is to the south.

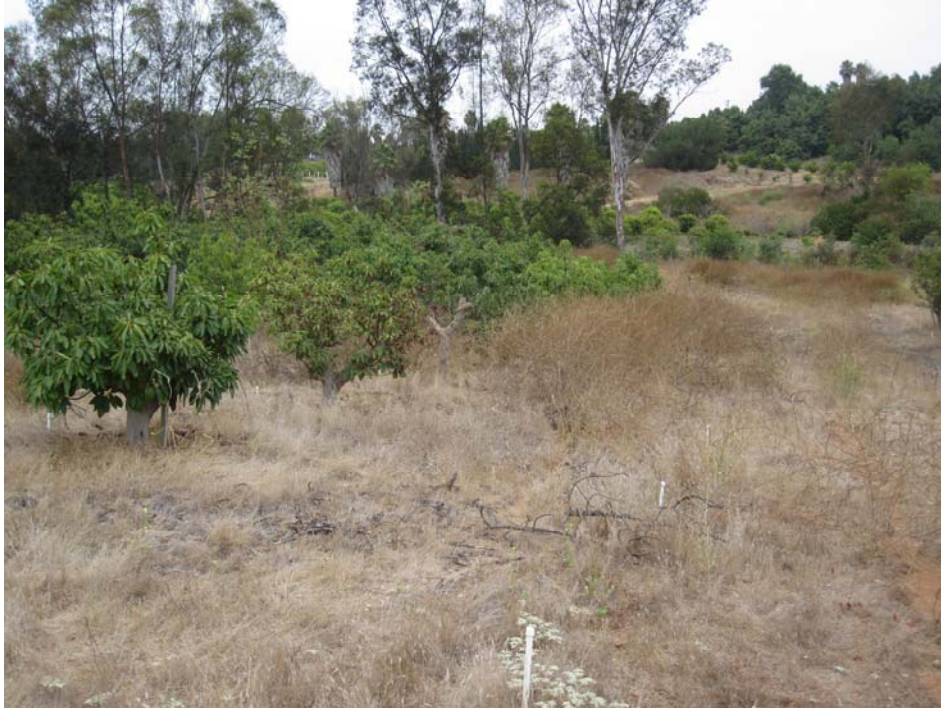
The balance of the subject property is comprised of citrus and avocado trees, undeveloped areas, and gently sloping terrain. EEI observed signs of above and below ground irrigation piping throughout the orchards. Overhead power lines and a single pole-mounted transformer were observed along the northwest corner of the subject property, which provided electrical service to the main residence. The electrical transformer appeared to be in good operating condition and no signs of leaking were noted.

Photograph 7 – View of the orchards located in the central portion of the subject property.

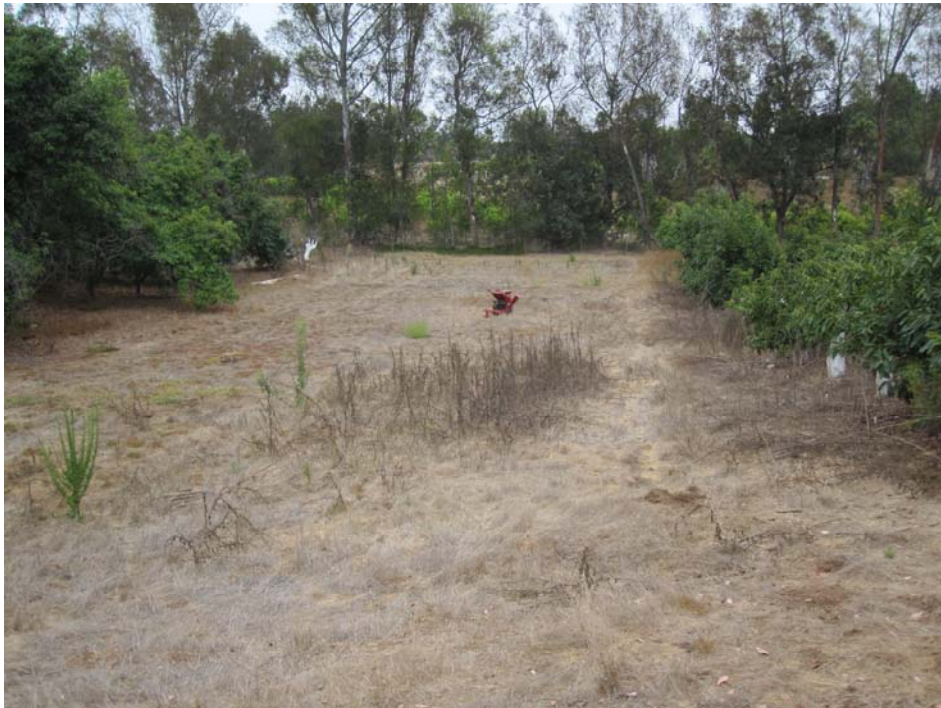
Photograph 8 – View of the orchards and a clearing within the central portion of the subject property. View is to the east.
