Revegetation Memo

To: Mark Hayden, WHP Warner Ranch LP
From: Vipul Joshi, Dudek
Subject: Warner Ranch—Preliminary Revegetation Plan
Date: July 19, 2013
cc: Ali Shapouri, Shapouri & Associates
Marcia Adams, Affinis
Attachment(s): Figure 1, Revegetation Plan

Subject: Warner Ranch – Preliminary Revegetation Plan

Conceptual Resource Management Plan for Warner Ranch

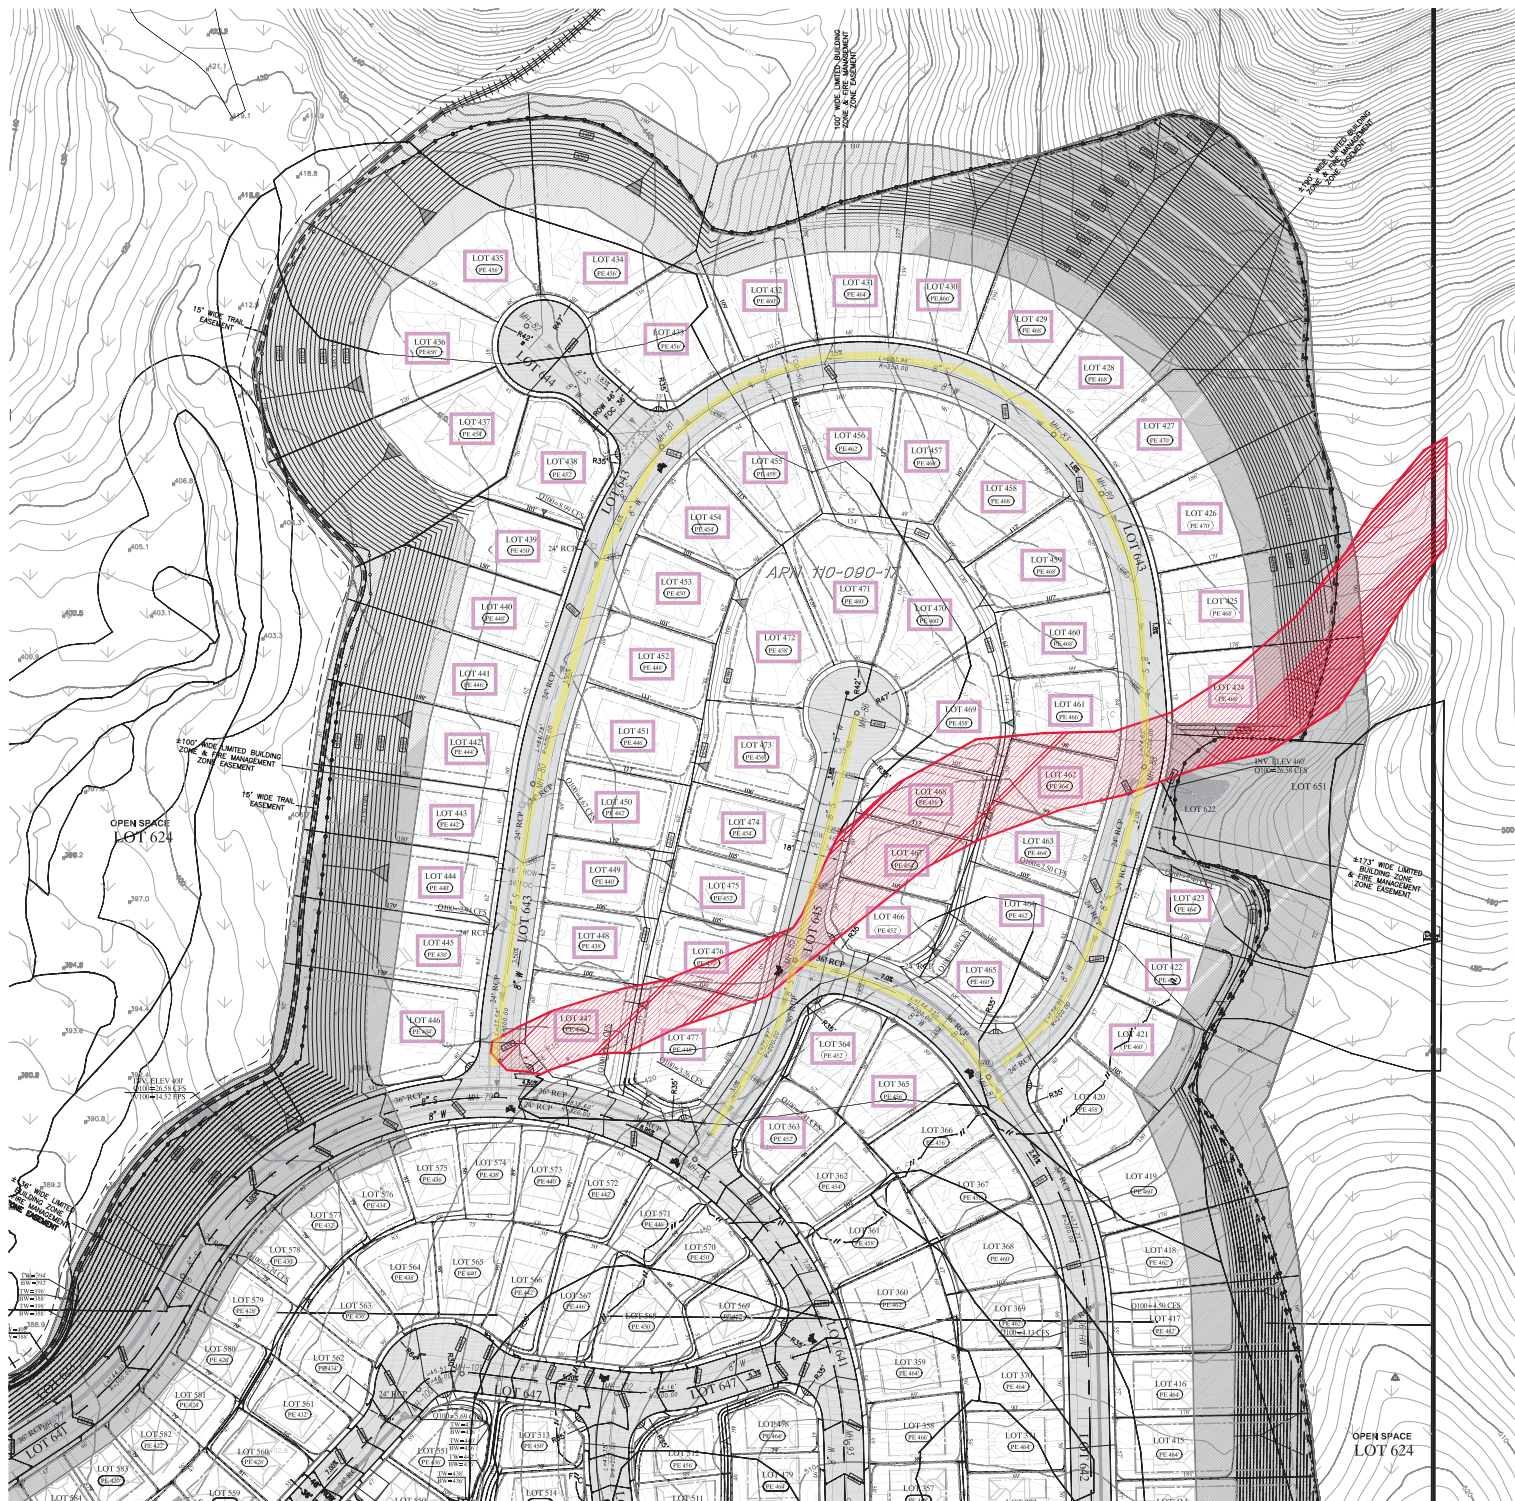
Exhibit "A"

LEGEND	SYMBOL
SUBDIVISION BOUNDARY	1/4"
PARCEL SECTION LINES	1/4"
PROPOSED LOT LINES	APN 10-090-01
PROPOSED RIGHT OF WAY	1/4"
INDIAN RES. BOUNDARY	1/4"
LIMITED BUILDING ZONE & FIRE MANAGEMENT ZONE EXEMPT (MIN. 100')	1/4"
OPEN SPACE	1/4"
OPEN SPACE EASEMENT	1/4"
AGRICULTURAL OPEN SPACE	1/4"
STREET CENTERLINE	1/4"
STREET SLOPE	1/4"
PROPOSED CONCRETE DITCH PER SORS 0-75	1/4"
CURB RAMP PER STD. DWG. 0-27	1/4"
LOT DIMENSIONS	1/4"
LOT NUMBER	LOT 355
LOT SETBACKS	1/4"
PAID ELEVATION	1/4"
PAID OUTLINE	1/4"
EXISTING GROUND CONTOURS	1/4"
EXISTING GROUND SPOT ELEVATION	1/4"
WATER VALVE TEE CONNECTION	1/4"
4" x 3" DIA. SEWER MANHOLE	1/4"
8" PVC WATER LINE	1/4"
8" GRAVITY SEWER LINE	1/4"
4" FORCE MAIN SEWER	1/4"
FINISHED GROUND CONTOURS	1/4"
FILL SYMBOL 2:1	1/4"
CUT SYMBOL	1/4"
PROPOSED KEYSTONE RETAINING WALL	1/4"
FIRE HYDRANT	1/4"
CROSS GUTTERS PER SORS 0-12	1/4"
DAYLIGHT LINE	1/4"
LIMITS OF GRADING	1/4"
ROP DRAINAGE PIPE	1/4"
PROPOSED EASEMENTS	1/4"

EXISTING AGRICULTURAL ROAD & TRAIL	1/4"
12' WIDE AGRICULTURAL ROAD & TRAIL	1/4"
8' WIDE PUBLIC TRAIL	1/4"
4' WIDE PRIVATE TRAIL	1/4"
BIO-INFILTRATION POND	1/4"
BIO-INFILTRATION SWALE	1/4"
PROPOSED PAVEMENT	1/4"
EXISTING PAVEMENT	1/4"
ROCK CATCHMENT FENCE	1/4"

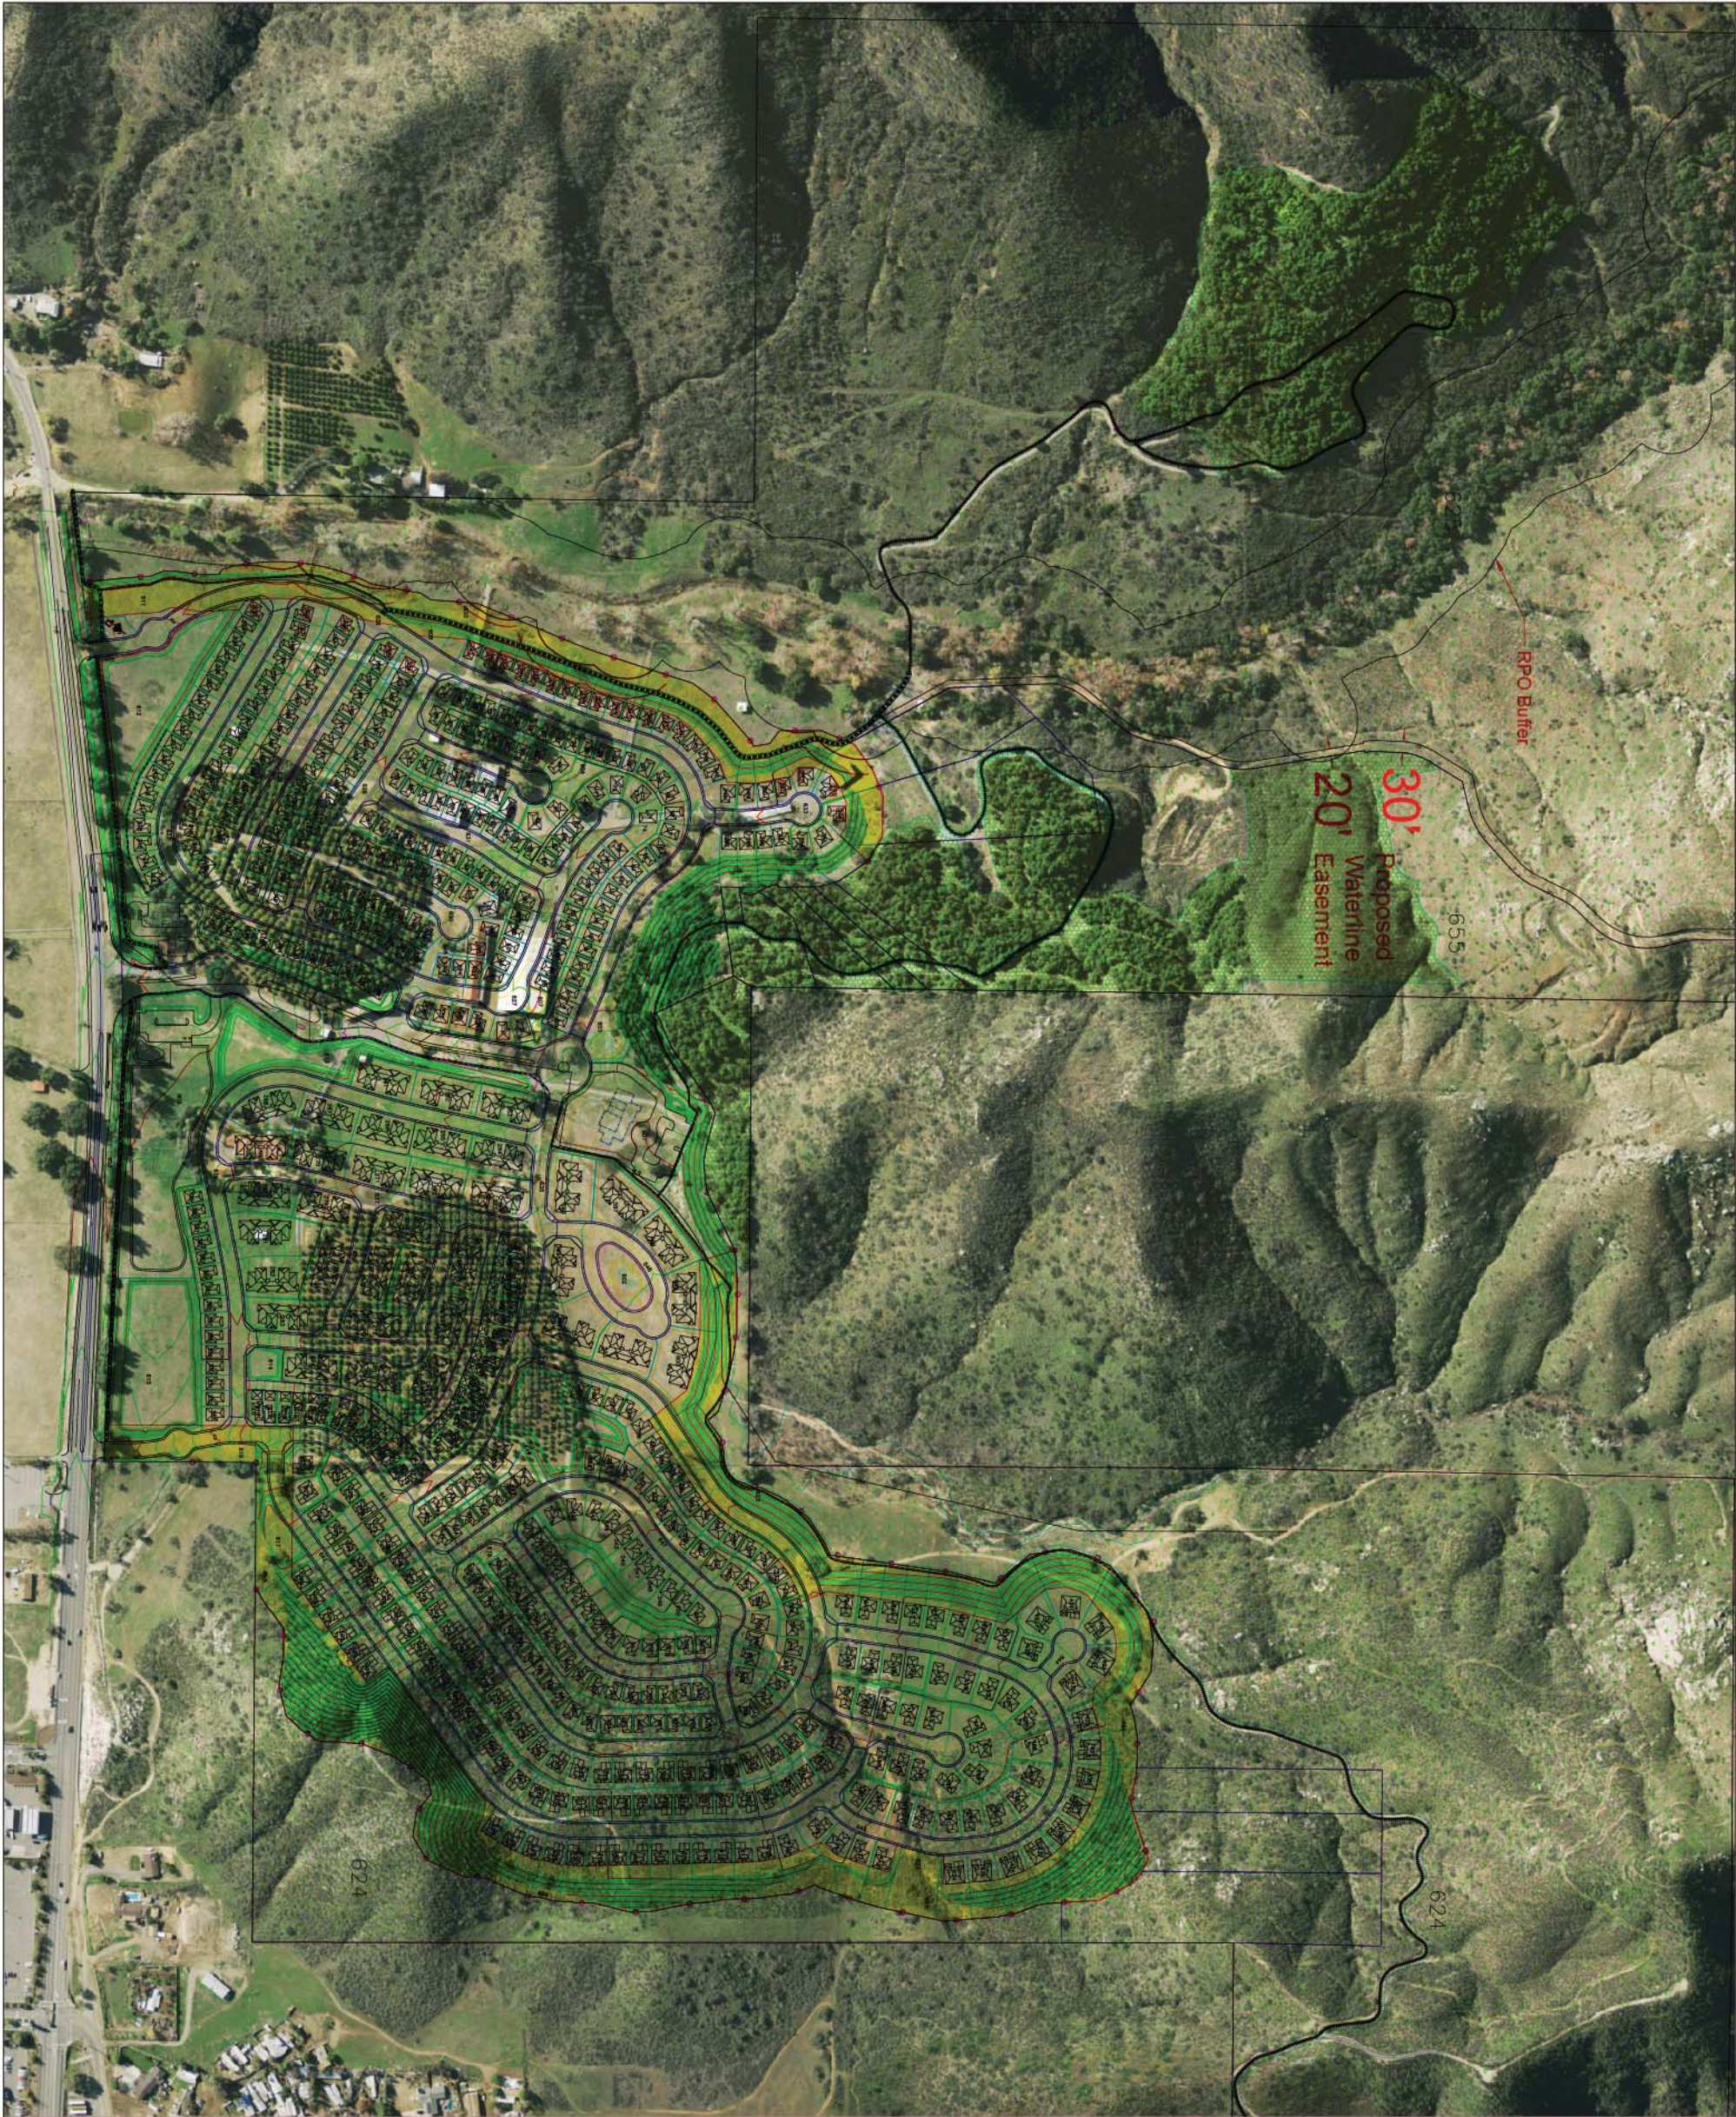
Southern cactus scrub occurs on gentle south-facing slopes on the project site (Figure 1). Southern cactus scrub is not described in Holland (1986) or Oberbauer et al. (2008). It is a rare form of coastal sage scrub, occurring in relatively isolated areas throughout San Diego County (e.g., Chula Vista, San Pasqual), as well as in other portions of Southern California and Baja California, Mexico. In the project area, this community consists of over 50% cover of prickly-pear cactus (*Opuntia littoralis*) and/or cholla (*Cylindropuntia prolifera*) with associated species typical of coastal sage scrub species and non-native grasses. Coastal sage scrub species present include California sagebrush (*Artemisia californica*), flat-top buckwheat (*Eriogonum fasciculatum*), and laurel sumac (*Malosma laurina*).

Several areas were identified for potential southern cactus scrub restoration that occur on south- or southwestern-facing slopes in existing orchards and coastal sage scrub. Areas identified for potential wetlands enhancement in the form of southern coast live oak riparian forest include riparian forest along Gomez Creek and oak woodlands in adjacent extensive agriculture areas (Figure 1).

A total of 3.50 acres of southern cactus scrub restoration areas are proposed, which will include one 2.40-acre site located along the parcel fence line on the northern side of the development footprint, adjacent to off-site habitat in the central portion of the site (Figure 1). Three smaller proposed restoration sites are located within pockets of open space throughout the corridor between the southeast preserve and the remainder of the site, which range in size from 0.28 to 0.52 acre.
