**PHASE I
ENVIRONMENTAL SITE ASSESSMENT**

**WARNER RANCH
10950 PALA ROAD
SAN DIEGO COUNTY, CALIFORNIA**

GEOCON PROJECT NO. 09536-06-01

MAY 13, 2005

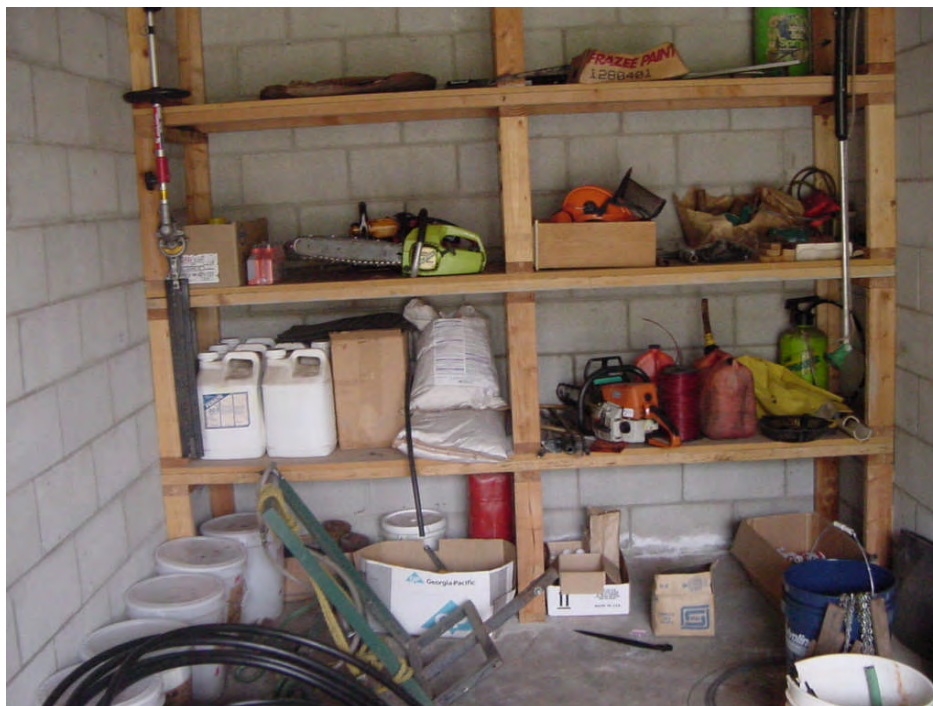
Small quantities of rodent bait and herbicide were stored in a hazardous material shed in the west-central portion of the Site. Small quantities of motor oil lubricants and irrigation supplies were also observed in garages and store rooms at the Site.

Photograph #1
Hazardous materials storage garage in west-central portion of the Site.

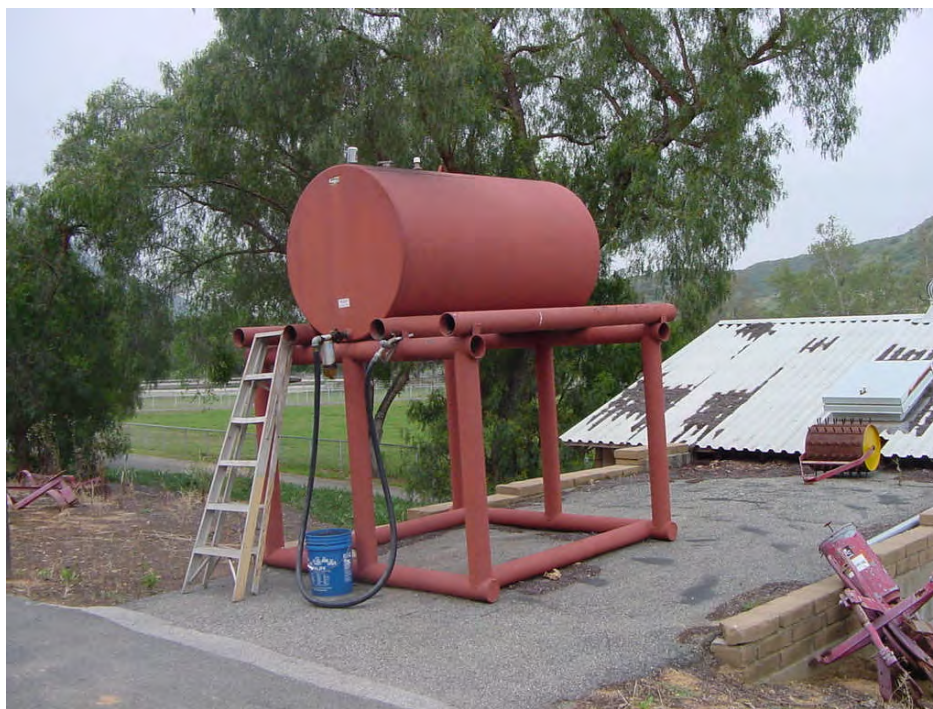
A 500-gallon gasoline above ground storage tank (AST) and a 1,500-gallon diesel AST were observed in the west-central portion of the Site. The diesel AST was not contained and minor staining was observed on soil beneath the dispenser. Two 250-gallon mobile “nurse” tanks, reportedly formerly used to fill smudge pots, were situated adjacent to the diesel AST. Heavy brush obscured the ground surface around the nurse tanks. The gasoline AST was situated on an asphalt slab. An abandoned tank was also observed in the northwest portion of the Site adjacent to a bee hive area. No staining or odors were indicated adjacent to the gasoline AST or abandoned tank.

Photograph #2
Gasoline AST adjacent to hazardous materials storage garage.

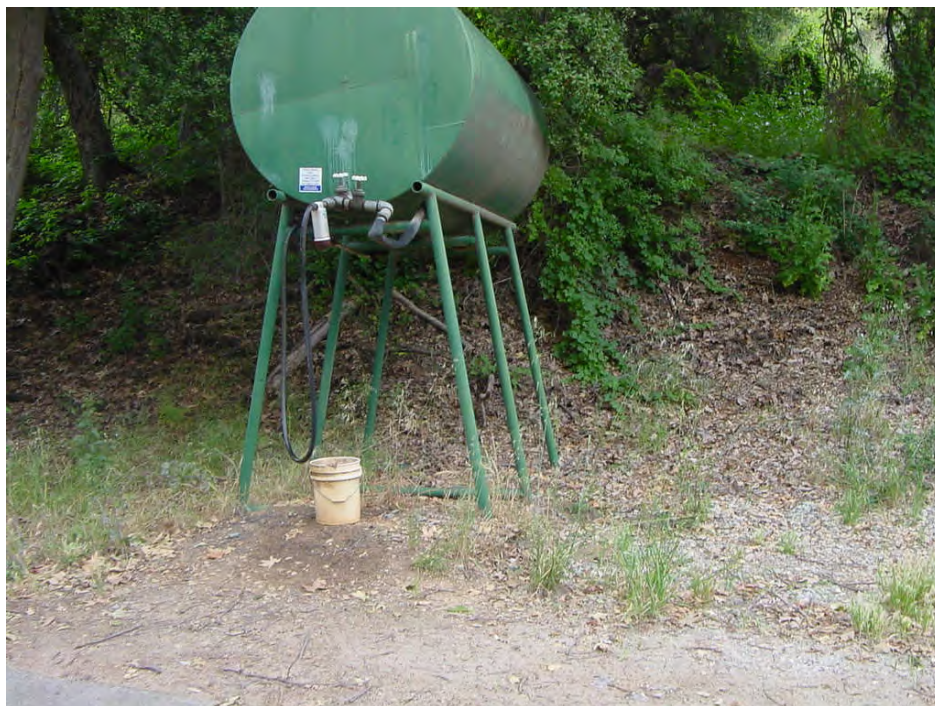
Photograph #3
Diesel AST with minor soil staining in west-central portion of the Site.

Geocon recommends limited assessments of the RECs and potential RECs identified during the ESA as follows.

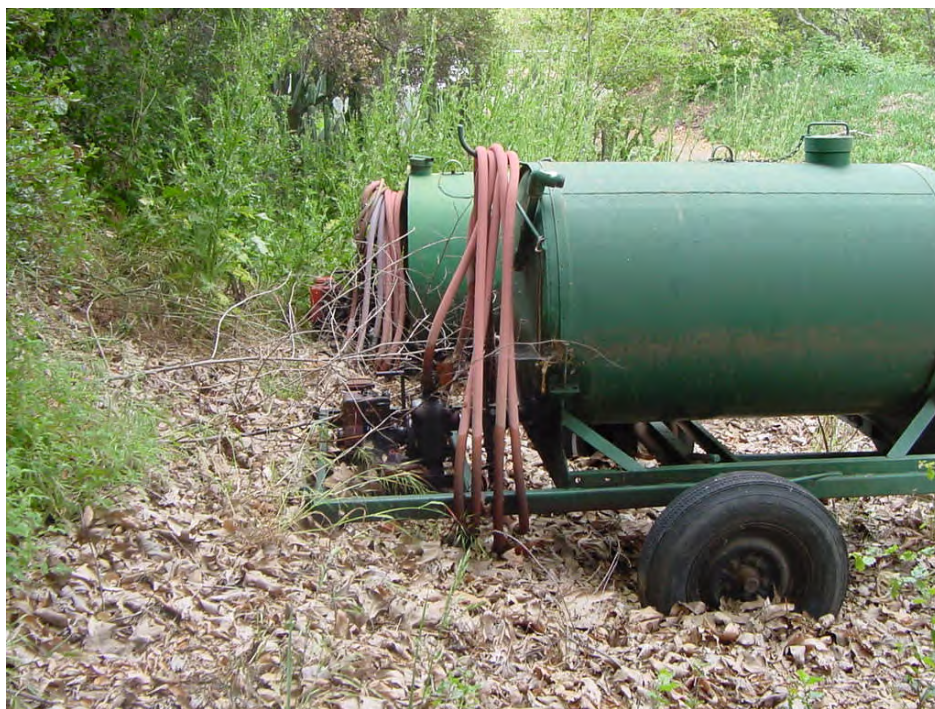
Small amounts of retail pesticides (rodent bait) and herbicides (Roundup) are used and stored onsite. Ms. Biondi also indicated that smudge pots, and the “nurse” fuel tanks used to fill them, had not been used for at least 12 years. Two 3,000-gallon USTs were removed from the western portion of the Site around 1986. The tanks were only a few years old and in good condition when removed. Two 500-gallon USTs, formerly used to fuel wind machines, were removed from the eastern citrus orchard in 2002. The abandoned tank in the northwest portion of the Site was a pressure tank for water.

Photograph #4
Nurse tanks adjacent to diesel AST.

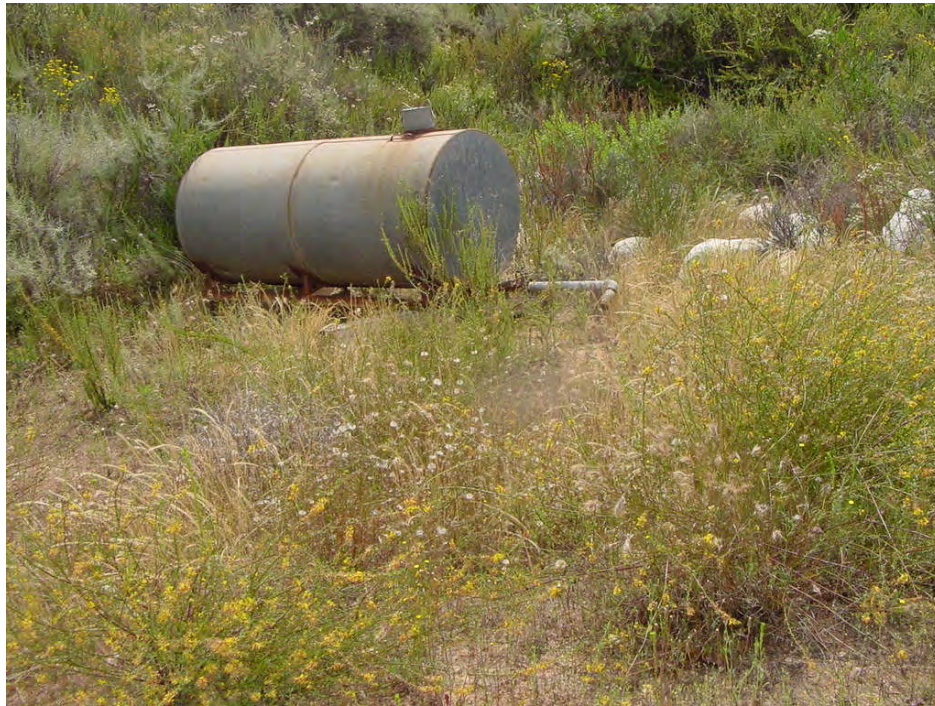
Photograph #5
Abandoned tank in west-central portion of the Site.

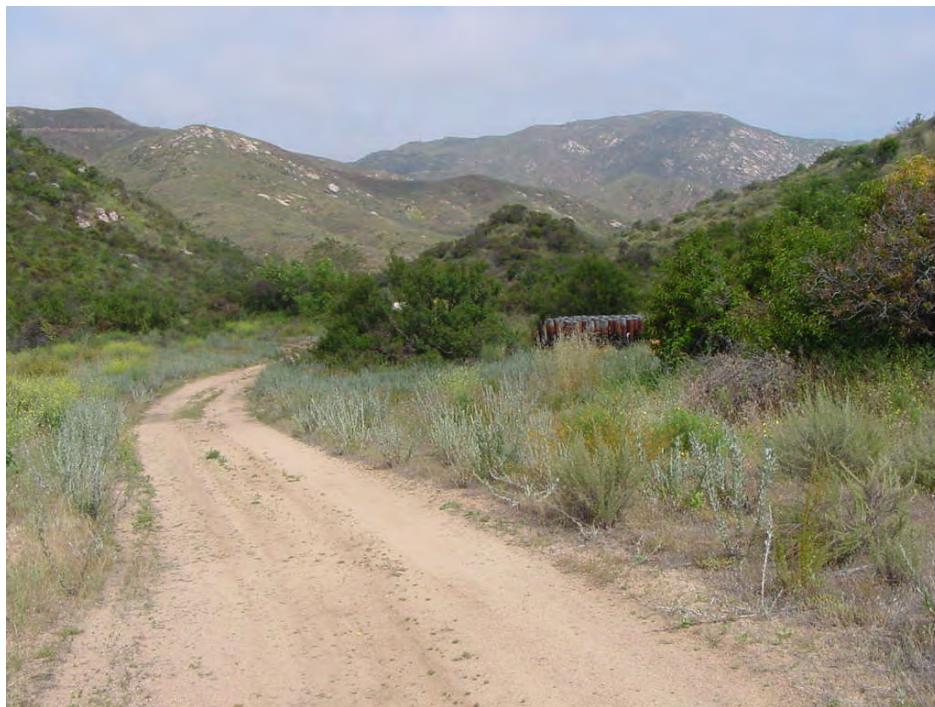
Approximately 200 diesel-burning smudge pots were observed in the east-central portion of the Site. Significant soil staining (an approximately 30' x 50' area) and hydrocarbons odors were apparent

Photograph #6
Northeast portion of the Site with smudge pots.

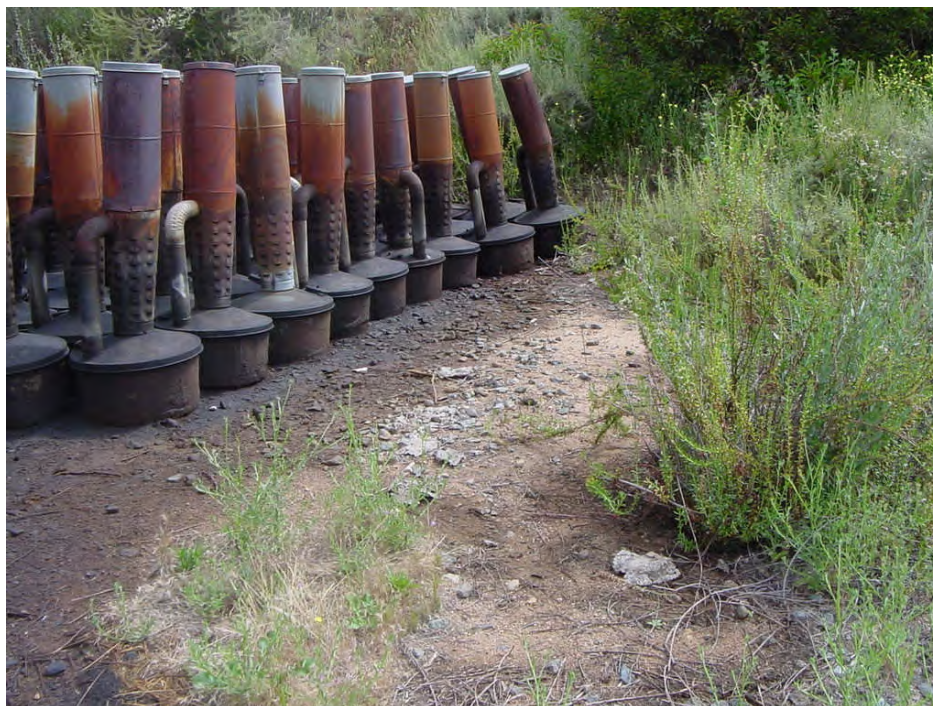
- Based on the age of the onsite structures, ACM and LCP may be present on building materials;
- There is no documentation of soil conditions under the former 5,000-gallon USTs in the southwestern portion of the Site;
- Historic agricultural use of the Site may have included application of organochlorine pesticides;
- Minor soil staining was observed adjacent to the diesel AST; and
- An approximately 1,500 square-foot area exhibits significant soil staining and hydrocarbon odors.

Photograph #7
Soil staining adjacent to smudge pots.

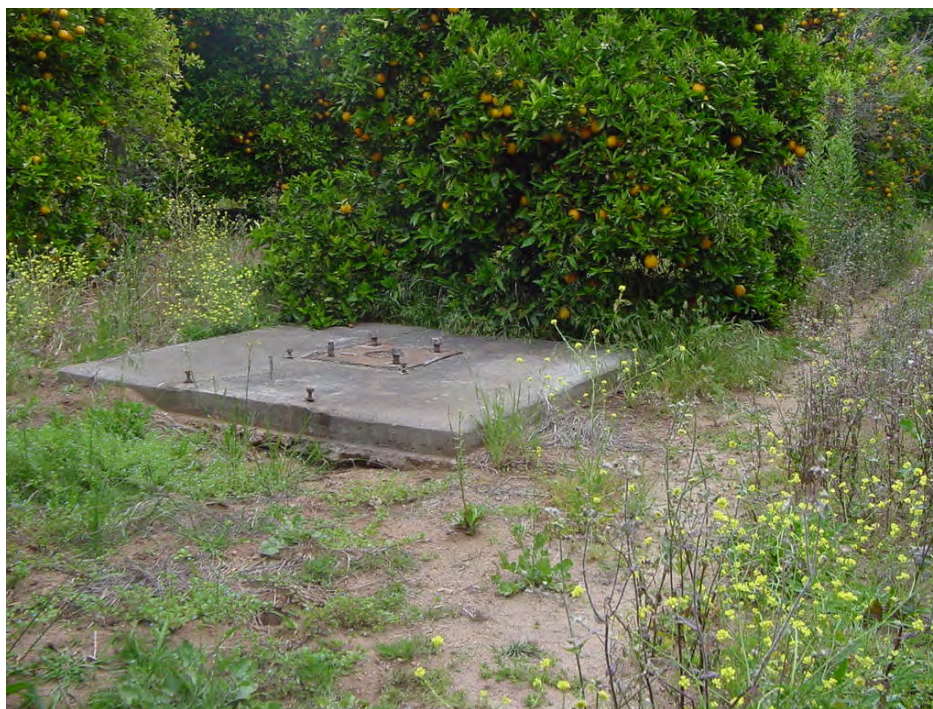
(280-gallon and 500-gallon) dated 1986 and subsequently remove the “wind machine” USTs in December 2001. A field report indicated that the tanks were removed in January 2002; one exhibited 2 holes and the other was in fair condition upon removal; soil underlying the tanks was “sandy clay” and in good condition with no staining or odors; and laboratory analytical data from soil samples collected beneath the USTs did not exhibit concentrations of petroleum hydrocarbons at or above laboratory detection limits. Copies of the DEH file documents were not available in time for inclusion in this report.

Photograph #8
Approximate location of former wind-machine UST #1.

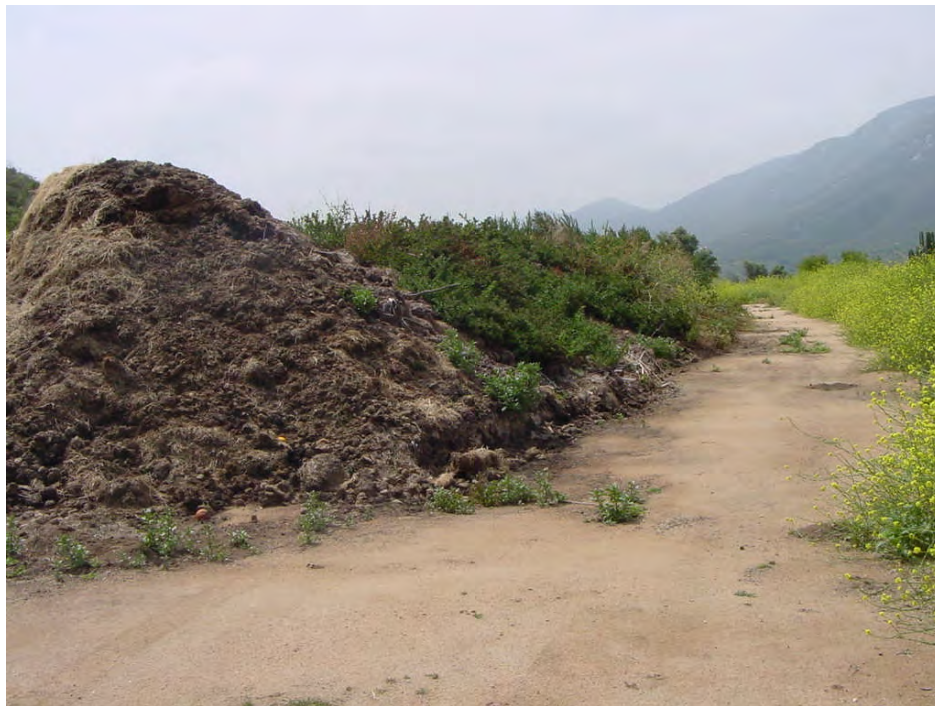
Photograph #9
Manure pile in southeast portion of the Site.

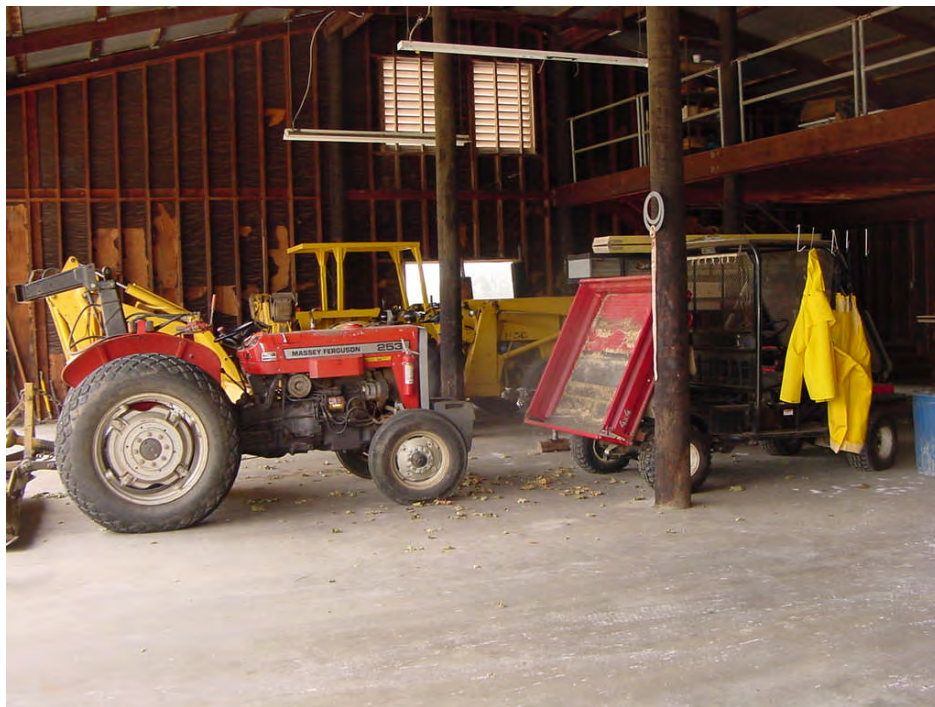
Photograph #10
Garage with maintenance equipment in western portion of the Site.
