LIMITED "PHASE II" ENVIRONMENTAL SITE CHARACTERIZATION PROPOSED SPIRIT OF JOY CHURCH SITE APN(S) 283-054-03-07-08-011 RAMONA, SAN DIEGO COUNTY, CALIFORNIA

W.O. E6065-SC MAY 25, 2010

GeoSoils, Inc.

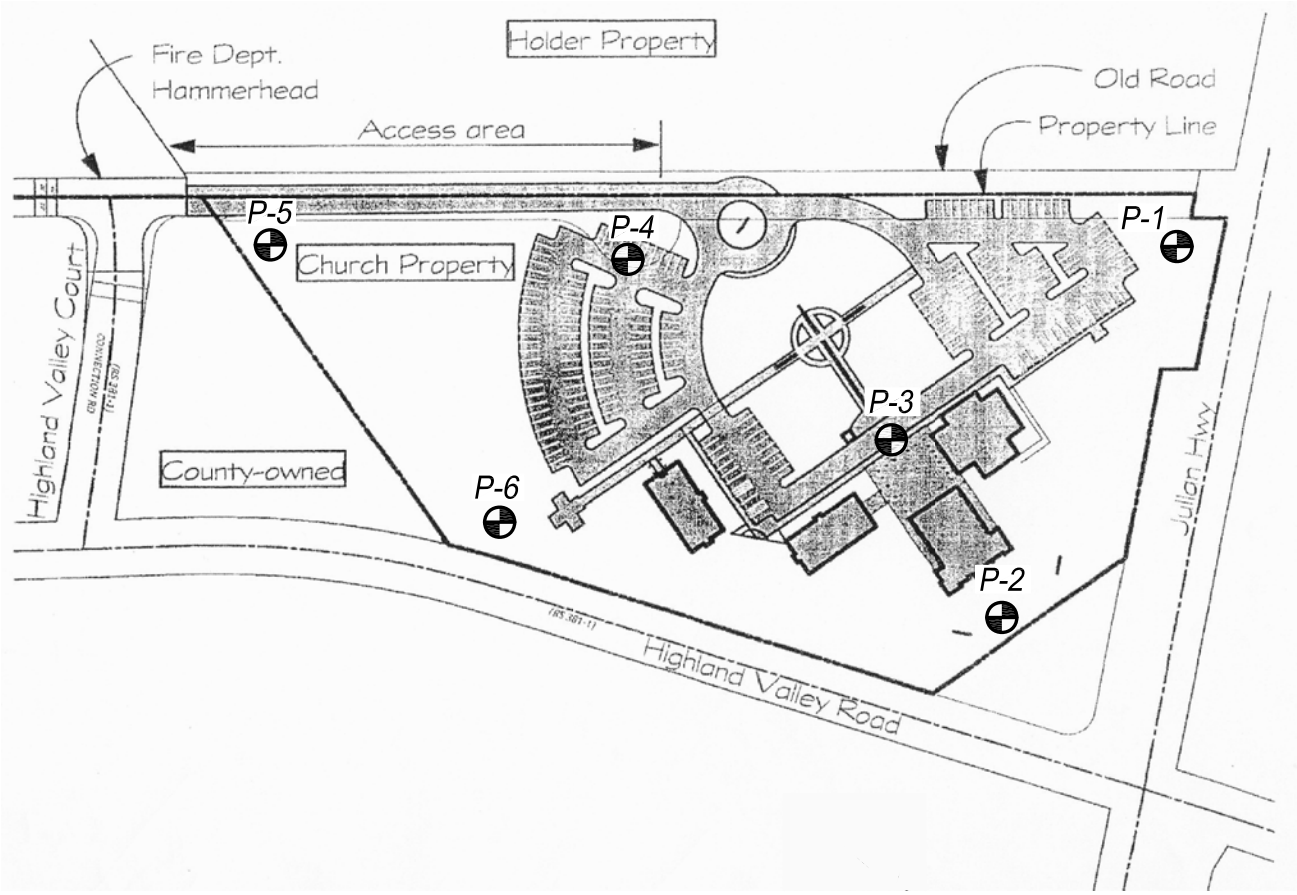
Figure 2

On May 6, 2010, GSI was onsite to collect surficial soil samples at a depth of 6 inches below existing grade. The location of these samples is shown on Figure 2. Test holes were excavated utilizing a hand auger. Samples were collected, stored, and transported to a California Department of Health Services (DHS) certified laboratory the next day, following quality assurance/quality control procedures (QA/QC) during all soil sampling activities. A Chain-of-Custody record was recorded with the laboratory and is included in the laboratory report in Appendix B.

Based upon the laboratory test results, there were no concentrations of analytes/compounds reported greater than the detection limits for Chlorinated Pesticides (EPA Test Method 8081A). All samples were reported as "not detected" (ND). For comparison purposes, the California Human Health Screening Levels (CHHSLs), developed by the California Environmental Protection Agency (Cal/EPA, 2005), are threshold values with generally accepted exposure factors to estimate concentrations in residential soil that do not represent a cancer risk to humans greater than one-in-one million (i.e., 1×10^{-6}). The CHHSLs are: 1.6 mg/kg for DDE and DDT; and, 2.3 mg/kg for DDD. Concentrations of DDD, DDE, DDT, were found to be ND, which is well below the threshold criteria established as a potential risk to human health (CHHSLs, 2005).

P-6 — Approximate location of soil sample for pesticide chemical analysis.

P-6 / ND — Laboratory test results for DDE, DDD and DDT are in mg/kg (ND=not detected). Samples were taken at a depth of 0.5 feet below existing ground surface.

precluded. Based on our limited involvement, further studies or action are not proposed from an environmental viewpoint with regard to pesticides at this time. Please note that additional data (typically included in a Phase I ESA), may require our conclusions and recommendations to be modified, in light of such new data.
