PHASE I
ENVIRONMENTAL SITE ASSESSMENT REPORT

1305 East Mission Road
Fallbrook, San Diego County, California 92028

RSB Project No. 20240829
Report Date: May 8, 2024

Prepared For:
Boulder Ridge Capital LLC

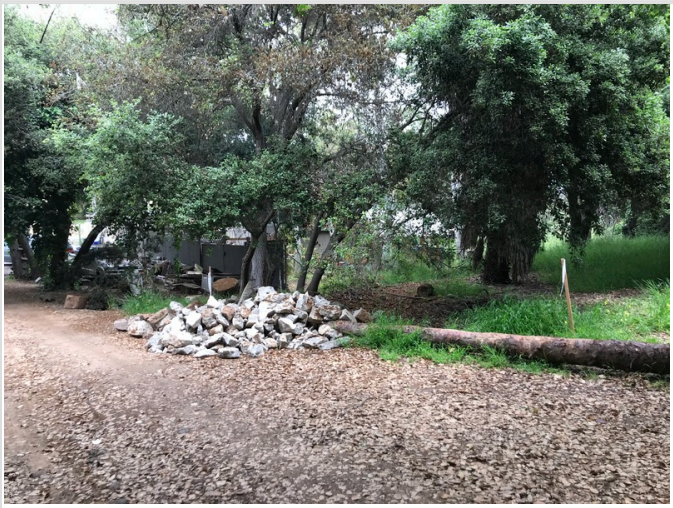
39. Construction debris on site
