**APPENDIX G  
LIMITED AGRICULTURAL CHEMICAL SAMPLING  
LABORATORY REPORT AND CHAIN OF CUSTODY**

At the request and authorization of Accretive Investments, Inc. (“Client”), EEI conducted a Phase I Environmental Site Assessment (ESA) for the property located at 8709 West Lilac Road, Escondido, California. The purpose of this Phase I ESA was to assess the presence or likely presence of an existing, historical, or threatened release of any hazardous substances or petroleum products into structures, soil, and/or groundwater beneath the subject property, to the extent practical (i.e., *recognized environmental conditions* as delineated in ASTM E1527-05).

We have performed a Phase I Environmental Site Assessment (ESA) in conformance with the scope and limitations of ASTM Designation E1527-05 for the subject property identified as APN 127-072-38, -40, -41, and -46, at 8709 West Lilac Road, Escondido, California. Any exceptions to, or deletions from, this practice are described in Section 7.0 of this report. Phase I ESA has revealed no evidence of recognized environmental conditions in connection with the property.

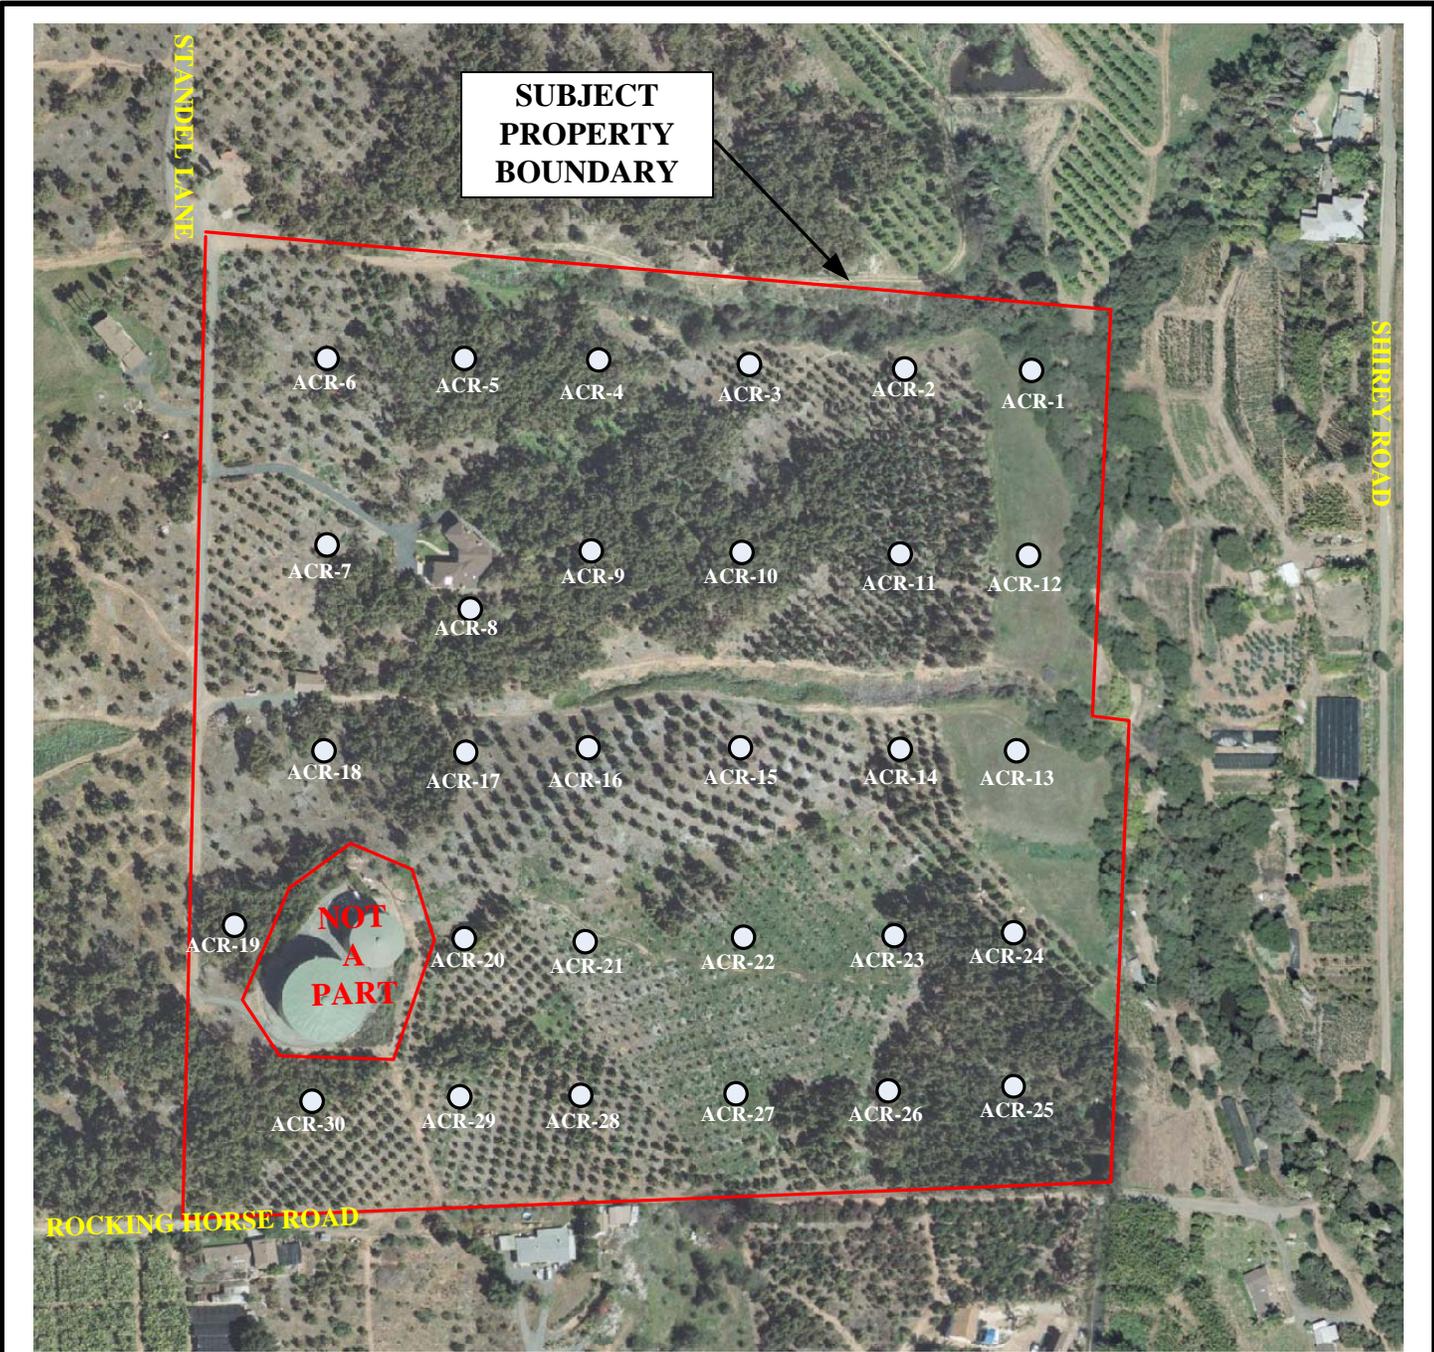
**FIGURE 3**

On March 21, 2012, EEI personnel mobilized to the subject property to conduct soil sampling activities with a shovel. Soil sampling locations were selected with the goal of collecting representative soil samples from the subject property. A total of thirty discrete locations (identified as ACR-1 through ACR-30, **Figure 3**) were chosen to provide representative coverage.

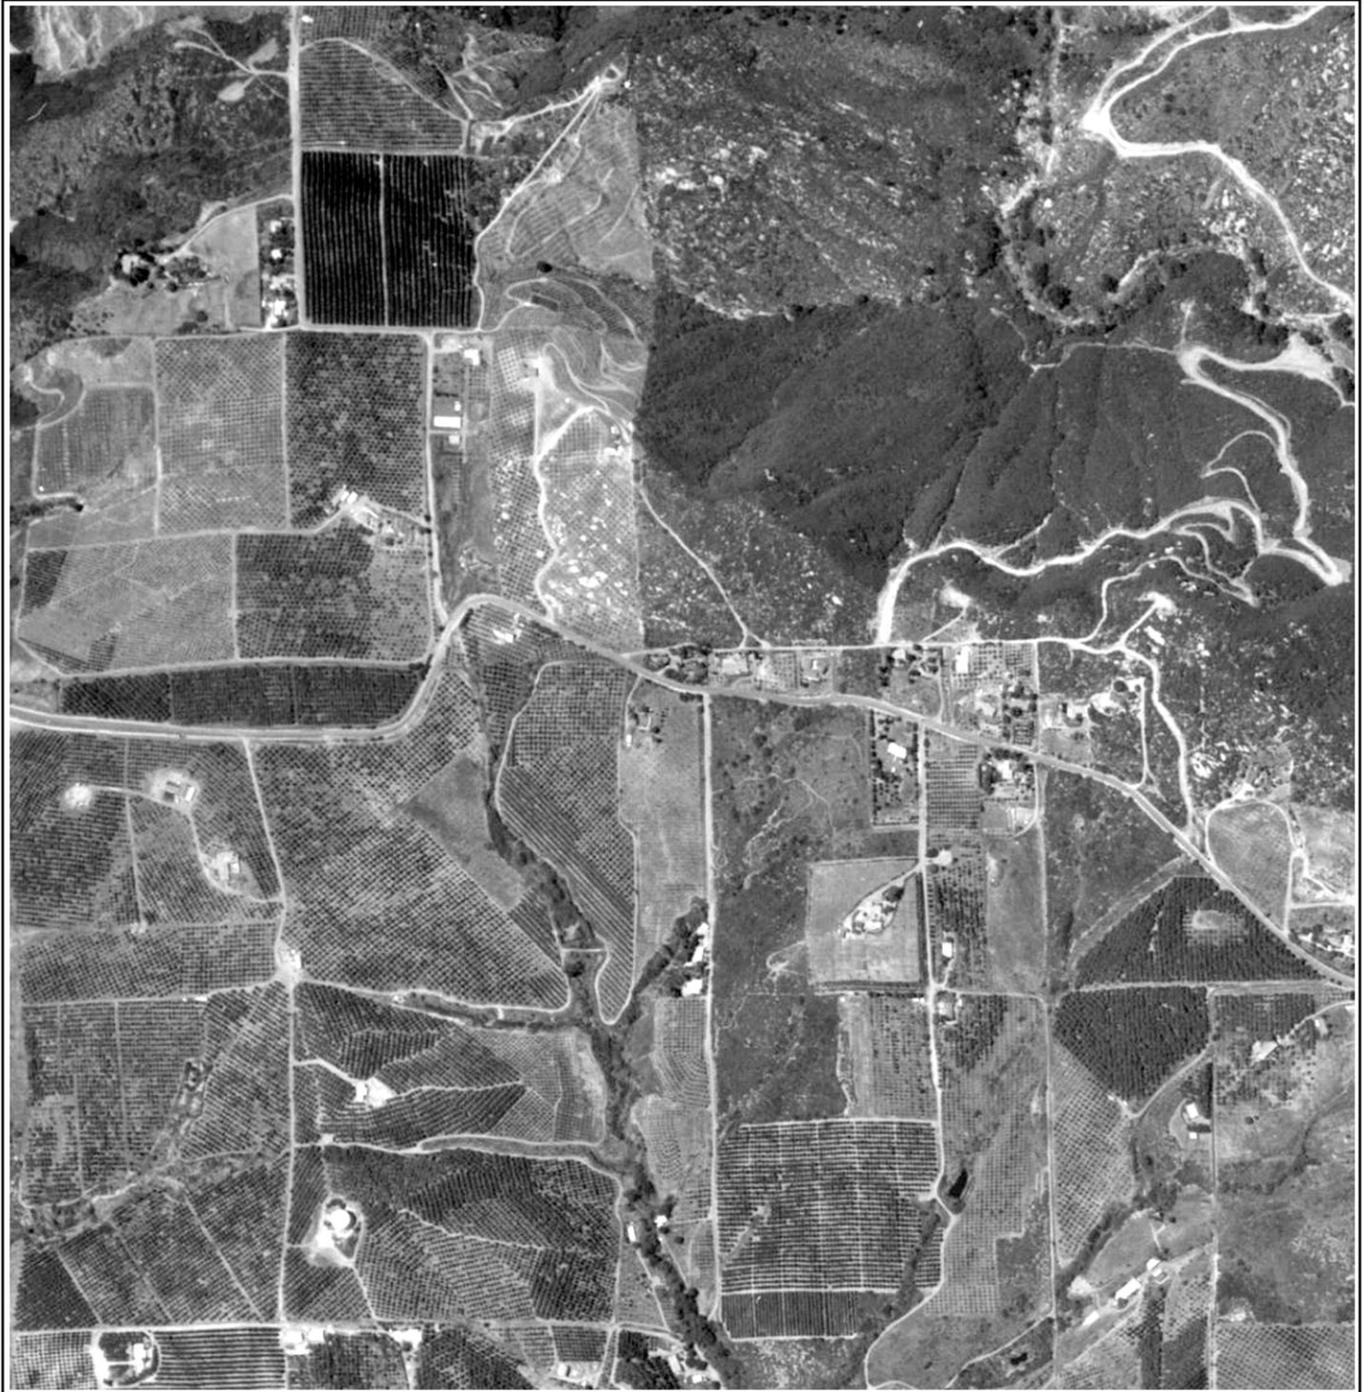
1975	Topographic Map 1:24,000	No apparent changes were noted to the subject property since the 1968 topographic map.
1980	Aerial Photograph 1:375	A clearing and a structure were present on the northwest portion of the subject property. No other apparent changes were noted to the subject property since the 1974 aerial photograph.
1990- 1991	Aerial Photograph 1:375	No apparent changes were noted to the subject property since the 1980 aerial photograph, except for the addition of another water tank within the southwest portion.
2002	Aerial Photograph 1:375	No apparent changes were noted to the subject property since the 1990-91 aerial photograph. Additional development was observed to the east.
March 2012	Aerial Photograph <u>Accretive Investments, Inc.</u>	The subject property appeared as its current configuration, which consisted of a residence on the northwest portion and agricultural land use on the remaining portions. Two water tanks remained within the southwest portion of the property. No other pertinent information or environmental issues were noted.

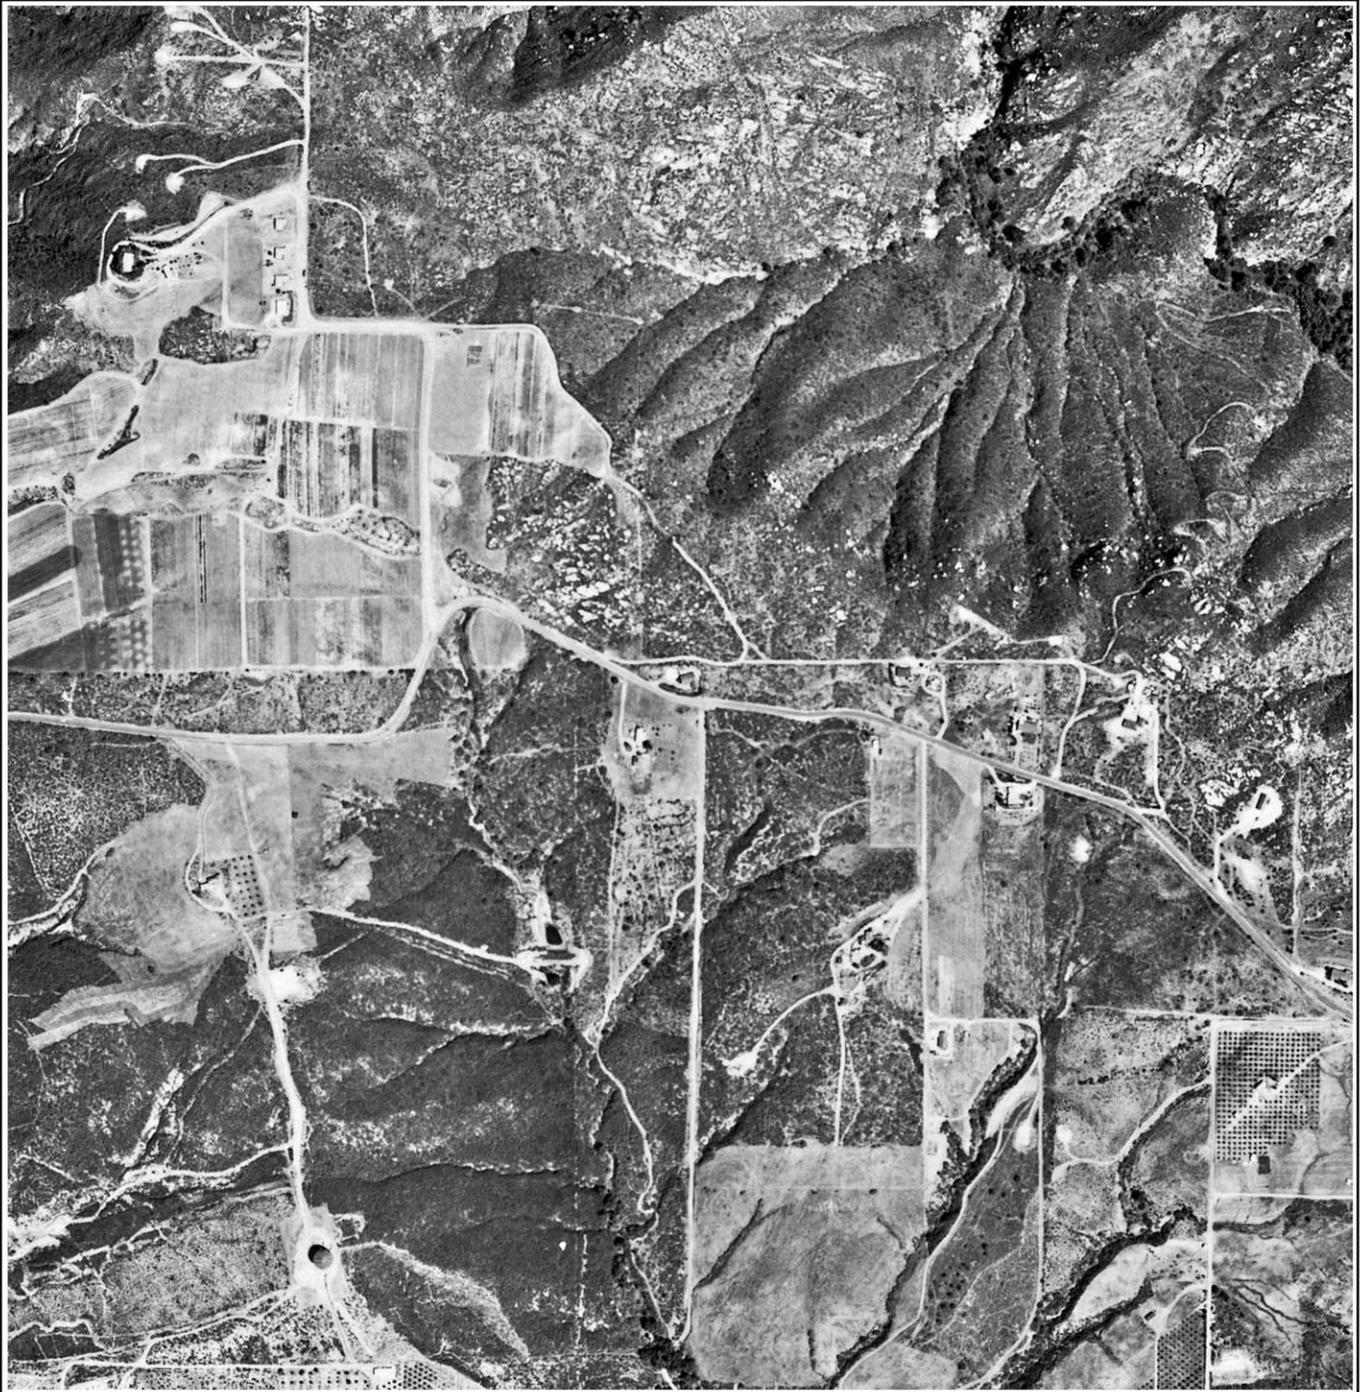
1963	Aerial Photograph 1:375	A water storage tank appeared within the southwest corner of the subject property. The remaining portion of the property appeared as undeveloped land. Orchards and residences appeared adjacent and to the south and southeast. Rural residential development appeared to the north.
1968	Topographic Map 1: 24,000	A water tank was present within the southwest corner of the subject property. The subject property and surrounding area was shaded green, which signified agricultural-related land use. Standel Lane and Shirey Road were present in the site vicinity.
1974	Aerial Photograph 1:375	The majority of the subject property appeared utilized for agricultural purposes as orchards. The water tank remained within southwest portion of the property. Unimproved road bisected the central portion of the property from east to west. Increased agricultural use (orchards) was observed in the surrounding area.
