County of San Diego Department of Public Works  
**Fiber Reinforced Asphalt Concrete (FRAC) Pilot Project**  
**Pilot Study Report Work Plan( 18 Month Review 10/22)**

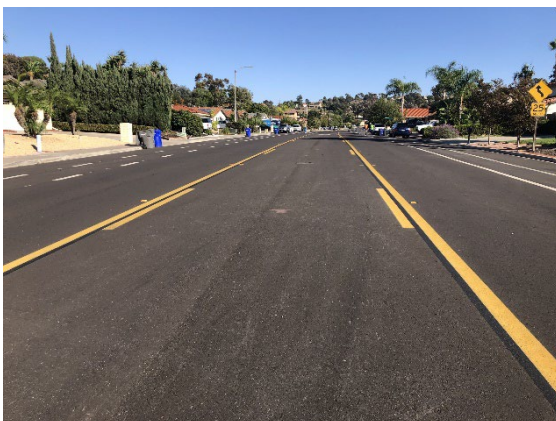
Photo 1-1-1: 6 Months

**6 Month Review Summary:** No signs of cracking or other distresses at were present at any of the 3 locations. This was the expected result given the short duration since construction was completed. Representative photographs were taken to document the condition and compare visually to future reviews.

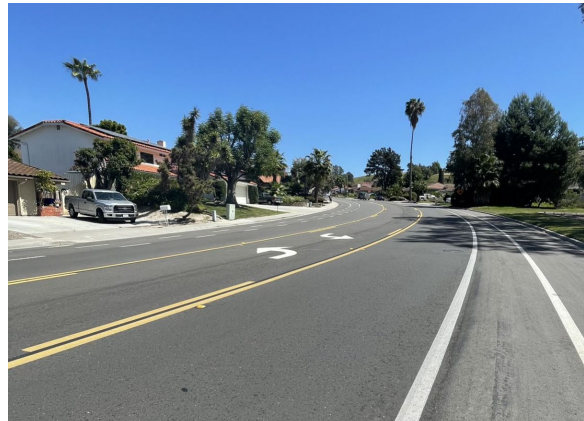
Photo 1-1-2: 12 Months

**12 Month Summary:** Still no signs of cracking or other distresses. The black color of the asphalt is beginning to fade, but no defects were noted. Representative photographs were taken to document the condition and compare visually to future reviews.

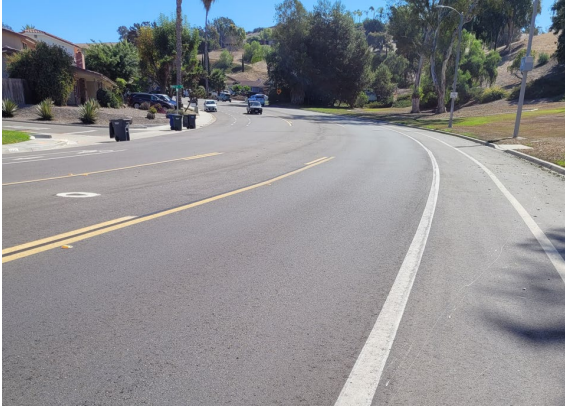
Photo 1-1-3: 18 Months

**18 Month Summary:** All segments are continuing to perform well. No signs of cracking or other distresses, but the surfacing is starting to fade. Representative photographs were taken to document the condition and compare visually to future reviews.

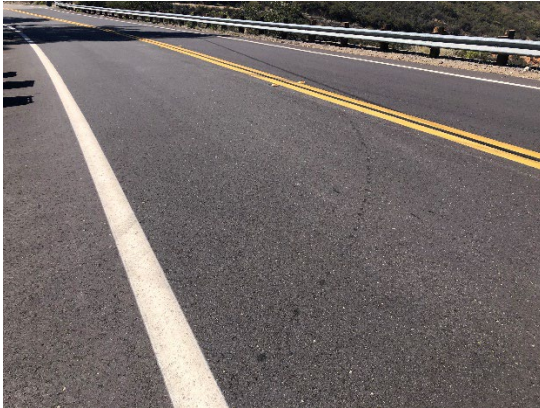
Photo 2-1-1: Skyline TT 6 Months

**6 Month Review Summary:** No signs of cracking or other distresses at were present. This was the expected result given the short duration since construction was completed. Representative photographs were taken to document the condition and compare visually to future reviews.

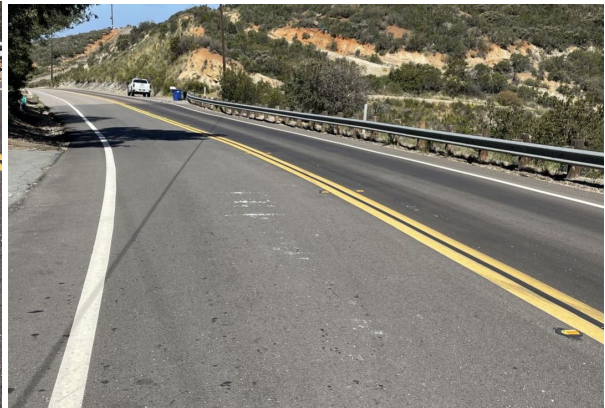
Photo 2-1-2: Skyline TT 12 Months

**12 Month Summary:** Still no signs of cracking or other distresses. The black color of the asphalt is beginning to fade, but no defects were noted. Representative photographs were taken to document the condition and compare visually to future reviews.

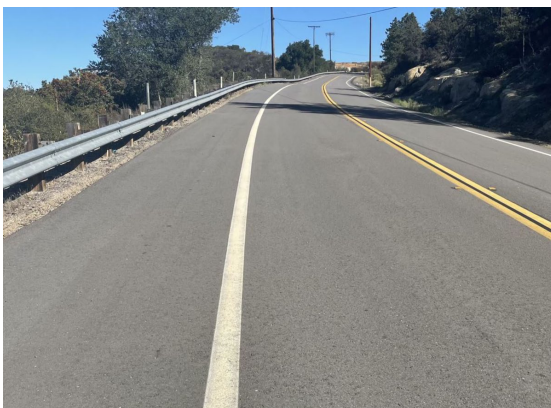
Photo 2-1-3: Skyline TT 18 Months

**18 Month Summary:** Minor hairline cracks are starting to develop in all sections. This appears to be the start of reflective cracking. Cracks are hard to identify visually. Next review will focus on the progression and the percentage of road affected.. Representative photographs were taken to document the condition and compare visually to future reviews.

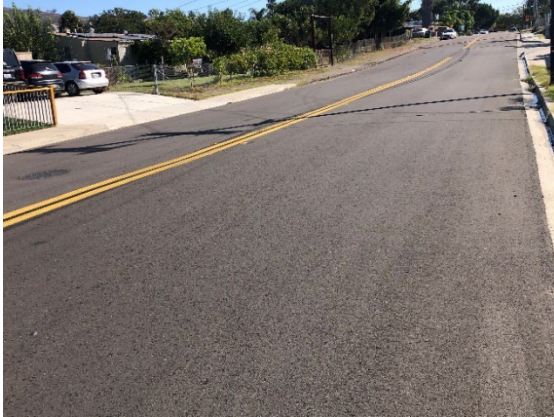
Photo 3-1-1: 6 Months

**6 Month Review Summary:** No signs of cracking or other distresses at were present at any of the 3 locations. This was the expected result given the short duration since construction was completed. Representative photographs were taken to document the condition and compare visually to future reviews.

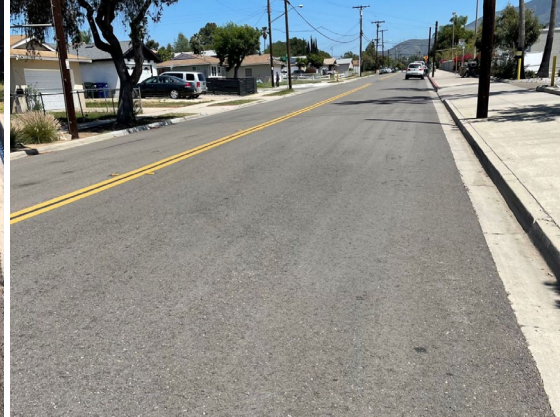
Photo 3-1-2: 12 Months

**12 Month Summary:** The majority of the roads we in a similar condition to the roads at 6 months. The black color is starting to fade but there were no signs of cracking with the exception of Orville St. Orville Street has 3 distinct areas that showed signs of fatigue related failures. Two of these locations are adjacent to commercial driveways. There is a large amount of delivery trucks using these driveways which likely contributed to the accelerated failure. Since these distresses presented shortly after construction and none of the other locations in the area have commercial driveways this study will disregard these spot areas and focus the comparison at locations similar in character to the other study roads.

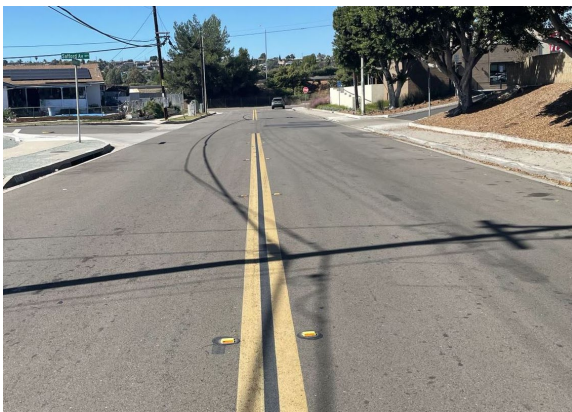
Photo 3-1-3: 18 Months

**18 Month Summary:** Locations 2-6 continue to perform well with no signs of cracking or other distress. Pavement starting to age, but no concerns at this time. Two hairline cracks are starting to develop at location 1 ( St George St, (FRAC) Orville Street had 3 distressed areas identified during the 12 month review. Those areas are continuing to fail at a faster rate than expected. Two of these locations are adjacent to commercial driveways. There is a large amount of delivery trucks using these driveways which likely contributed to the accelerated failure. Since these distresses presented shortly after

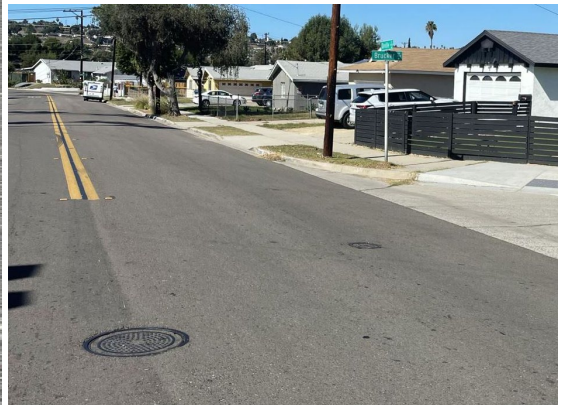
Photo3-7-6: 18 Months

construction and none of the other locations in the area have commercial driveways this study will disregard these spot areas and focus the comparison at locations similar in character to the other study roads. Additionally there were several areas along Orville that started to develop hairline cracks.

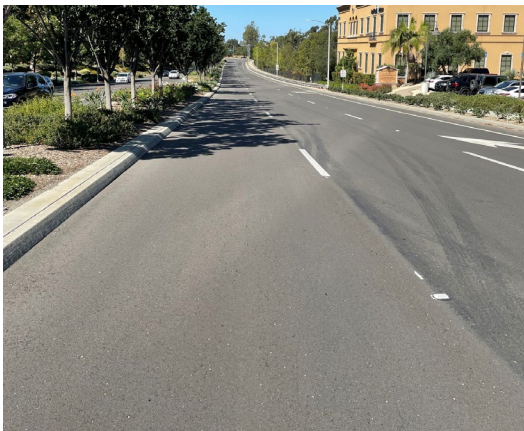
Photo 4-1-1: 6 Months (WB)

**6 Month Review Summary:** No signs of cracking or other distresses were present at any of the 2 locations. This was the expected result given the short duration since construction was completed. Representative photographs were taken to document the condition and compare visually to future reviews.

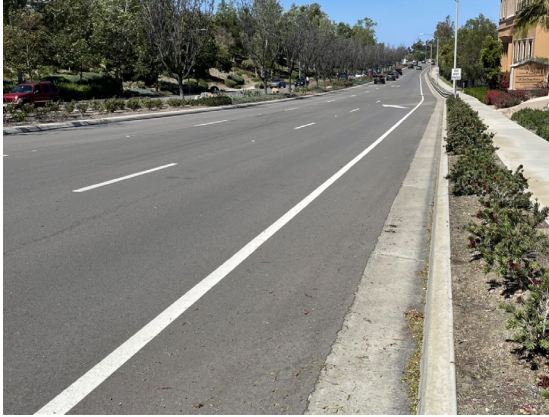
Photo 4-1-3: 12 Months (WB)

**12 Month Summary:** Still no signs of cracking or other distresses. The black color of the asphalt is beginning to fade, but no defects were noted. Representative photographs were taken to document the condition and compare visually to future reviews.

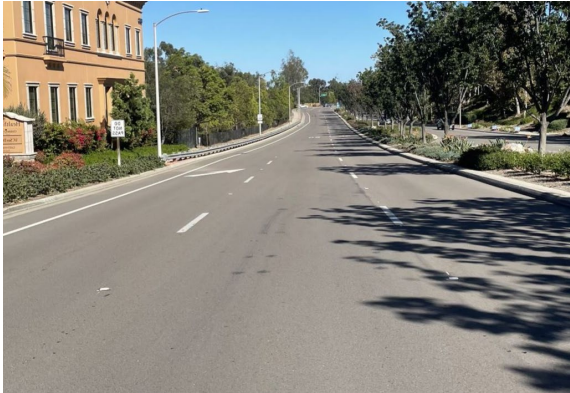
Photo 4-1-5: 18 Months (WB)

**18 Month Summary:** All locations are still performing well. No signs of reflective cracking. The asphalt continues to age, but there is nothing to compare in terms of the pilot study at this point. Representative photographs were taken to document the condition and compare visually to future reviews.
