GEOTECHNICAL EVALUATIONS EXISTING WATER STORAGE RESERVOIR PROPOSED SHADOW RUN RANCH RESIDENTIAL DEVELOPMENT PAUMA VALLEY, NORTH SAN DIEGO COUNTY, CALIFORNIA

URS Project No. 27661027.10000

November 25, 2013
Revised December 31, 2013

Subject: Geotechnical Evaluation
Existing Water Storage Reservoir
Proposed Shadow Run Ranch Residential Development
Pauma Valley, North San Diego County, California
URS Project No. 27661027.00001

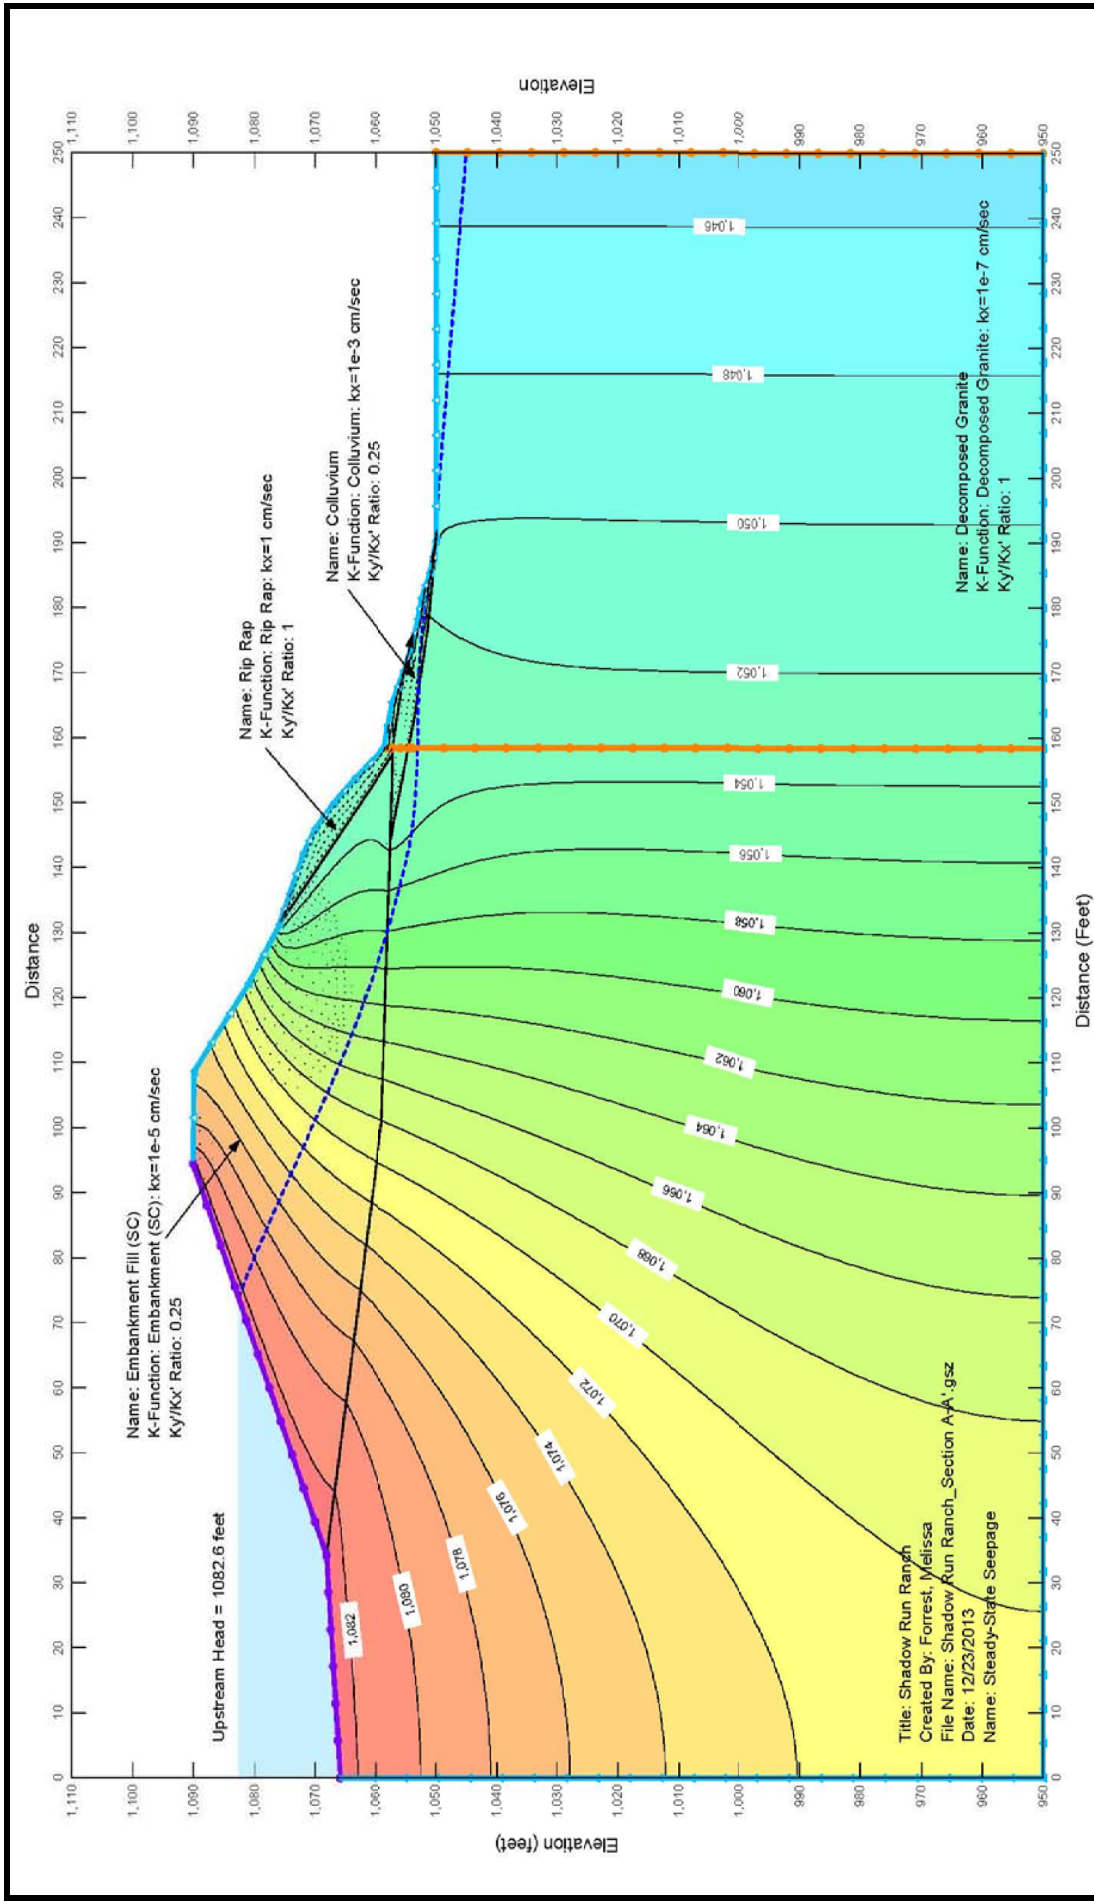
Figure 11

SEEP/W modeling suggests the maximum hydraulic gradients are located along the interface between the embankment and DG foundation. The maximum gradients are about 0.4 which is at the critical gradient (0.3 to 0.4) required for possible piping failures (Cedergren, 1977). However, the foundation below the highest part of the embankment is in weathered granitics, which are not erodible by piping. The topsoil/colluvium layer does not appear to extend below the full footprint of the dam. Therefore there is no continuous flow path from the toe to the reservoir. The topsoil/colluvium itself is a relatively heterogeneous mixture of clayey sand with cobbles not likely conducive to backward erosion and piping below the dam.

Seepage Analyses of Cross Section A-A' Steady State Conditions

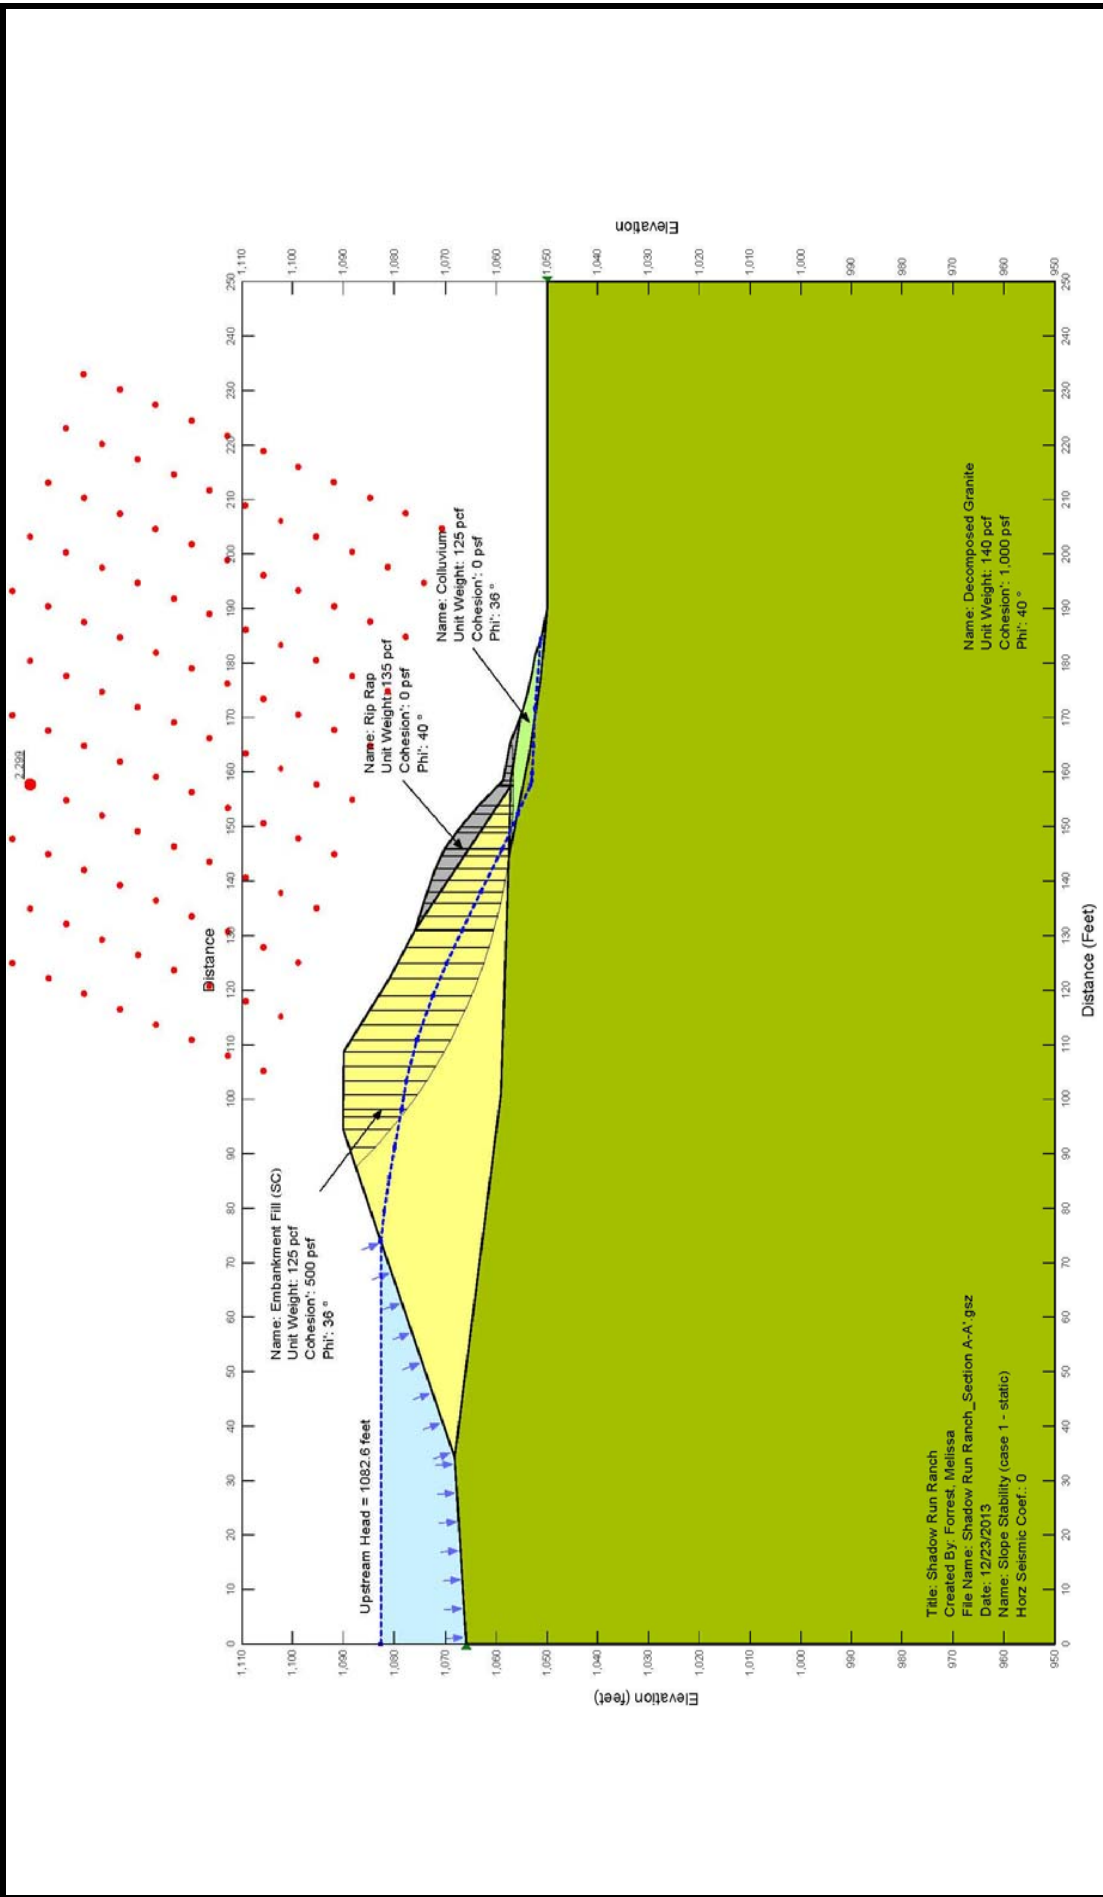
7. The stability analyses indicate that the earthen embankment for the reservoir will be stable for all static and post liquefaction conditions. One pseudostatic case with conservative assumptions did have a factor of safety less than 1.1; however, the predicted seismically induced deformations are acceptable.

Slope Stability of Cross Section A-A' Static Conditions		URS
Shadow Run Ranch Pauma Valley, California		Date: 12/30/2013
		Figure 15

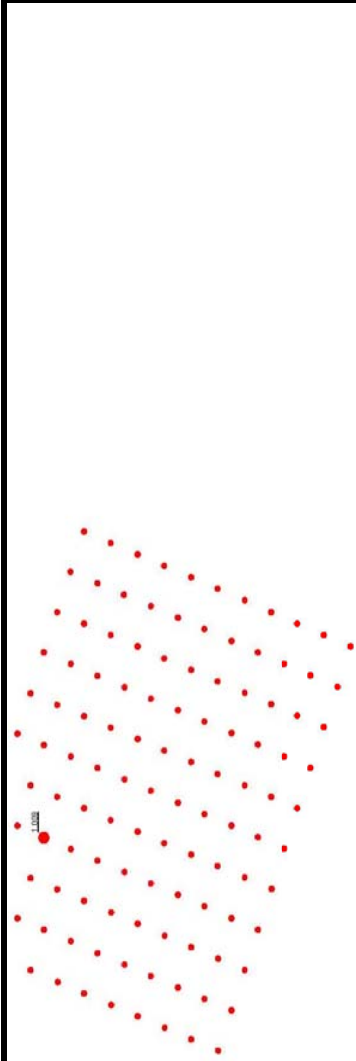
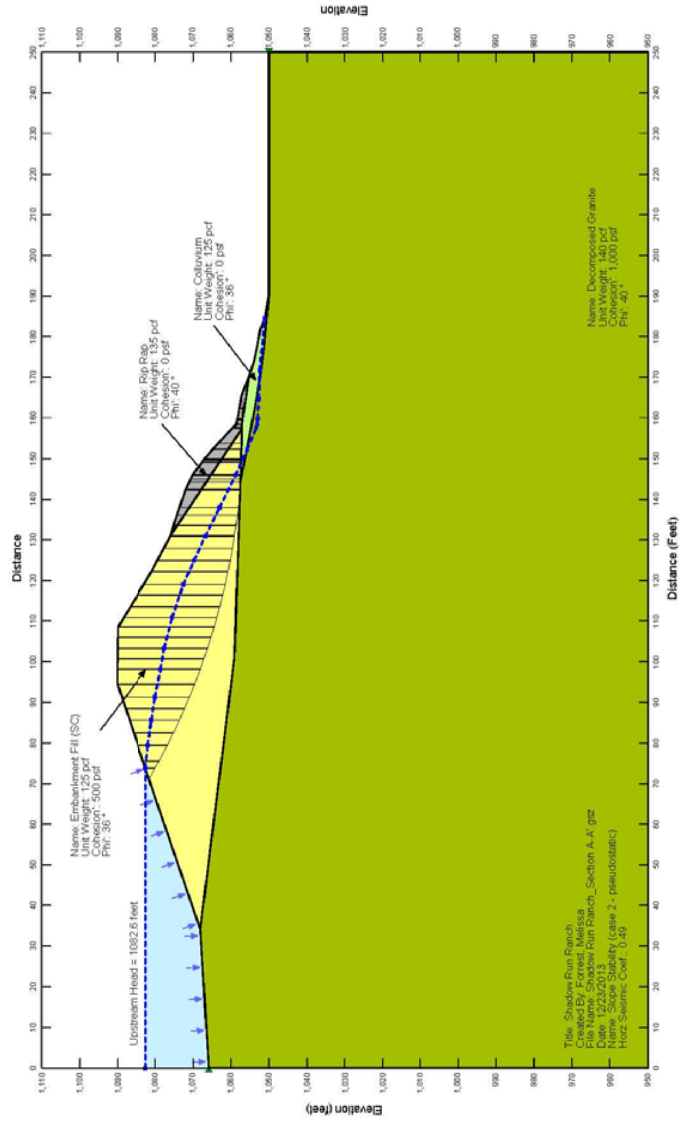
URS	Slope Stability of Cross Section A-A' Pseudo-Static Conditions	
Date: 12/30/2013	Shadow Run Ranch	
Figure 20	Pauma Valley, California

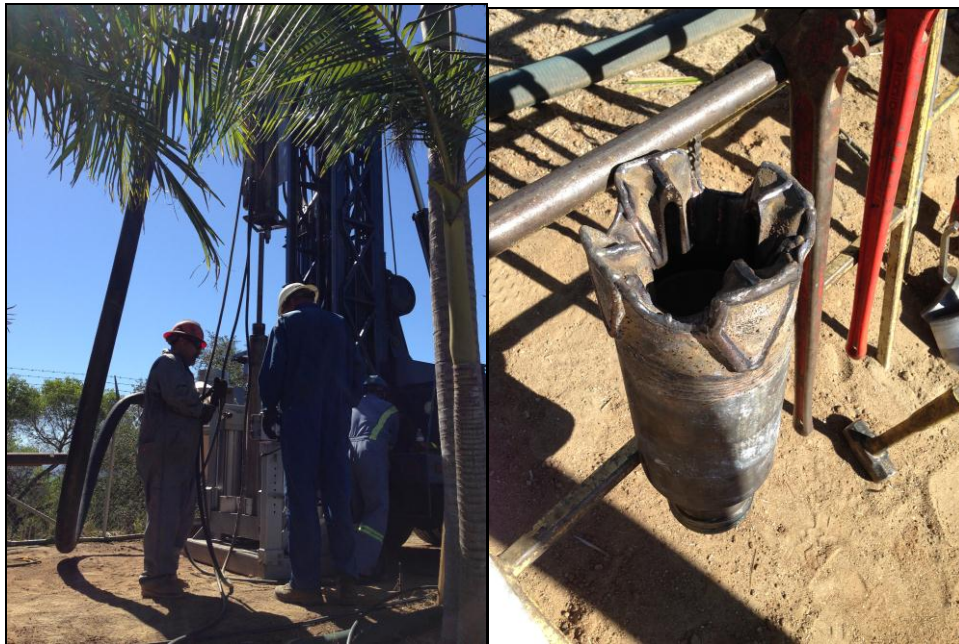
Positioning the 140-lb hammer for SPT sampling (left). The Becker “open bit” on the right.

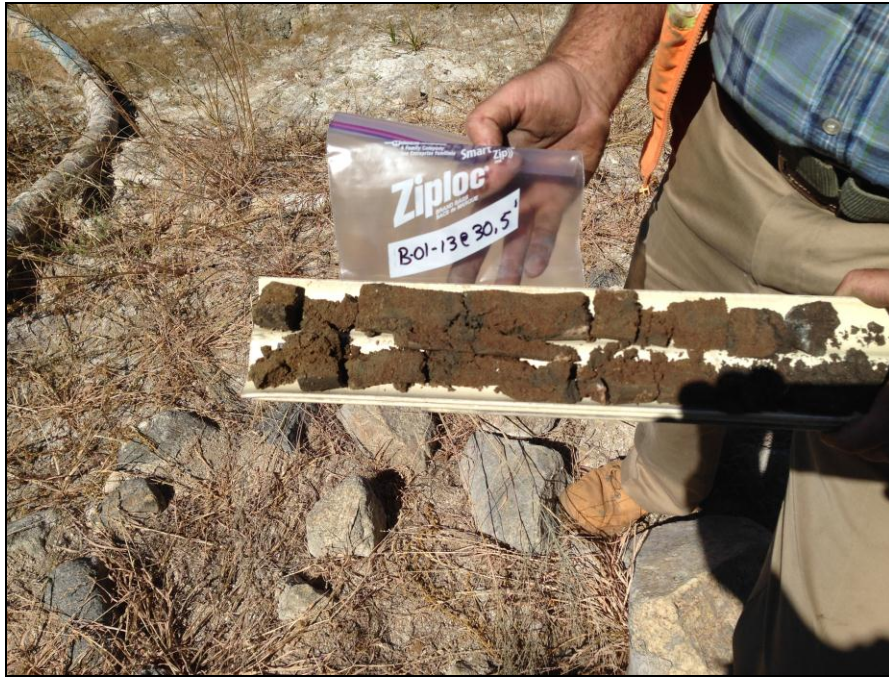
Boring B-1: Sample 13 collected with an SPT sampler at 30.5 feet. Sample was collected at the top of highly/completely weathered granitic rock.

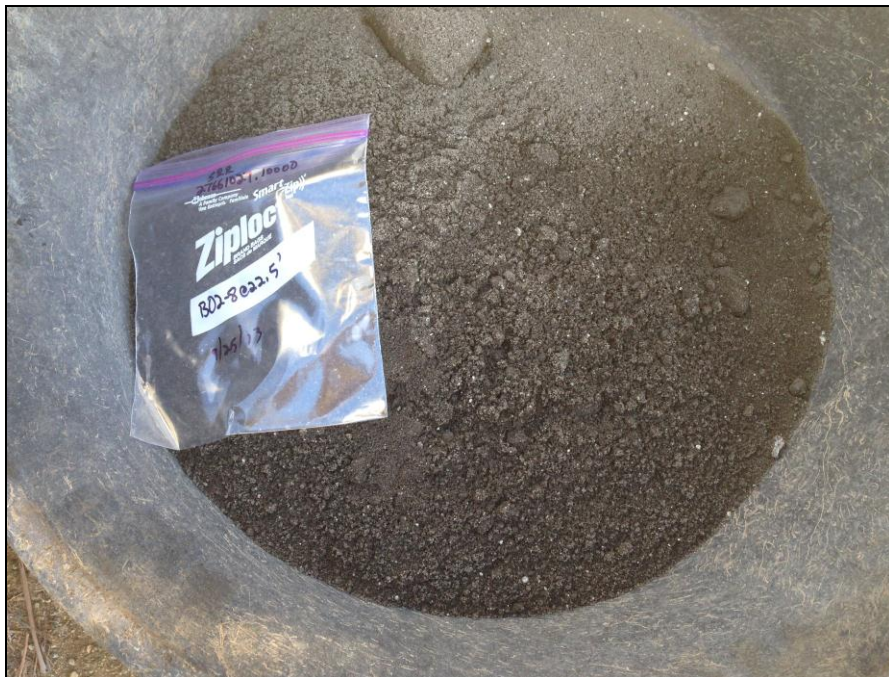
Boring B-2: Sample 8 collected from the Becker cyclone at 22.5 feet. Sample was clayey sand ("dg" soil) collected at the bottom of the embankment fill.

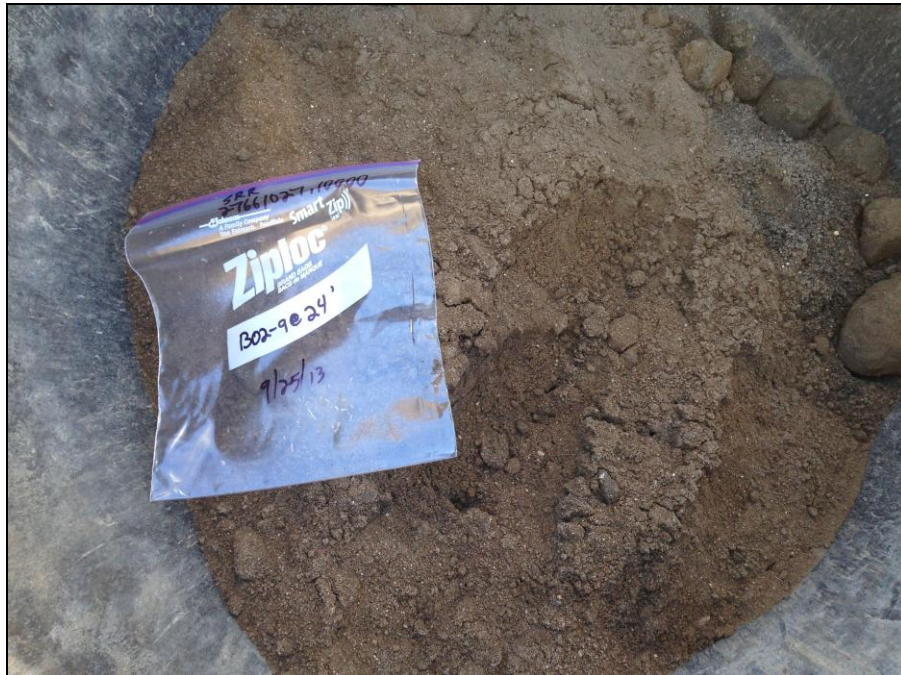
Boring B-2: Sample 9 collected from the Becker cyclone at 24 feet. Sample was collected at the top of highly/completely weathered granitic rock, which breaks down to clayey sand with gravel-sized rock fragments. The Becker open bit allowed continuous logging of the cuttings from the cyclone.

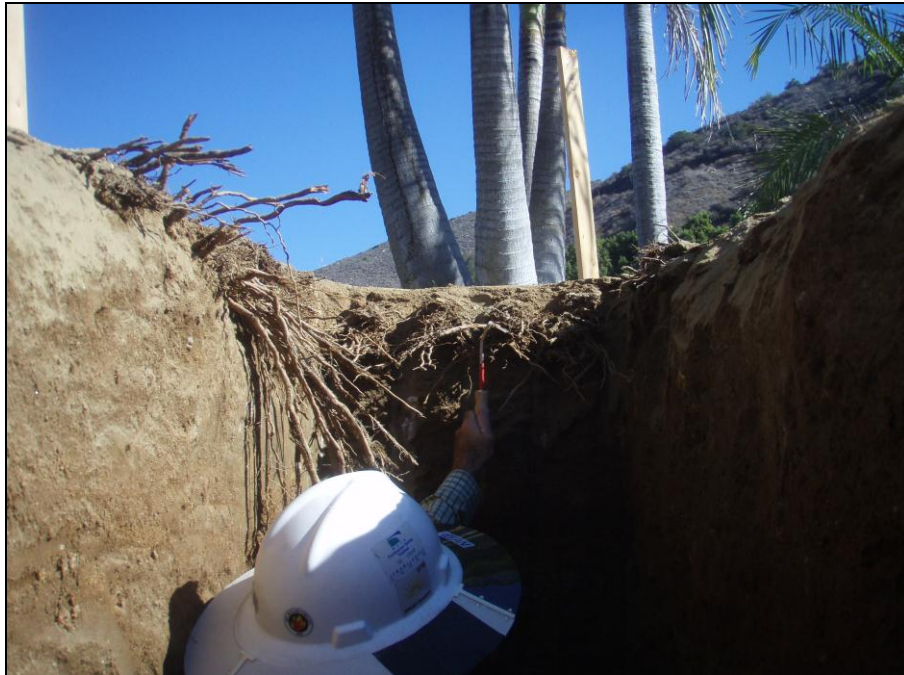
Palm tree roots were exposed at the top of Test Pit TP-2.

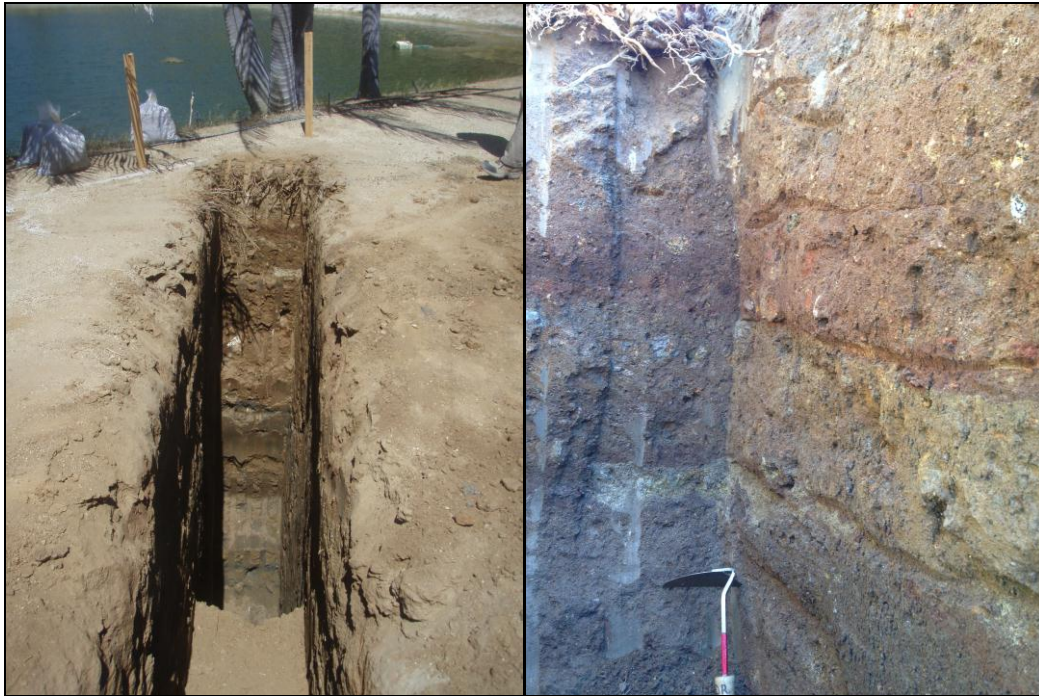
Test Pit TP-2: The embankment fill soil had been placed in thin lifts. The test pit sidewalls appeared stable with no sloughing to the total depth of the excavation (about 14.5 feet bgs),

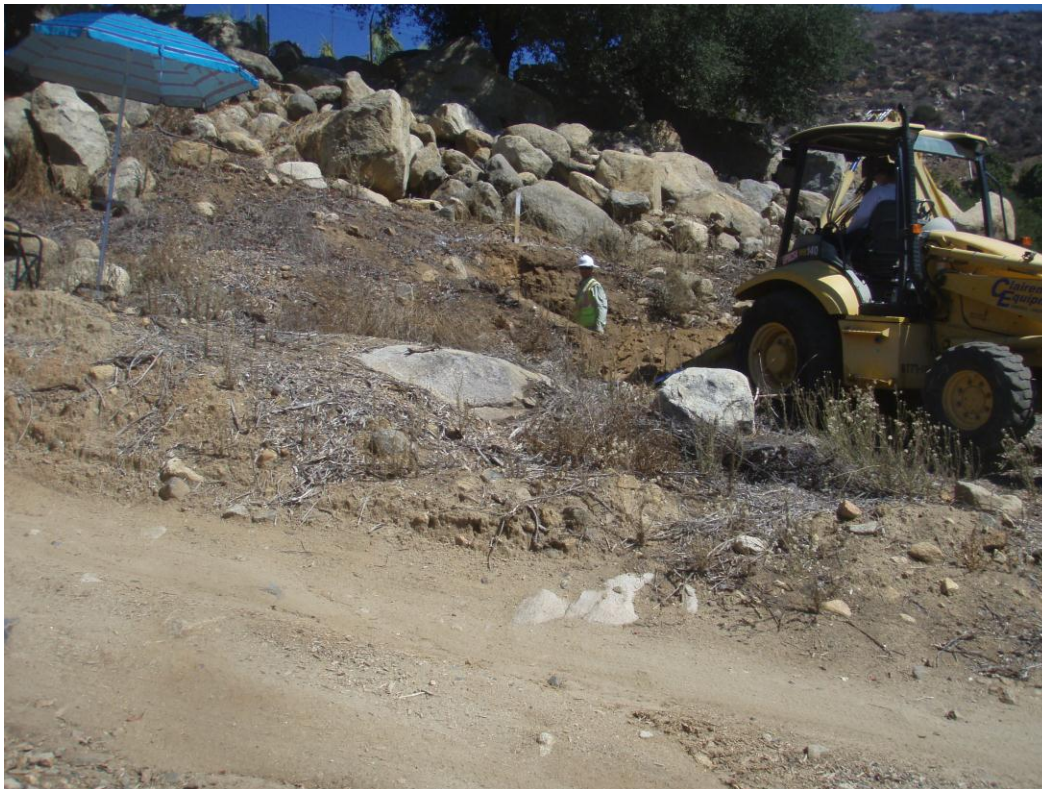
Test Pit TP-5 was excavated at the toe of the embankment fill slope.

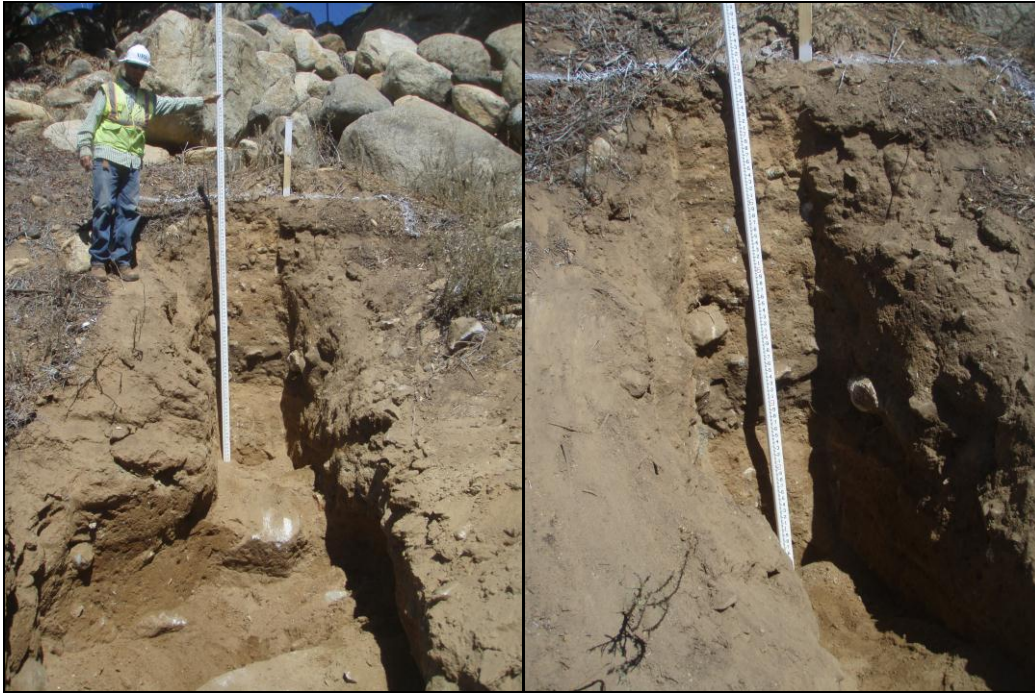
Test Pit TP-5 exposed gravelly/cobbly clayey sand fill, overlying topsoil/colluvium. The test pit met refusal on weathered granitic boulders.

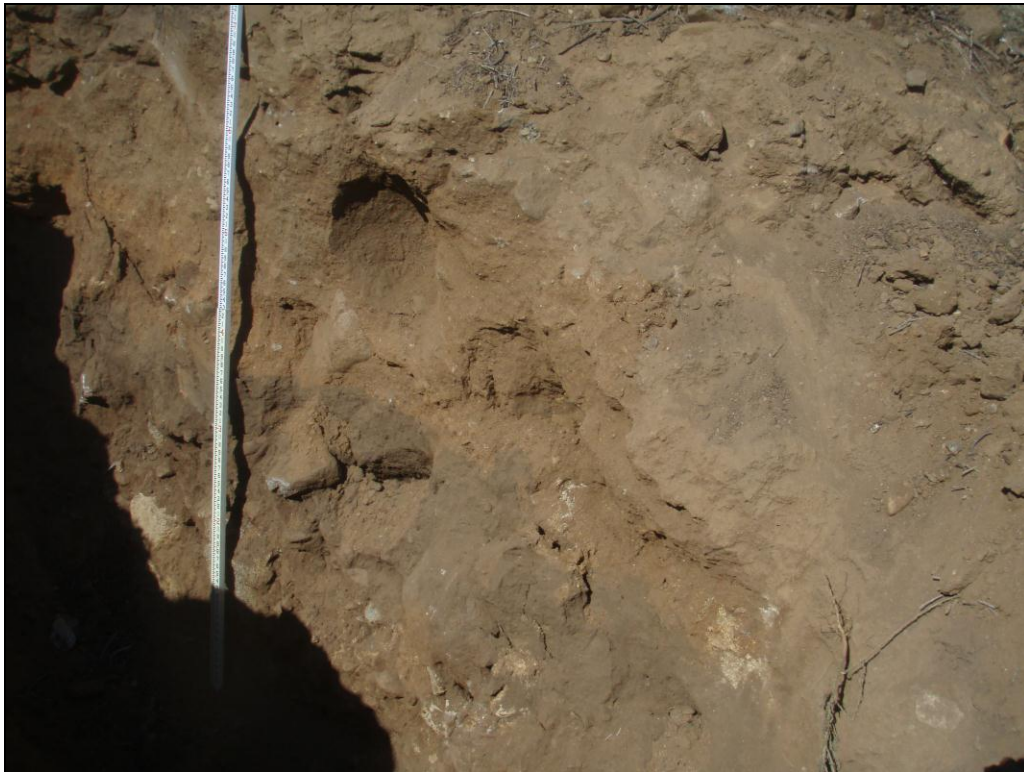
Test Pit TP-6 was in gravelly fill overlying topsoil/colluvium at the embankment toe.
