**GEO TECHNICAL INVESTIGATION
AND
GEOLOGIC FAULT INVESTIGATION**

**CEDAR/KETTNER
PARKING/RESIDENTIAL STRUCTURE
SAN DIEGO, CALIFORNIA**

**SEPTEMBER 18, 2003
REVISED OCTOBER 14, 2003**

Subject: CEDAR/KETTNER PARKING/RESIDENTIAL STRUCTURE
SAN DIEGO, CALIFORNIA
GEOTECHNICAL INVESTIGATION
AND GEOLOGIC FAULT INVESTIGATION

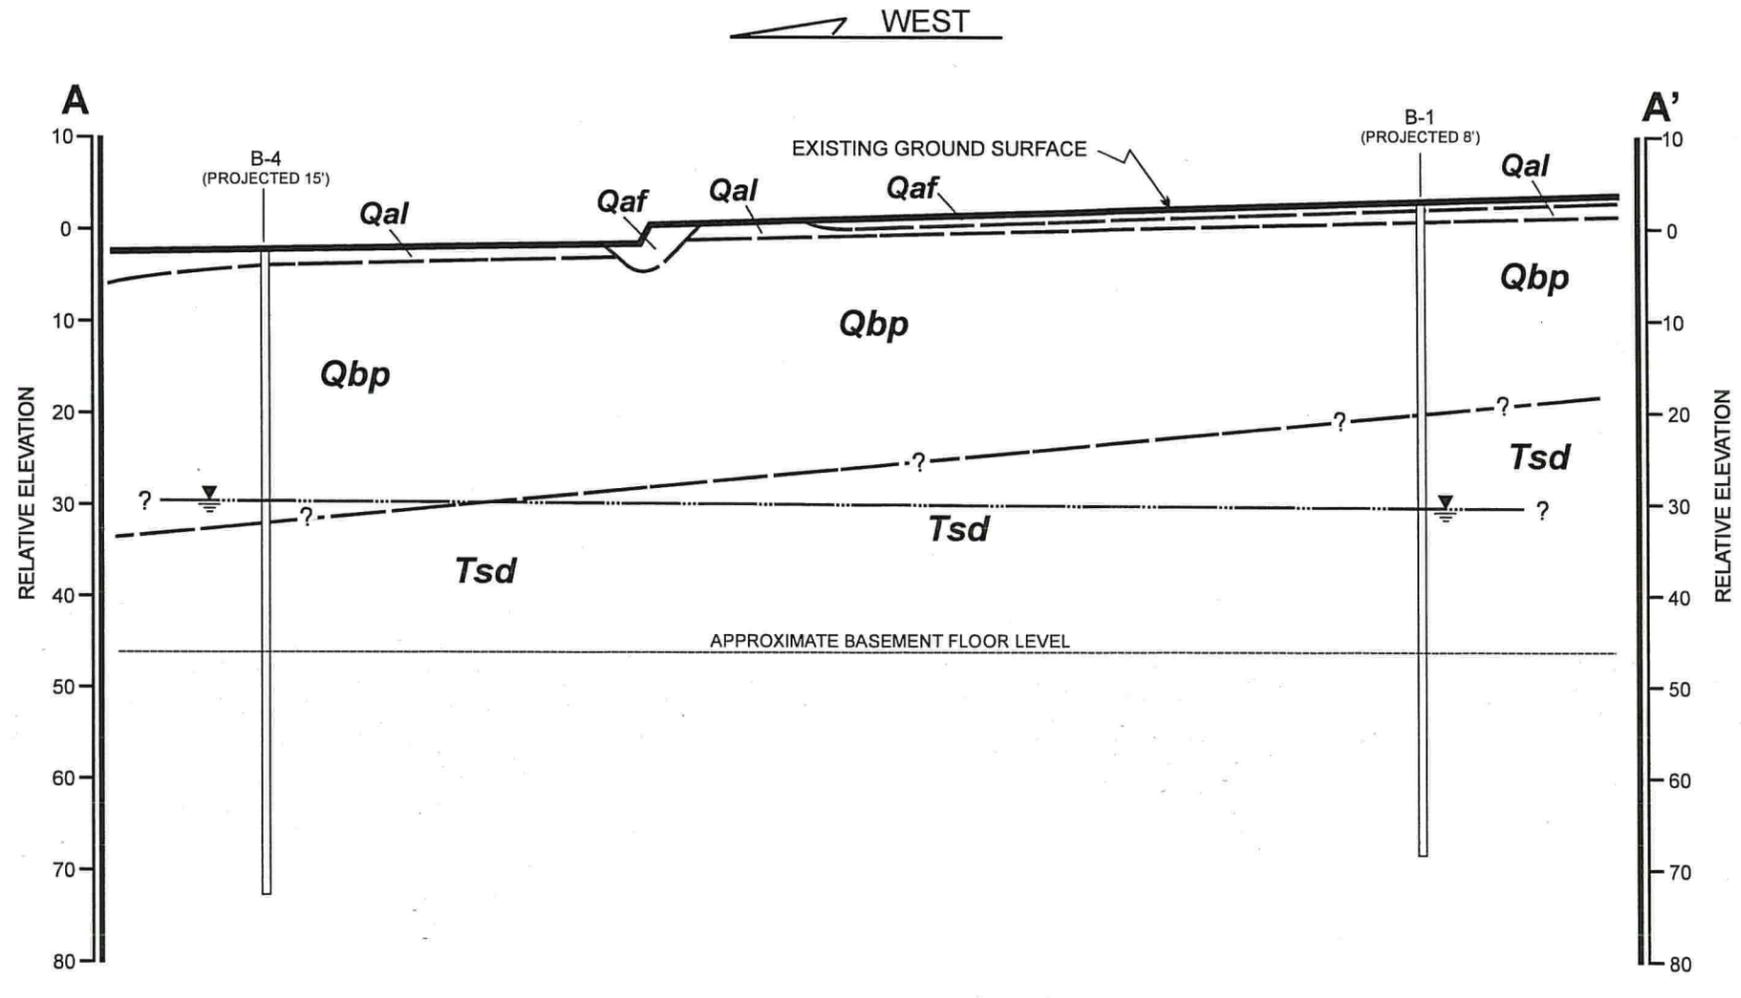
GEOLOGIC CROSS-SECTION

SCALE : 1" = 20' (HORIZ. = VERT.)

Our field investigation encountered four geologic units: fill, alluvium, Bay Point Formation, and San Diego Formation. The occurrence and distribution of each unit, including a description of the unit, are shown on the boring logs in Appendix A and on the Site Plan, Figure 2. A geologic cross-section is presented on Figure 3. Each geologic unit is also described below.

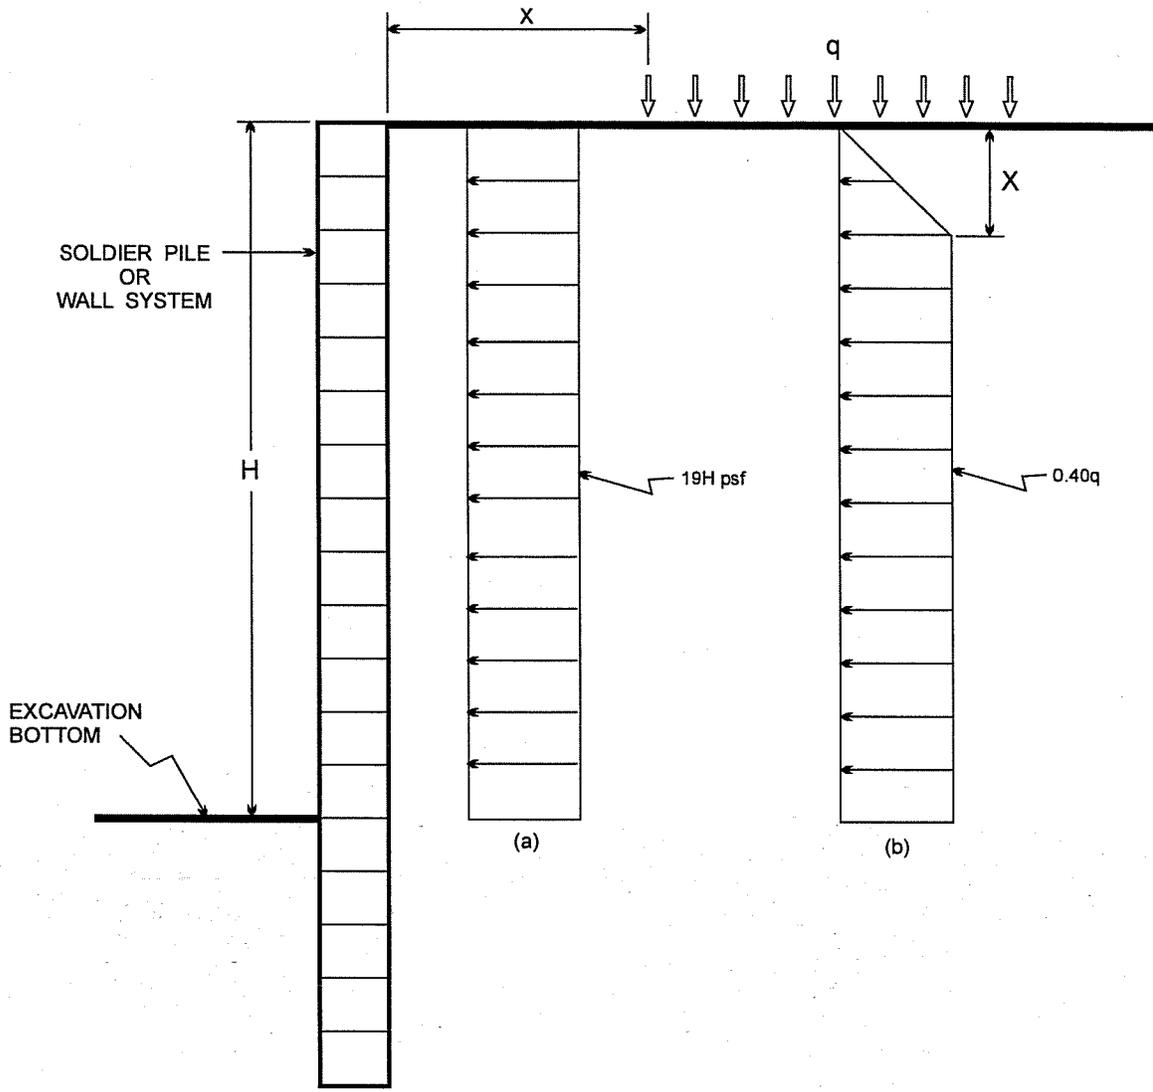
PD / RSS		DSK / E0000	DATE 10-14-2003	PROJECT NO. 06851 - 22 - 02	FIG. 5
----------	--	-------------	-----------------	-----------------------------	--------

(a).....SOIL PRESSURE
 (b).....UNIFORM SURCHARGE

- 7.7.4 Temporary cantilevered shoring can be designed for an active soil pressure equivalent to the pressure exerted by a fluid density of 30 pcf. Temporary tied-back shoring should be designed using a lateral pressure envelope acting uniformly on the back of the shoring and applying a pressure equal to $19H$, where H is the height of the shoring in feet (resulting pressure in pounds per square foot). Also, lateral earth pressure due to the surcharging effects of adjacent structures or traffic loads should be considered where appropriate during design of the shoring system (see Figure 4). Lateral loads due to adjacent footings should also be included (see Figure 5).

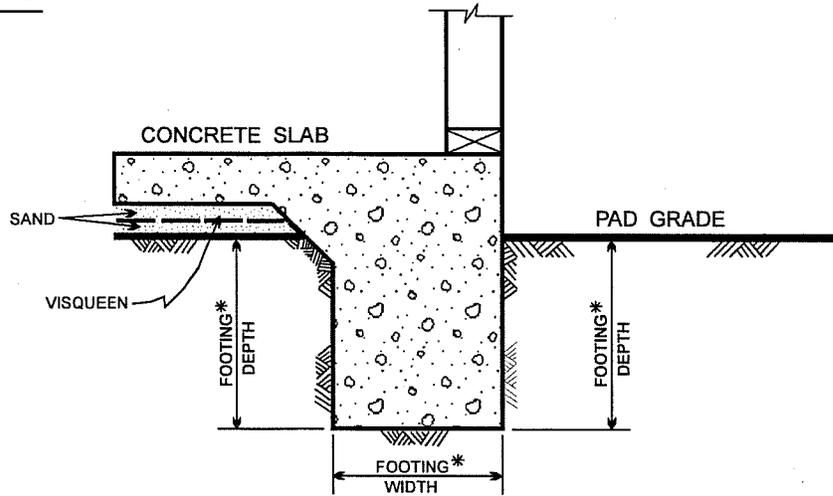
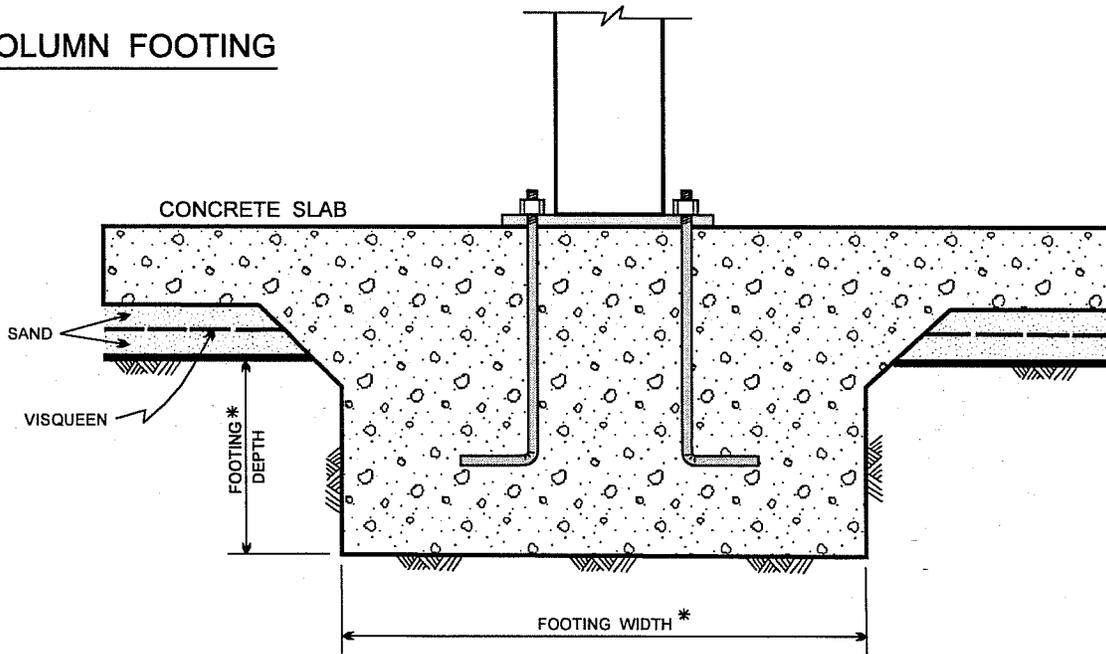
FIG 9

WALL FOOTING

COLUMN FOOTING

*.....SEE REPORT FOR FOUNDATION WIDTH AND DEPTH RECOMMENDATION

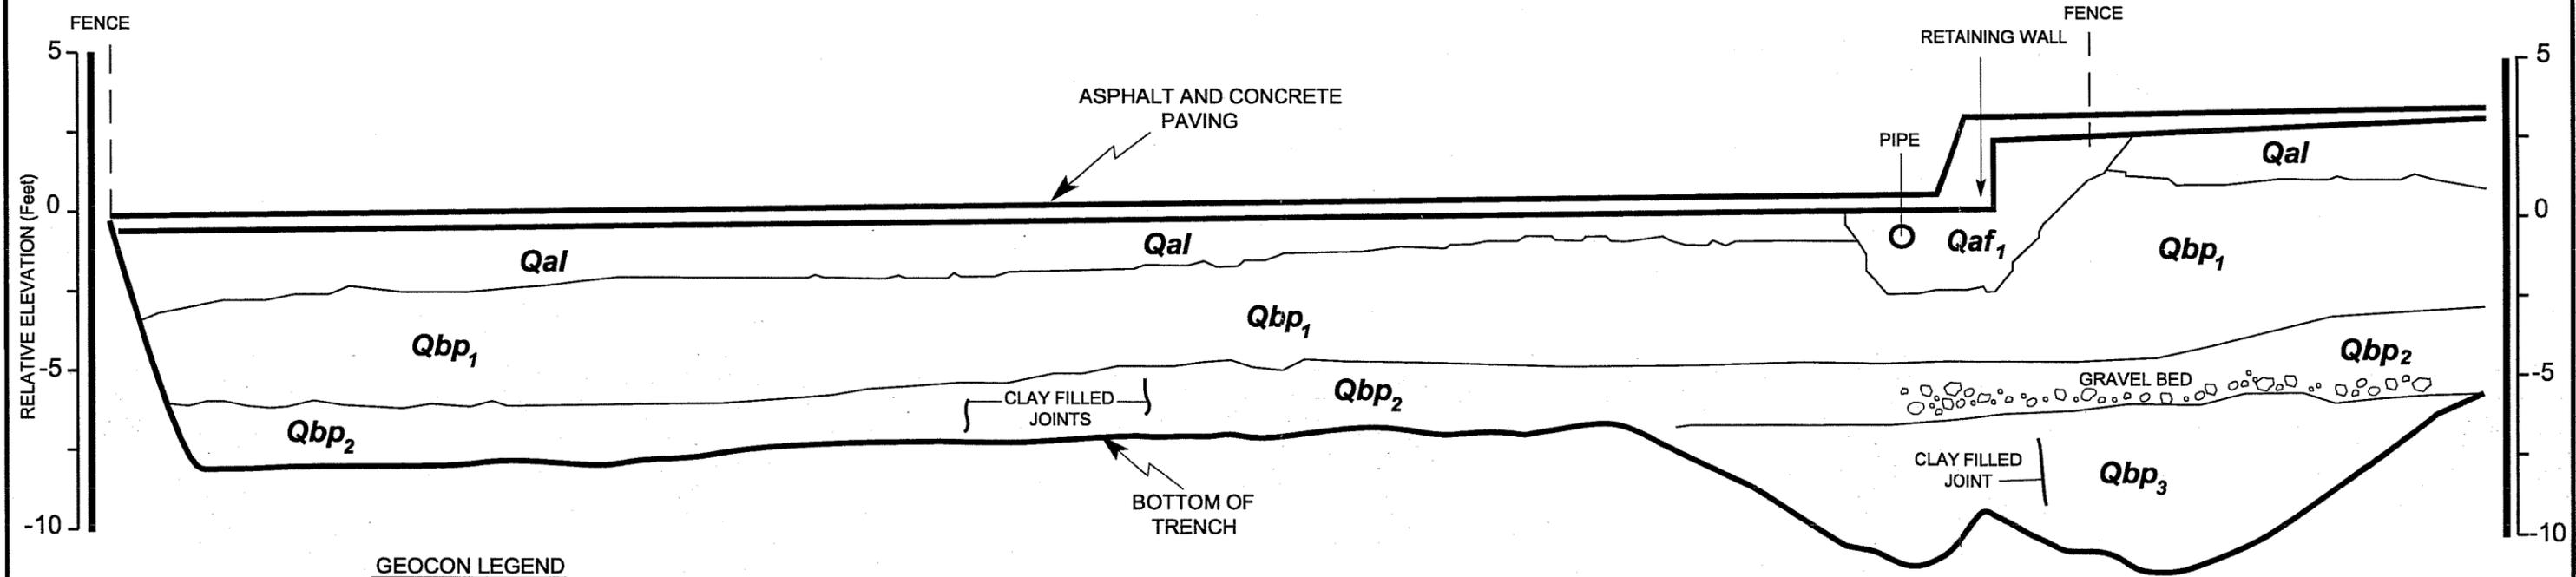
- Qaf**FILL
- Qaf₁**Loose, damp, dark, yellowish - brown, Silty, fine to coarse SAND(SM), with gravel scattered debris, including brick, glass and wood
- Qaf₂**Loose, to medium dense, damp, olive - gray, Clayey SAND(SC), scattered debris

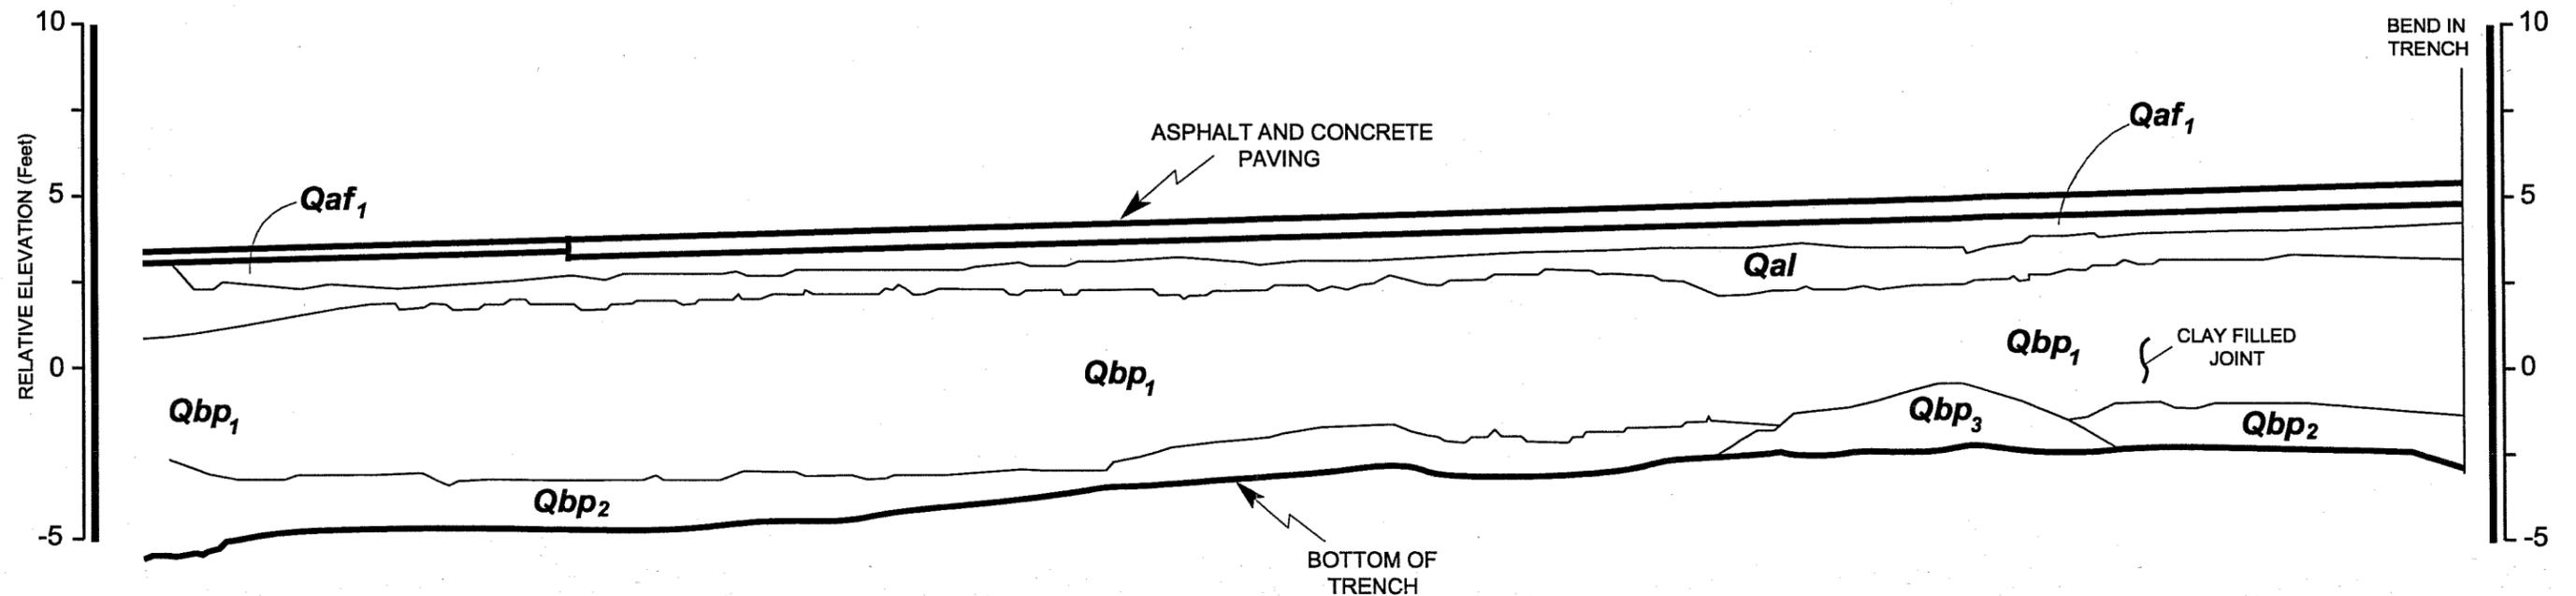
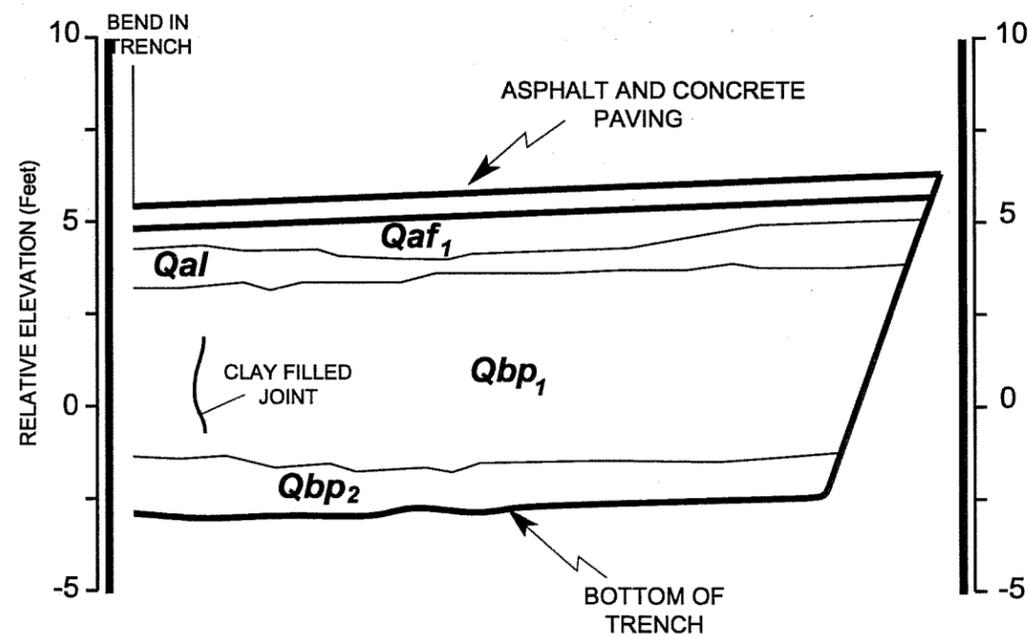
- QafFILL
- Qaf₁Loose, damp, dark, yellowish - brown, Silty, fine to coarse SAND(SM), with gravel scattered debris, including brick, glass and wood
- Qaf₂Loose, to medium dense, damp, olive - gray, Clayey SAND(SC), scattered debris

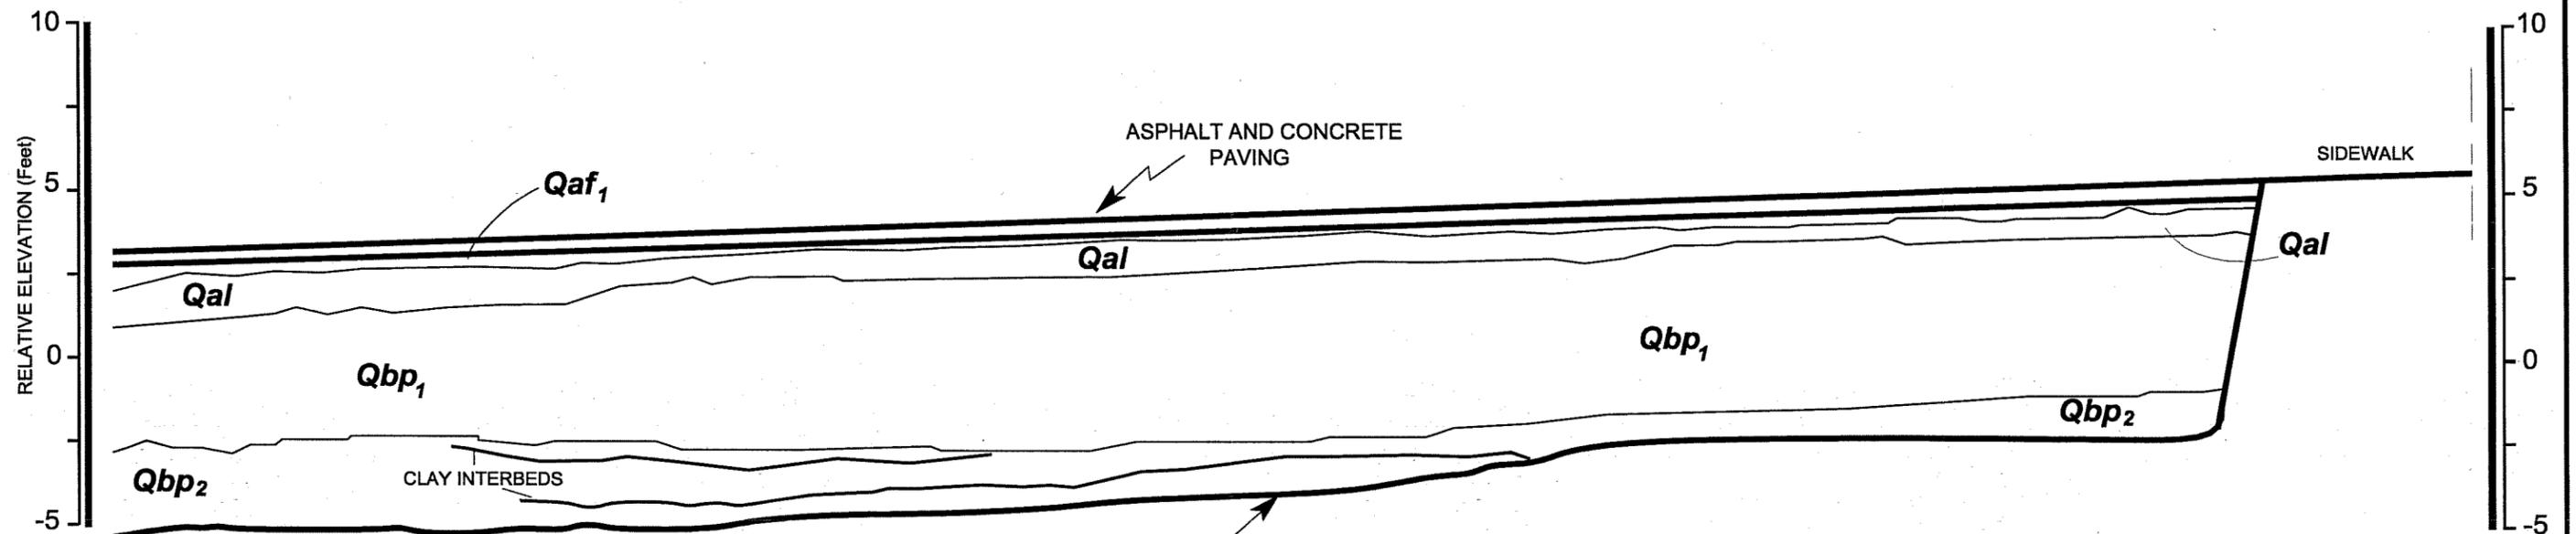
- Qaf**FILL
- Qaf₁**Loose, damp, dark, yellowish - brown, Silty, fine to coarse SAND(SM), with gravel scattered debris, including brick, glass and wood
- Qaf₂**Loose, to medium dense, damp, olive - gray, Clayey SAND(SC), scattered debris

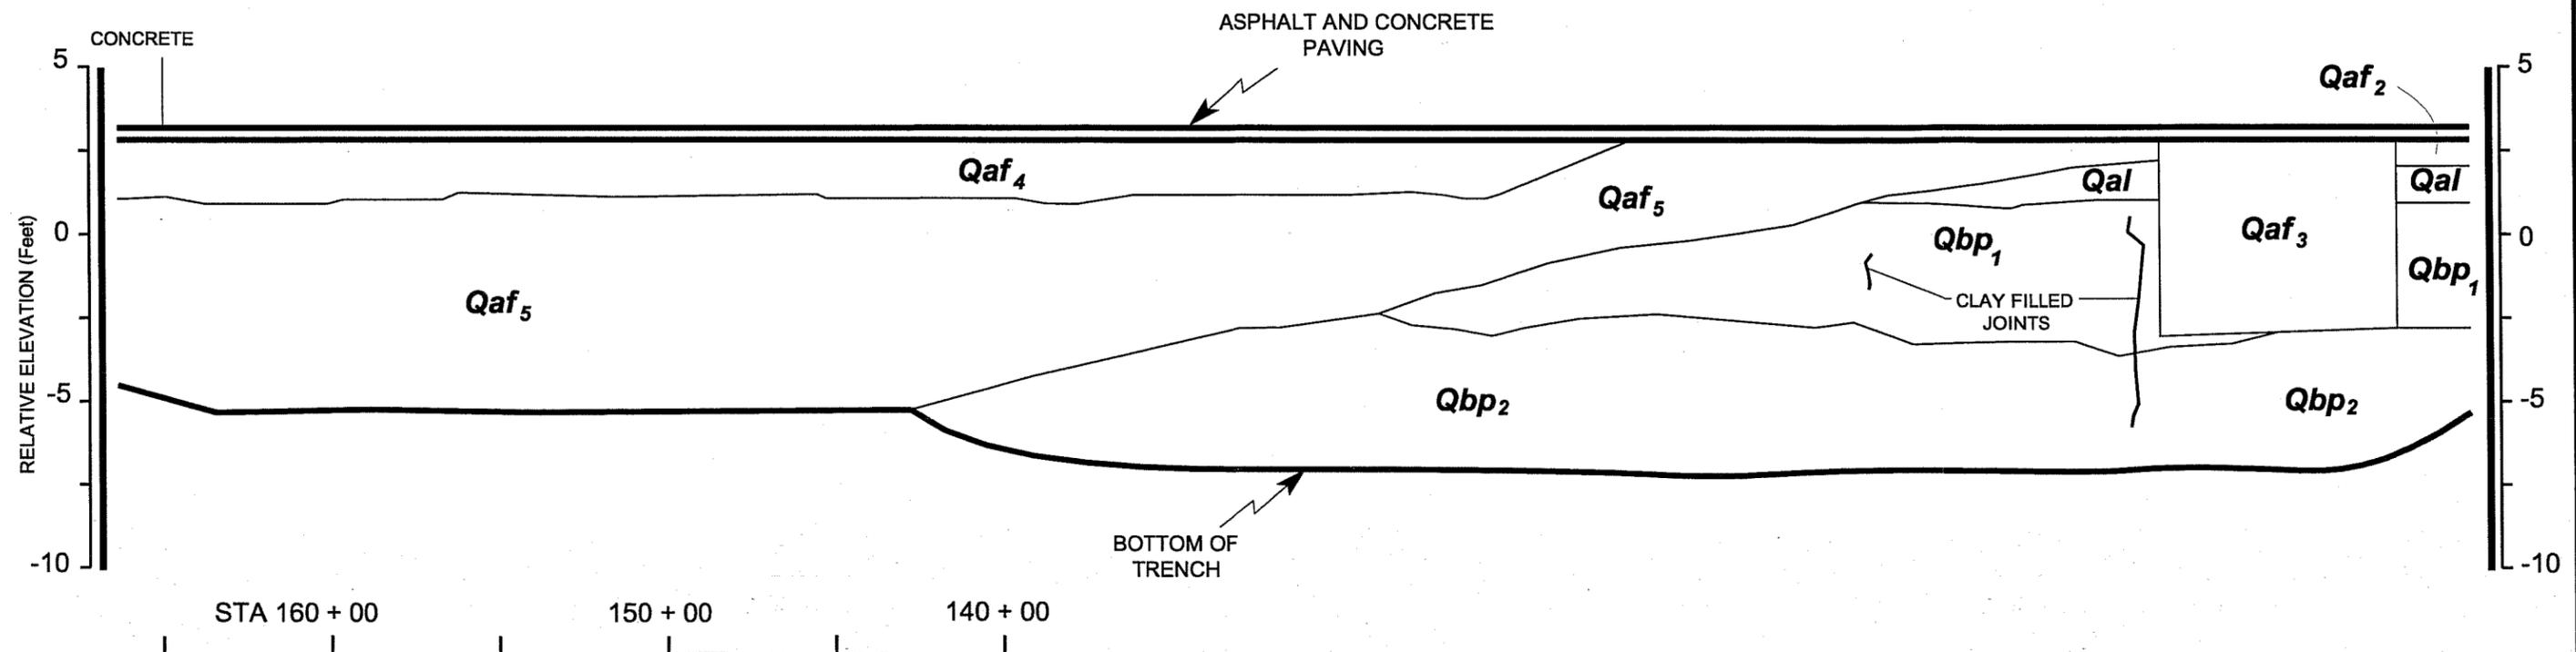
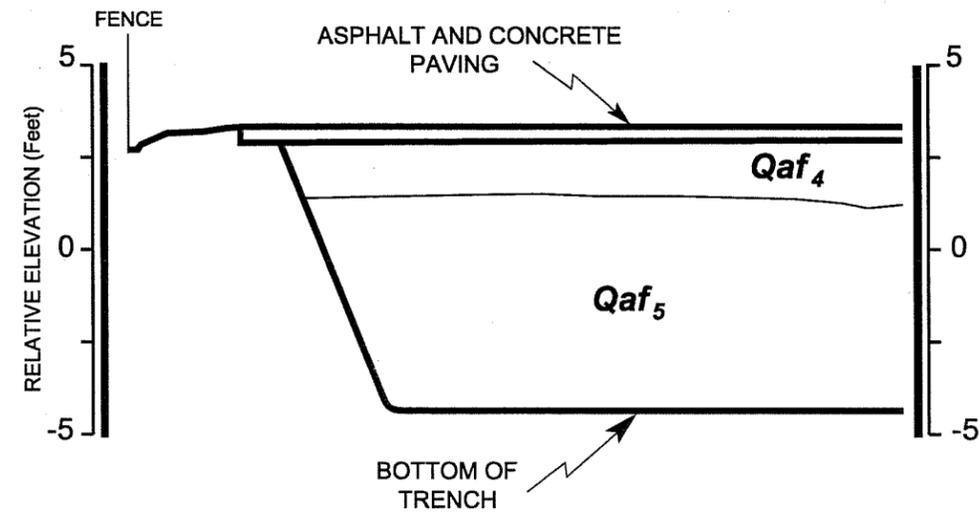
- Qaf**FILL
- Qaf₁**Loose, damp, dark, yellowish - brown, Silty, fine to coarse SAND(SM), with gravel scattered debris, including brick, glass and wood
- Qaf₂**Loose, to medium dense, damp, olive - gray, Clayey SAND(SC), scattered debris

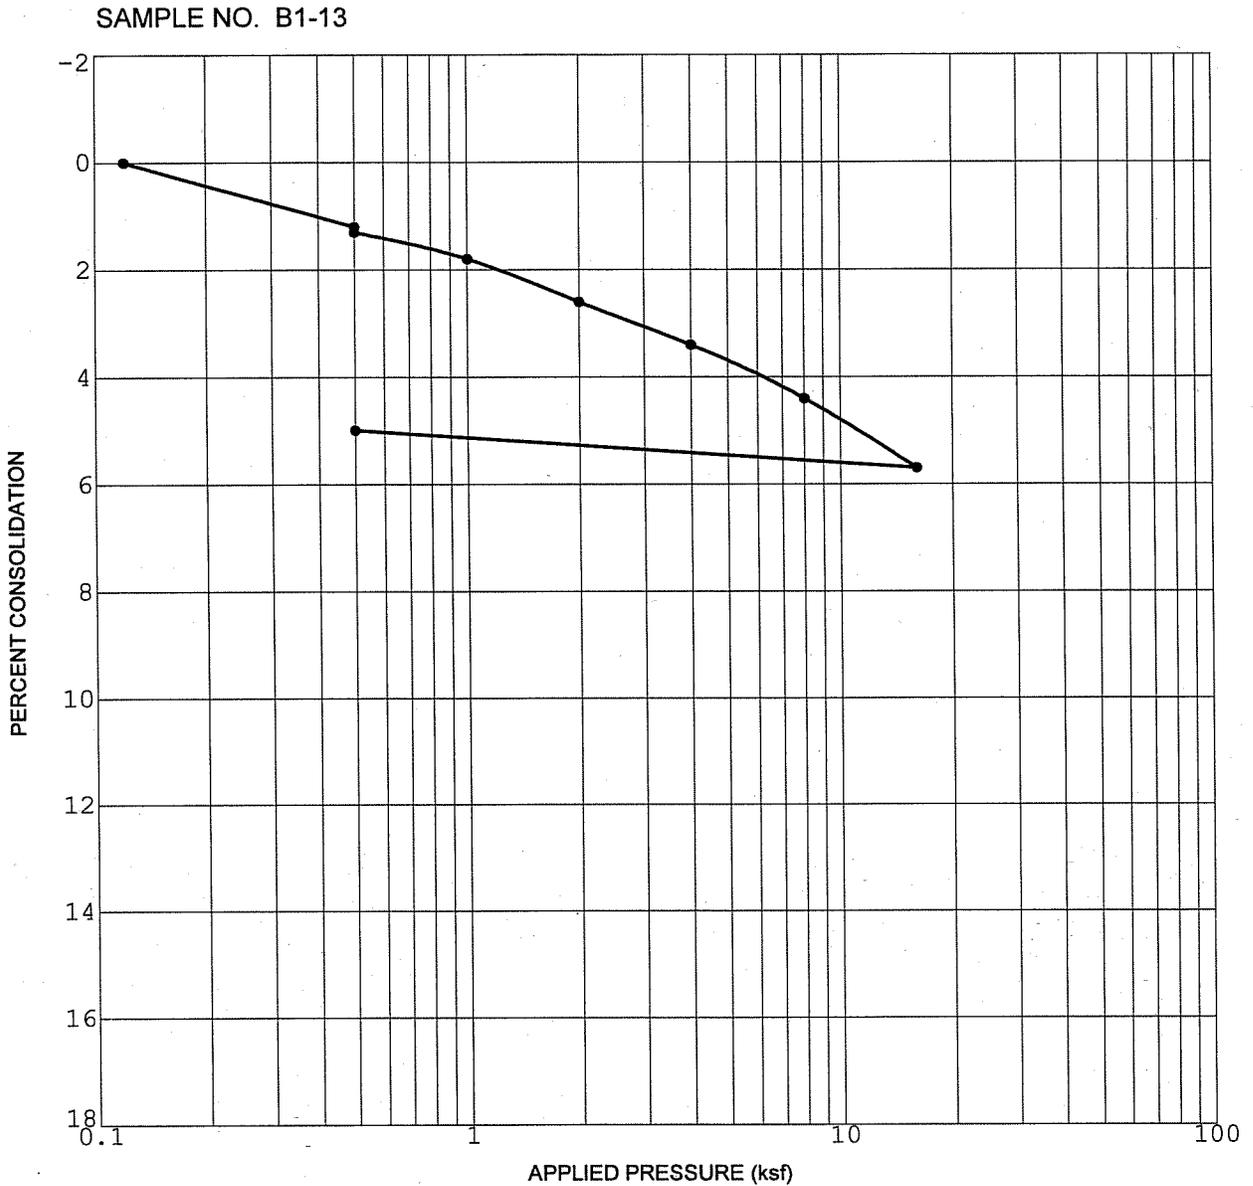
Initial Dry Density (kg/m3)	107.3
Initial Water Content (%)	21.1

Initial Saturation (%)	100+
Sample Saturated at (ksf)	0.5

- Table B-I, Summary of Laboratory Direct Shear Test Results
- Table B-II, Summary of Laboratory Expansion Index Test Results
- Table B-III, Summary of Laboratory pH and Resistivity Test Results
- Table B-IV, Summary of Laboratory Water-Soluble Sulfate Test Results
- Table B-V, Summary of Laboratory Maximum Dry Density and Optimum Moisture Content Test Results
- Table B-VI, Summary of Laboratory R-Value Test Results
- Figure B-1, Consolidation Curve

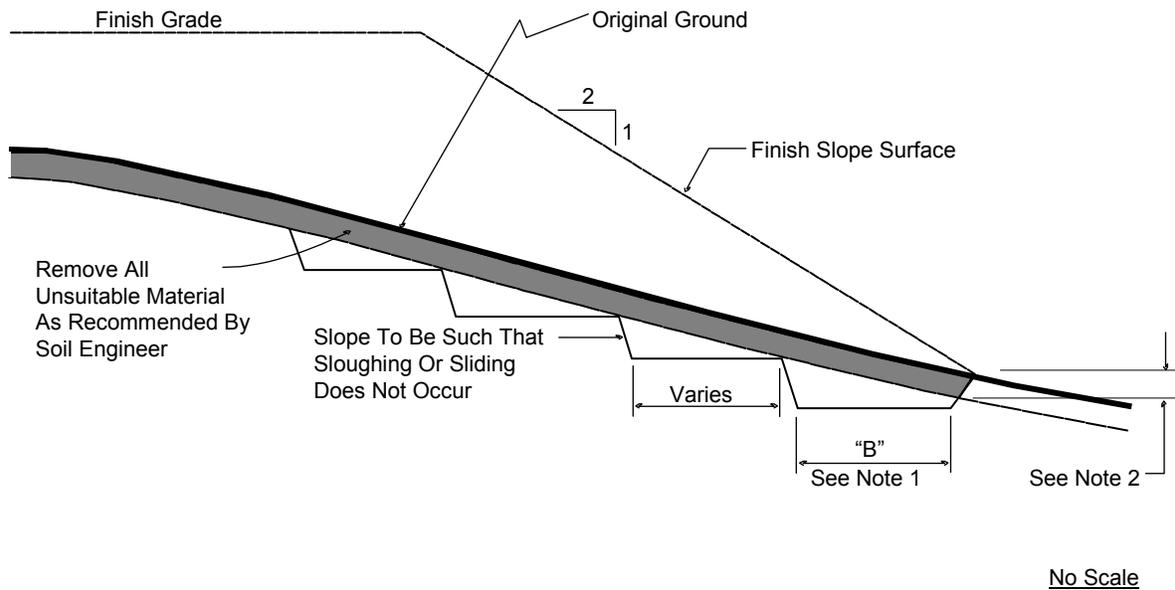
TYPICAL BENCHING DETAIL

- 4.4. Where the slope ratio of the original ground is steeper than 6:1 (horizontal:vertical), or where recommended by the Consultant, the original ground should be benched in accordance with the following illustration.

- (1) Key width "B" should be a minimum of 10 feet wide, or sufficiently wide to permit complete coverage with the compaction equipment used. The base of the key should be graded horizontal, or inclined slightly into the natural slope.
- (2) The outside of the bottom key should be below the topsoil or unsuitable surficial material and at least 2 feet into dense formational material. Where hard rock is exposed in the bottom of the key, the depth and configuration of the key may be modified as approved by the Consultant.
