RE: Other County Requirements (Addendum to Geotechnical Plan)

## SHADOW RUN RANCH, PAUMA VALLEY

### PRELIMINARY GRADING PLAN

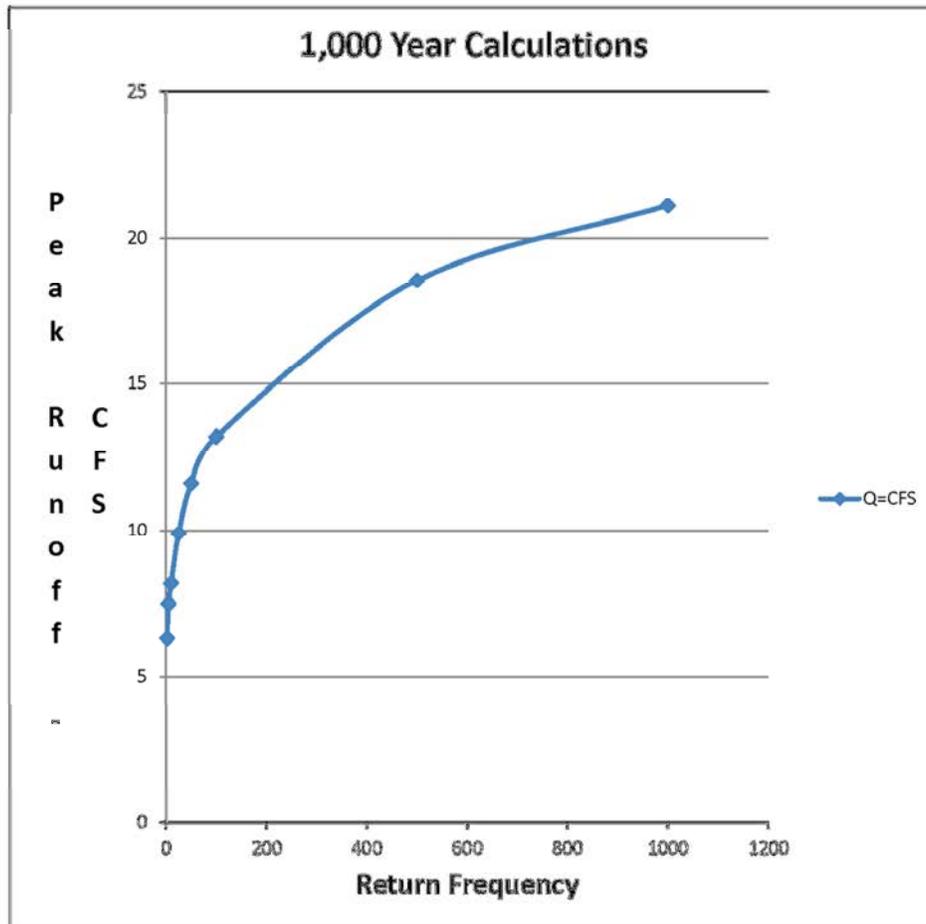
Yr	Q=CFS
2	6.3
5	7.5
10	8.2
25	9.9
50	11.6
100	13.2
500	18.56
1000	21.1

The peak runoff for the 2, 5, 10, 25, 50 and 100 year frequency storms have been calculated on the previous page and summarize on this page, in accordance with the requirements of the County of San Diego Hydrology Manual. The relationship between the values of the storms remains fairly consistent. The relationship between runoff intensity / flow is 1.6:1 for storm frequencies that have a return frequency that is 10:1. For example:

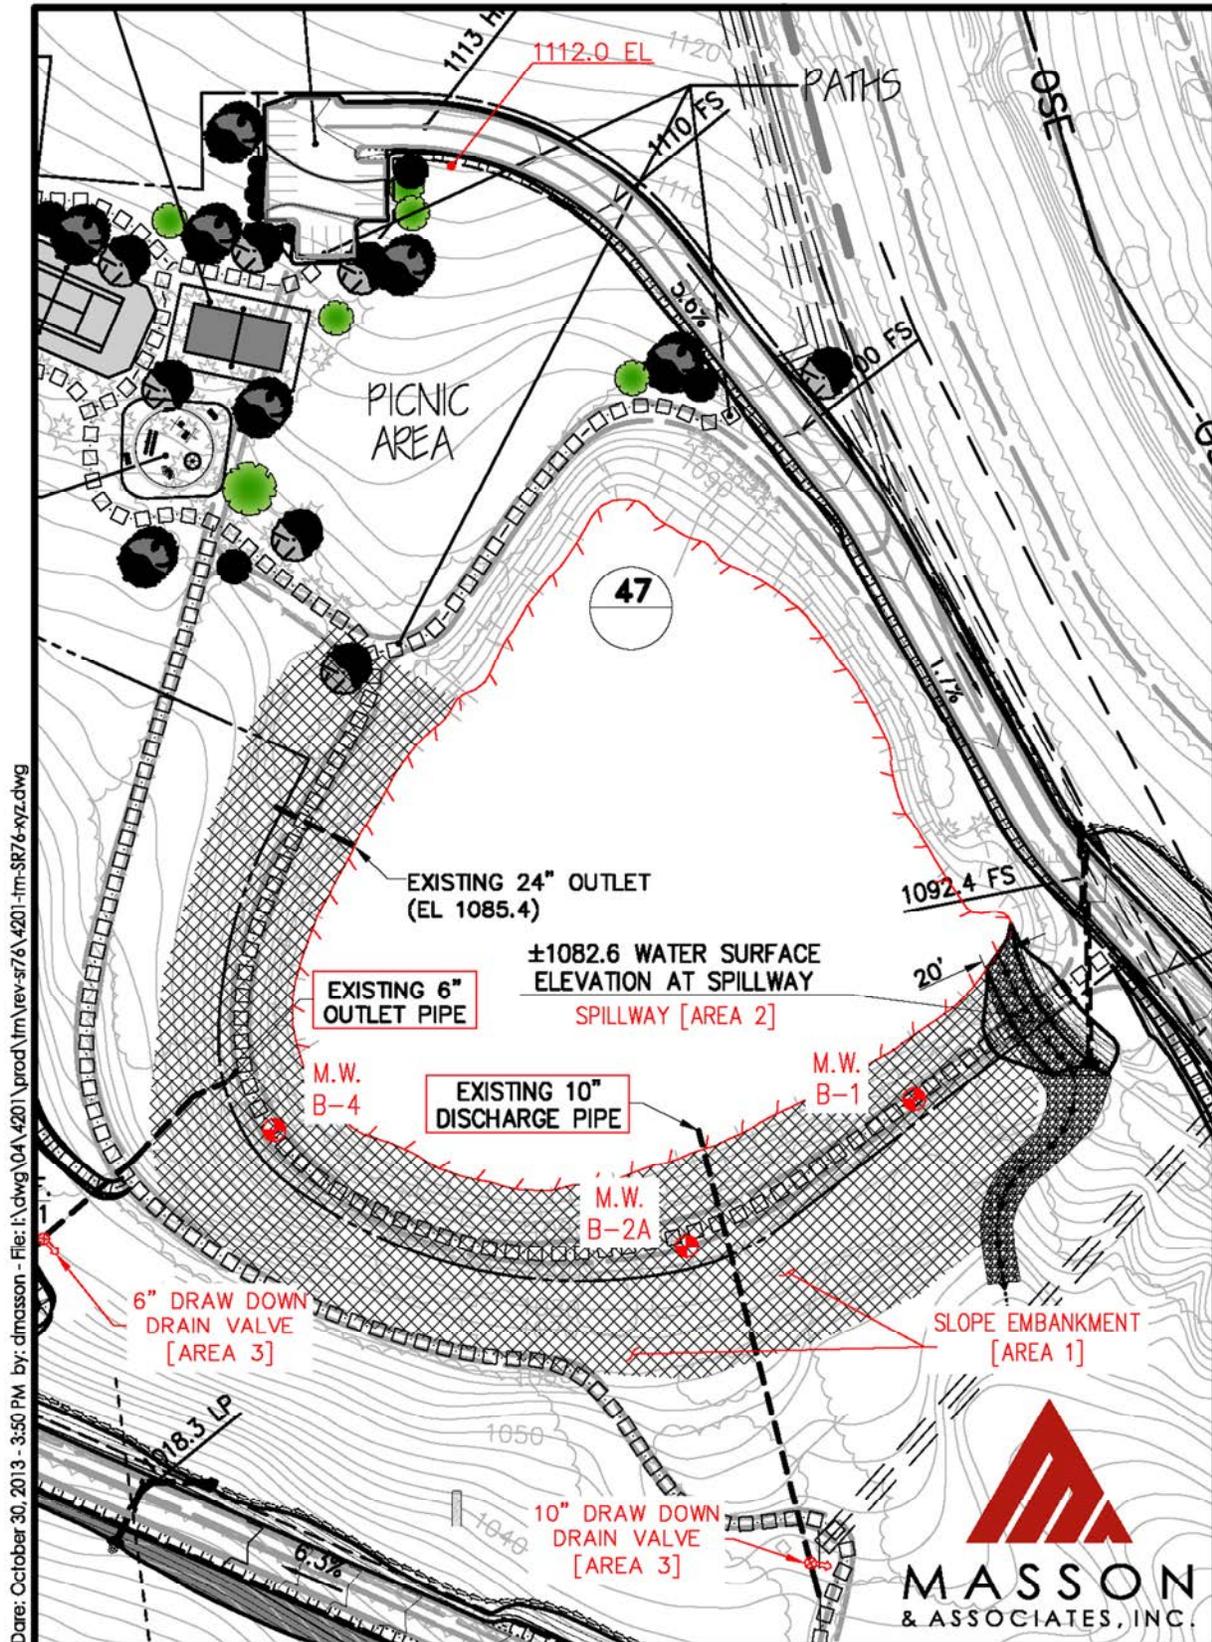
Reservoir area:

1. Reservoir embankment [AREA 1]
  - a. Stability
  - b. Landscaping
  - c. Irrigation
  - d. Burrowing animals
2. Reservoir spillway [AREA 2]
  - a. Stability
  - b. Energy dissipaters
  - c. Scour
3. Reservoir drain lines [AREA-3]
  - a. Pipeline condition
  - b. Shutoff valves
  - c. Drain valves
4. Monitoring wells [AREA-4]
  - a. Depth to ground water

The grove manager shall visually inspect on a quarterly basis, the entire slope embankment [Area 1] of the reservoir including the spillway [Area 2] looking for any settlement, surface cracking, burrowing animals, overwatering and seepage. In addition the (2) 6” drain line pipes and (1) 10” drain line pipe [Area 3] shall be tested monthly, to ensure the valves and drain capacities are working properly.

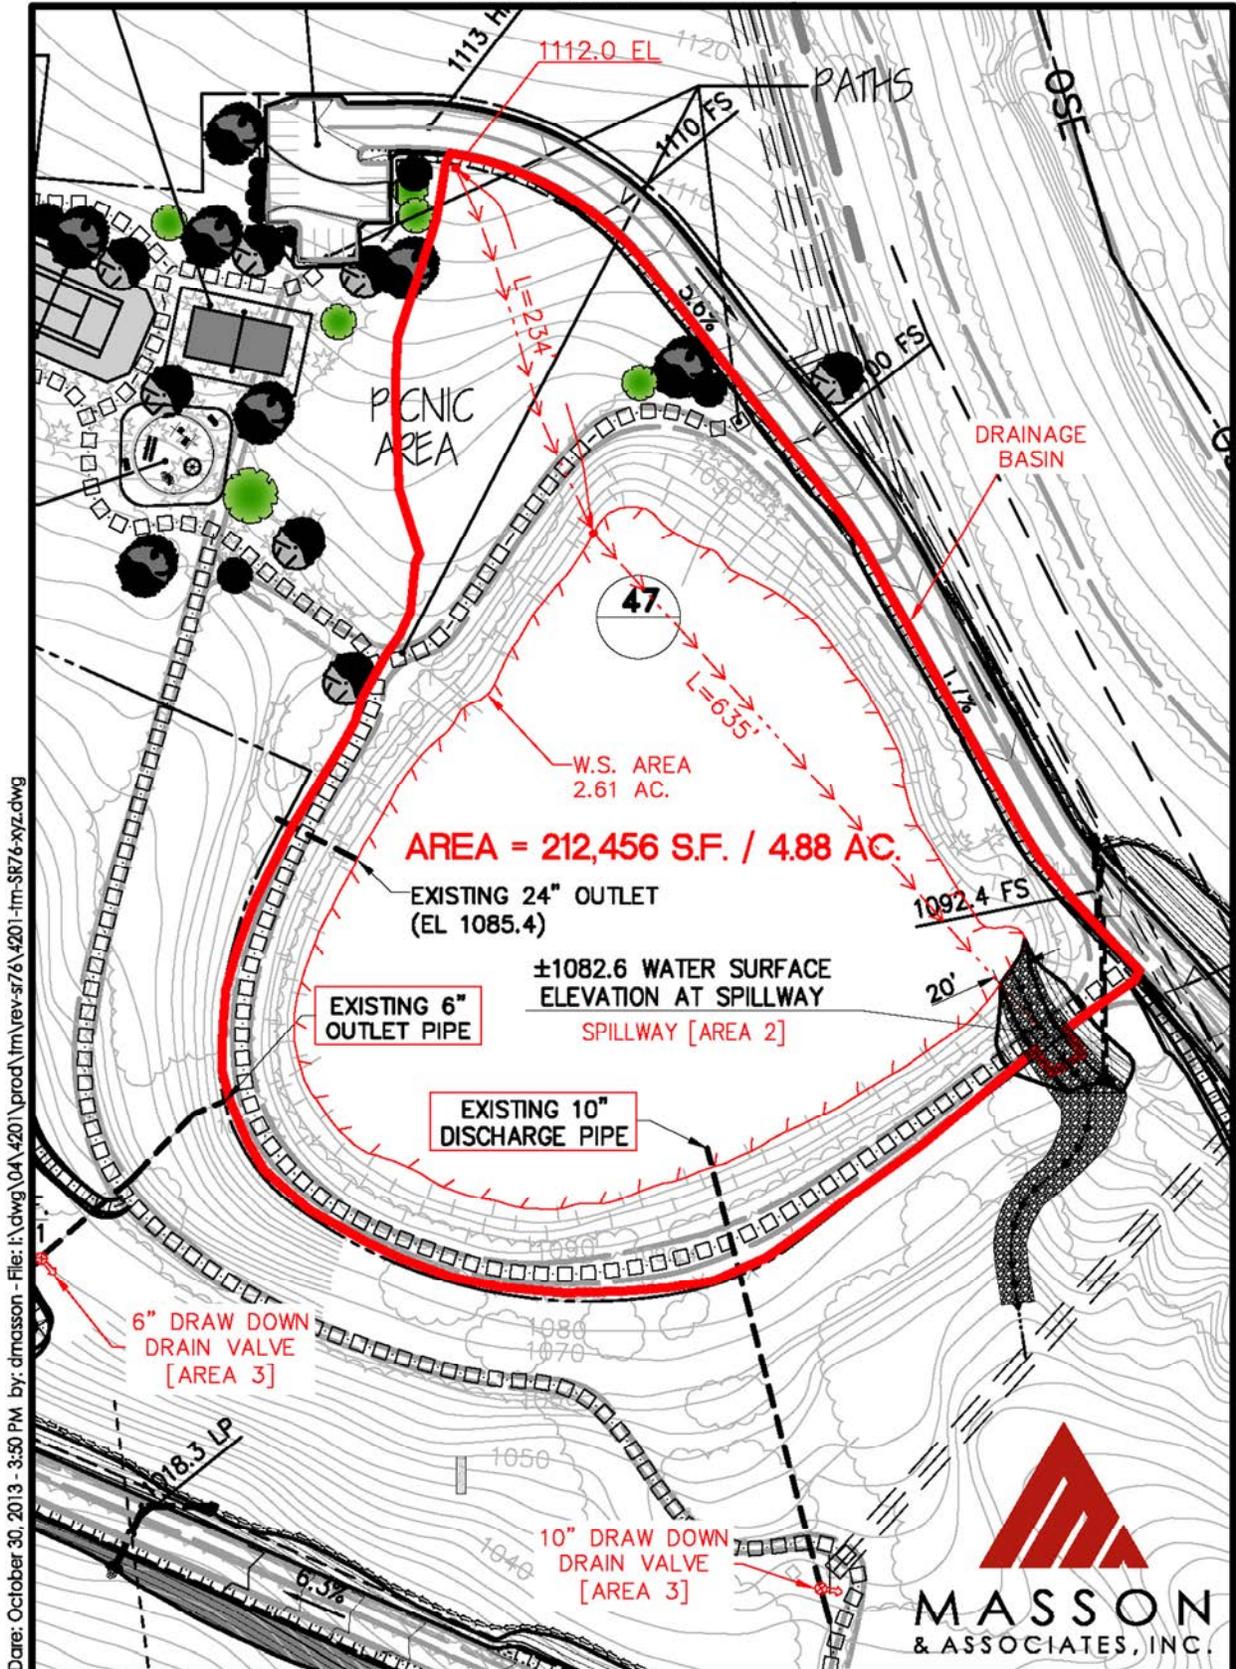
# DRAINAGE - EXHIBIT

Per the exhibit above there are two existing drawdown pipes 6" and 10" that can be used to drain the entire reservoir within 3 days per the calculations provided below.

The goal of this O&M is to ensure safety and operational conditions of all reservoir systems on a monthly basis. Testing the valves on the two (2) 6” irrigation/down drain lines and the one (1) 10” down drain line shall be maintained and operational to be opened in case of an emergency to drawdown ½ the reservoir capacity within 7 days, and completely drain the reservoir within 20 days.
