ASBESTOS/LEAD SURVEY: HELIX WATER DISTRICT STORAGE YARD AND HISTORIC FLUME AREA, PIPE SYSTEM, PUMP HOUSE, AND SHED, 14003 EL MONTE ROAD, LAKESIDE, 92040

INTER-DEPARTMENTAL CORRESPONDENCE

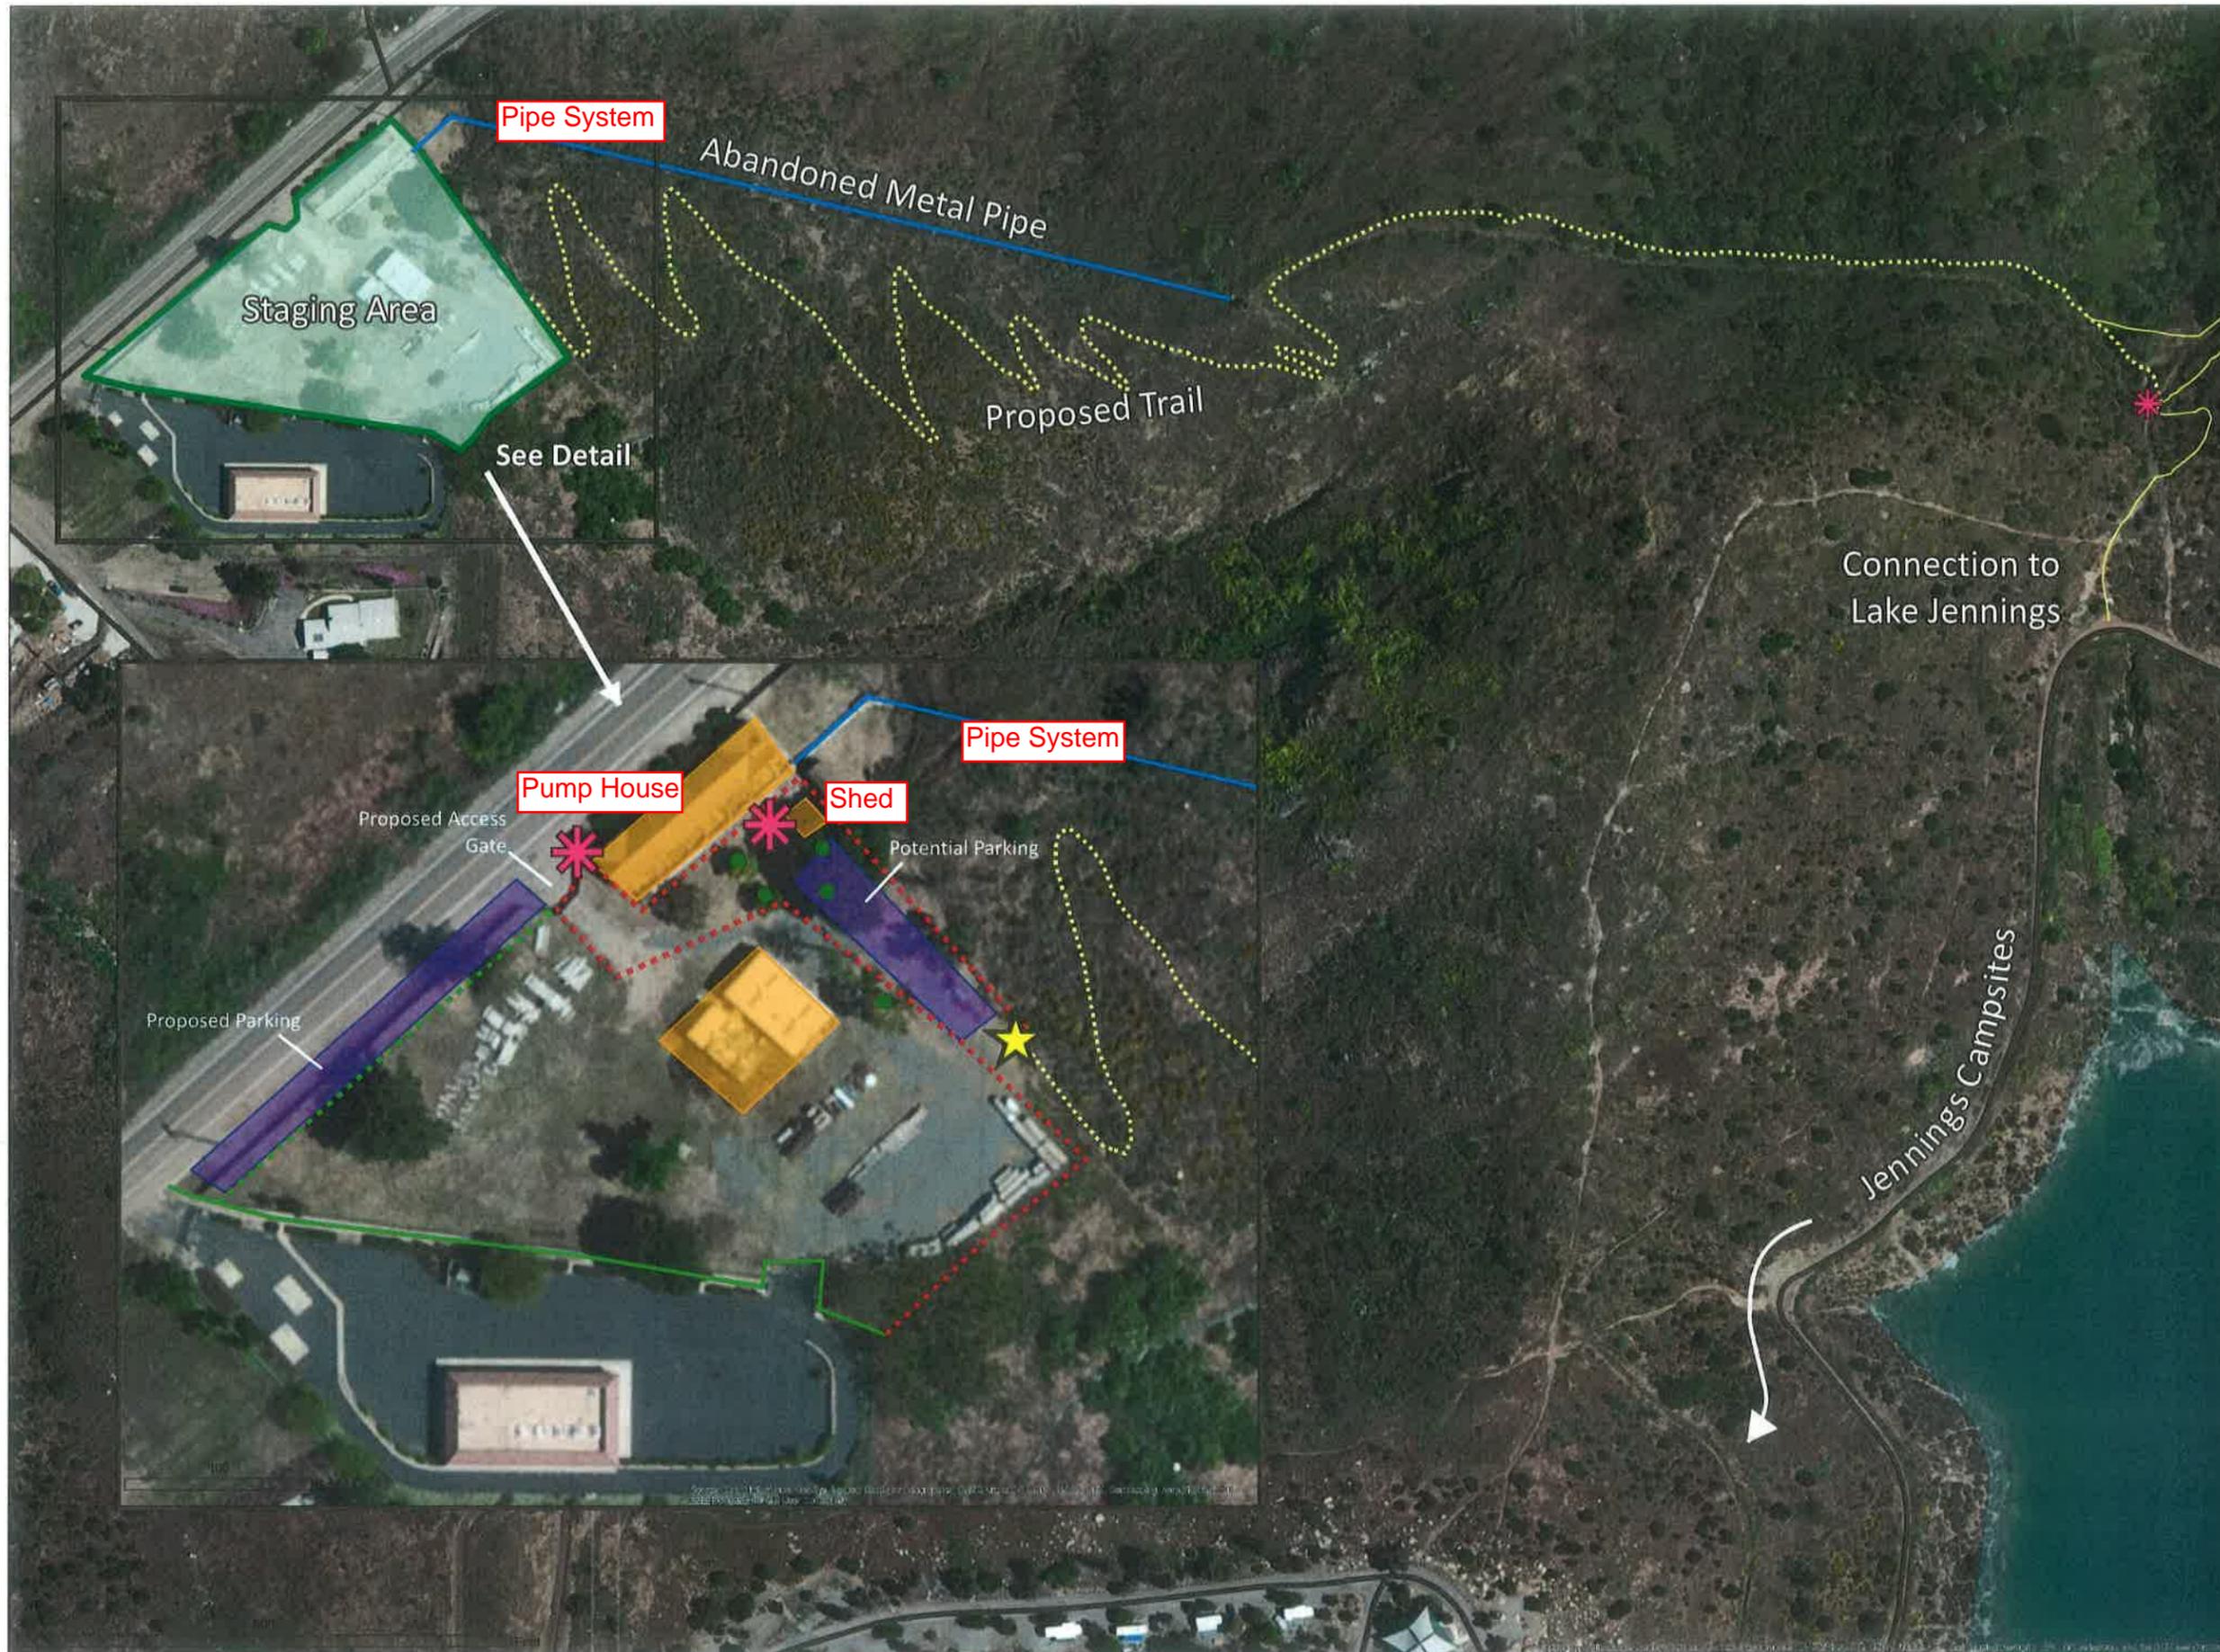
Helix Flume Trail

- Approximate Staging Area
- Proposed Flume Trail
- Proposed Trailhead and Signage
- Signage
- Tree
- Fencing
 - Existing Fencing
 - Existing Fencing Proposed To Change
 - Proposed Fencing
 - Abandoned Metal Pipe
 - Proposed and Potential Parking Areas
 - Existing Buildings
