We have performed a Phase I Environmental Site Assessment (ESA) in conformance with the scope and limitations of ASTM Designation E1527-05 for the proposed roadway expansion property including: an approximately 2,700 linear foot section of Covey Lane, west of West Lilac Road to the Lilac Hills Master Planned Community Development boundary, Escondido, California. Any exceptions to, or deletions from, this practice are described in Section 7.0 of this report. This Phase I ESA has revealed no evidence of *recognized environmental conditions* in connection with the property, except for the following:

SITE LOCATION MAP
 ACCRETIVE INVESTMENTS, INC.
 Lilac Hills Master Planned Community Development
 Roadway Expansion Property
 Covey Lane west from West Lilac Road
 Escondido, California 92026
 EEI Project Number ACR-71507
 Created July 2012

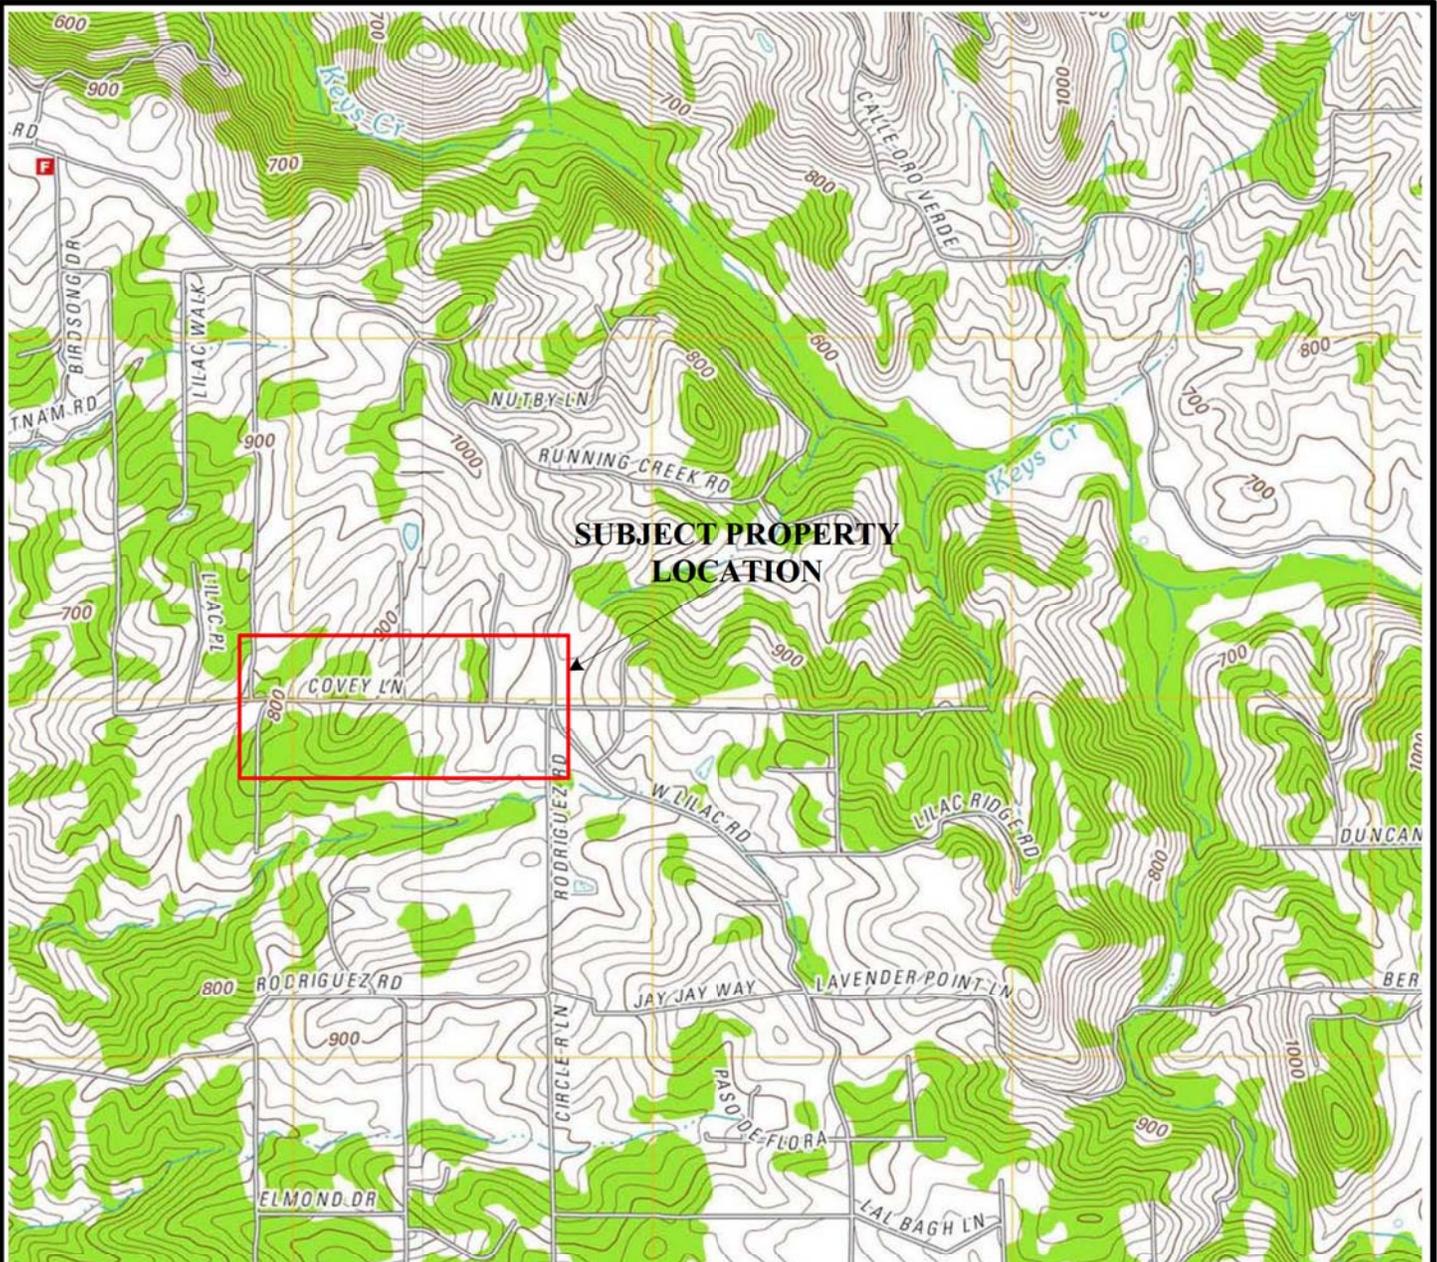
FIGURE 1

Map Source: USGS, Pala, California 7.5 Minute Quadrangle map (USGS, 2012)

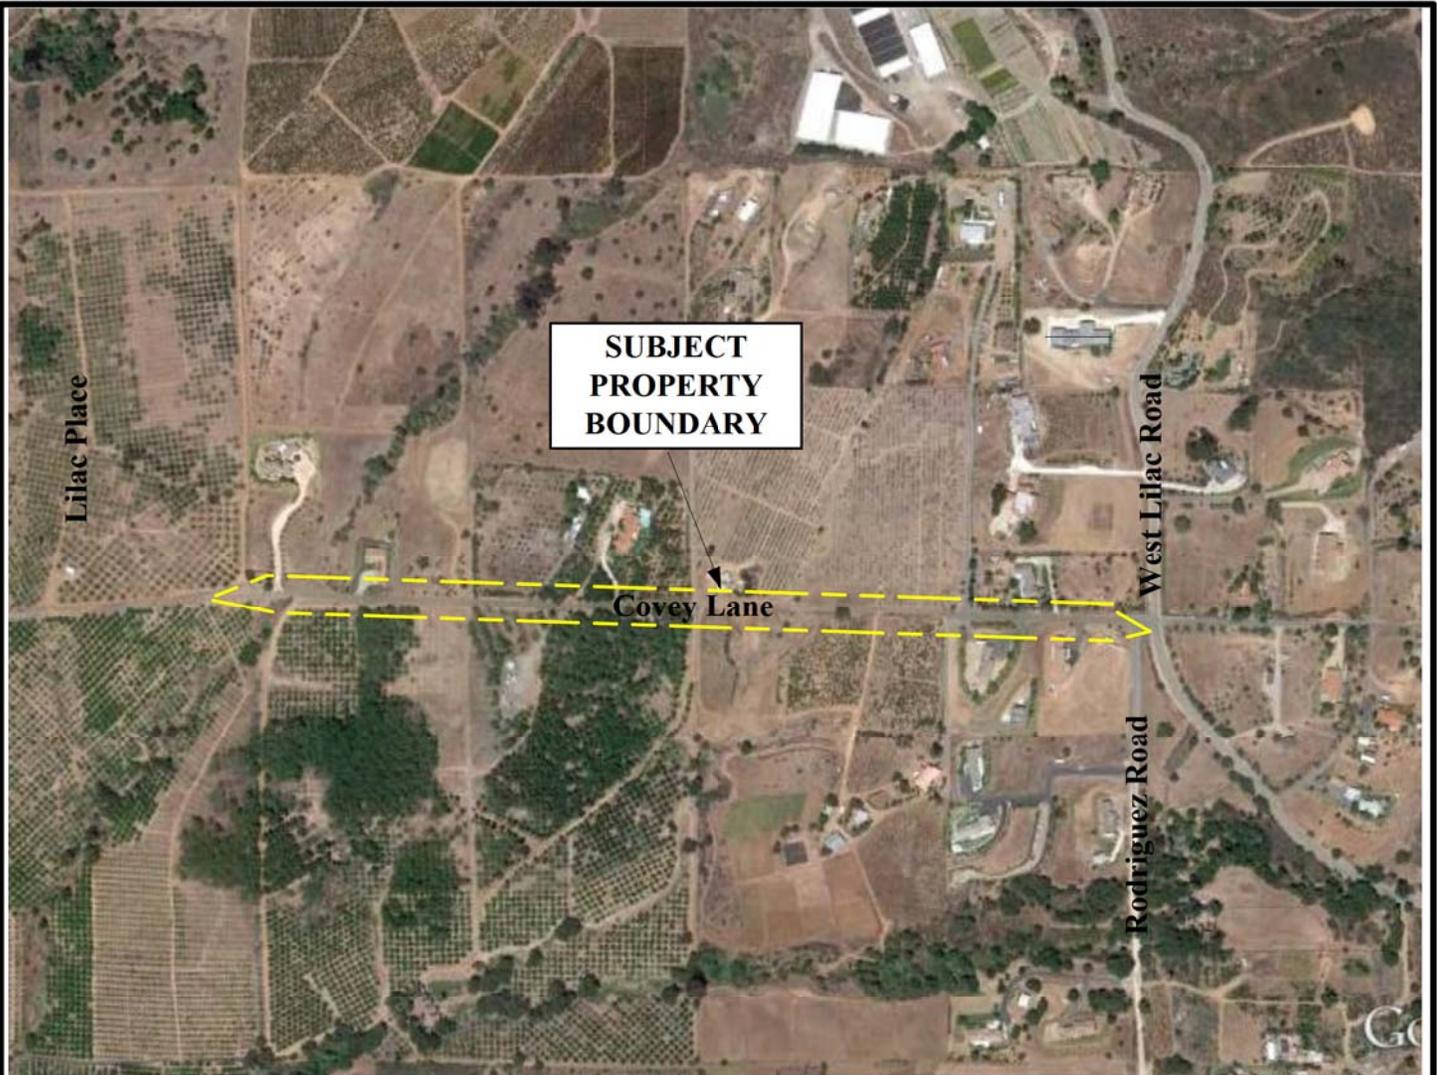
FIGURE 2

Map Source: Google Earth®, August 23, 2010

Aerial photographs and historical topographical maps were reviewed to identify historical land development and any surface conditions which may have impacted the subject property. Photographs and historical topographic maps dating 1946, 1949, 1953, 1963, 1976, 1980, 1982, 1988, 1990/91, 2002, 2008, and 2012 were obtained and reviewed from Track Info Services/FirstSearch®, an environmental information/database retrieval service. A 2010 aerial photograph was obtained from Google Earth® and reviewed, a copy of which is included herein (**Figure 2**).

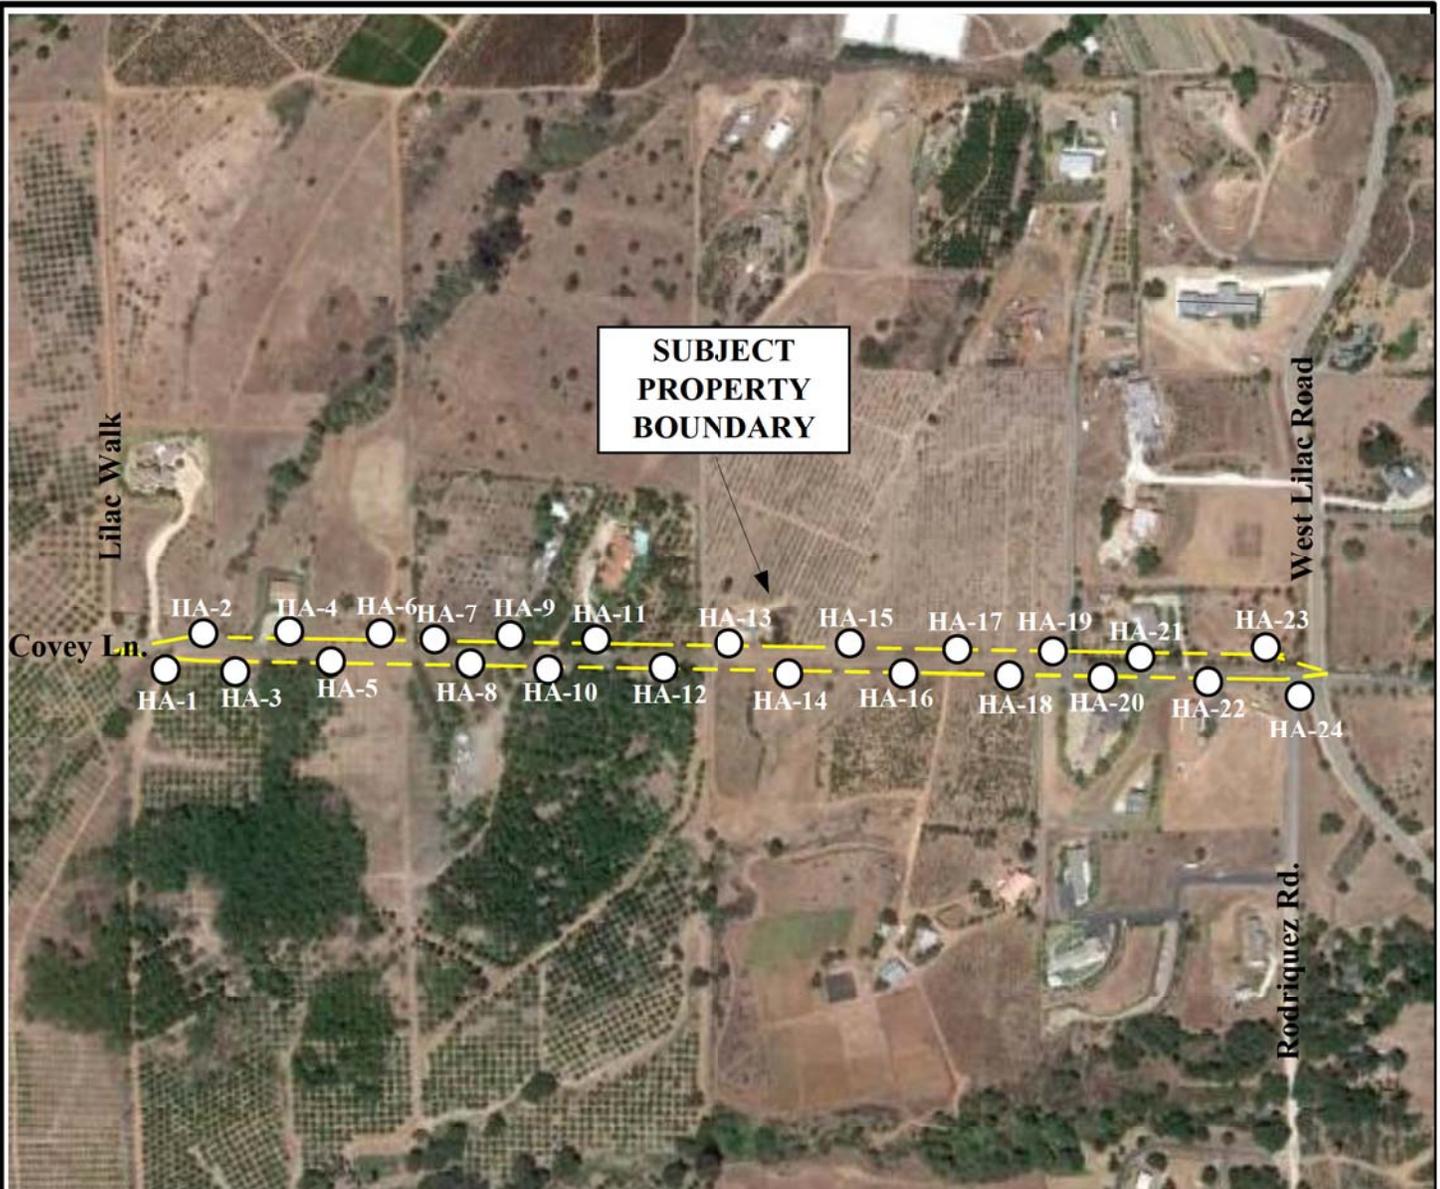
FIGURE 3

Map Source: Google Earth®, August 23, 2010

On July 25, 2012, EEI personnel mobilized to the subject property to conduct soil sampling activities. Soil sampling locations from both sides of Covey Lane were selected with the goal of collecting representative soil samples from the subject property. A total of twenty-four (24) discrete locations (identified as HA-1 through HA-24, **Figure 3**) were chosen to provide representative coverage.

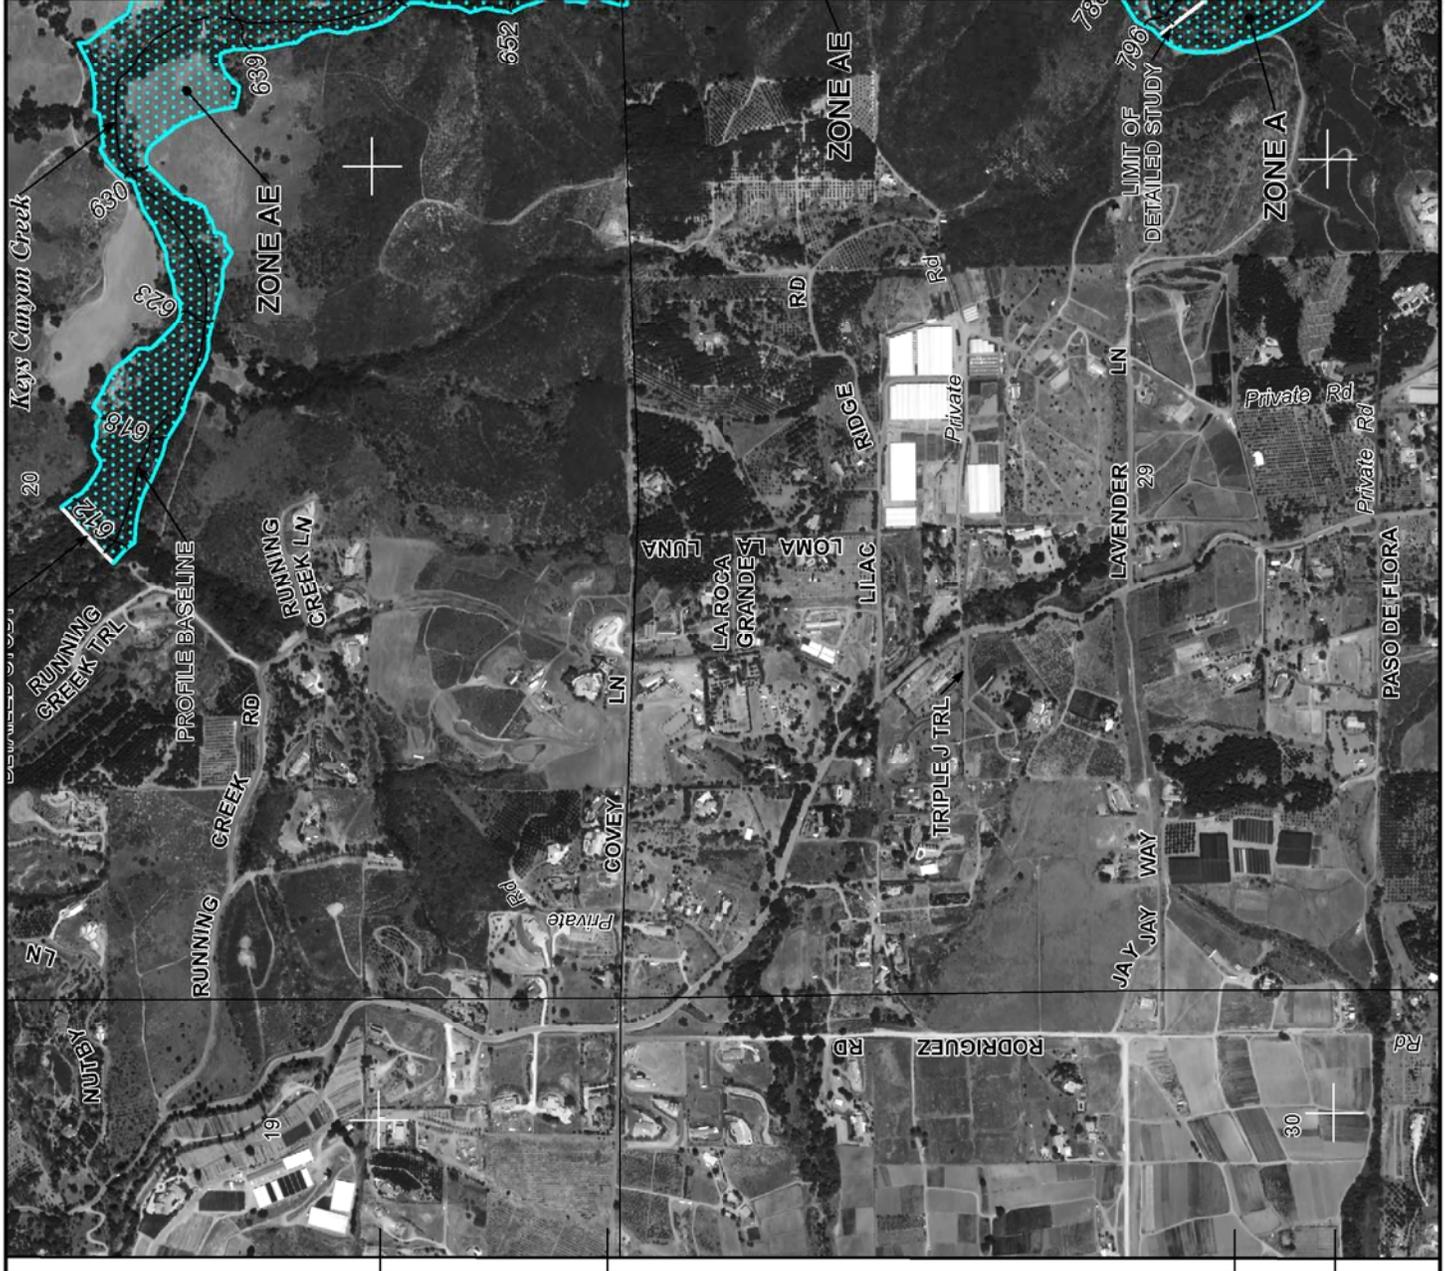
PANEL 0515G

NATIONAL FLOOD INSURANCE PROGRAM

This is an official copy of a portion of the above referenced flood map. It was extracted using F-MIT On-Line. This map does not reflect changes or amendments which may have been made subsequent to the date on the title block. For the latest product information about National Flood Insurance Program flood maps check the FEMA Flood Map Store at www.msc.fema.gov

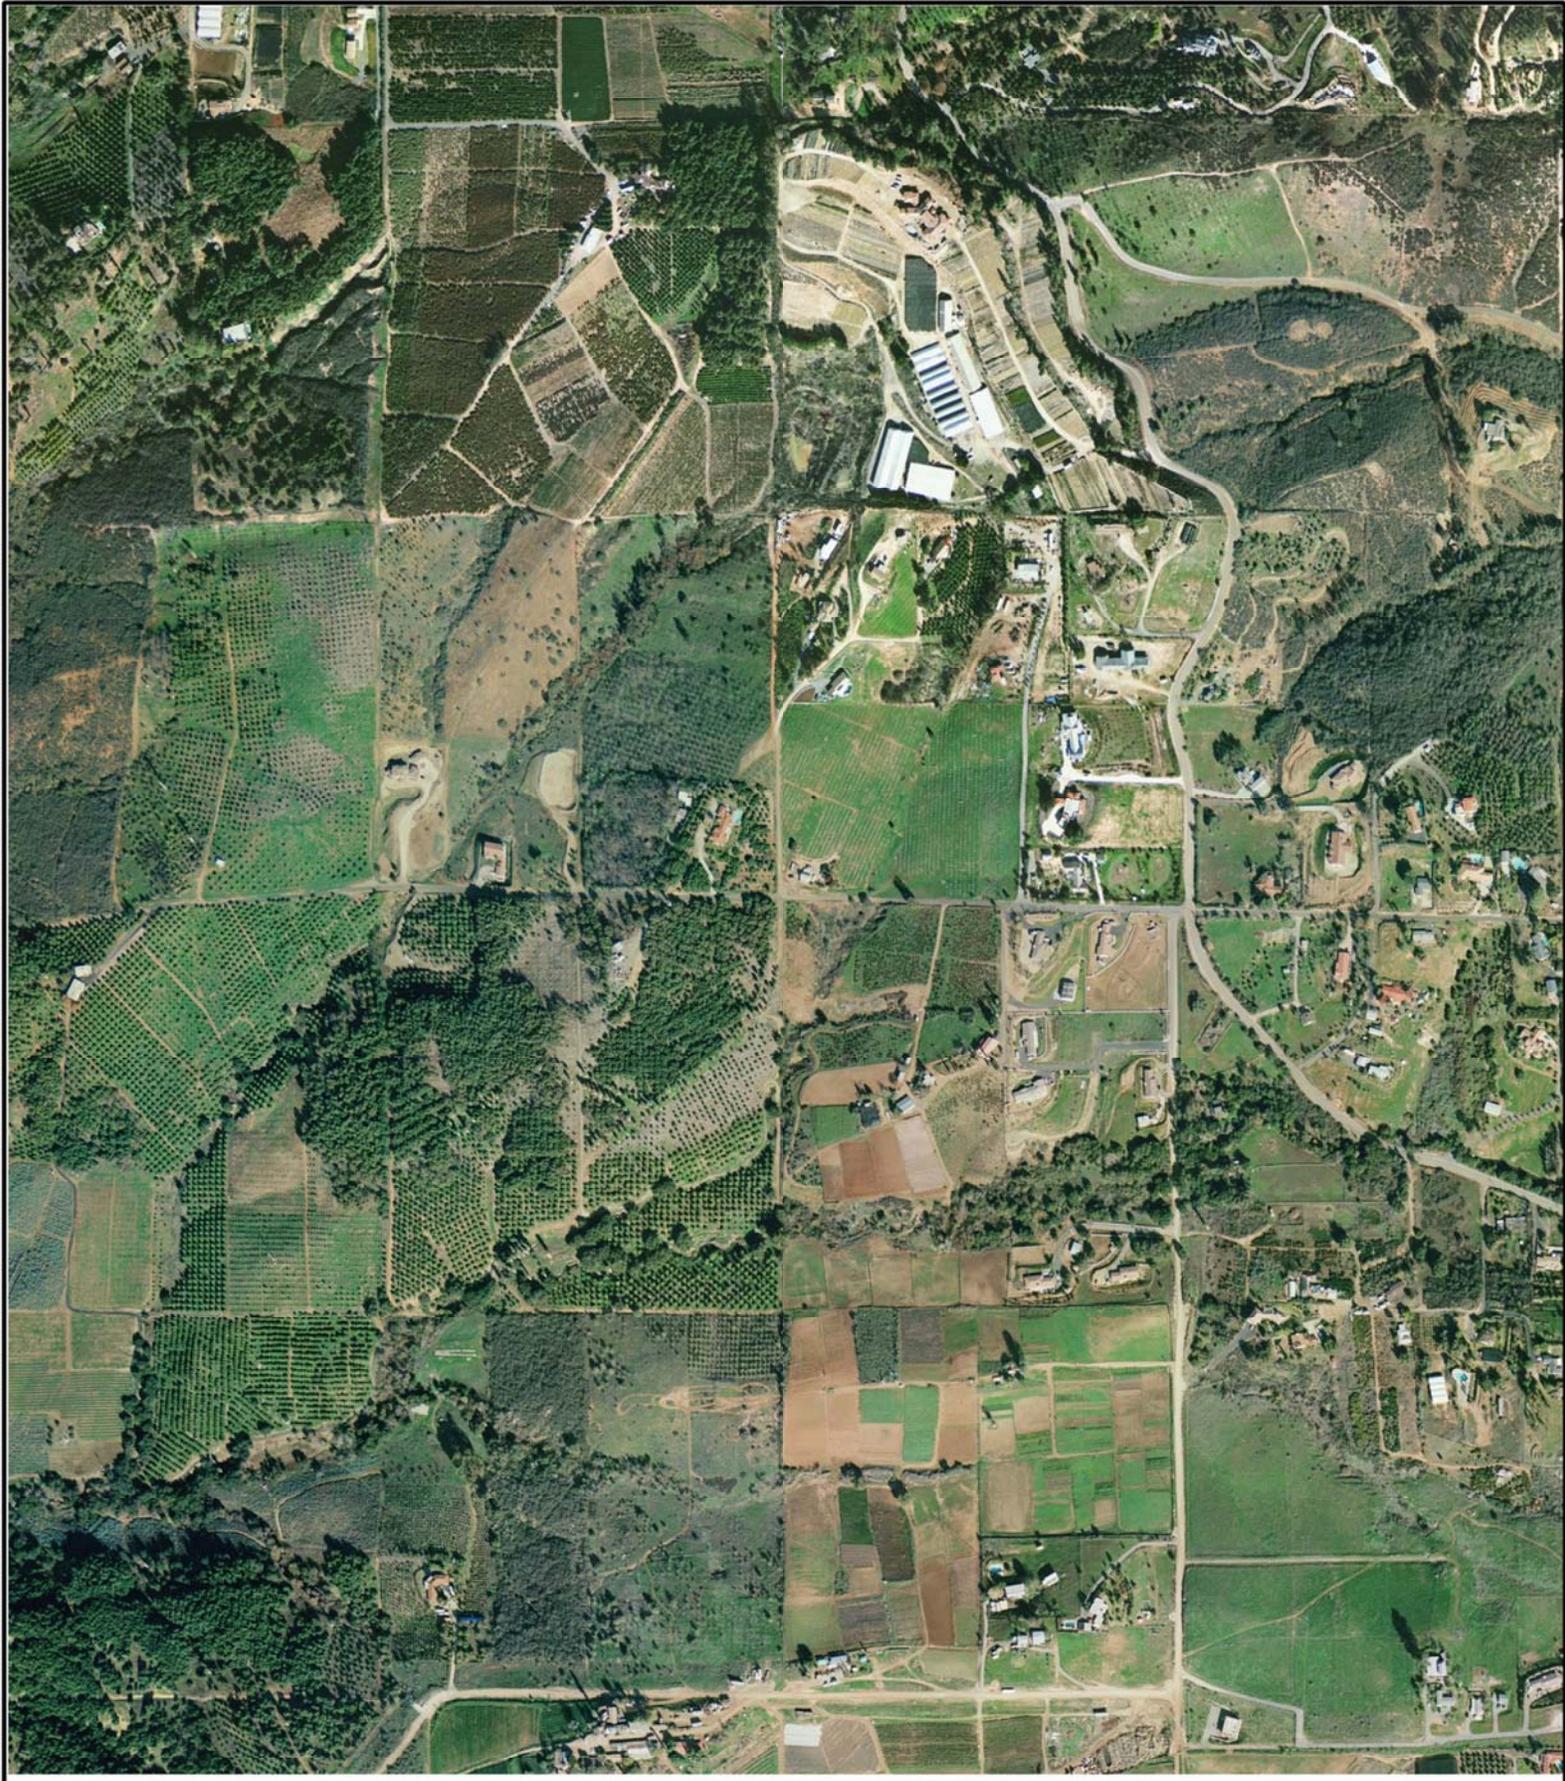
Historical Aerial Photo
2008

**COVEY LN
ESCONDIDO, CA 92026**

1 inch equals 685 feet

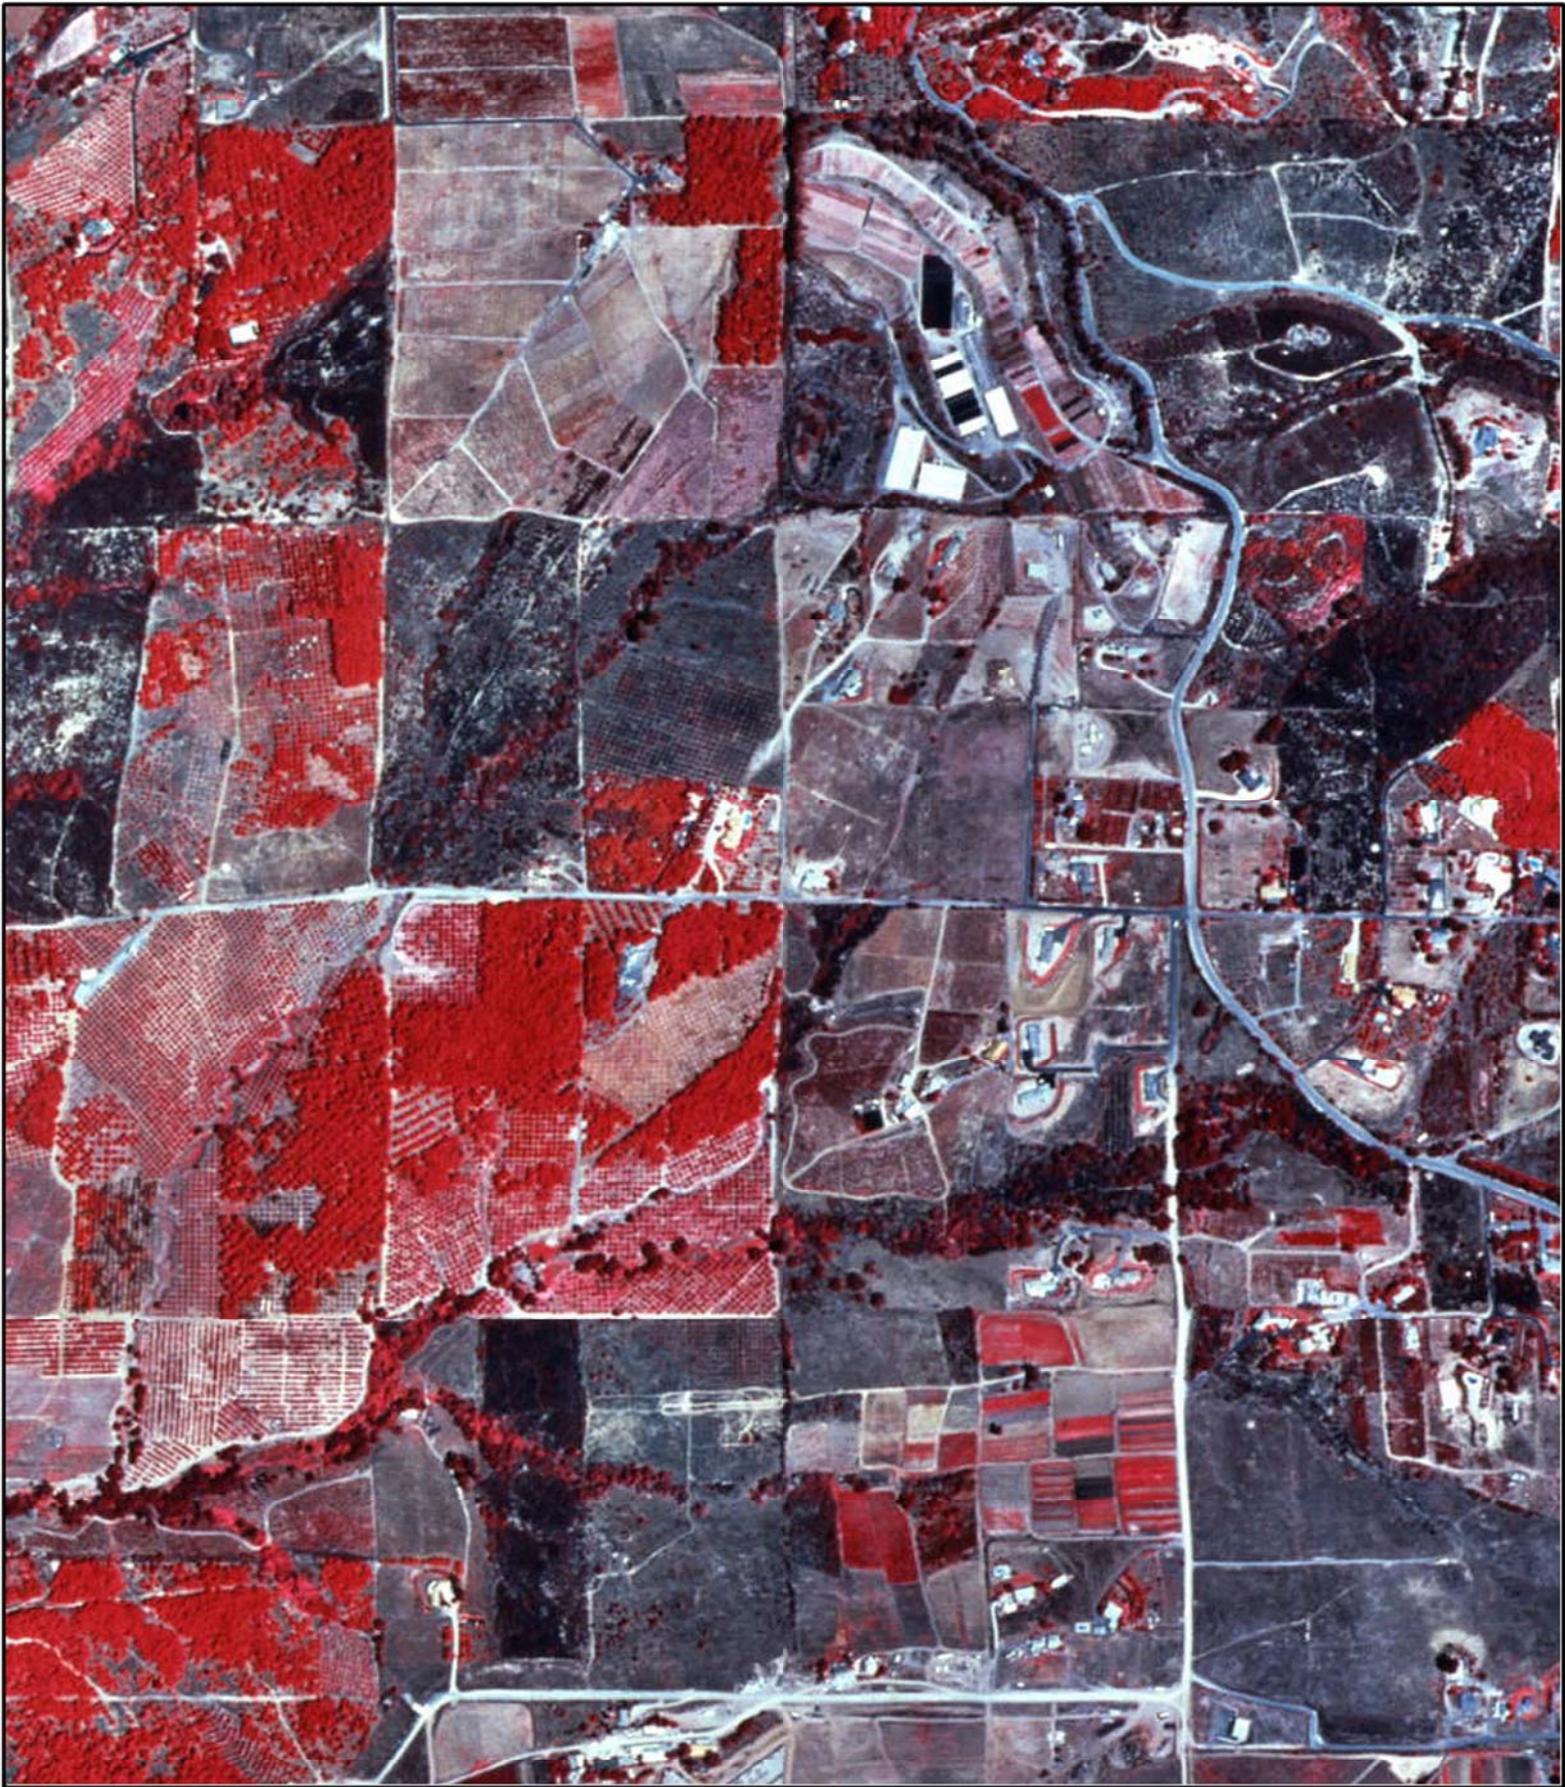
Historical Aerial Photo
2002

**COVEY LN
ESCONDIDO, CA 92026**
