5.0 VISUAL IMPACT ASSESSMENT

Eighteen key views were selected for consideration to depict representative views of the project features as seen from within the project viewshed. The key views were comprehensively evaluated and seven key views that best depicted the visual impacts of the project from the perspective of different viewer groups at different points in time during the project duration were selected (Key Views 1 through 7). Figure 3 shows the location of the 18 key views in relation to the project site. Figures 17a, 17b, and 17c contain photographs from the 18 key views. The comprehensive evaluation of the all 18 key views based on the viewer groups, and potentially visible project features is summarized in Table 4.

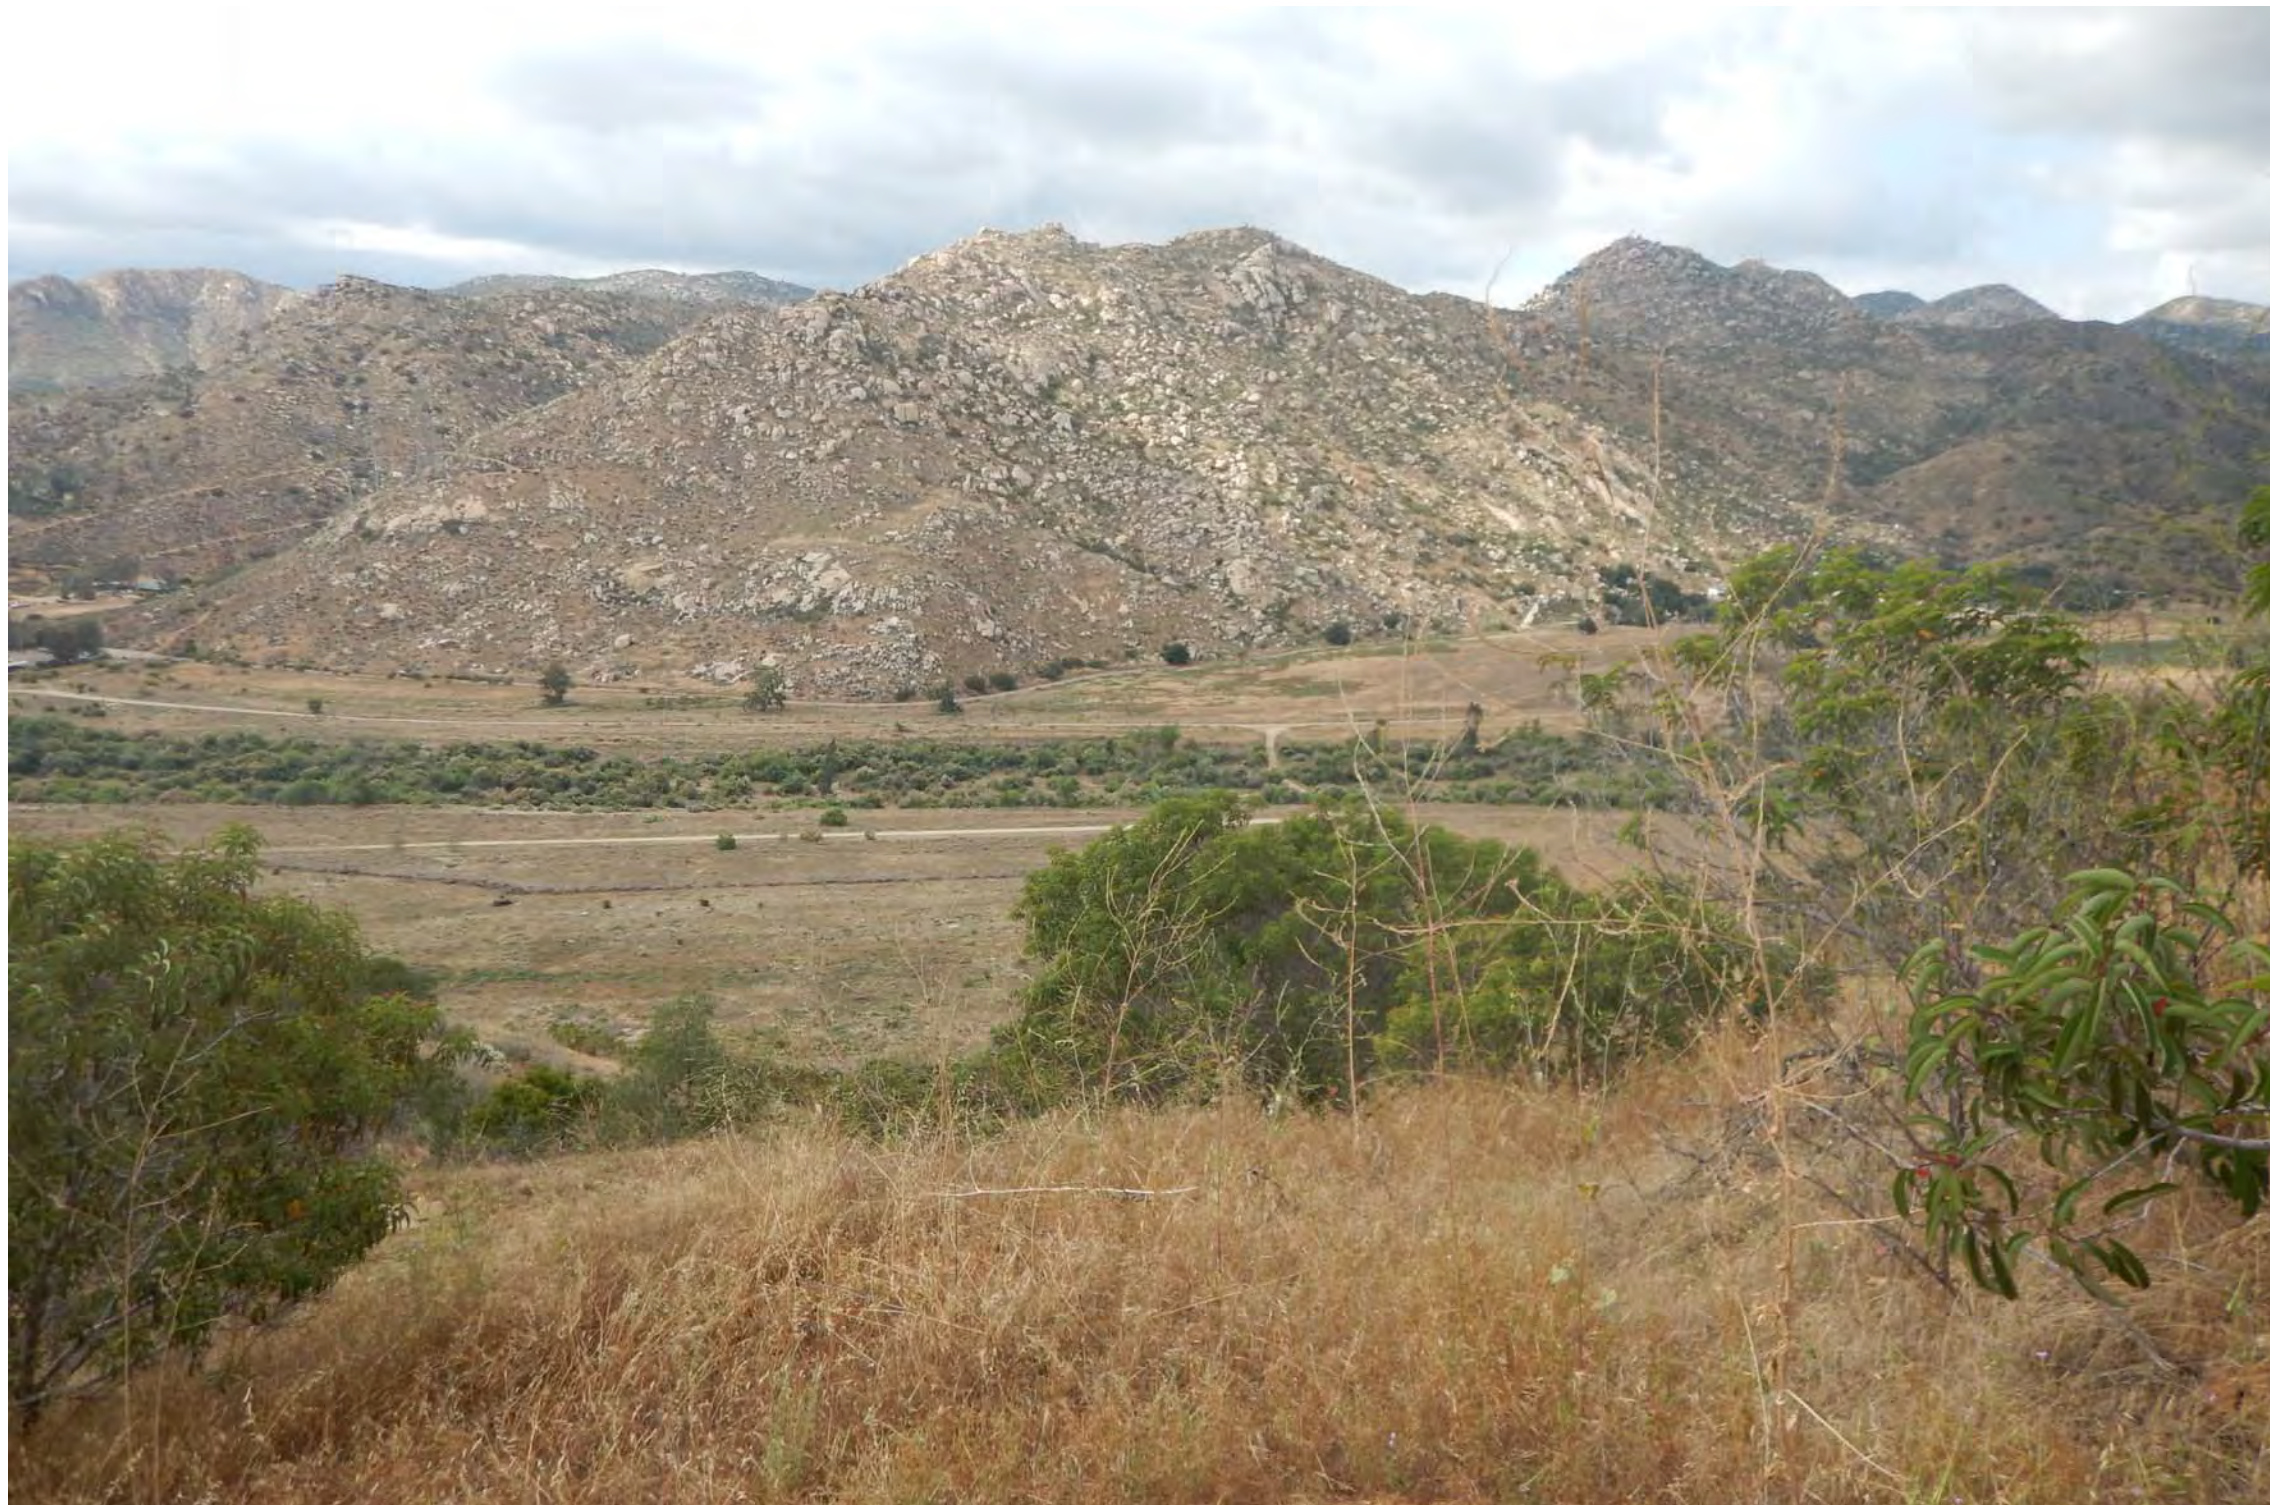
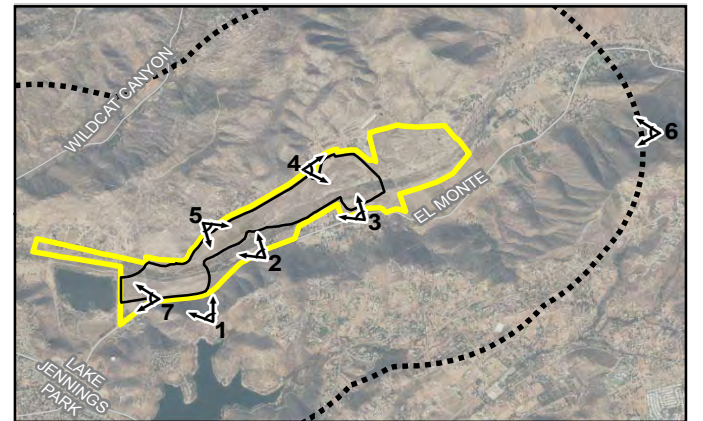
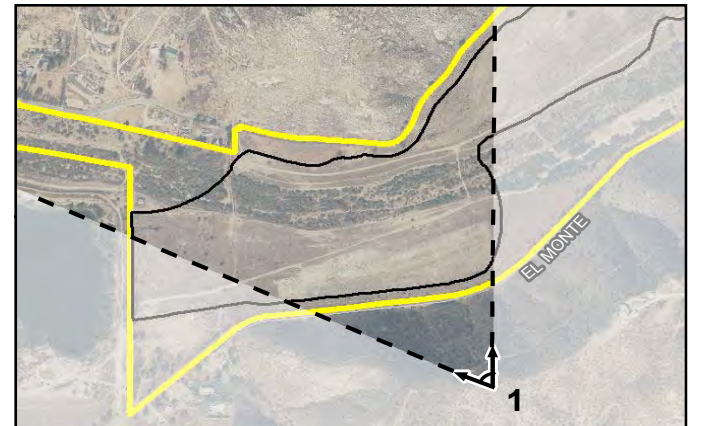
Figure 18a
Key View 1 Existing Conditions

Existing Perspective

- Trail at Lake Jennings Campground
- 772 feet above sea level
- 32.87° Latitude/-116.89° Longitude
- Located south of Proposed Project
- Looking down valley (west) from top of ridge
- Public view
- Lowland Disturbed, Riparian River Channel, Lowland Residential, and Undisturbed Canyon Slopes LUs

Currently, the river valley in the view consists of flat areas covered with low-growing vegetation cut through by a swath of darker-green, taller trees, as seen on Figure 18a. The view is characterized by natural, undulating lines. Green and brown vegetation dominates the view; although the light colored rock formations across the valley on the canyon slopes also are present, adding to the natural colors. The valley floor and adjacent slopes are dominant in the view, and are in scale with each other providing high continuity as well.

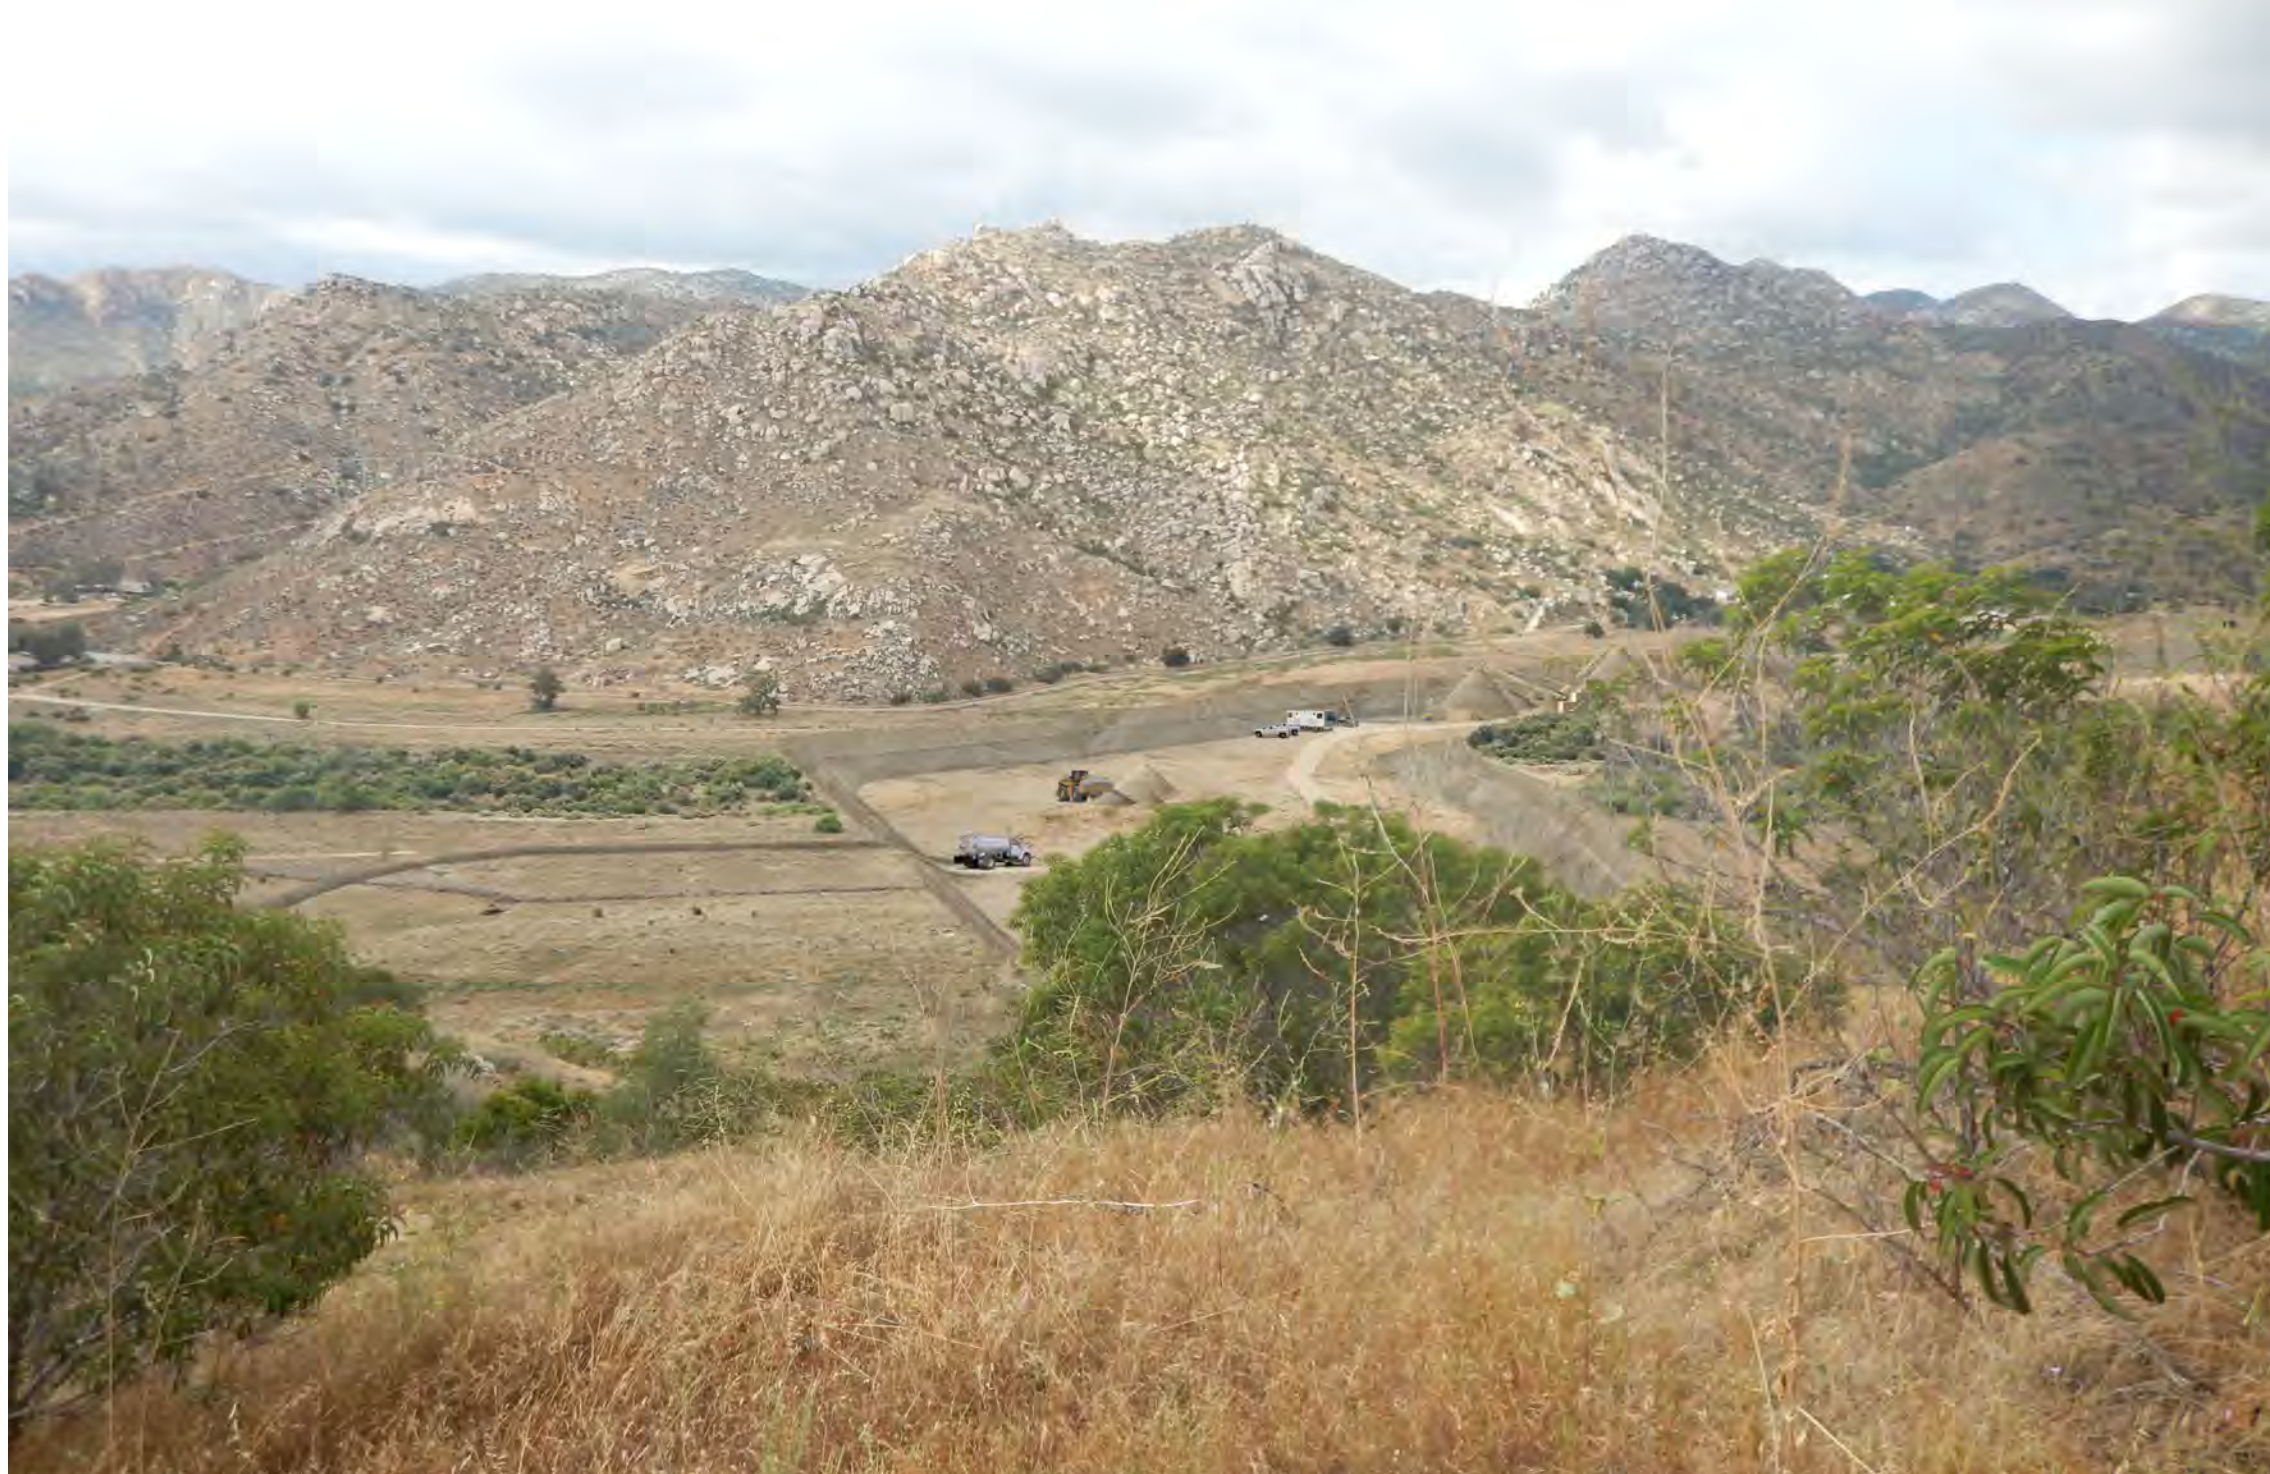
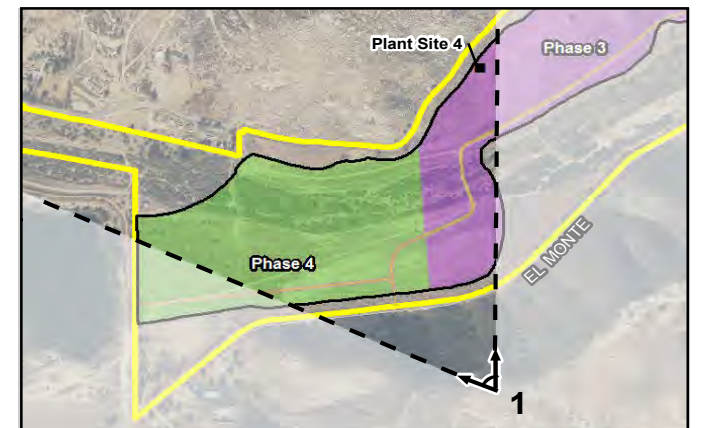
Figure 18b
Key View 1 Simulation

Simulated Environment

- Project Year 9
- Phase 3 excavation activities
- Processing Plant Site 4
- Phase 4 pre-excitation
- Phase 1, Type "D" Pathway
- Phase 4, Type "C" Primitive Trail

Phase 3 excavation activities and Plant Site 4 are visible in the middleground at right of view, in the Key View 1 Simulation. The features shown on Figure 18b reflect 9 years after project initiation and include the portable processing plant project elements, associated equipment, haul road and cut slopes resulting from excavation activities in Phase 3. The Phase 3 project elements would be in this location for approximately one year. No reclamation from previous phases is visible in this view. The eastern extent of Phase 4 is located in the center of the view.

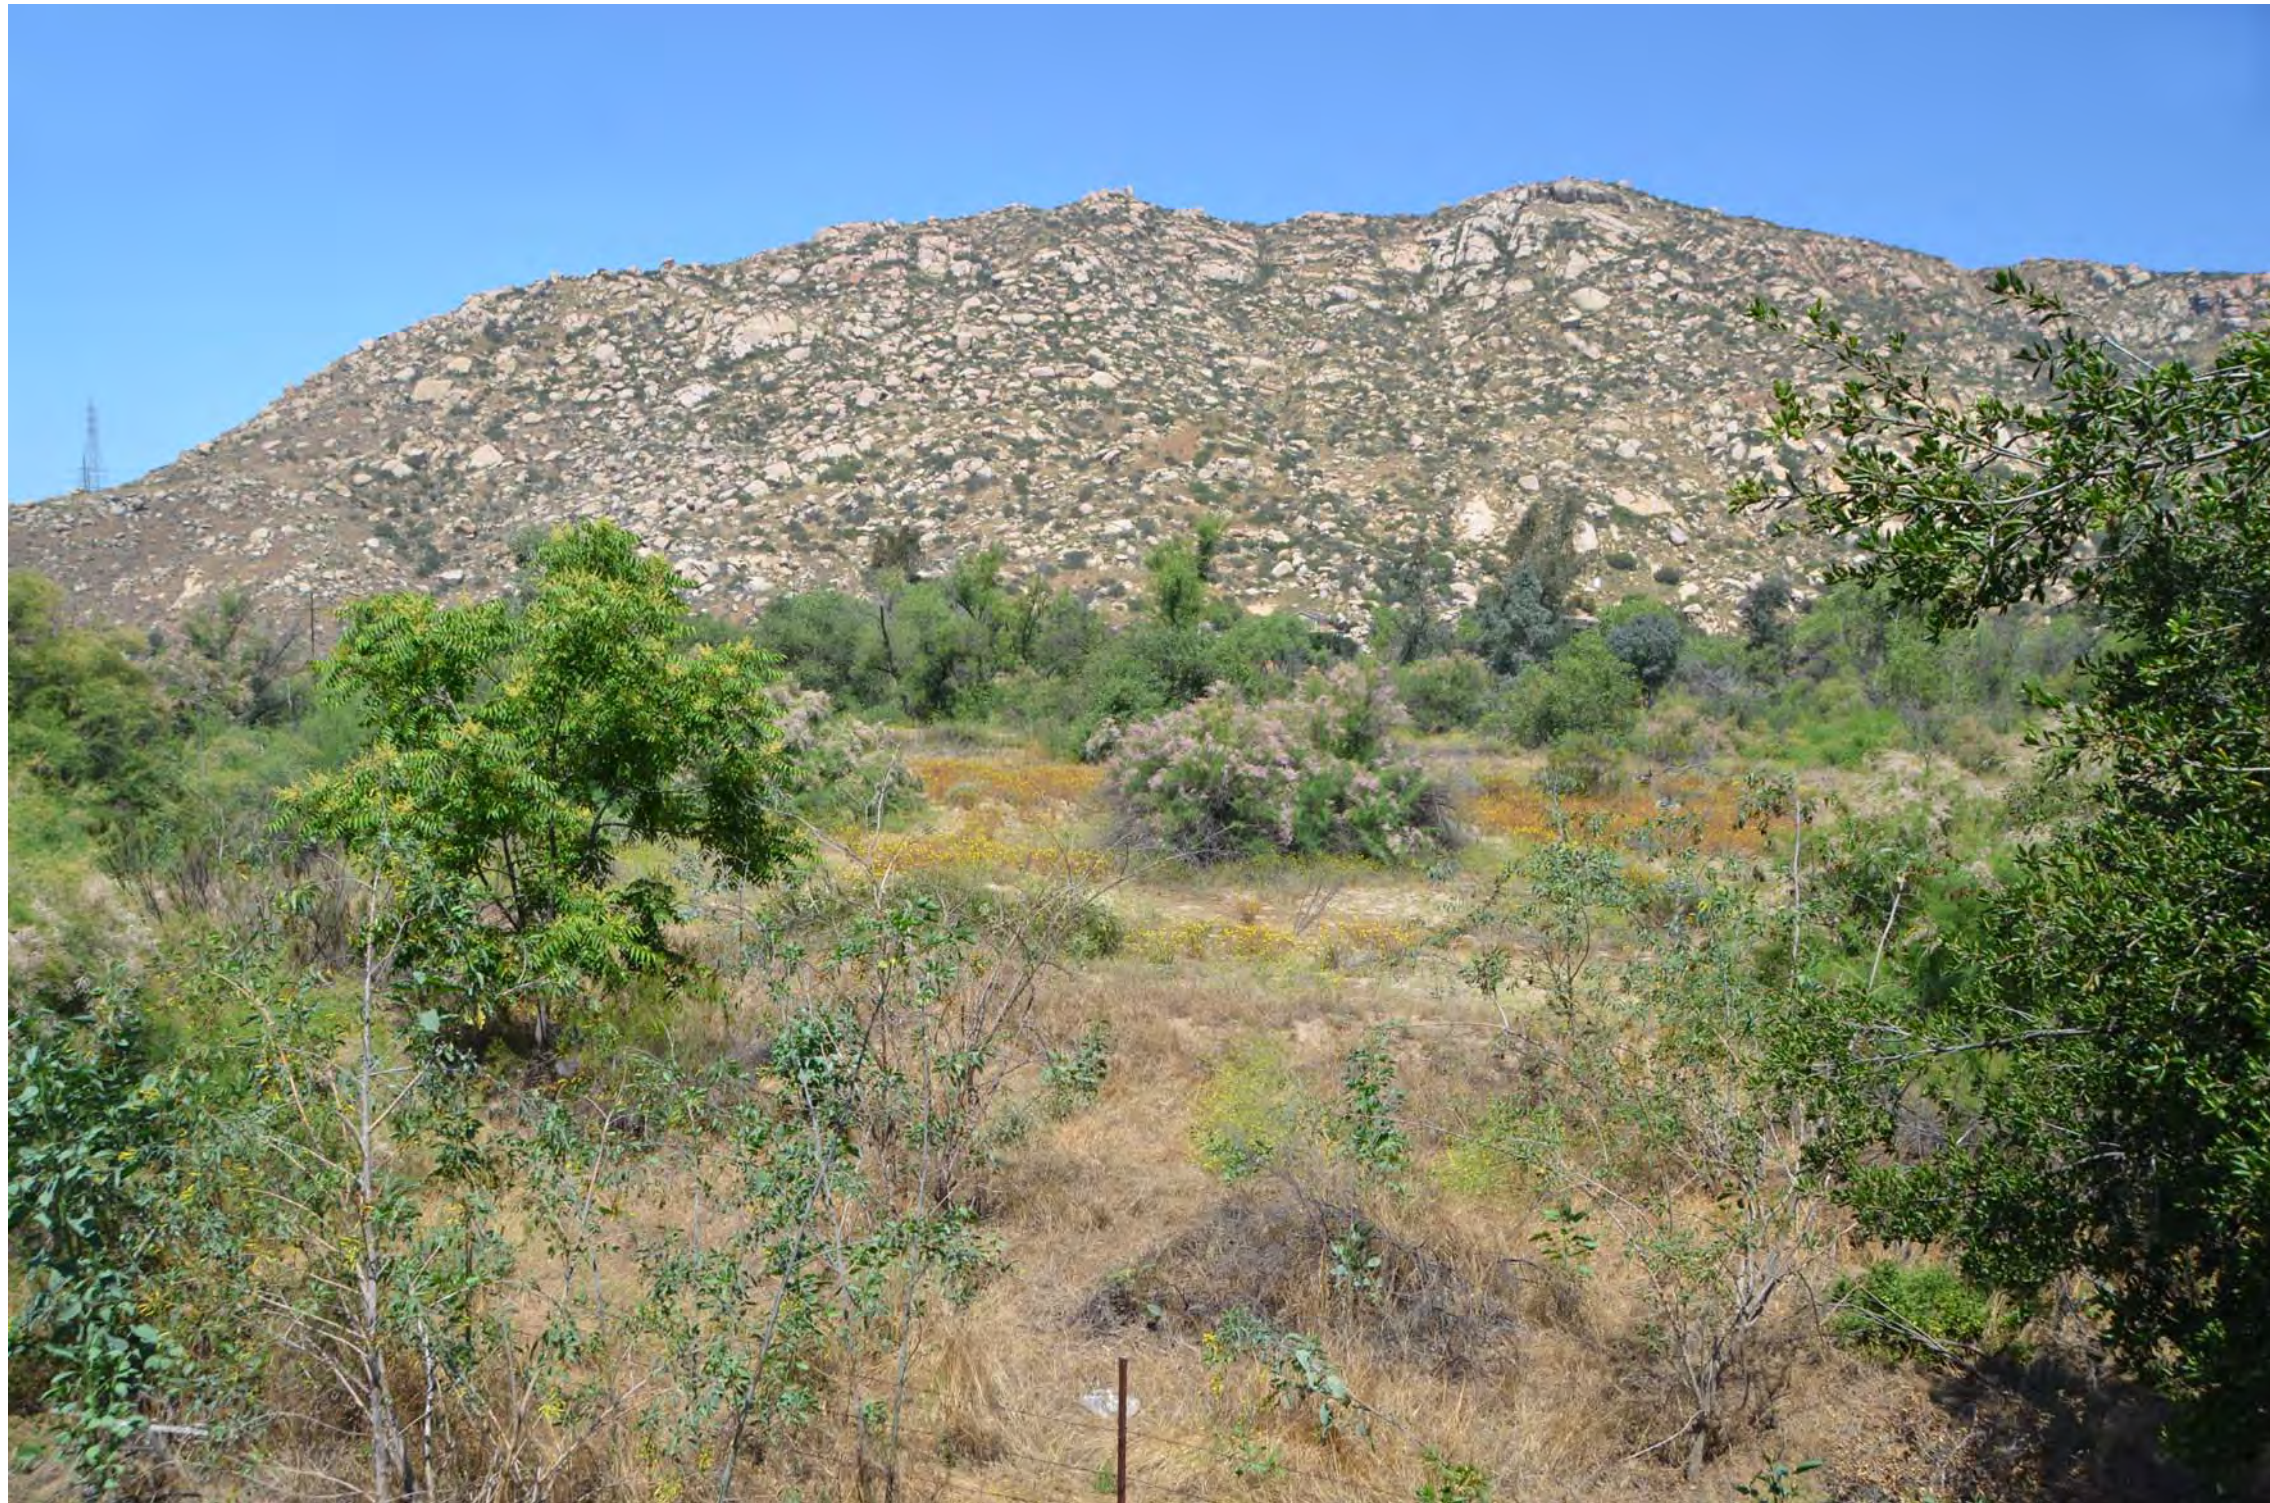
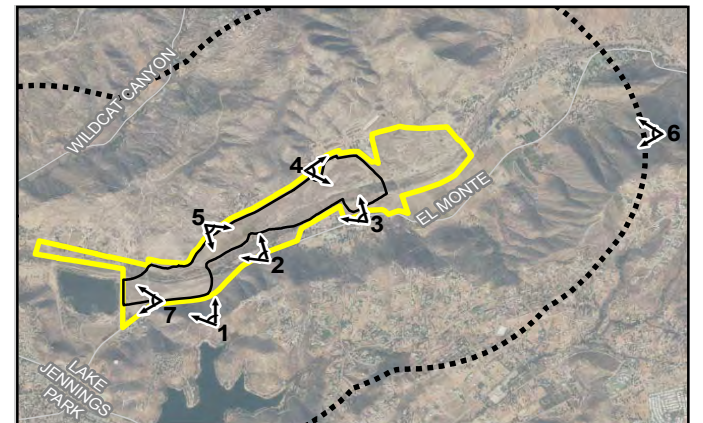
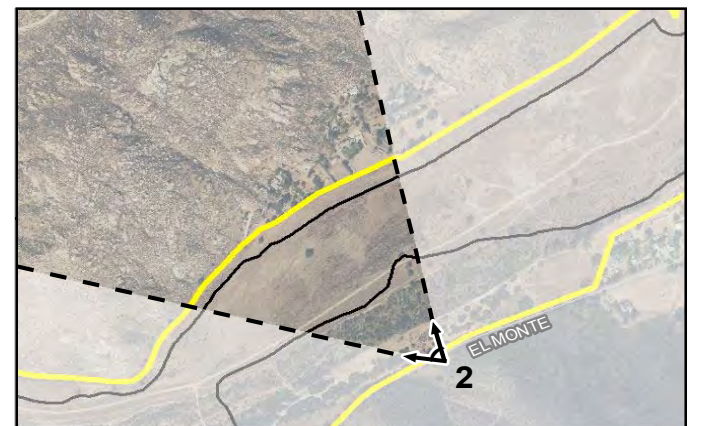
Figure 19a
Key View 2 Existing Conditions

Existing Perspective

- From El Monte Road
- 457 feet above sea level
- 32.87° Latitude/-116.88° Longitude
- Looking northwest across the valley
- Public view
- Riparian River Channel, Lowland Disturbed, and Undisturbed Canyon Slopes LUs

Green and brown vegetation colors dominate the view in Figure 19a. The vegetation has fine textures, in contrast to the coarse rocky slopes in the background. The view has high unity and intactness, since it is divided between the natural vegetation of the river area and the natural rocks and plants on the mountain slope. The vividness is moderately high, with the rocky nature of the slope providing the most memorable element of the view. Overall, Key View 2 has high visual quality.

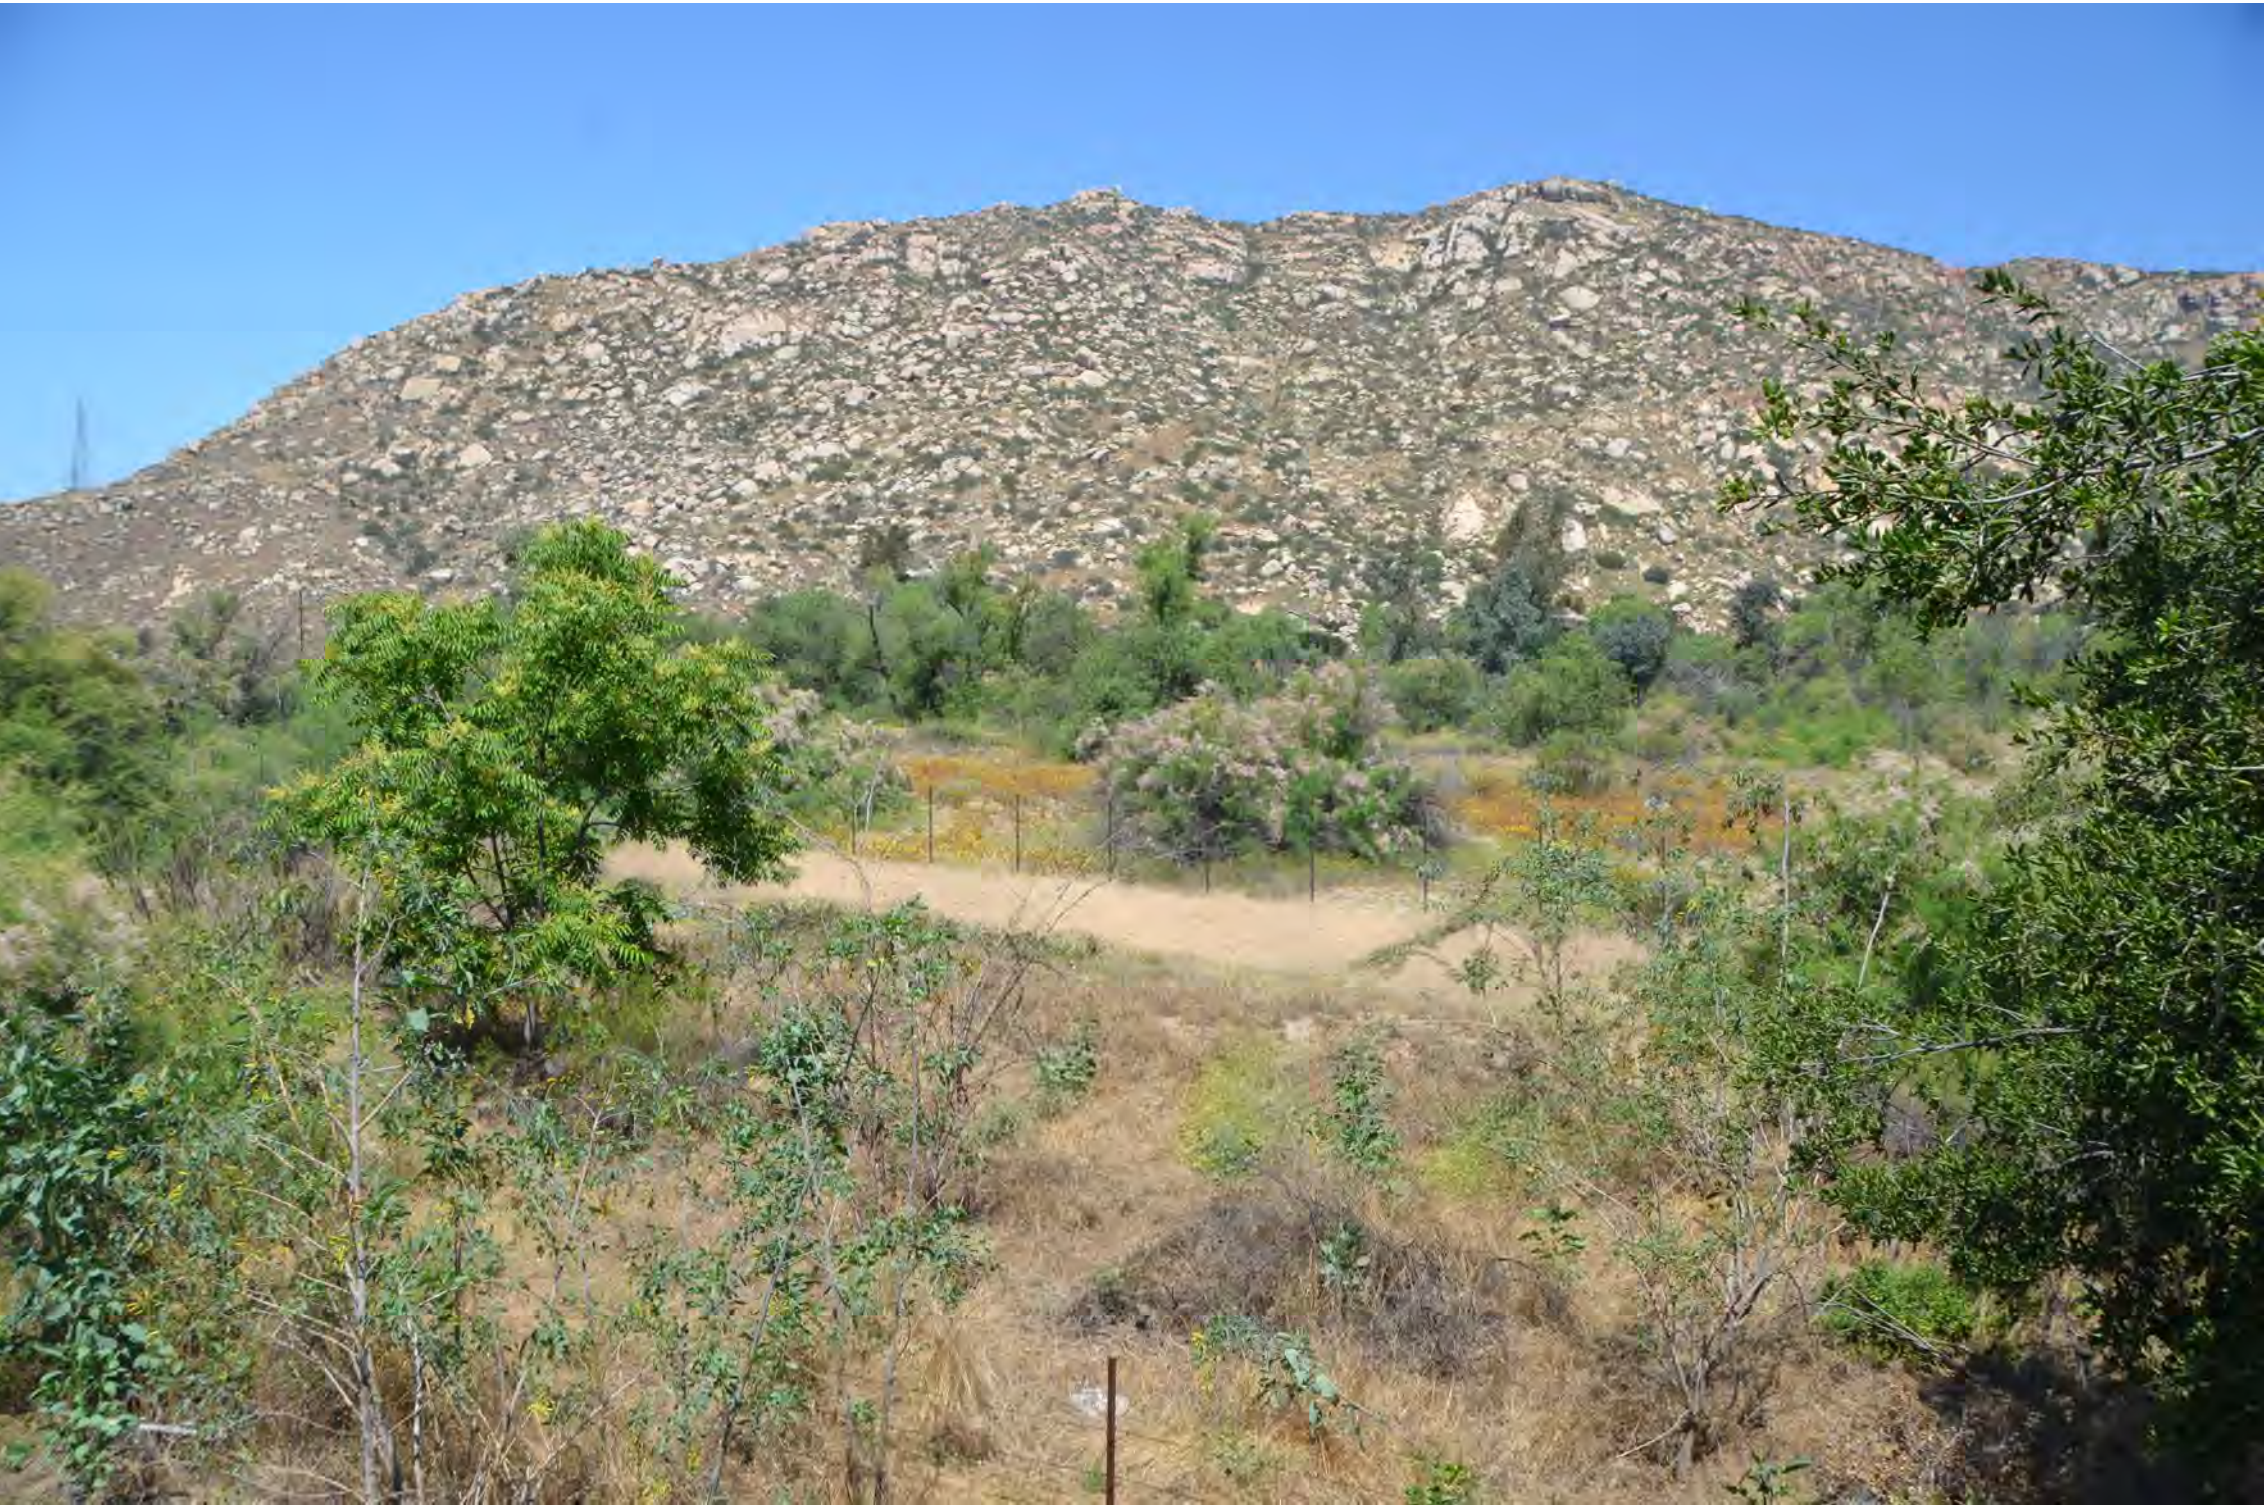
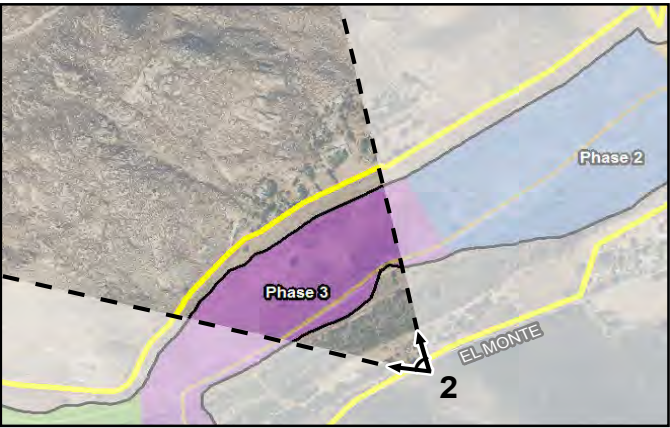
Figure 19b
Key View 2 Simulation

Simulated Environment

- No phases are observed from this perspective because of the low elevation of the key view
- Phase 1, Type "D" Pathway

Project features at Key View 2 include clearing of soil and vegetation and excavation activities associated with Phase 3; including project elements (portable processing plant project elements, associated equipment, haul road, and cut slopes). Following excavation, stabilized post-extraction landforms would be revegetated with a diverse native seed mix and container plants. Viewers from this perspective on El Monte Road would not observe excavation, reclamation, or revegetation activities associated with the project.

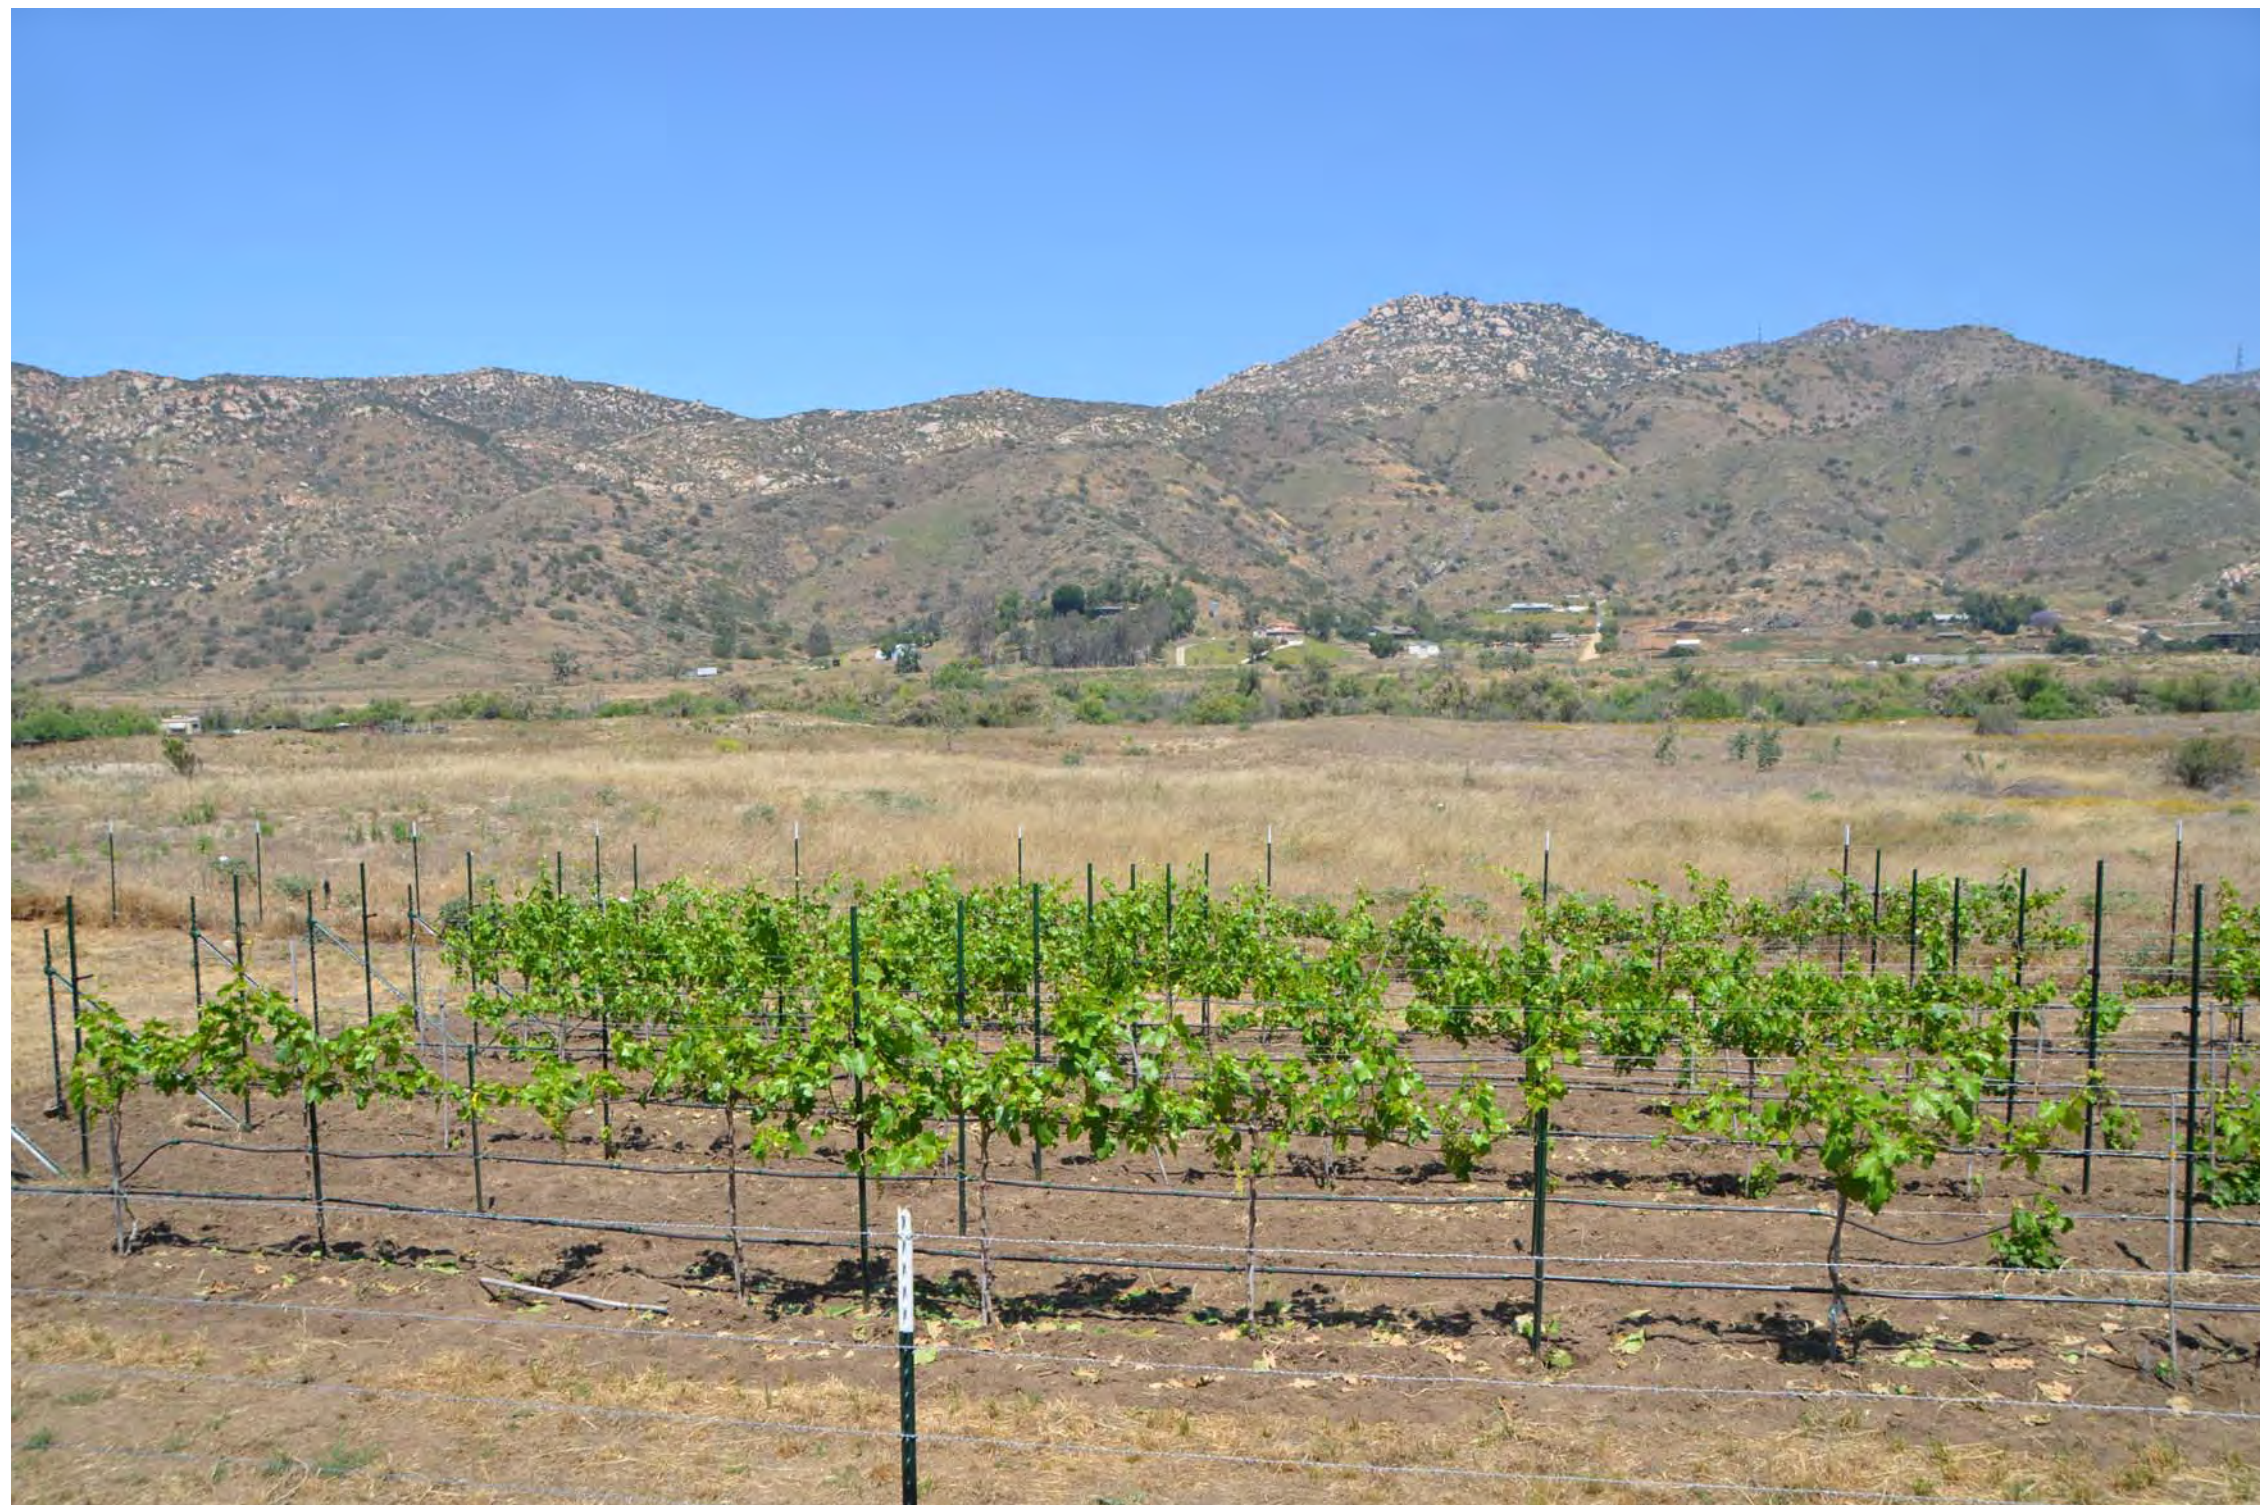
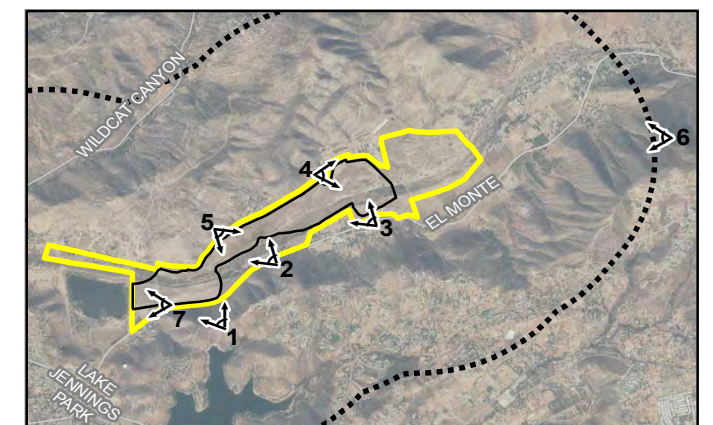
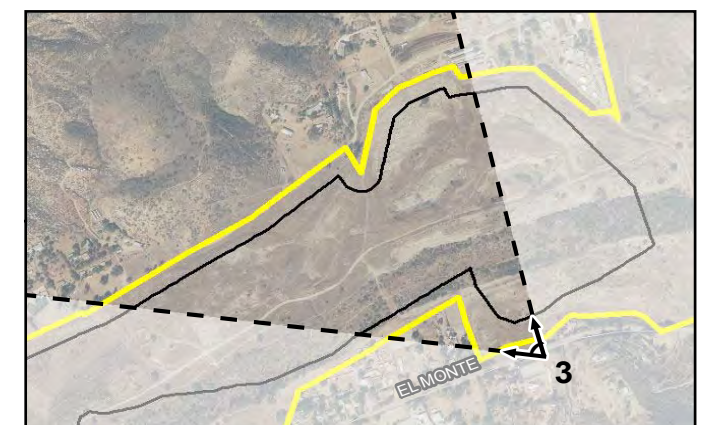
Figure 20a
Key View 3 Existing Conditions

Existing Perspective

- From El Monte Road
- 480 feet above sea level
- 32.88° Latitude/-116.87° Longitude
- Looking northwest across the valley
- Public view
- Lowland Agriculture, Lowland Disturbed, Riparian River Channel, and Undisturbed Canyon Slopes LUs

Green and browns of vegetation on the valley floor and on the canyon slopes across the valley dominate the colors within Key View 3, shown on Figure 20a. The slopes in the background of the view are more uniformly vegetated than the slopes present in Key Views 1 and 2, although rocky slopes are visible at the left side of the view. The Lowland Residential structures in the middleground are varied, single story, spread out, and intermixed with mature vegetation. A small number of neatly rowed grape vines are visible in the foreground, adjacent to El Monte Road. The view consists of curving and gently undulating lines and vegetation with medium textures. The portions of residential roads visible in the middleground consist of straight lines and curves and because they are mostly unpaved, do not contrast with the natural setting. A few power transmission towers are visible along the ridgeline across the valley, in the background of the view.
