5.0 VISUAL IMPACT ASSESSMENT

Eighteen key views were selected for consideration to depict representative views of the project features as seen from within the project viewshed. The key views were comprehensively evaluated and seven key views that best depicted the visual impacts of the project from the perspective of different viewer groups at different points in time during the project duration were selected (Key Views 1 through 7). Figure 3 shows the location of the 18 key views in relation to the project site. Figures 17a, 17b, and 17c contain photographs from the 18 key views. The comprehensive evaluation of the all 18 key views based on the viewer groups, and potentially visible project features is summarized in Table 4.

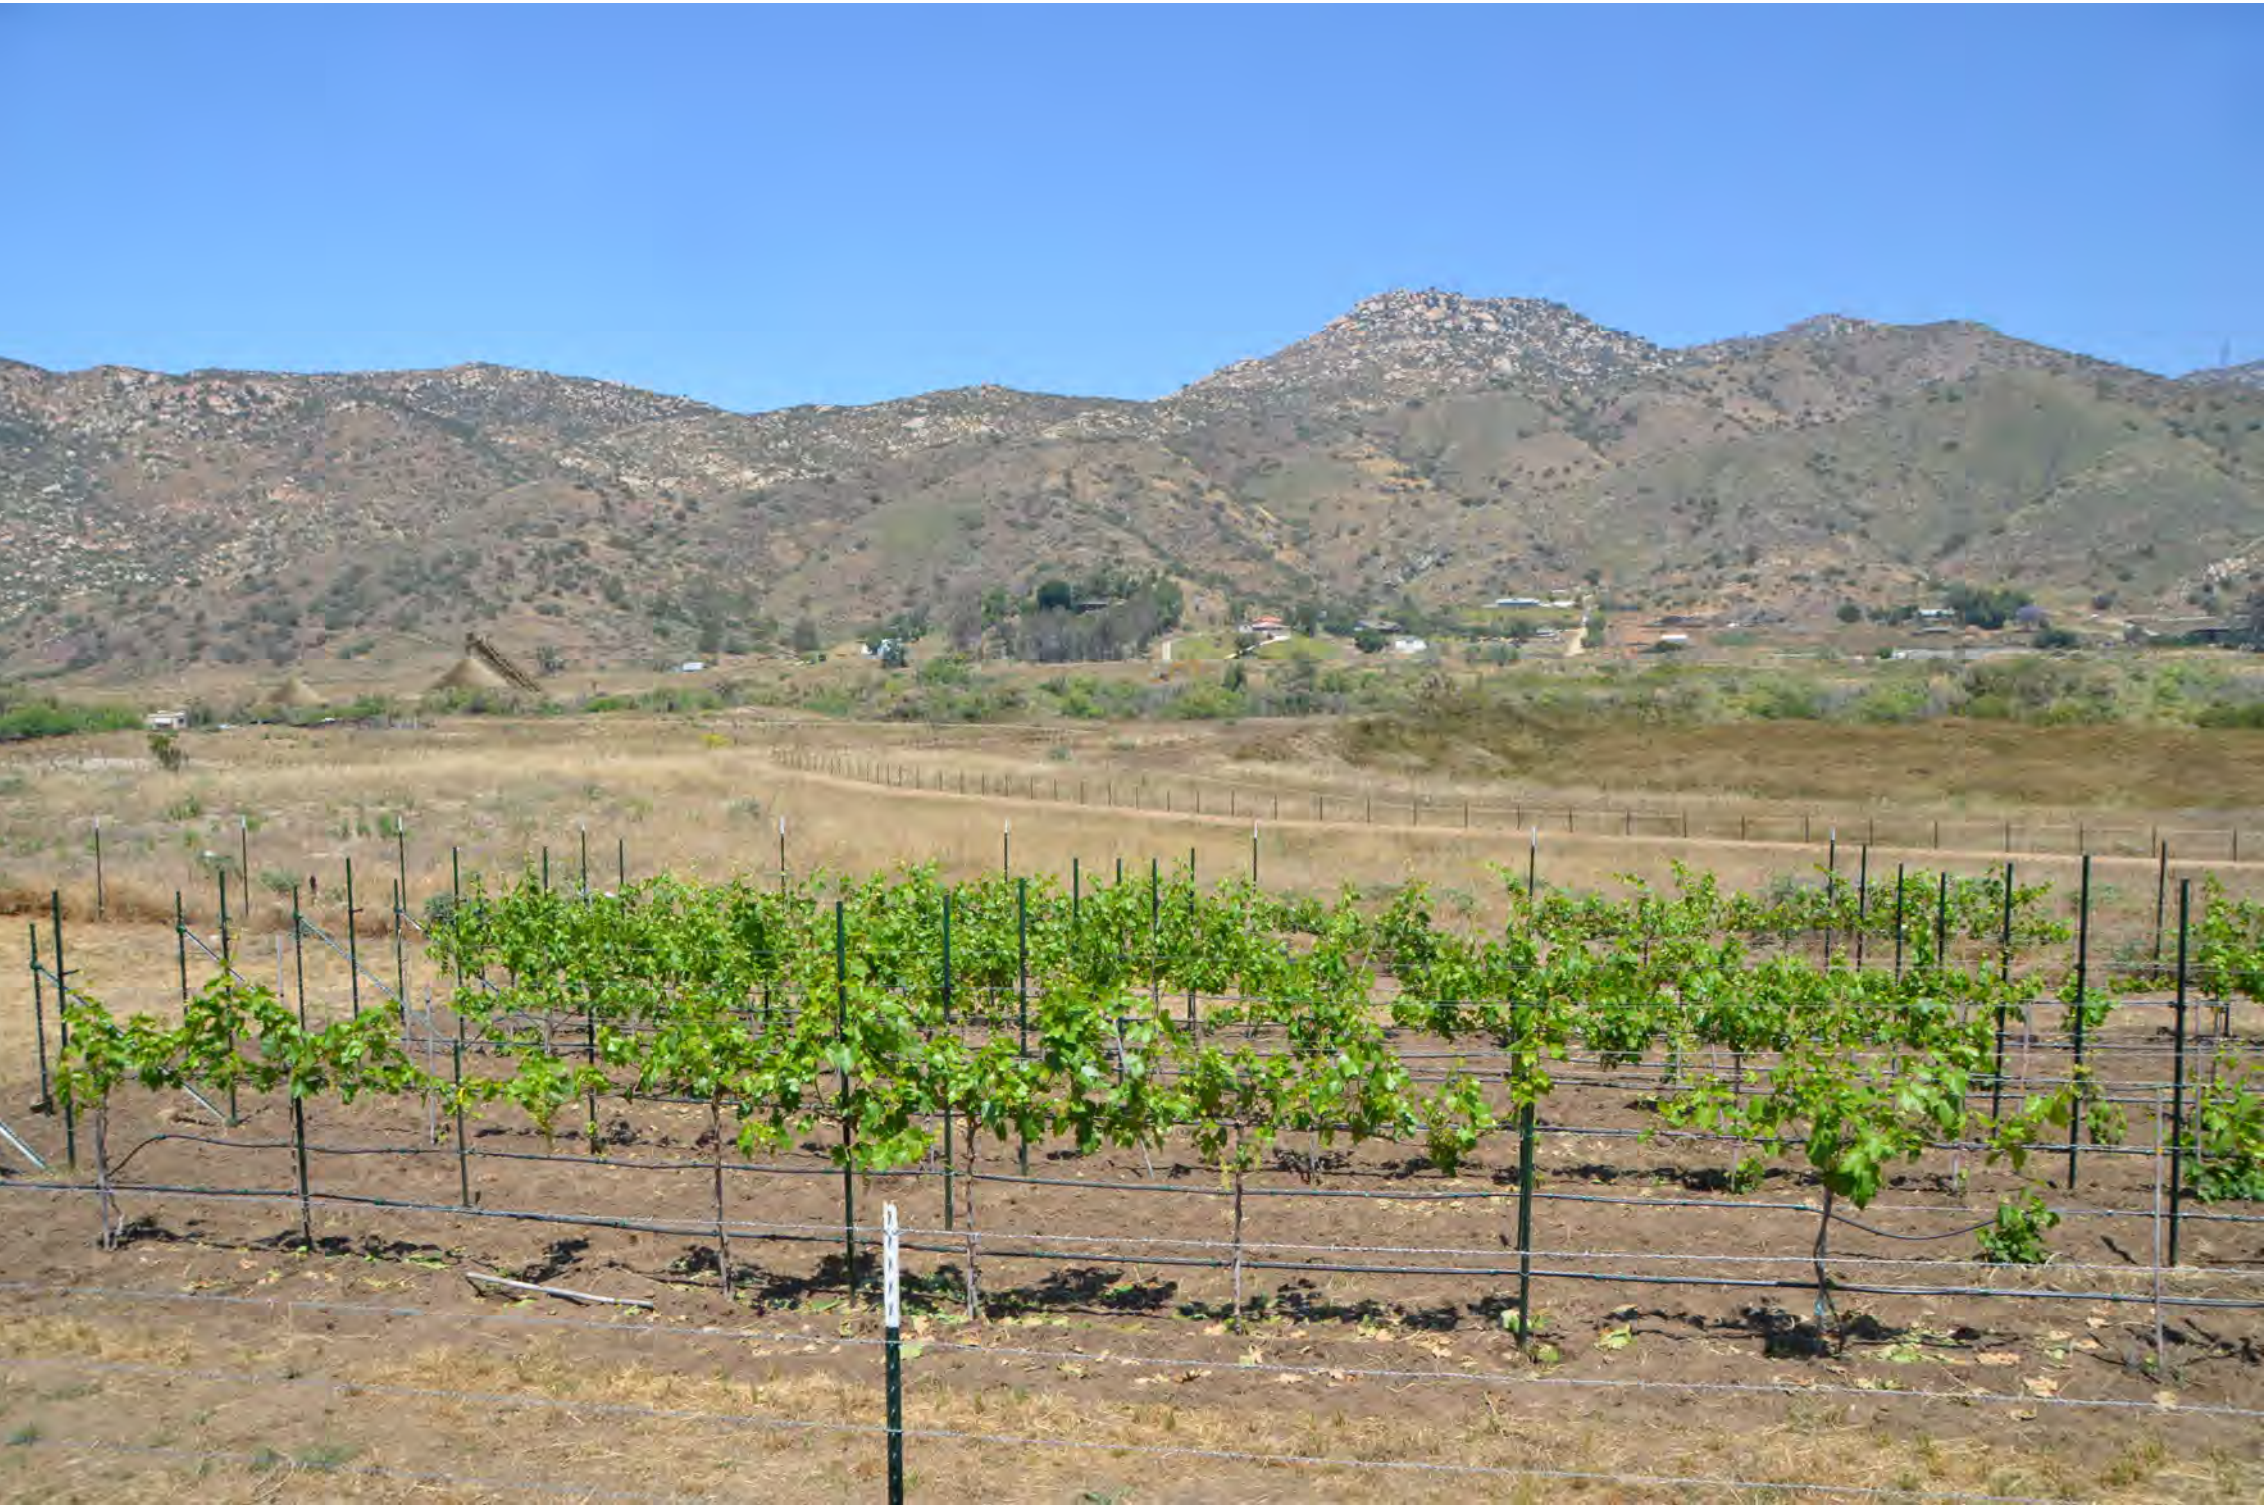
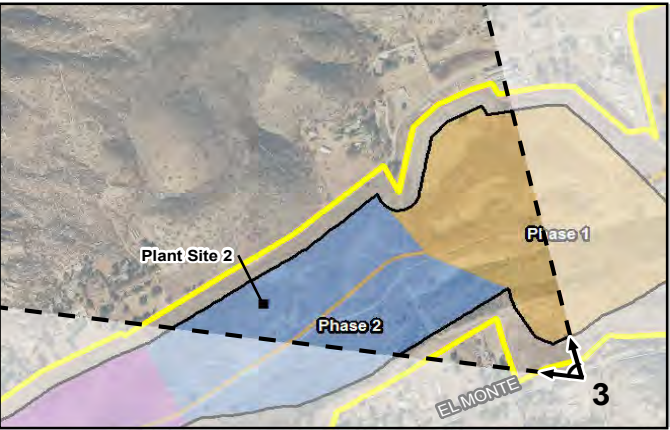
Figure 20b
Key View 3 Simulation

Simulated Environment

- Project Year 6
- Phase 2 excavation activities
- Phase 1 reclamation
- Phase 1, Type "D" Pathway
- Phase 4, Type "C" Primitive Trail

Reclamation of completed Phase 1 and 2 would be visible in the middleground of Key View 3. Stabilized post-extraction landforms would be revegetated with a diverse native seed mix and container plants. The Key View 3 Simulation (Figure 20b) shows revegetation completed in Phase 1 at two years after planting (right side of view) and revegetation of Phase 2 at less than one year after planting (left side of view). The landforms in the foreground and background would be undisturbed by the project.

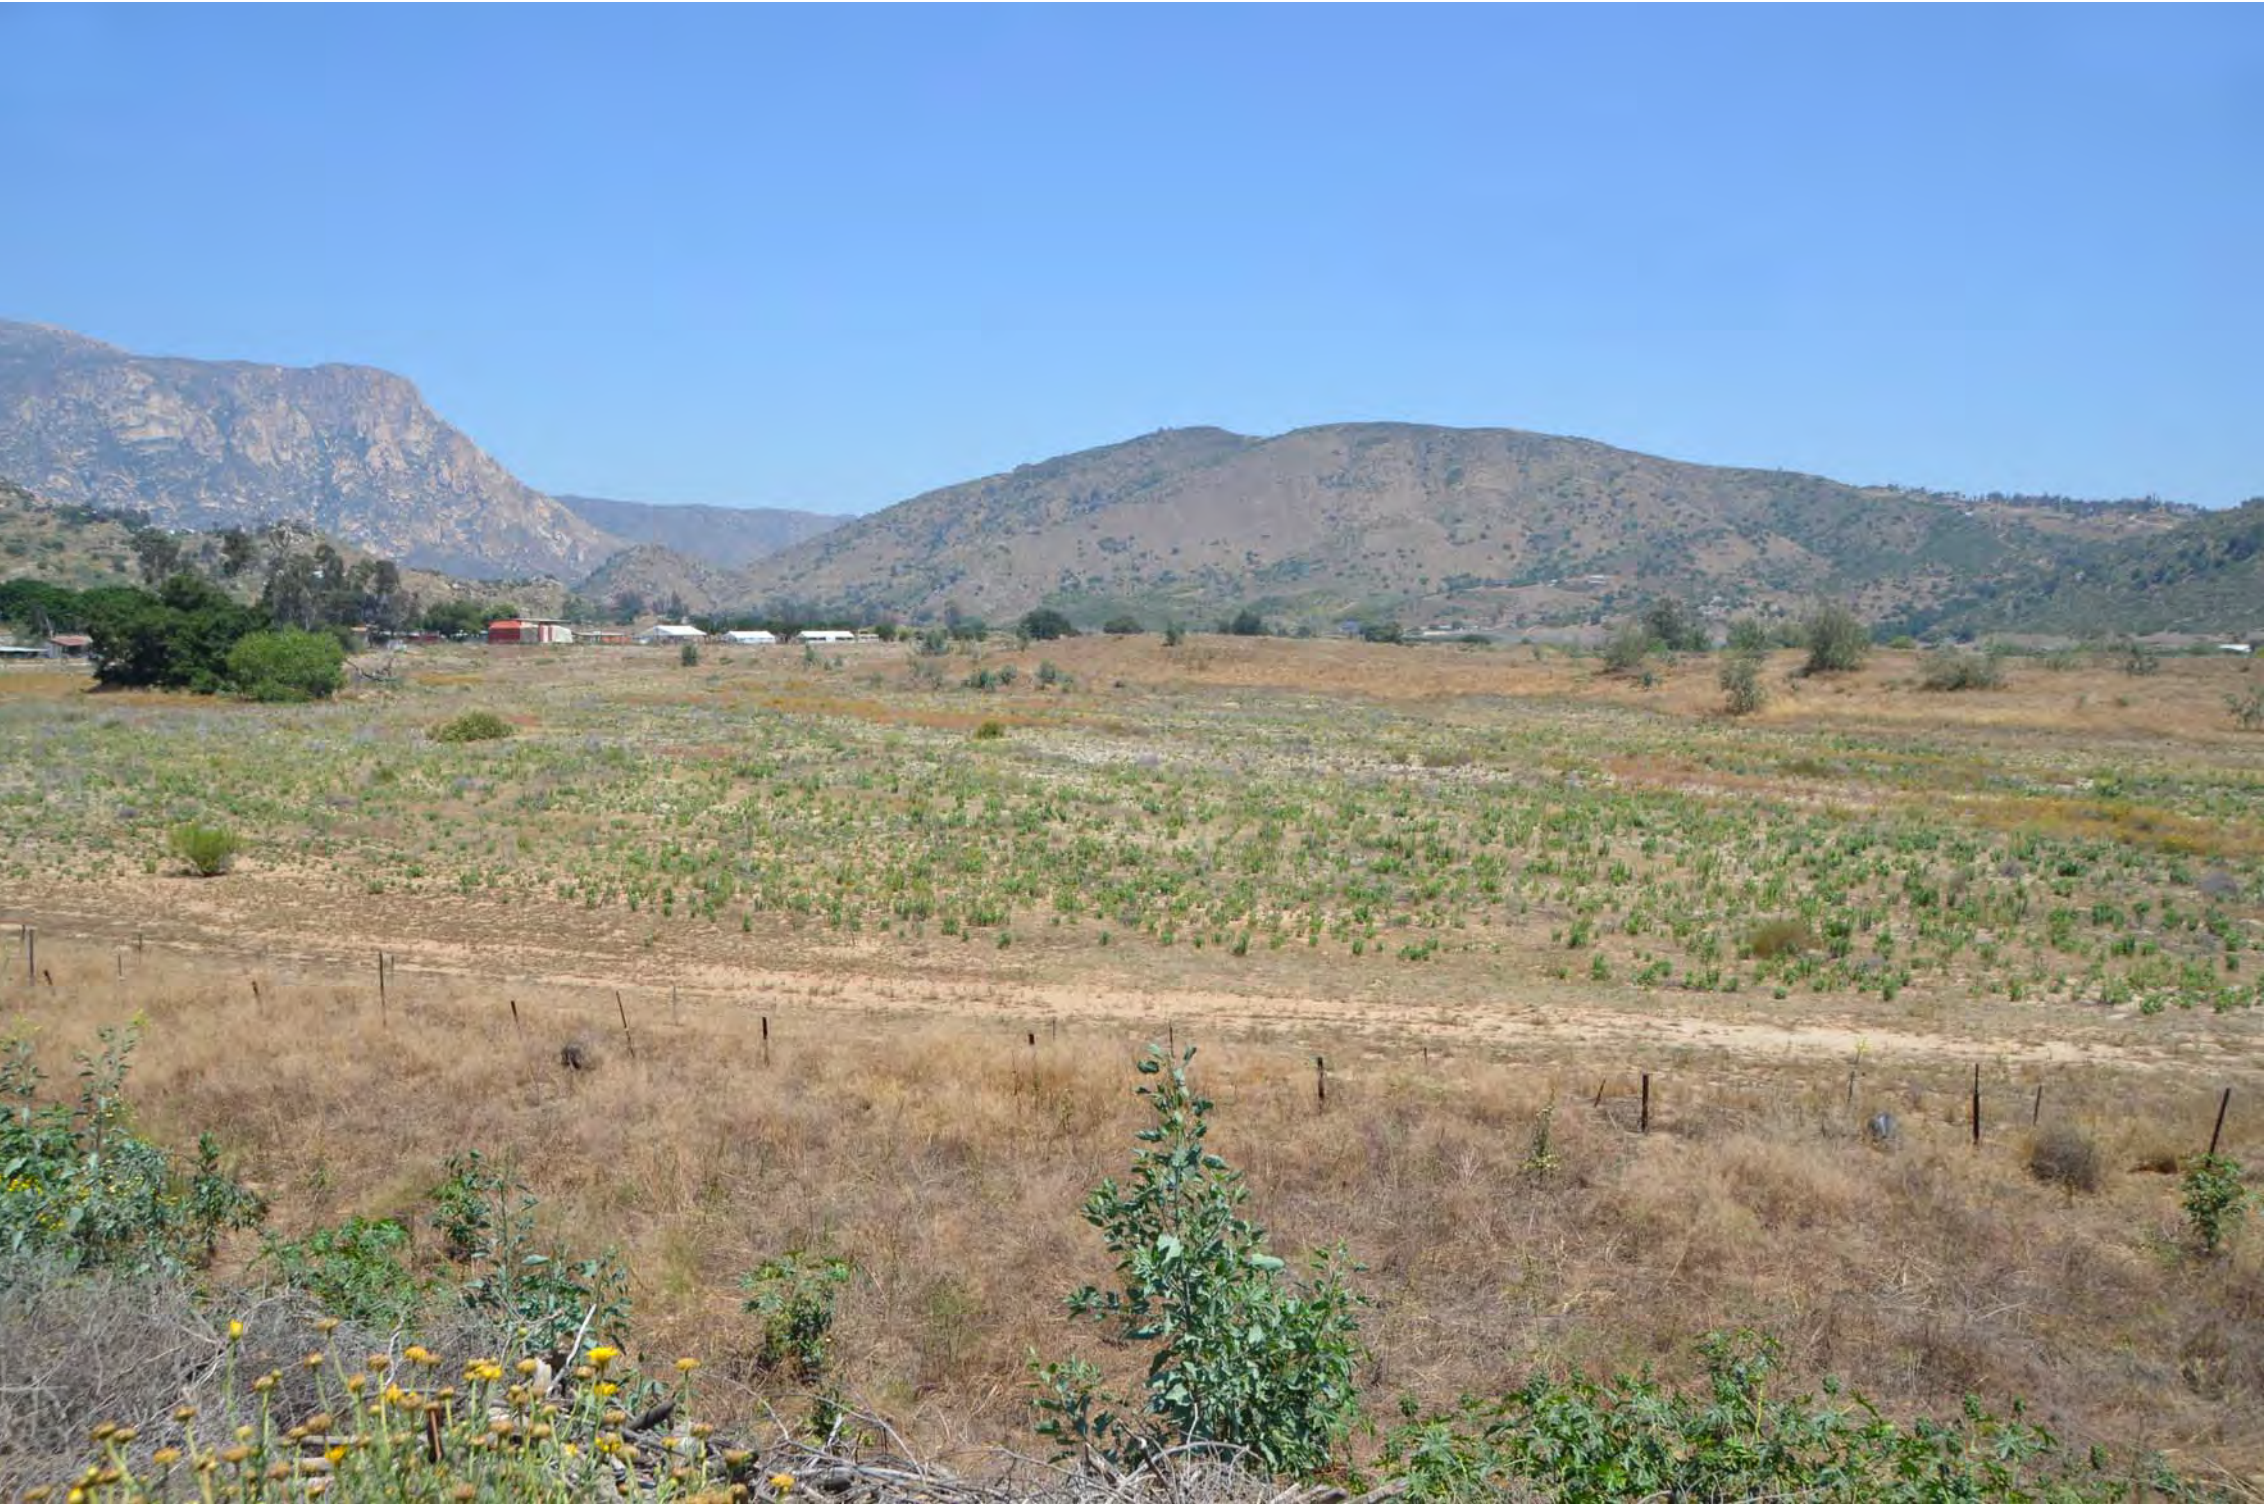
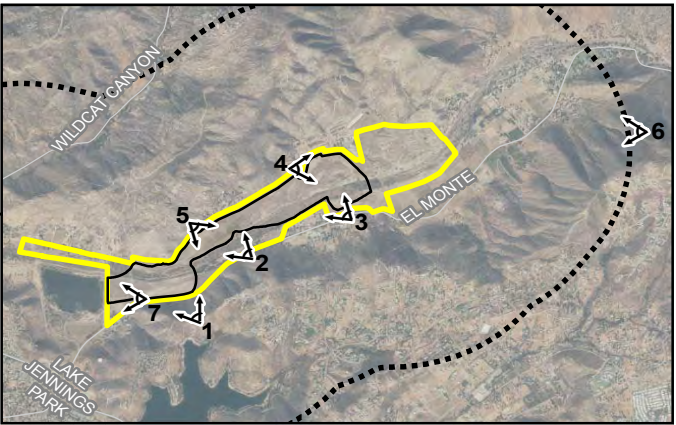
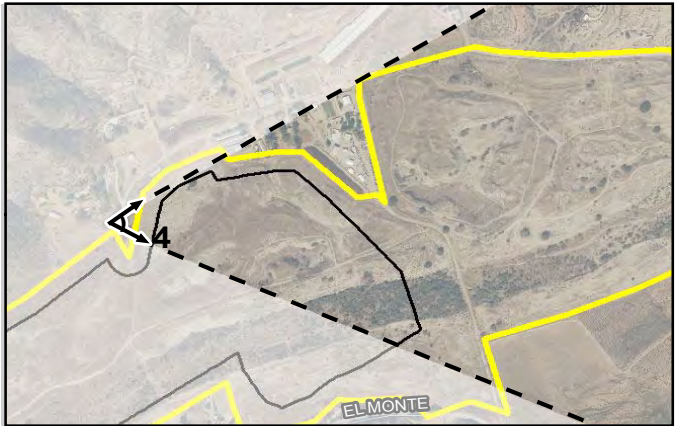
Figure 21a
Key View 4 Existing Conditions

- Existing Perspective
- From Willow Road
 - 468 feet above sea level
 - 32.88° Latitude/-116.88° Longitude
 - Looking east up the valley
 - Public and private views
 - Lowland Agriculture, Lowland Residential, Undisturbed Canyon Slopes, and Ridgeline Residential LUs

Greens and browns of valley floor vegetation and on distant slopes dominate the colors within the view, as shown on Figure 21a. The slopes that make up most of this background are more uniformly vegetated than the slopes in Key View 1 and Key View 2, although the rocky slopes are visible at the left side of the view. Brightly colored flowers and darker green ornamental vegetation is seen in the foreground. The view consists of curving and gently undulating lines and vegetation with medium to coarse textures.

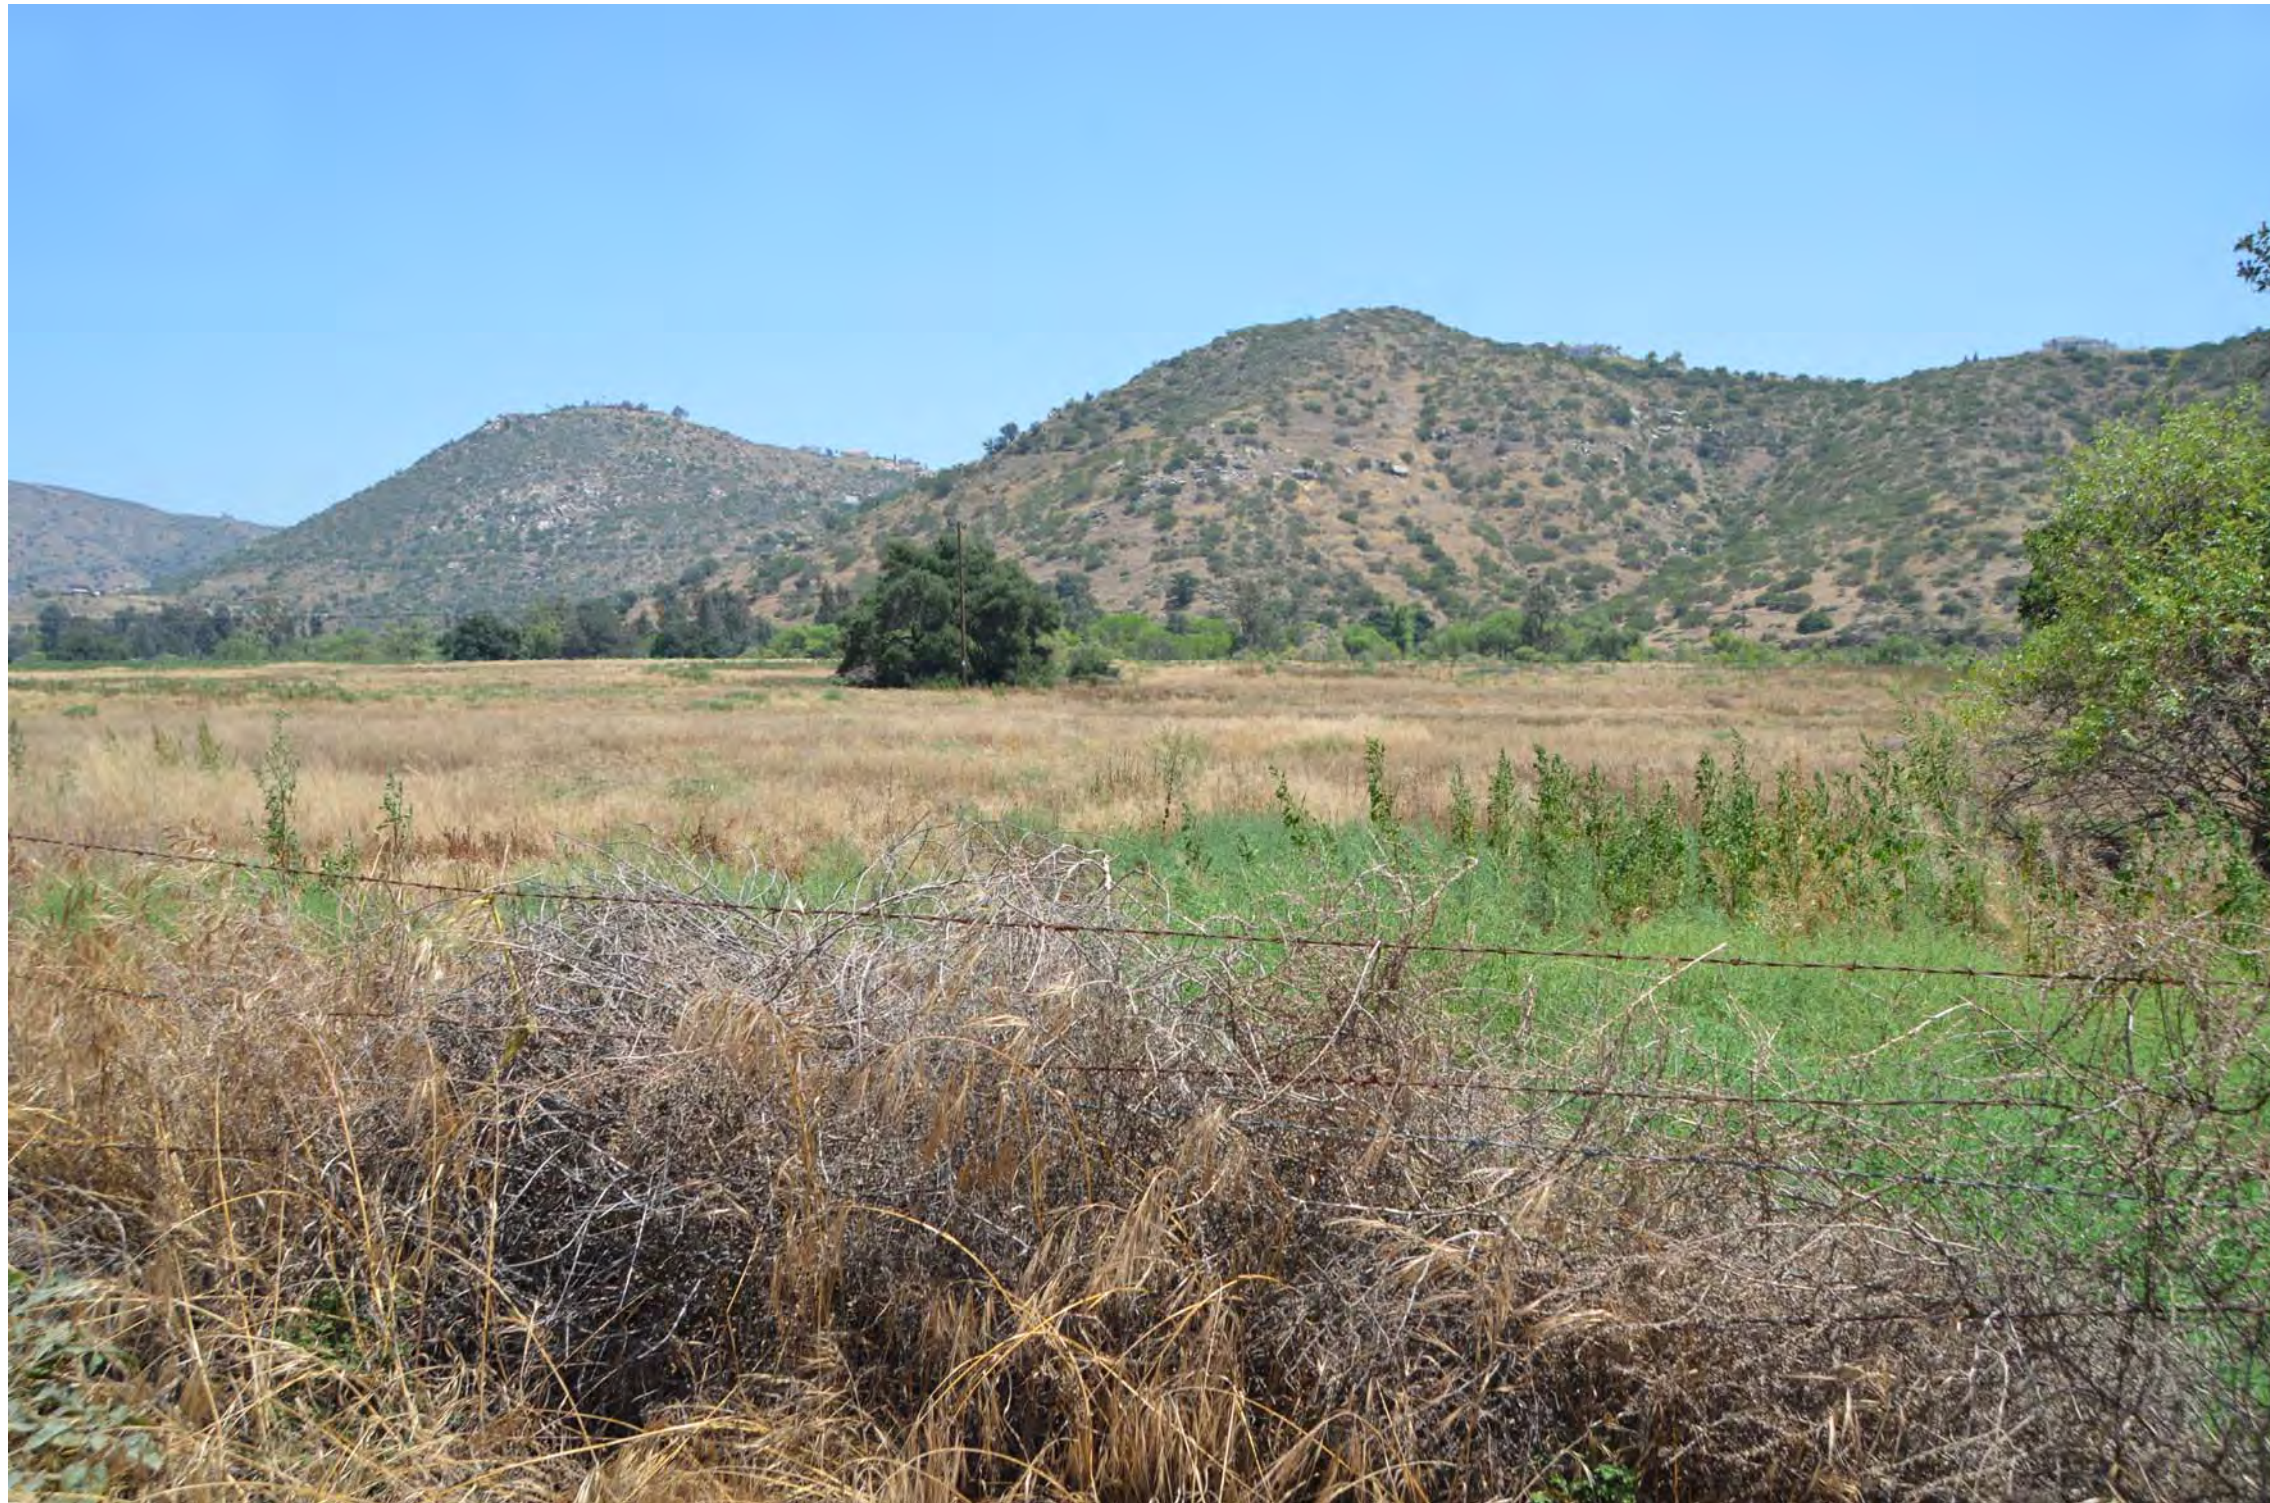
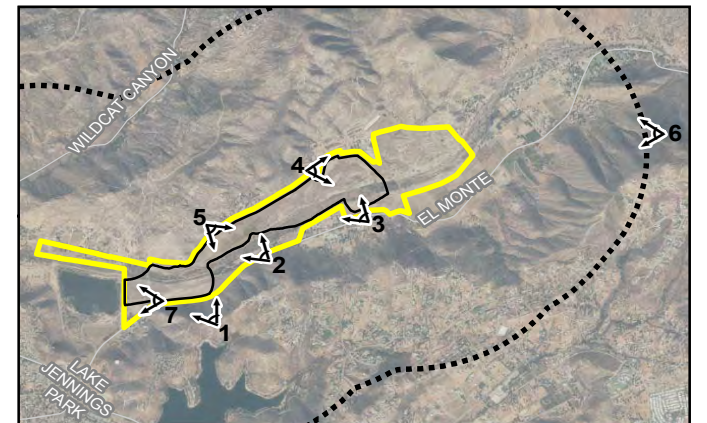
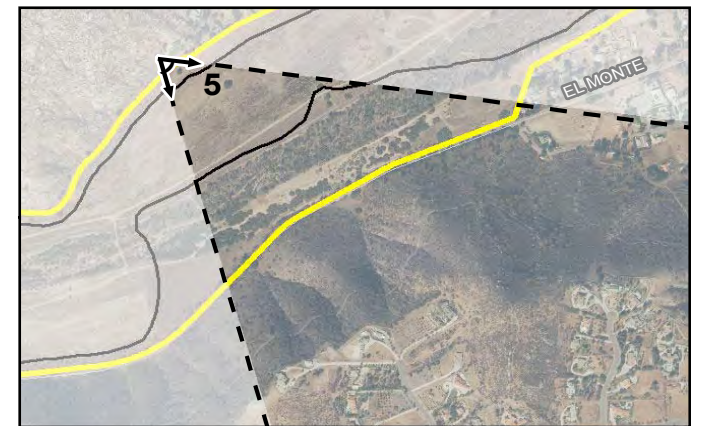
Figure 22a
Key View 5 Existing Conditions

Existing Perspective

- From Willow Road
- 436 feet above sea level
- 32.87° Latitude/-116.89° Longitude
- Looking southeast across the valley
- Public view
- Lowland Disturbed, Undisturbed Canyon Slopes, and Ridgeline Residential LUs

As with the other key views, the visual environment of Key View 5 is dominated by the green and brown vegetation of the valley floor and background slopes, as shown on Figure 22a. Rocks are visible on the slopes and houses are located on the ridge, but overall, the moderately smooth textures and undulating lines dominate the view. The visual features within the scene are continuous, with little diversity visible. No highly contrasting or out of scale elements are present. The intactness and unity of the view are high. While there are no memorable individual features in the view, the vividness is moderately high due to the visual pattern of the combined components.

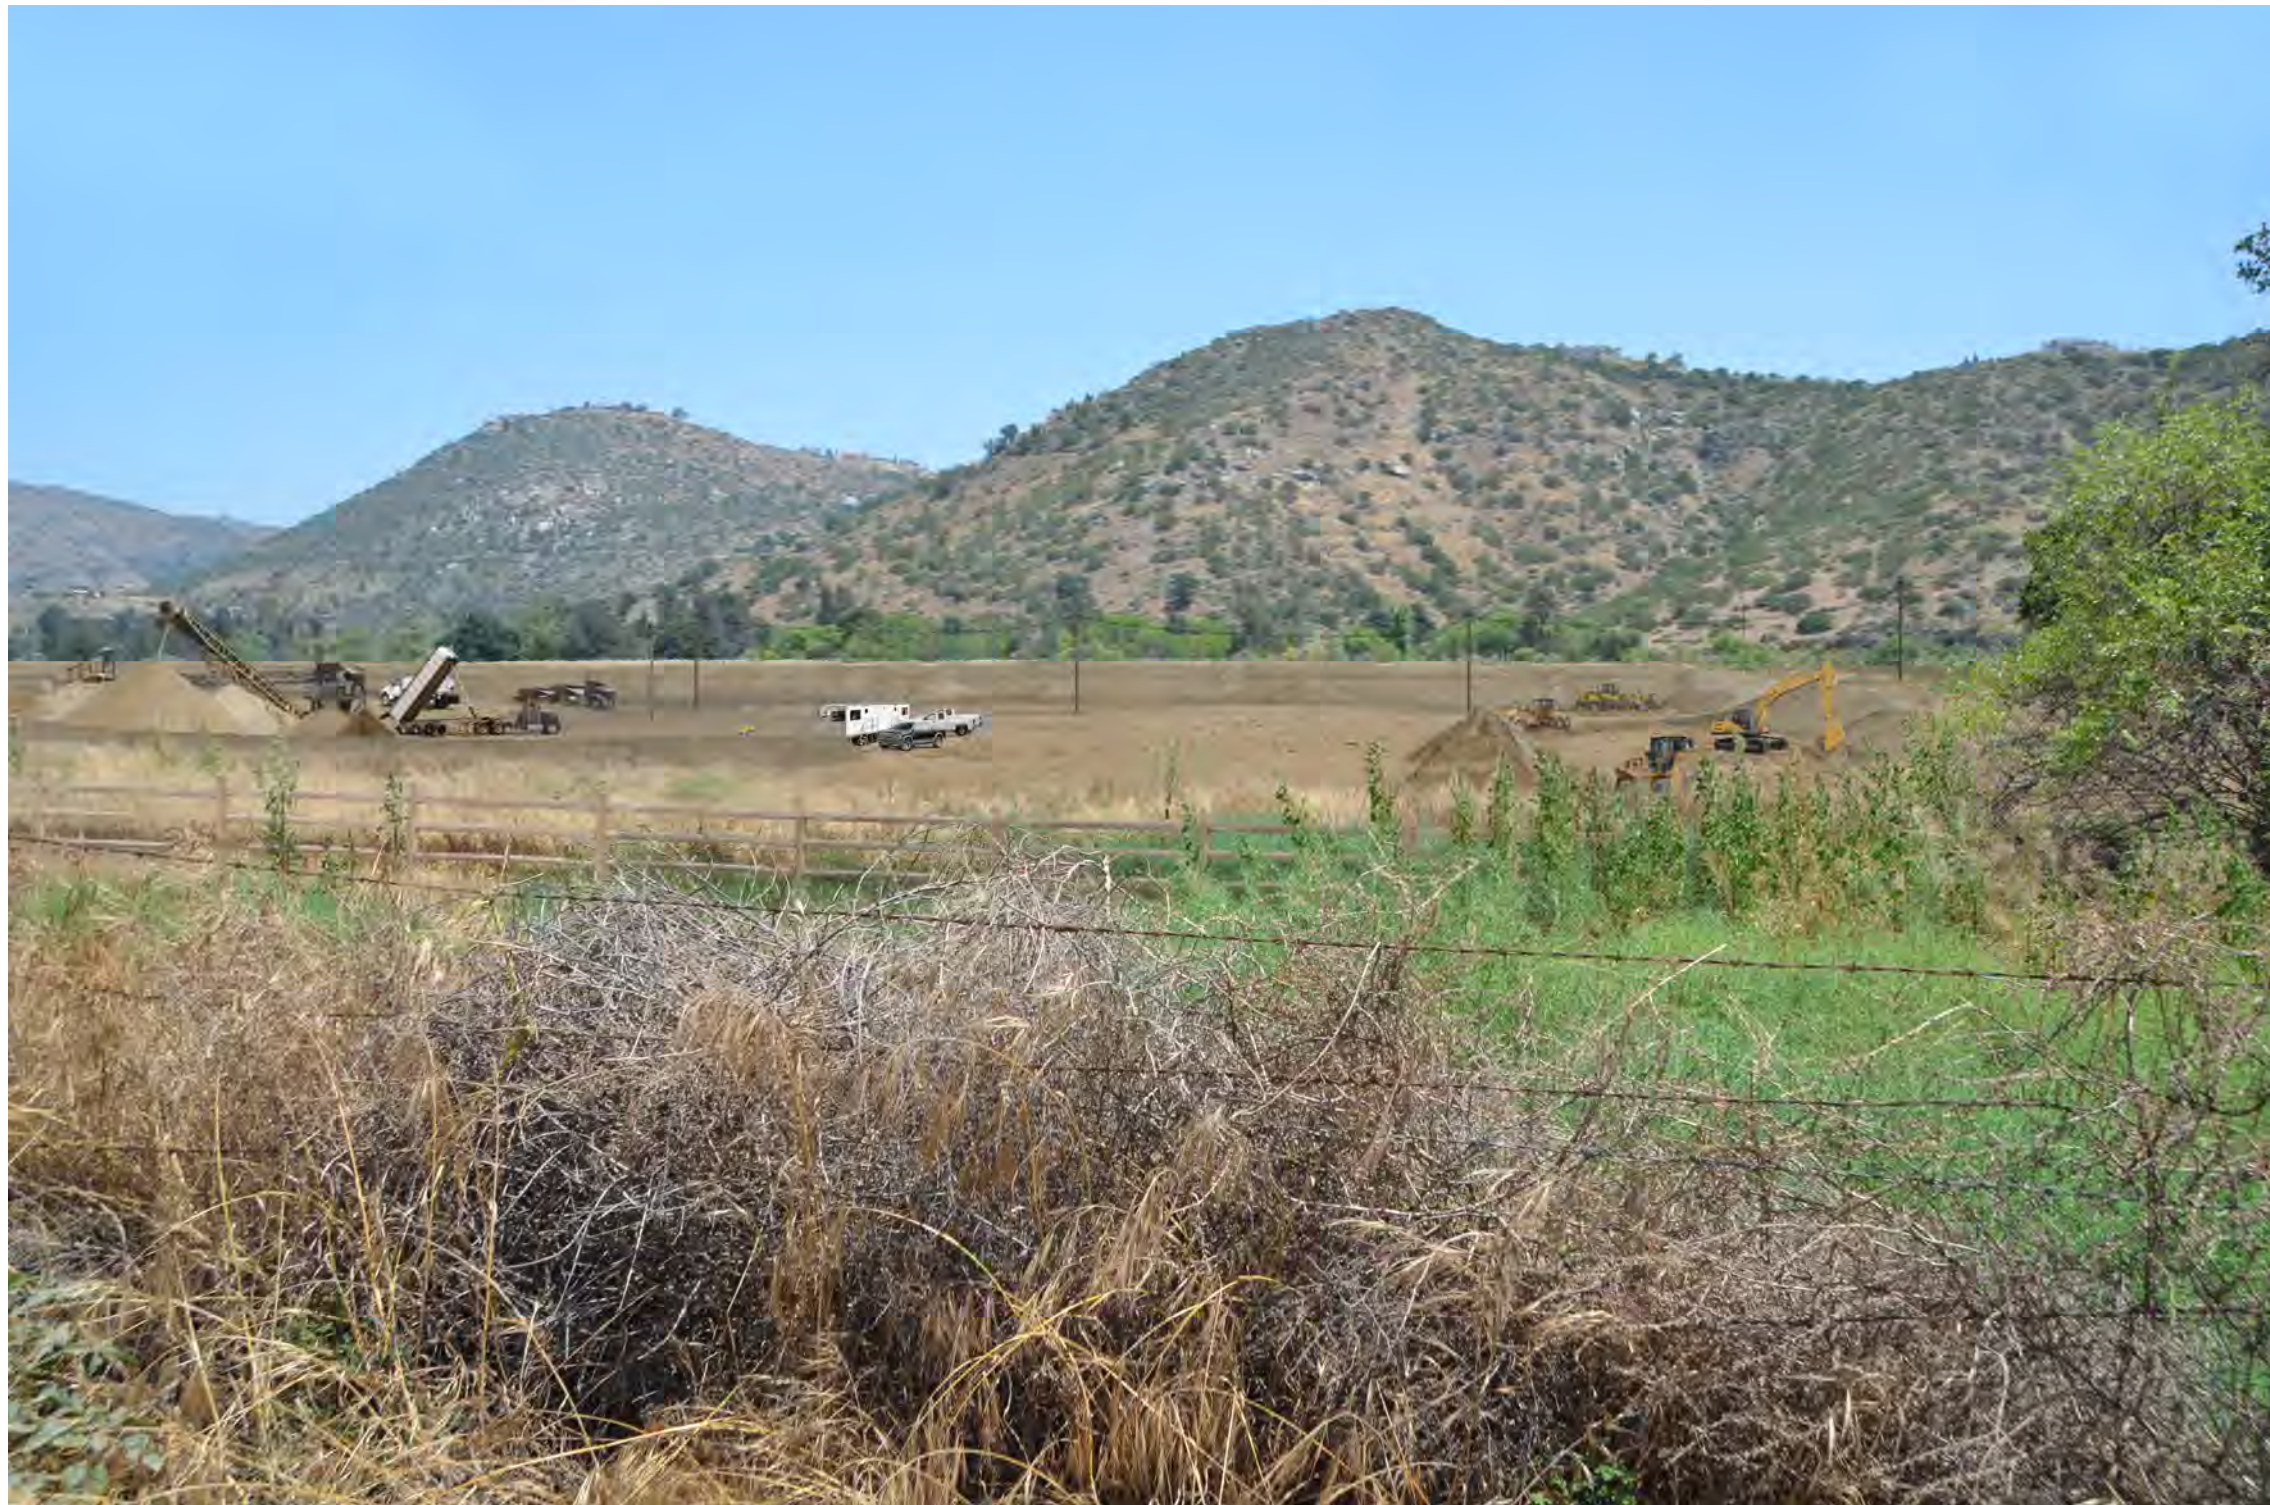
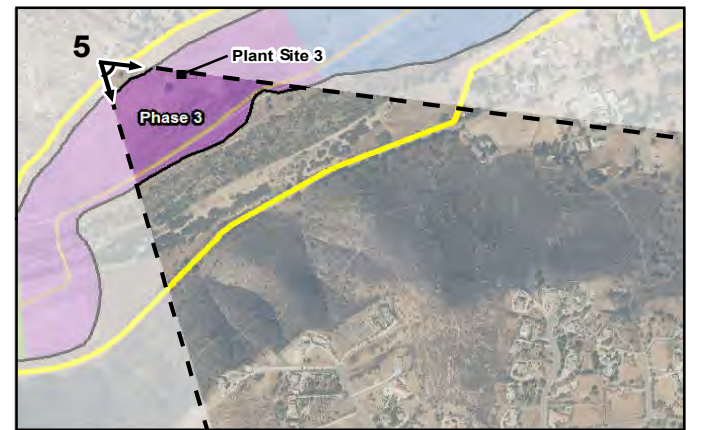
Figure 22b
Key View 5 Simulation

Simulated Environment

- Project Year 8
- Phase 3 excavation activities
- Processing Plant Site 3
- Phase 4, Type "C" Primitive Trail

From Key View 5, along Willow Road, most of Phase 3 would be visible (refer to Figure 22b). Phases 1 and 2 would be located east of Key View 5, to the viewer's left. As shown in the simulation, a portion of the haul road and berm surrounding the processing plant would be visible from Key View 5 but the most visible feature would be the processing plant and stockpiles, which would be located in the left of the view.

After Phase 3 is complete, the processing plant and stockpiles would be moved to a point west (to the right) of the view and just outside the frame of the photograph. Vegetation within the Phase 3 would be cleared and exposed soil and mining equipment would be highly visible from Willow Road at Key View 5. The vegetation in the foreground and background would remain undisturbed for the length of the project, since these areas are located within the 150-foot road buffer and slopes beyond the project footprint.

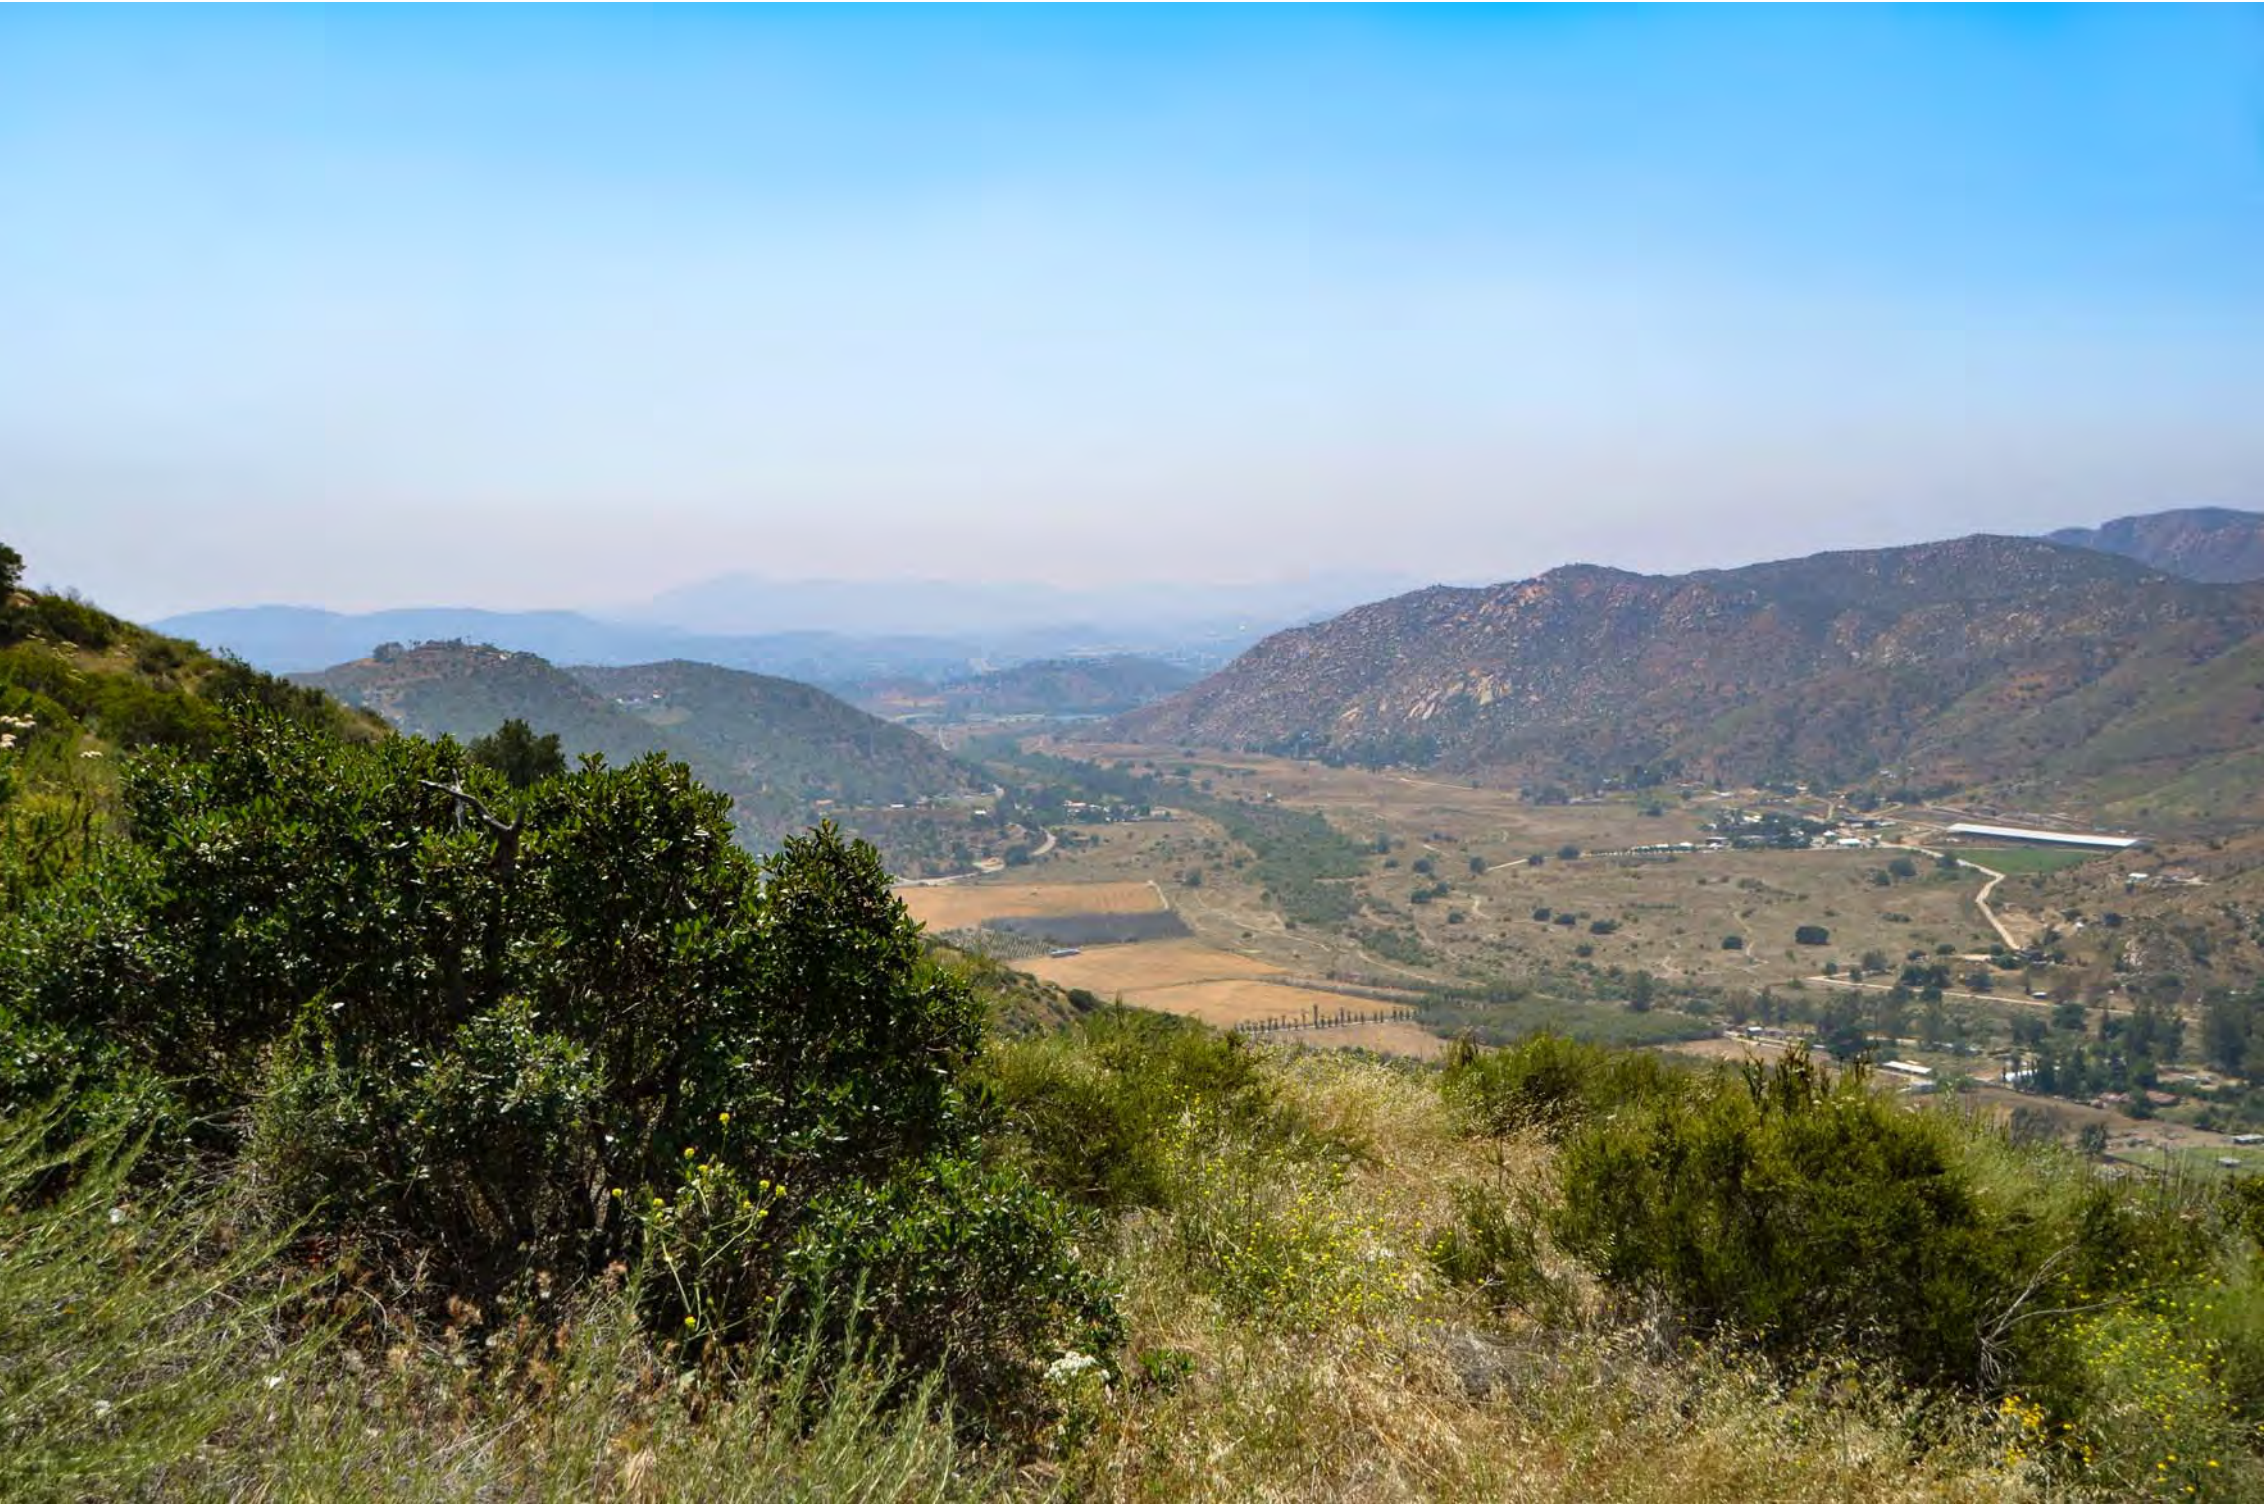
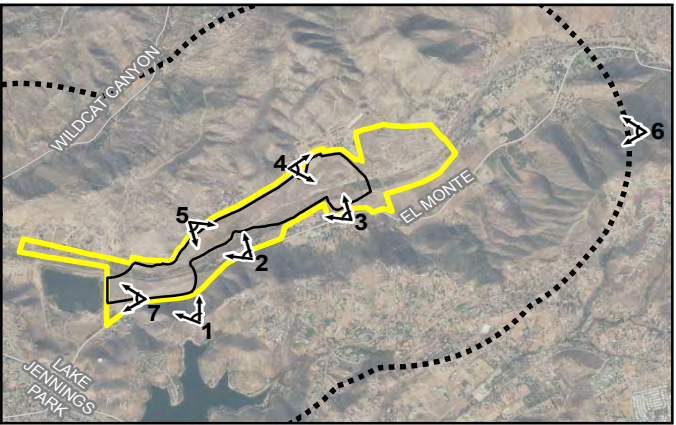
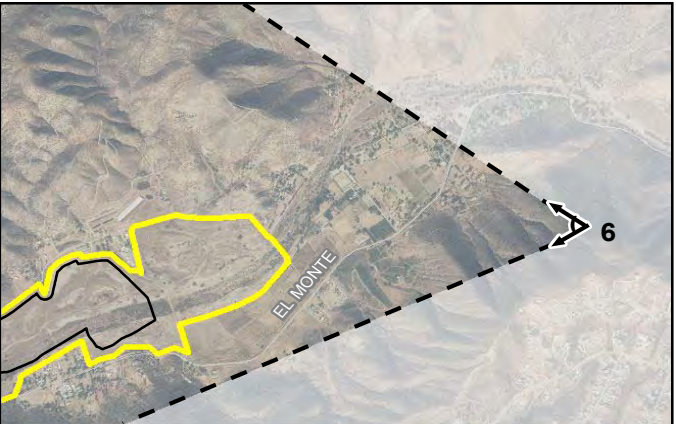
Figure 23a
Key View 6 Existing Conditions

- Existing Perspective
- From El Monte Park Trail, above El Monte County Park
 - 1,401 feet above sea level
 - 32.88° Latitude/-116.84° Longitude
 - Two miles east of the Proposed Project
 - Public/Private views
 - Lowland Residential, Lowland Agricultural, Lowland Disturbed, Undisturbed Canyon Slopes, Suburban, and Ridgeline Residential LUs

The colors that make up the visual environment of Key View 6 are more varied than within the other key views, from bright greens of agricultural areas to dark purples of distant native vegetation and the atmosphere-dulled blues of the background ridges, as shown on Figure 23a. Tans, browns, and yellow-tinged greens fill the valley, while tan rocks are scattered across the dull green hillside of the northern side of the valley. Undulating horizon lines and the curving
