5.0 VISUAL IMPACT ASSESSMENT

Eighteen key views were selected for consideration to depict representative views of the project features as seen from within the project viewshed. The key views were comprehensively evaluated and seven key views that best depicted the visual impacts of the project from the perspective of different viewer groups at different points in time during the project duration were selected (Key Views 1 through 7). Figure 3 shows the location of the 18 key views in relation to the project site. Figures 17a, 17b, and 17c contain photographs from the 18 key views. The comprehensive evaluation of the all 18 key views based on the viewer groups, and potentially visible project features is summarized in Table 4.

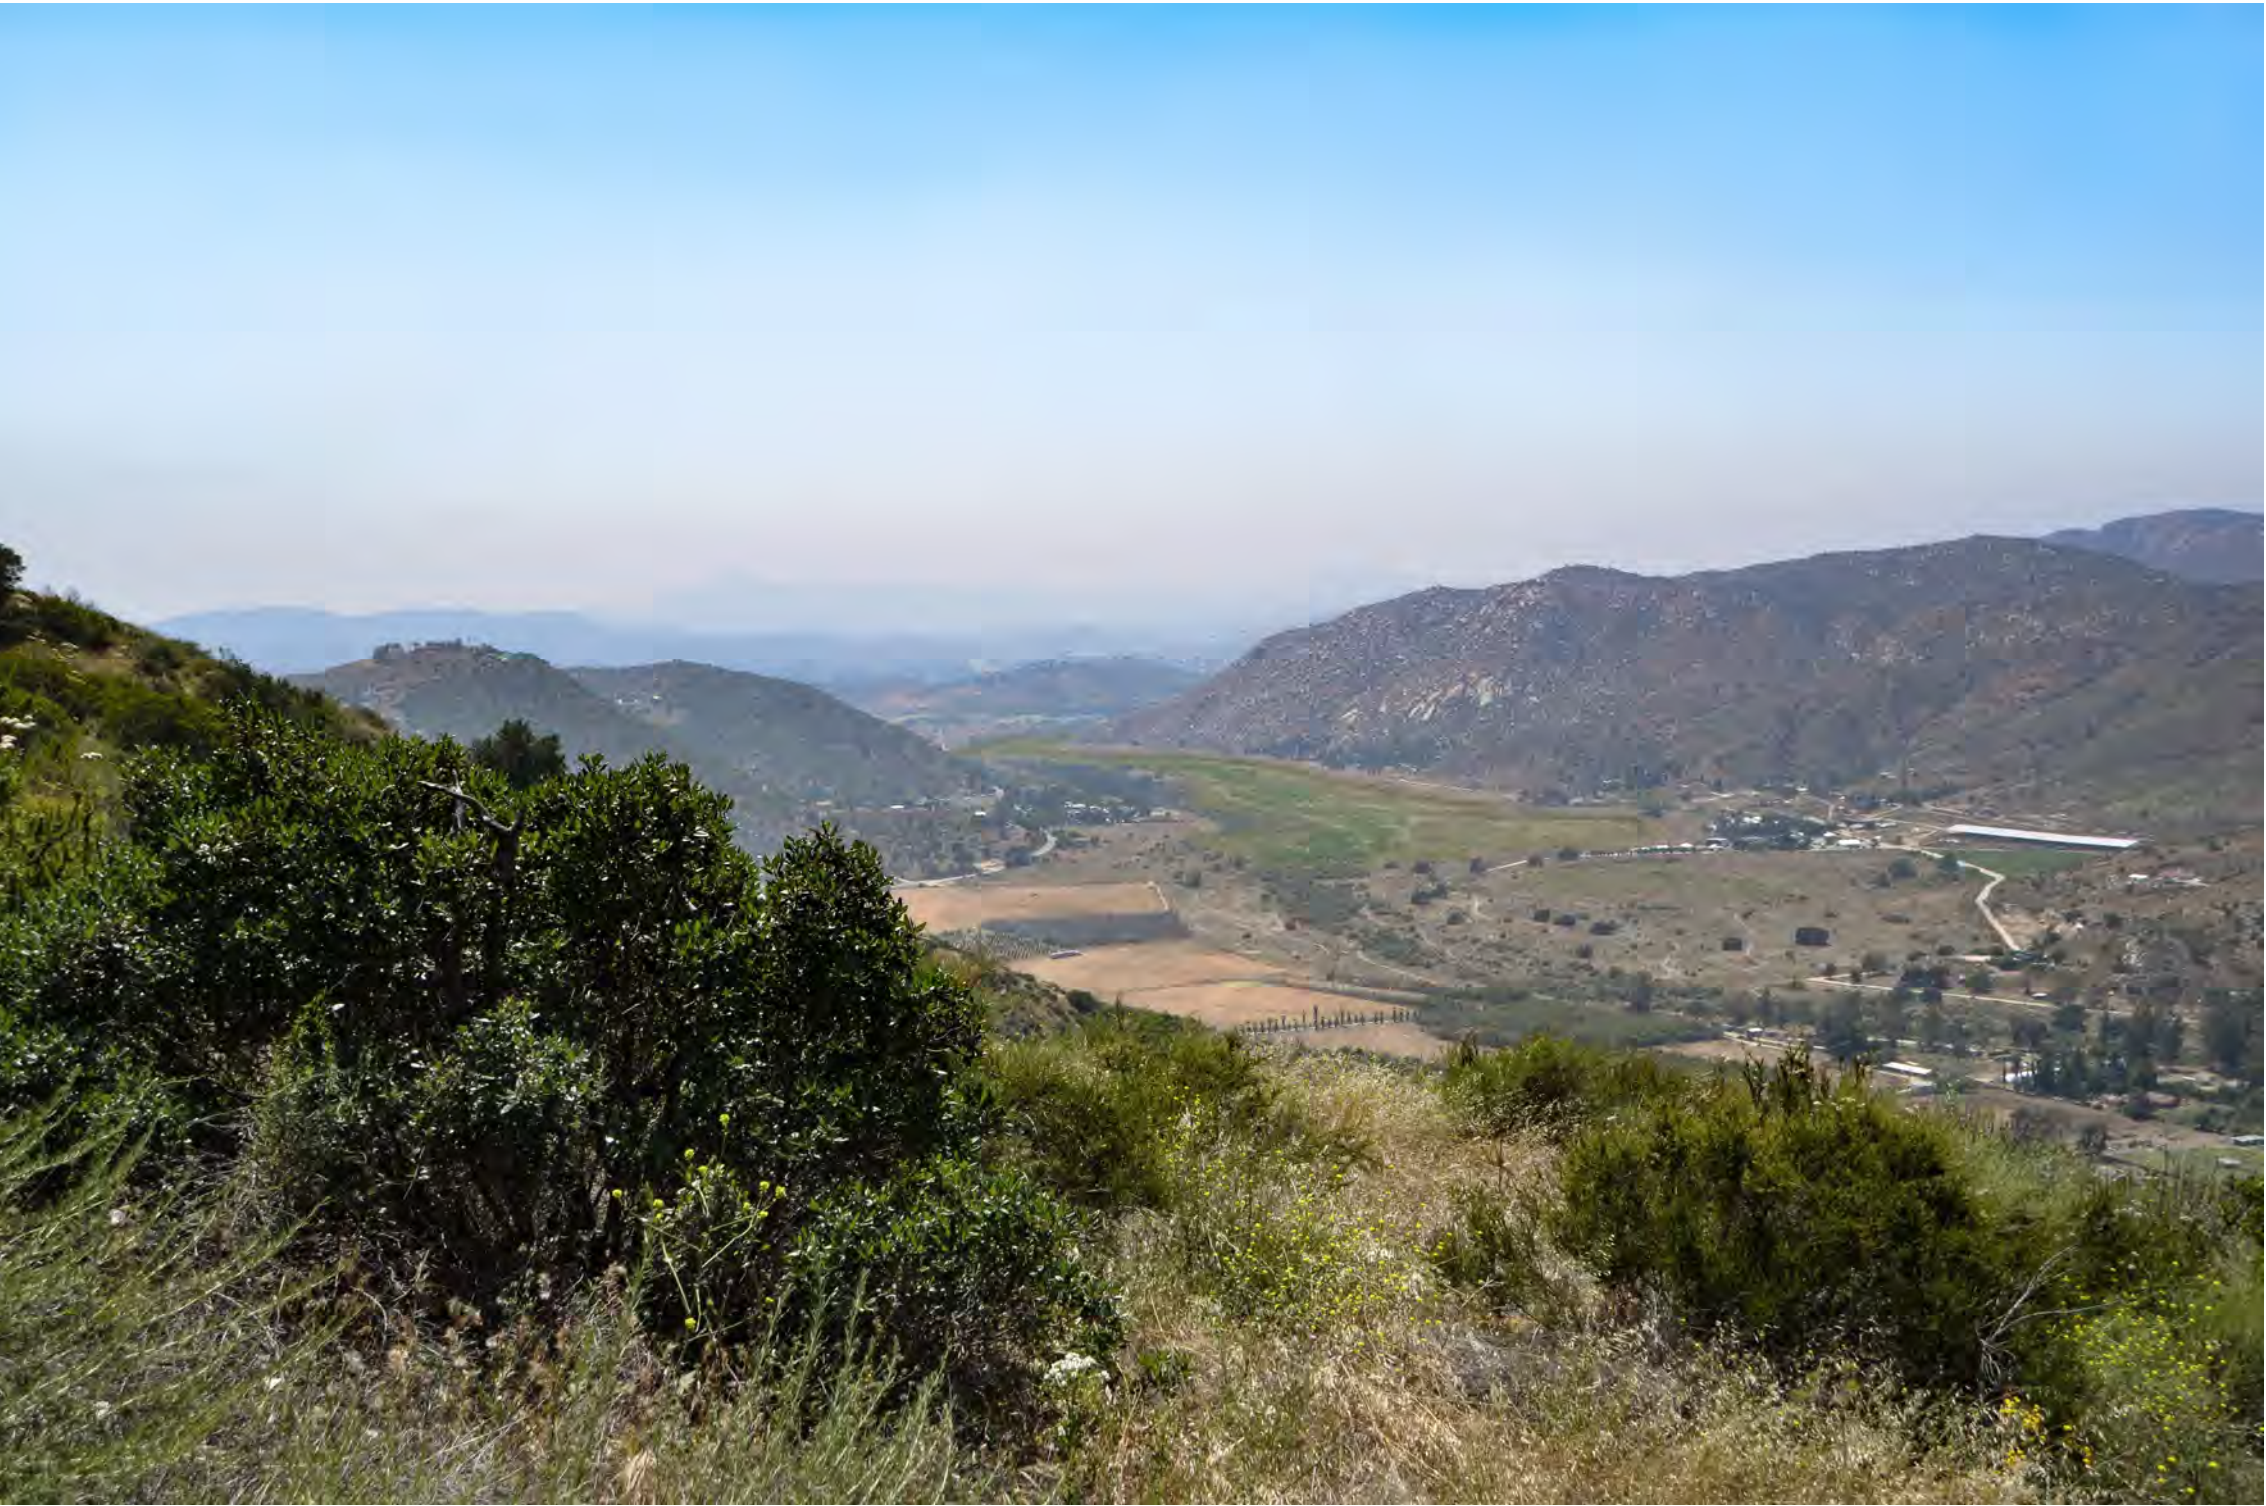
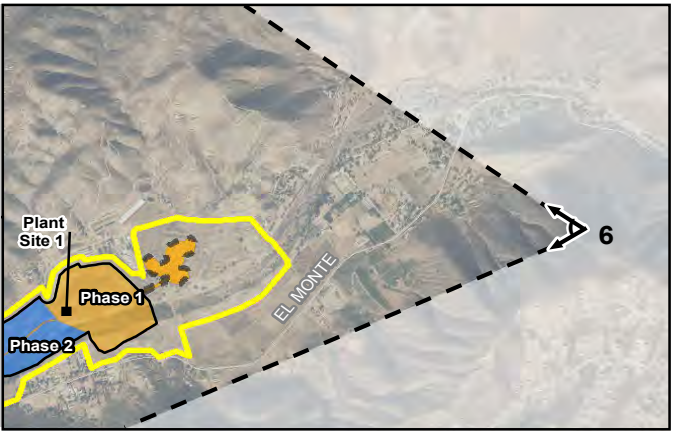
Figure 23b
Key View 6 Simulation

Simulated Environment

- Project Year 16
- All phases (post-reclamation)
- Phase 1, Type "D" Pathway
- Phase 4, Type "C" Primitive Trail

Almost all of the project would be visible from Key View 6, as shown in Figure 23b. The Key View 6 Simulation reflects the view at 16 years past project initiation. The reclamation of each phase would be complete. Stabilized post-extraction landforms would be revegetated with a diverse native seed mix and container plants. The reclaimed project site visible in this view has the appearance of a healthy, incrementally maturing, natural wild land, which is free of undesirable invasive species. The slopes on either side of the valley from this view would remain undisturbed.

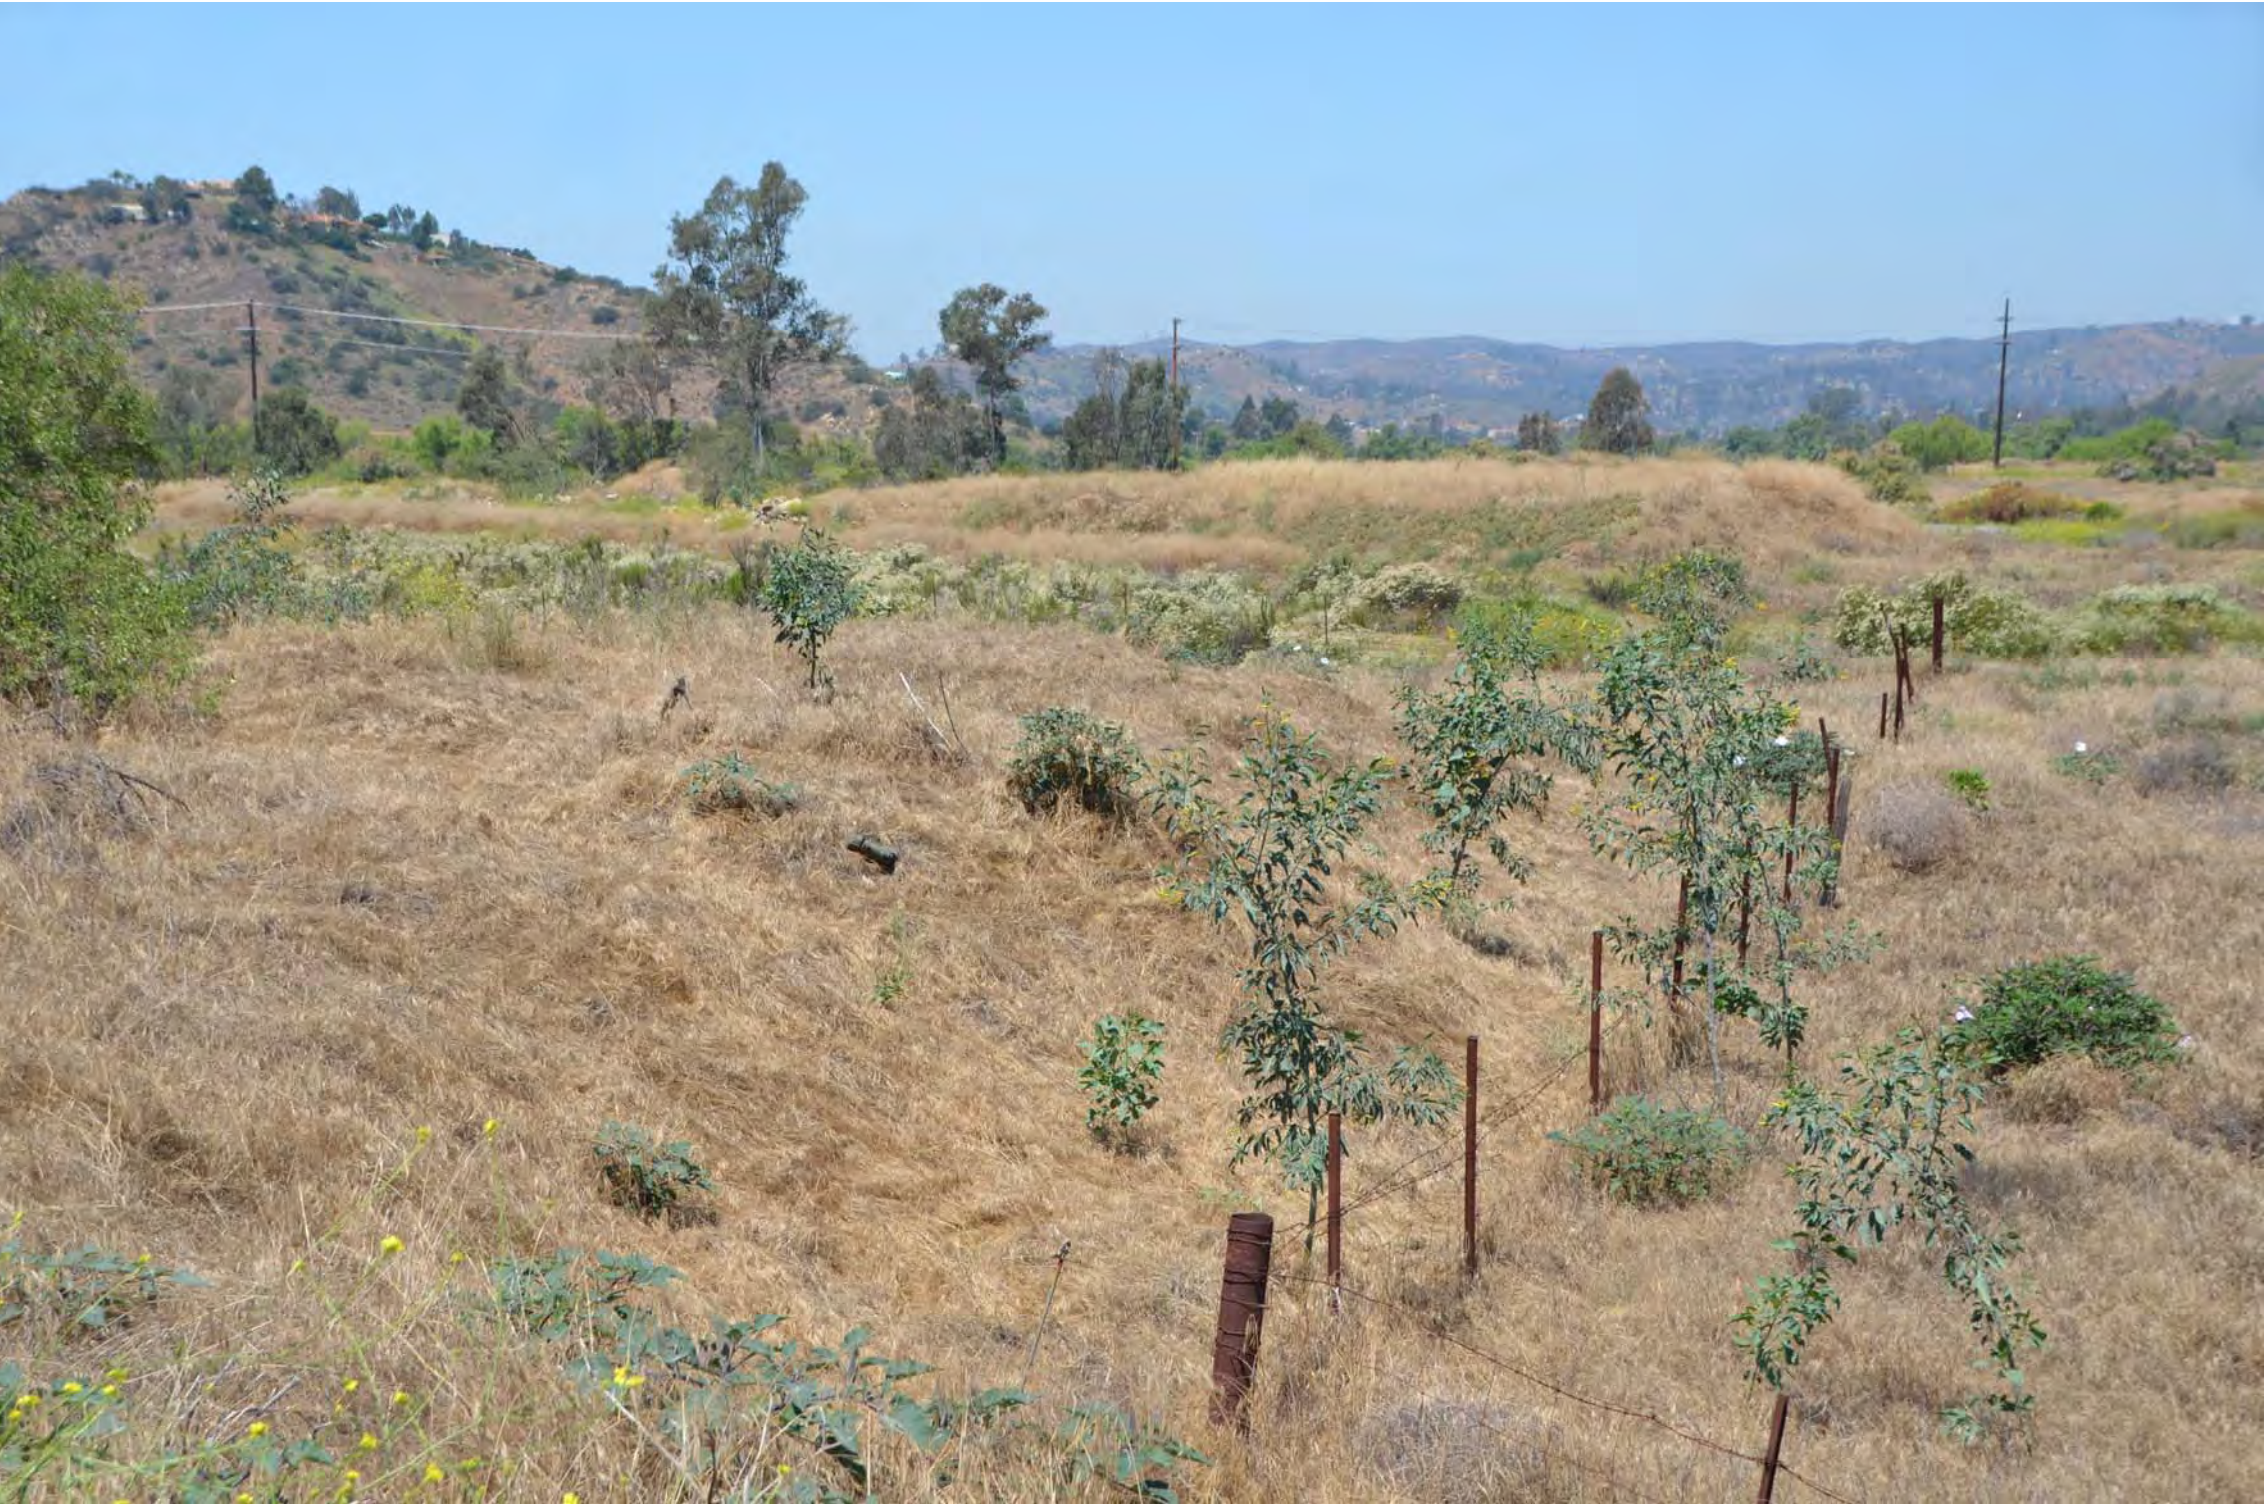
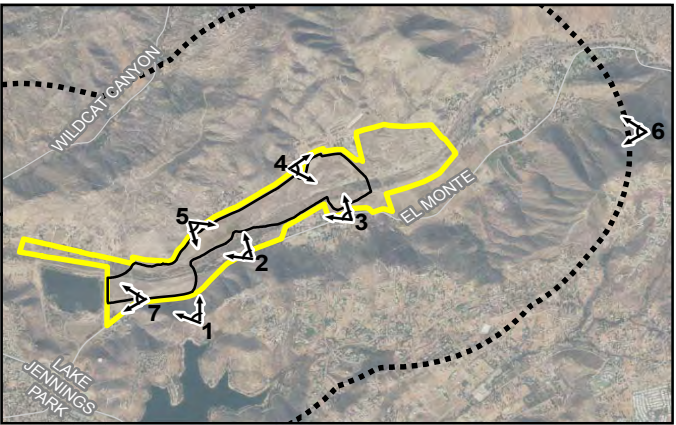
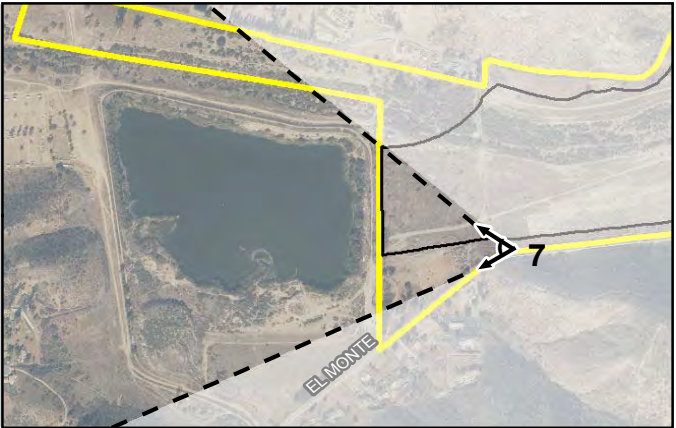
Figure 24a
Key View 7 Existing Conditions

- Existing Perspective
- From El Monte Road
 - 451 feet above sea level
 - 32.87° Latitude/-116.89° Longitude
 - Looking west
 - Public views
 - Lowland Residential, Riparian River Channel, Undisturbed Canyon Slopes, Lowland Disturbed, Suburban, and Ridgeline Residential LUs

The Key View 7 photograph shows mostly brown and green vegetation, with little variation as to color and texture, although the rocks on the hillside in the background provide some variety of texture and color (refer to Figure 24a). The riparian vegetation is not highly visible, although some trees stand out in the view. The dominant elements are the valley floor, and canyon and rocky background slopes.

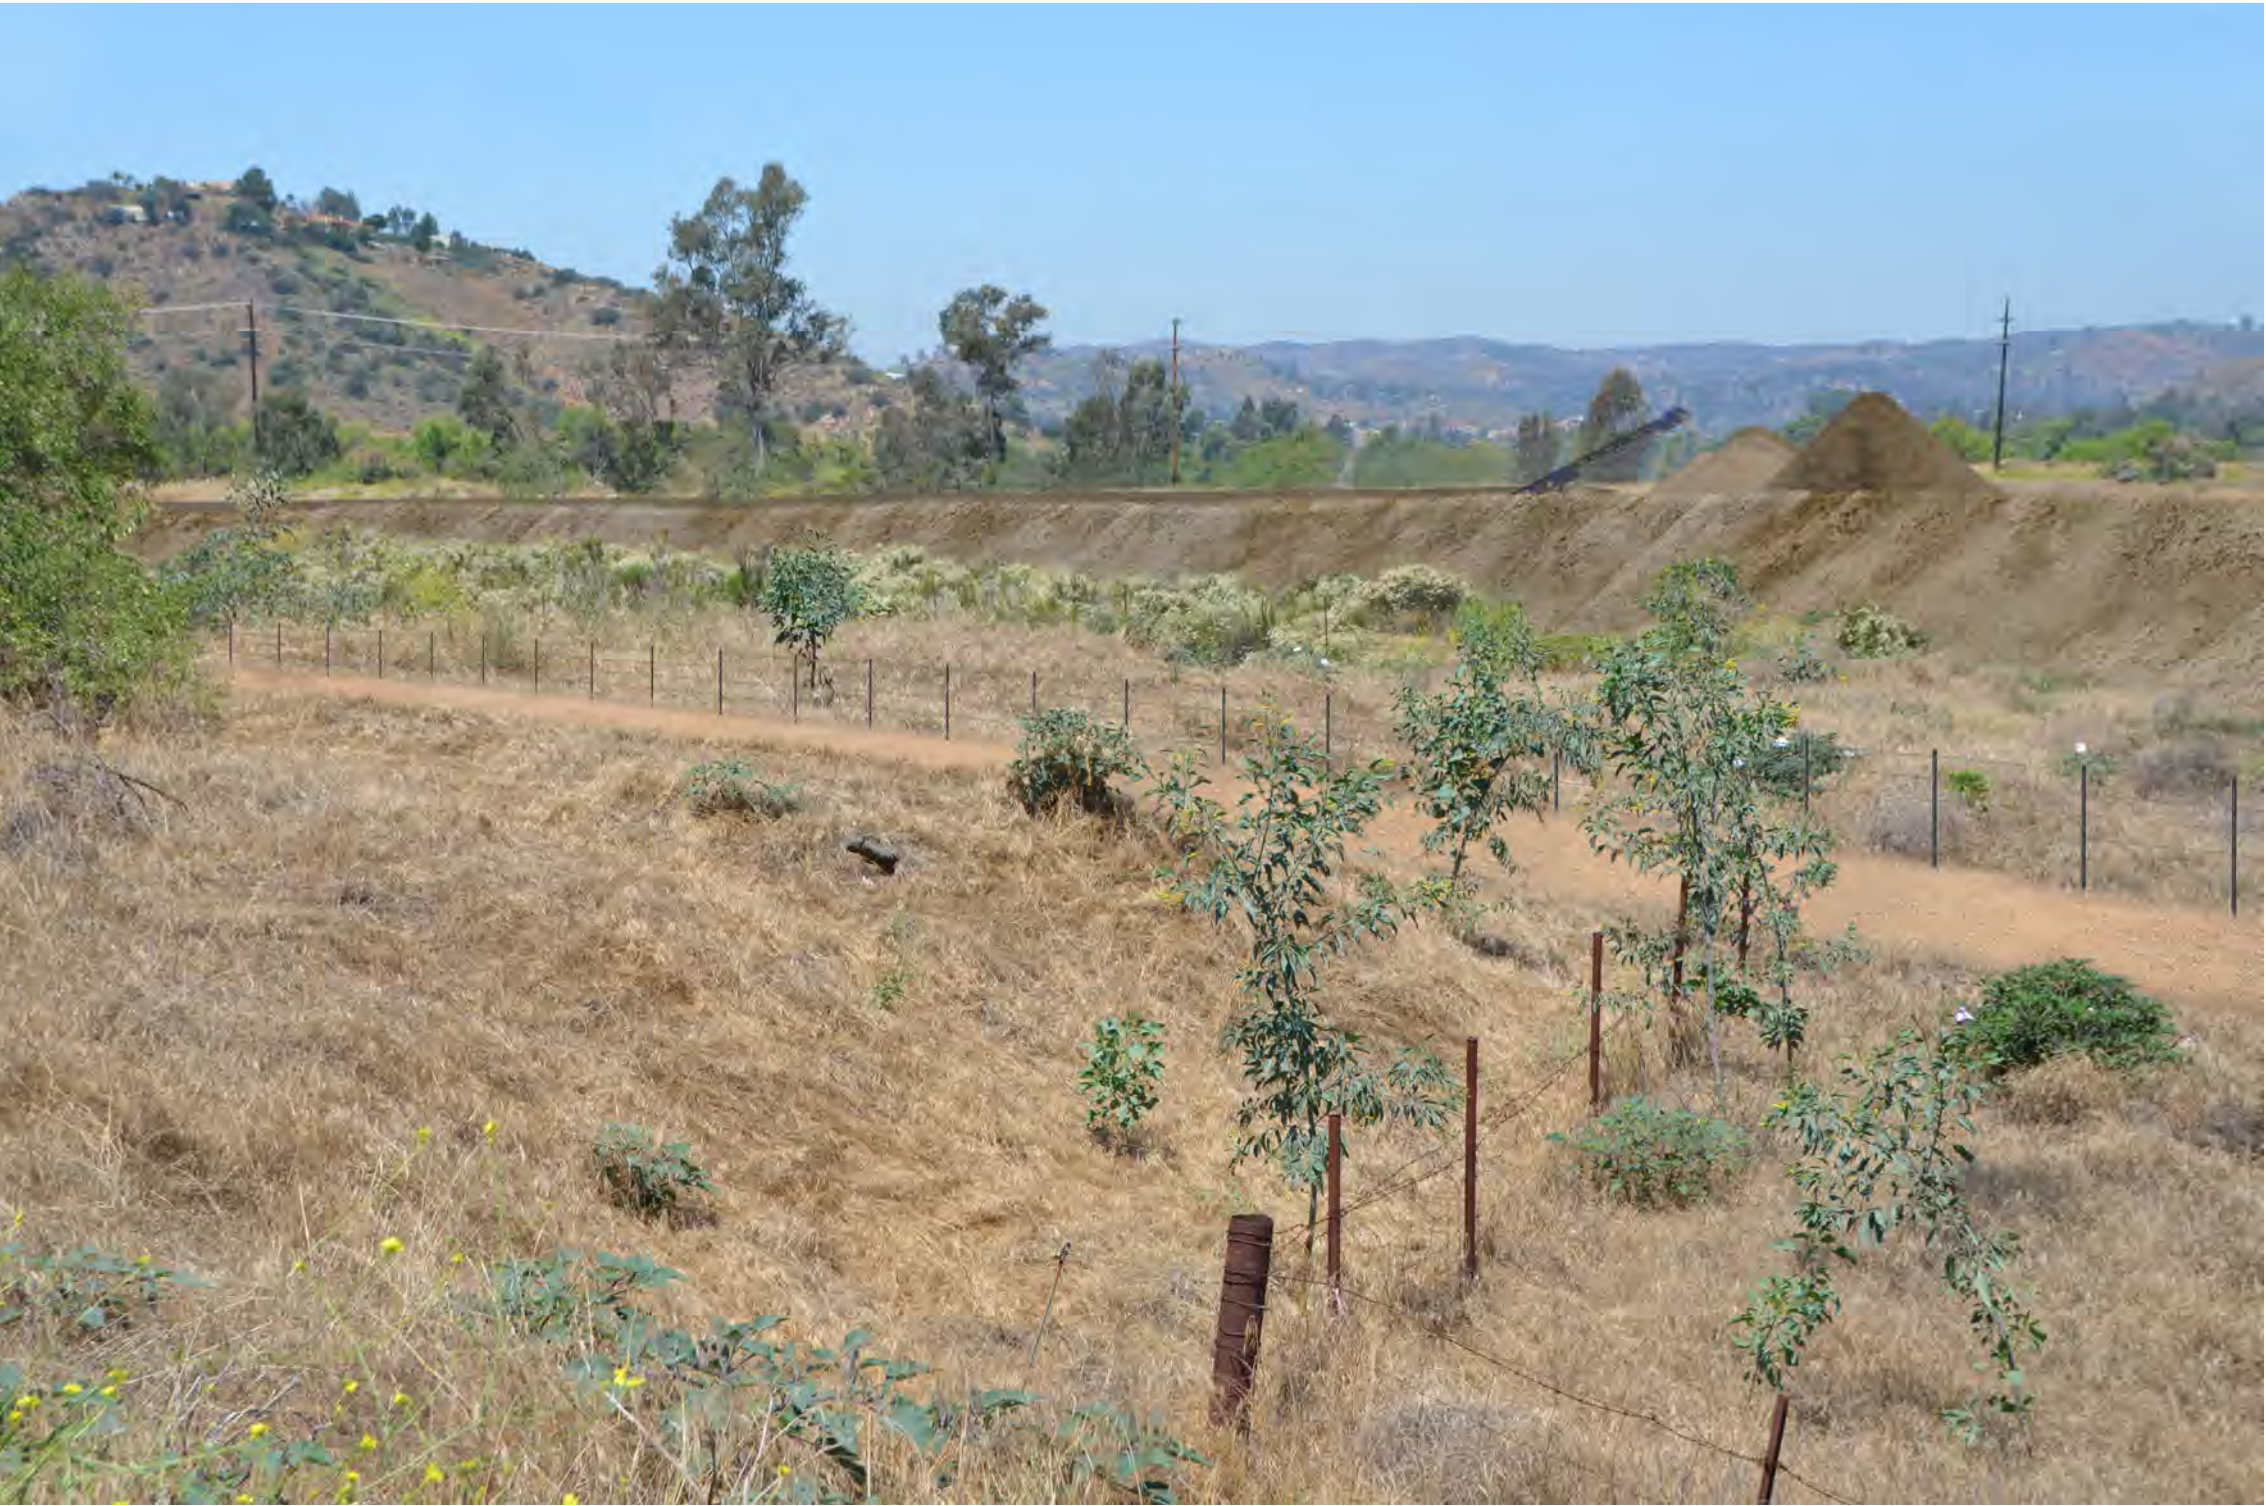
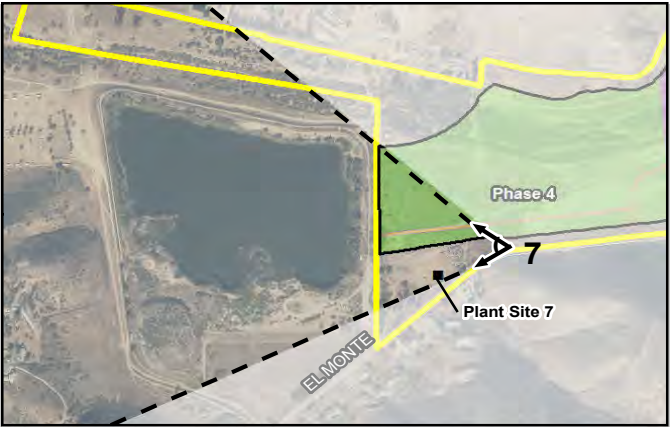
Figure 24b
Key View 7 Simulation

Simulated Environment

- Project Year 11
- Phase 4 excavation activities
- Processing Plant Site 7
- Phase 1, Type "D" Pathway

The Key View 7 Simulation reflects the project 11 years after project initiation; during Phase 4 mining activities (refer to Figure 24b). Phase 4 would be the only portion of the project visible from Key View 7. Due to the low elevation at this view, the exposed soil and much of the project's operational elements would not be highly visible until Phase 4, when the western portion of the project site would be cleared and grading and mining operations would begin. The final location of the portable processing plant (Plant Site 7) is shown in the center-right of the simulation.
