An Experimental Determination of a Real Fire Performance of a Non-Load Bearing Glass Wall Assembly

Article in *Fire Technology* · March 2007

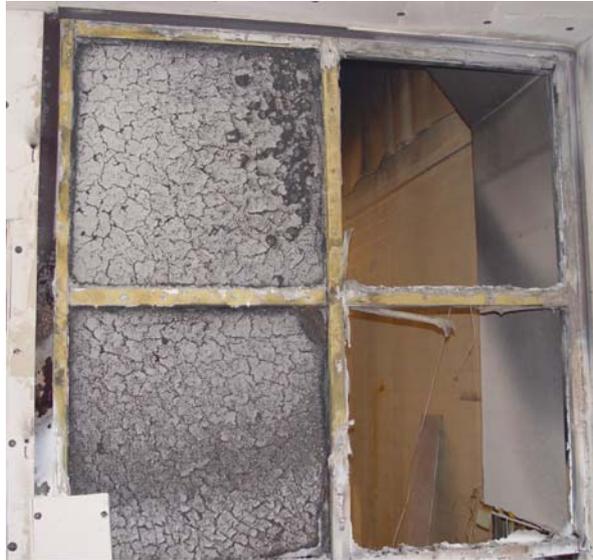
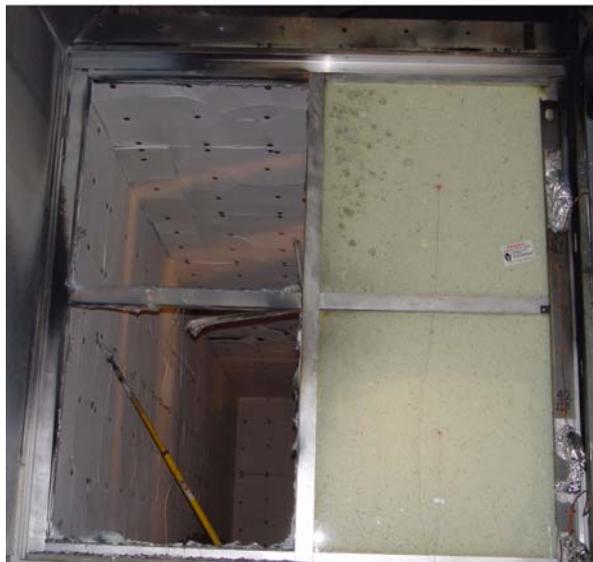
Figure 2. (a) Digital pictures of the exposed glass face immediately after the fire exposure. (b) Digital pictures of the unexposed glass face immediately after the fire exposure.

Figure 2(a)–(b) displays pictures the exposed face and unexposed face of the glass assembly upon completion of the fire test. Clearly, the two single-pane glass sections were destroyed during fire testing. As for the double-pane glass sections, the inside glass panes were destroyed but the glass panes on the unexposed side were completely intact (see Figure 2(b)). The gel insulation between the two panels frosted extensively.
