STORM WATER MANAGEMENT INVESTIGATION

CHABAD JEWISH CENTER IMPROVEMENTS 14906 VIA DE LA VALLE SAN DIEGO COUNTY, CALIFORNIA

**JUNE 14, 2023
PROJECT NO. G3134-52-01**

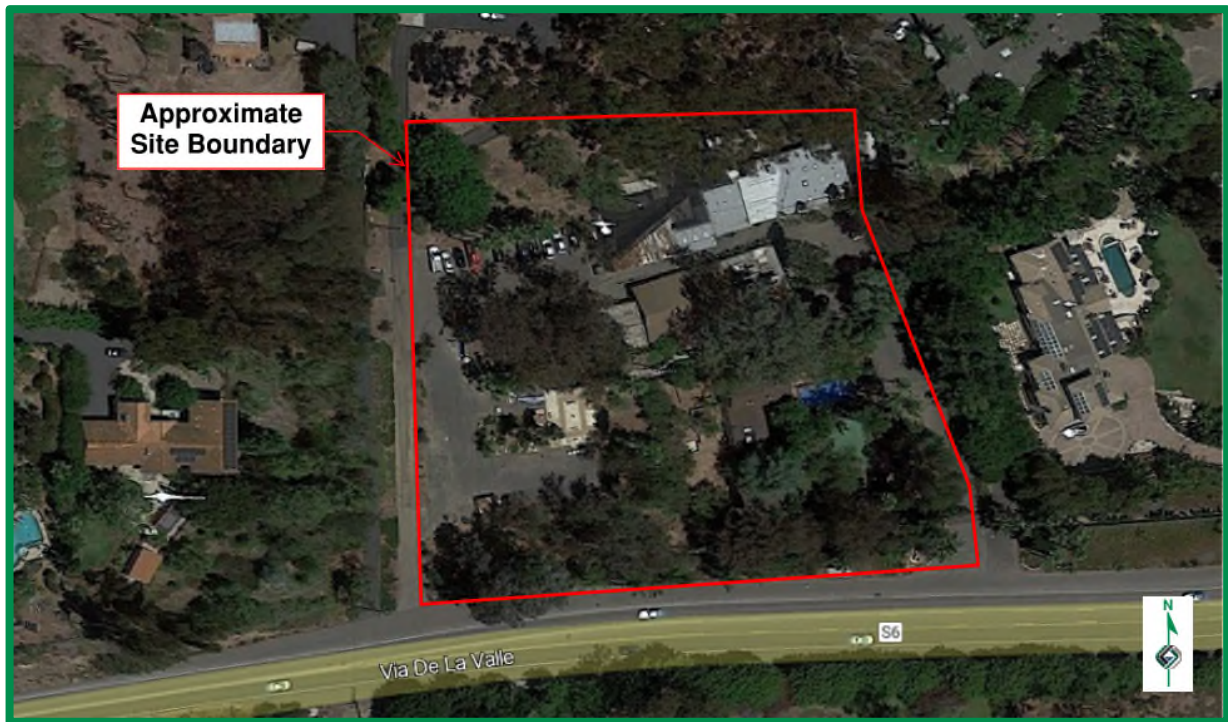
The property is located at 14906 Via de la Valle in the Rancho Santa Fe area in San Diego County, California. The property currently consists of a few commercial and retail buildings, and some ancillary structures, along with accommodating pavement, utilities, flatwork and landscaping. The property gently to moderately slopes to the southeast with elevations ranging from about 100 feet to 70 feet above Mean Sea Level (MSL) from north to south, respectively. The Existing Site Map shows the current site conditions.
