Groundwater Resources Investigation Report Tierra del Sol Solar Farm Project

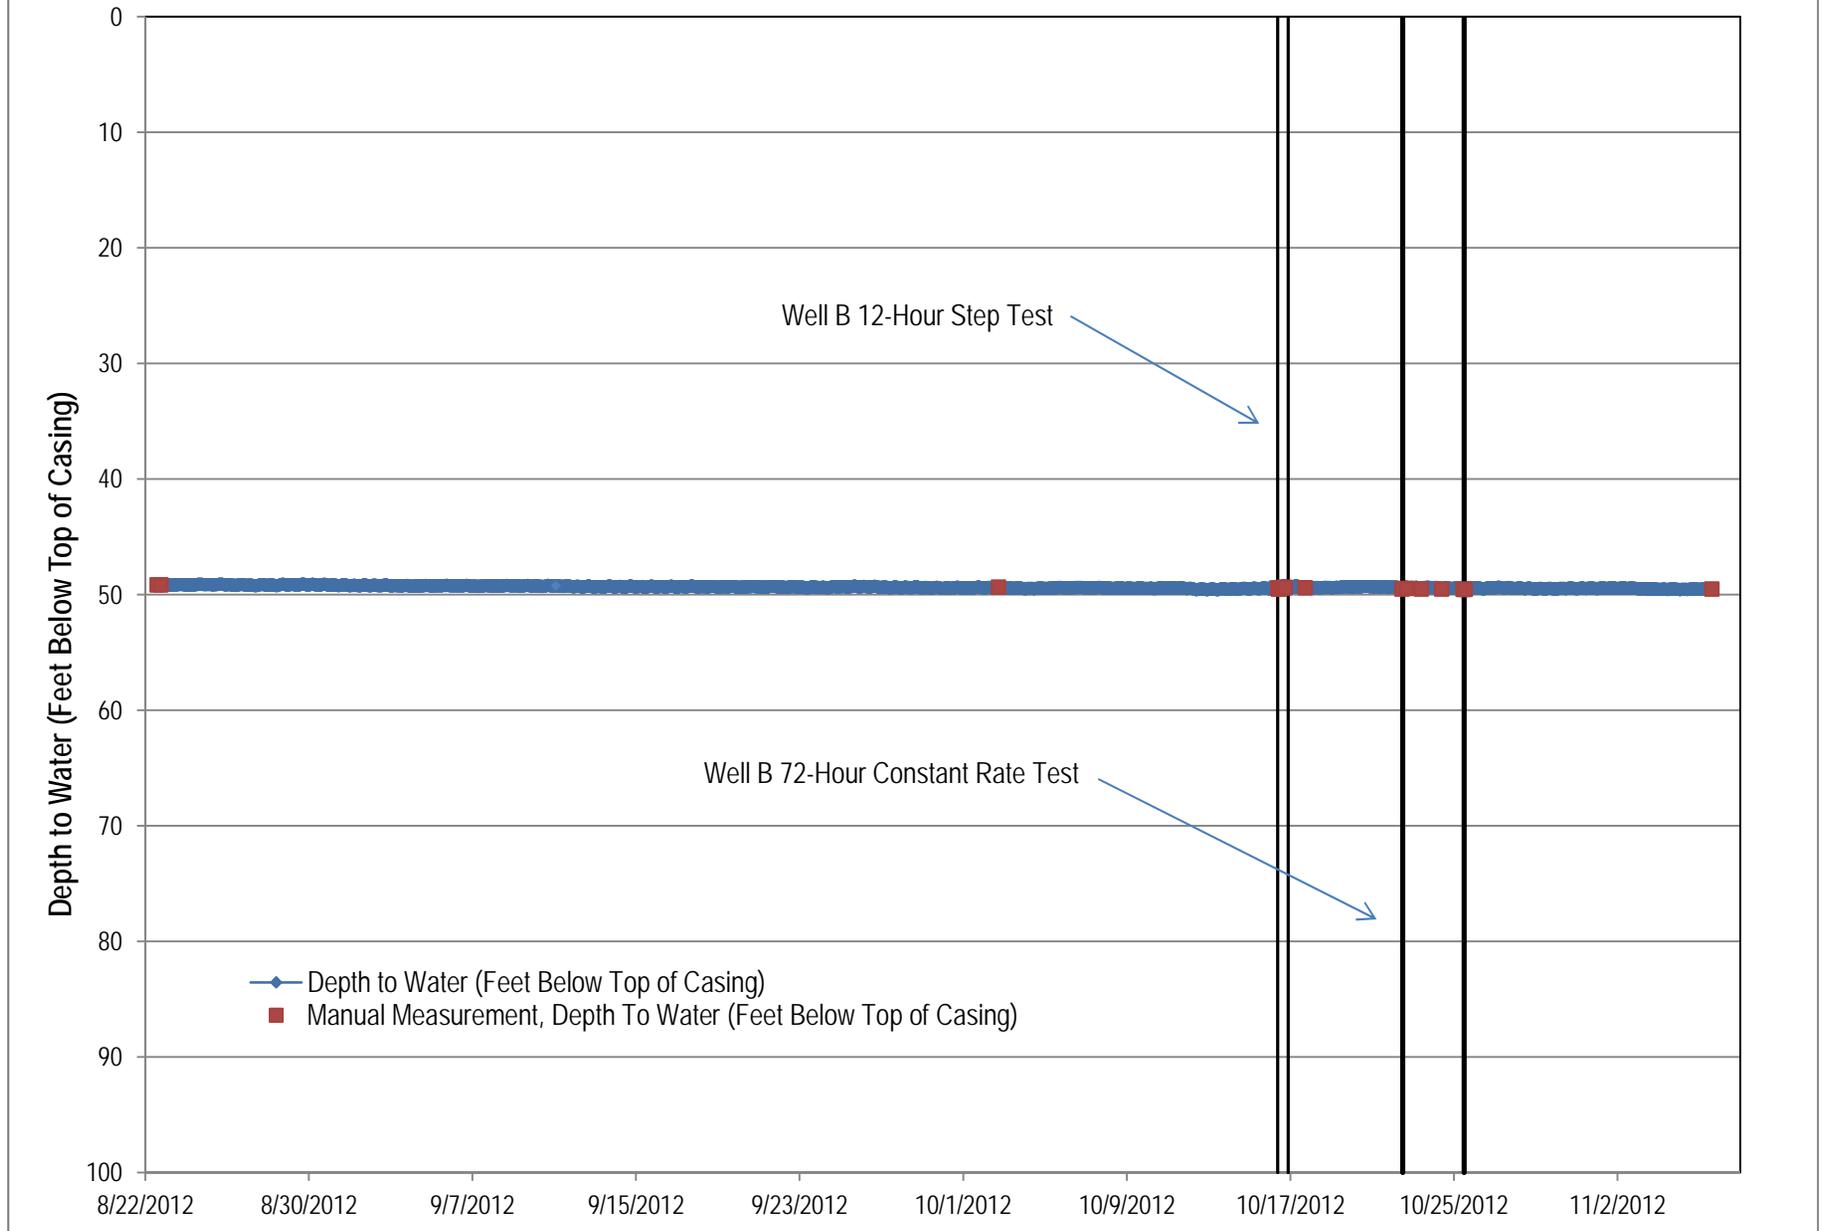
Figure 12. On-site Well 1 Water Level Data

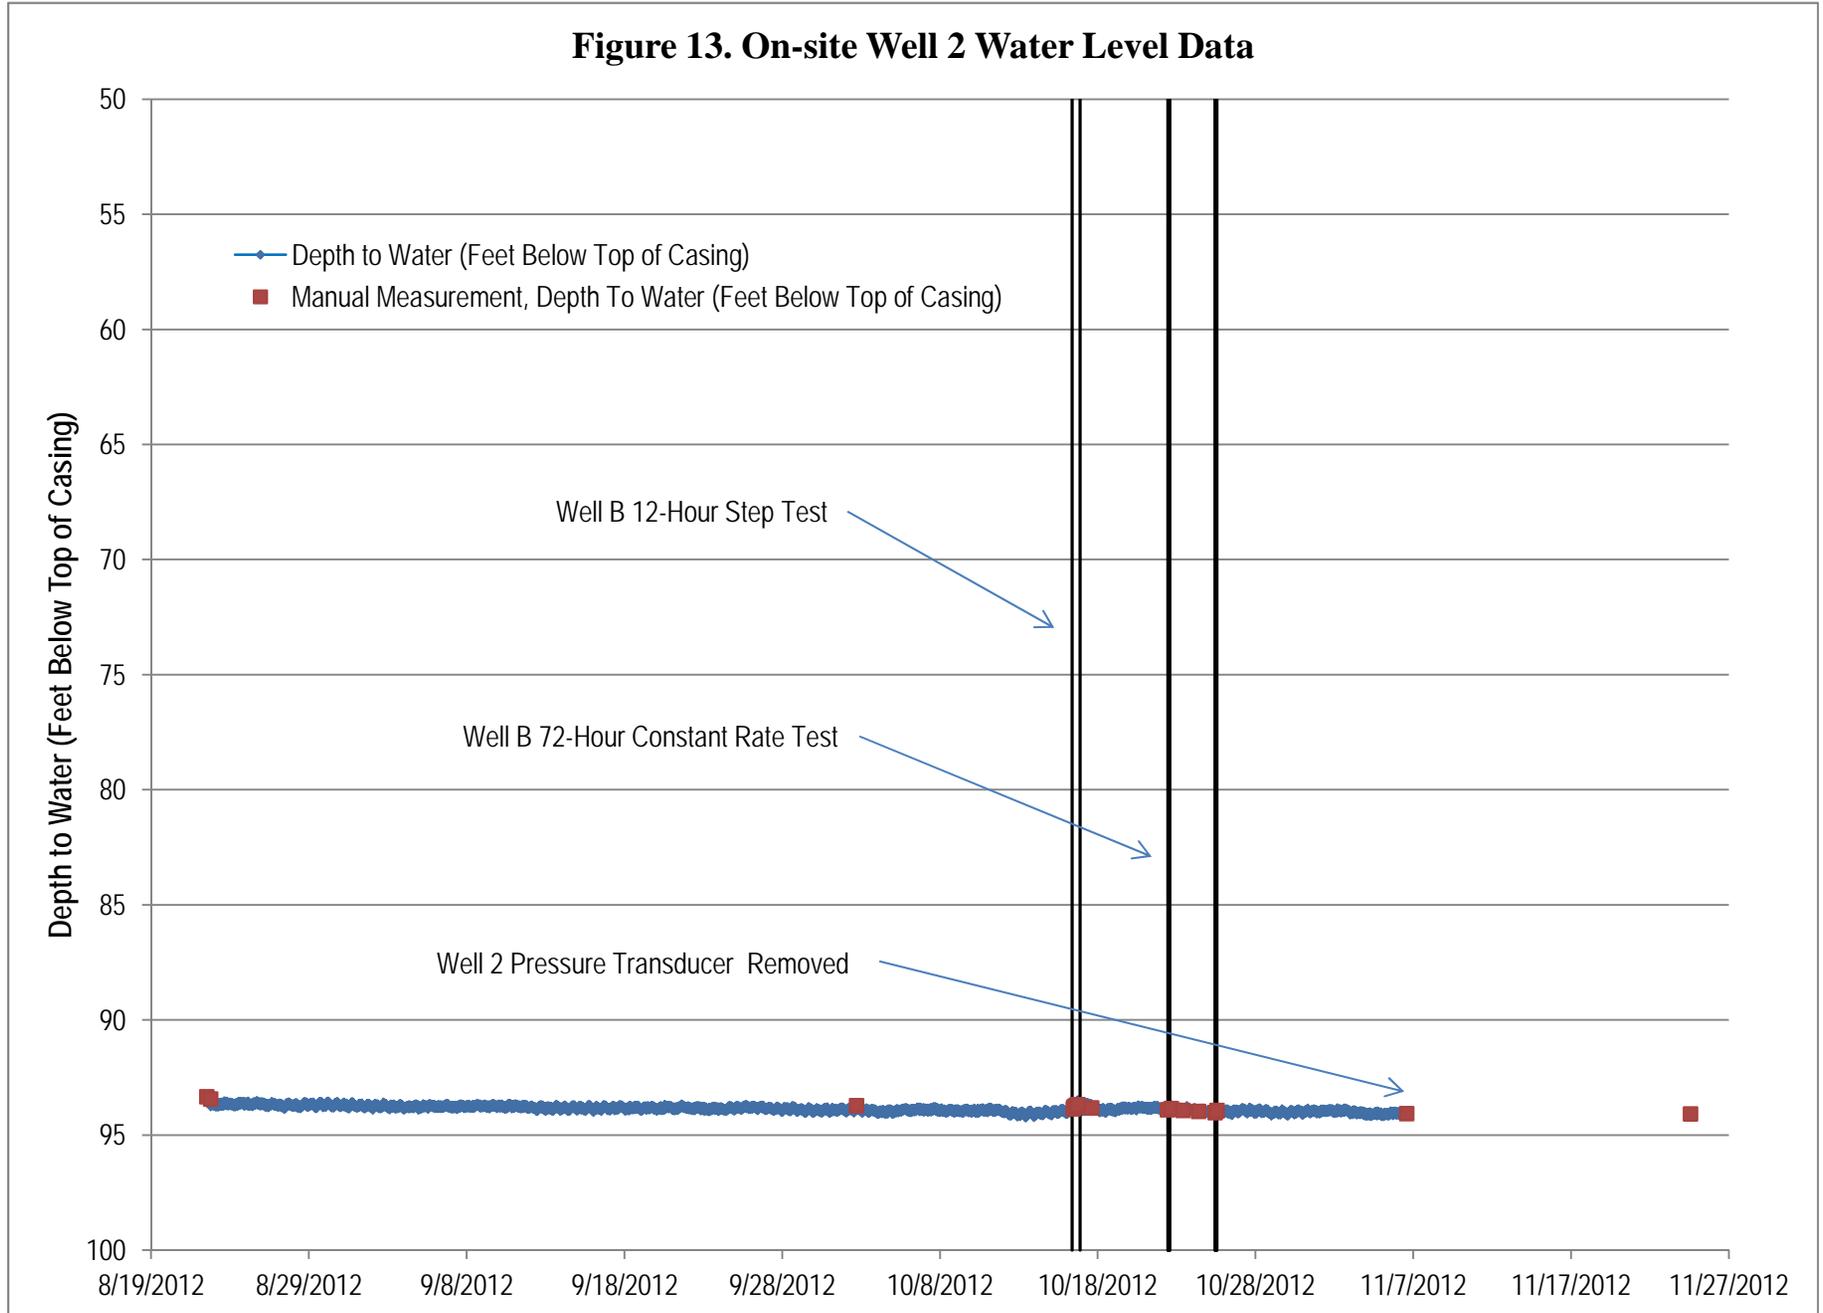
Figure 13. On-site Well 2 Water Level Data

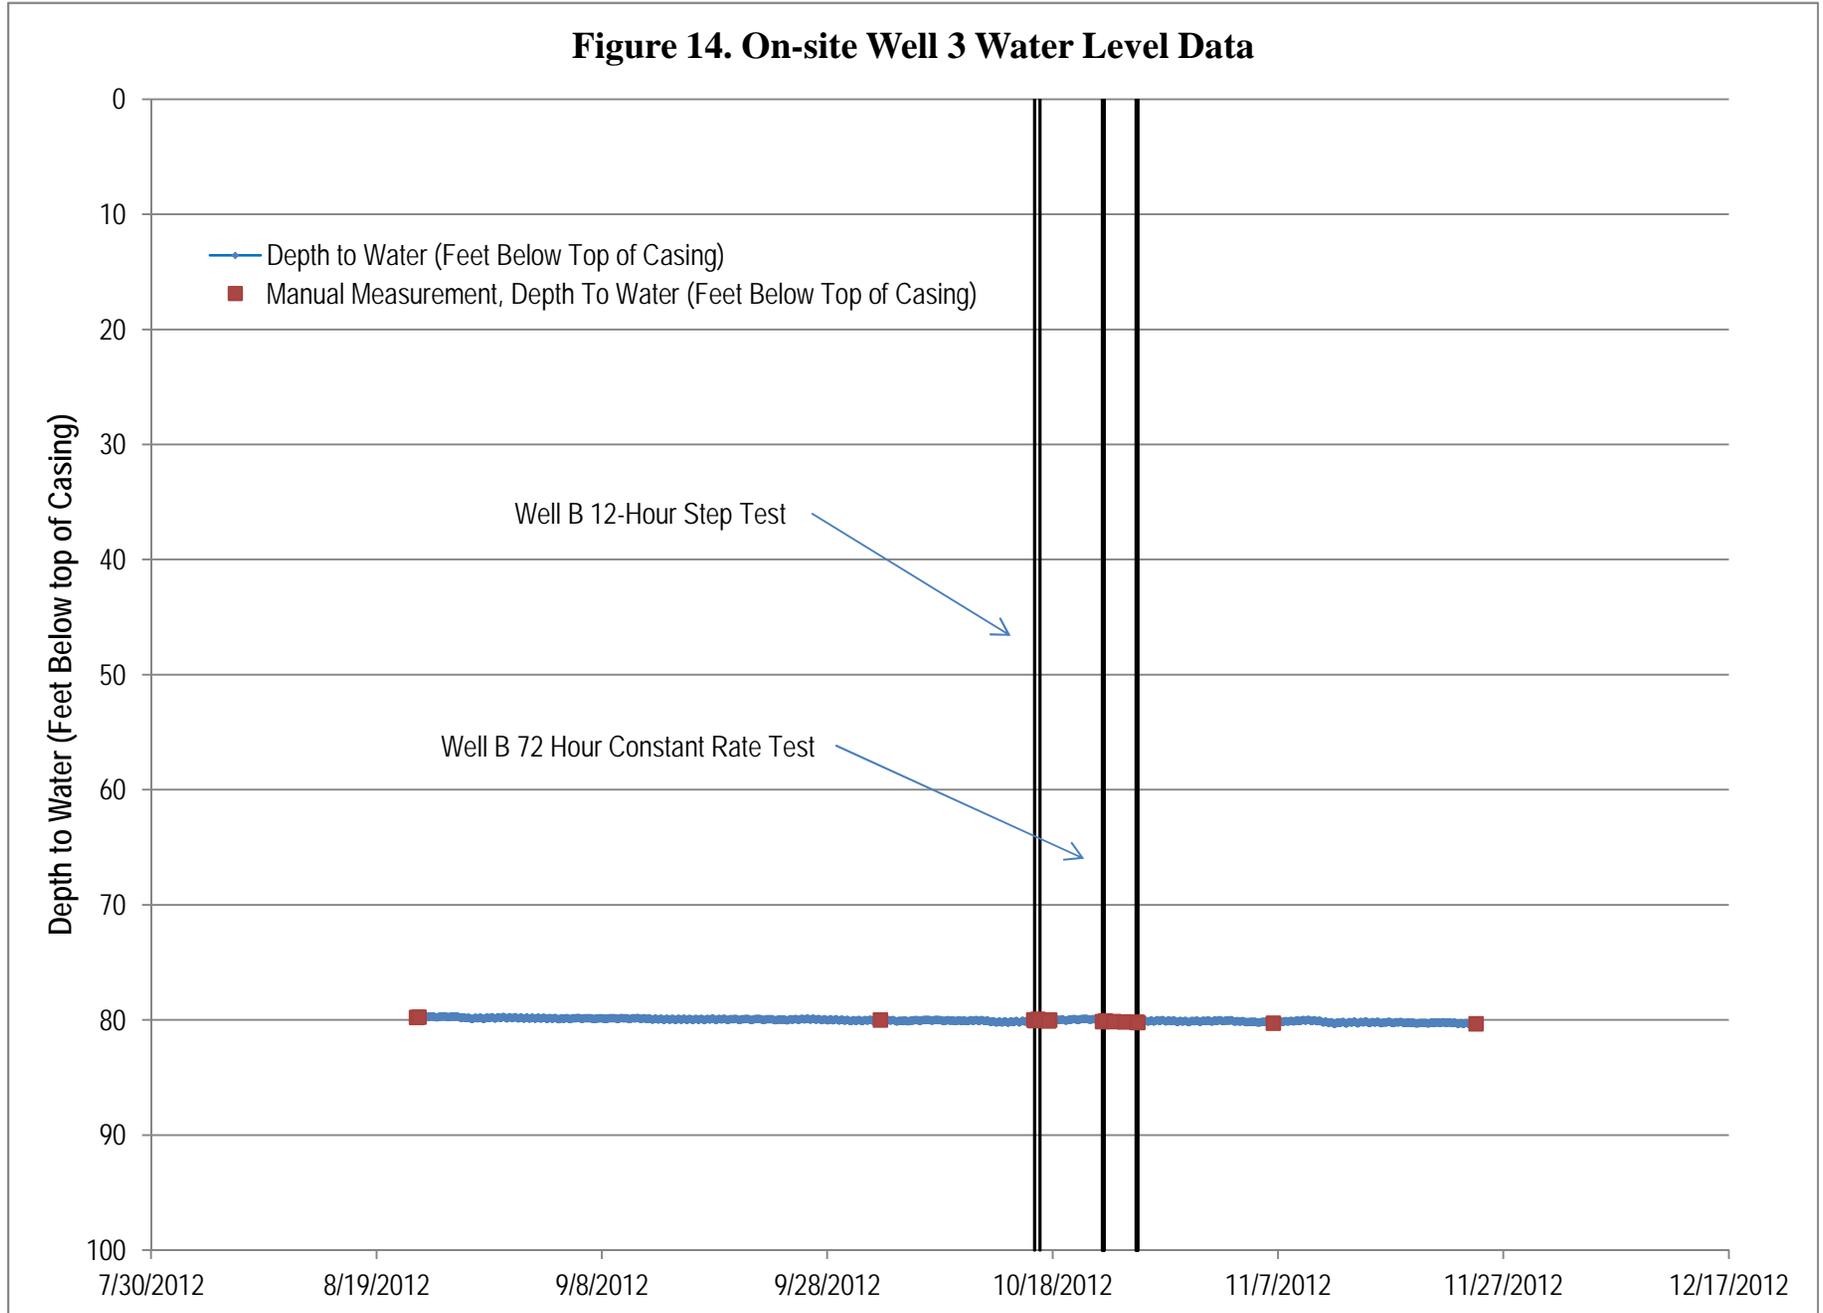
Figure 14. On-site Well 3 Water Level Data

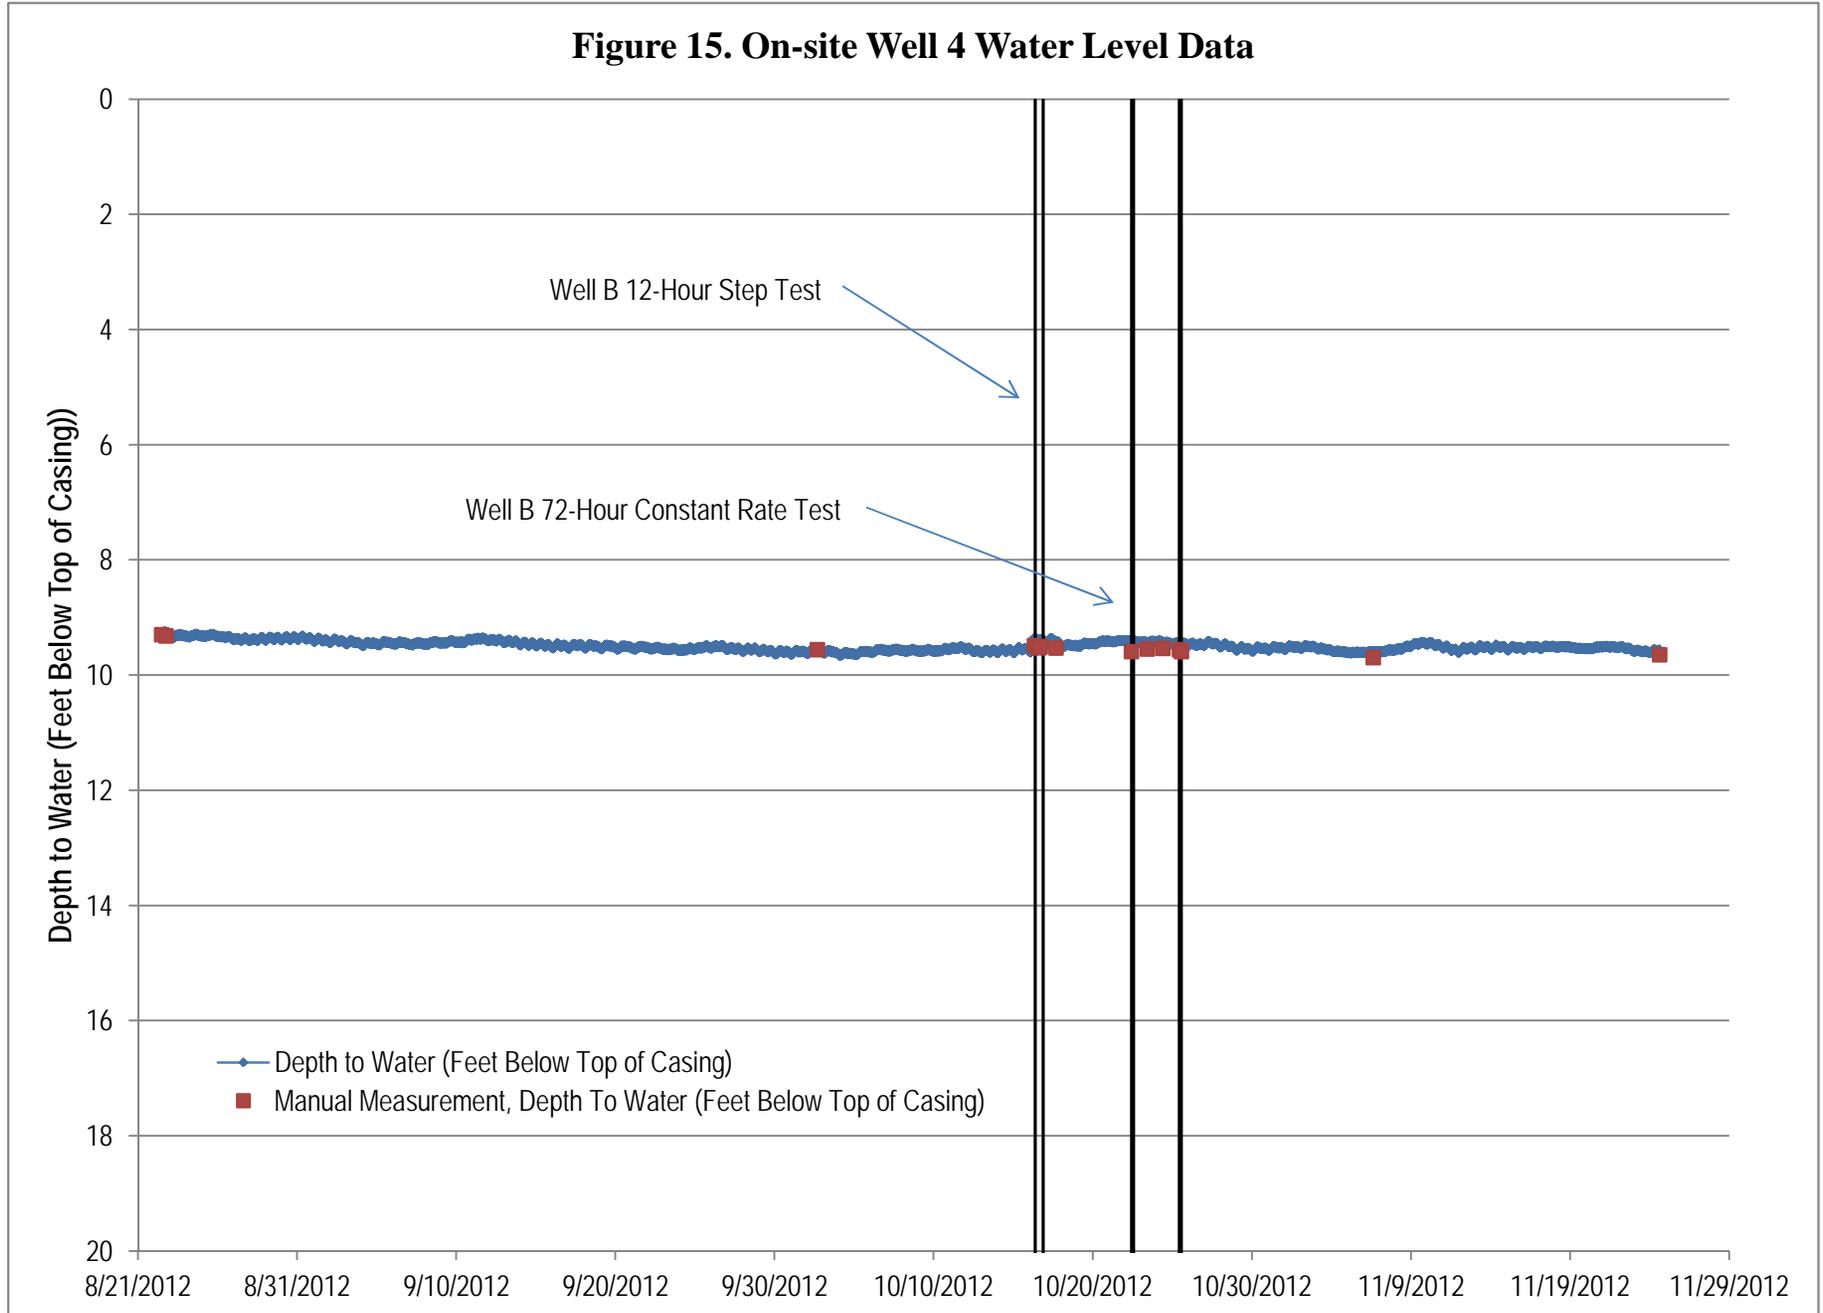
Figure 15. On-site Well 4 Water Level Data

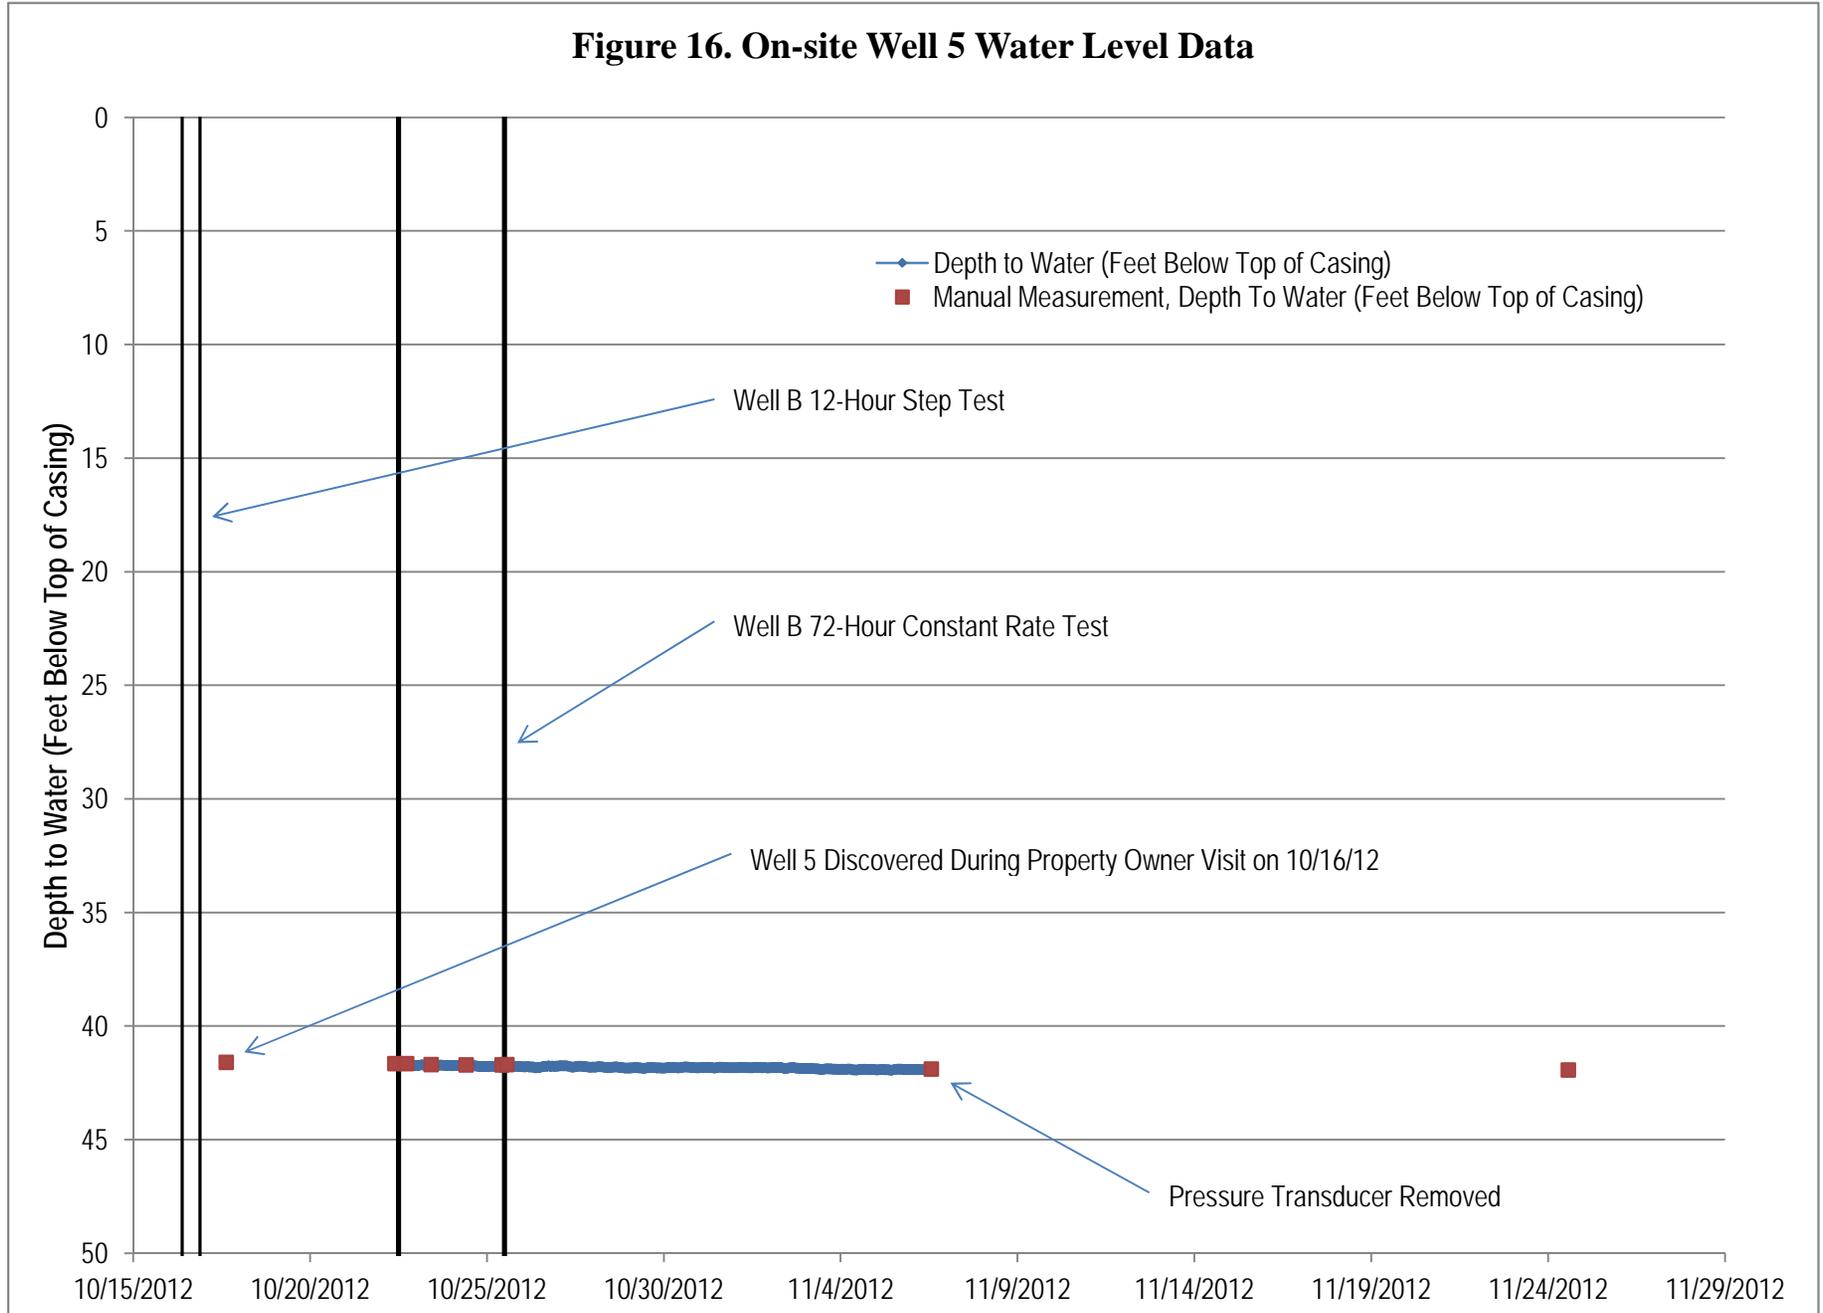
Figure 16. On-site Well 5 Water Level Data

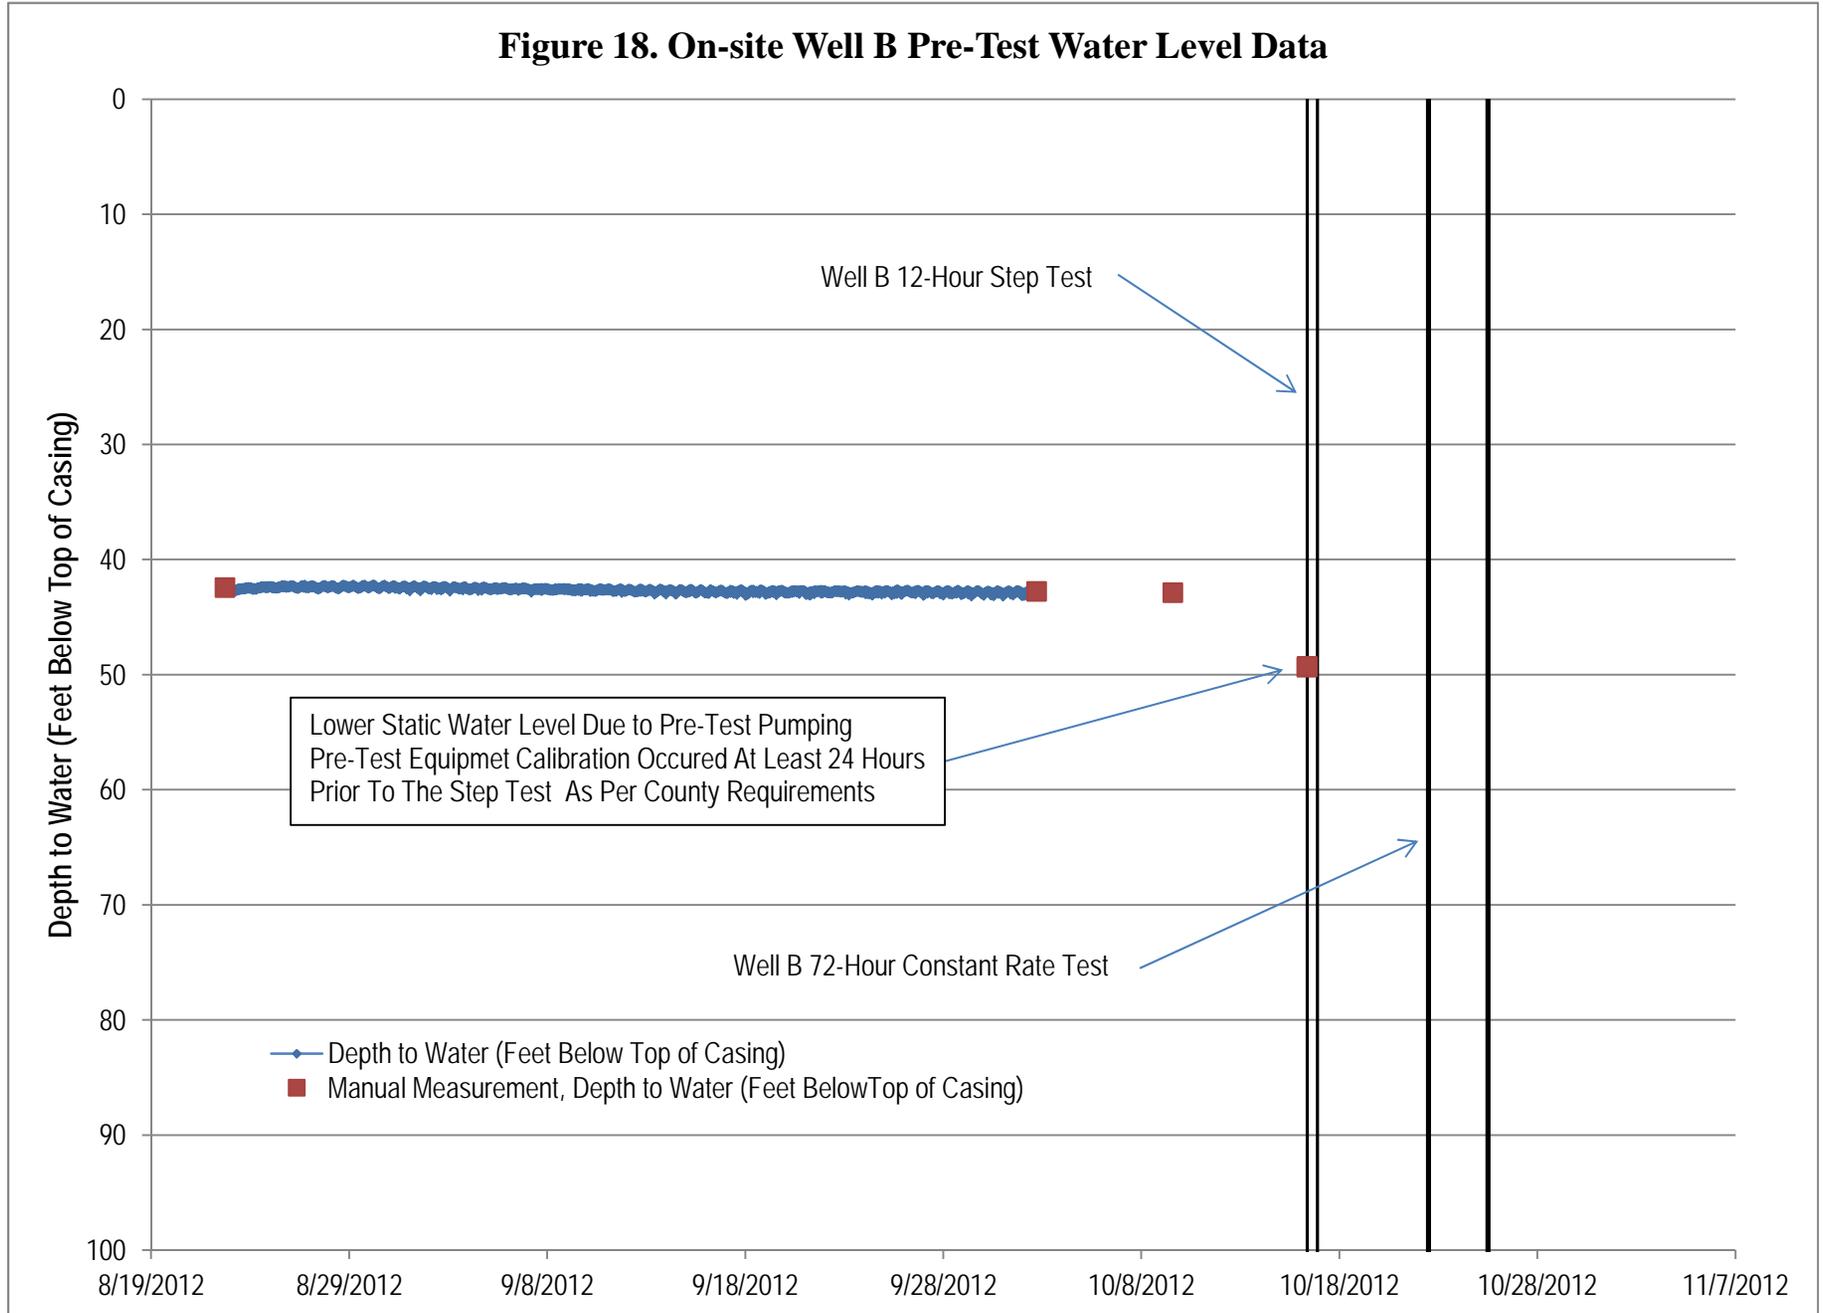
Figure 18. On-site Well B Pre-Test Water Level Data

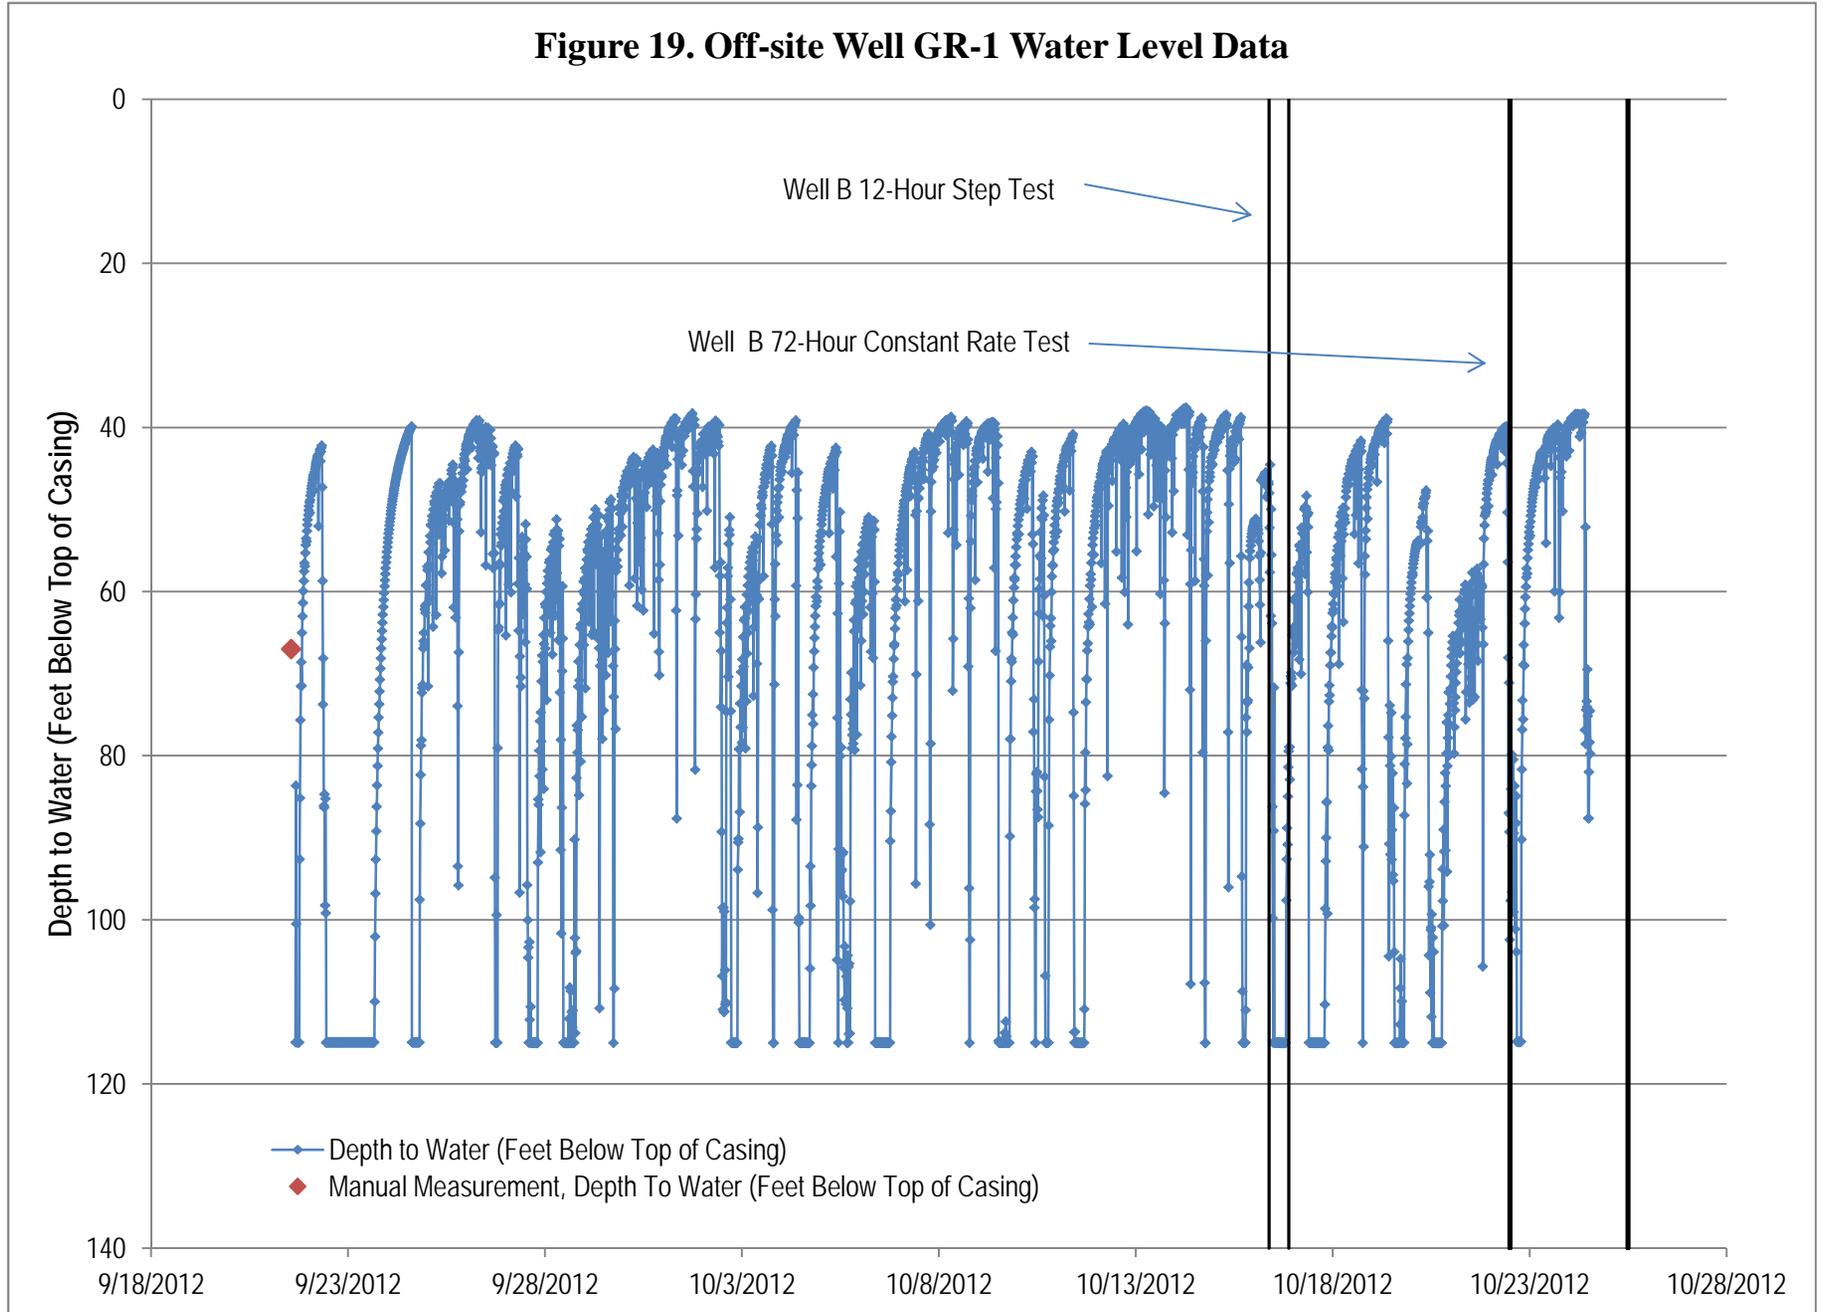
Figure 19. Off-site Well GR-1 Water Level Data

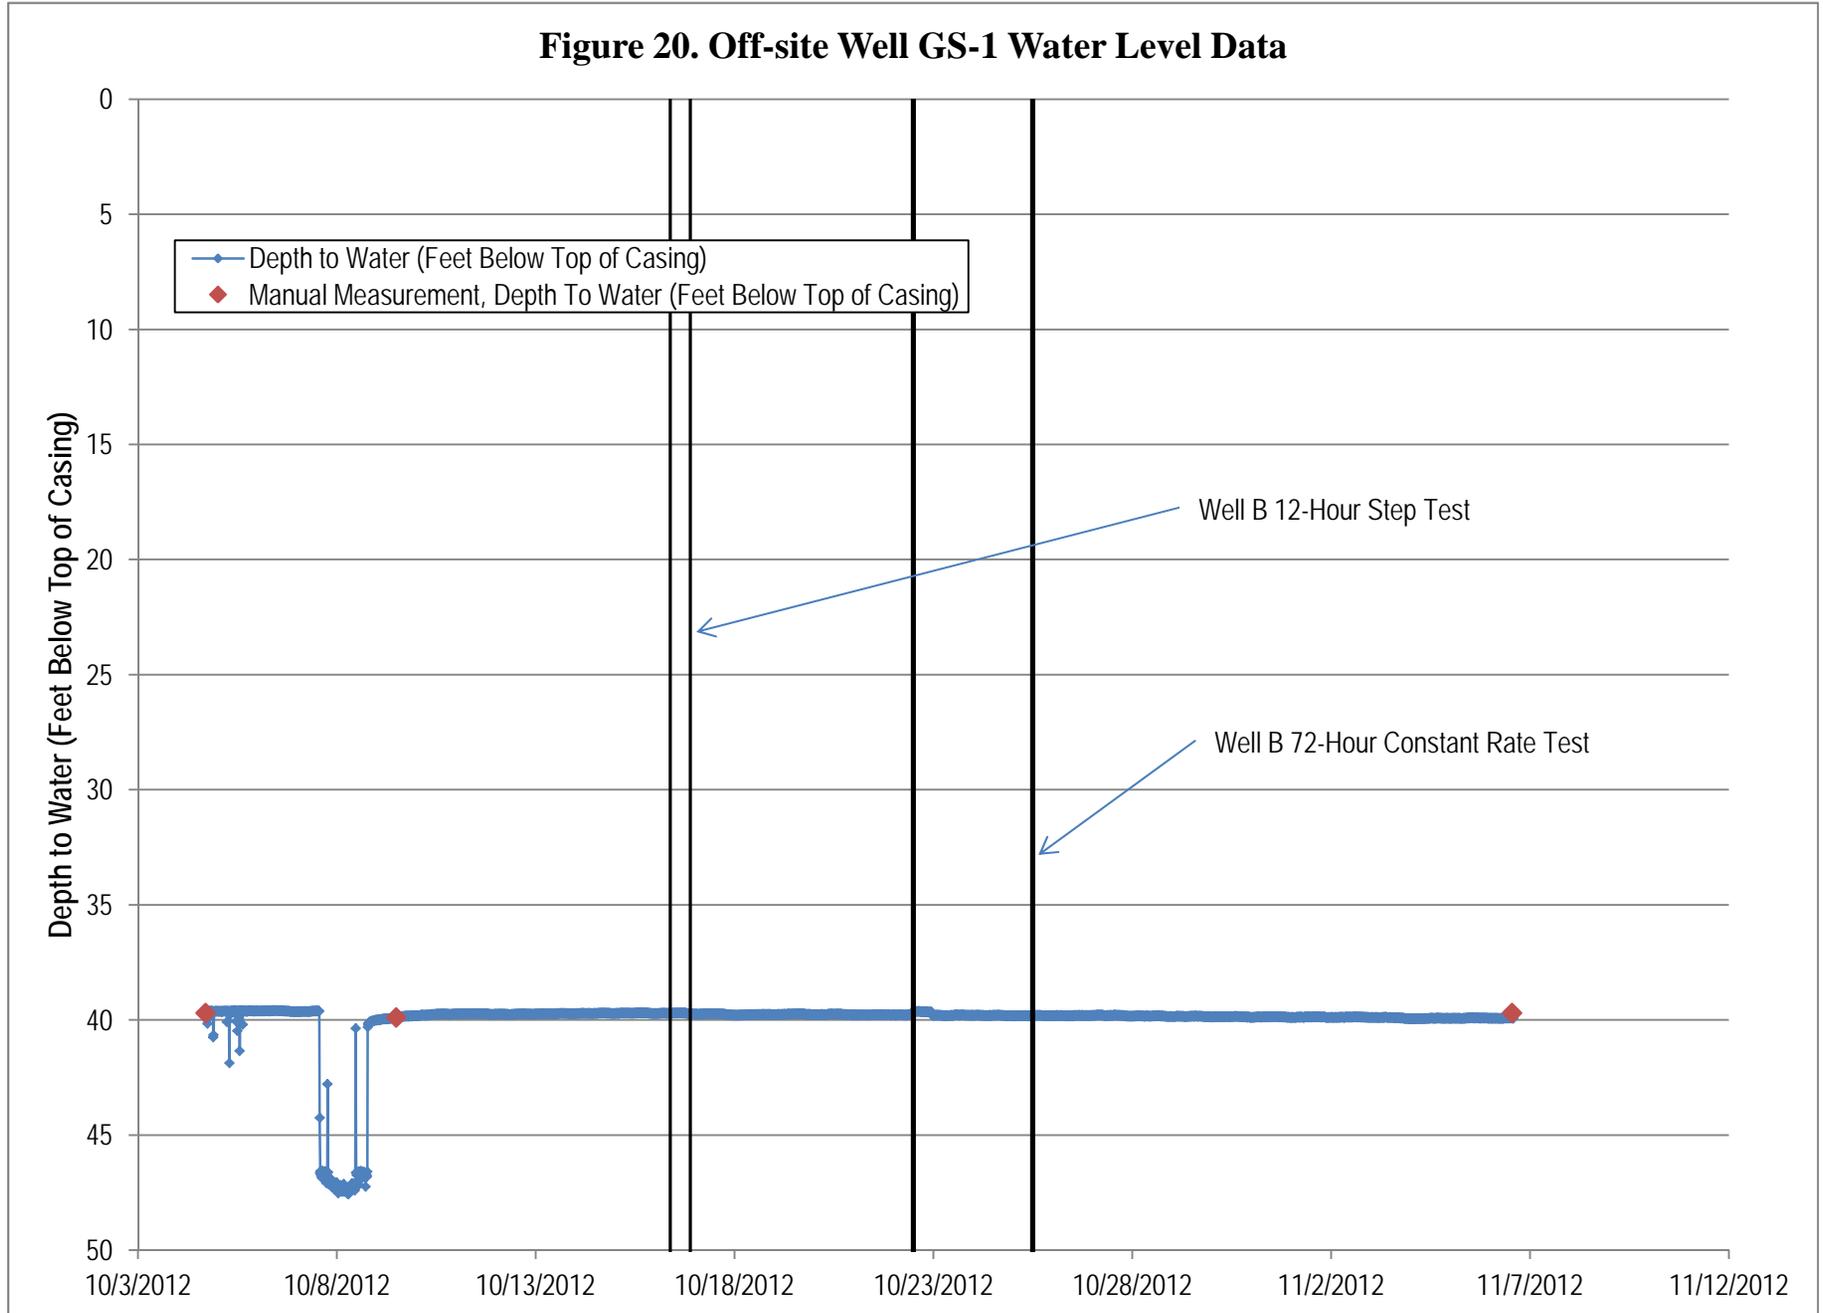
Figure 20. Off-site Well GS-1 Water Level Data

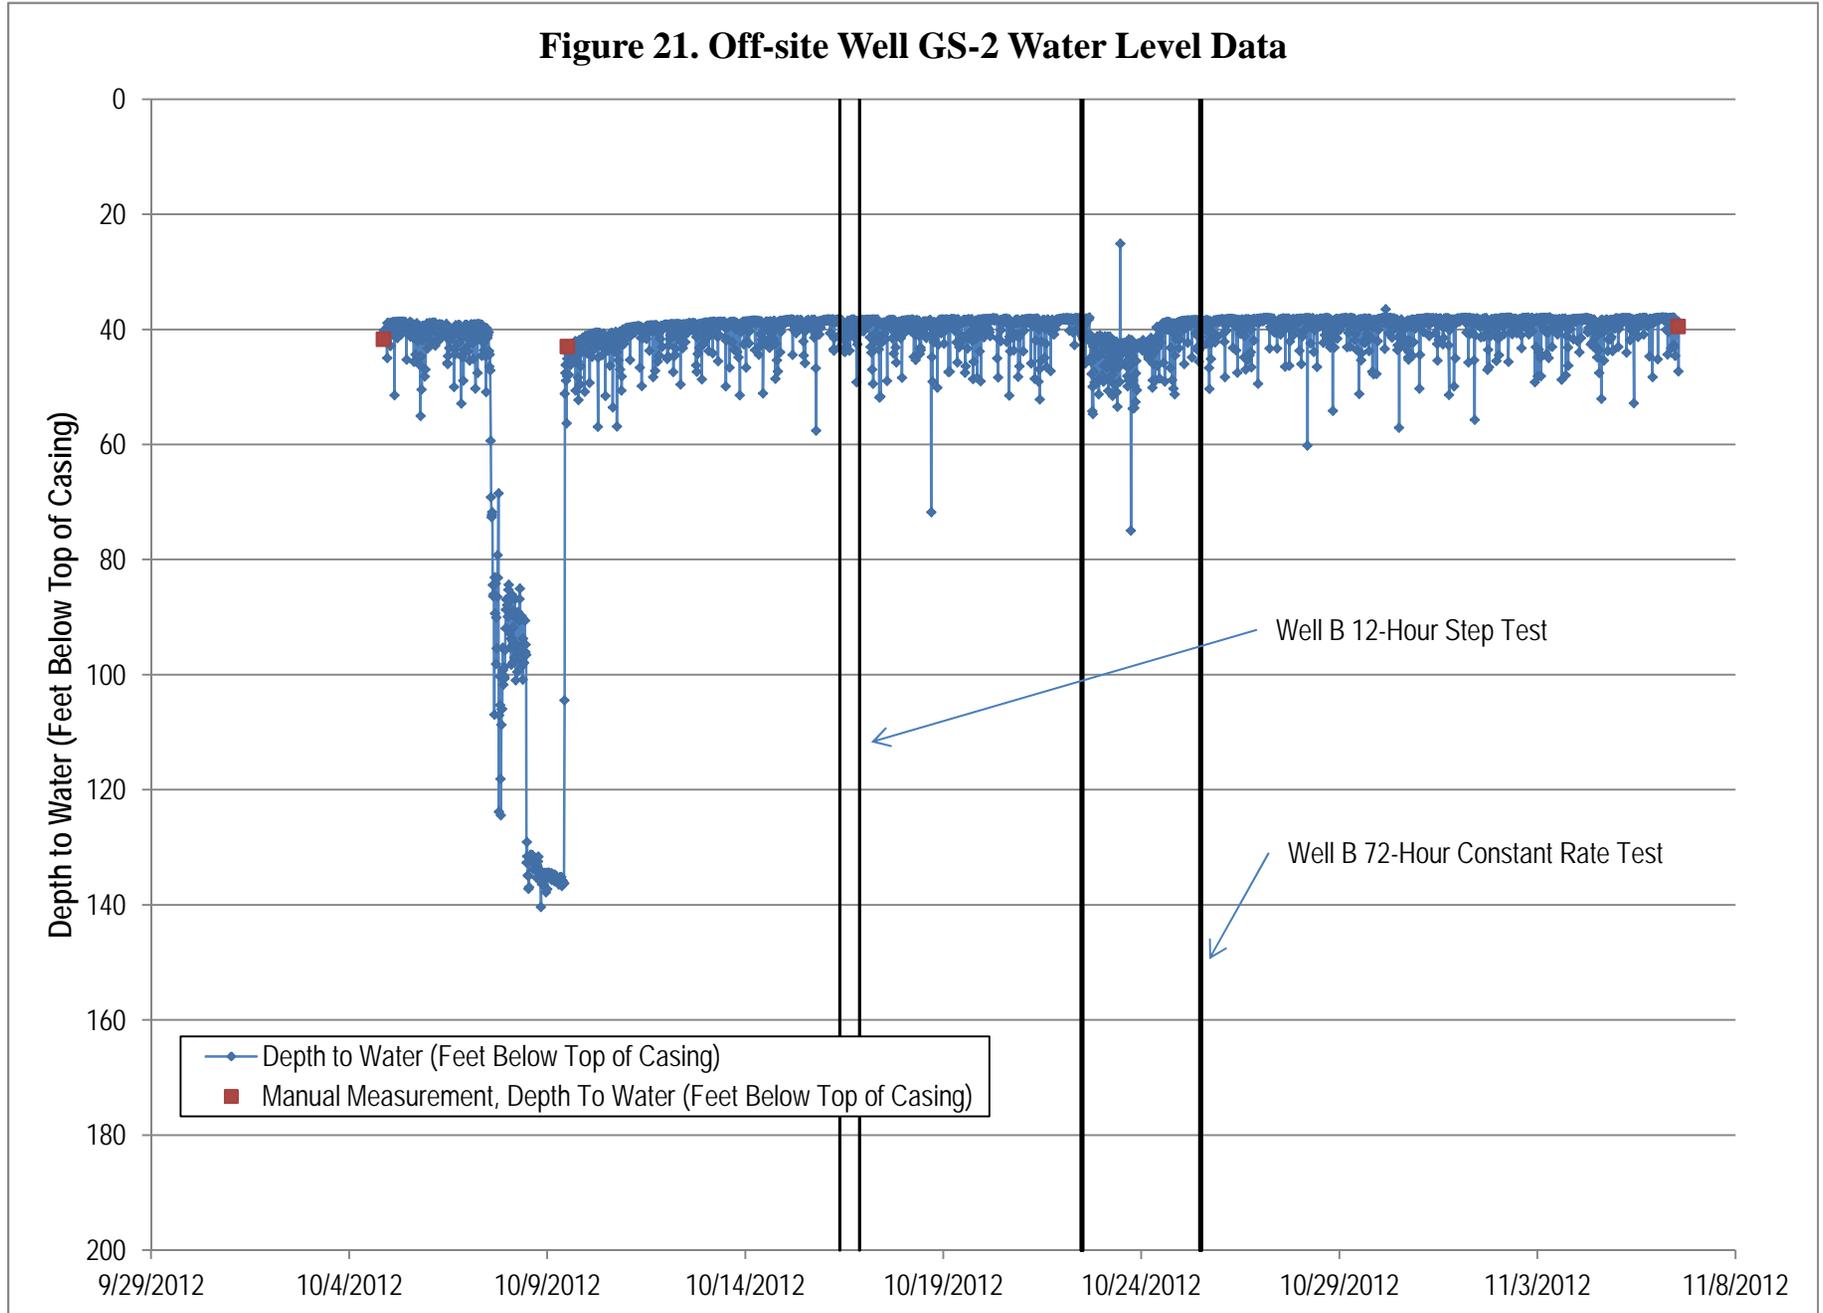
Figure 21. Off-site Well GS-2 Water Level Data
