Groundwater Resources Investigation Report Tierra del Sol Solar Farm Project

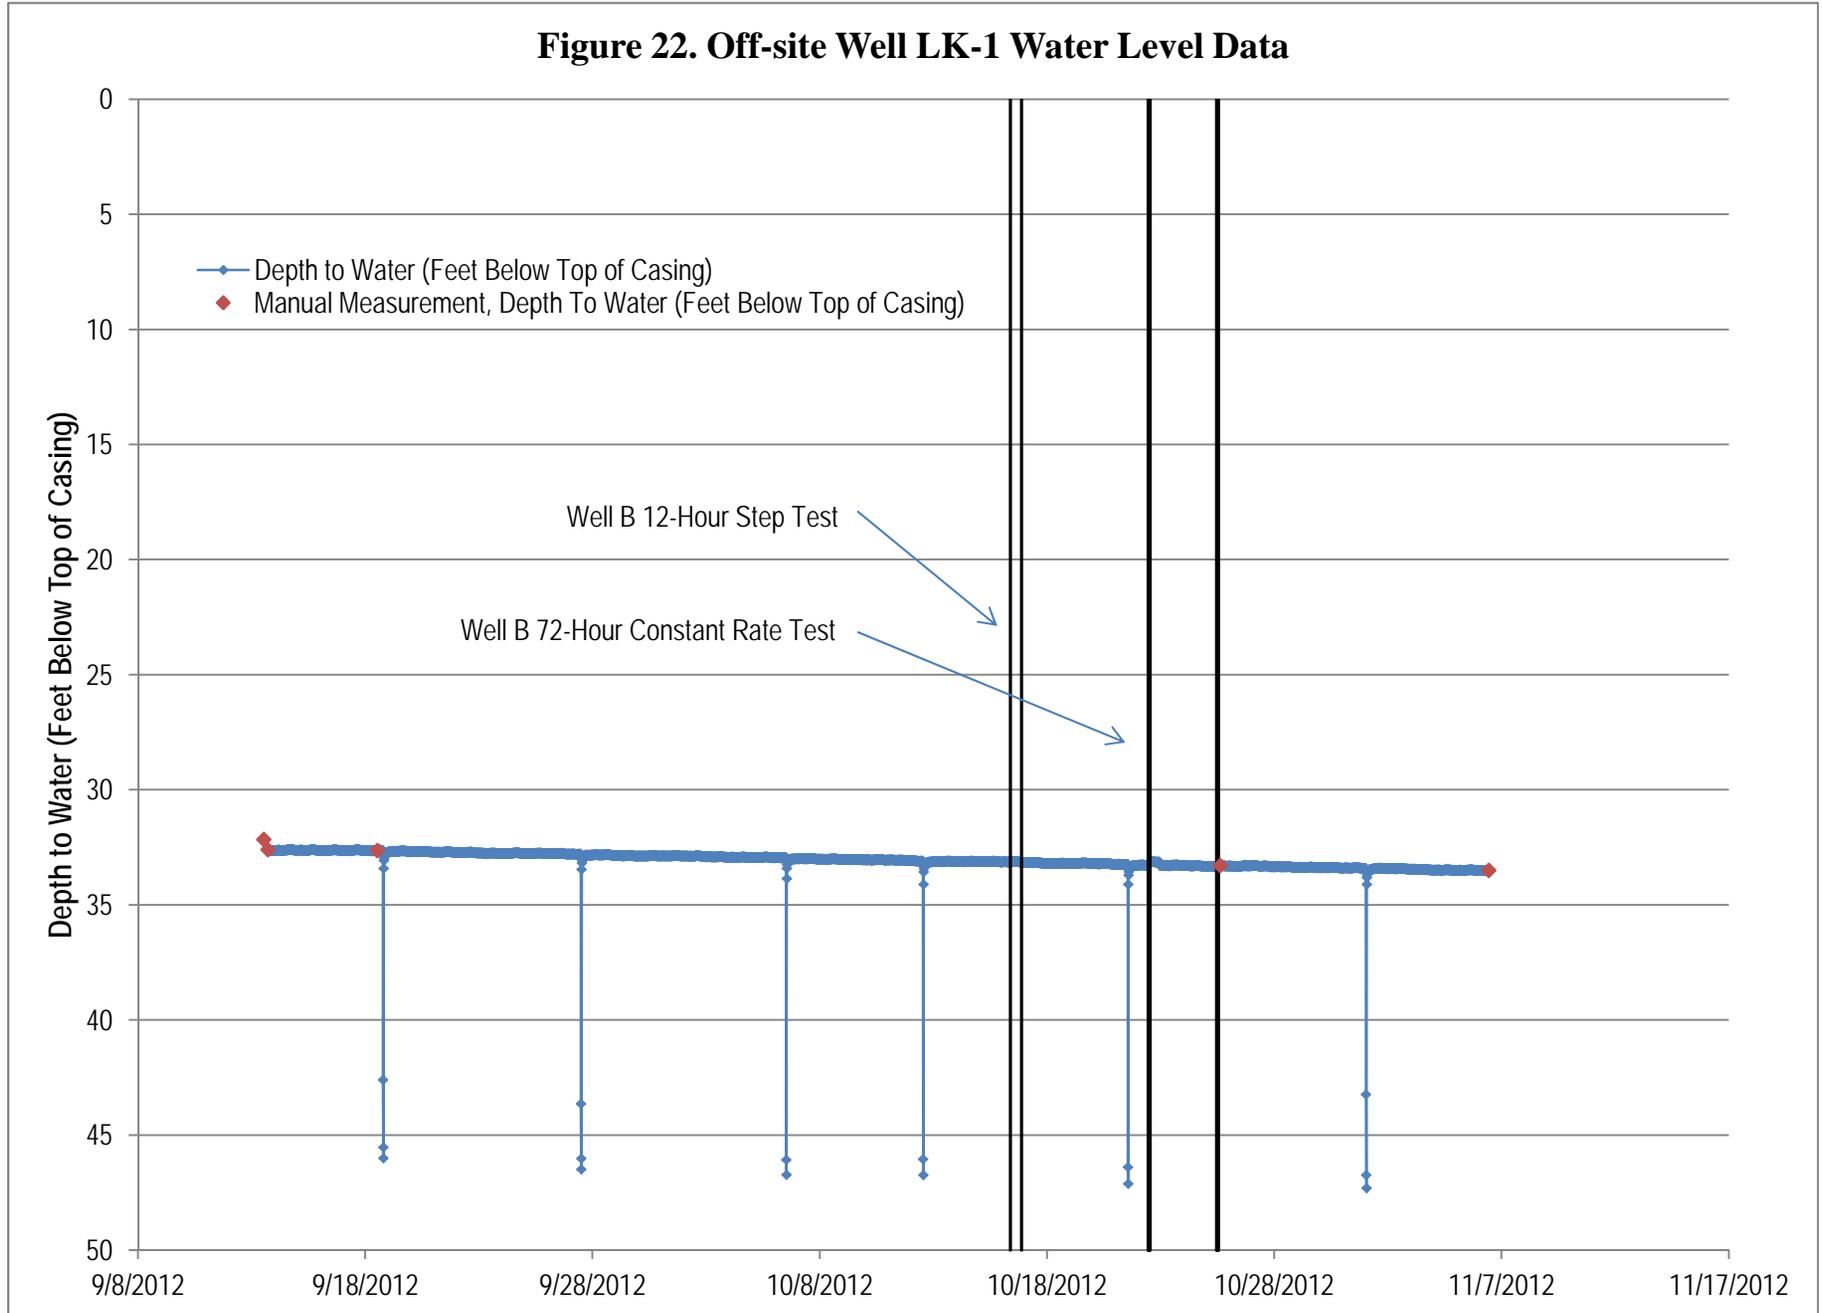
Figure 22. Off-site Well LK-1 Water Level Data

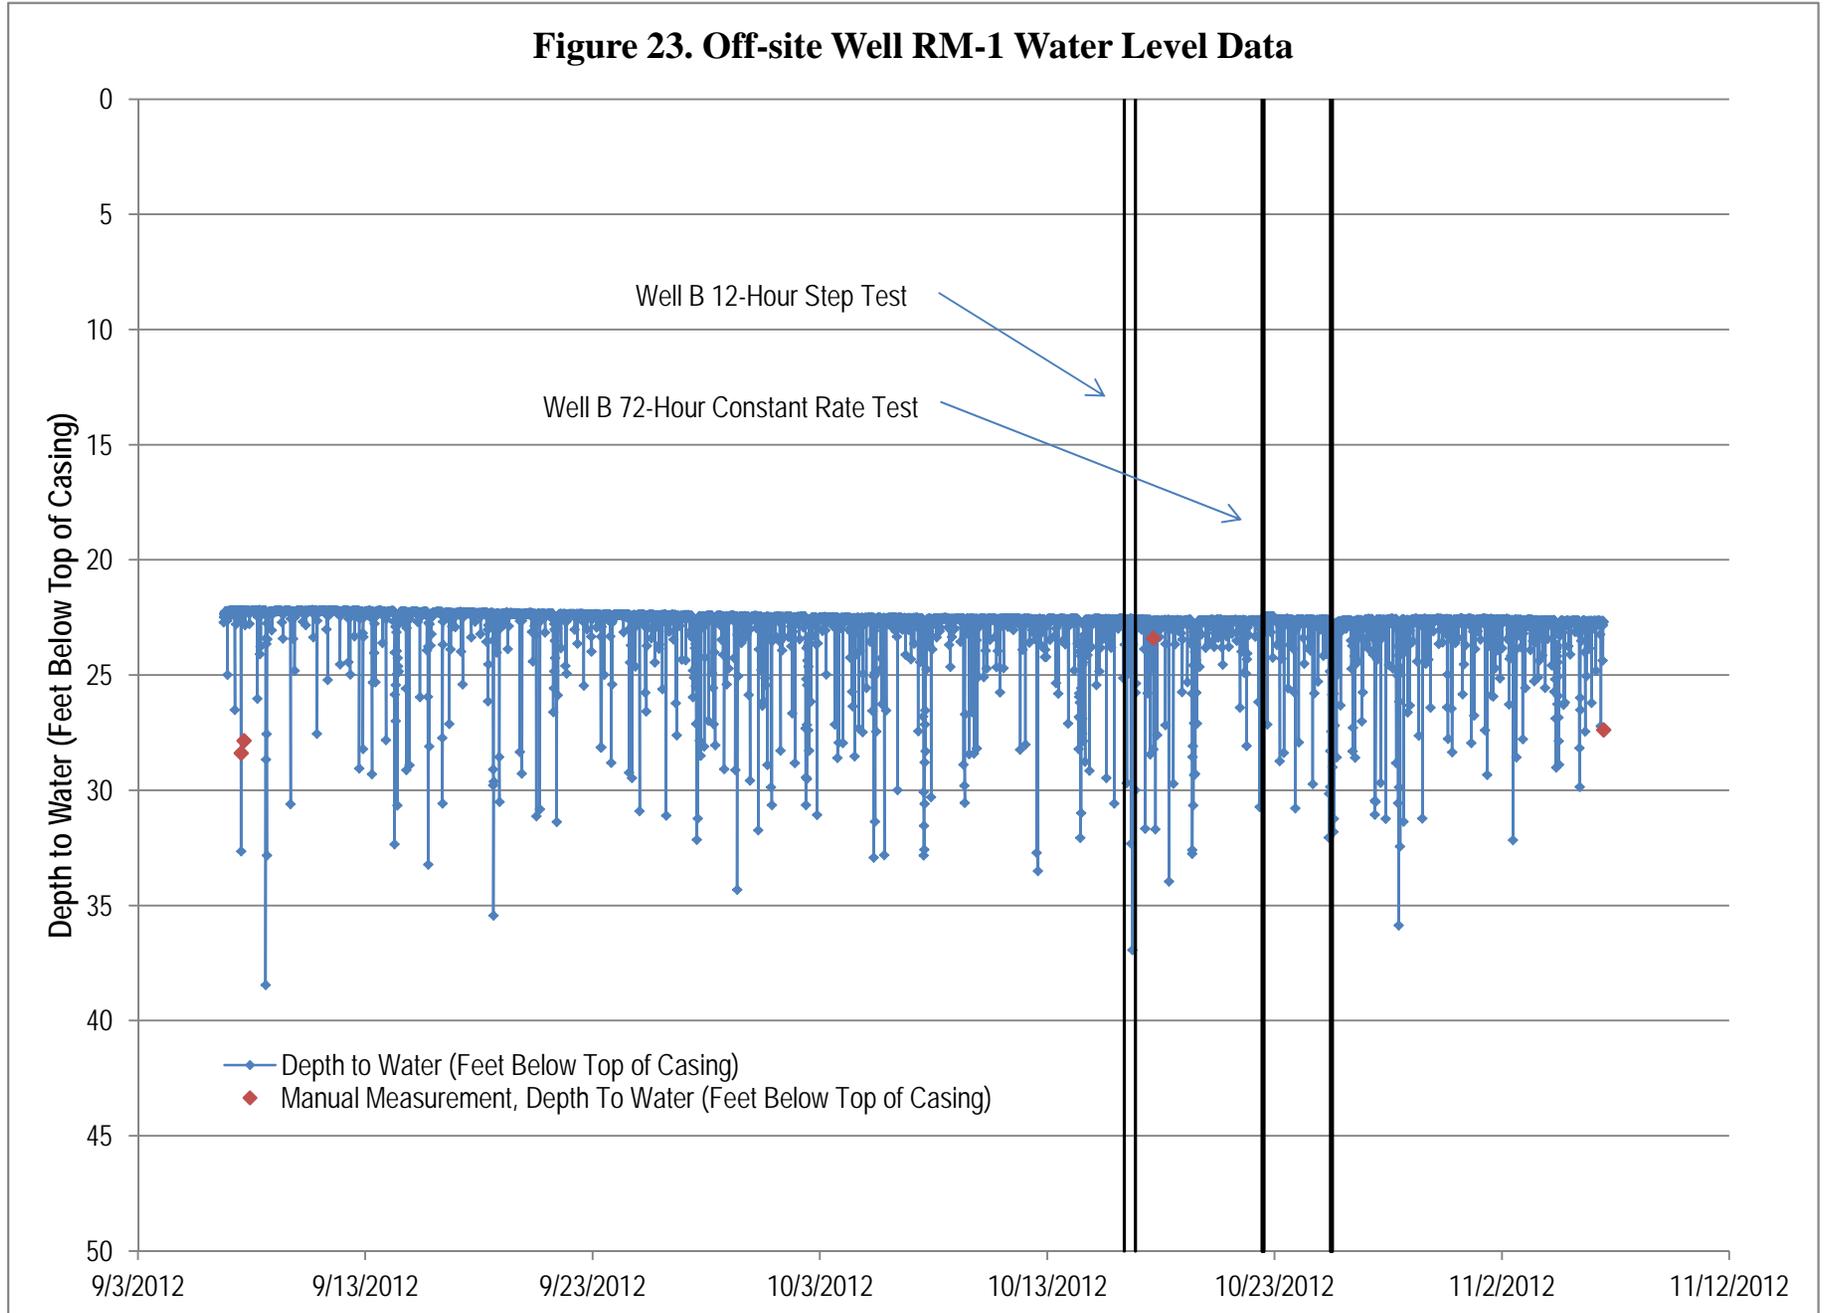
Figure 23. Off-site Well RM-1 Water Level Data

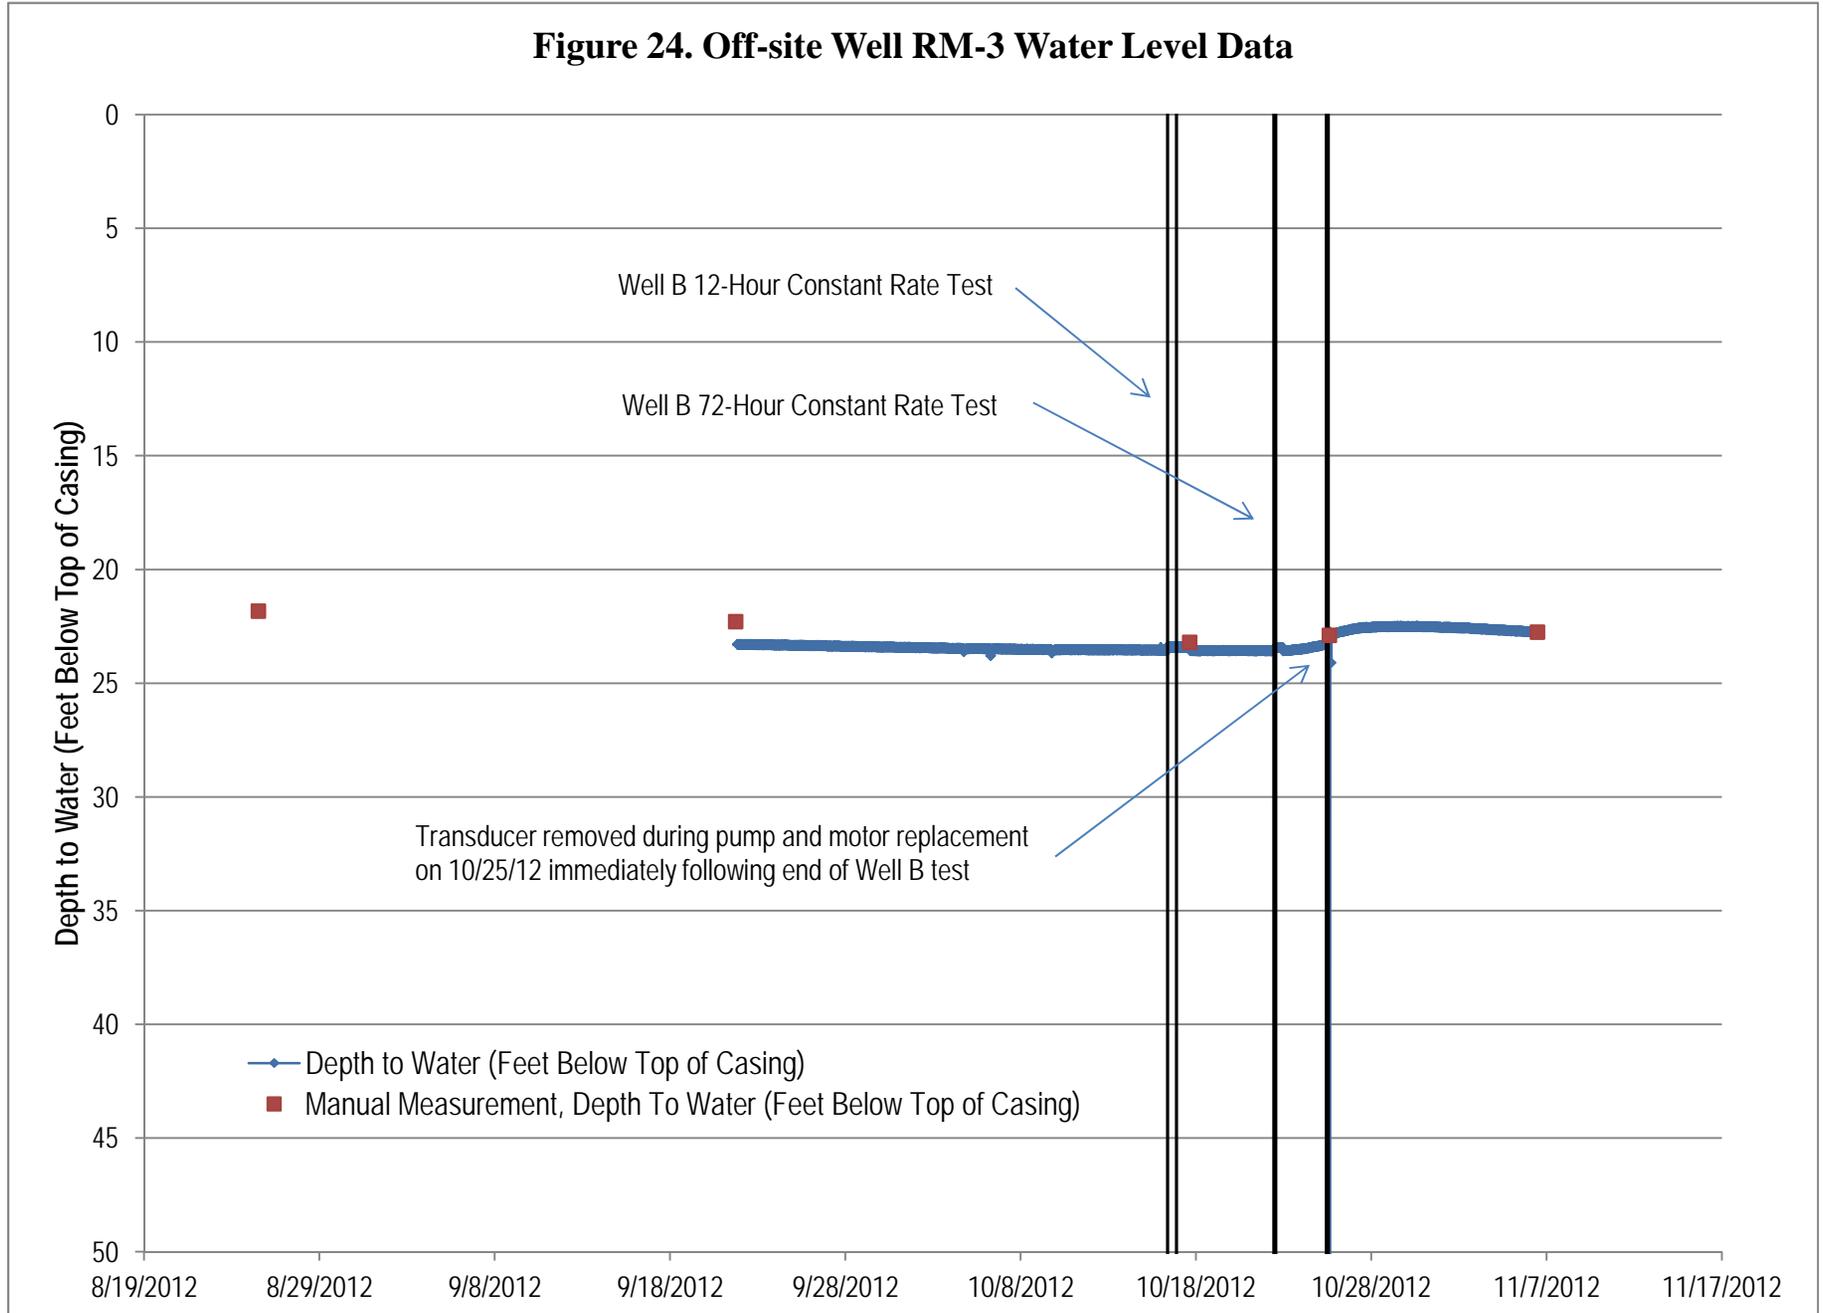
Figure 24. Off-site Well RM-3 Water Level Data

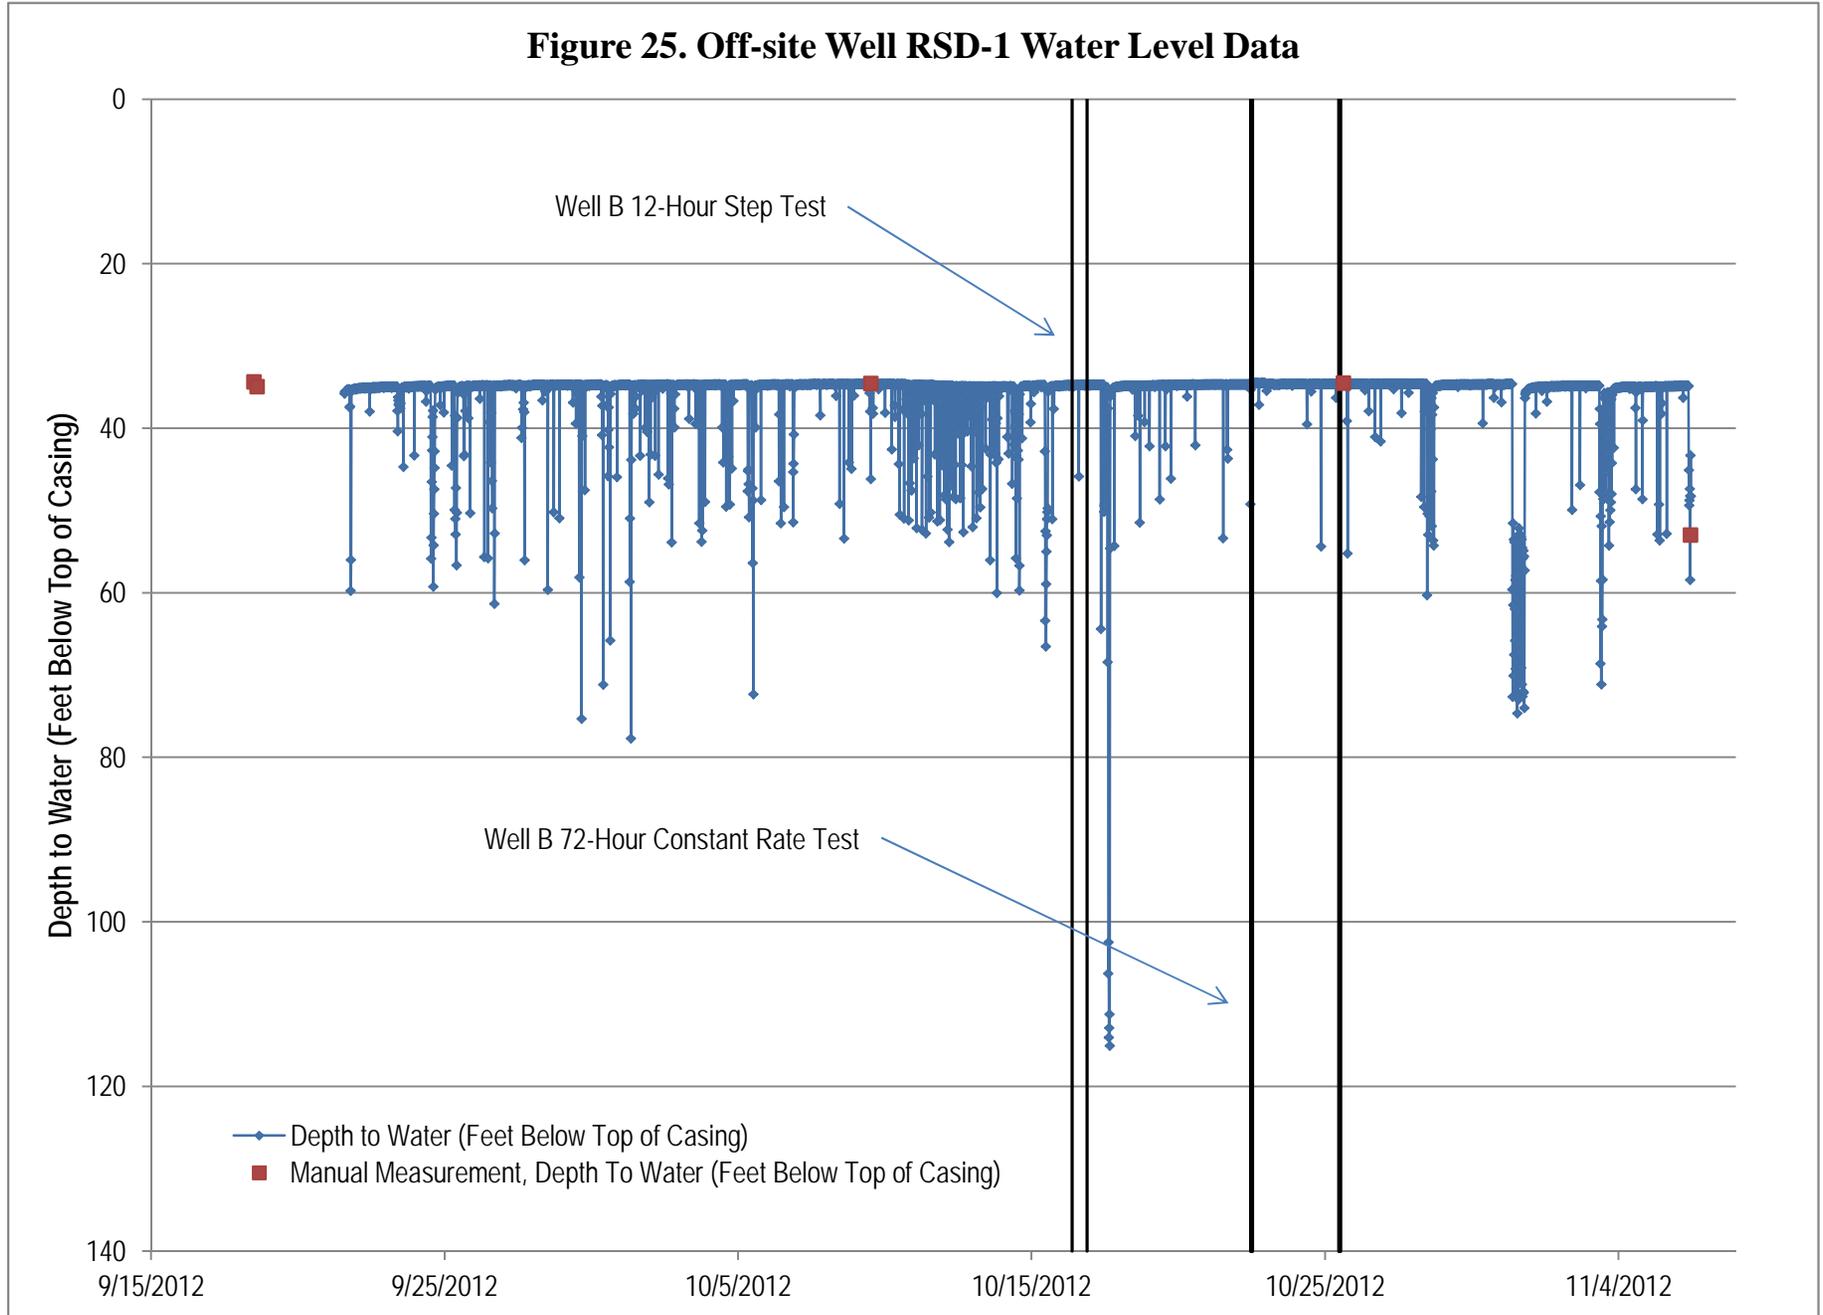
Figure 25. Off-site Well RSD-1 Water Level Data

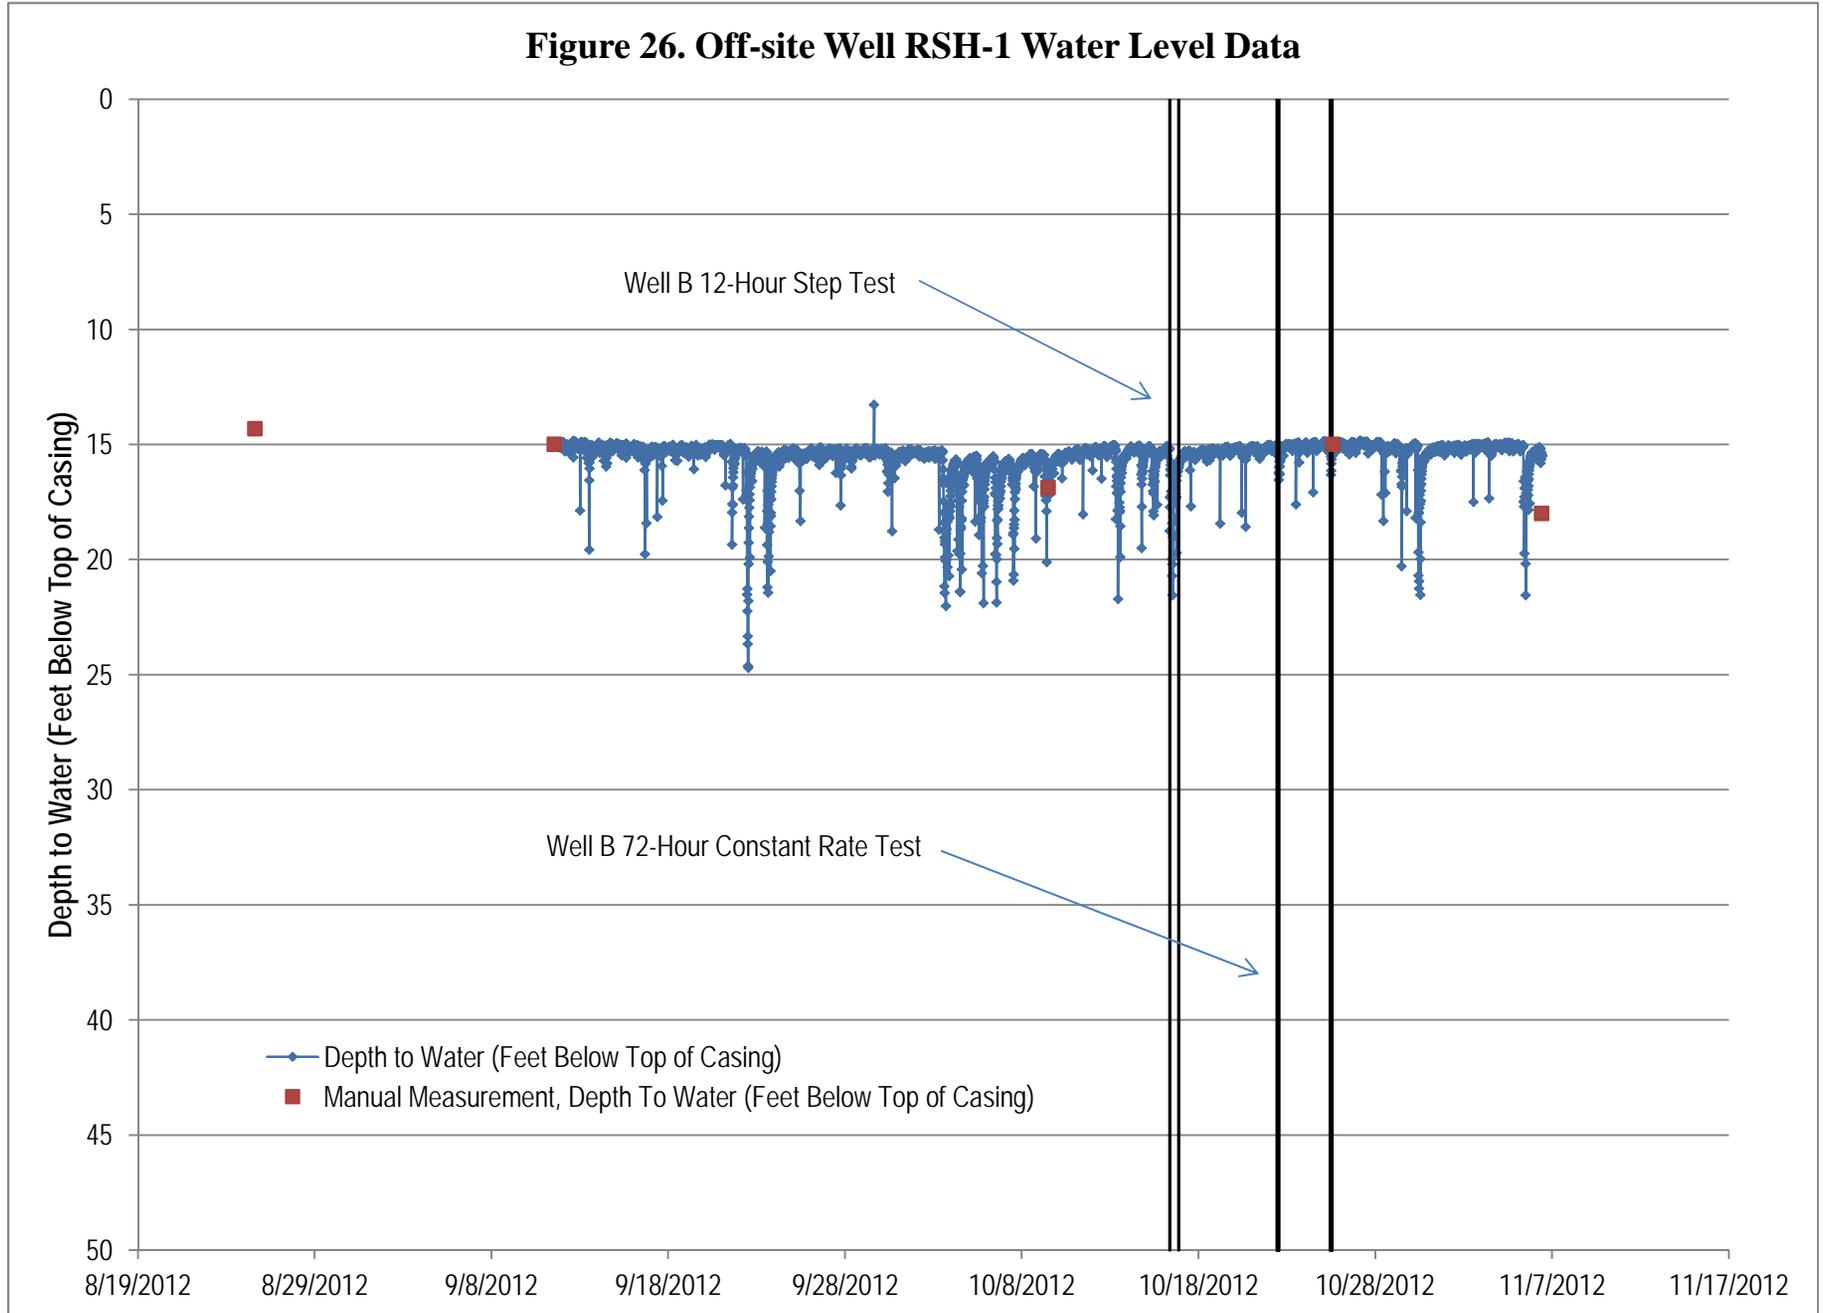
Figure 26. Off-site Well RSH-1 Water Level Data

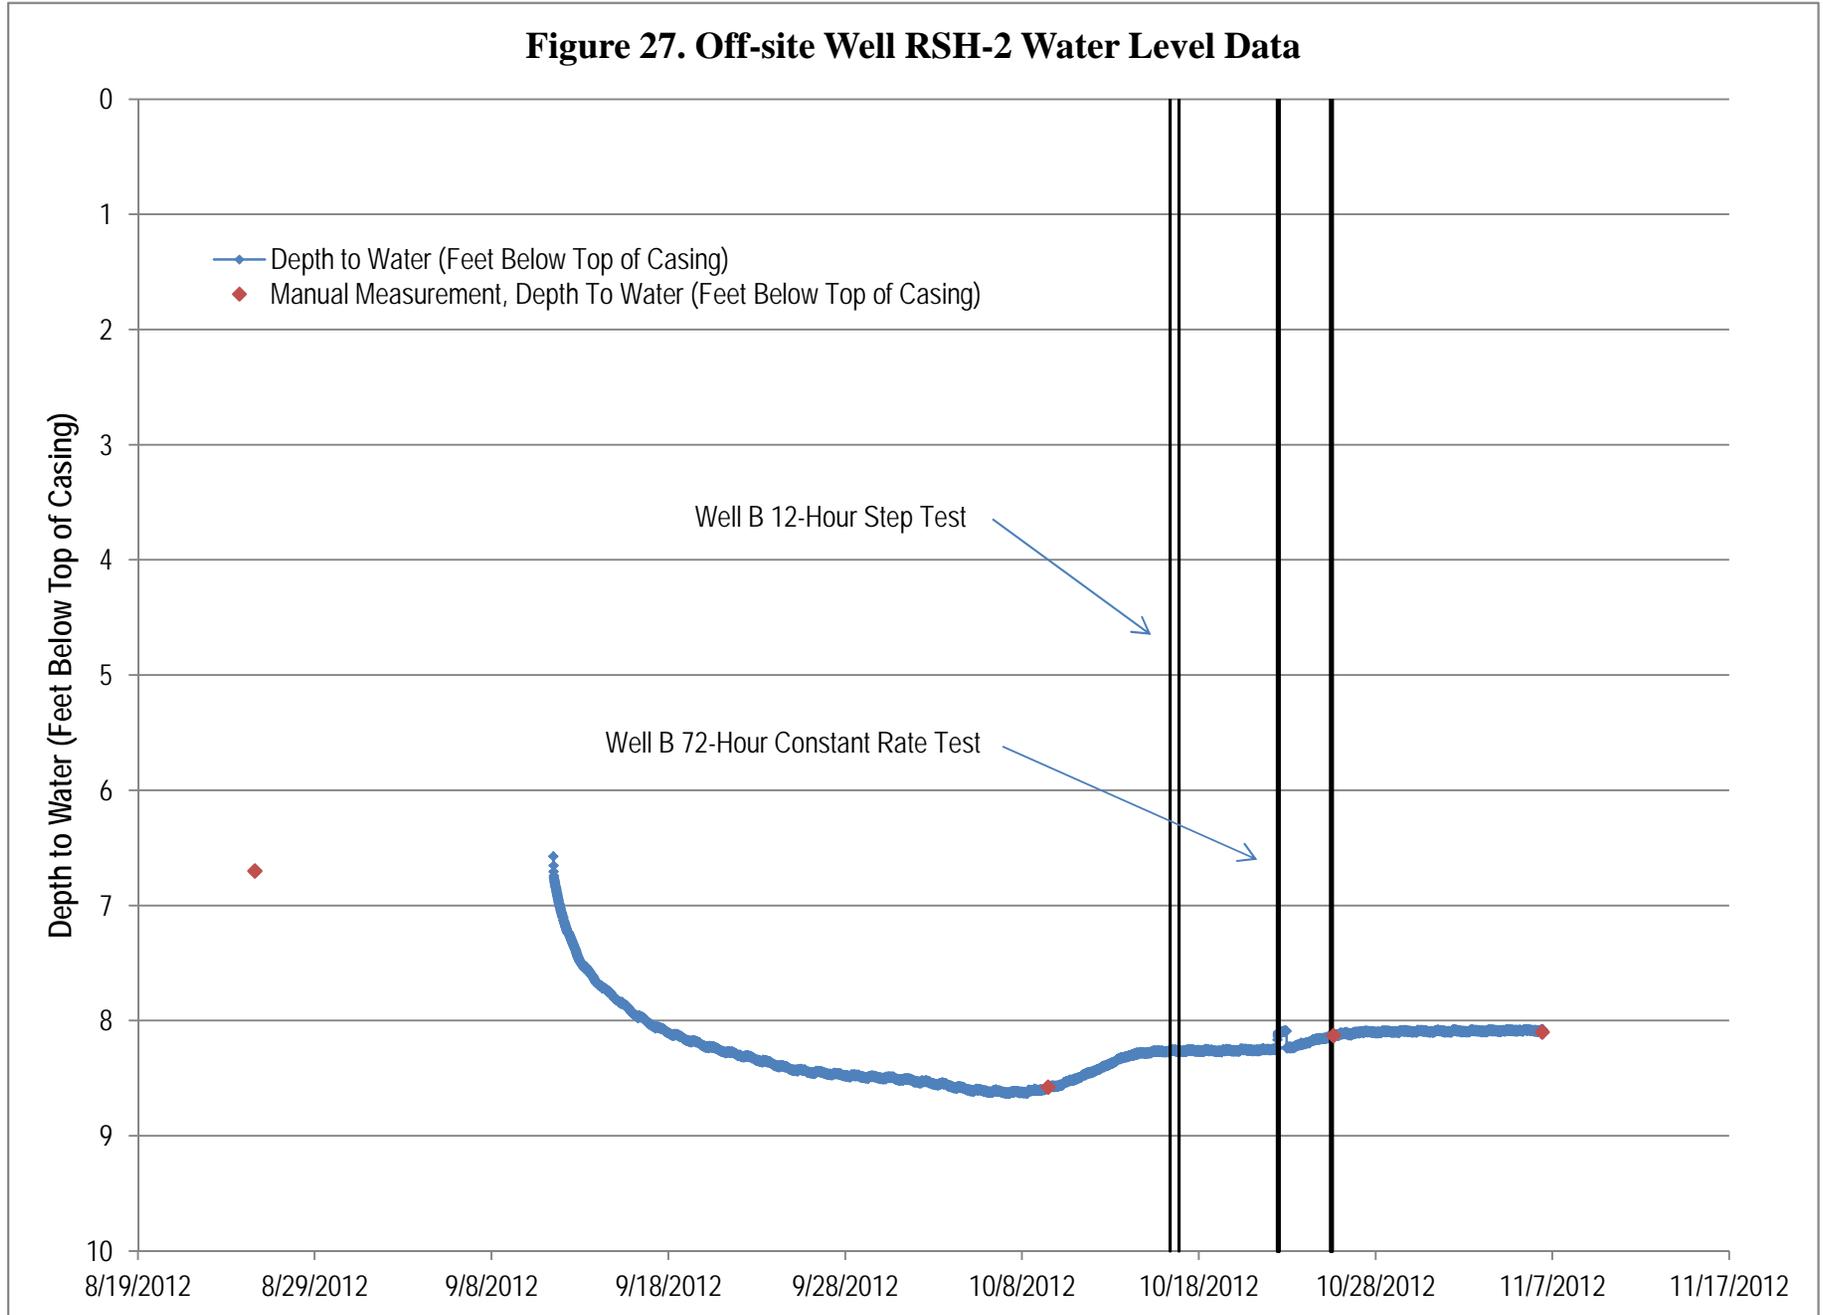
Figure 27. Off-site Well RSH-2 Water Level Data

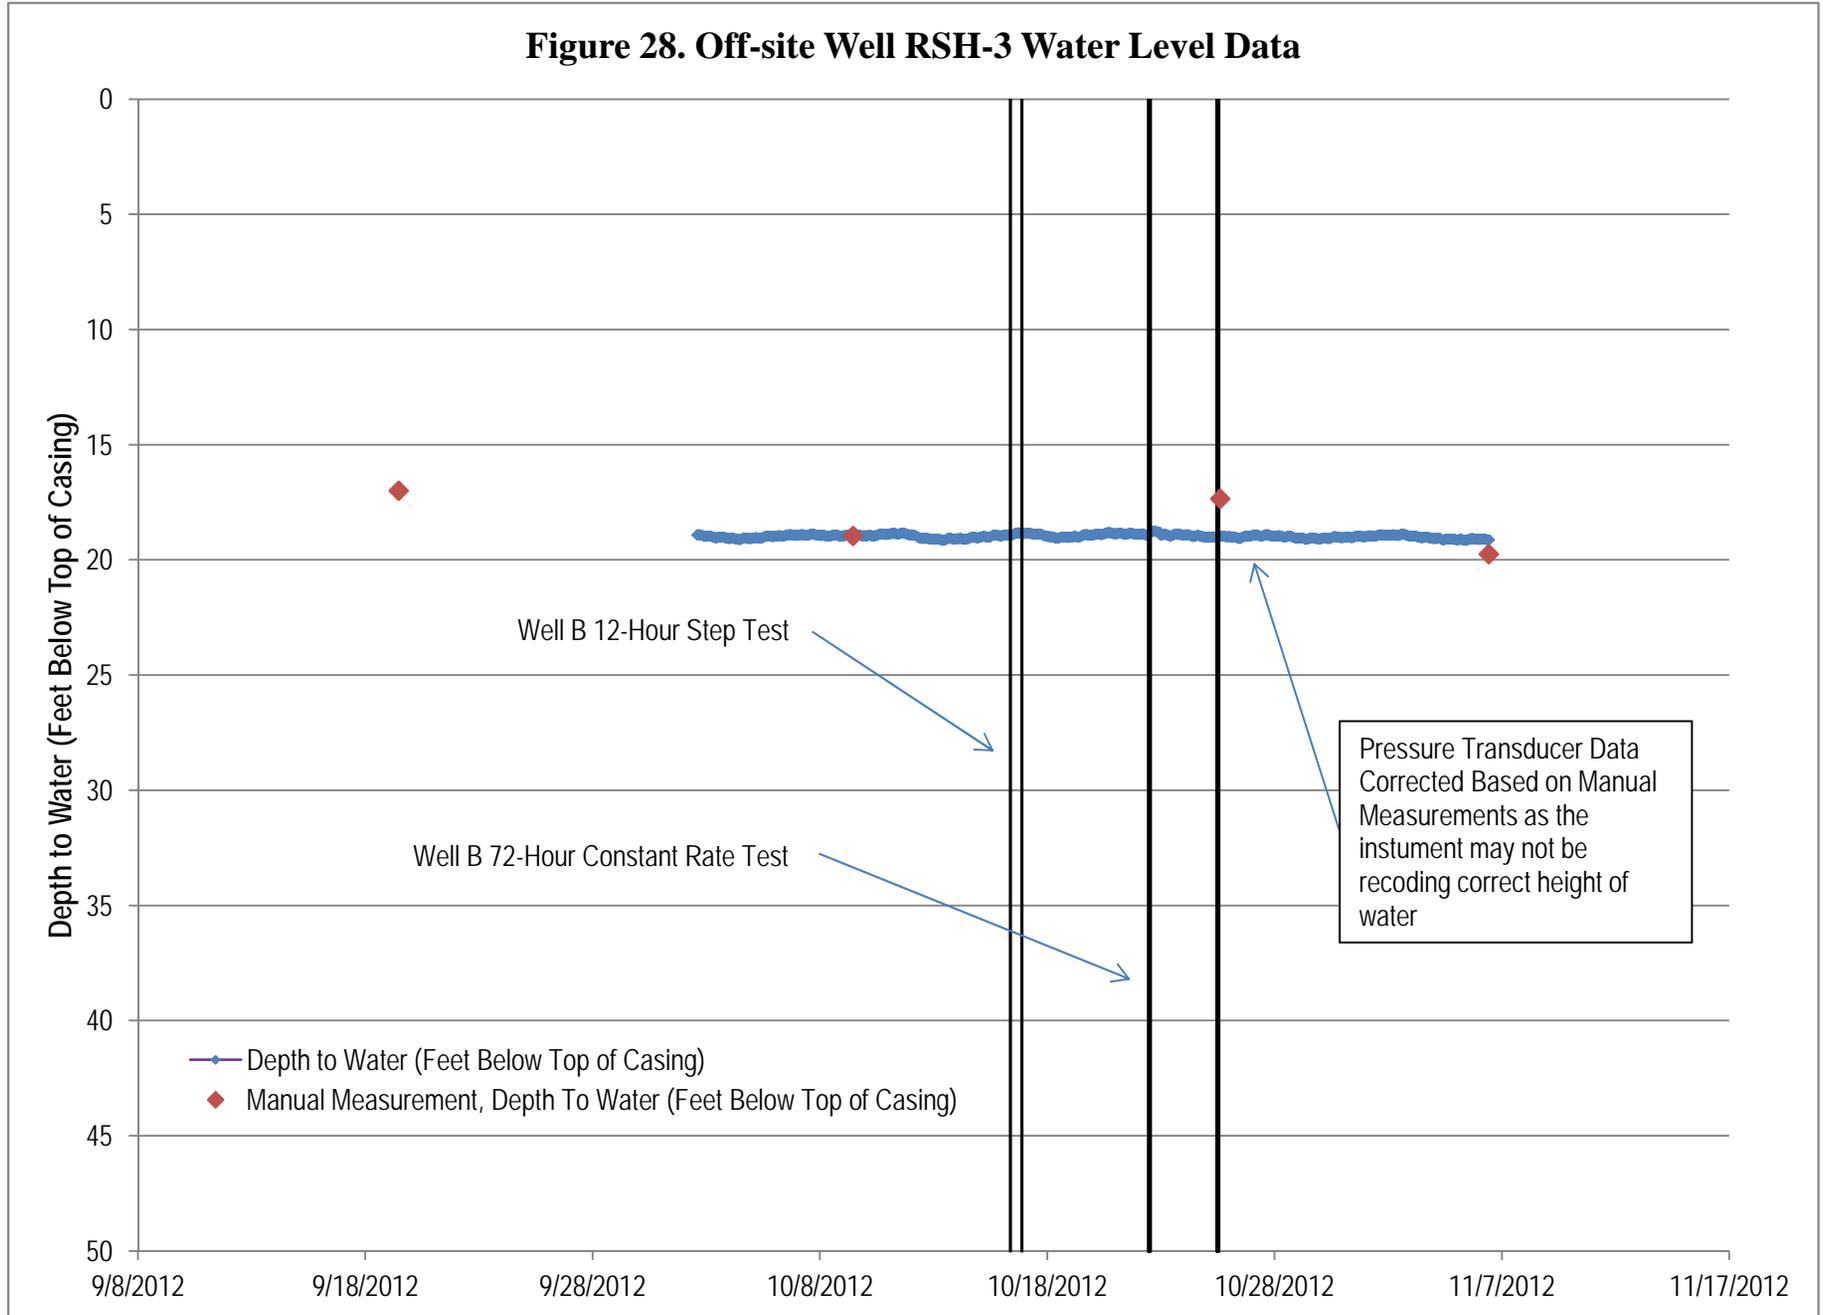
Figure 28. Off-site Well RSH-3 Water Level Data

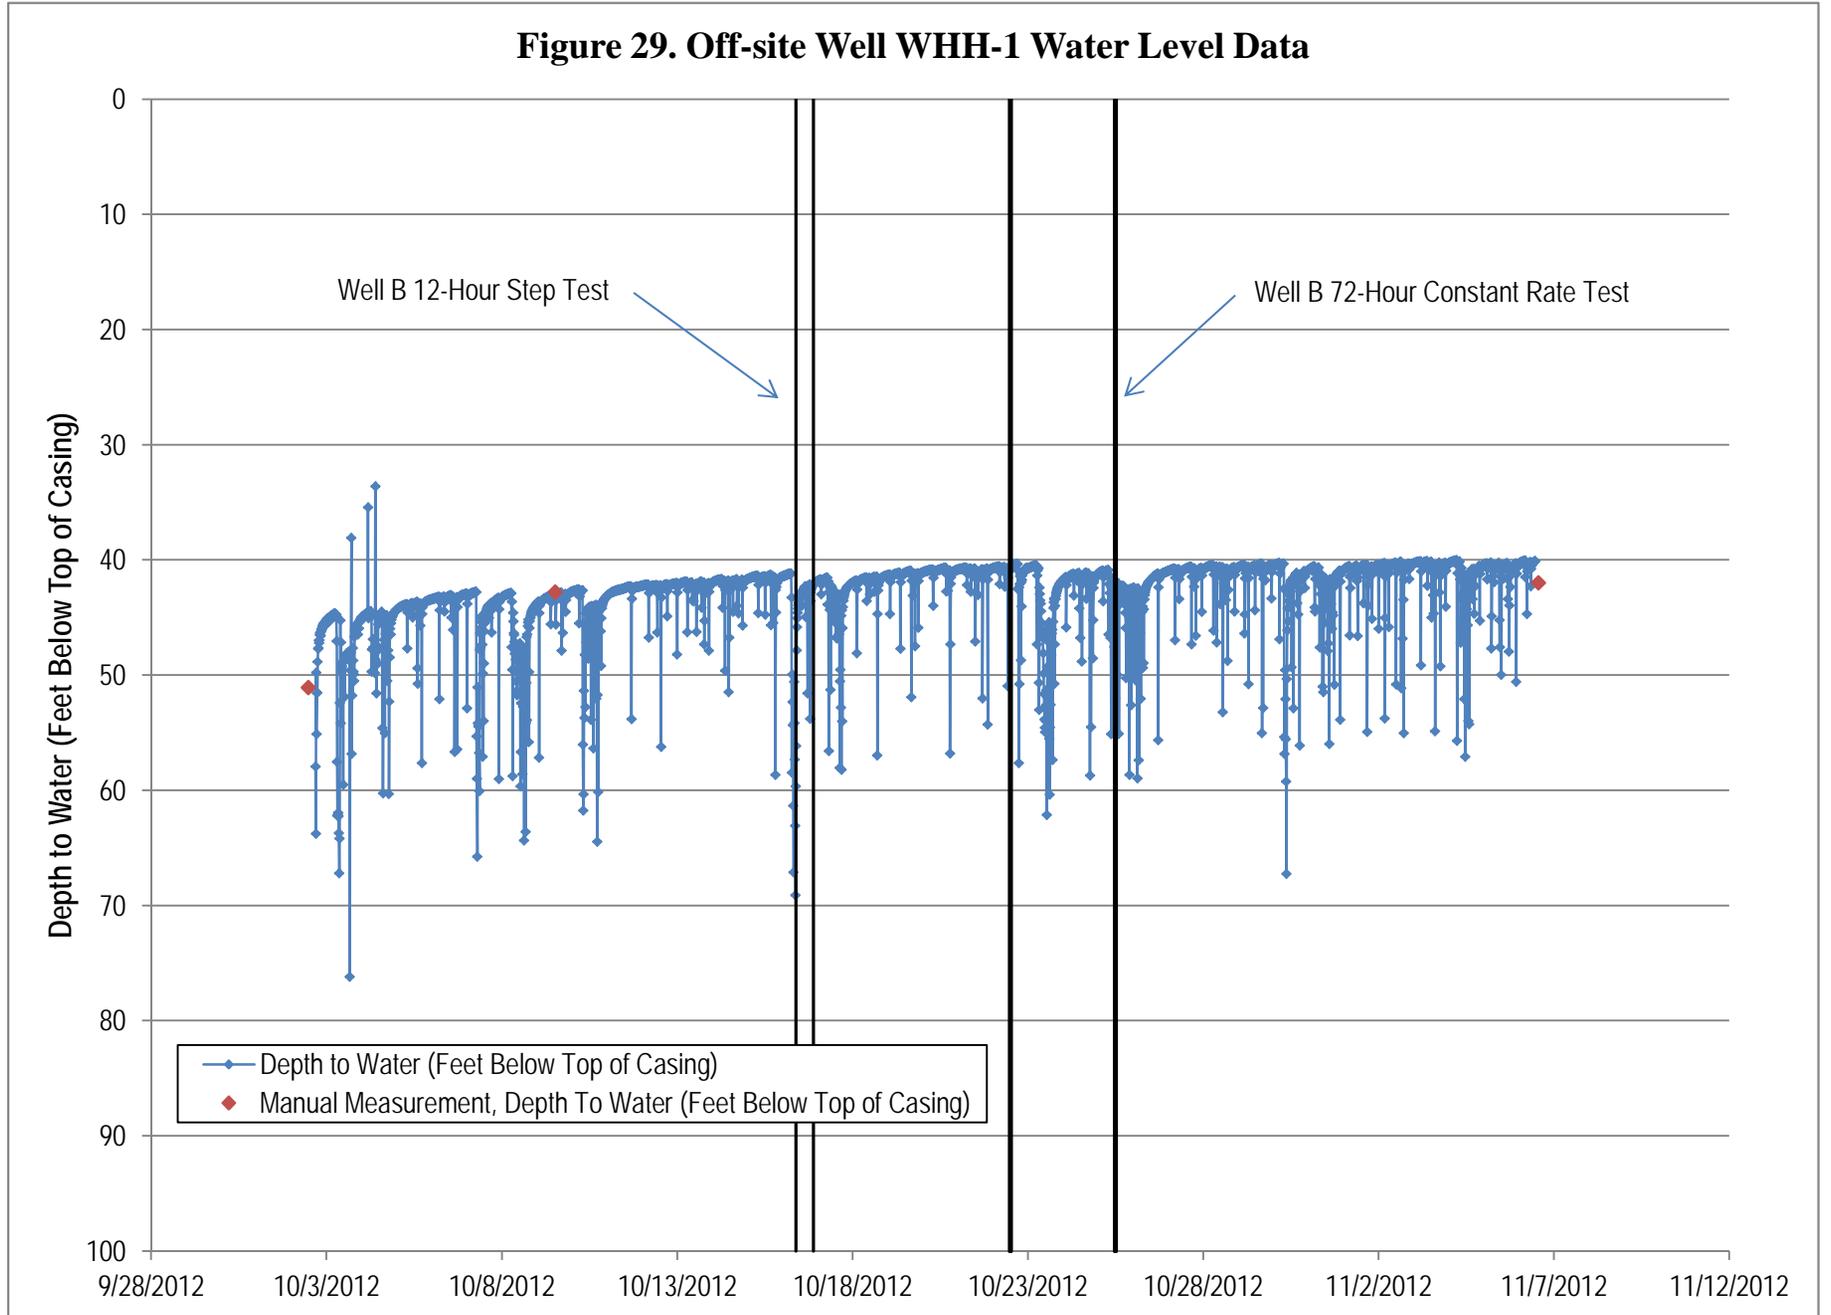
Figure 29. Off-site Well WHH-1 Water Level Data

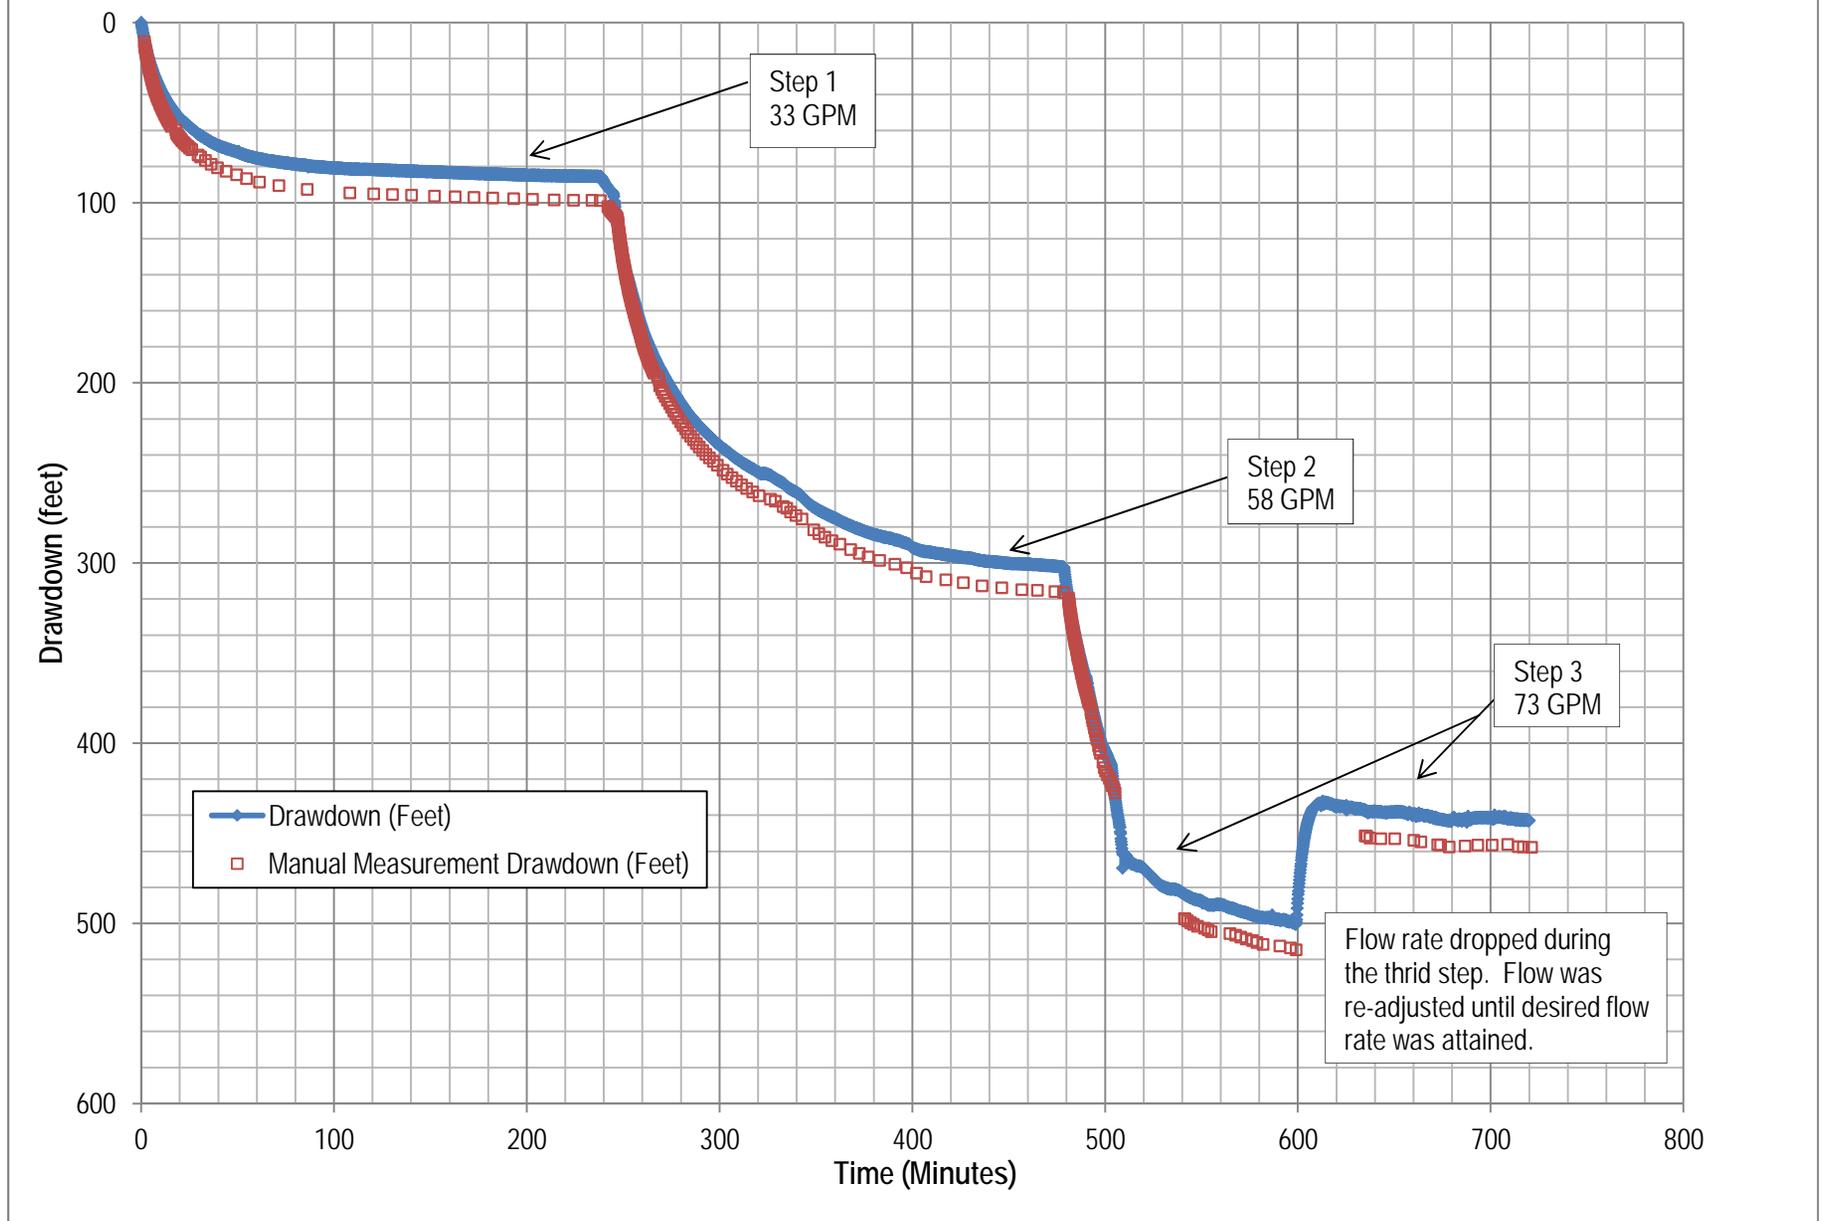
Figure 30. Onsite Well B Step Test Water Level Drawdown
