Groundwater Resources Investigation Report Tierra del Sol Solar Farm Project

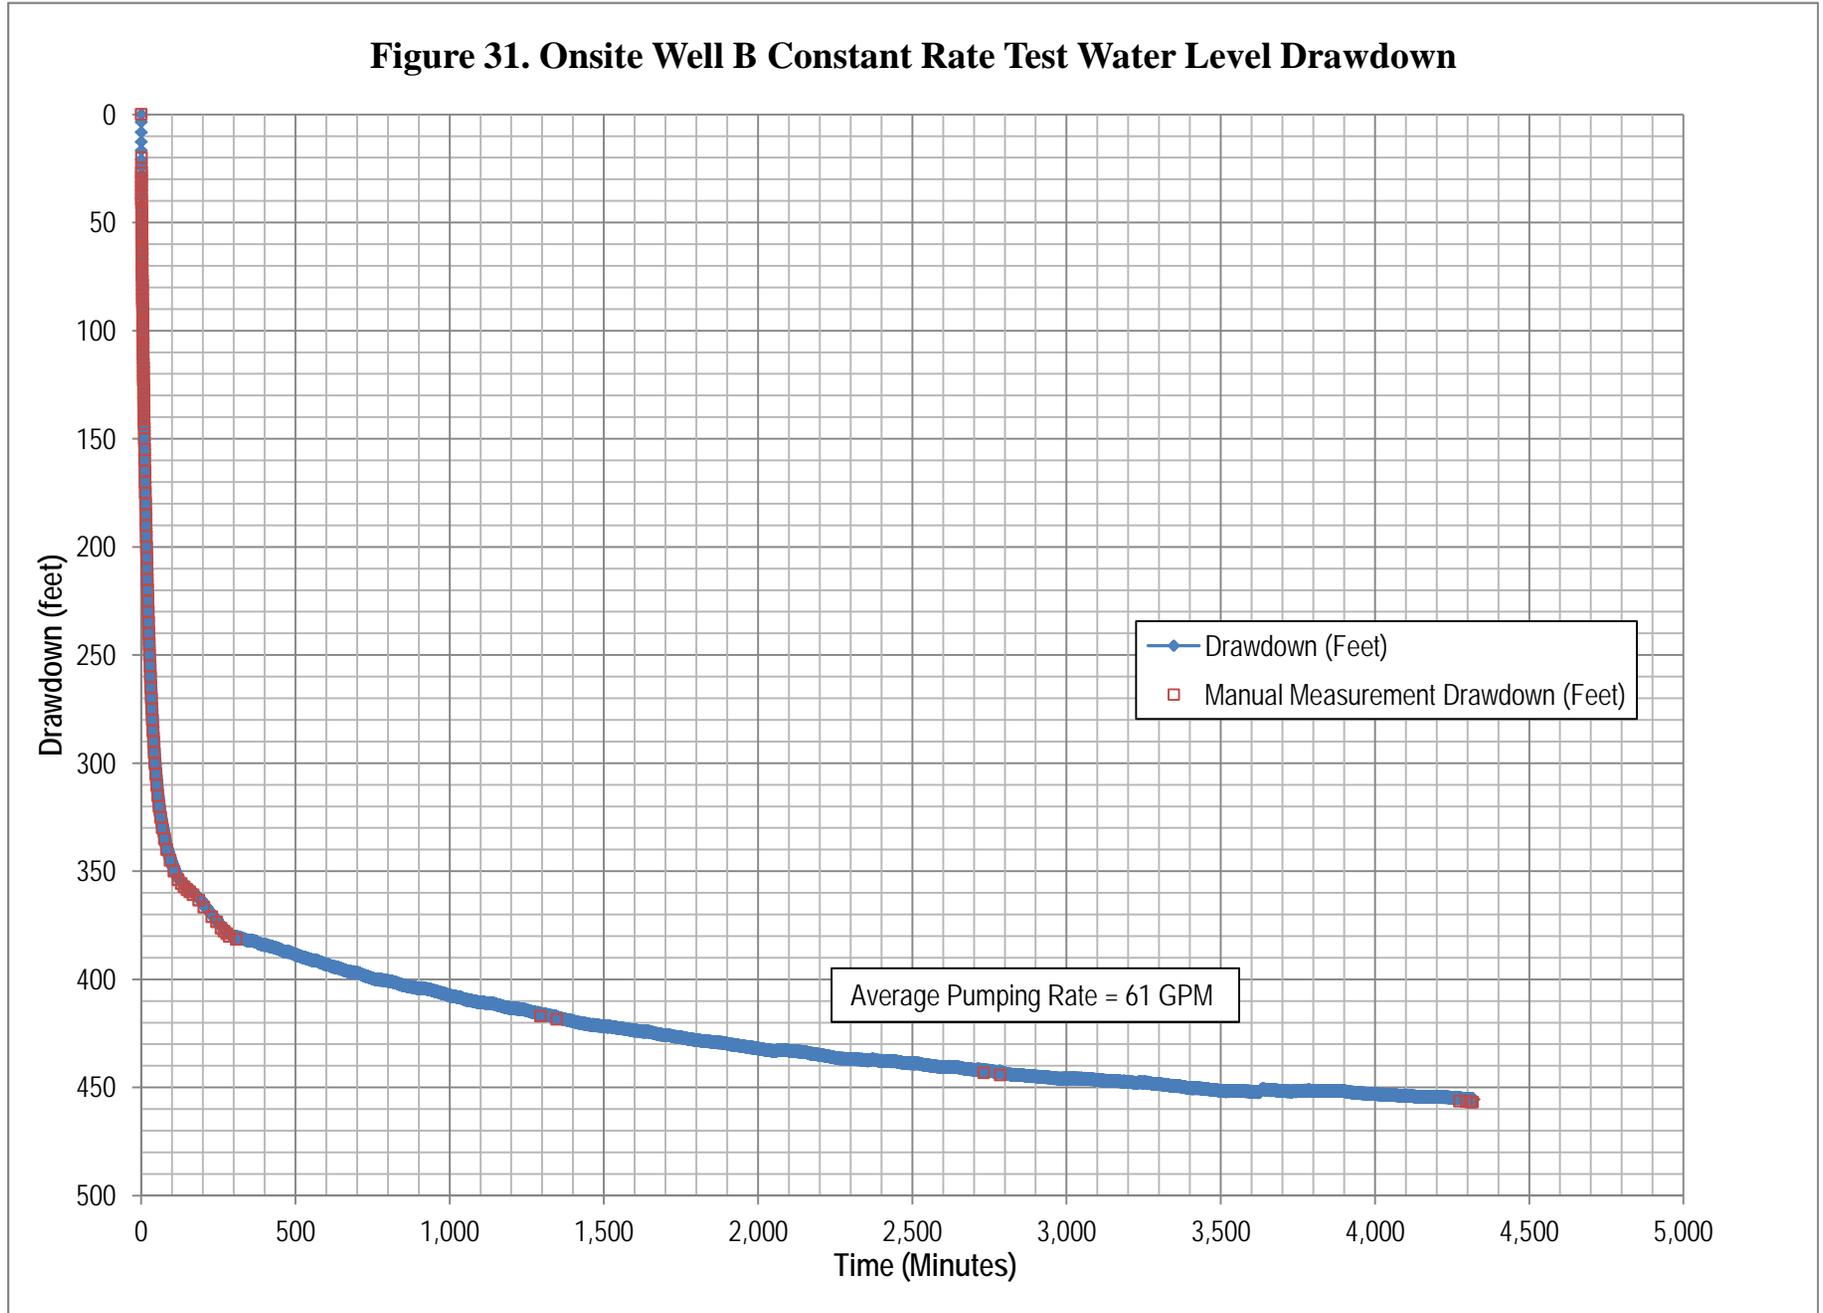
Figure 31. Onsite Well B Constant Rate Test Water Level Drawdown

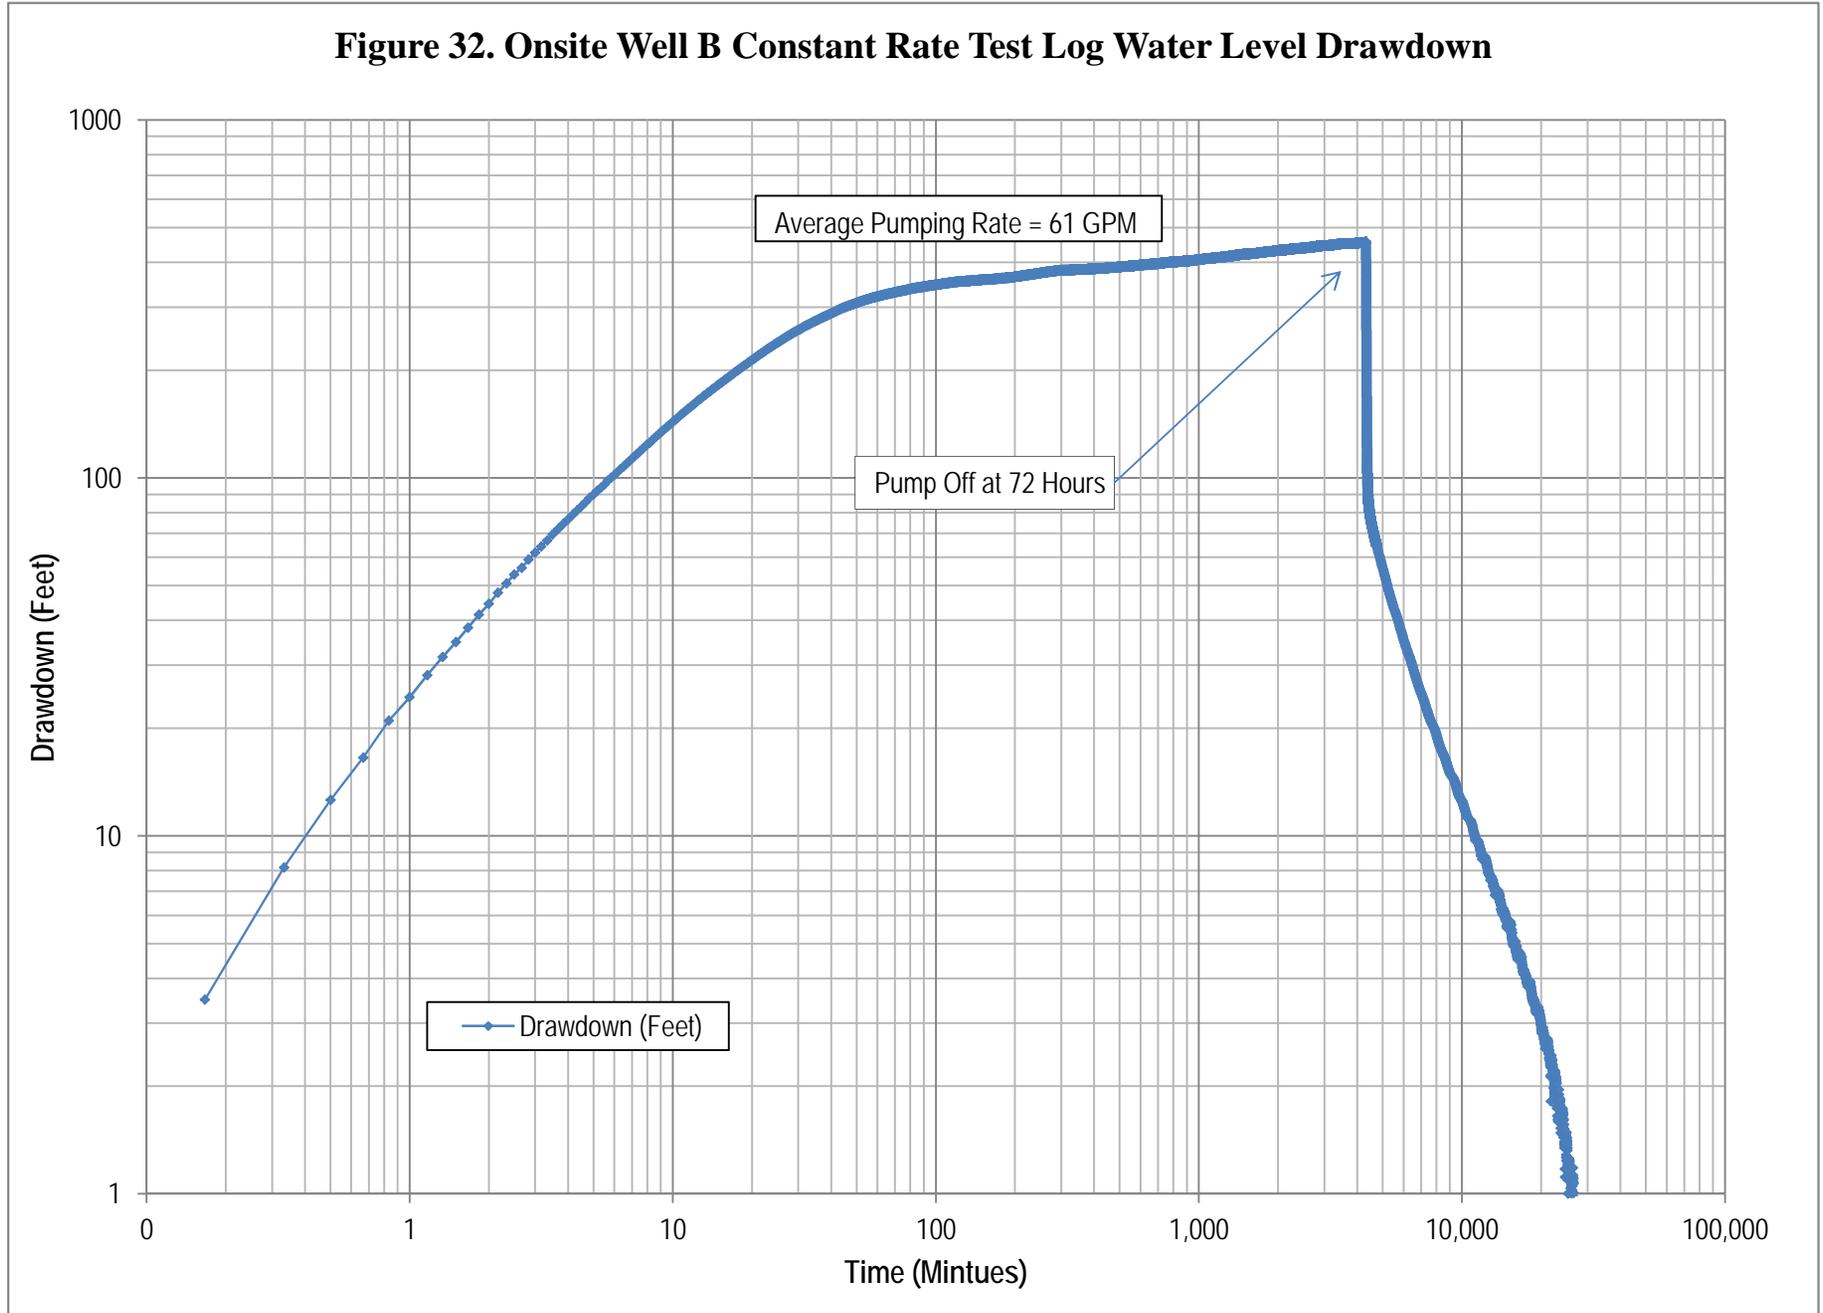
Figure 32. Onsite Well B Constant Rate Test Log Water Level Drawdown

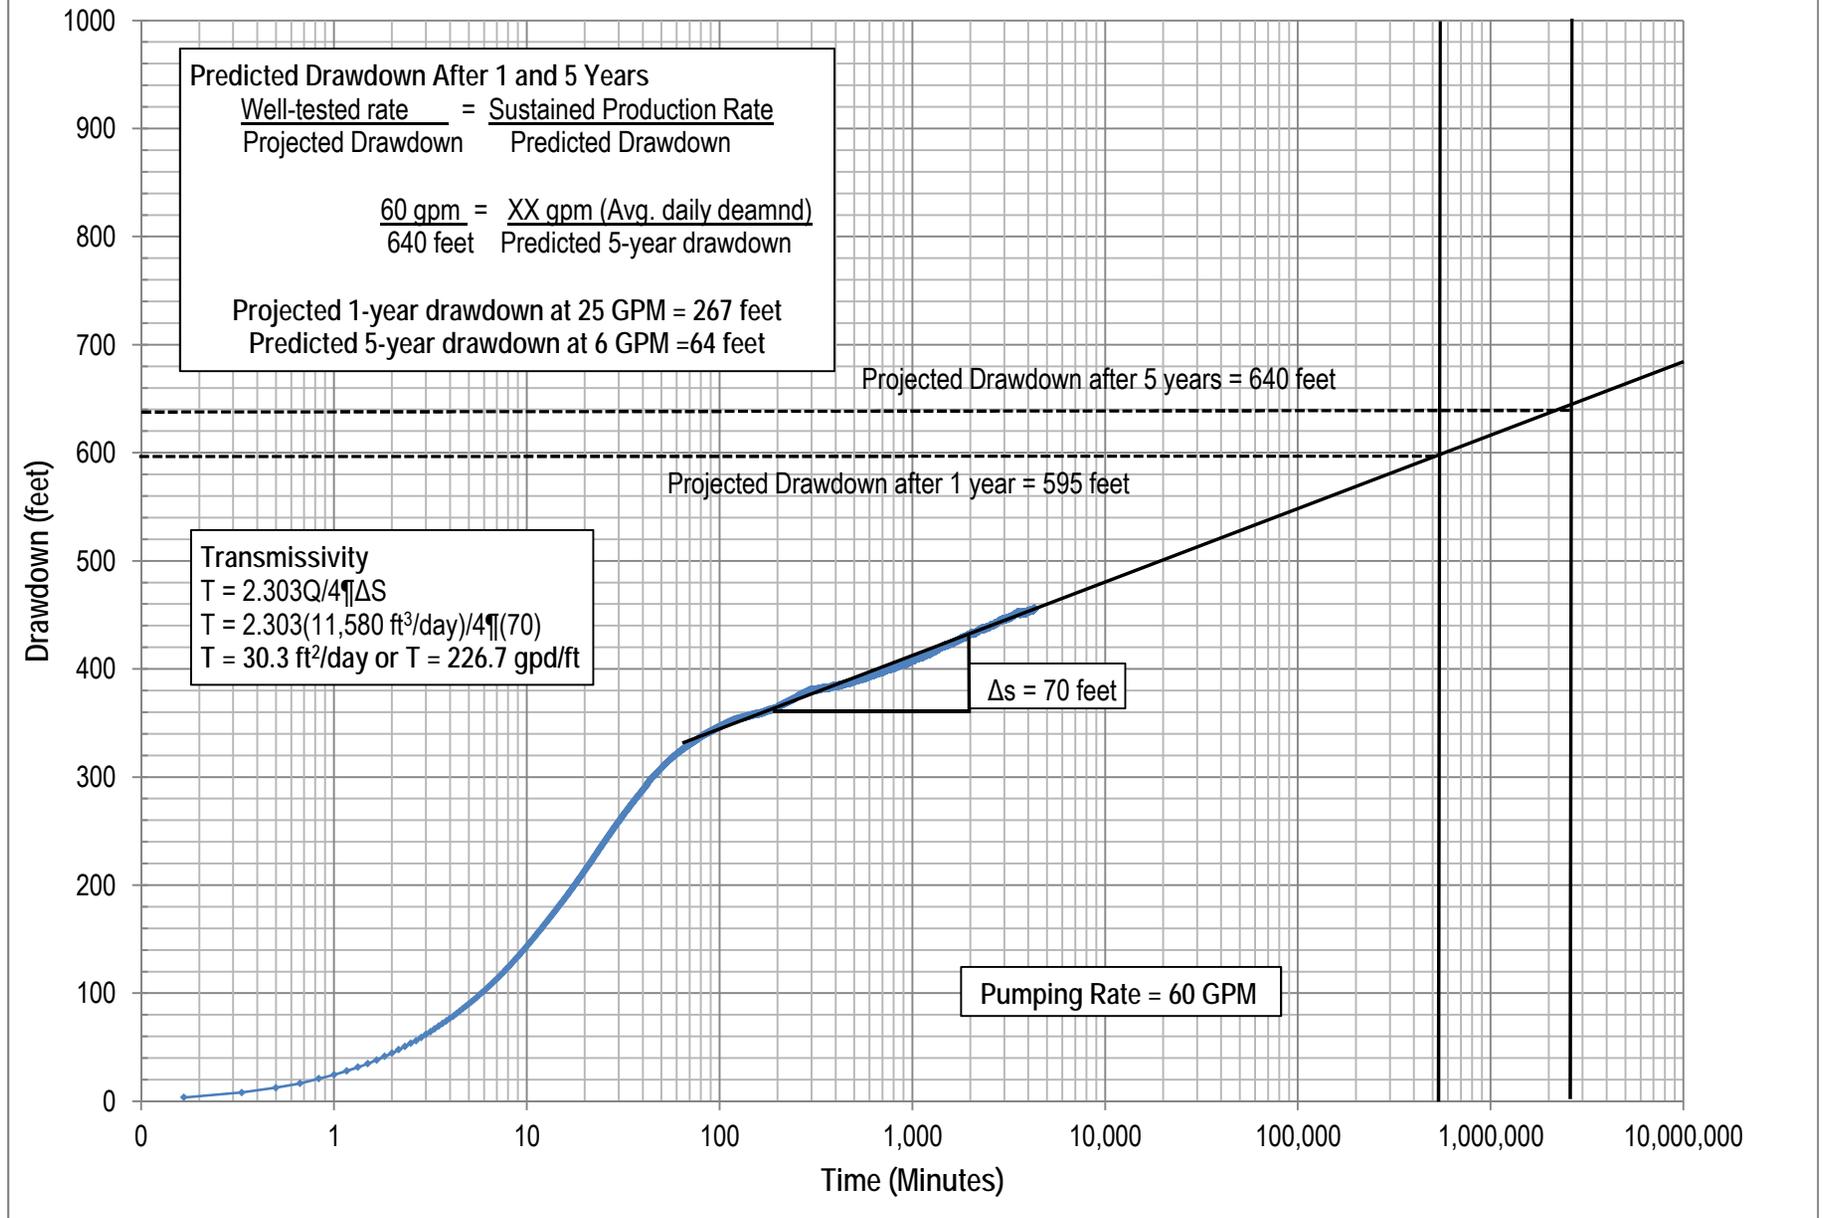
Figure 33. Onsite Well B Constant Rate Test Jacob Straight Line Analysis

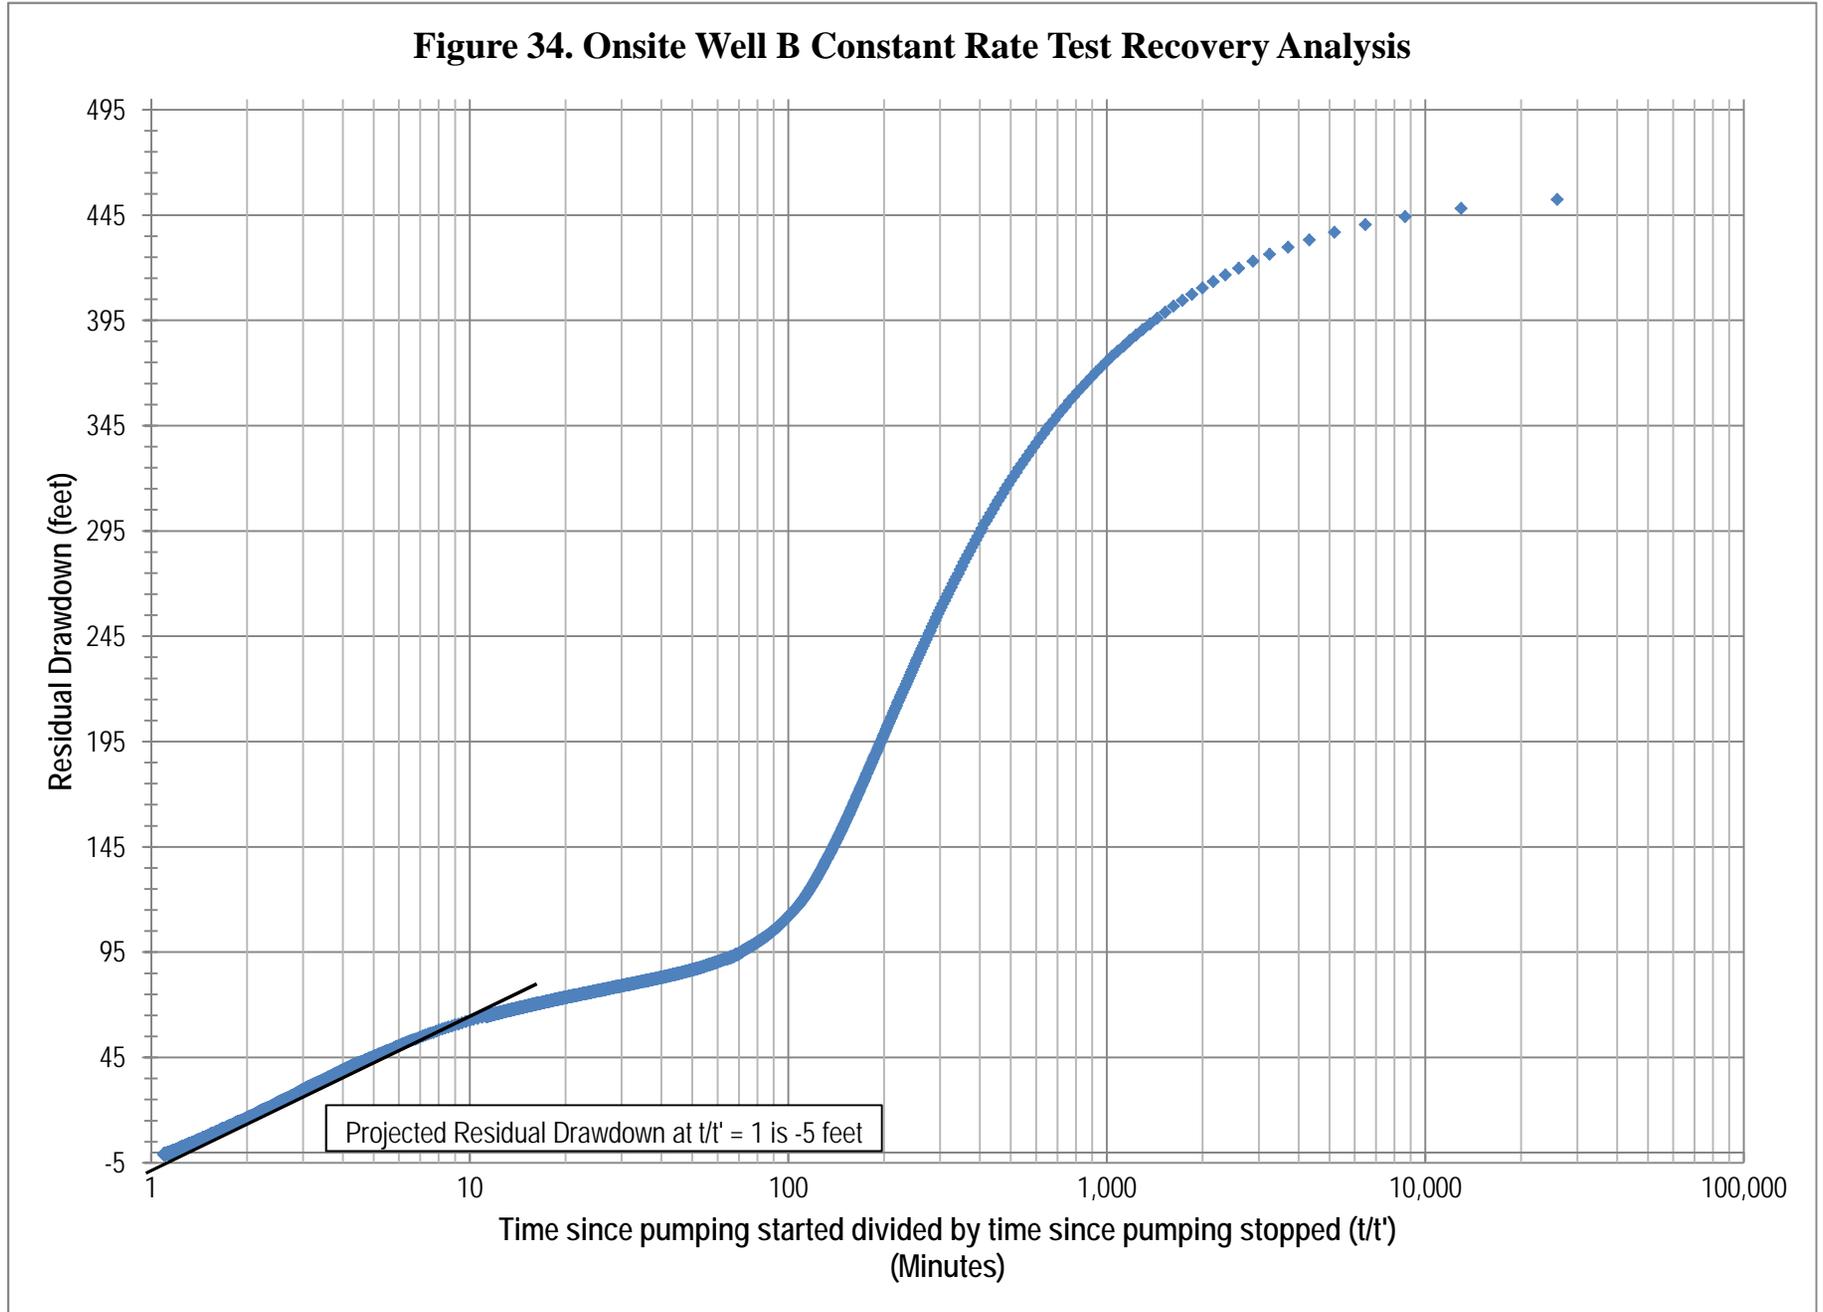
Figure 34. Onsite Well B Constant Rate Test Recovery Analysis
