ADVANCED GEOTECHNICAL SOLUTIONS, INC.

Report No. 1102-01-B-9

Subject: *EIR Level Geotechnical Review of Tentative Tract Map, Lilac Hills Ranch Community, Escondido, California*

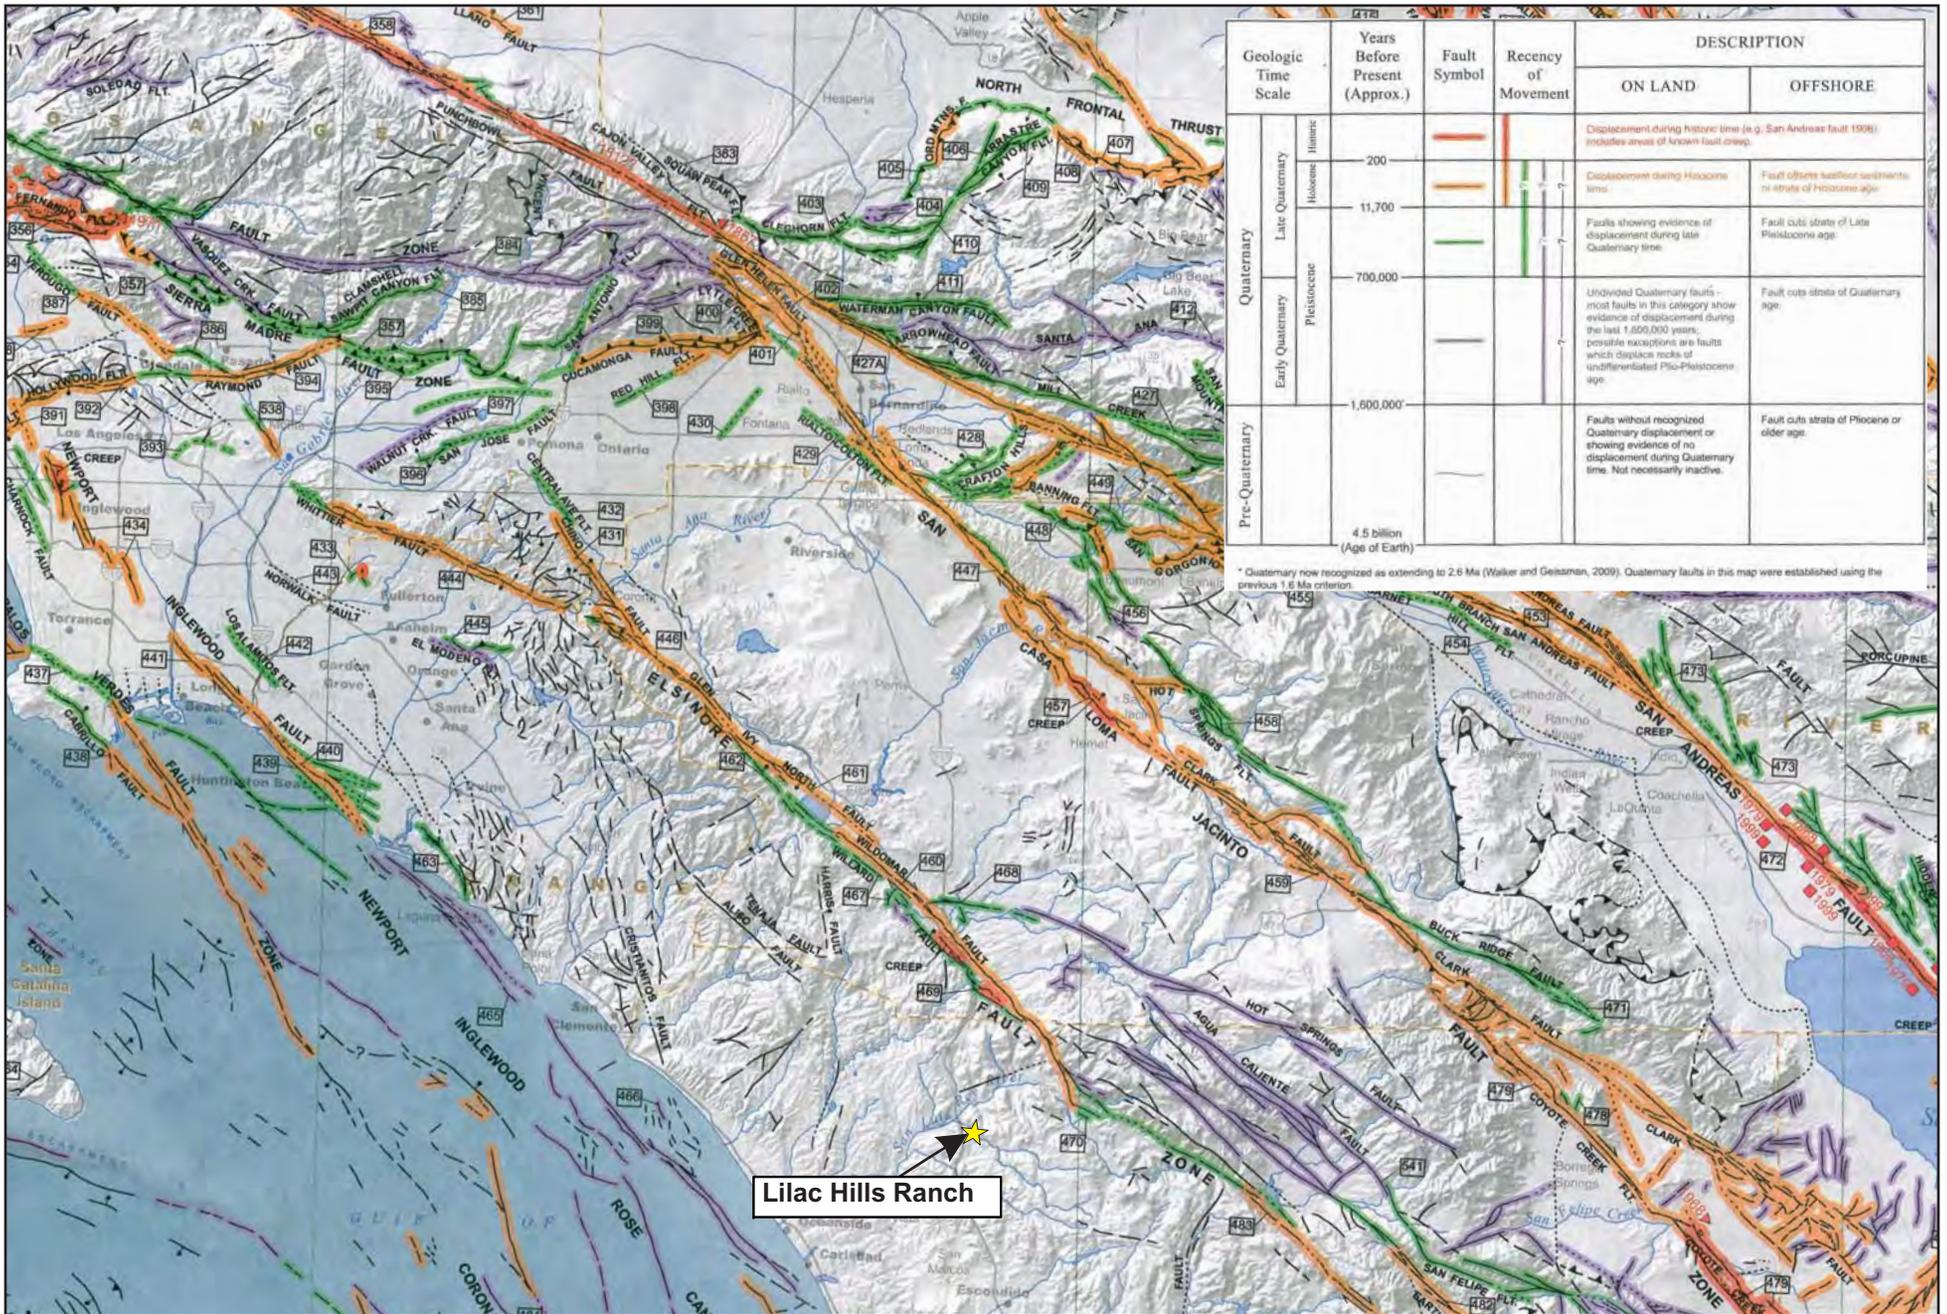
Alquist-Priolo County Special Studies Fault Zones and San Diego County Fault Zones are not located onsite (Figure 4). The most influential geologic faults potentially affecting the property are the active and potentially active Williard, Wildomar, Wolf Valley and Temecula segments of the Elsinore Fault System. No faults have been mapped onsite on published geologic maps and none were observed during this and previous geologic studies.

Geologic Time Scale	Years Before Present (Approx.)	Fault Symbol	Recency of Movement	DESCRIPTION	
				ON LAND	OFFSHORE
Quaternary	Late Quaternary			Displacement during historic time (e.g. San Andreas fault 1906) includes areas of known fault creep.	Fault offsets surficial sediments or strata of Holocene age.
				Faults showing evidence of displacement during late Quaternary time.	Fault cuts strata of Late Pleistocene age.
	Early Quaternary			Unidentified Quaternary faults; most faults in this category show evidence of displacement during the last 1,600,000 years; possible exceptions are faults which displace rocks of undifferentiated Pliocene-Pleistocene age.	Fault cuts strata of Quaternary age.
Pre-Quaternary					Faults without recognized Quaternary displacement or showing evidence of no displacement during Quaternary time. Not necessarily inactive.

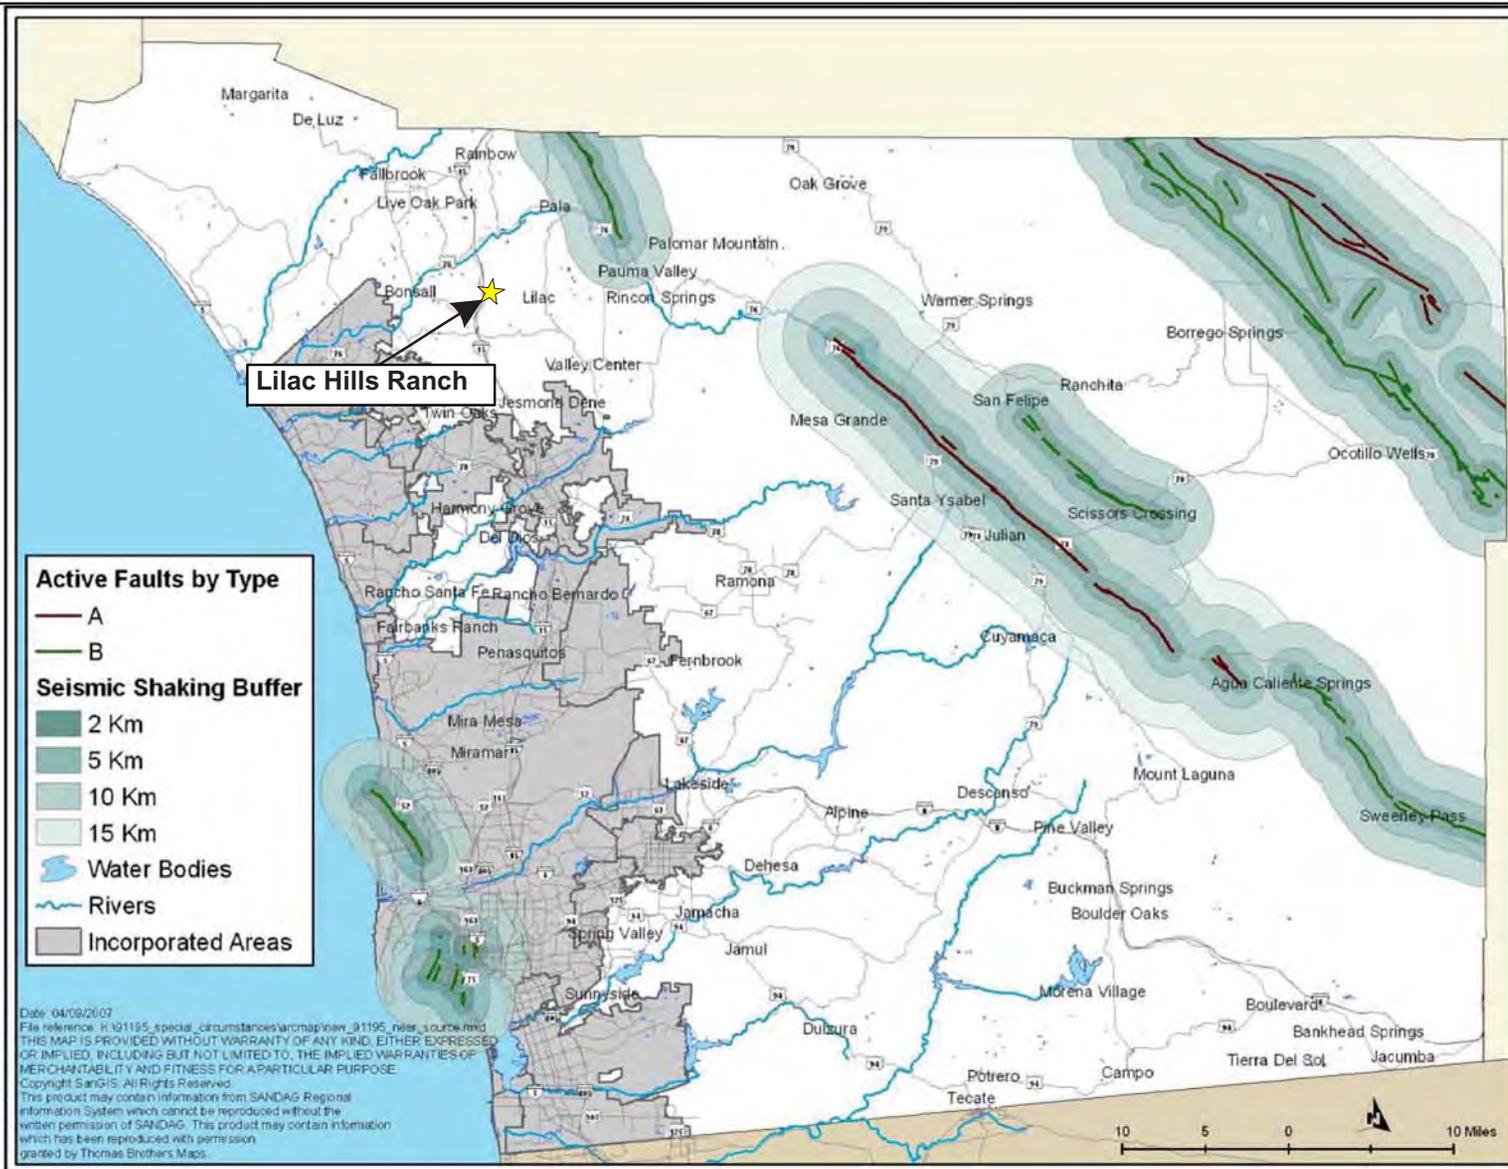
The site is located in the tectonically active Southern California area, and will therefore likely experience shaking effects from earthquakes. The Near Source Shaking Zones of the County of San Diego (Figure 5) shows the distance of the site from near source shaking zones. The type and severity of seismic hazards affecting the site are to a large degree dependent upon the distance to the causative fault, the intensity of the seismic event, the direction of propagation of the seismic wave and the underlying soil characteristics. The seismic hazard may be primary, such as surface rupture and/or ground shaking, or secondary, such as liquefaction, seismically induced slope failure or dynamic settlement. The following is a site-specific discussion of ground motion parameters, earthquake-induced landslide hazards, settlement, and liquefaction. The purpose of this analysis is to identify potential seismic hazards and propose mitigations, if necessary, to reduce the hazard to an acceptable level of risk. The following seismic hazards discussion is guided by the California Building Code (2010), CDMG (2008), and Martin and Lew (1998).

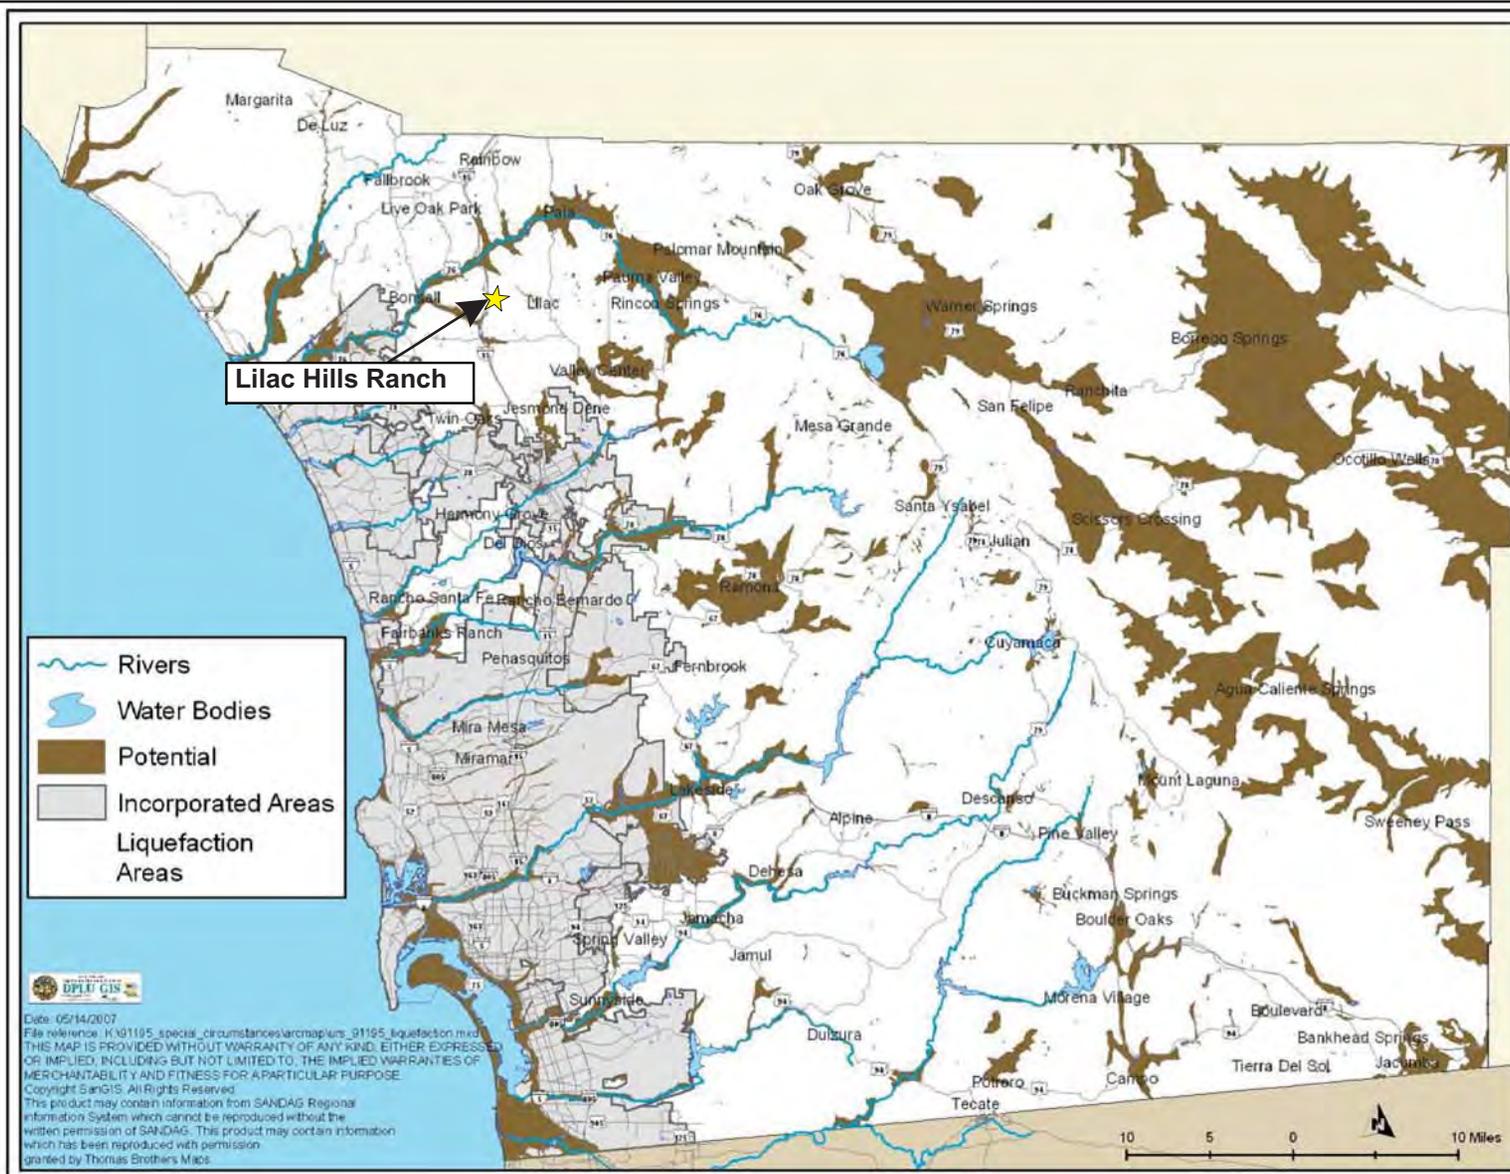
Potential Liquefaction Areas

Liquefaction is the phenomenon in which the buildup of excess pore pressures, in saturated granular soils due to seismic agitation, results in a temporary “quick” or “liquefied” condition. The site is not within an area zoned by the County of San Diego as a Potential Liquefaction Area (Figure 6). After remedial grading, saturated alluvium will be entirely removed within the projects development footprint. The remedial grading as recommended herein will render the potential for liquefaction to be nil.

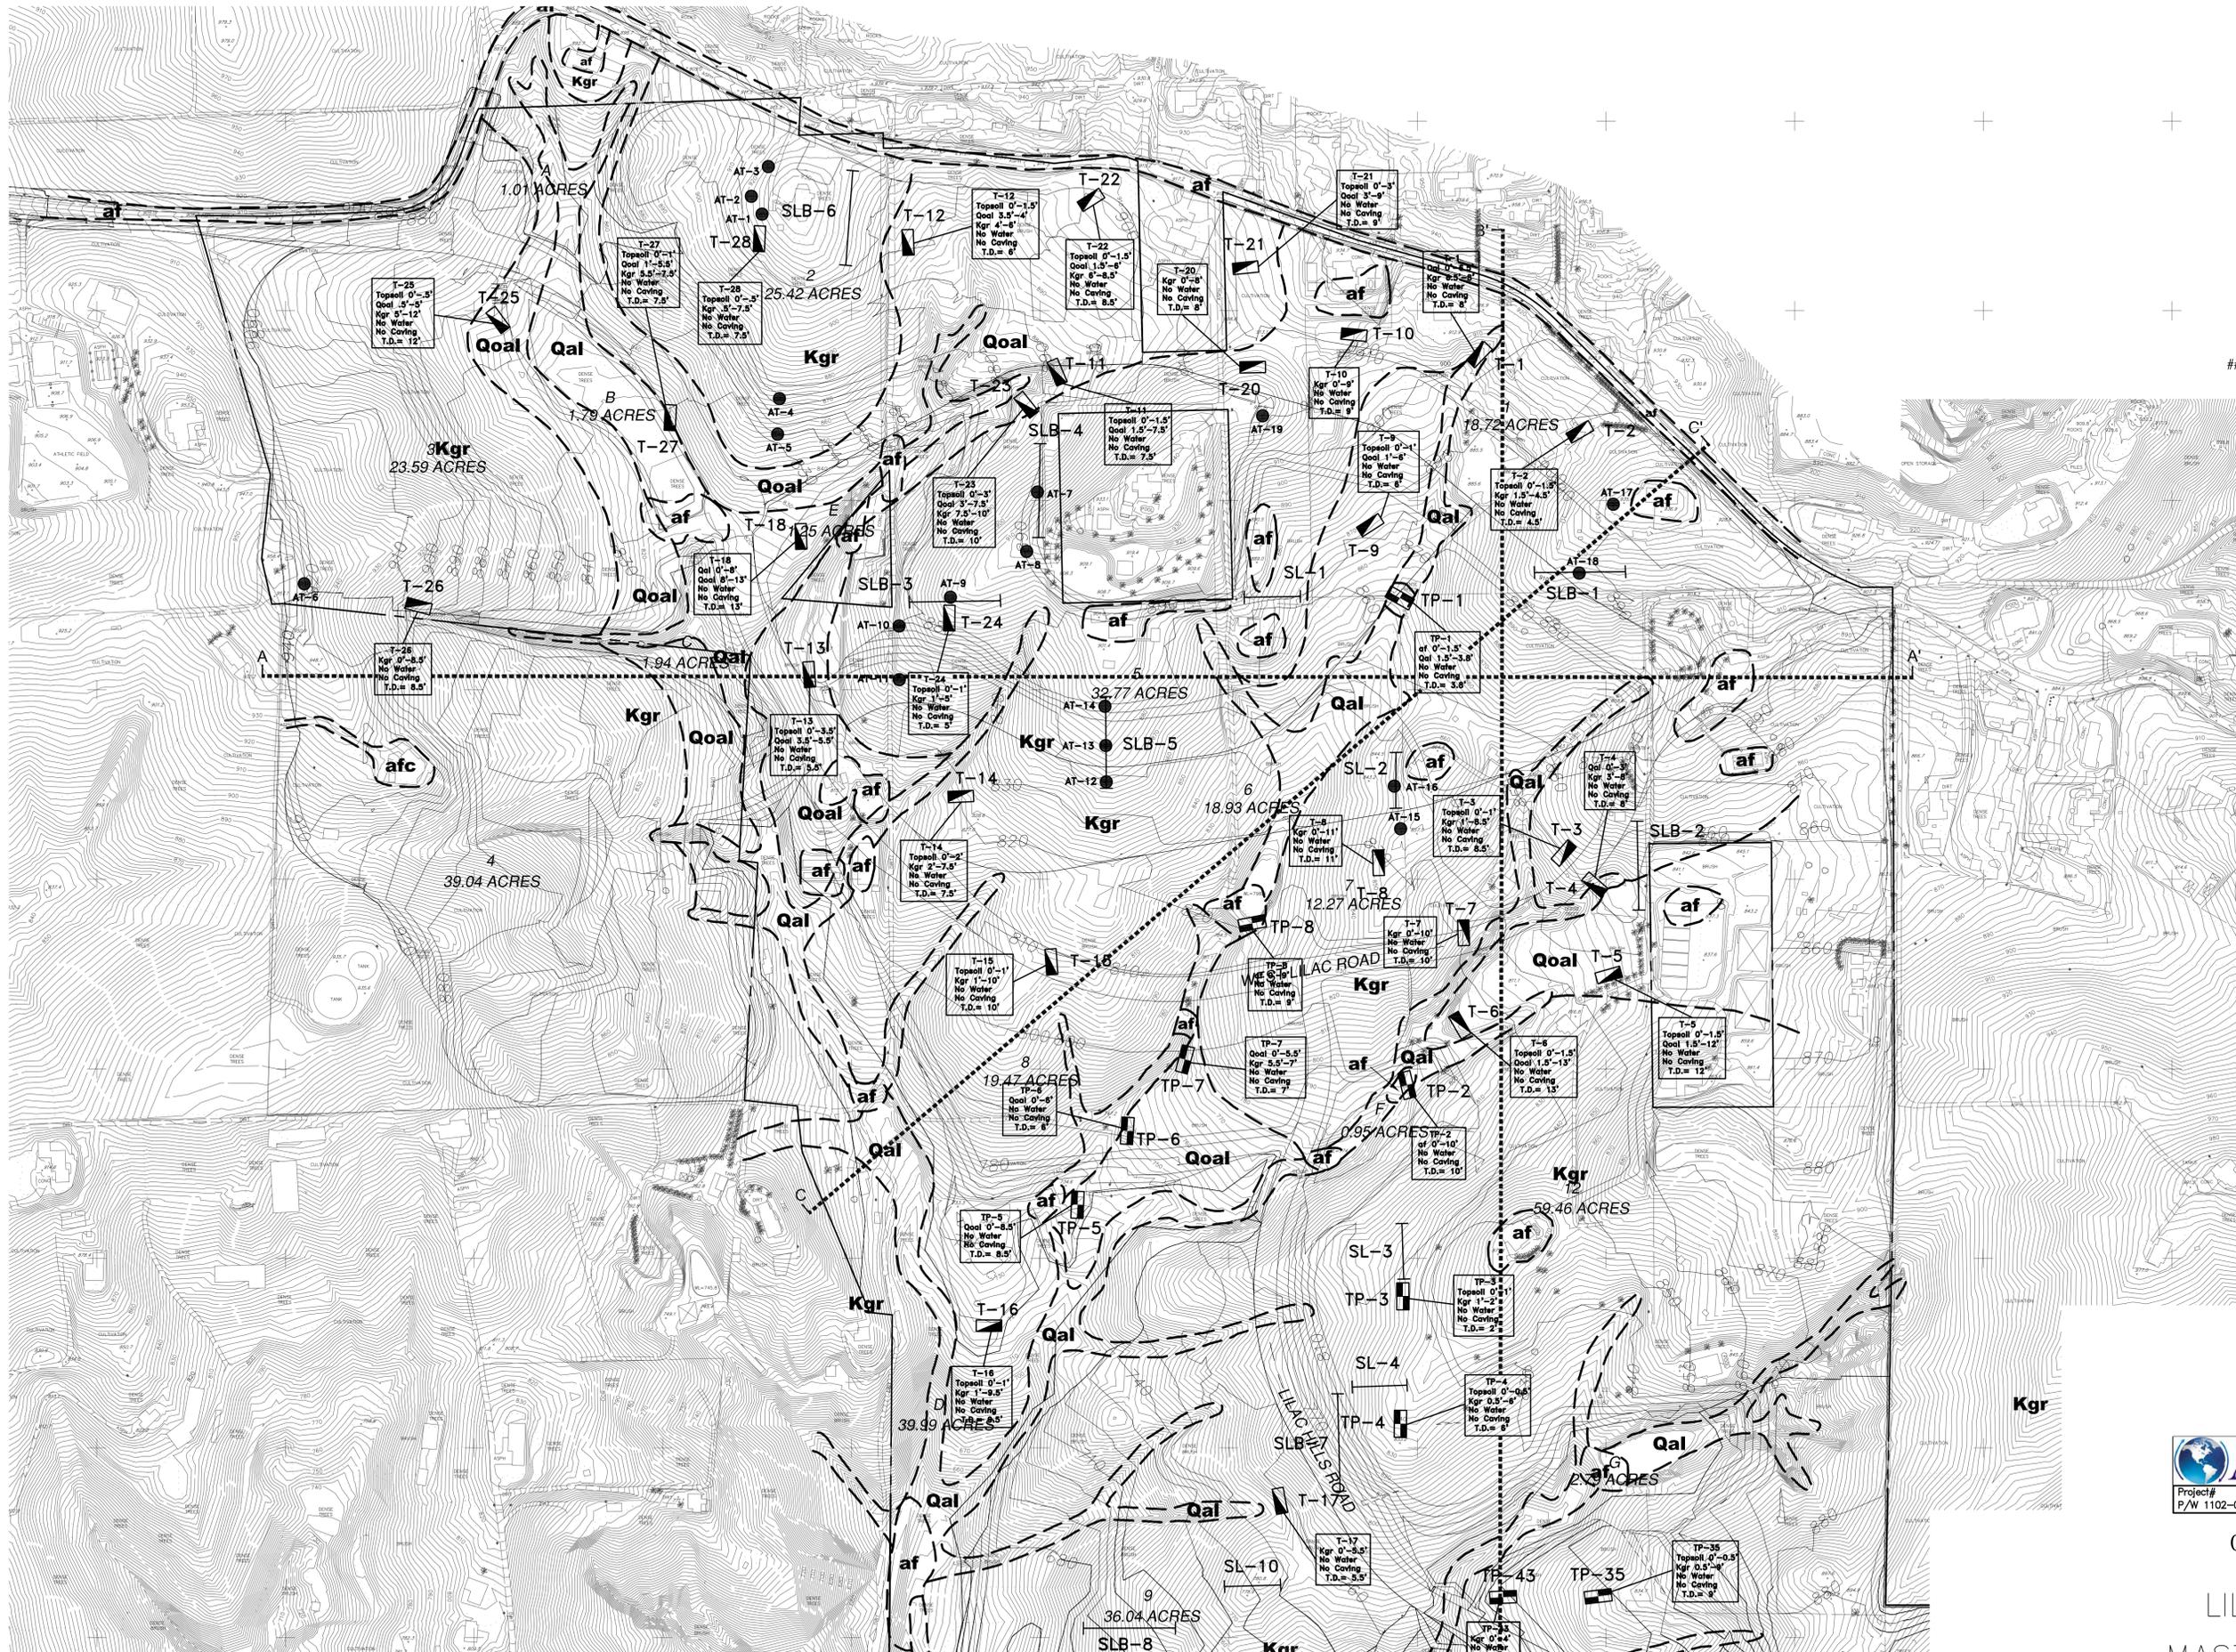
Alluvial deposits occupy the canyon areas and active drainage courses throughout the project and the mapped locations are shown on Sheets 1 and 2. The Holocene-aged alluvium varies from a light orange brown to light to medium brown silty and clayey sand to sandy silt that is damp to locally wet, loose and soft to moderately dense and firm. The thickness of the alluvium logged in the borings and trenches reached maximum depths of 13 to 14 feet and are likely deeper in unexplored areas such as portions of the dominant drainage on the southwest portion of the project.

Identified and discussed as “granite” in this document, the Tonalite of Couser Canyon is a “granitic-type” rock that underlies the entire Tentative Tract with a small exception of some Granodiorite of Indian Mountain mapped by Kennedy (2000) and Tan (2000) along the northern boundary of the project. In most areas this unit is deeply weathered and hard boulder corestones were observed at ground surface in only a few areas area. These outcrops are shown on Sheets 1 and 2.

As part of our services AGS has integrated appurtenant information from this and previous investigations on the Mater Tentative Tract Map grading prepared by Landmark Consulting (Sheets 1 thru 3), prepared cross-sections A-A' through E-E' (Sheets 4 and 5) and prepared this report with our findings and recommendations.

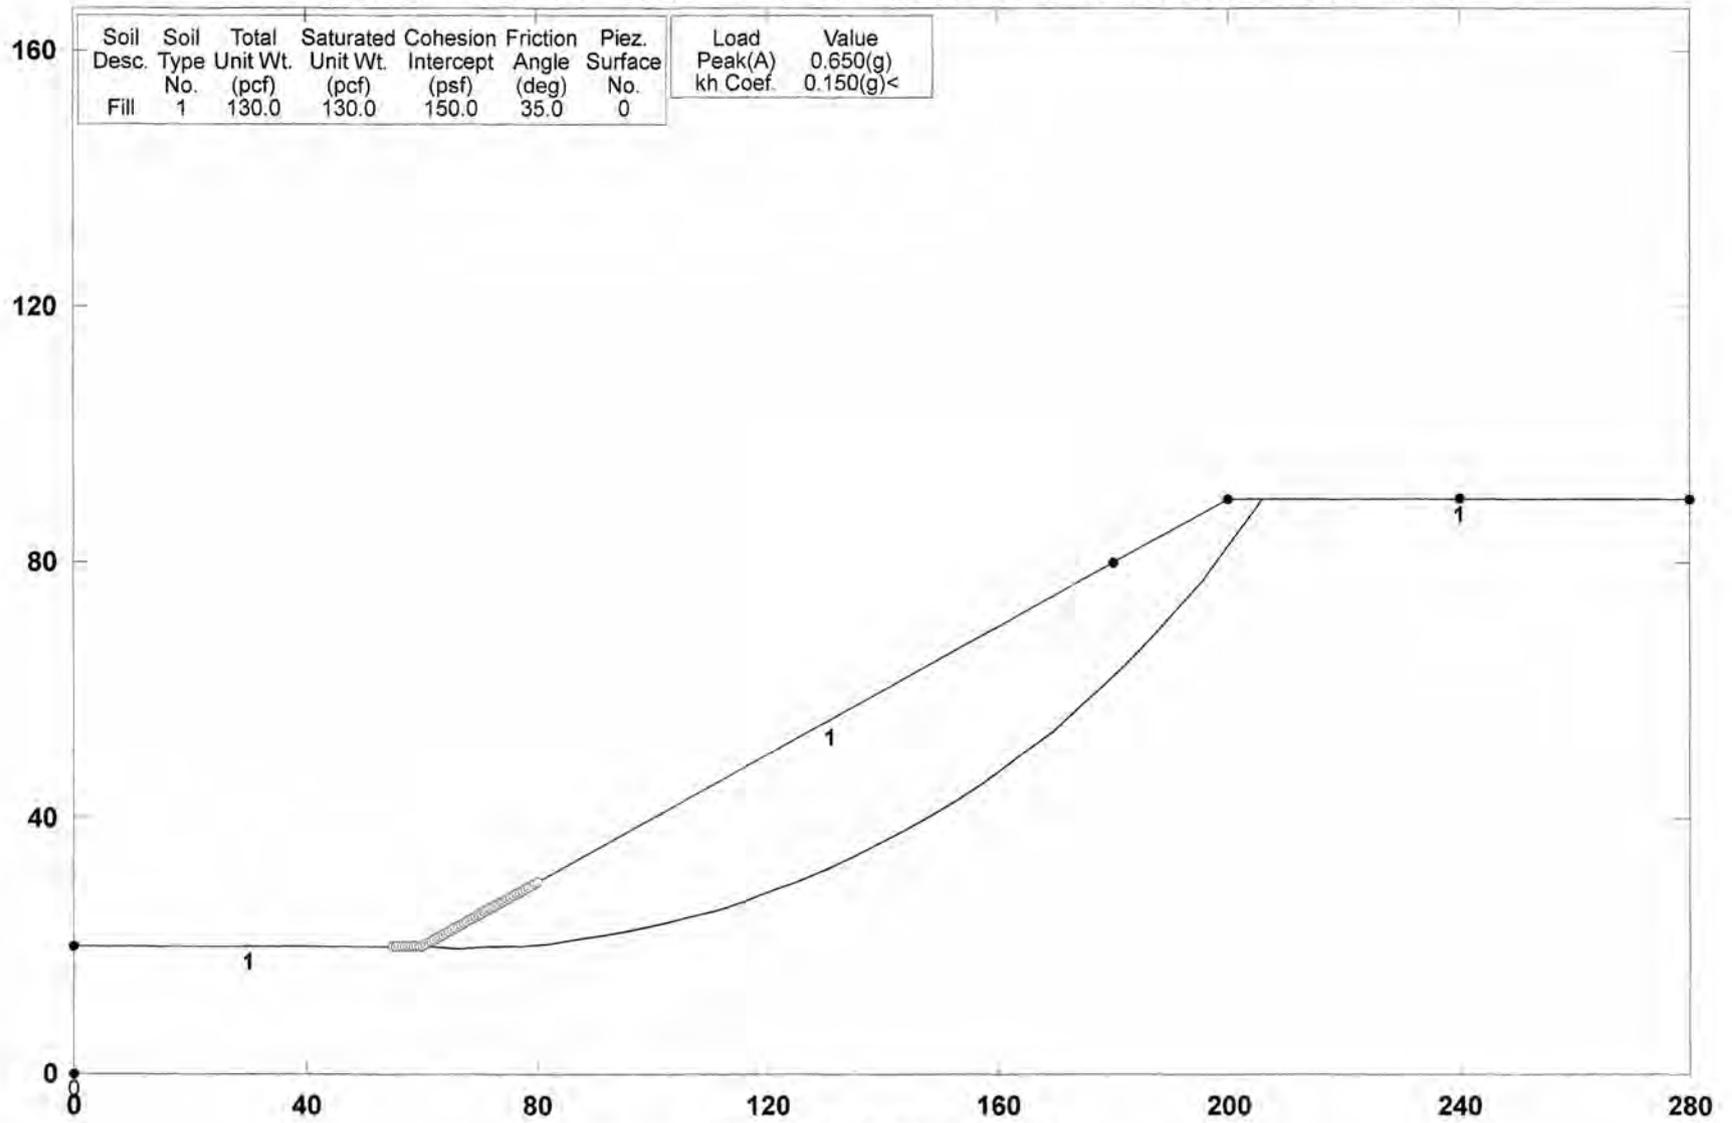
GSTABL7 v.2 FSmin=1.302
 Safety Factors Are Calculated By The Modified Bishop Method

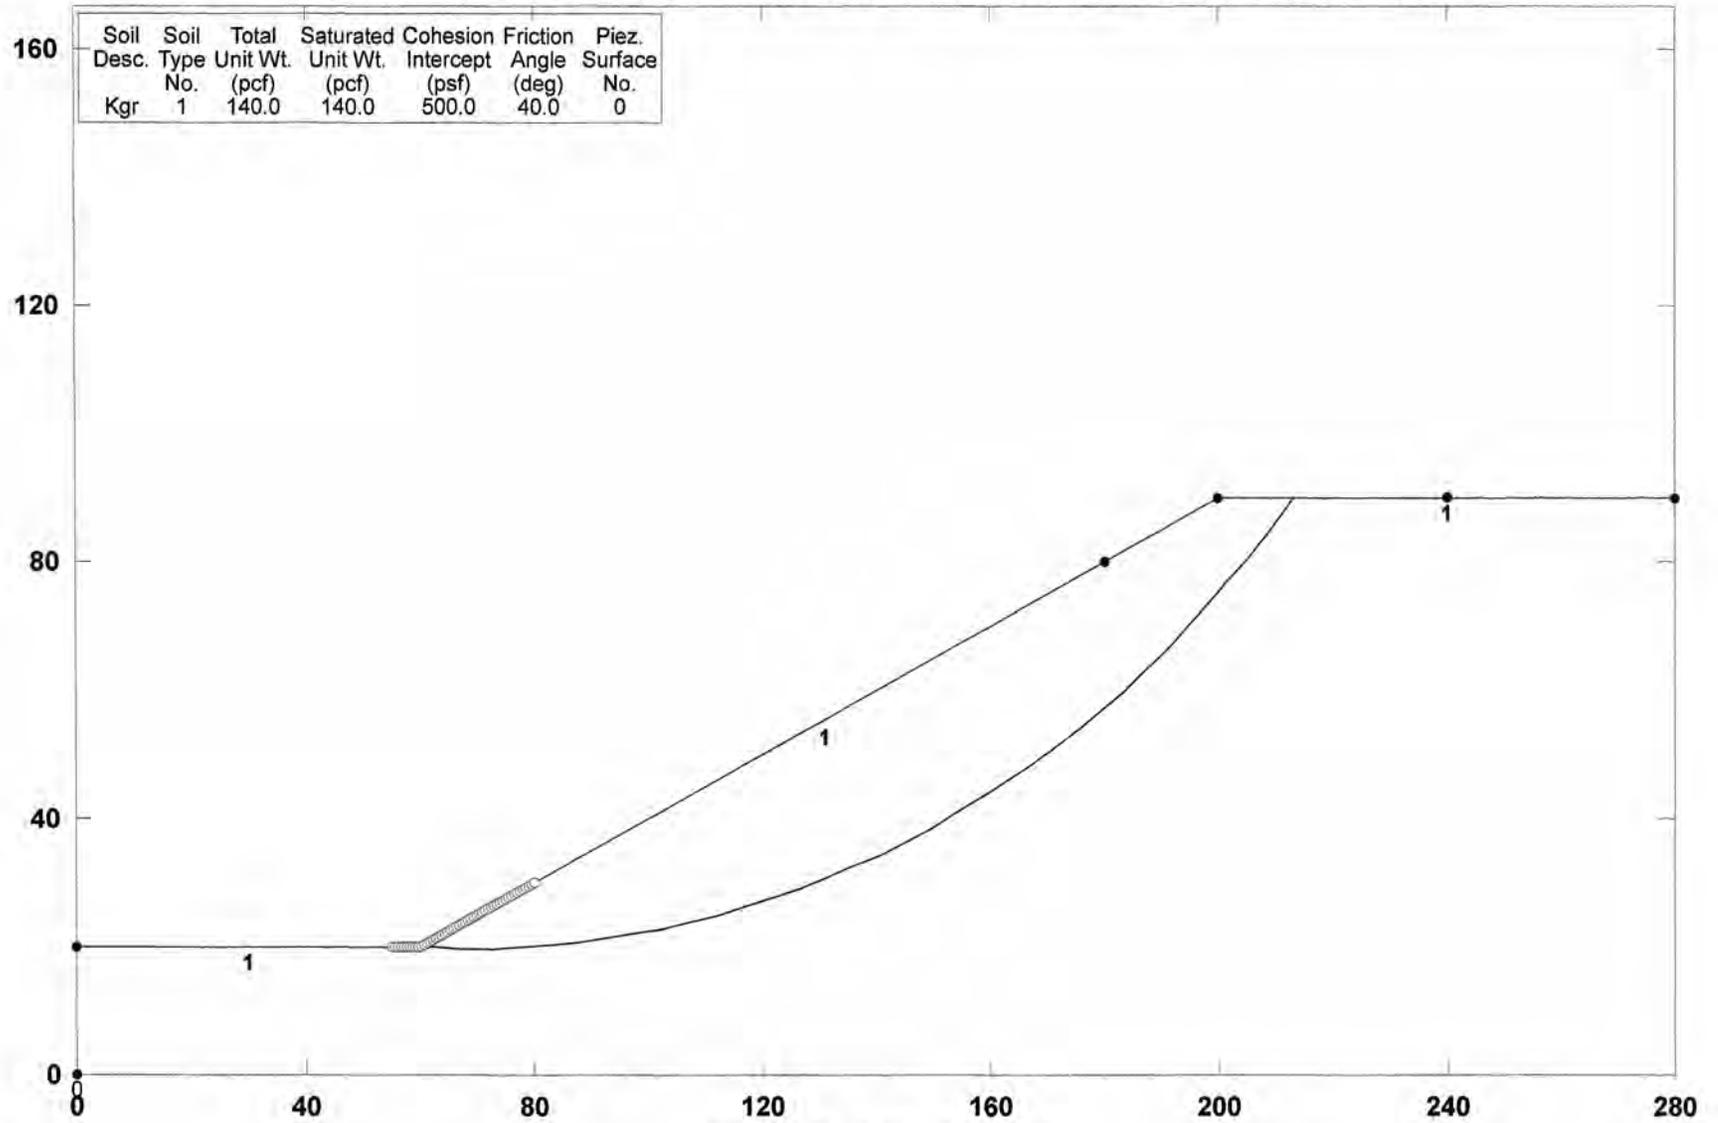
GSTABL7 v.2 FSmin=2.517
 Safety Factors Are Calculated By The Modified Bishop Method

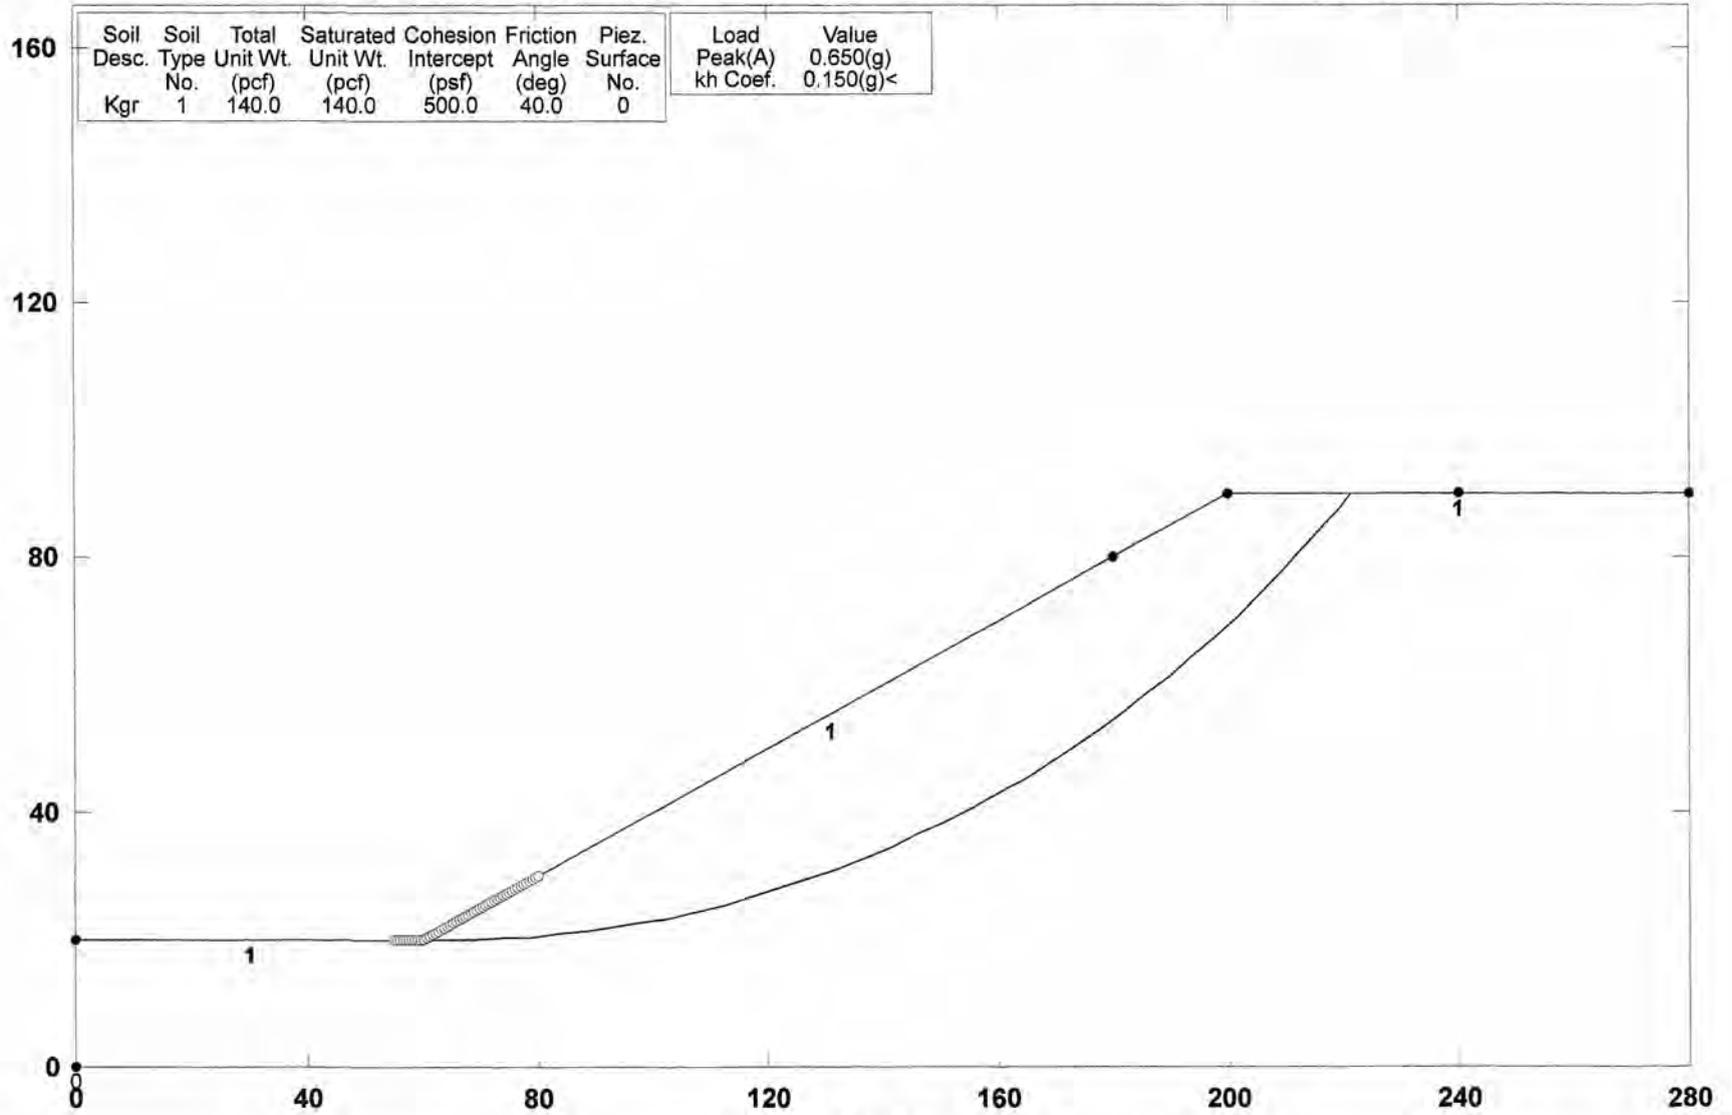
GSTABL7 v.2 FSmin=1.834

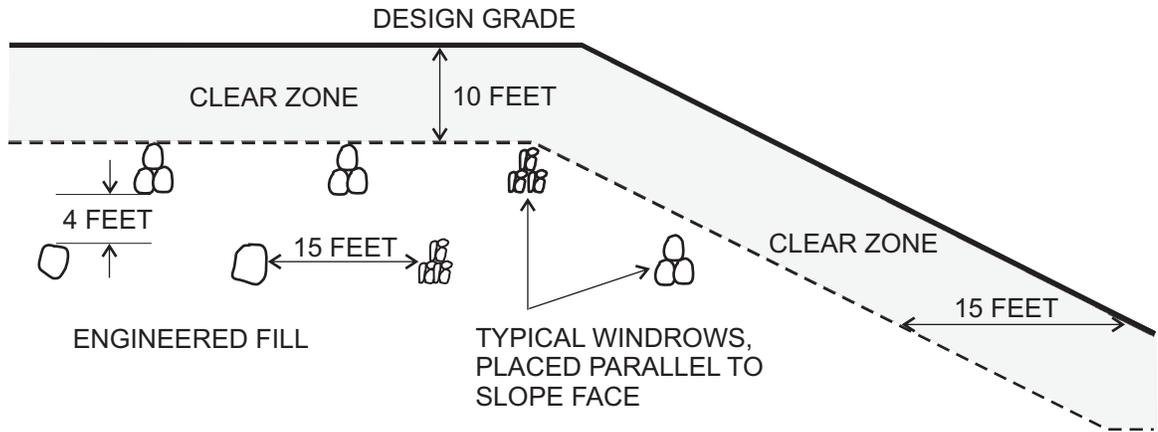
CLEAR ZONE DIMENSIONS FOR REFERENCE ONLY, ACTUAL DEPTH, WIDTH, WINDROW LENGTH, ETC. TO BE BASED ON ELEVATIONS OF FOUNDATIONS, UTILITIES OR OTHER STRUCTURES PER THE GEOTECHNICAL CONSULTANT OR GOVERNING AGENCY APPROVAL

OVERSIZED MATERIAL DISPOSAL PROFILE

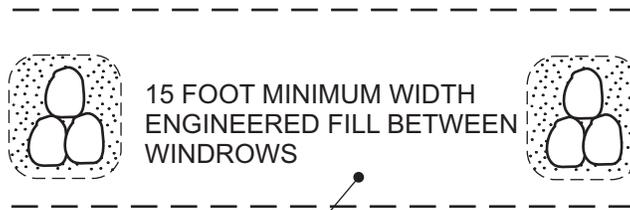
WINDROW CROSS-SECTION

HORIZONTALLY PLACED ENGINEERED FILL, FREE OF OVERSIZED MATERIALS AND COMPACTED TO MINIMUM PROJECT STANDARDS

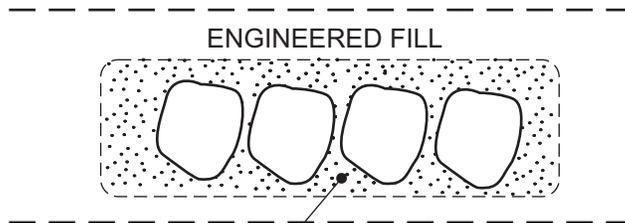
WINDROW PROFILE

GRANULAR MATERIAL APPROVED BY THE GEOTECHNICAL CONSULTANT AND CONSOLIDATED IN-PLACE BY FLOODING
